Sun City Resort Complex: Proposed Expansion

Aquatic Biodiversity and Impact Assessment

SUN4642

June 2018

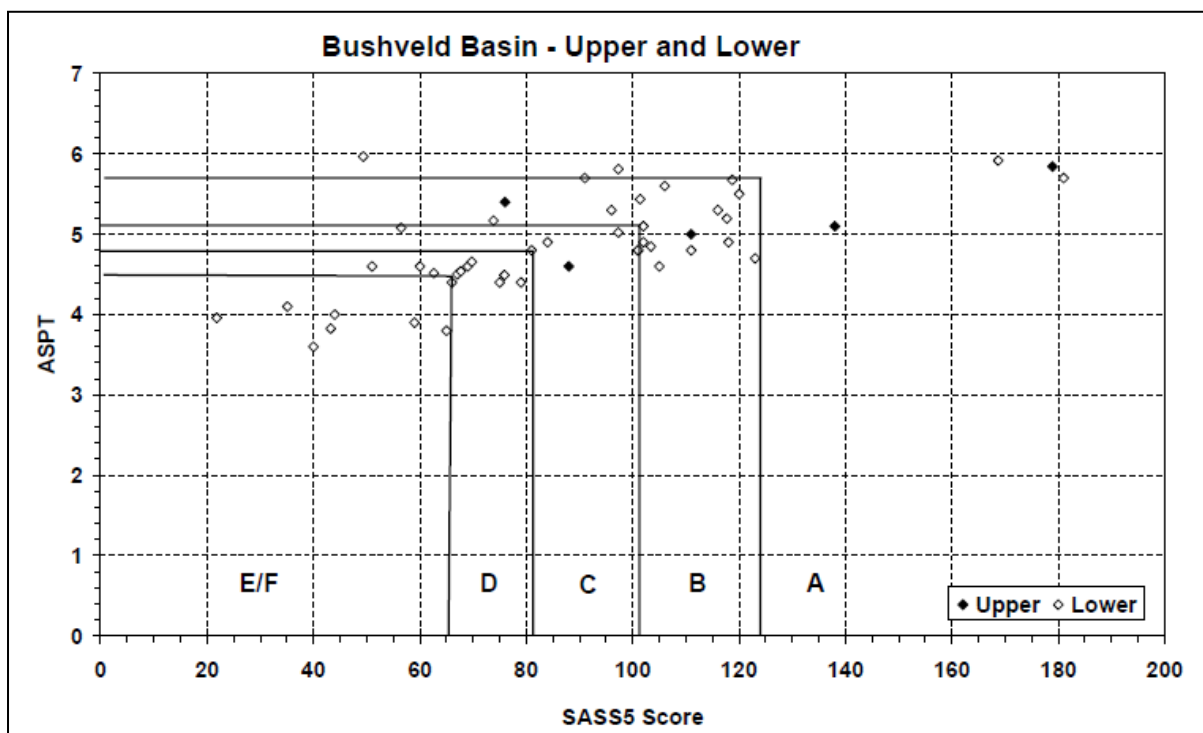
Figure 4-2: Guidelines Used for the Interpretation and Classification of the SASS5 Scores (Dallas, 2007)

All SASS5 and ASPT scores are compared with the SASS5 Data Interpretation Guidelines (Dallas, 2007) for the Bushveld Basin lower relief ecoregion (Figure 4-2). This method seeks to develop biological bands depicting the various ecological states and is derived from data

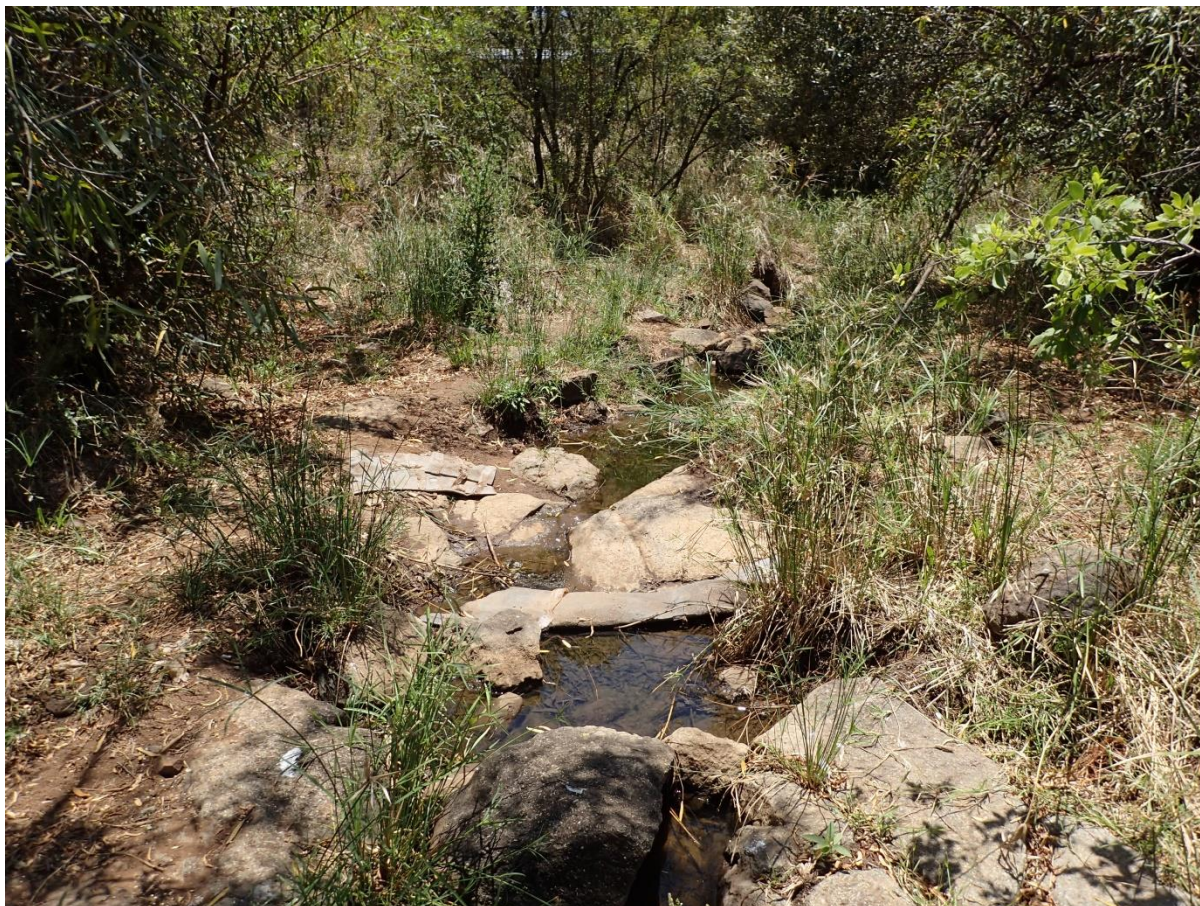
Figure 7-1: Water Observed from the Nursery Located Upstream from Site CT1

During the low flow survey, water emanating from the Resort's nursery located upstream from Site CT1 was observed (Figure 7-1). The exact chemistry of this water is not yet fully described as only *in situ* testing was conducted. However, it is suspected that this water is contributing to the elevated conductivity value of 1260 µS/cm recorded at Site CT1 as no other potential upstream sources of this contamination could be defined during the survey. Attention was to be paid at this site during the high flow survey in order to better understand the high conductivity. However, no water quality could be recorded during the survey as the site was observed as dry.

The results of the PES determination indicate that the Central Tributary is in a moderately to largely modified state (Ecological Category C/D). This overall Ecological Category for the reach can be attributed mainly to the poor instream ecological components (i.e. macroinvertebrates and fish as a result of the low rainfall experienced) compounded by poor water quality impacts associated mainly with the low water levels and possibly due to the observed discharge from the Resort’s nursery.

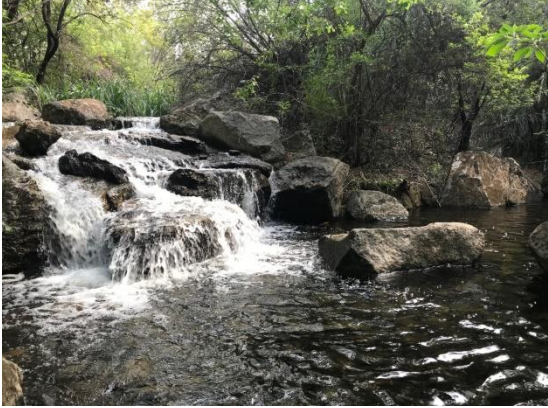
Site	Low Flow (November 2017)	High Flow (January 2018)
Pal UP

A photograph of a stream with low water flow. The water is shallow and flows over several large, dark rocks. The surrounding area is lush with green trees and bushes.

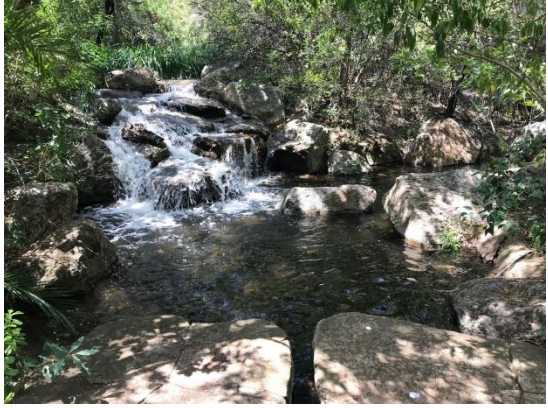
A photograph of the same stream with high water flow. The water is turbulent and white with foam as it cascades over the rocks. The surrounding vegetation is dense and green.
