SALT ROCK BEACH ESTATES CC

# REINFORCEMENT OF SALT ROCK SEA WALL

## DRAFT BASIC ASSESSMENT REPORT [DC29/0023/2017]

PROJECT NO.: 48410  
DATE: FEBRUARY 2018

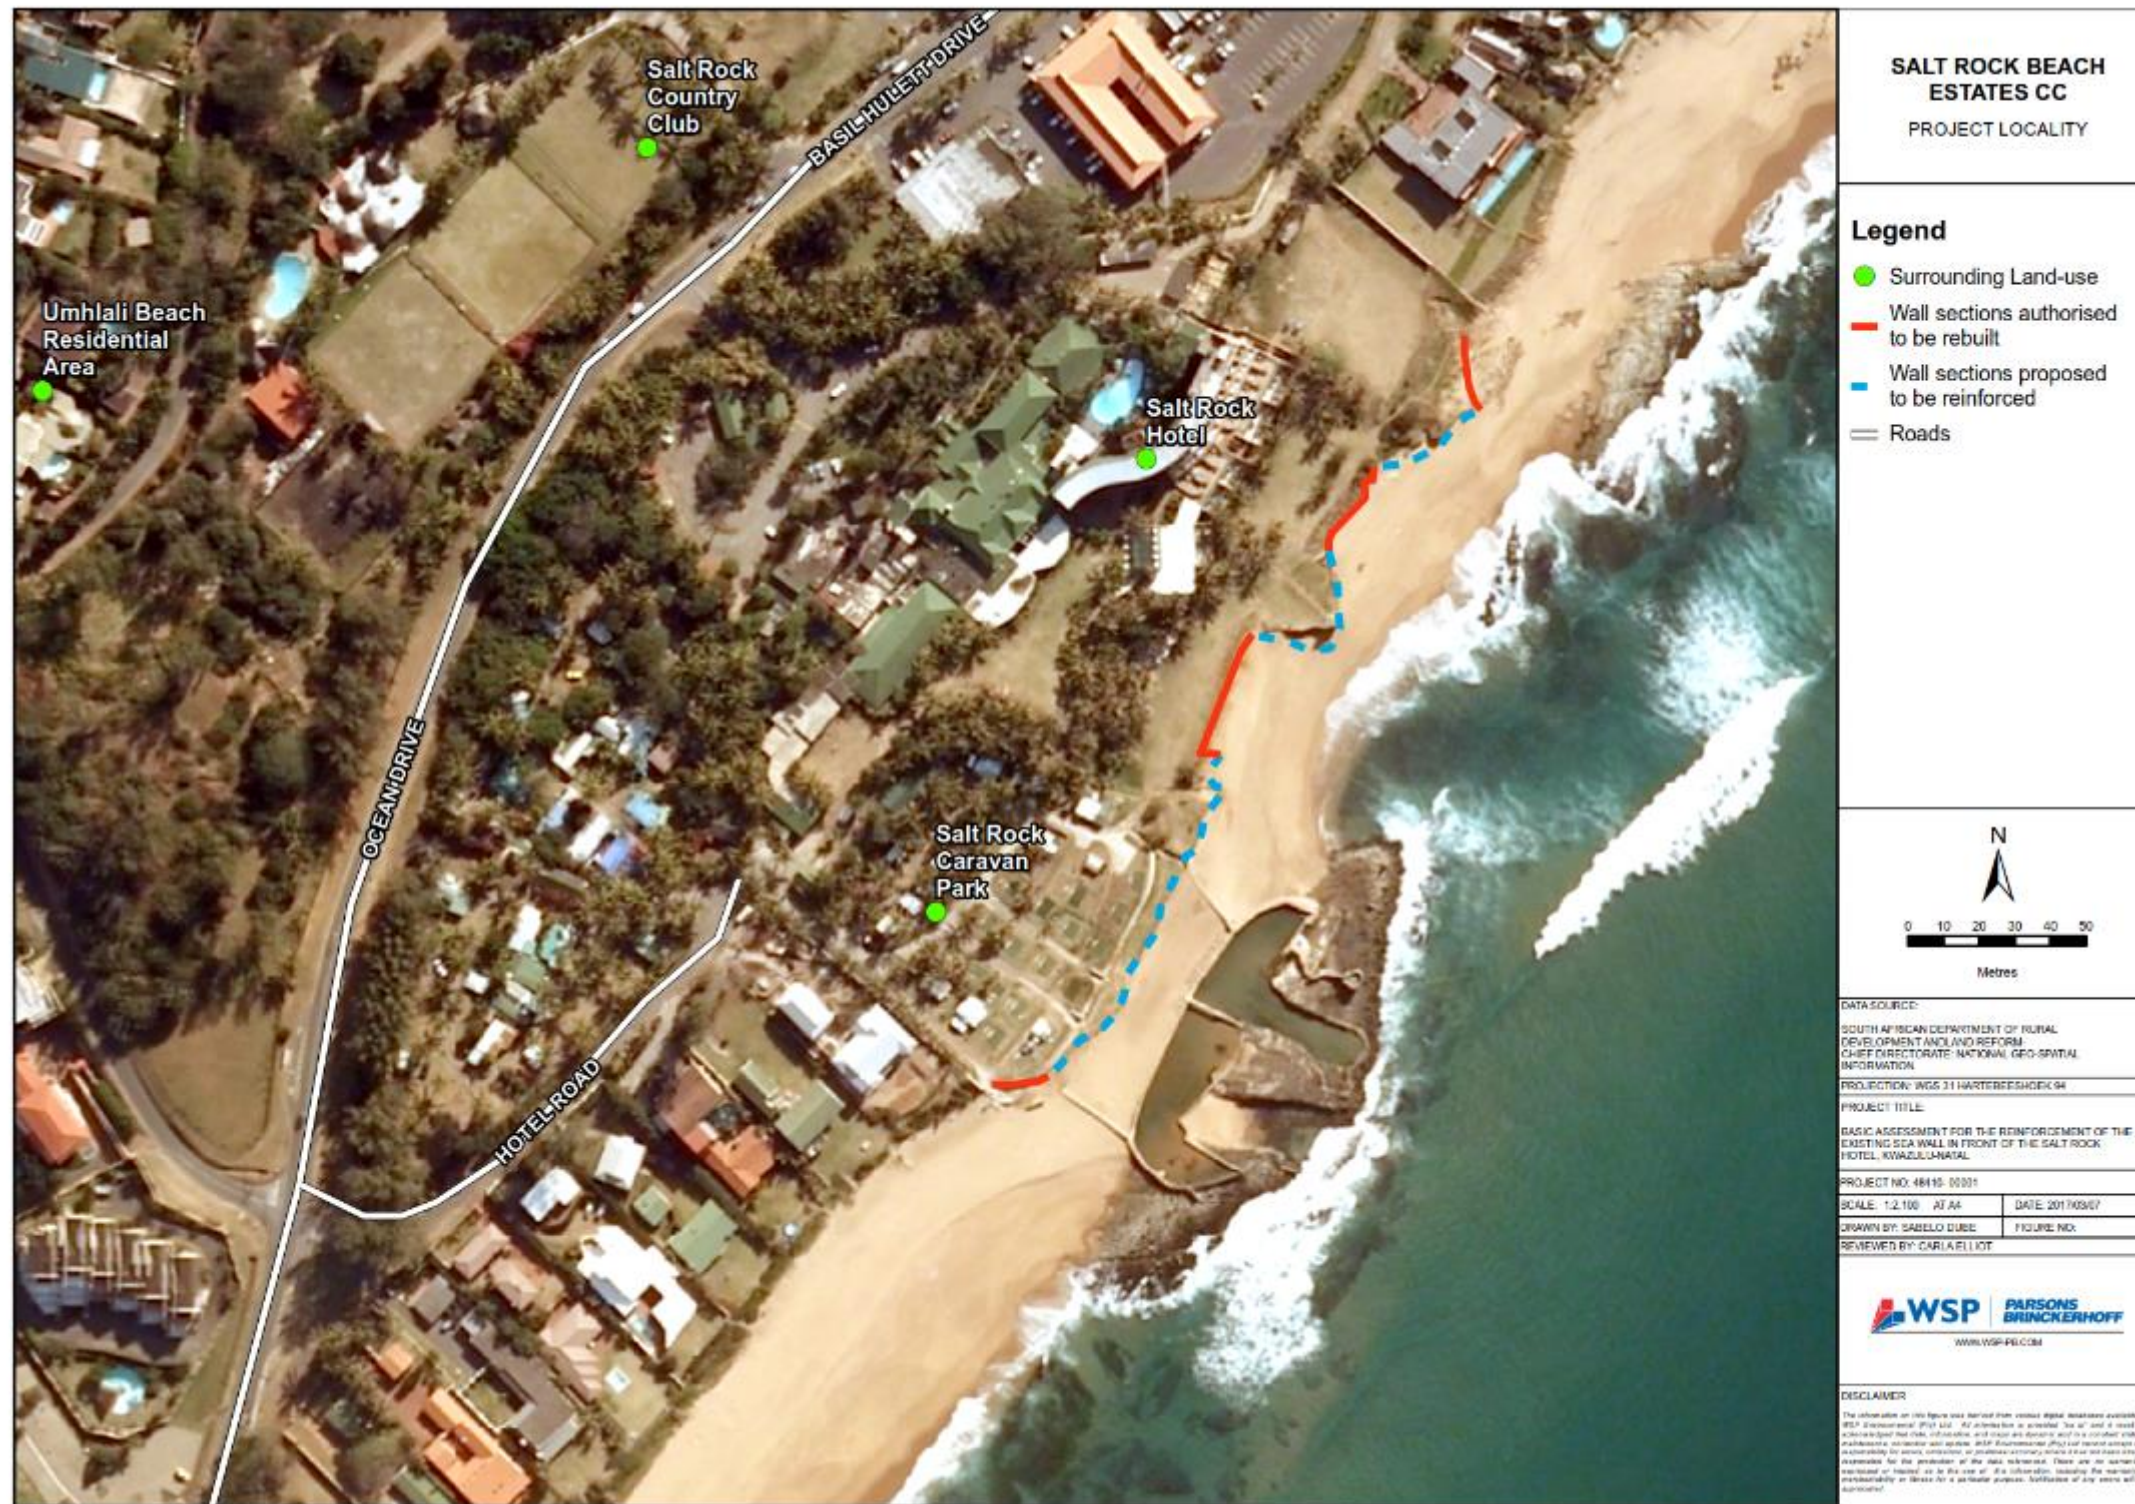
**Figure 2:** Locality map indicating the location of the Sea Wall and proposed repair (WSP, 2017))

The damaged seawall is located along the seaward boundary of the Salt Rock Hotel at 59 Basil Hulett Drive, Lot 900 Salt Rock (**Figure 2**). Photos showing the existing condition of wall are included in **Appendix B**.

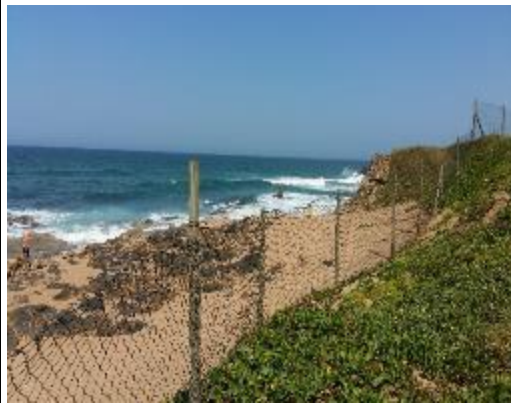
**Figure 5 Southern view of sea wall location where wall is to be re-built**

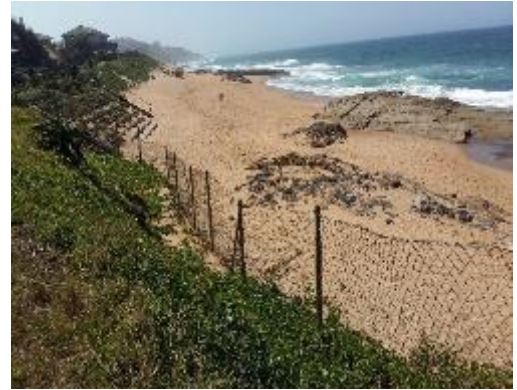
**Figure 6 Northern view of sea wall location where wall is to be re-built**

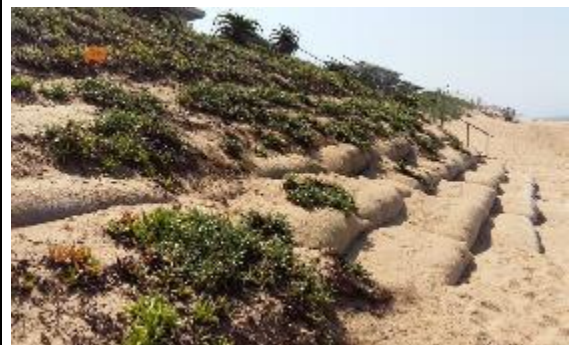
**Figure 8 Vegetation cover on sandbags on northern property as example of proposed rehabilitation for sea wall northern tie in area.**

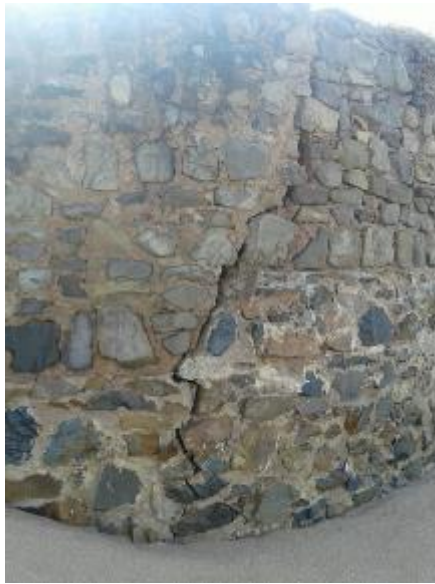
**Figure 9 Evidence of fractures within remaining portion of sea wall.**

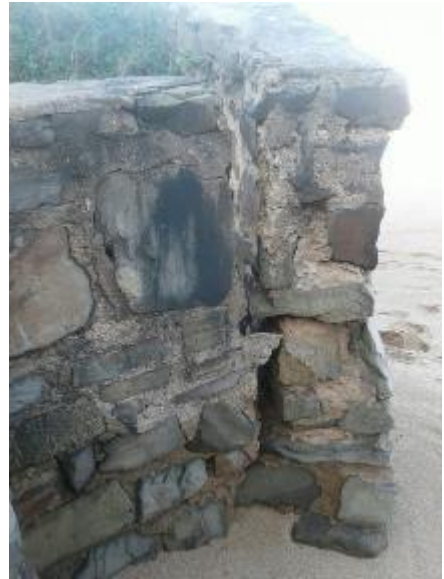
**Figure 10 Cross Section View of remaining portion of sea wall.**

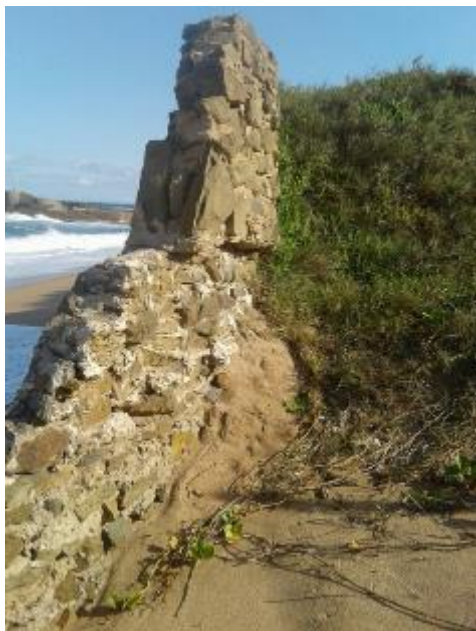
**Figure 11 Section of wall requiring reinforcement of remaining portion and tie in to section to be rebuilt.**

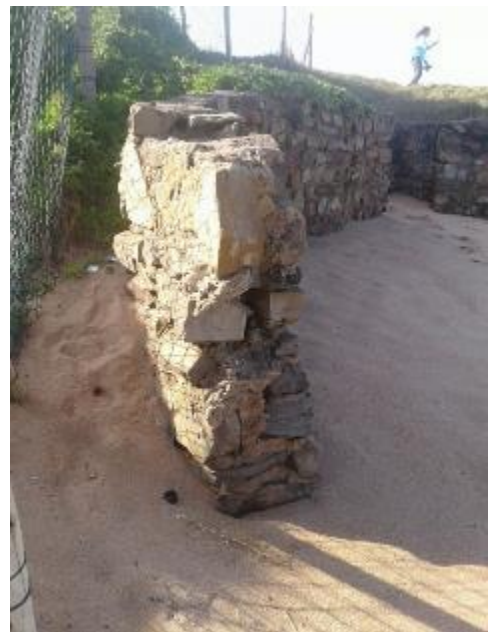
**Figure 12 Section of wall requiring reinforcement of remaining portion and tie in to section to be rebuilt.**
