CONSTRUCTION OF THE BABOYI RIVER PEDESTRIAN BRIDGE DC21/0039/2012

Draft Basic Assessment Report

April 2013

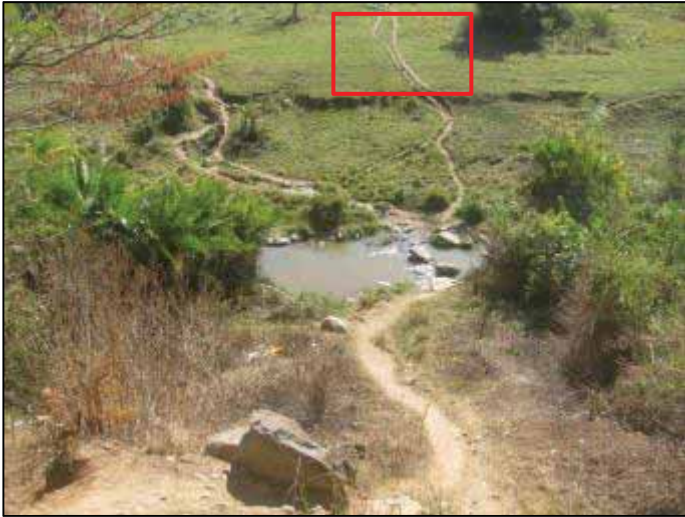
Figure 1: Photographer facing north, a view across the Boboyi River from the southern banks showing the approximate location where the bridge will be on the northern side (Red).

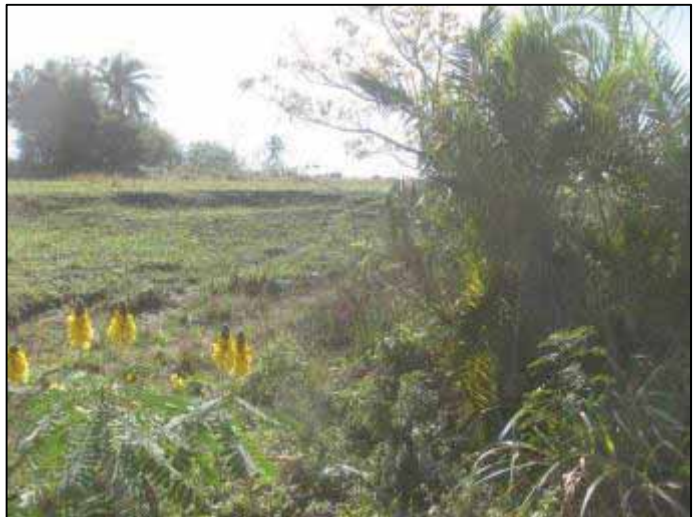
Figure 2: Photographer facing north-east, a view of the northern bank of the Boboyi River and the vegetation thereon.

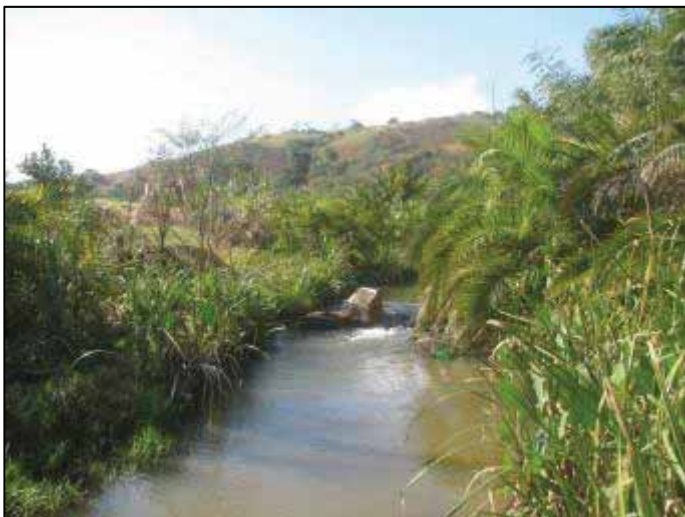
Figure 3: Photographer facing east, a view upstream of the Boboyi River showing the size of the river and the northern and southern river banks.

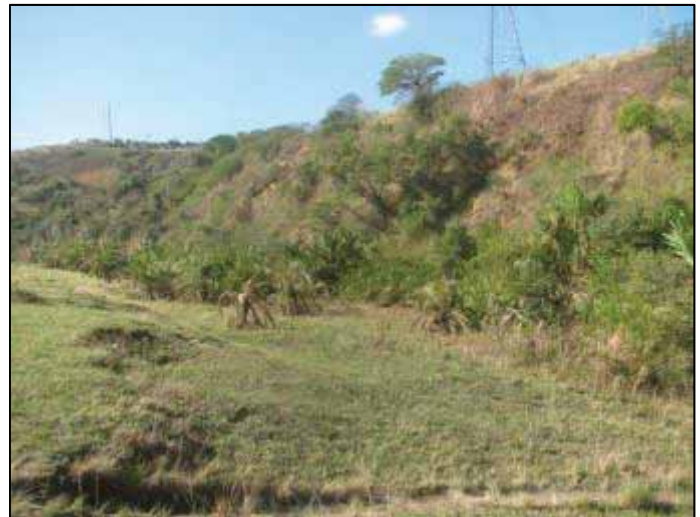
Figure 4: Photographer facing south-east, a view across the Boboyi River of the steep southern river bank and the vegetation located thereon.

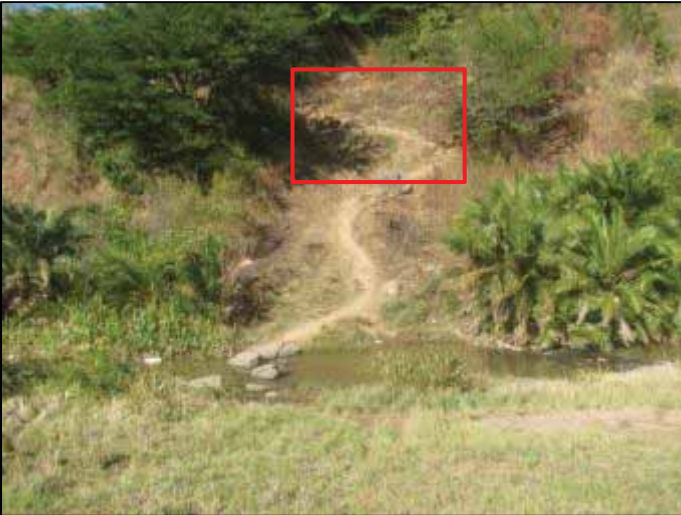
Figure 5: Photographer facing south, a view across the Boboyi River from the northern bank showing the approximate location where the bridge will be on the southern side (Red).

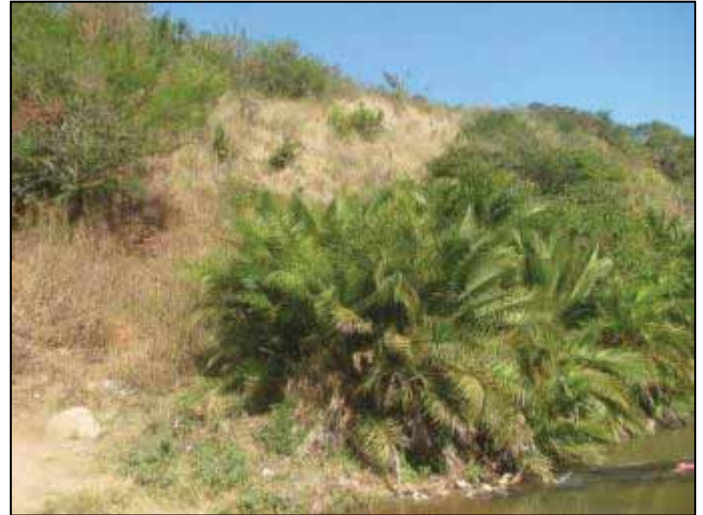
Figure 6: Photographer facing south west, a view across the Boboyi River to the northern banks of the river showing the vegetation thereon.

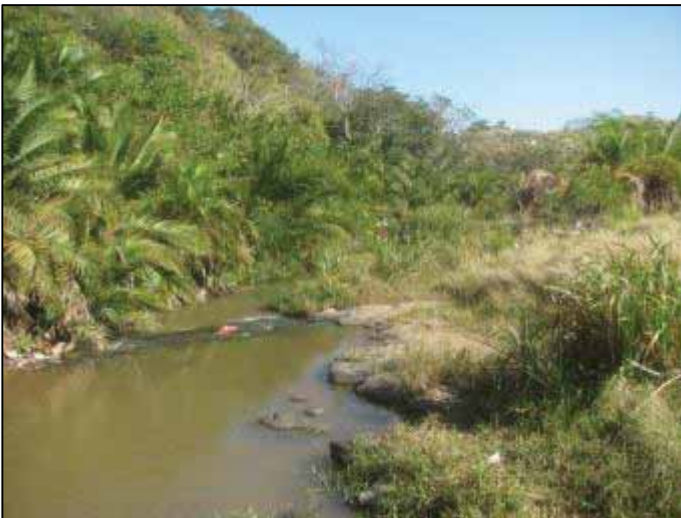
Figure 7: Photographer facing west, a view downstream of the Boboyi River showing the size of the river and the northern and southern river banks.

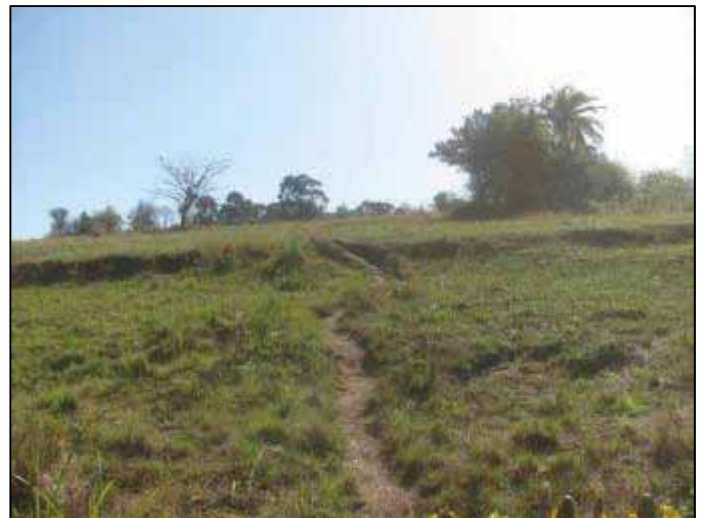
Figure 8: Photographer facing north-west, a view of the northern banks of the river showing the vegetation thereon.

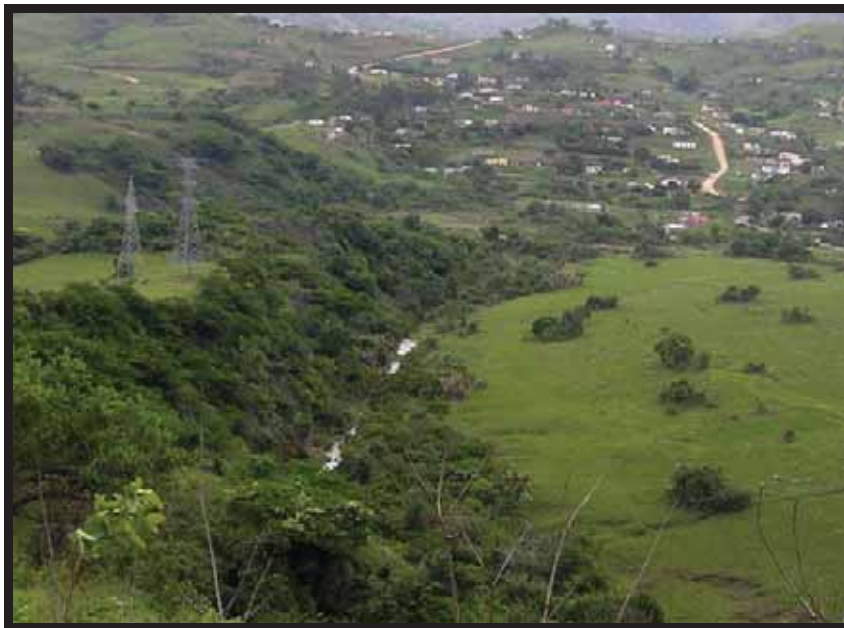
Figure 3. View over the study area: The open field to the right (north bank) of the Boboyi River contains some informal graves. These are spatially removed from the domestic sphere (village) in the near distance as they belong to paupers, homeless people, and people who died under unnatural conditions.

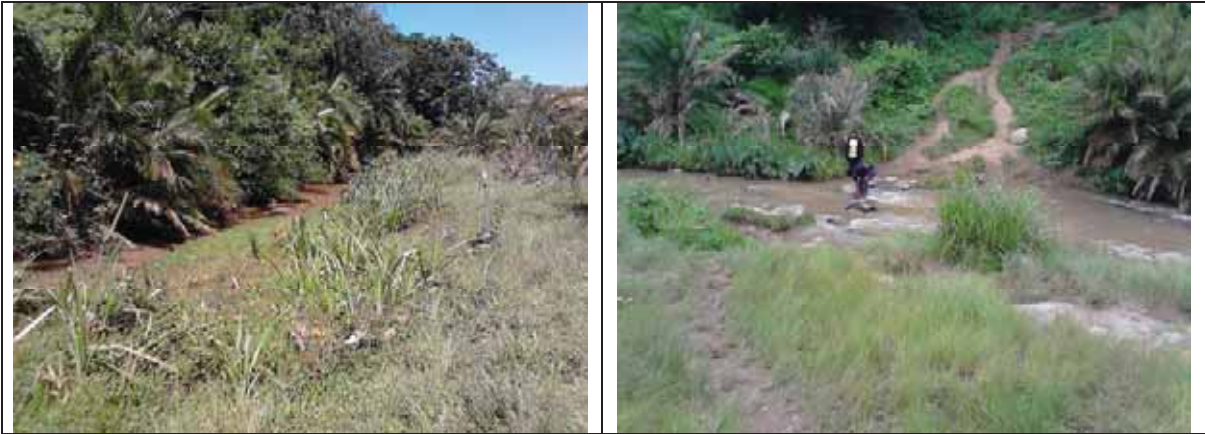
Diagram 1: General Site Appearance

A view of the study area is shown in Diagram 1 below.

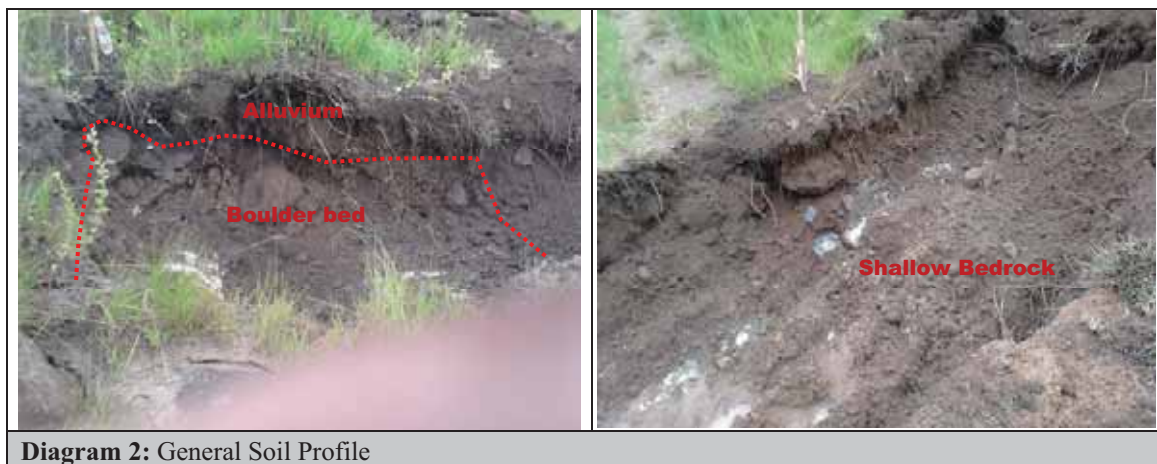
The relationship between the various layers is illustrated in the inferred geological cross section given in Table 3 with an indication of the typical subsoil geology encountered across the site given in Diagram 2 below.

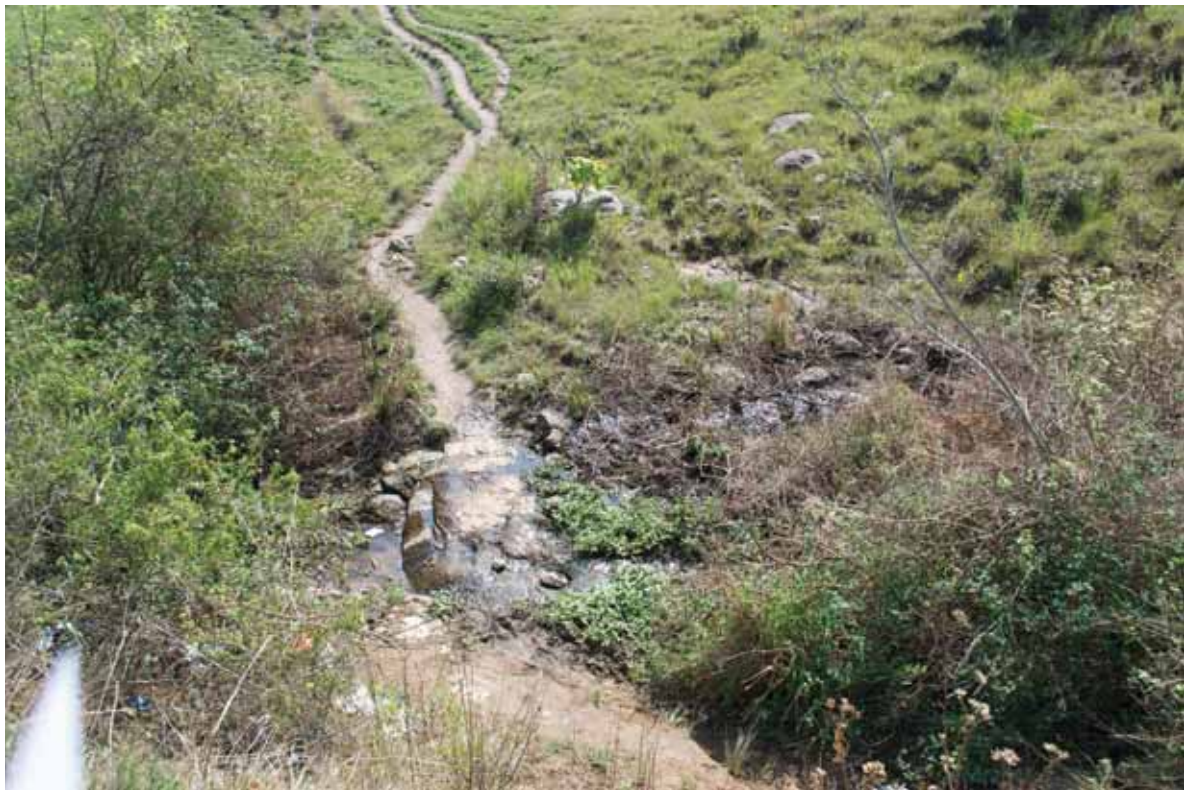
Plate 4. View of the site of the location of the culvert showing the reduced woody fringe and path devoid of herbaceous vegetation

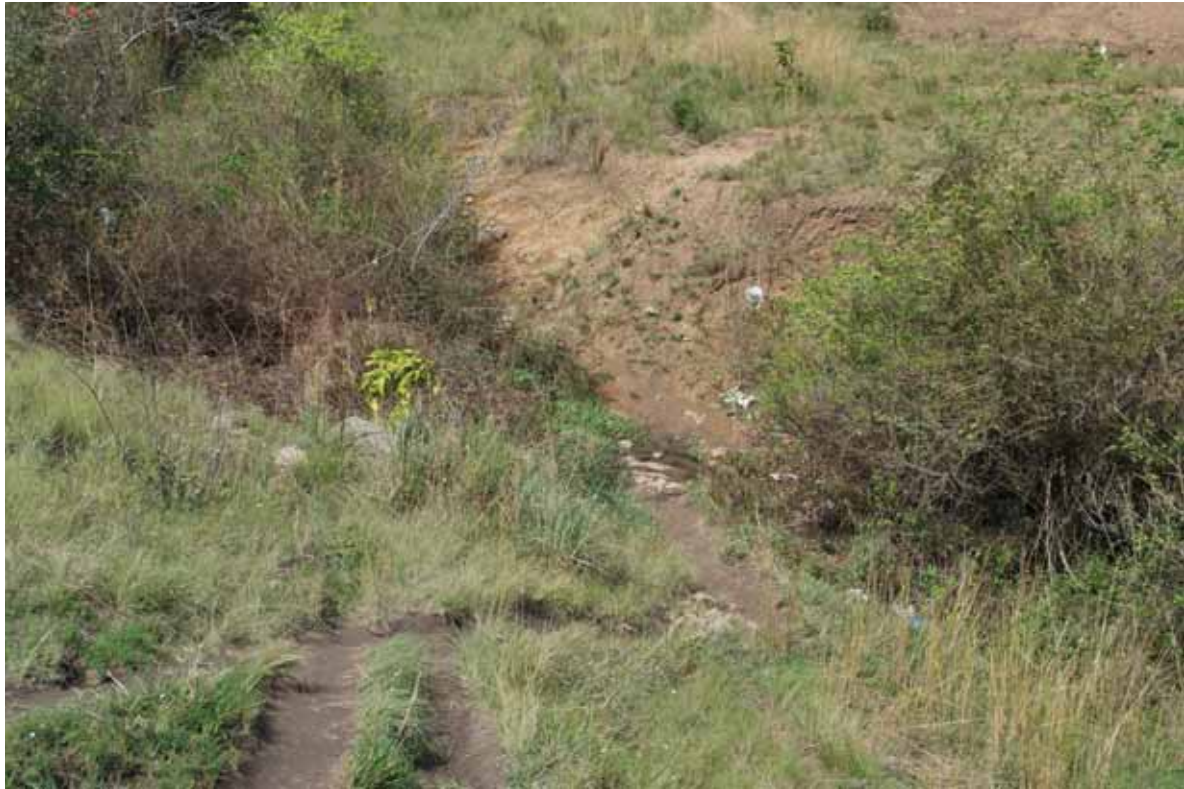
Plate 5. View from the opposite bank of the site of the proposed culvert showing the reduced woody fringe and path without herbaceous vegetation.

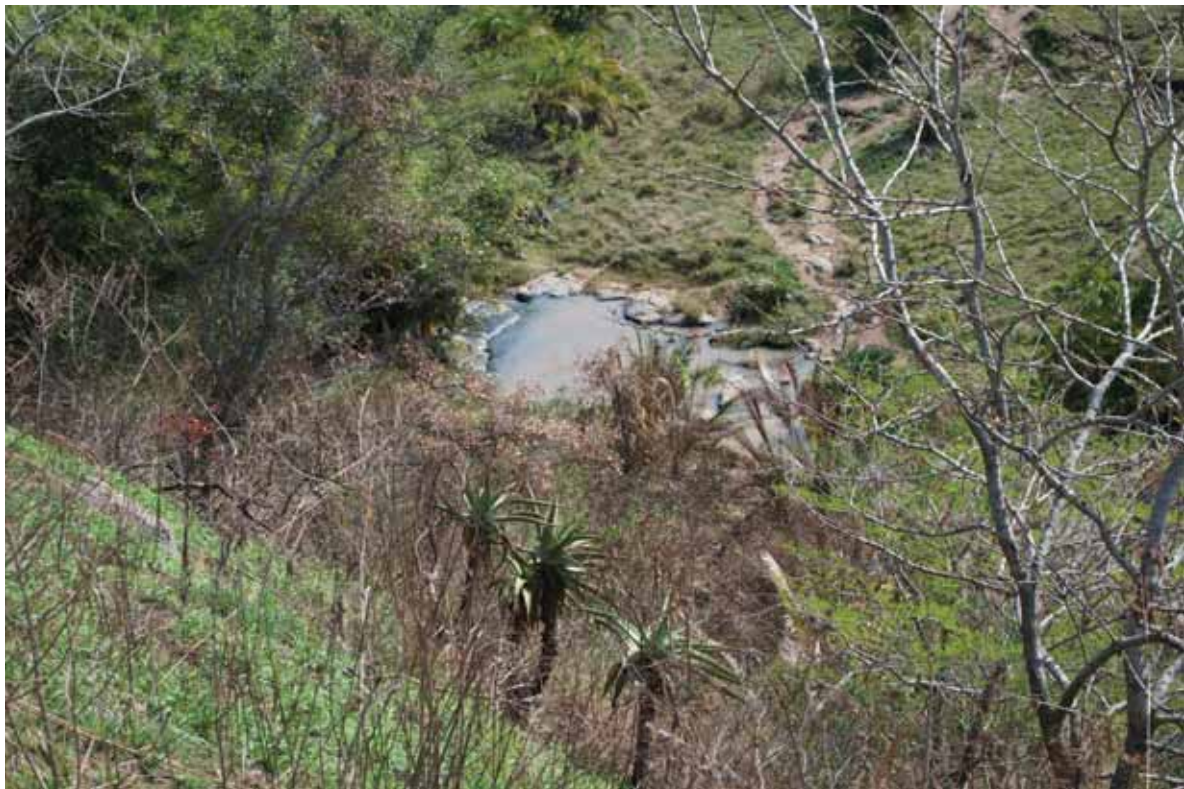
Plate 6. View of the location of the proposed pedestrian bridge from the hill above the stream showing the gap in the woody fringe and reduced herbaceous vegetation along the footpath.

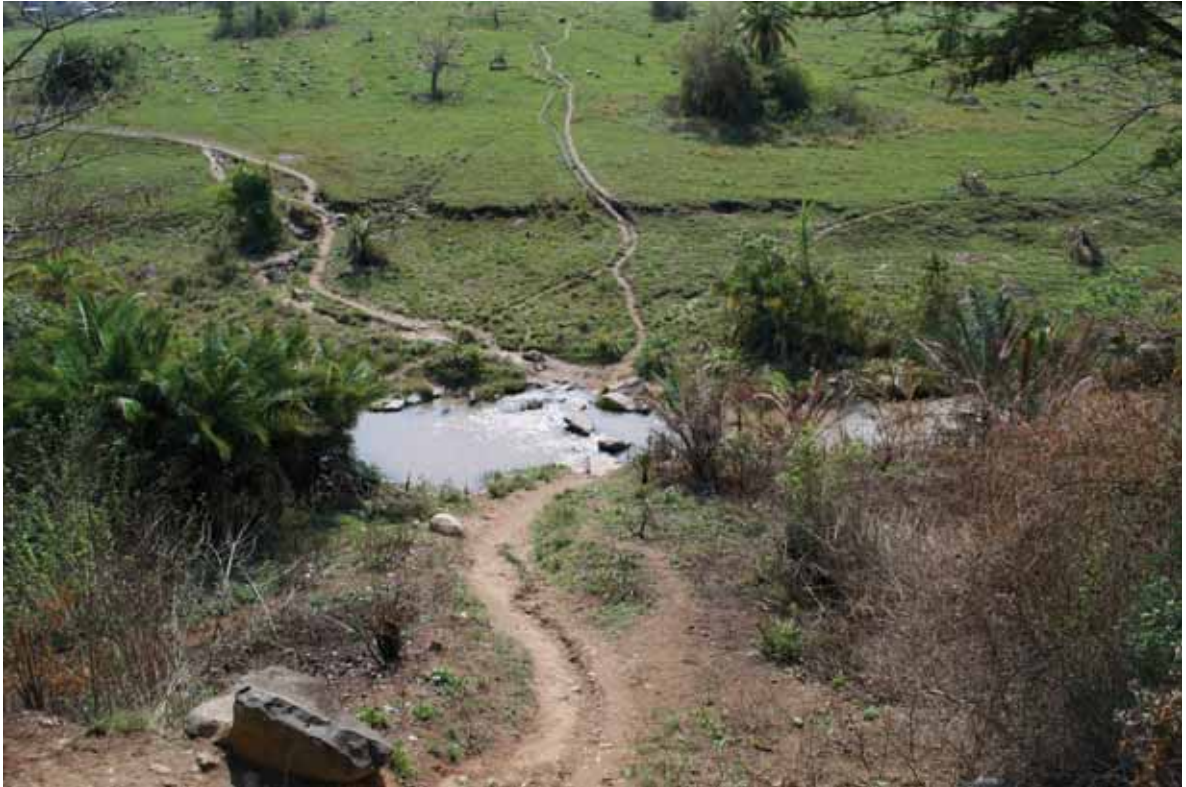
Plate 7. View of the location of the proposed pedestrian bridge showing the gap in the woody fringe and reduced herbaceous vegetation along the footpaths.

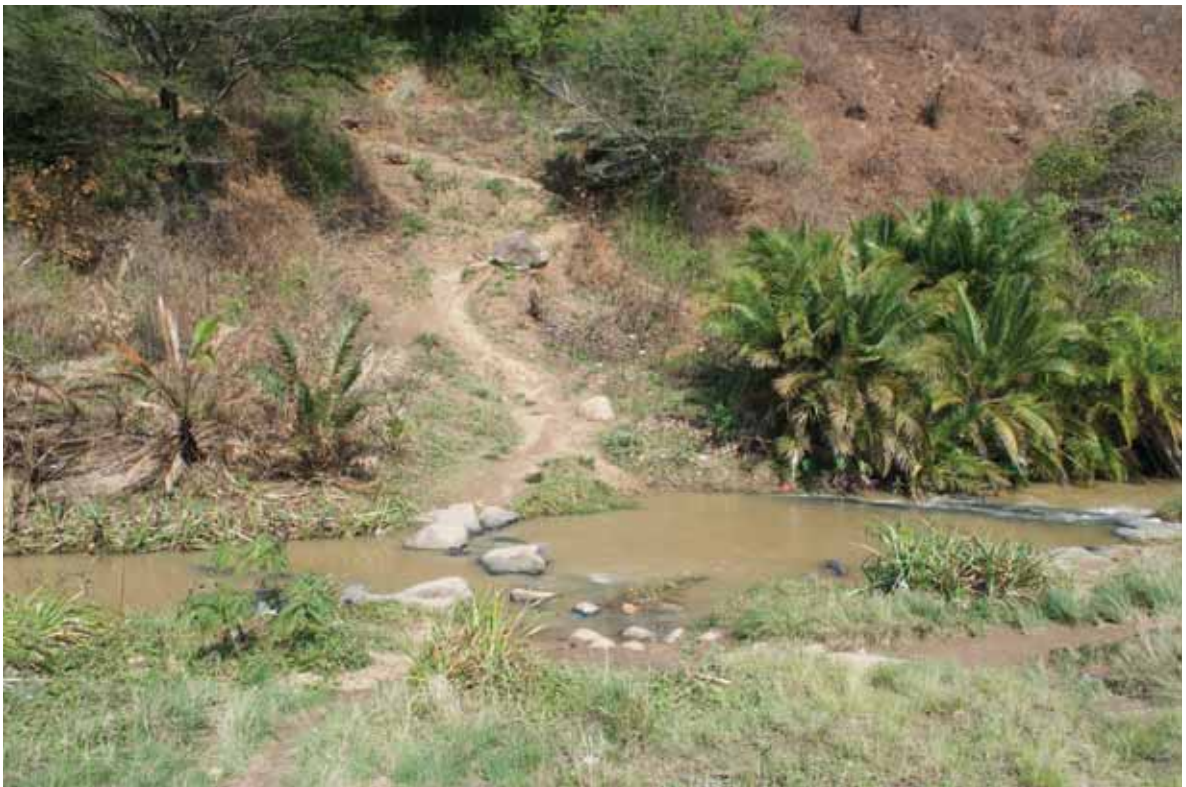
Plate 8. View from the opposite bank of the location of the proposed pedestrian bridge showing the gap in the woody fringe and reduced herbaceous vegetation along the footpaths.

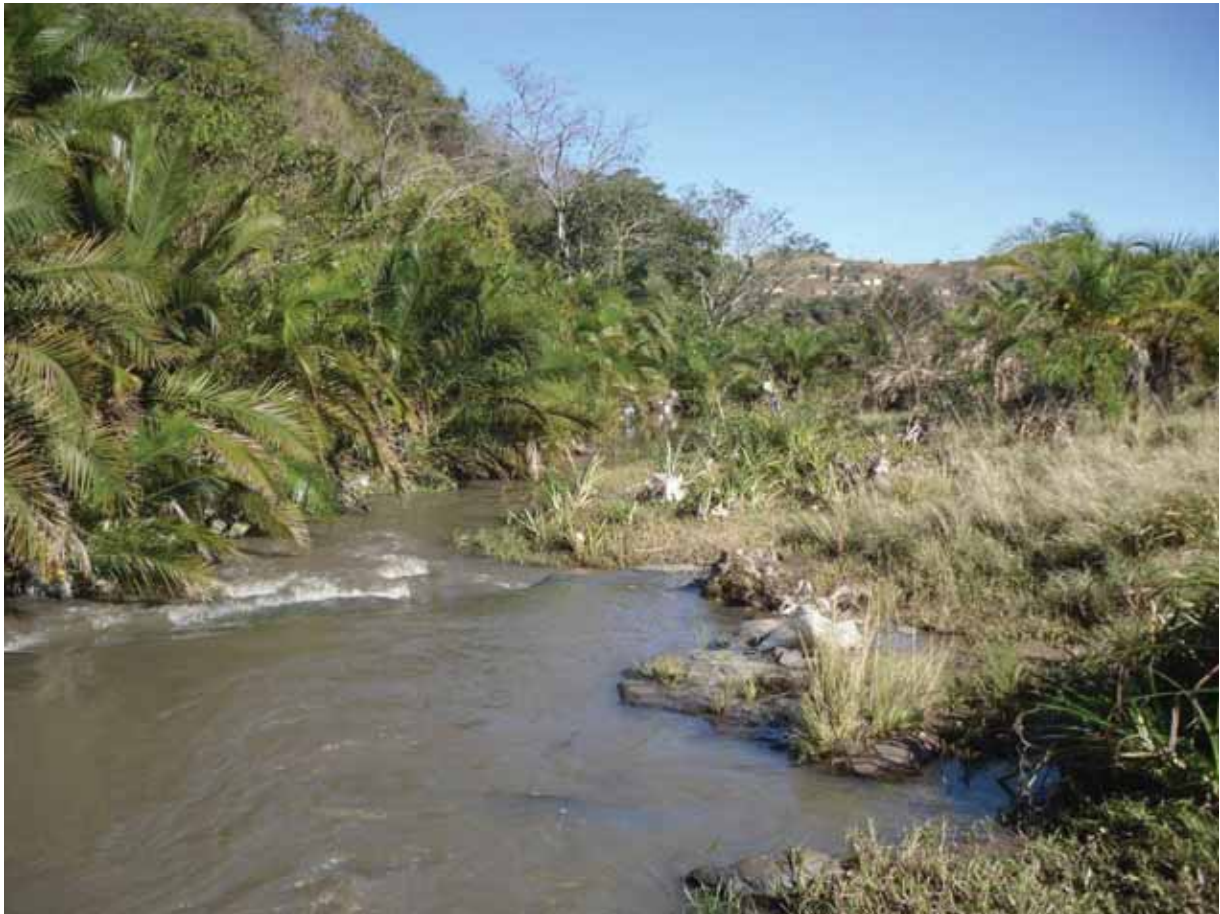
Figure 2. Litter and debris washed up onto plants on the flood bench

A series of footpaths have been worn along the proposed alignment and litter is scattered along the path. Litter and debris were prolific along the flood bench and were indicative of the recent heavy rains.

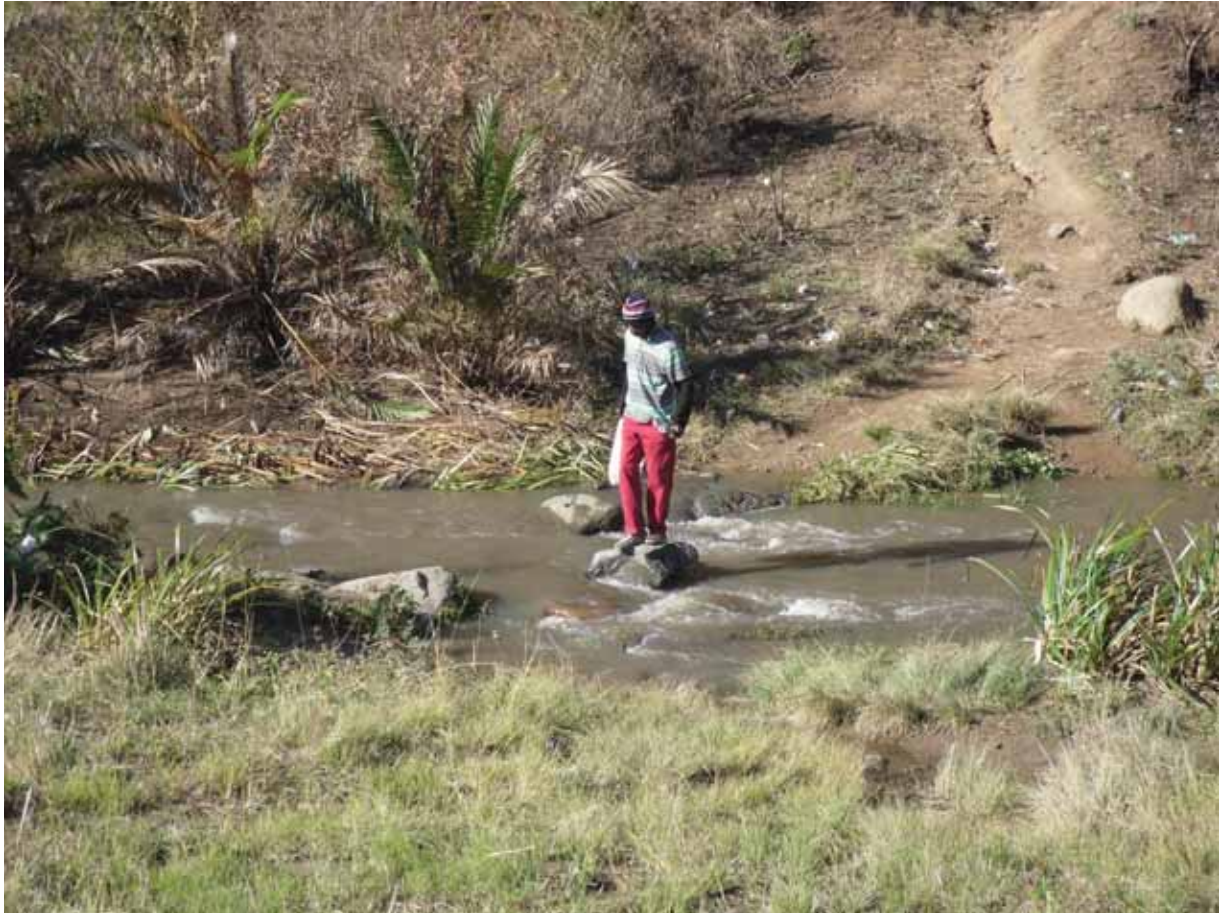
Figure 3. The existing crossing point

The river at the main crossing was still in full flood, and was an indication of the extent of depth and velocities of flow that are reached in flood conditions, and the difficulty of crossing.

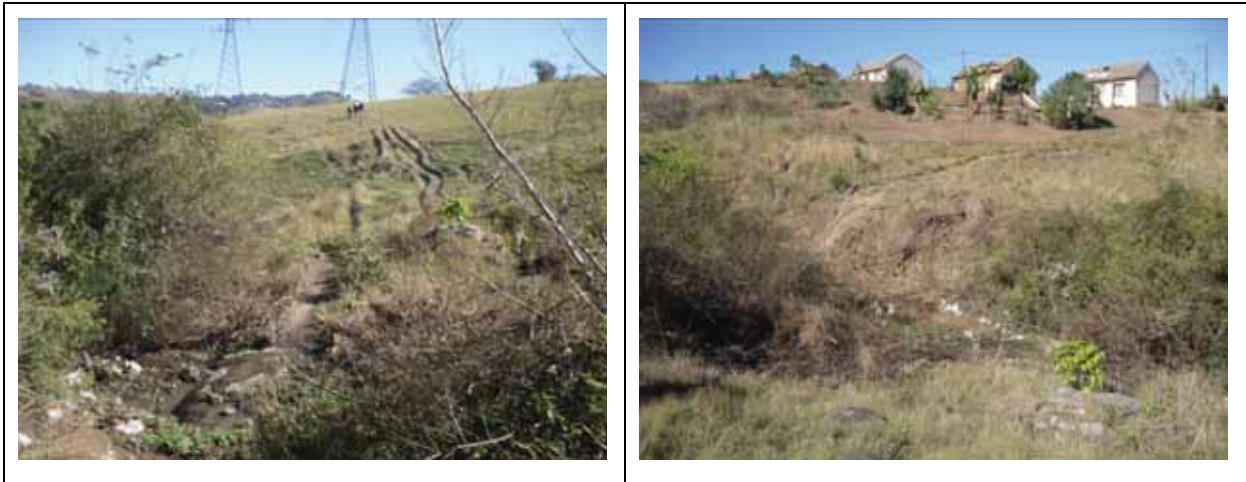
Figure 4. Looking south and north of the small tributary crossing respectively

The second crossing occurs on small tributary entering into the first tributary further downstream.

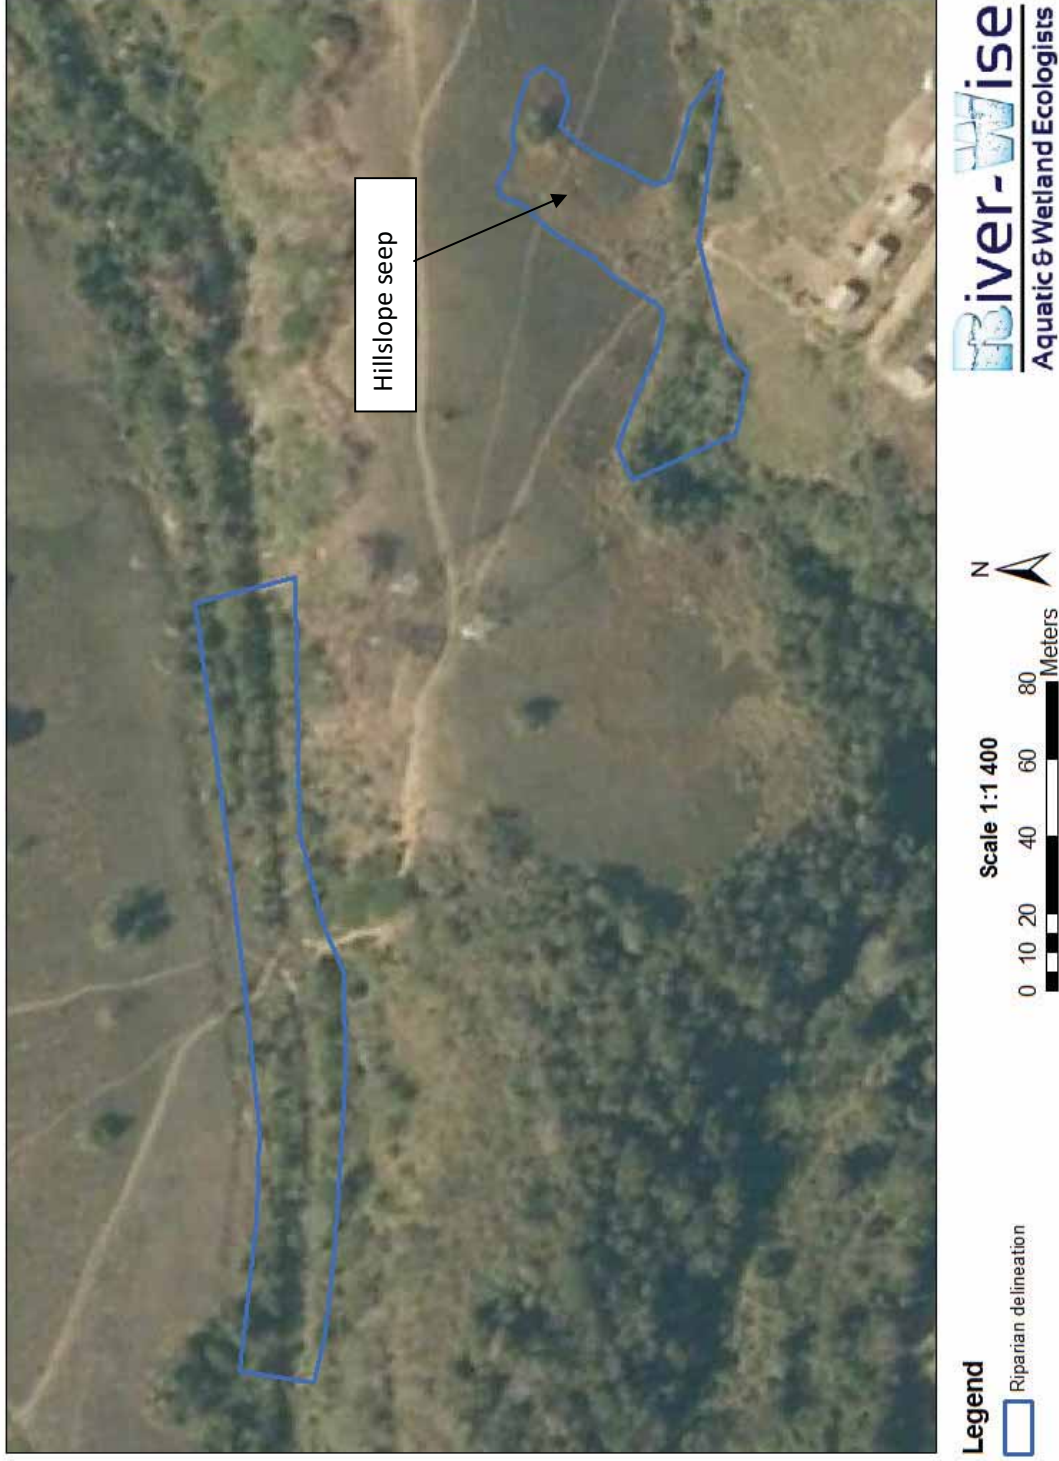
Figure 6. Riparian Zone delineation

The riparian zone at both of the proposed crossings was delineated. The delineations are shown in Figure 6, below.

The riparian zone delineated is best classified as a Riparian B Channel which is seasonal. Primary inputs are from overland flow from catchment runoff and concentrated surface flow from upstream tributaries. There is a flood bench which is periodically inundated during floods.

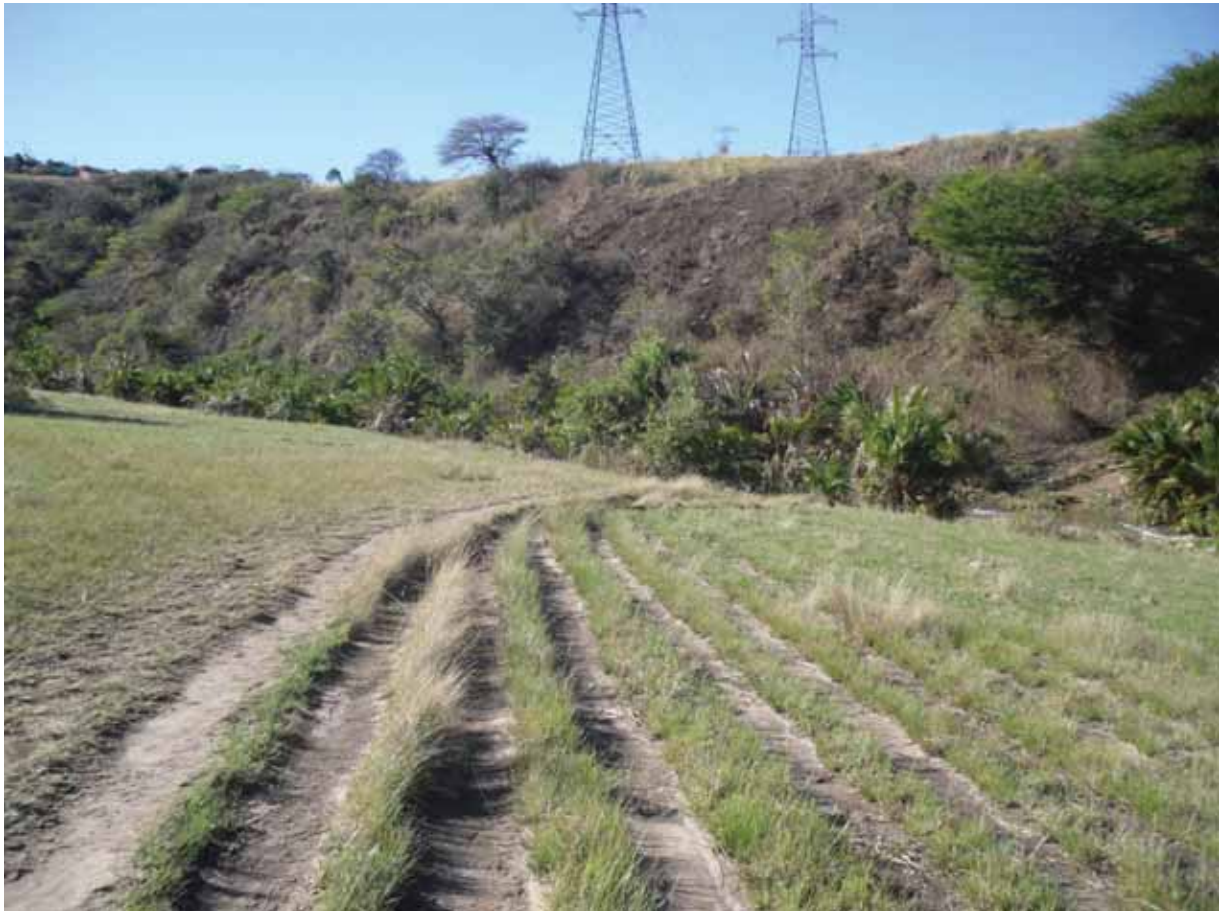
Figure 7. Riparian zone at the proposed bridge site

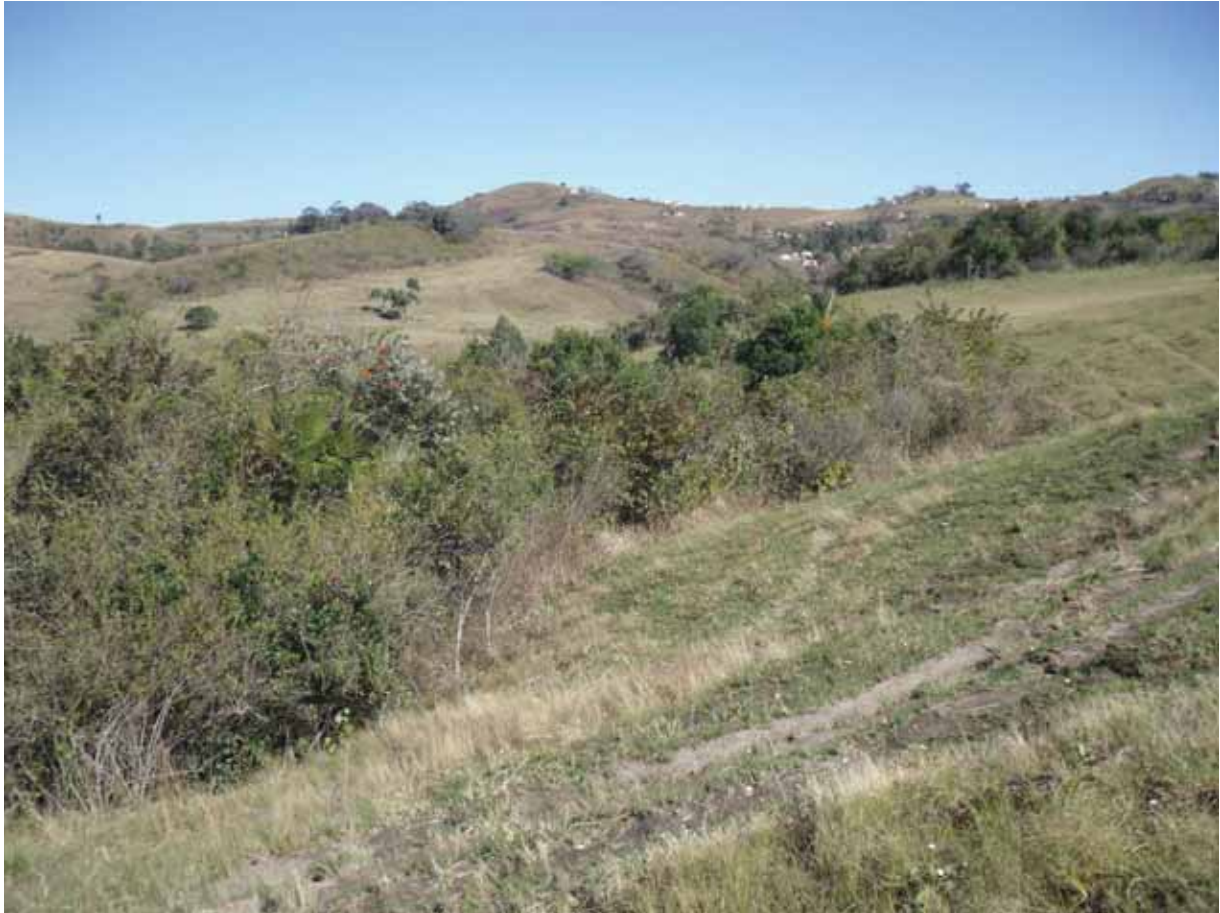
Figure 8. Smaller riparian tributary

There is small hillslope seep feeding into the tributary to the north east of the proposed crossing, which is probably the result of a perched water table.

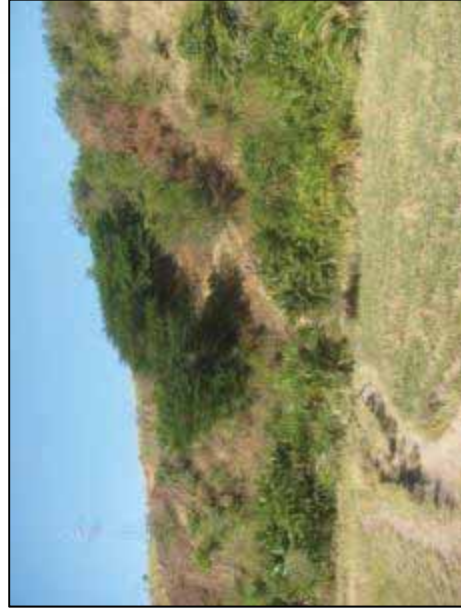
Figure 3: A view across the south-east banks of the river showing vegetation in close proximity to the site. It is not anticipated that vegetation will be damaged during construction, however, if required, only vegetation in the development footprint is allowed to be removed.

- The surrounding indigenous riverine vegetation may be impacted upon during the construction phase; this however must be avoided as far as possible (Figure 3).
- The Contractor is responsible for informing all employees about the need to prevent any harmful effects on indigenous vegetation on or around the construction site as a result of their activities.
- Workers should be informed of the areas of important indigenous/ riverine vegetation and the importance of protecting these.
- Pesticides and herbicides may not be used on the construction site. Removal of any alien vegetation should be done by hand where possible.
- Only vegetation directly impacted by the bridge must be removed.

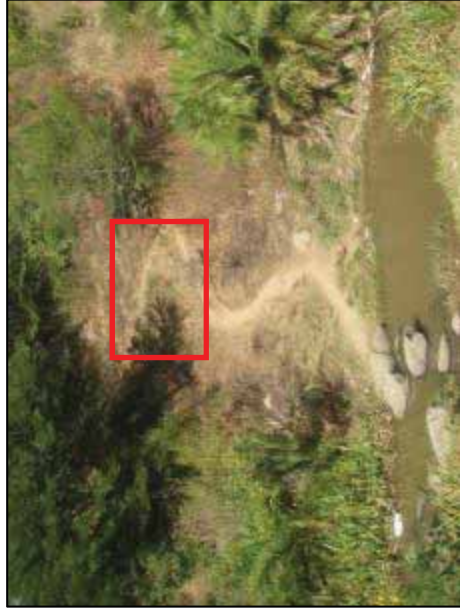
Figure 4: A view of the approximate point at which the bridge will begin on the southern banks (Red Square). Erosion could potentially result in this vicinity and the appropriate controls should be implemented to minimize erosion.

- Any runoff from the construction site must not be allowed to cause excessive erosion or sediment input in to the rivers (Figure 4).
- Flow of stormwater must not be impeded during construction.

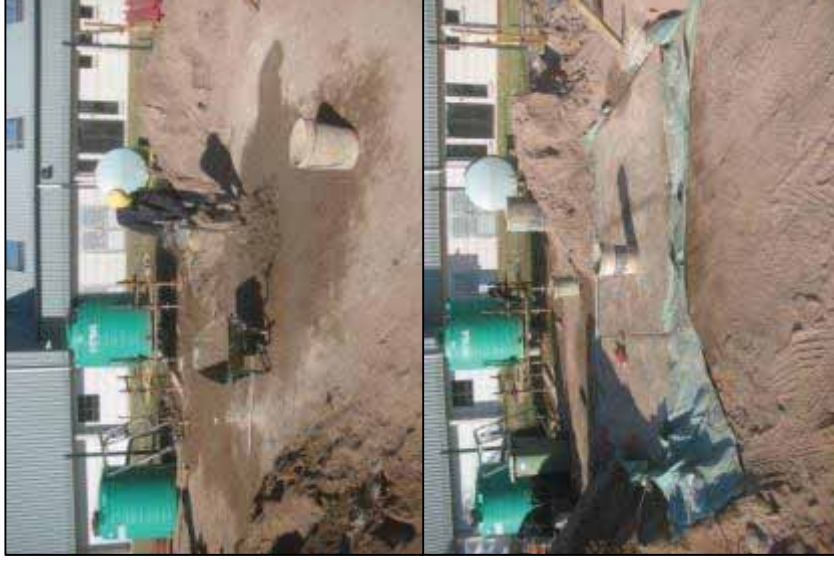
Figure 6: An example of mixing and moving concrete using an impermeable plastic sheet.

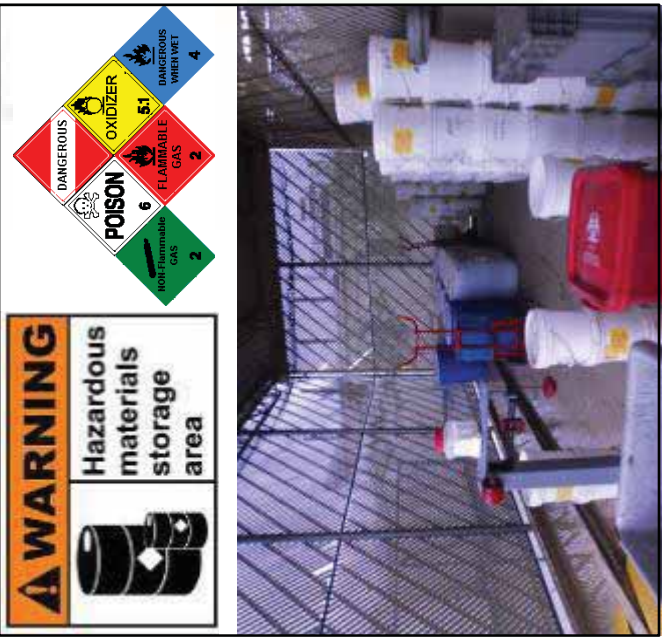
<p>Figure 11: A hazardous material storage area that is hard-surfaced (impermeable), bunded, secure and undercover. Signage is required indicating the presence of hazardous material.</p>	<p>Construction</p> <ul style="list-style-type: none"> Hazardous materials to be stored separately. All hazardous chemicals to be returned to the storage area at the site camp each night. Fuel storage areas must be bunded with a catchpit of at least 110% the storage capacity of the fuel storage container. This bund must have a controlled stormwater outlet with a filter. Concrete waste must be disposed of at an appropriate waste site. A separate drum should be available for storage of contaminated soil. Staff dealing with these materials/substances must be aware of their potential impacts and follow the appropriate safety measures. Transport of hazardous materials around the site should be limited, and materials must be transported in sealed bags/containers. Mixing/decanting of all chemicals and hazardous substances must take place either on a tray or on an impermeable surface. Waste from these should then be disposed of to a suitable waste site. Decanting of any chemical should be done within the confines of a suitably sized drip tray. Decanting from large containers (e.g. 210L drums) must be done using a hand pump. Drip trays are to be cleaned out daily and material collected disposed of as hazardous waste.

<p>The image shows a 'WARNING Hazardous materials storage area' sign with a pictogram of drums. To the right is a photograph of a fenced-in storage area containing numerous white and blue drums, some on a pallet, and a red bin.</p>	<p>Site Inception</p> <ul style="list-style-type: none"> Material Safety Data Sheets (MSDSs) must be readily available on site for all chemicals and hazardous substances to be used on site. Where possible and available, MSDSs should additionally include information on ecological impacts and measures to minimize negative environmental impacts during accidental releases or escapes (Figure 11). Ensure all staff are trained on proper hazardous waste disposal. Hazardous storage are to be hard surfaced and bunded with an impermeable liner to protect groundwater quality and undercover. The Contractor must submit a method statement to this effect to the Engineer for approval. Hazardous storage areas must not be located near any indigenous vegetation areas. Storage areas containing hazardous substances/materials must be clearly signed. The hazardous materials storage area must be fully secured to prevent people and animals from accessing it. Hazardous material storage areas must not be within 30m of the river.

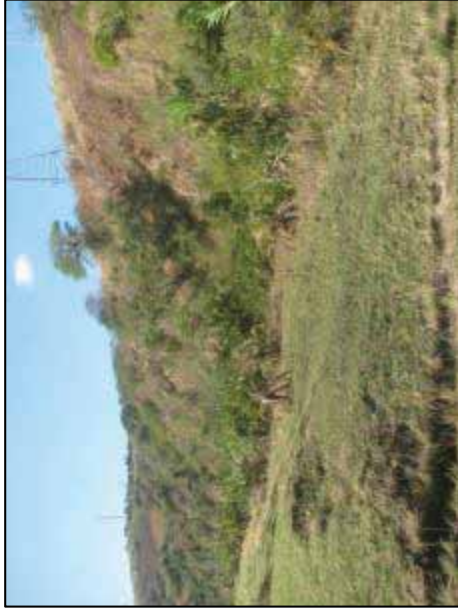
Figure 12: The southern banks of the river are well vegetated but steep and any disturbance to the vegetation could result in the potential for erosion increasing. The relevant erosion control measures should be implemented to prevent erosion from potentially occurring.

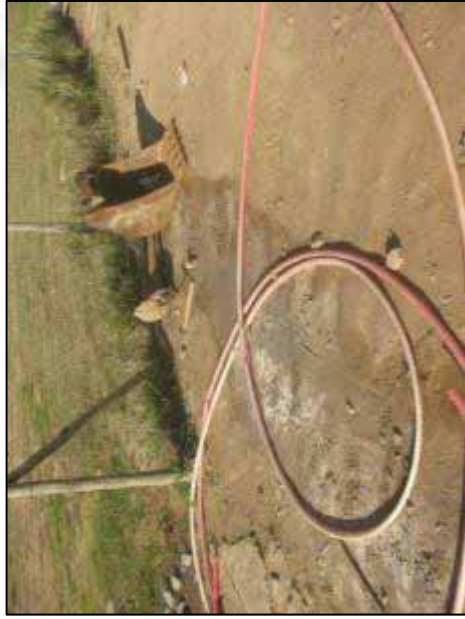
Figure 14: Illustrating an example of water runoff generated from washing vehicles that may contaminate the surrounding environment. Washing and refueling on site must take place within the designated area with suitable precautionary equipment available.

- All vehicles and equipment must be kept in good working order to maximize efficiency and minimize pollution.
- All maintenance, including washing and repairs of plant on site must take place off site (Figure 14).
- Washing of equipment must be conducted offsite where grey water can be collected or disposed.
- The Contractor must ensure that no contamination of soil or vegetation occurs.
- The Contractor must ensure that no contamination of soil or vegetation occurs.
- Drip trays must be used to collect used oil, lubricants, etc. during minor maintenance.
- Drip trays must be provided for all stationary plant.

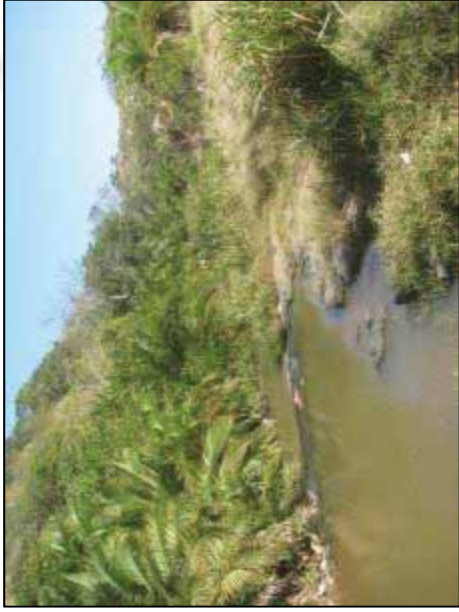
Figure 15: The Baboyi River and surrounding vegetation that must be protected from erosion and contaminants.

- The Contractor must only work within the river as required for the execution of the work.
- The Baboyi River must be protected from erosion and direct or indirect spills of pollutants, e.g. sediment, refuse, sewage, cement, oils, fuels, chemicals, wastewater etc. (Figure 15).

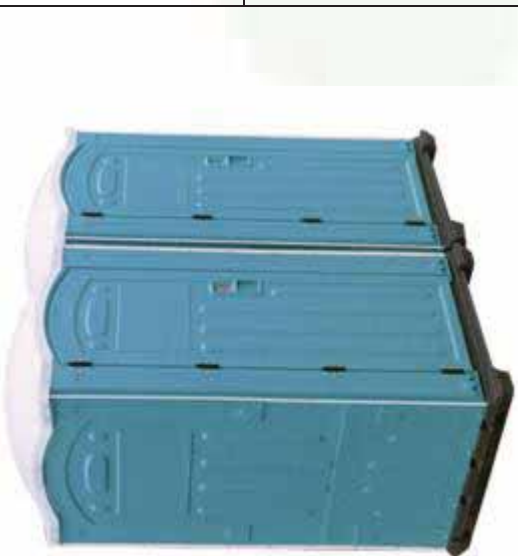
<p style="text-align: center;">www.furnitureminimalist.com</p> <p>Figure 16: An example of portable site toilets which can be used on site. No pit latrines are to be dug.</p>	<p>Site Inception</p> <ul style="list-style-type: none"> ▪ Workers must be briefed by the person in charge of managing construction / management activities on the <i>do's</i> and <i>don'ts</i> on the property, when workers arrive at the property. This must be repeated in weekly toolbox talks. ▪ No alcohol, drugs, snares, slingshots or animals may be brought onto the property. ▪ Adequate toilets must be available on site for use by construction staff at all times (Figure 16). ▪ The digging of pit latrines is not allowed under any circumstances. ▪ None of the open areas or the surrounding bush may be used as a toilet facility. <p>Construction</p> <ul style="list-style-type: none"> ▪ No fires may be made on the property. ▪ Workers that are under the influence of alcohol or drugs may not operate chainsaws, vehicles or other machinery. ▪ The harvesting of firewood, medicinal plants, tree bark, flowers or other natural materials is forbidden on the site and adjacent properties. ▪ No workers may sleep on the property unless proper accommodations for this have been established. ▪ Prior to the commencement of construction, all workers need to know what possible archaeological or historical objects of value may look like, and to notify the site manager if one is found.

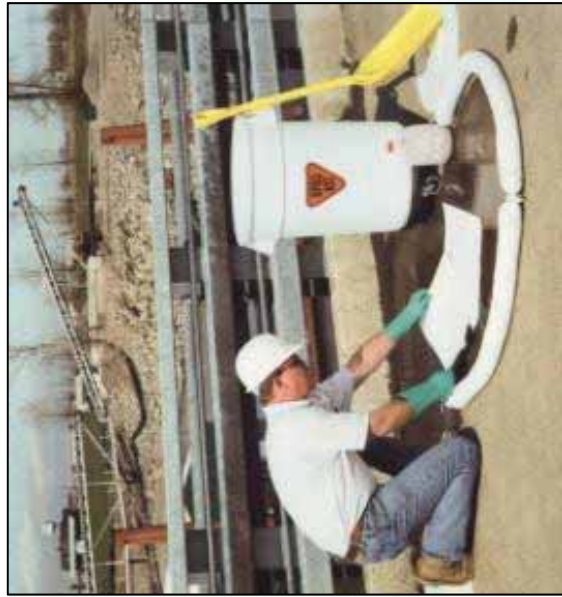
Figure 17: The use of a spill kit during an emergency response to an accidental spill.

- Keep clearly marked absorbent material on site to contain spills if they occur.
- If a spill occurs, stop the source, contain it, clean up in accordance with MSDSs and notify relevant authorities.

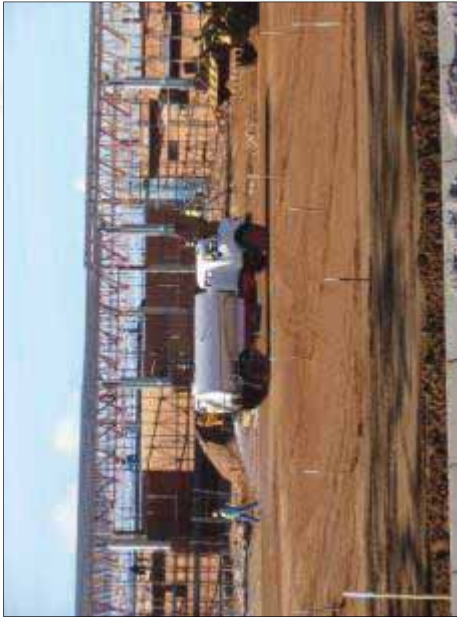
Figure 18: An example of dust suppression at a construction site to control dust generation.

- The contractor must ensure that the necessary equipment is in place to control dust generated during construction (Figure 18).

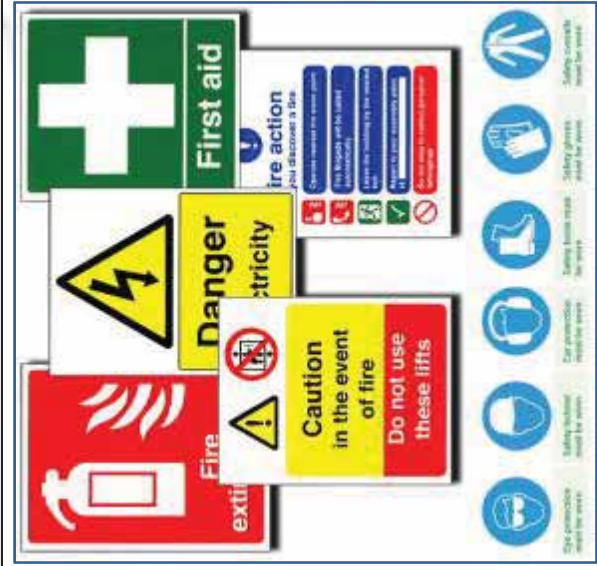
Figure 19: Relevant requirements for health and safety within a construction site, including PPE.

- All construction staff must be provided with relevant Personal Protective Equipment (PPE) (Figure 19).
