Hydrological Scoping Report for the Wonderstone Driekuil Mine Expansion

March 2022

Project Name	Hydrological Scoping Report for the Wonderstone Driekuil Mine Expansion
Report Type	Scoping Report
Client	EnviroGistics (Pty) Ltd
Project Number	ENG042
Report Number	02
Report Status	Draft
Submission Date	14 March 2022
Author	Andy Pirie (M.Sc., Pr.Sci.Nat.114988)
Author Signature

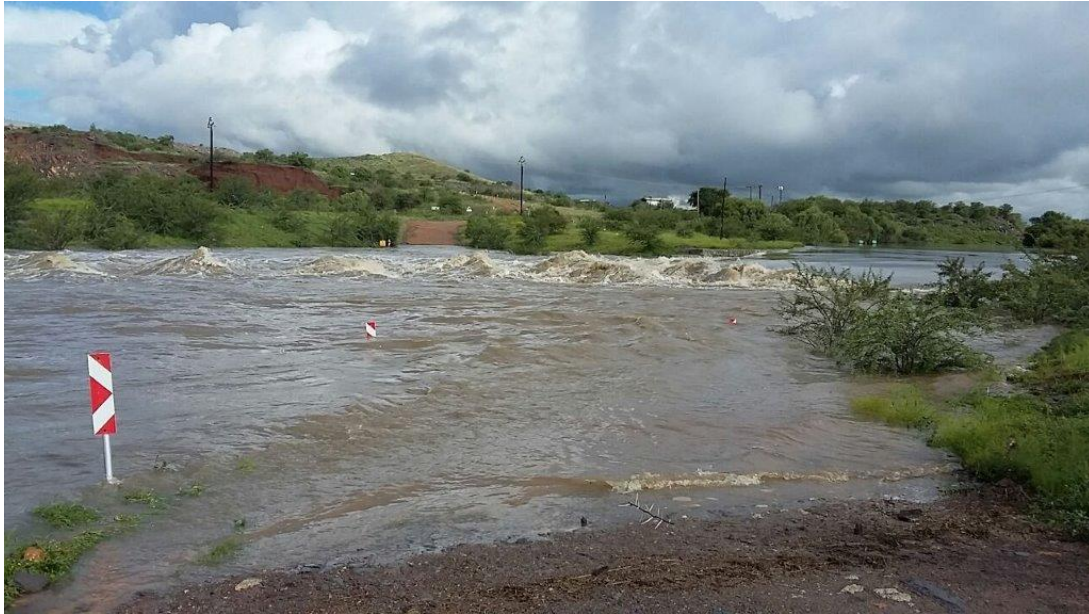
Figure 3-6: Driekuilspruit river crossing below the Driekuilspruit Dam wall during the 2017 flood

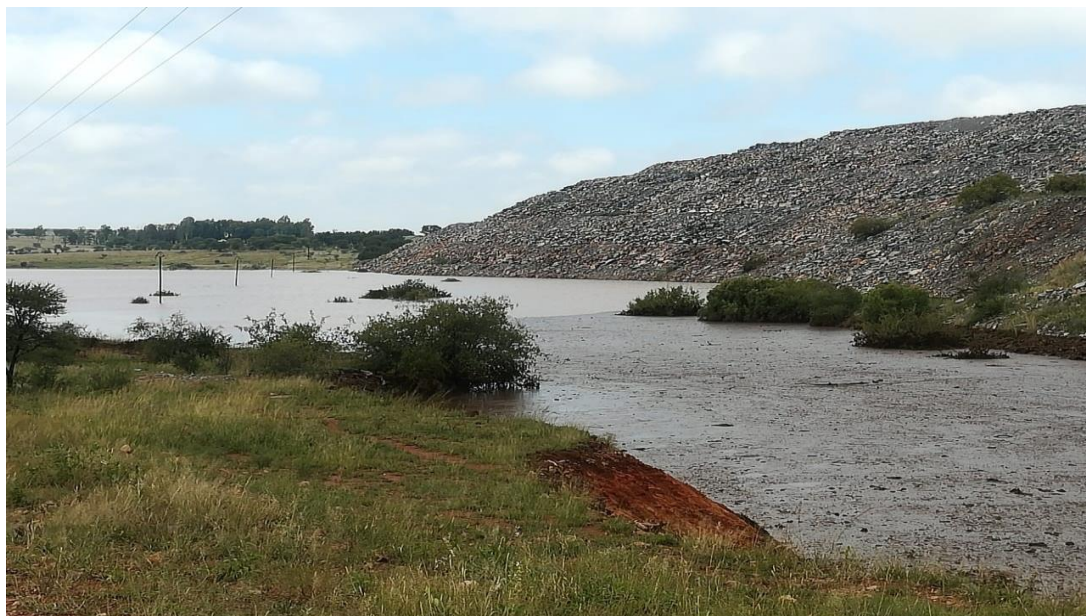
Figure 3-7: Backing up of water to the east of the WRD during 2019

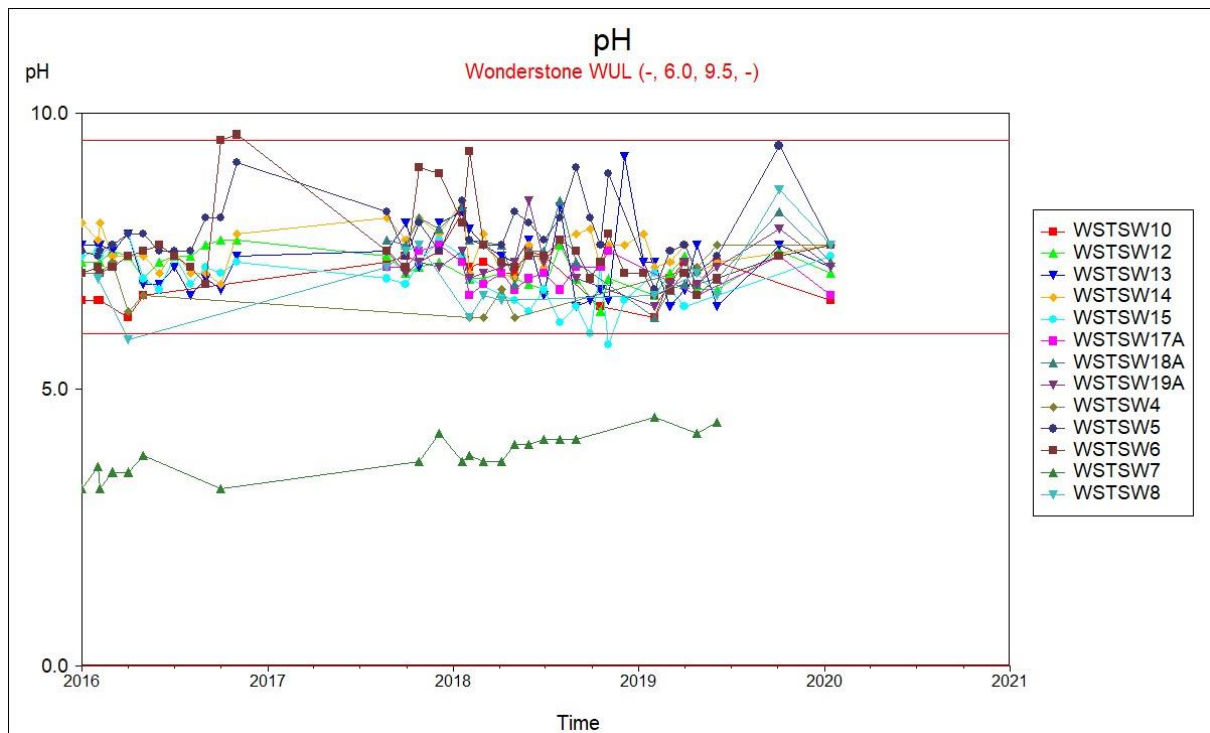
- The trends in pH at the surface water monitoring points are indicated in Figure 3-10. The pH at all monitoring points was mostly within the required limits except at WSTSW7, which is the monitoring point in the Pit. WSTSW7 has consistently been below the required pH limit of 6 since 2016, indicating acidic conditions within the Pit water. An improving trend is noted with the pH at WSTSW7 increasing steadily from 3.2 in October 2016, to 4.4 in June 2019. Backfilling of the Pit with waste rock commenced in August 2018 (Digby Wells Environmental, 2020). The improvement in the pH could be as a result of the backfilling. Future monitoring will provide an indication of whether this is the case (should there be water available to sample in the pit, as the pit generally only has water after sufficient rainfall has occurred);

Figure 3-10: Trends in pH at the surface water monitoring points (Digby Wells Environmental, 2020)

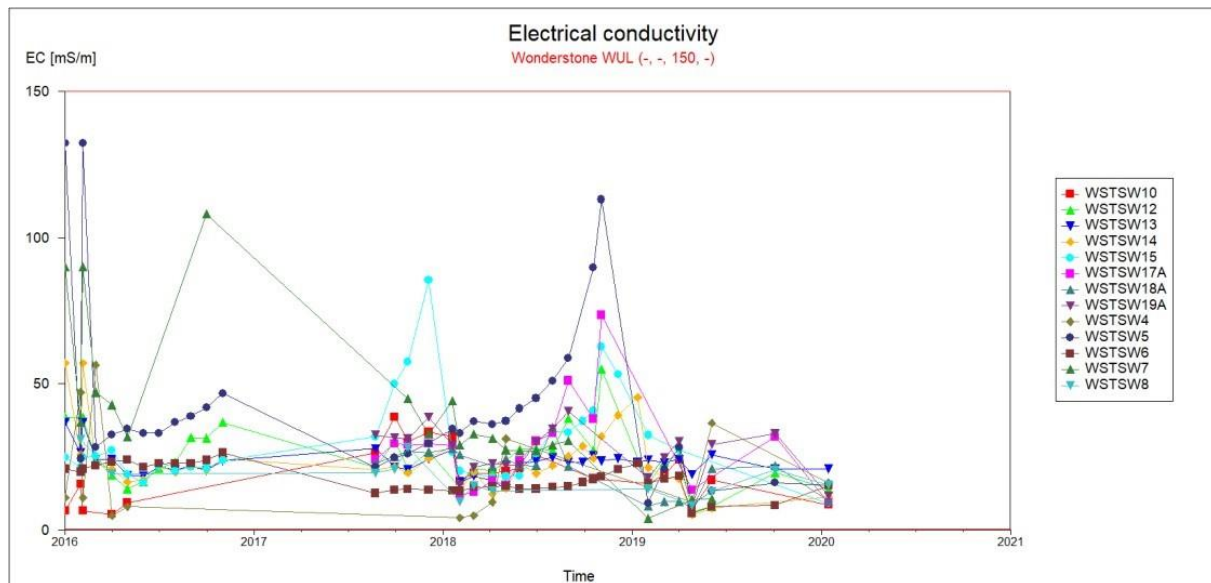
- The trends in Electrical Conductivity (EC) at the surface water monitoring points are shown on Figure 3-11. EC provides an indication of the salinity of water. EC at all monitoring points was within the specified limit of 150 mS/m. What is notable, is the increase in EC at the Driekuilspruit Dam (WSTSW5) over the 2018 period. The increase was attributed to decreasing dam levels as a result of evaporation and low rainfall in 2018 (Digby Wells Environmental, 2020). EC within the Driekuilspruit Dam significantly decreased in 2019, with increased rainfall occurring;

Figure 3-11: Trends in electrical conductivity at the surface water monitoring points (Digby Wells Environmental, 2020)

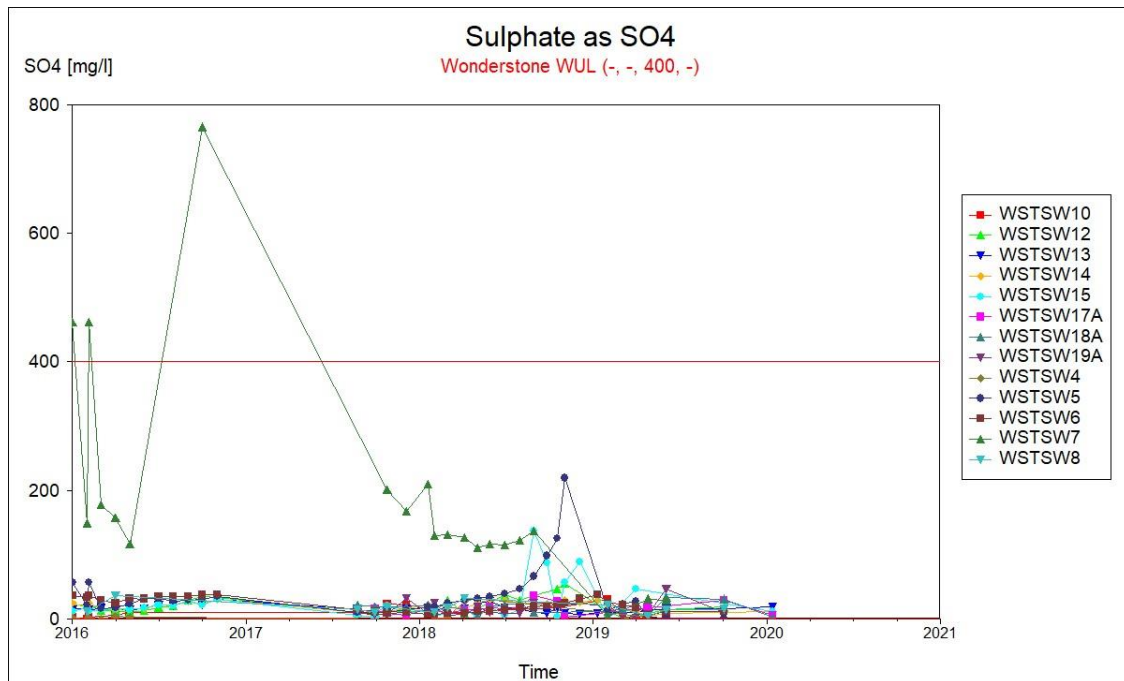
- Sulphate has also been within the limit at all monitoring points except at the Pit (WSTSW7), where it has been exceeded on three occasions (Figure 3-13). The sulphate concentrations have generally been higher at the Pit in comparison to the other surface water monitoring points;
- Nitrate has been within the limit at all monitoring points;
- Fluoride has been exceeded on three occasions at the Driekuilspruit Dam (WSTSW5), but has been within the limit at all other monitoring points since 2016. The exceedance of fluoride is not clearly understood (Digby Wells Environmental, 2020);

Figure 3-13: Trends in sulphate at the surface water monitoring points (Digby Wells Environmental, 2020)

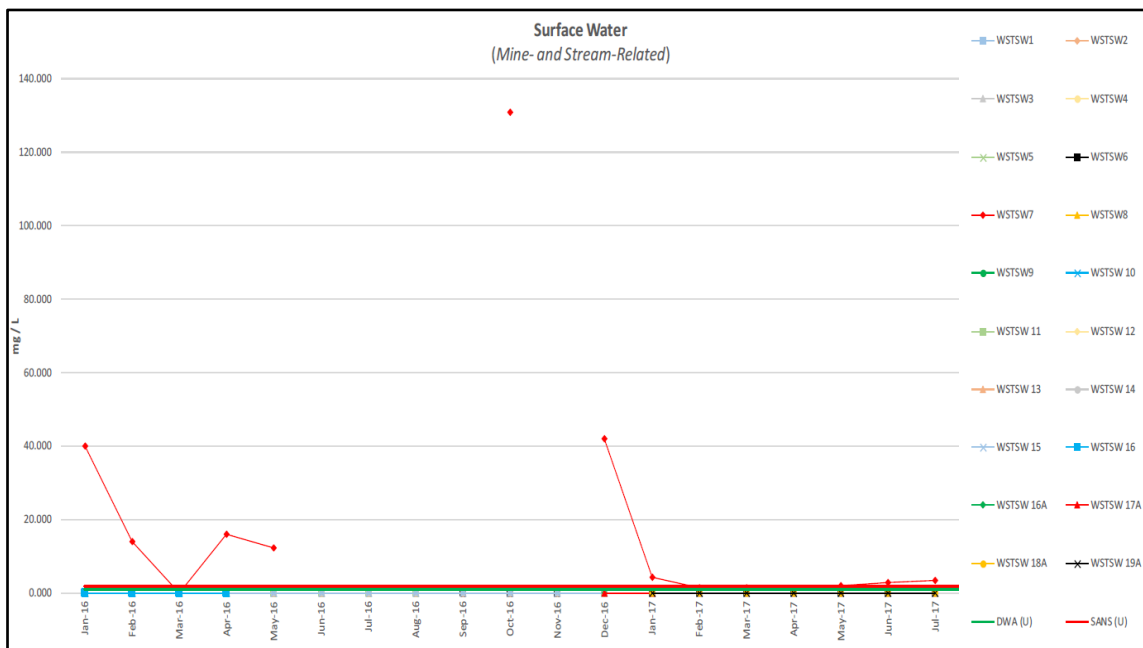
- Arsenic, boron and zinc were all within limits;
- Copper exceeded the SANS limit of 2 mg/l at the Pit (WSTSW7) on most of the sampling occasions, with a maximum of 131 mg/l occurring in October 2016 (Figure 3-15). The highest copper concentrations coincide with the lowest pH values at the Pit. Copper was within limits at all of the other monitoring points;

Figure 3-15: Trends in copper at the surface water monitoring points (Storm Water Solutions, 2017)

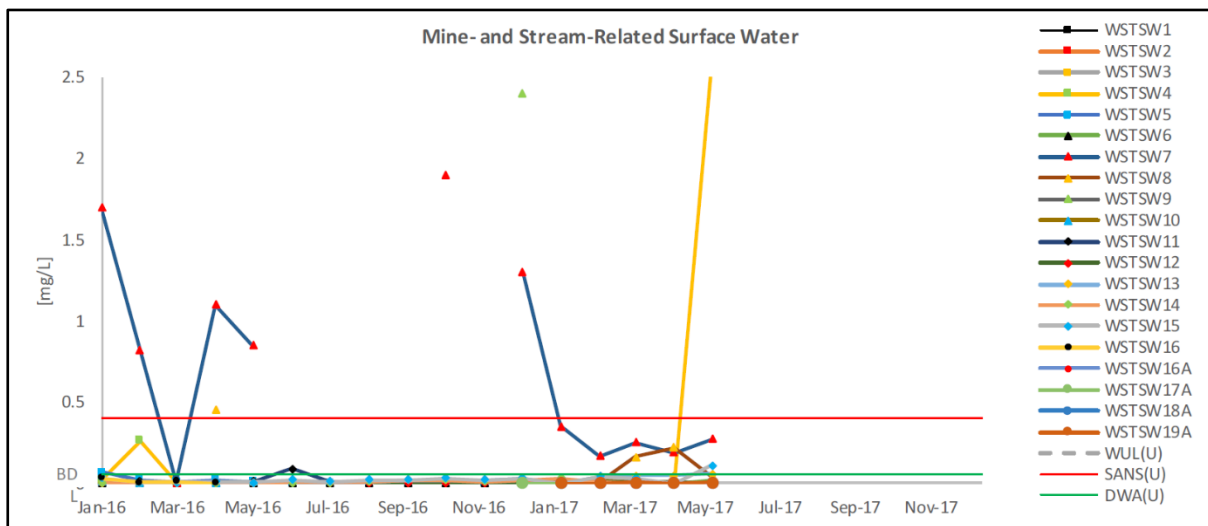
- Elevated levels of manganese exceeding the SANS limit of 0.4 mg/l occurred at the Pit (WSTSW7), upstream (WSTSW4) and downstream (WSTSW8) on the Driekuilspruit, as well as where the unnamed stream meets the WRD to the east of the mine. The highest recorded manganese concentration of 2.6 mg/l occurred upstream of the mine at WSTSW4. As with aluminium and copper, the highest manganese concentrations coincide with the lowest pH values at the Pit;

Figure 3-17: Trends in manganese at the surface water monitoring points (Storm Water Solutions, 2017)

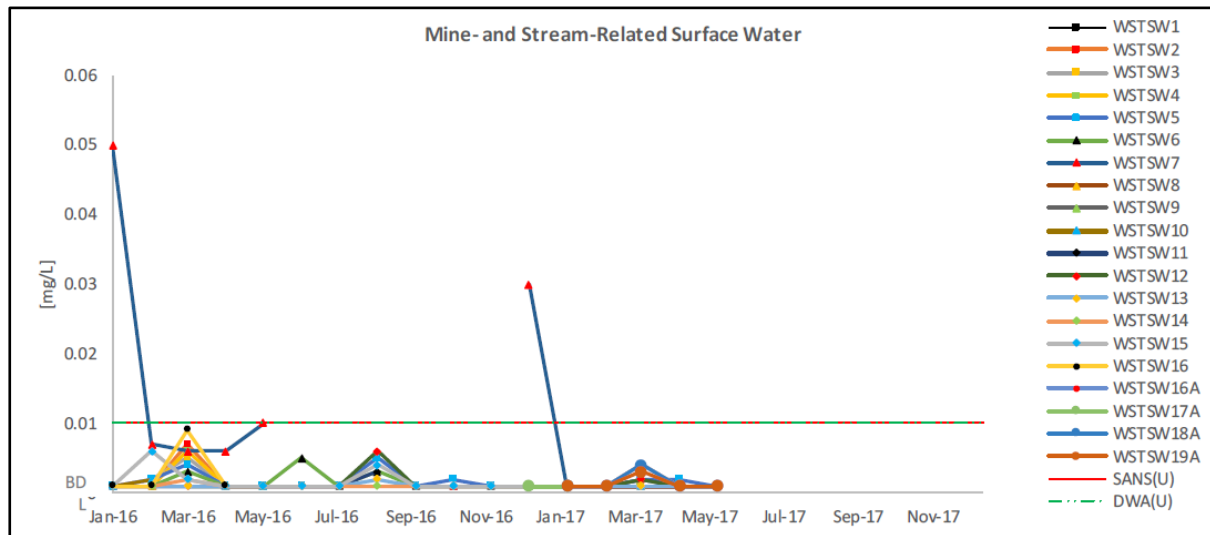
- Lead has been within the SANS limit of 0.01 mg/l at all monitoring points except at the Pit on two occasions (Figure 3-18); and

Figure 3-18: Trends in lead at the surface water monitoring points (Storm Water Solutions, 2017)
