## SCREENING REPORT FOR THE PROPOSED MINING PERMIT

TO MINE AGGREGATE ON PORTION 16 OF THE FARM HERMANUS KRAAL NO.  
1186, SITUATED IN THE MAGISTERIAL DISTRICT OF LADYSMITH, KWA-ZULU-  
NATAL

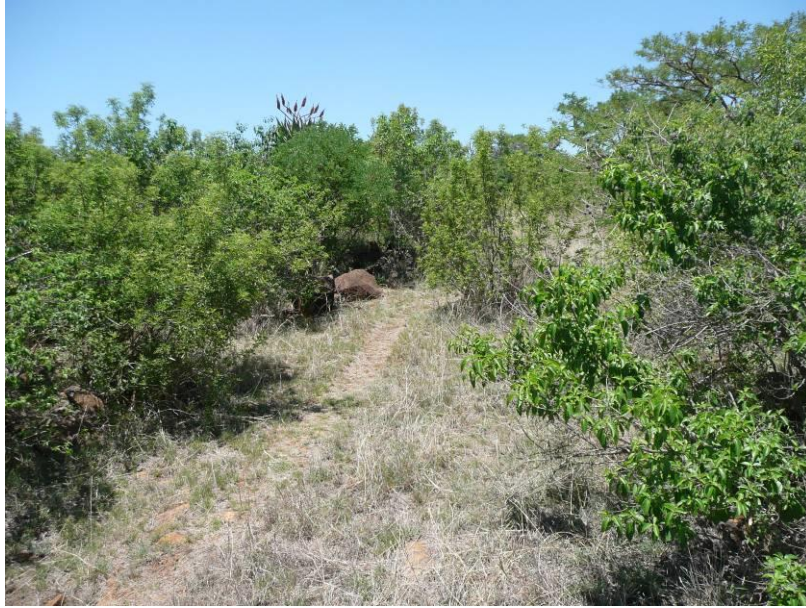
Figure 3: Dirt path leading to the edge of the existing quarry rock face. Please note dense vegetation either side of the path

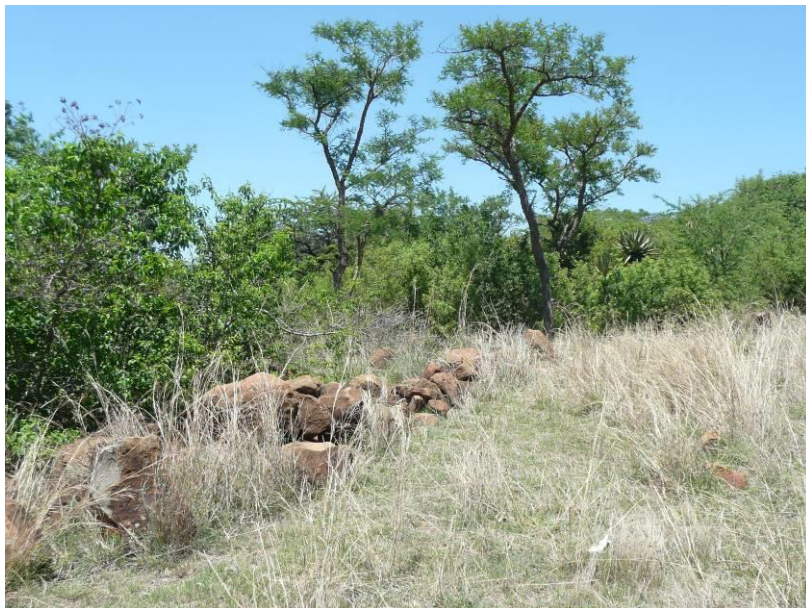
Figure 4: Stone walls found on site. Noted grassed clearing fringed by dense woodland that is a common occurrence on the site and the remainder of the property. Please note specimens of the Acacia species *Acacia nilotica* and the small tree species *Dichrostachys cinerea* in the background

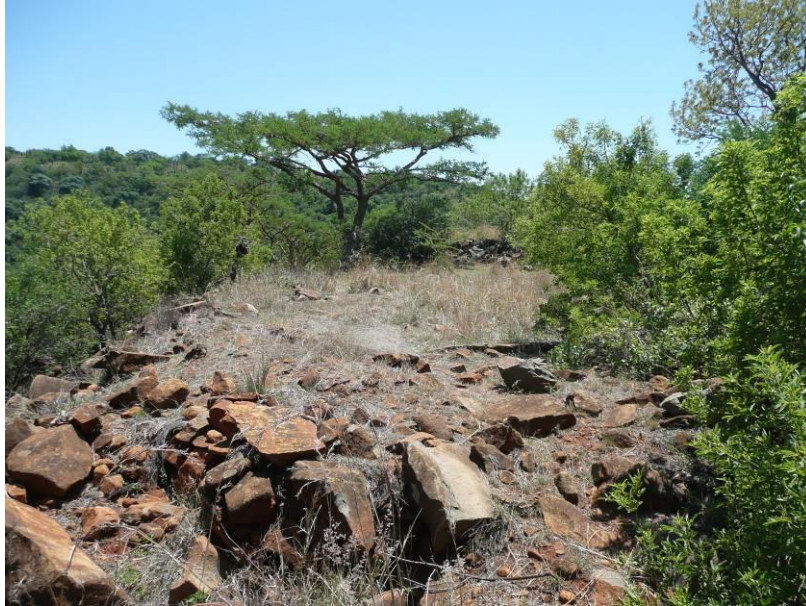
**Figure 5: Remnants of the foundations and walls of a structure on the site. Note mature specimen of *Acacia sieberiana* in the background.**

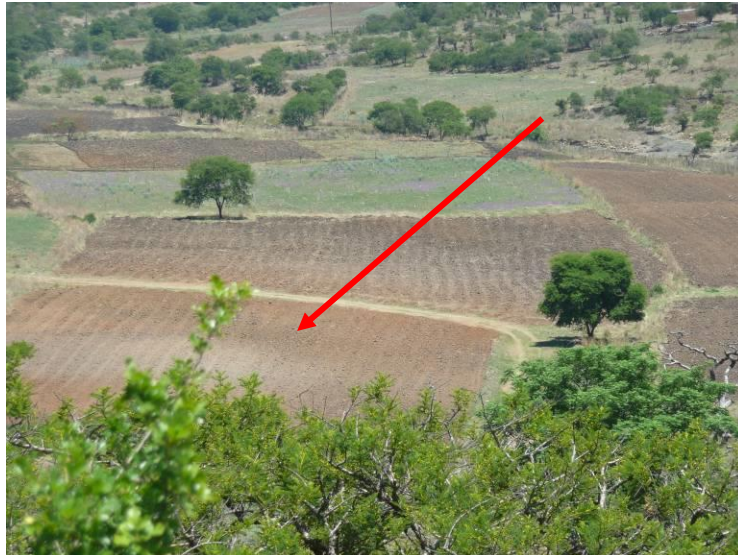
**Figure 7: Piece of cultivated land where the mining site camp will be located. Please note the dirt access road leading to the mining site in the image**

The proposed site camp falls on a piece of cultivated land within the KwaZulu-Natal Hinderland Thornveld vegetation unit. However, the area had been cleared and ploughed at the time of inspection and no indigenous vegetation was note in the area.

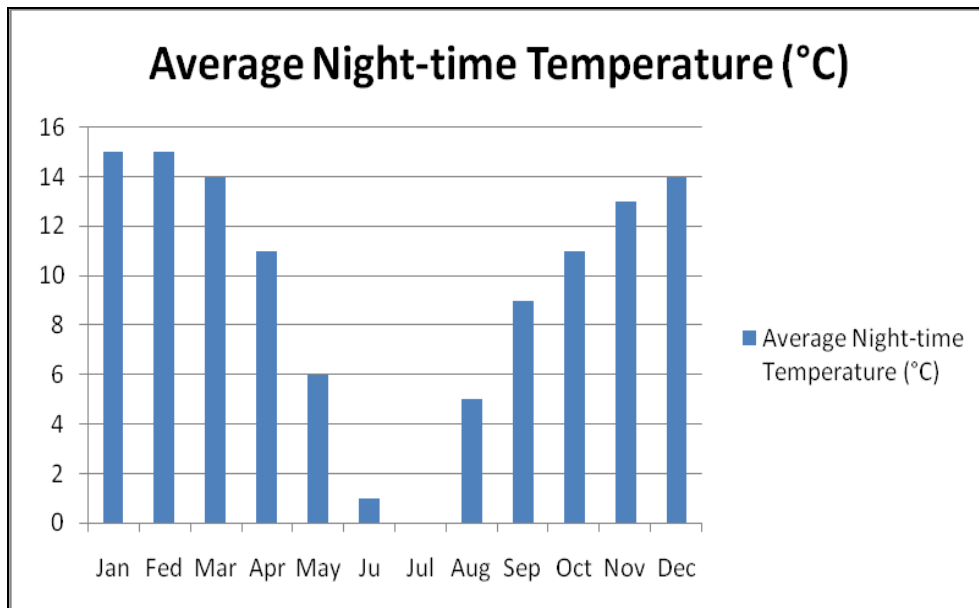
Figure 10: Average night-time temperature for Colenso and surrounding area

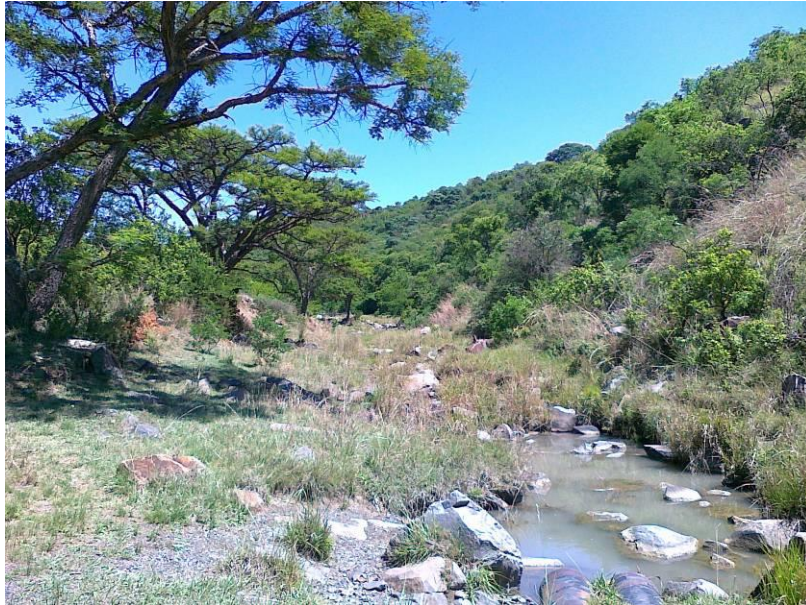
**Figure 12: The watercourse that runs from west to east, across the front of the site.**

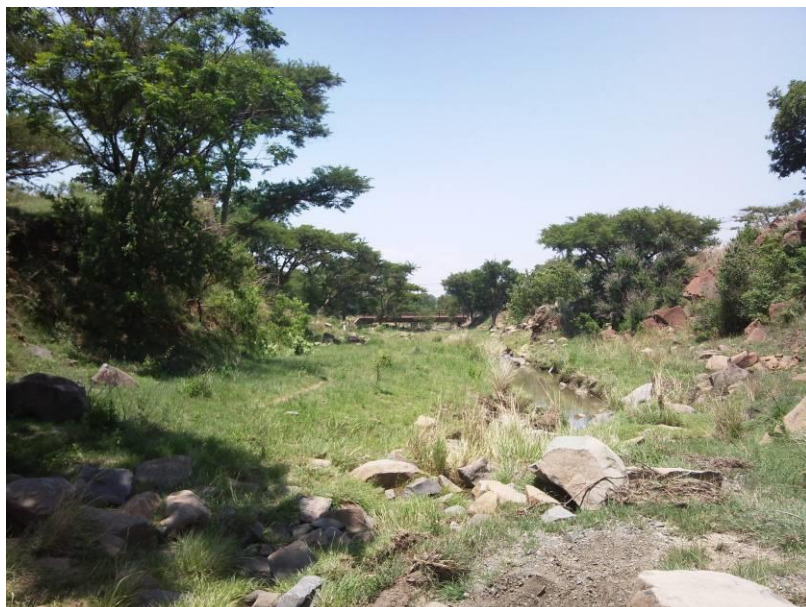
**Figure 13: Looking back towards the railway line and the location of the deteriorating structures from the previous mining operations on the property**

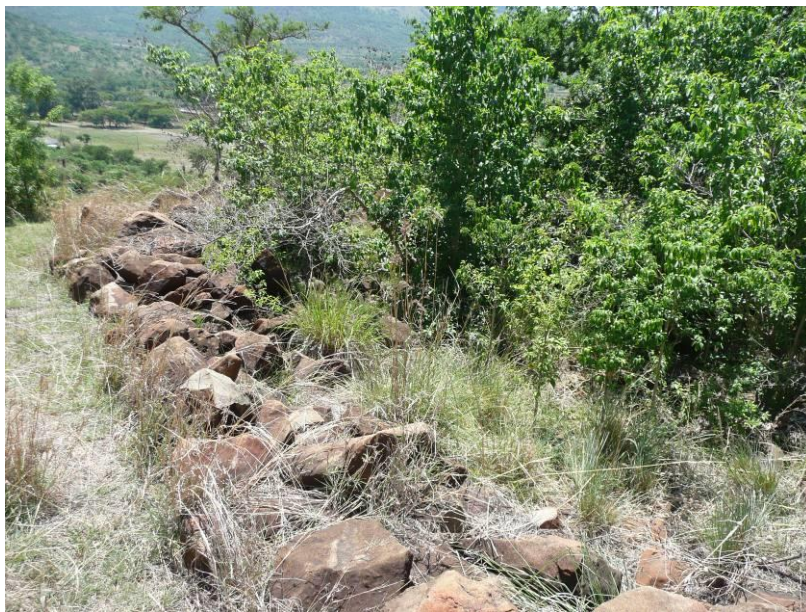
**Figure 14: Stone wall found near the edge of the quarry rock face on the proposed quarry site**

Figures 14 to 17 below are of the suspected heritage sites found on the proposed quarry site during the second site inspection.

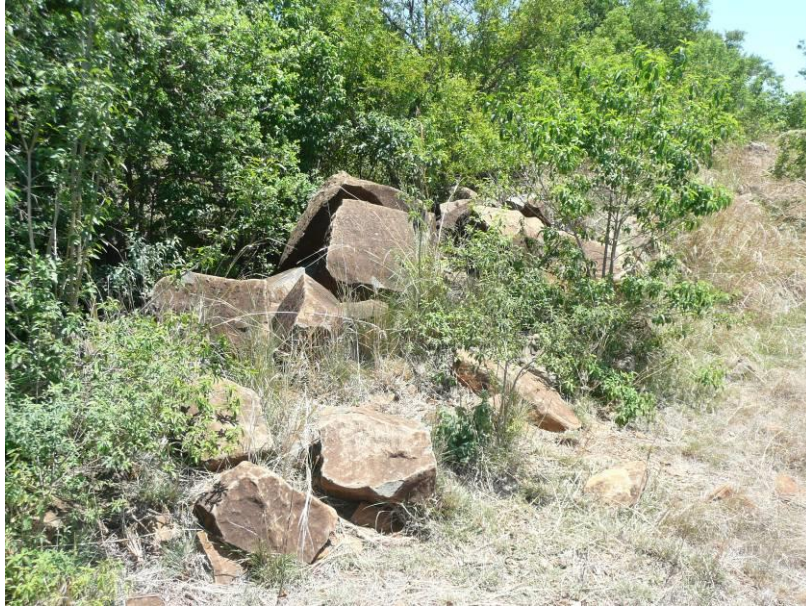
**Figure 15: Stone structure covered in vegetation on the proposed quarry site**

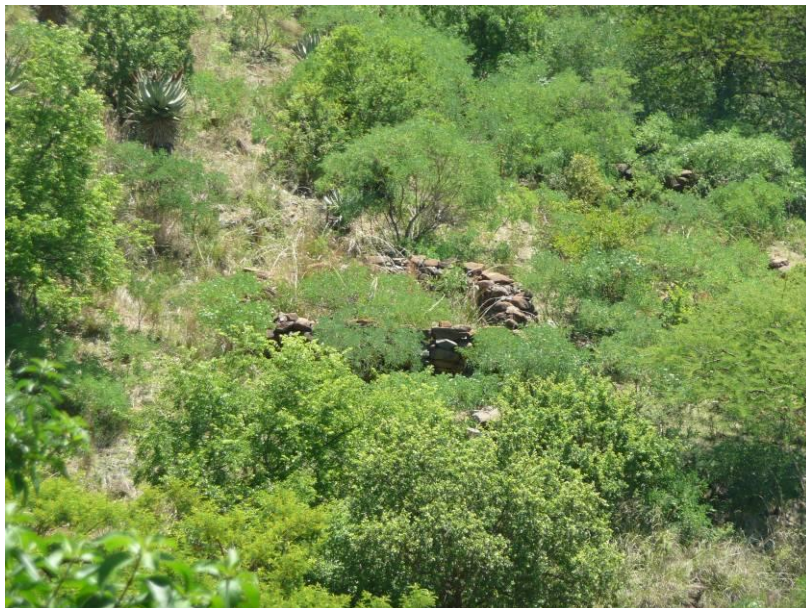
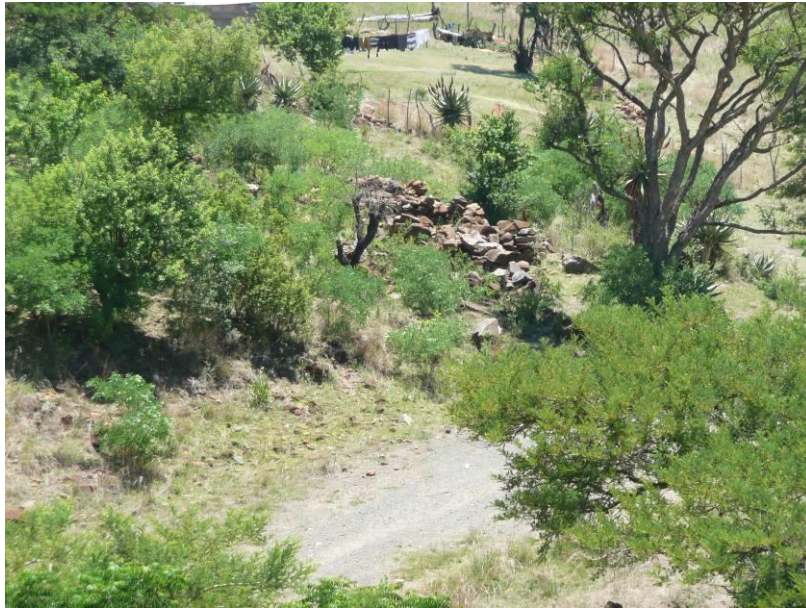
**Figure 16 & 17: Stone structures observed from the top of the koppie in the valley below**

- A man-made platform of rocks near the edge of the quarry.
- Stone walling located in the centre of the proposed quarry site. Site consisted of stonewalled circular of around 2 metre radius.
- Several stone walls and foundations observed from the top of the koppie in the valley below.
