PROJECT PROPOSAL: INSTALLATION OF SITE SAFETY INFRASTRUCTURE AT “COOPER’S B” AT THE COOPERS’S CAVE NATIONAL HERITAGE SITE, CRADLE OF HUMANKIND WORLD HERITAGE SITE, GAUTENG PROVINCE

Site Safety Inspection Findings: Cooper’s Cave

1.2 Proposed Installation:

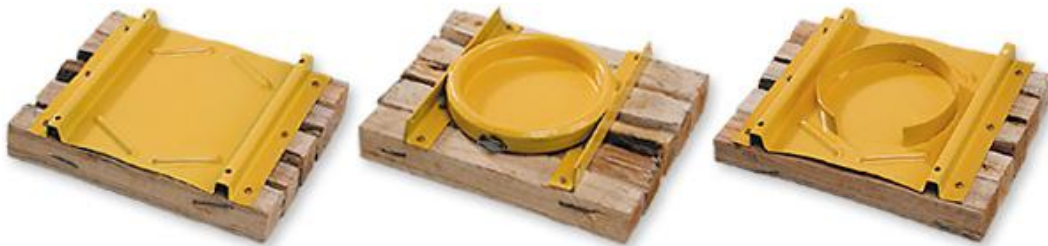
LOAD SPREADING HEAD BOARDS

Below are some photographs of examples of the headboards and mine poles suggested for the Cooper's Cave site safety infrastructure installation.

- The installation of a row of large diameter (>200mm) wooden mine poles, at the base of the talus cone (beyond the drop off).
- Spacing the poles approximately 1m apart.
- A load spreading headboard must be placed at the base of each mine pole to prevent bearing or sliding failure in the soft material
- A board / netting should be placed between the mine poles to stop rolling rocks.

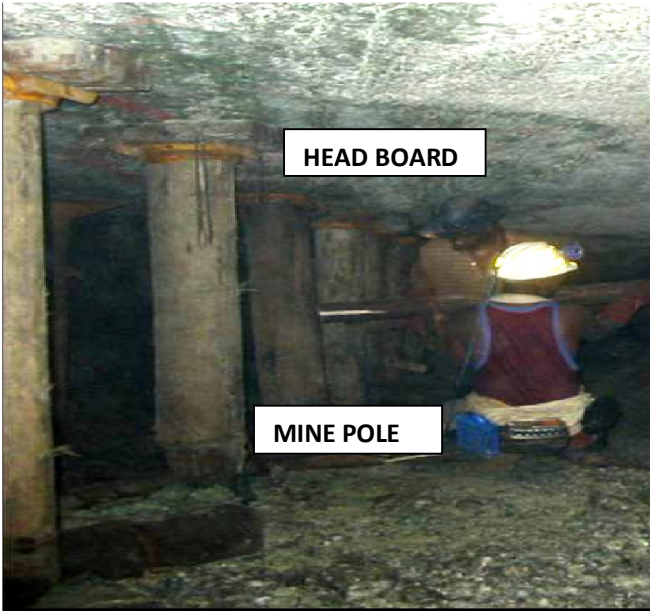
**INSTALLED LOAD SPREADING HEAD
BOARDS AND MINE POLES** (these poles
are thicker than those proposed for the
Cooper's Cave installation)
