**PROPOSED MULTI-PURPOSE RETAIL AND OFFICE
DEVELOPMENT, SUGAR RUSH PARK NEAR
BALLITO, KWAZULU-NATAL**

Phase 1 Heritage Impact Assessment

April 2023

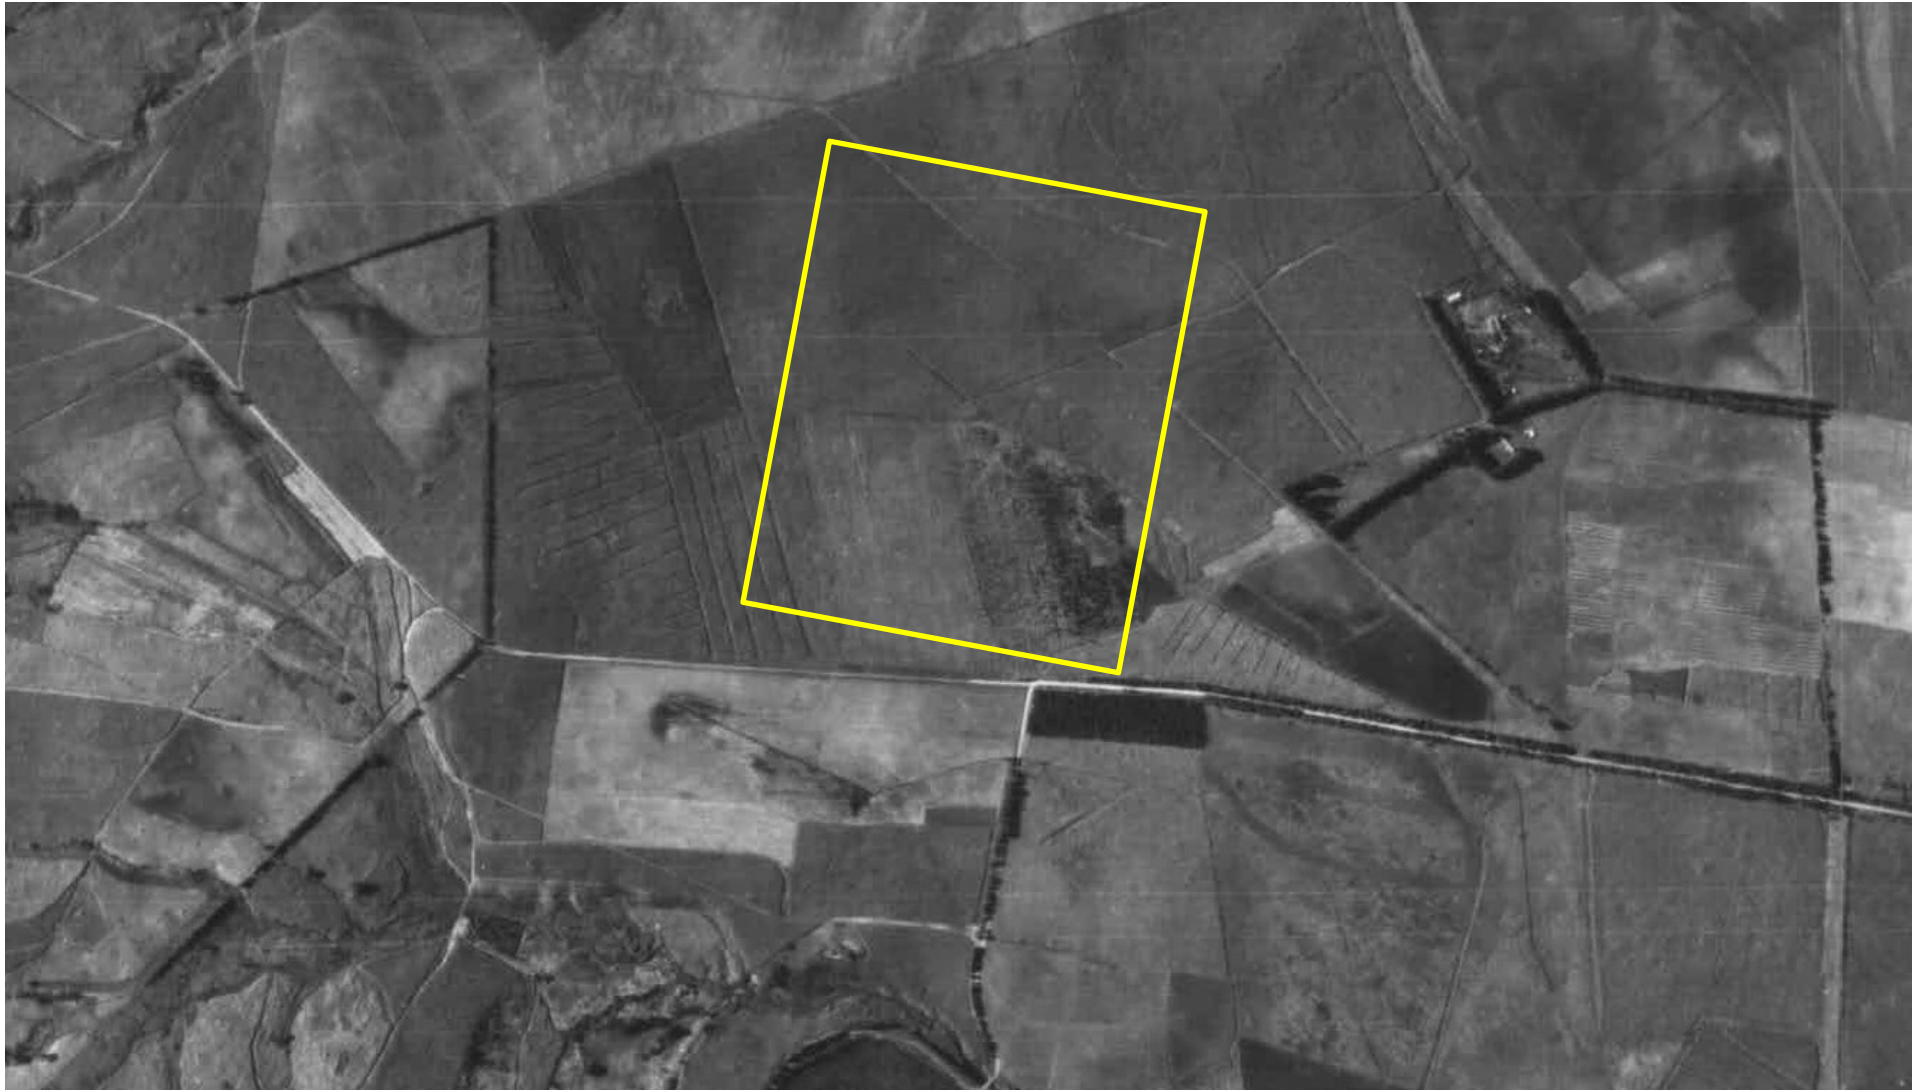
The 1937 aerial photograph of the project site (outlined in yellow) (**Fig. 3**) shows an area mainly under sugar cane cultivation. The structures to the east of the site are structures associated with Collisheen Estate. The Ensenembi road is visible going towards the R102 road which is not visible in the image.

Figure 3: 1937 aerial photograph of project site and surrounds

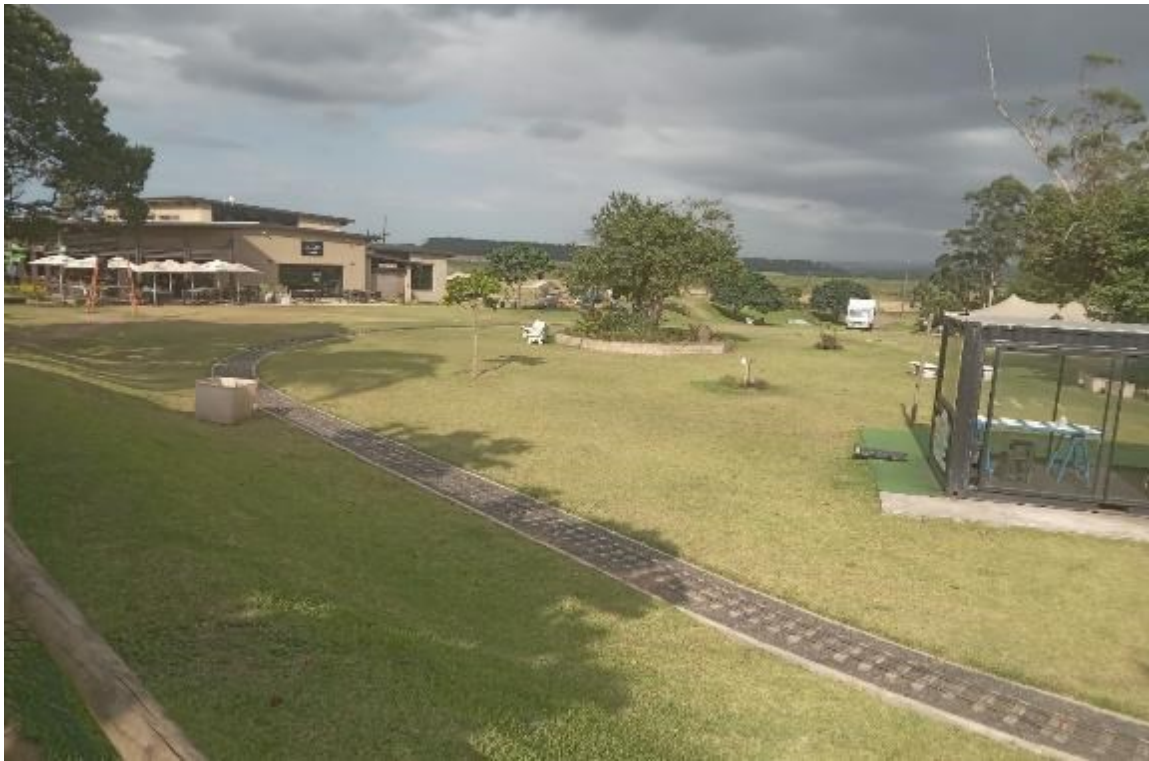
Figure 5: View of existing activity on Sugar Rush Park

The project site was inspected on foot. The area where existing activities take place such as restaurants, entertainment areas, etc., is highly disturbed. This disturbance is in the northern half of Sugar Rush Park. Google Earth historical imagery shows that Sugar Rush Park started to develop from about 2014 / 2015.

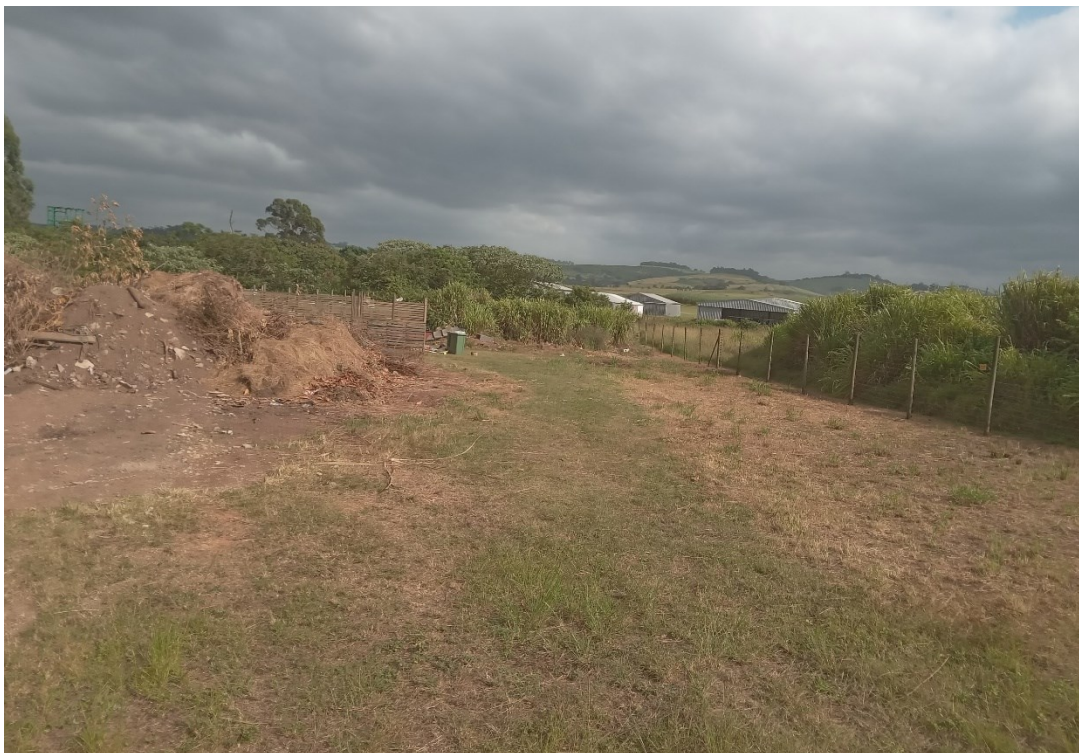
Figure 7: Northern boundary looking westwards

Fig. 7 shows the northern boundary of Sugar Rusk Park with the hangers and other structures associated with the Ballito Airfield depicted in the background. The airfield falls outside the area intended for development. In the foreground is an area where excess vegetation and soil are kept.

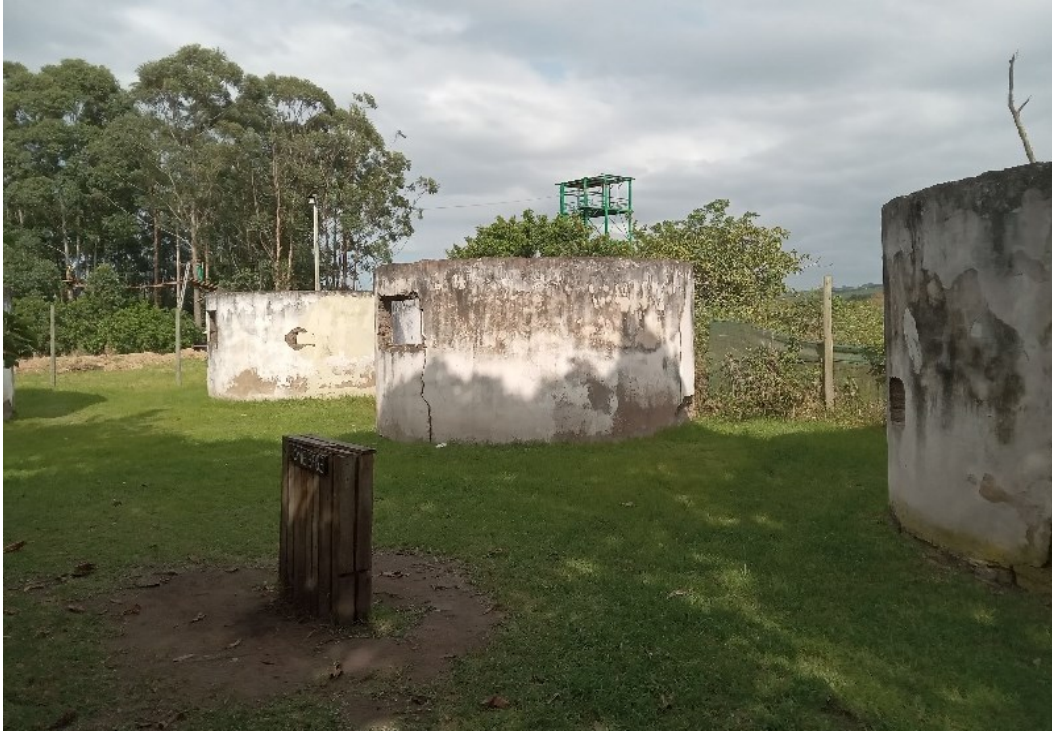
In the north-western corner of the site, close to the airfield are several structures that appear to form a worker's compound. There are the remains of several round dwellings as well as a central structure where, because of the presence of fireplaces and chimneys, it is assumed was where those living in the compound cooked, the kitchen. There are a number of other associated structures. Several of these structures are or appear to be older than 60 years.

Figure 8: Remains of round dwelling structures

The specialist who undertook the Phase 1 HIA is not a built heritage specialist so if this section of the project site is to be developed, then the structures will need to be assessed by a built heritage specialist who will ascertain their age and their heritage significance.

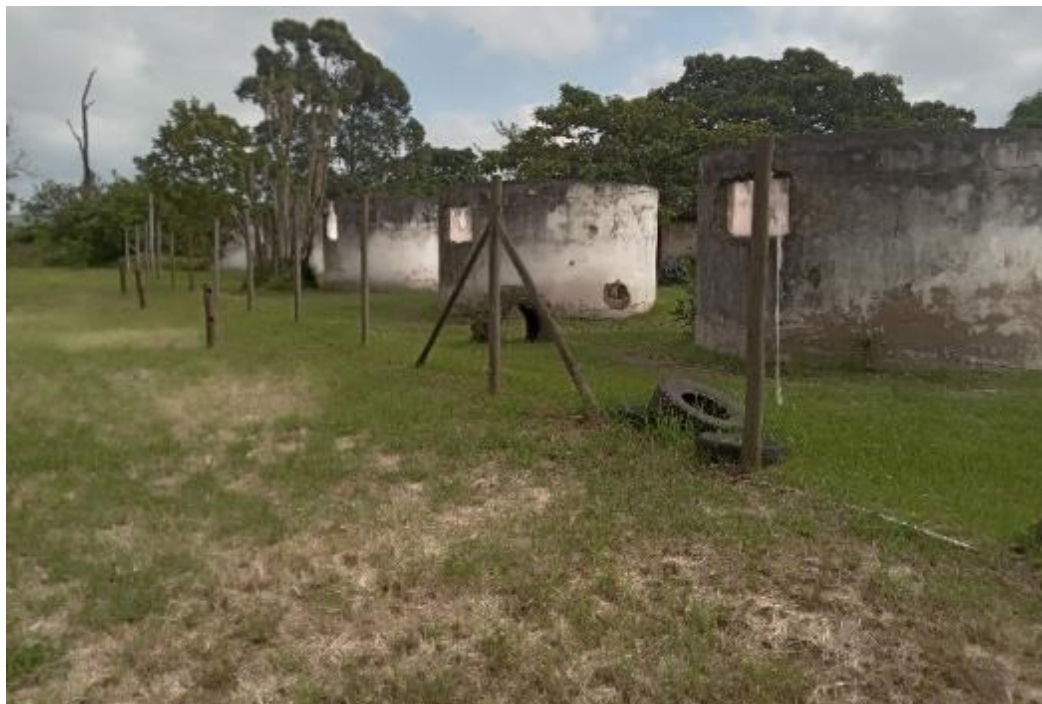
Figure 9: View of round structures from back of compound

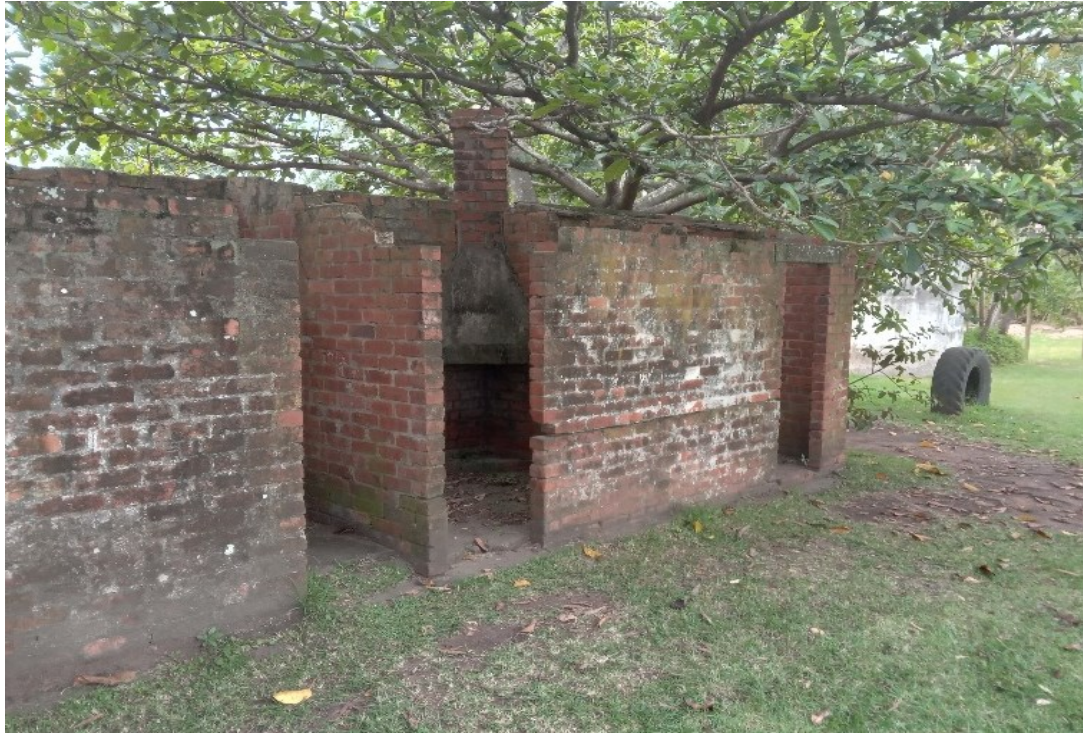
Figure 10: 'Cooking' / kitchen structure with fireplace and chimney visible

Structure used as kitchen for residents of compound; >60 years	29°29'26.1"S 31°10'42.0"E	Low-medium heritage significance	If the area is to be developed & structures demolished, then built heritage specialist to confirm age & significance of structure

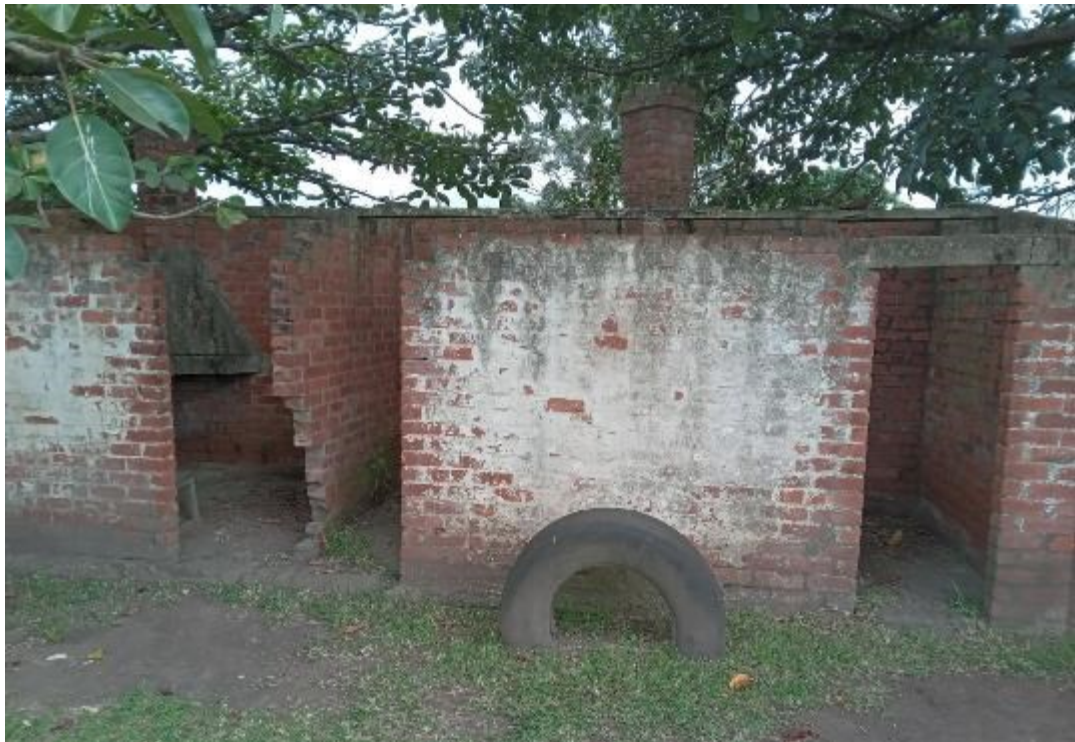
Figure 11: 'Kitchen' structure

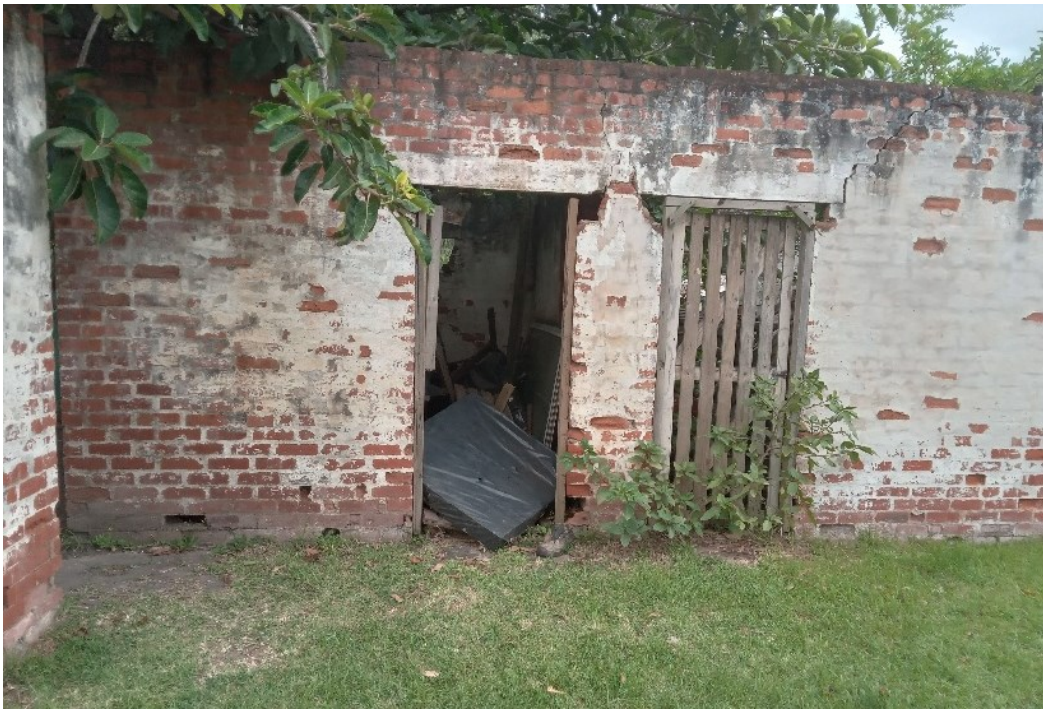
Figure 12: Structure in compound

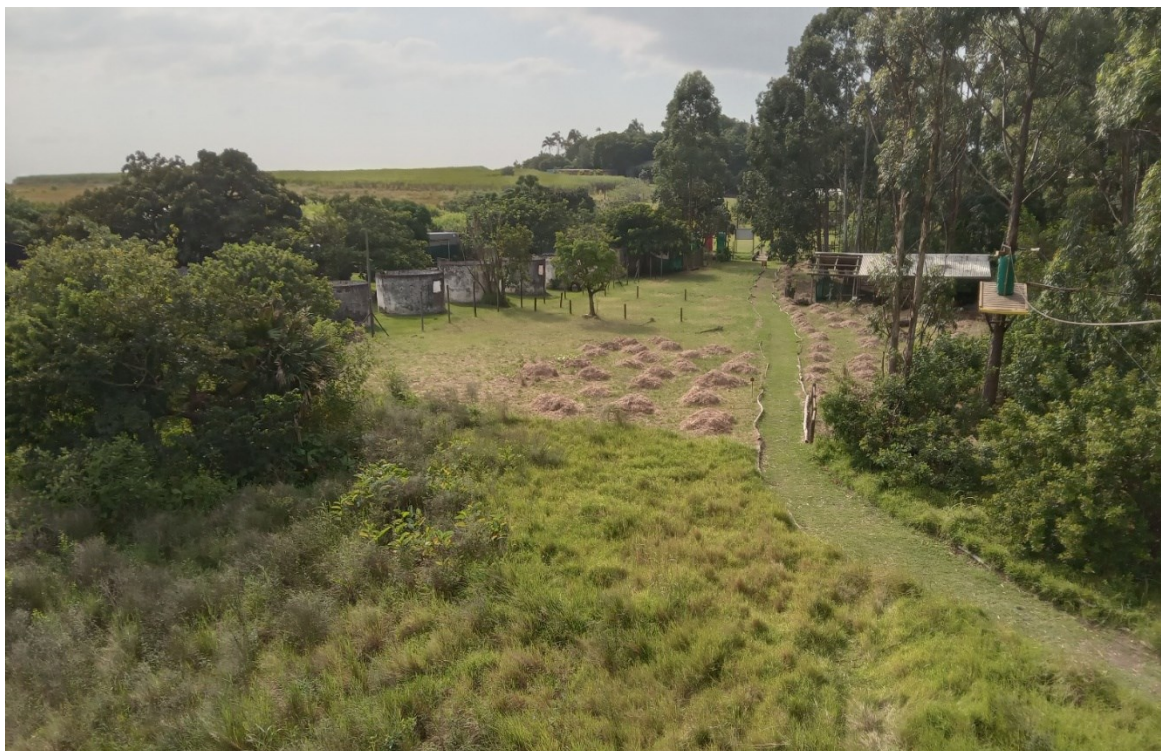
Figure 13: View of compound from viewing deck

Immediately south of the compound is a grove of eucalyptus trees in which there is an elevated tree walk and a high viewing deck. The area was inspected but no heritage sites were found in this section. There are pathways amongst the trees and areas where visitors can sit.

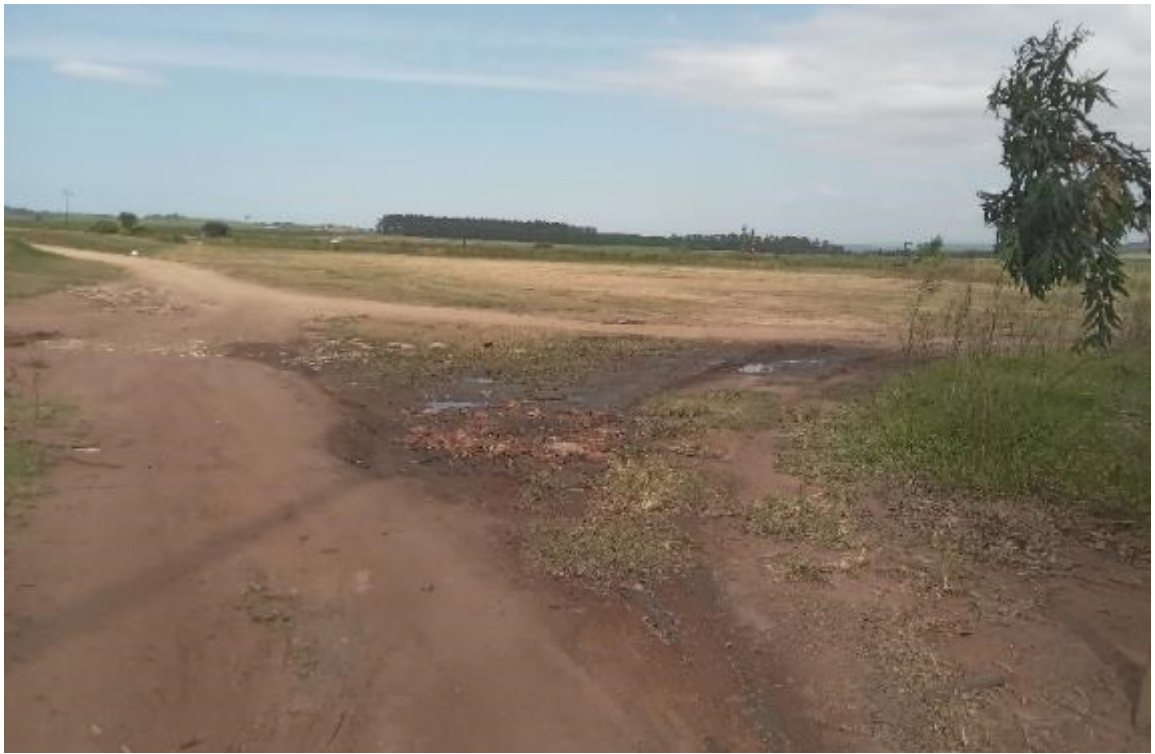
Figure 16: View across development area

The area east and south of the grove of trees and of the dam consists mainly of recovering farm land with roads and paths crossing the area, some of which are used by cyclists. No heritage resources were found here.

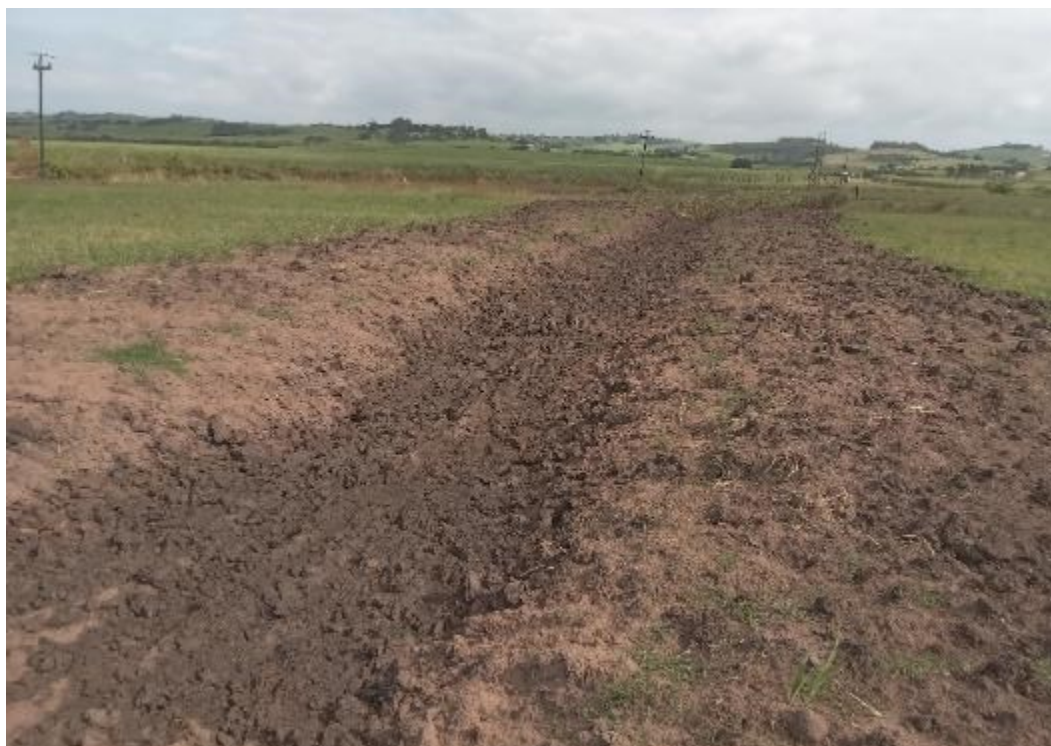
A newly dug drainage line was found running parallel to the southern boundary of the project site.

Figure 19: Cleared drainage line
