## **BUILT HERITAGE ASSESSMENT (PH 2 HERITAGE IMPACT ASSESSMENT) : SUGAR RUSH PARK, PTN 206 OF COMPENSATION FARM, KWADUKUZA**

<i>Client Name :</i>	Confluence SD
<i>Document Title:</i>	Heritage Impact Assessment of proposed development on
<i>Reference :</i>	Sugar Rush Park Ballito_Phase 1 HIA Report (JLB Consult April2023)
<i>File Name :</i>	SugarRush-HIA-2BE-2023-06-20
<i>Address:</i>	----
<i>Cadastral description :</i>	Portion 206 of farm Compensation no.868, KwaDukuza, Illembe district
<i>Site area :</i>	142484 ha
<i>Consolidation :</i>	Nil
<i>Zoning :</i>	Agricultural 1
<i>Municipality:</i>	KwaDukuza, Illembe district

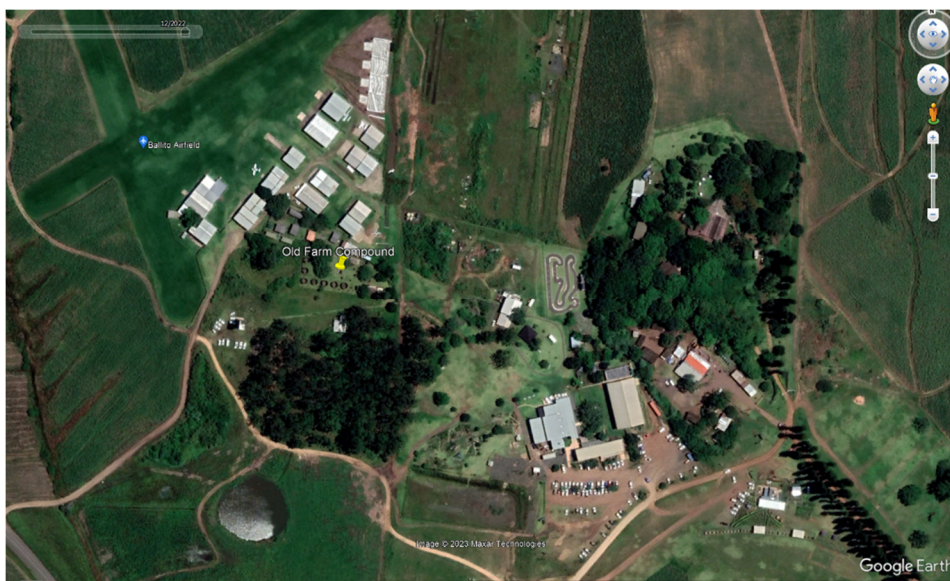
The immediate context is agricultural, the land is flat and undulating.

The farm is accessed by Esenembi Road (off R102) and bordered by the Remainder (Collisheen Farm) on the other 3 sides. The Ballito airstrip forms the NW boundary.

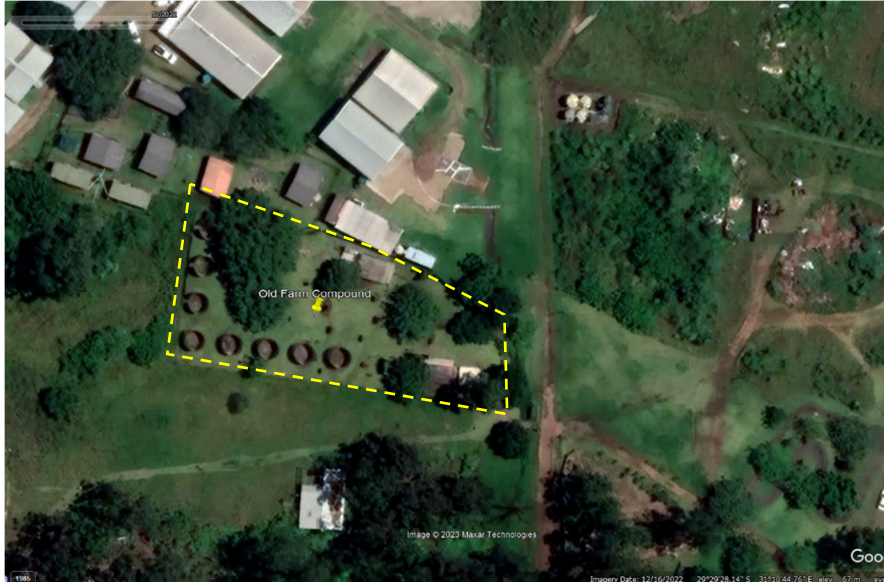
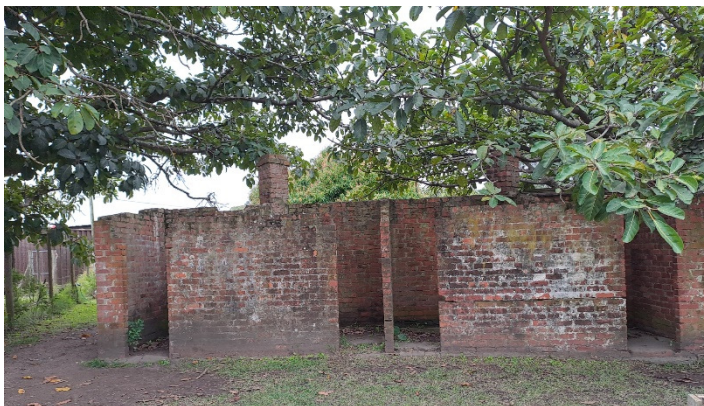
The group of structures comprised 8 (unroofed) circular walled structures and three clay brick rectangular structures. The rectangular structures are built of clay brick commons and cement lintols – most timber frames have disappeared or disintegrated.

The structures are currently used for laser-tag games. The circular structures are built of concrete block, the circular rooms arranged around the brick structures.

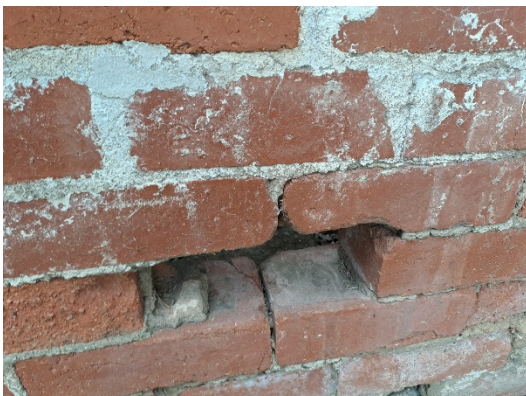
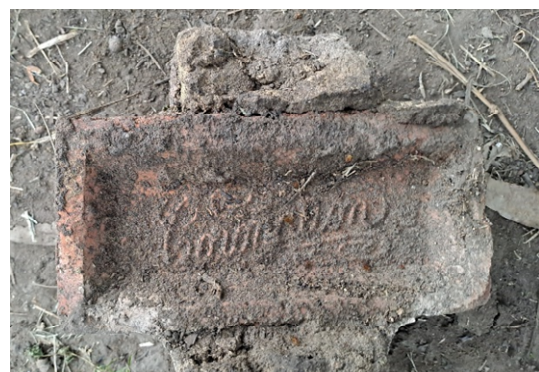
Samples of the bricks were photographed and revealed the age of the structures : some bricks displayed the inscription “Coronation” in small cursive writing.

The “Coronation Brick and Tile company” came into being on 12 May 1937, the date of King George VI and Queen Elizabeth’s Coronation.

The bricks were pressed initially with “Coronation” imprinted. The inscription ceased to be used from 1950 onwards. Therefore, the brick structures are most likely the oldest structures on the site, the arrangement of rooms indicate that they were workers accommodation with communal cooking (built-in fireplaces) and ablution facilities.

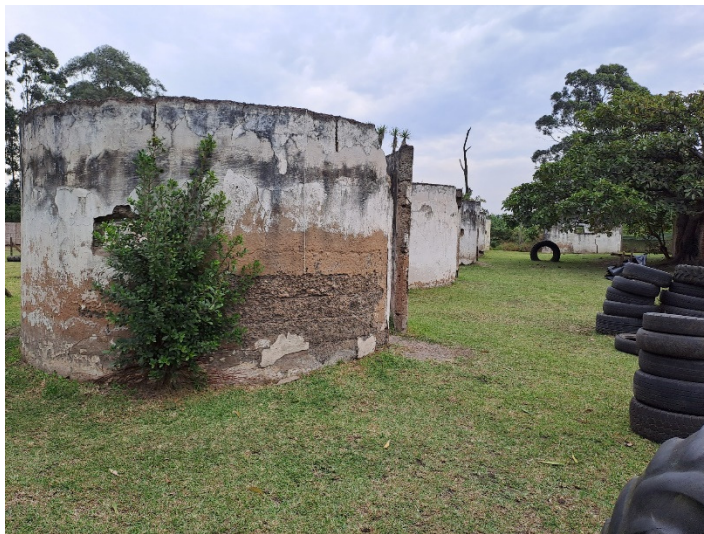
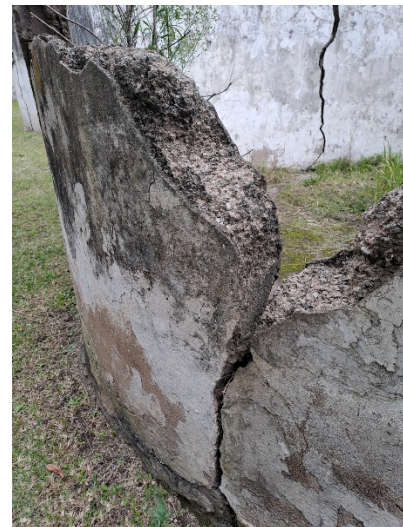
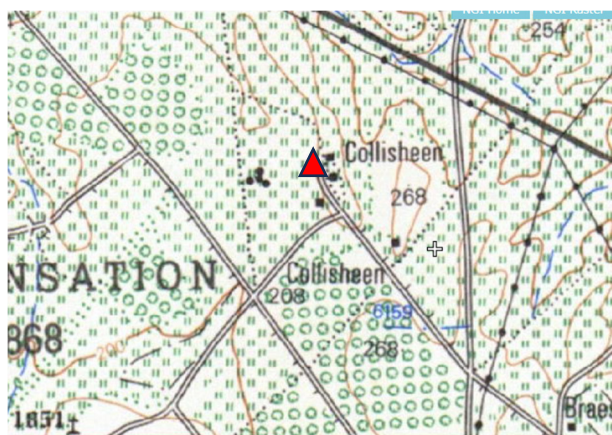
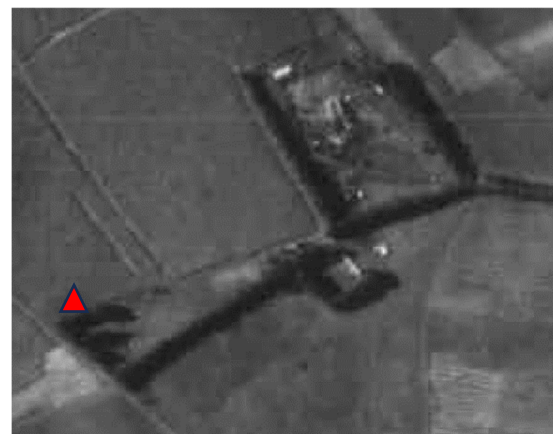
The aerial photograph from 1937 show the farm house and sheds, but the location of the structures is not well defined. The location point shows trees which may have sheltered the structures from view. It was common that workers housing was built a distance away from the main farmstead.

It is assumed that the “rondavels” or circular houses were built later to provide additional or bigger workers housing. They are not visible on the 1937 aerial photograph nor the earliest Topo-map. They can be assumed to have been built between 1937 and 1968.

The structures are assessed with low heritage significance.

They are recommended as **“Not Conservation Worthy” (NCW)**, but do require a permit for demolition or alteration according to the KZNARI Act and the NHA.
