**SUN GARDEN PV FACILITY NEAR RIEBEEK EAST:
FAUNA & FLORA SPECIALIST IMPACT ASSESSMENT REPORT**

November 2021

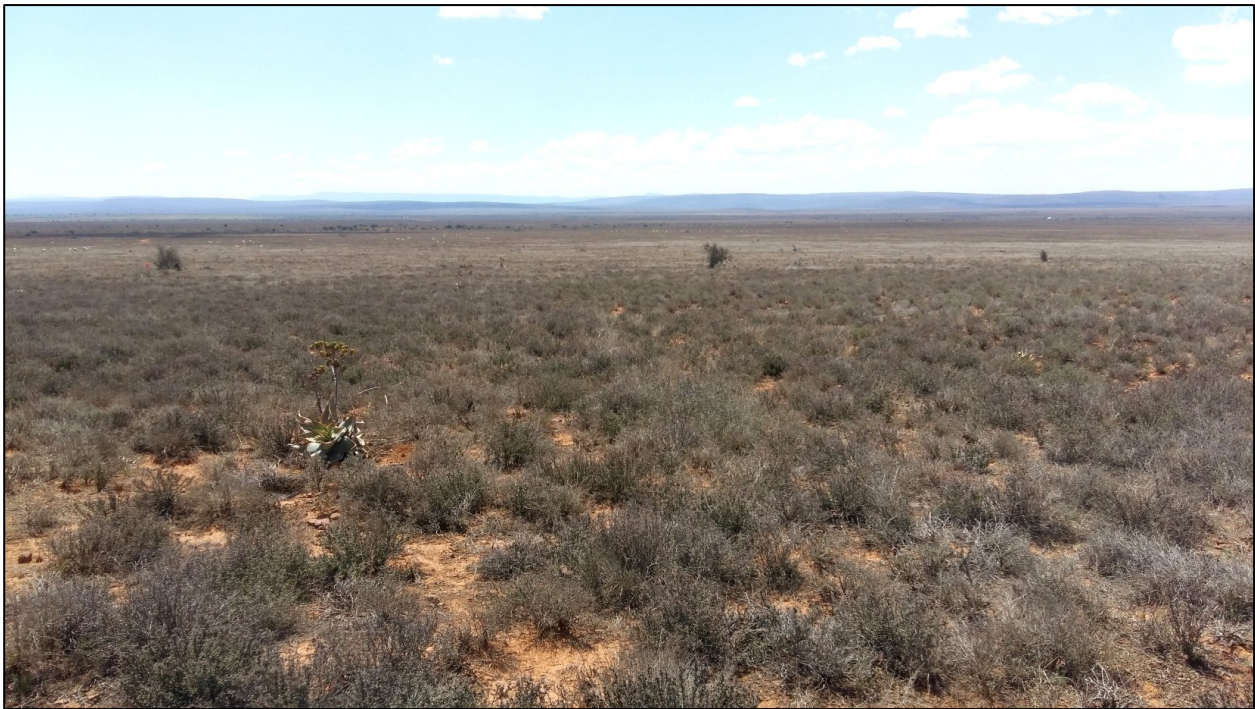
Figure 3. View over the open plains which characterise the central and northern parts of the Sun Garden PV site, with typical vegetation representative of the Albany Broken Veld vegetation type.

In practice the lower (northern) slopes of the site consist of open plains with few woody species present (Figure 3), while the upper slopes of the site (southern boundary) have a significantly higher woody species density and can be considered transitional with Kowie Thicket (Figure 4). There are also several small drainage lines and washes present which are characterised by the presence of woody species such as *Vachellia karroo* and *Searsia pallens*.

The open plains of the Sun Garden PV area consist of open plains with occasional scattered trees and shrubs. Dominant species include *Pentzia incana*, *Asparagus glaucus*, *Ruschia spinosa*,

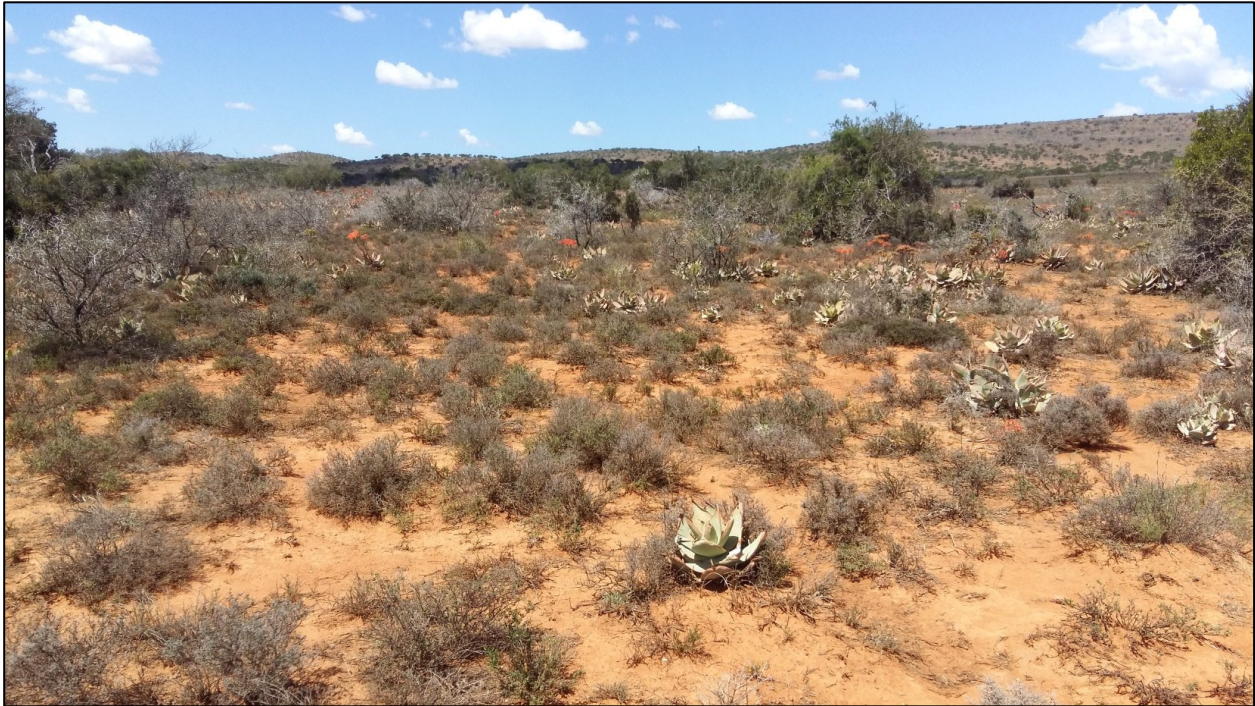
Figure 4. The Albany Broken Veld on the upper slopes of the Sun Garden PV site has a higher abundance of trees and woody species and there are areas with a high density of *Aloe striata*.

The upper slopes of the Sun Garden PV area have a higher density of trees and bush clumps, as well as some areas with a high density of *Aloe striata* (**Figure 4**). Trees and tall shrubs present include *Euclea undulata*, *Schotia afra*, *Searsia rigida*, *Azima tetraacantha*, *Mystroxydon aethiopicum* subsp. *aethiopicum*, *Carissa bispinosa* and *Vachallia karroo*. The shrub and grass layer is dominated by *Pentzia incana*, *Drosanthemum lique*, *Cadaba aphylla*, *Asparagus striatus*, *Asparagus suaveolens*, *Lycium prunus-spinosa*, *Digitaria eriantha* and *Tragus koelerioides*. Due to the higher diversity and tree density, the upper slopes of the Sun Garden site is considered moderate sensitivity compared to the adjacent plains.

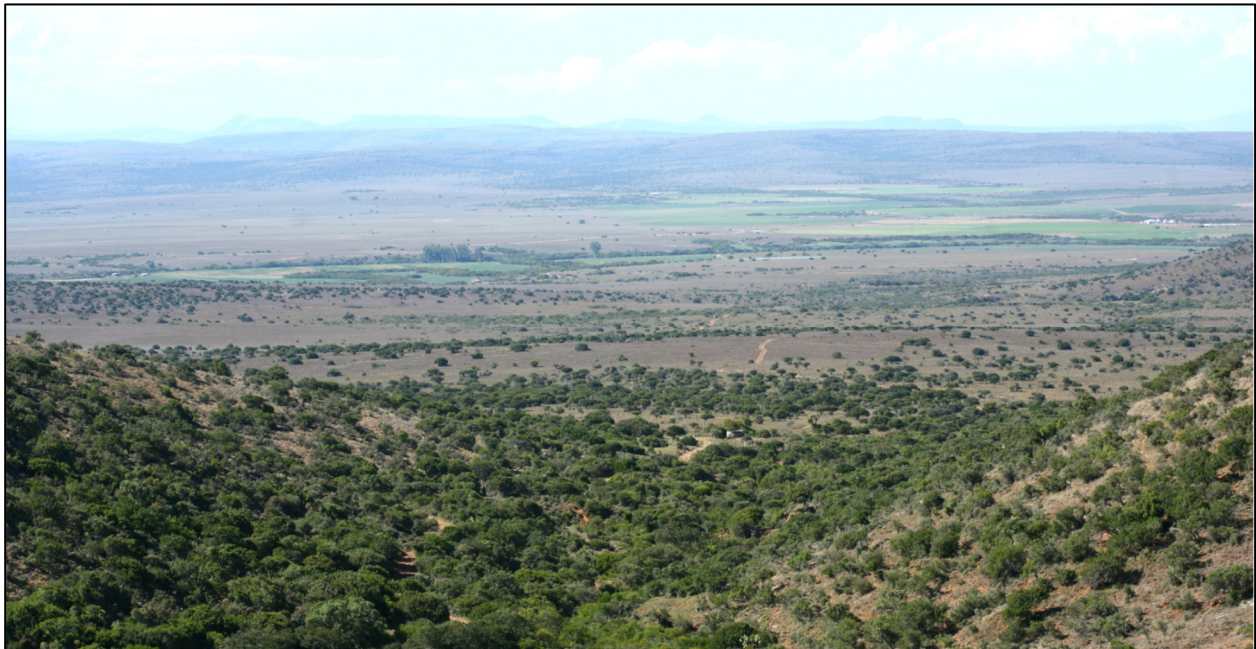
Figure 5. The power line route to the MTS traverses these north-facing slopes mapped as Kowie Thicket, but rather represent a transitional area between Kowie Thicket and Albany Broken Veld.

Although there is no Kowie Thicket within the PV area, a significant proportion of the grid connection route to the MTS runs through this vegetation type. Kowie Thicket is restricted to the Eastern Cape Province, where it occurs in the river valleys of the Bushmans, Kariega, Kowie, Kleinemonde and Kap Rivers from near the Great Fish River Mouth to Kenton-on-Sea, extending inland up these valleys past Grahamstown to just past Riebeeck East and Alicedale to north of the Zuurberg at elevations of up to 700m. Dominant and characteristic species observed on the hills near the site include *Euphorbia triangularis*, *Aloe speciosa*, *Schotia afra* var. *afra*, *Acacia natalitia*, *Cussonia spicata*, *Elaeodendron croceum*, *Maytenus undata*, *Pappea capensis*, *Ptaeroxylon obliquum*, *Sideroxylon inerme*, *Azima tetracantha*, *Gymnosporia polyacantha*, *Allophylus decipiens*, *Carissa bispinosa* subsp. *bispinosa*, *Clausena anisata*, *Ehretia rigida*, *Euclea undulata*, *Grewia occidentalis*, *Gymnosporia heterophylla*, *Mystroxydon aethiopicum*, *Olea europaea* subsp. *africana*, *Putterlickia pyracantha*, *Rhus longispina*, *R. lucida*, *Crassula cultrata*, *Portulacaria afra*, *Cotyledon orbiculata*, *C. velutina*, *C. tetragona*, *Kalanchoe rotundifolia*, *Mestoklema tuberosum*, *Pelargonium peltatum*, *Sarcostemma viminalis*, *Plumbago auriculata*, *Asparagus aethiopicus*, *Jasminum angulare*, *Rhoicissus digitata*, *Cynodon dactylon*, *C. incompletus*, *Eragrostis curvula*, *Sporobolus fimbriatus*, *Themeda triandra*, *Eragrostis obtusa*, *Panicum maximum*, *Sansevieria aethiopica* and *S. hyacinthoides*. These areas are considered generally more sensitive than the adjacent Albany Broken Veld.

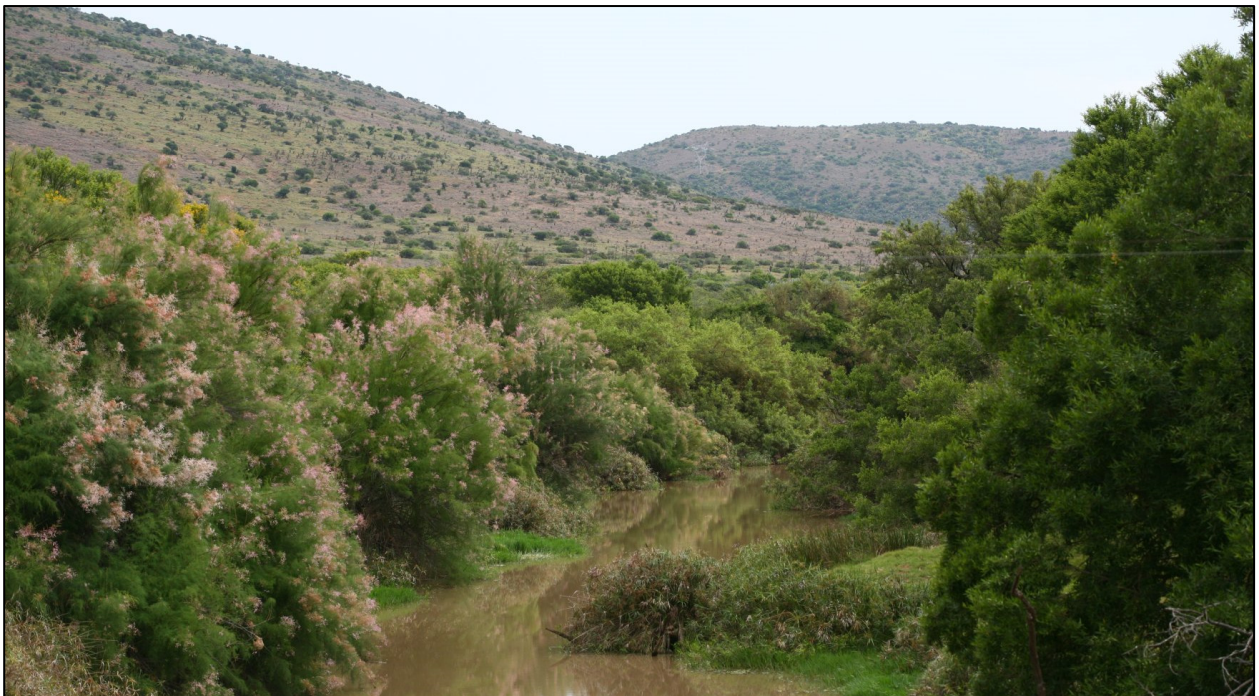
Figure 6. The Klein Fish River near the power line crossing point, representative of the Southern Karoo Riviere vegetation type. The river is lined by *Tamarix usneoides*, *Vachellia karoo* and *Searsia lancea*.

Although there are no significant drainage features within or near the Sun Garden PV area, the power line route to the MTS traverses the Little Fish River, which is characterised by the presence of the Southern Karoo Riviere vegetation type. The Southern Karoo Riviere vegetation type is associated with the rivers of the central karoo such as the Buffels, Bloed, Dwyka, Gamka, Sout, Kariega and Sundays Rivers. About 12% has been transformed as a result of intensive agriculture and the construction of dams. Although it is classified as Least Threatened, it is associated with rivers and drainage lines and as such represents areas that are considered ecologically significant.

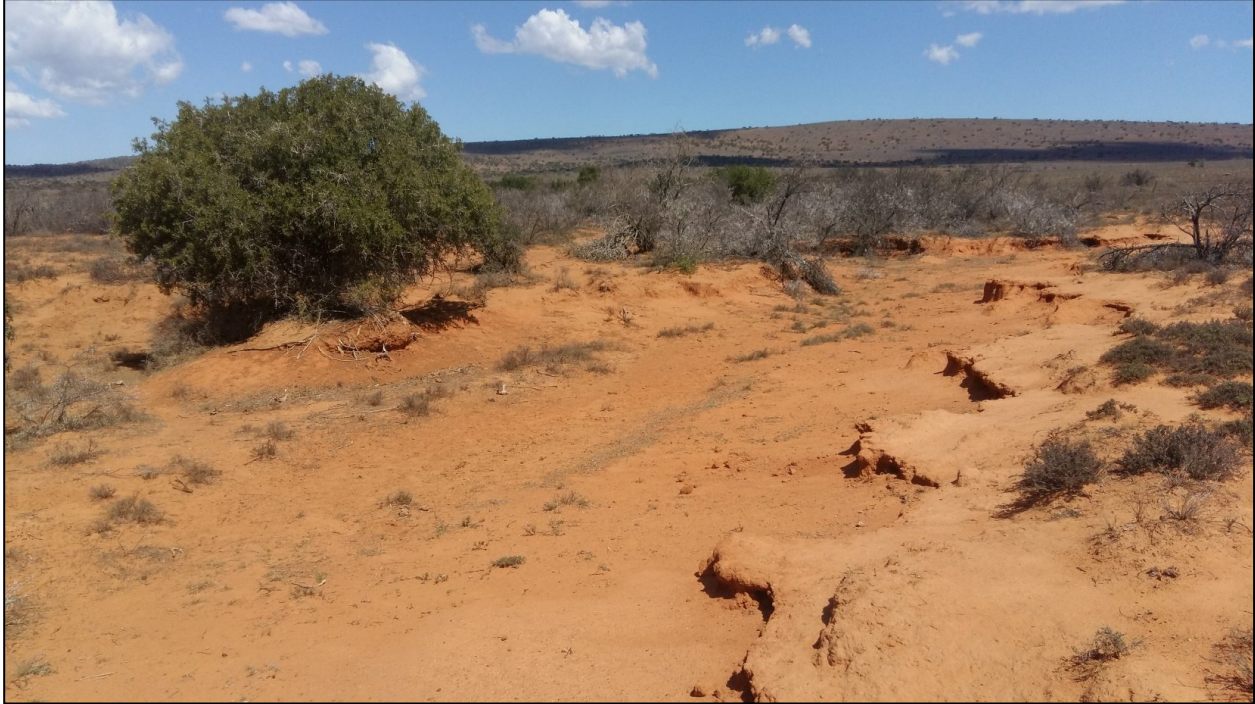
Figure 11. The soils of the Sun Garden site are considered fairly vulnerable to erosion and specific measures to manage runoff so as to reduce and combat erosion would need to be an important element of the development.

The impact of greatest potential concern regarding the Sun Garden PV facility would be the location of parts of the facility on a fairly steep slope with soils that appear to have high erodibility. The panels would generate a lot of run off and combined with the high levels of disturbance that would occur after construction, the potential for erosion problems at the site are high. Consequently, specific mitigation measures to reduce and manage erosion and runoff at the site are recommended. Specific input from a specialist with experience in this field should be used to reduce potential erosion impacts at the site and the recommended measures would need to be integrated into the design and construction of the facility.

- The facility must have a detailed runoff and erosion management plan that takes account of the vulnerability of the area to erosion damage. This should be developed with input from a specialist with specific experience in this regard.
