**ERASMUS PARK TOWNSHIP DEVELOPMENT, PRETORIA
SUPPLEMENTARY DOLOMITE STABILITY ASSESSMENT
ACROSS ZONE 2**

DATE January 2017

REFERENCE V16/099 – 5324

STATUS Draft – For Comment by CGS

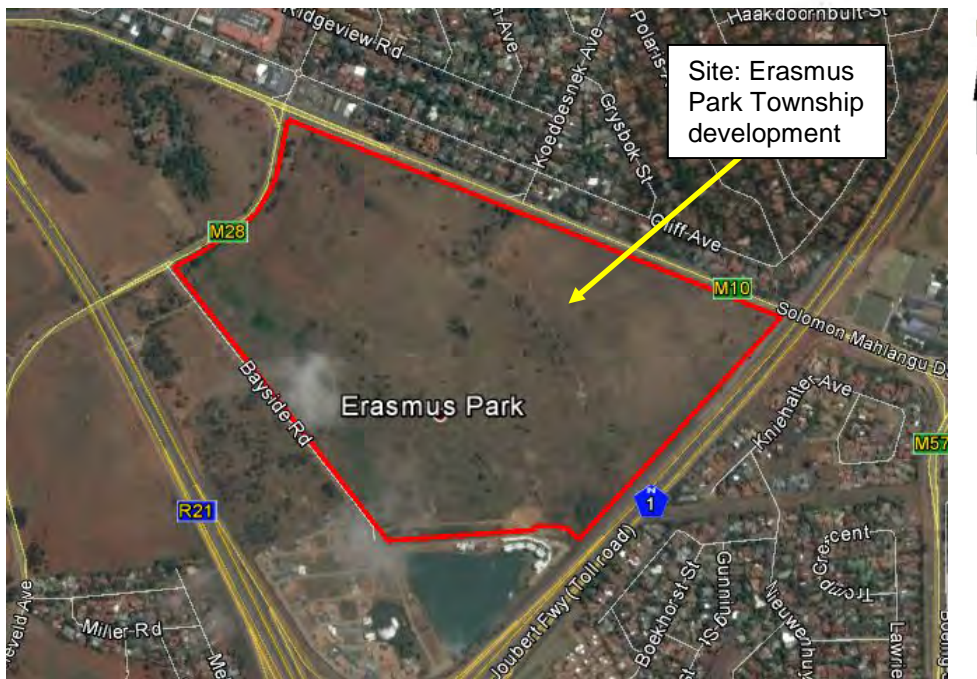
Figure 2: GENERAL SITE LAYOUT

A locality plan is given in **Figure 1** with the site indicated by the red box. A general site layout is given in **Figure 2**.
