**Date:** 23 November 2017

**Ref:** SAS 217167

## **RE: FRESHWATER RESOURCE VERIFICATION FOR THE PROPOSED BEZUIDENHOUT VALLEY CLINIC UPGRADE IN BEZUIDENHOUT VALLEY, JOHANNESBURG, GAUTENG**

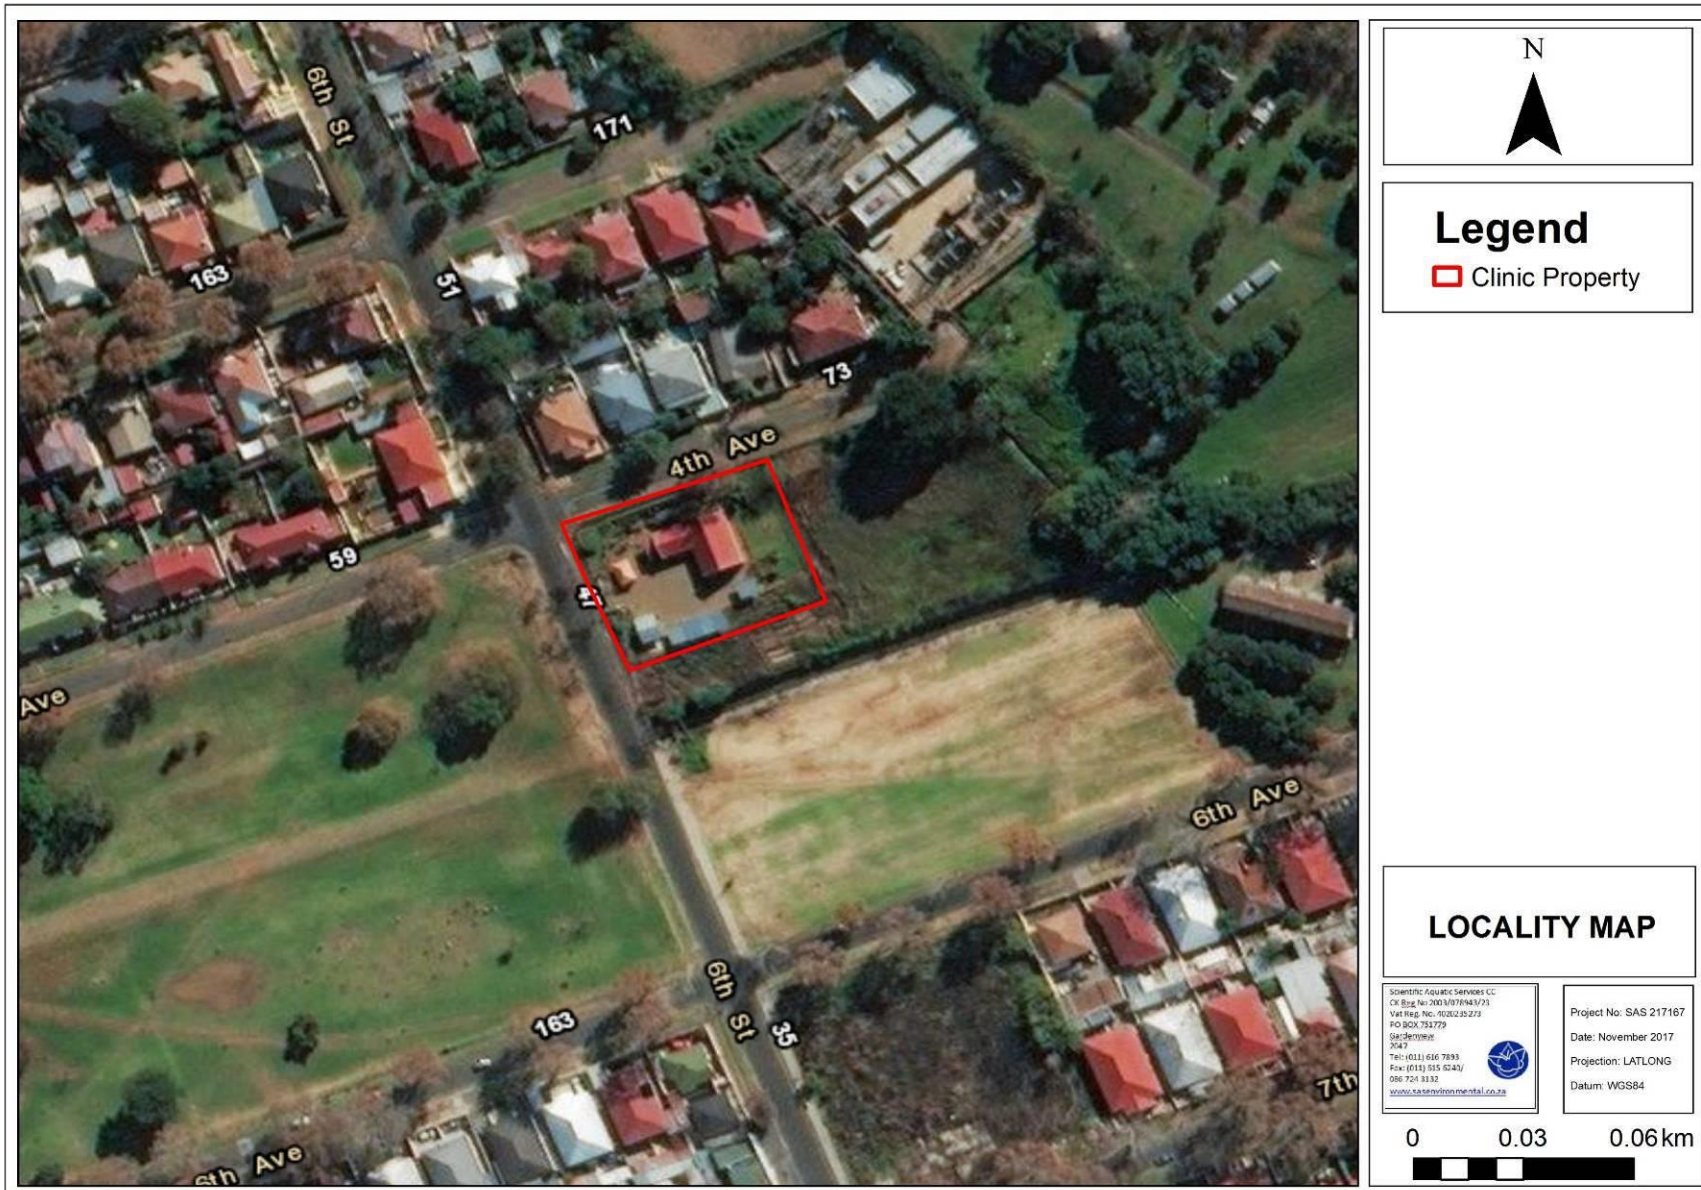
Figure 1: Digital satellite image depicting the location of the existing Bezuidenhout Valley clinic in relation to surrounding areas.

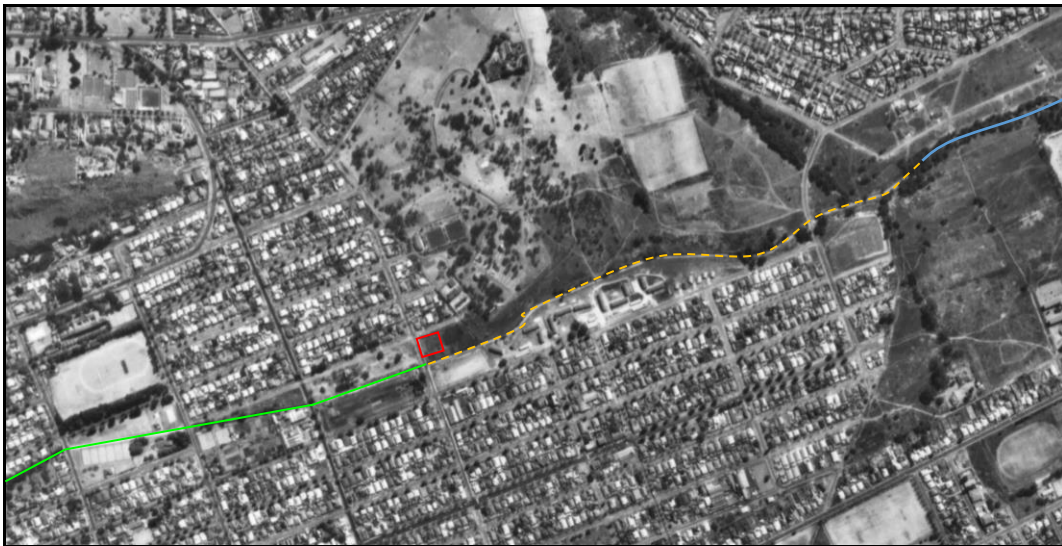
**Figure 3: Historical imagery (circa 1962), indicating the extensive residential development surrounding the Bezuidenhout Valley Clinic property (red square), the canalised portion of the Jukskei River (orange line) joining to the natural watercourse (blue line). The green line indicates an underground portion of the canal which daylights at the south-western corner of the clinic property.**

1. Appendix B presents the drainage of the larger area conceptually overlaid on a digital satellite image. The following key points are highlighted:
  - a. The area surrounding the existing clinic saw widespread development which is already evident in aerial photography taken in the early 1960's (Figure 3). This indicates that even at this point in history the drainage of this area was formally canalised as part of the stormwater management of the area;

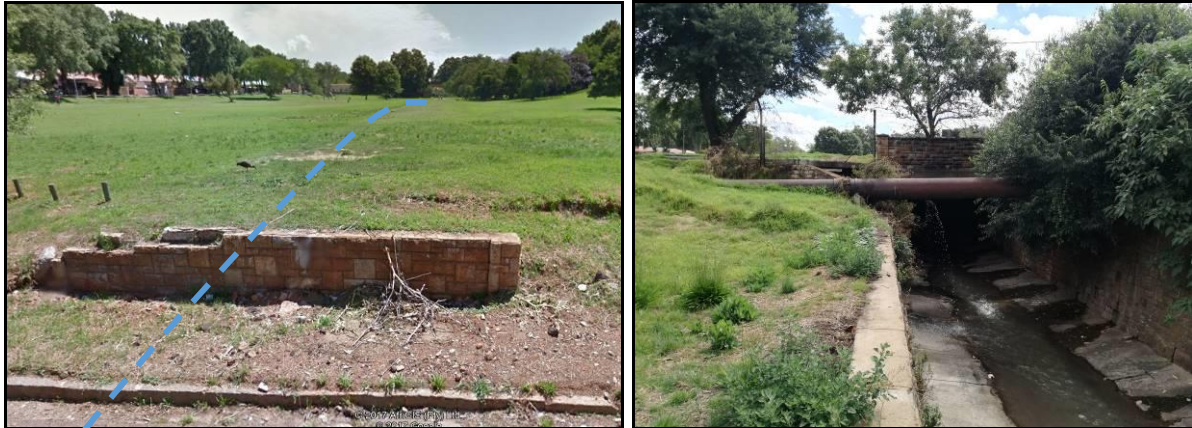
**Figure 4:** Left: The area west of 6<sup>th</sup> Street where the canal is underground (blue line), before it daylights to the east of 6<sup>th</sup> Street. Right: The canal daylights east of 6<sup>th</sup> Street, south to the clinic property (located to the right in this photograph).

- c. Downgradient to the south-west of the clinic property, the system daylights into the open canal (Figure 4) which is located to the south of the clinic property within an open space area (Figure 5);

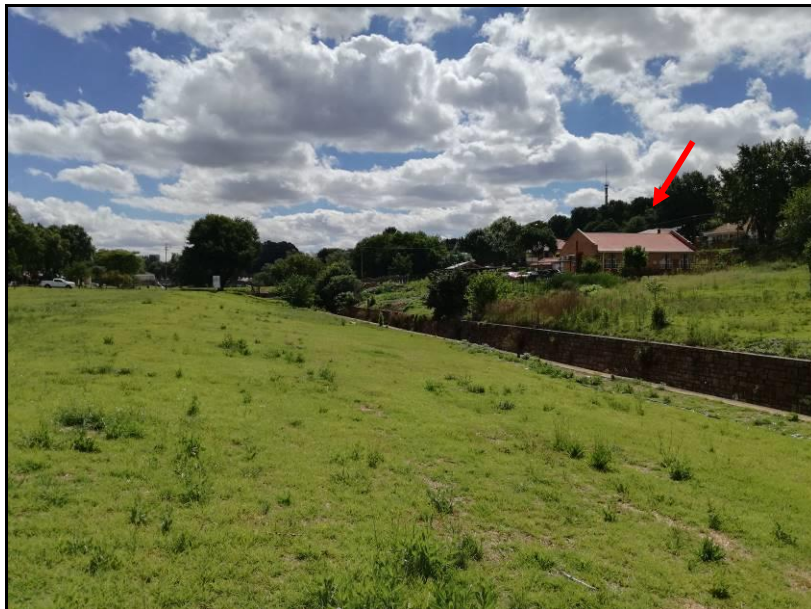
**Figure 5:** The formalised canal, located within an open space area, south of the clinic property (red arrow).

2. No natural vegetation associated with wetlands or riparian zones of watercourses was present alongside the concrete canal. The open space area (south of the canal) has been shaped and is dominated by Kikuyu grass (*Pennisetum clandestinum*), and alien grass species. On the western side of the canal (east of the clinic property) a vegetable garden has been established, whilst the remaining area is dominated by alien invasive species and terrestrial vegetation;

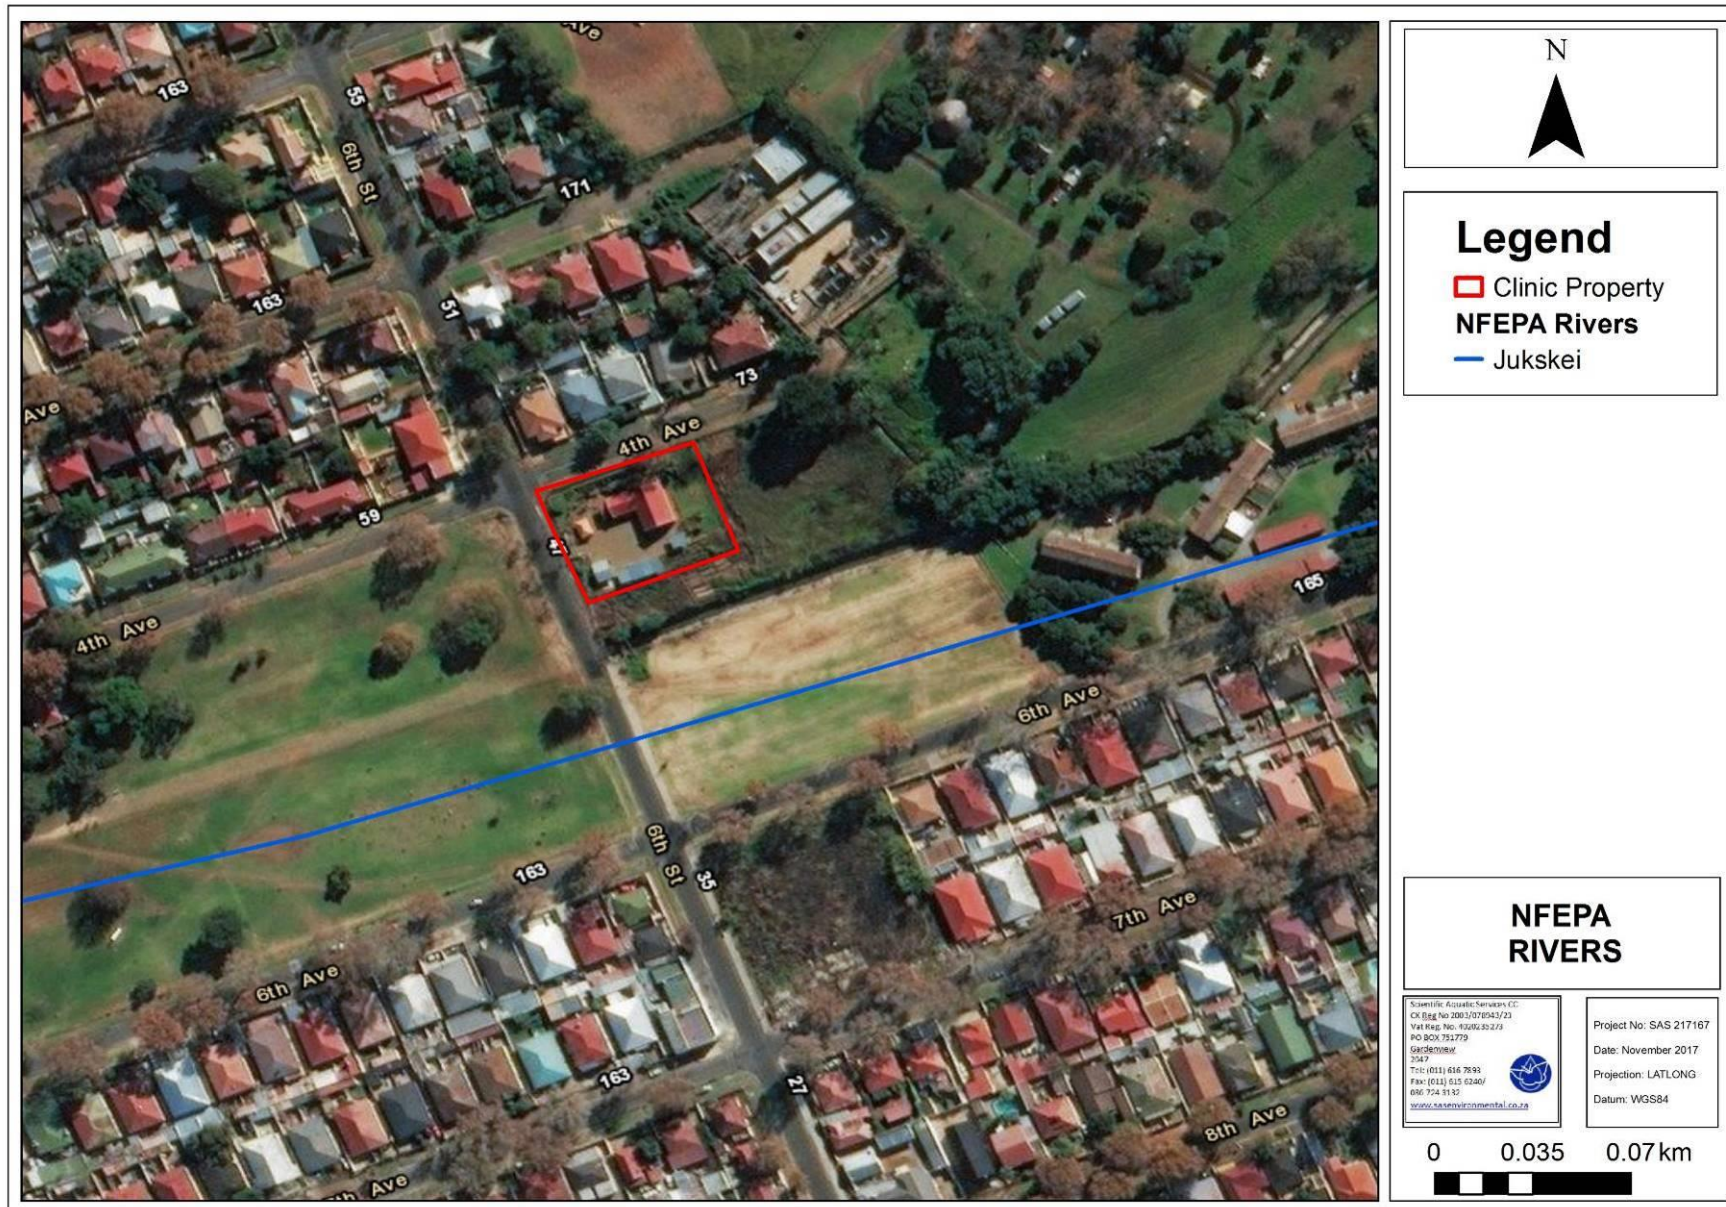
Figure A1: The locality of the Jukskei River south of the clinic property, as identified by the NFEPA (2009) database.

Dominant primary terrain morphology	Plains; Low Relief	NFEPA Rivers (Figure A1)	The Jukskei River is situated approximately 500m south of the clinic property and is indicated by NFEPA to be in a largely modified (Class D) ecological condition.
Dominant primary vegetation types	Rocky Highveld Grassland		
	Mixed Bushveld	Detail of the clinic property in terms of the Gauteng Conservation Plan (C-Plan V3.3, 2011) (Figure A1 & A2)	
Altitude (m a.m.s.l)	1300-1900	Critical Biodiversity Area (CBA)	No CBA is located within close proximity to the clinic property. A CBA is located approximately 6.2km north west of the clinic property. A CBA is an area considered important for the survival of threatened species and includes valuable ecosystems such as wetlands, untransformed vegetation and ridges.
MAP (mm)	500 to 700		
Coefficient of Variation (% of MAP)	20 to 34		
Rainfall concentration index	55 to 64	Ecological Support Area (ESA) (Figure A2)	The clinic property as well as the area south thereof, is considered to be part of an ESA. An ESA provides connectivity and important ecological processes between CBAs and is therefore important in terms of habitat conservation

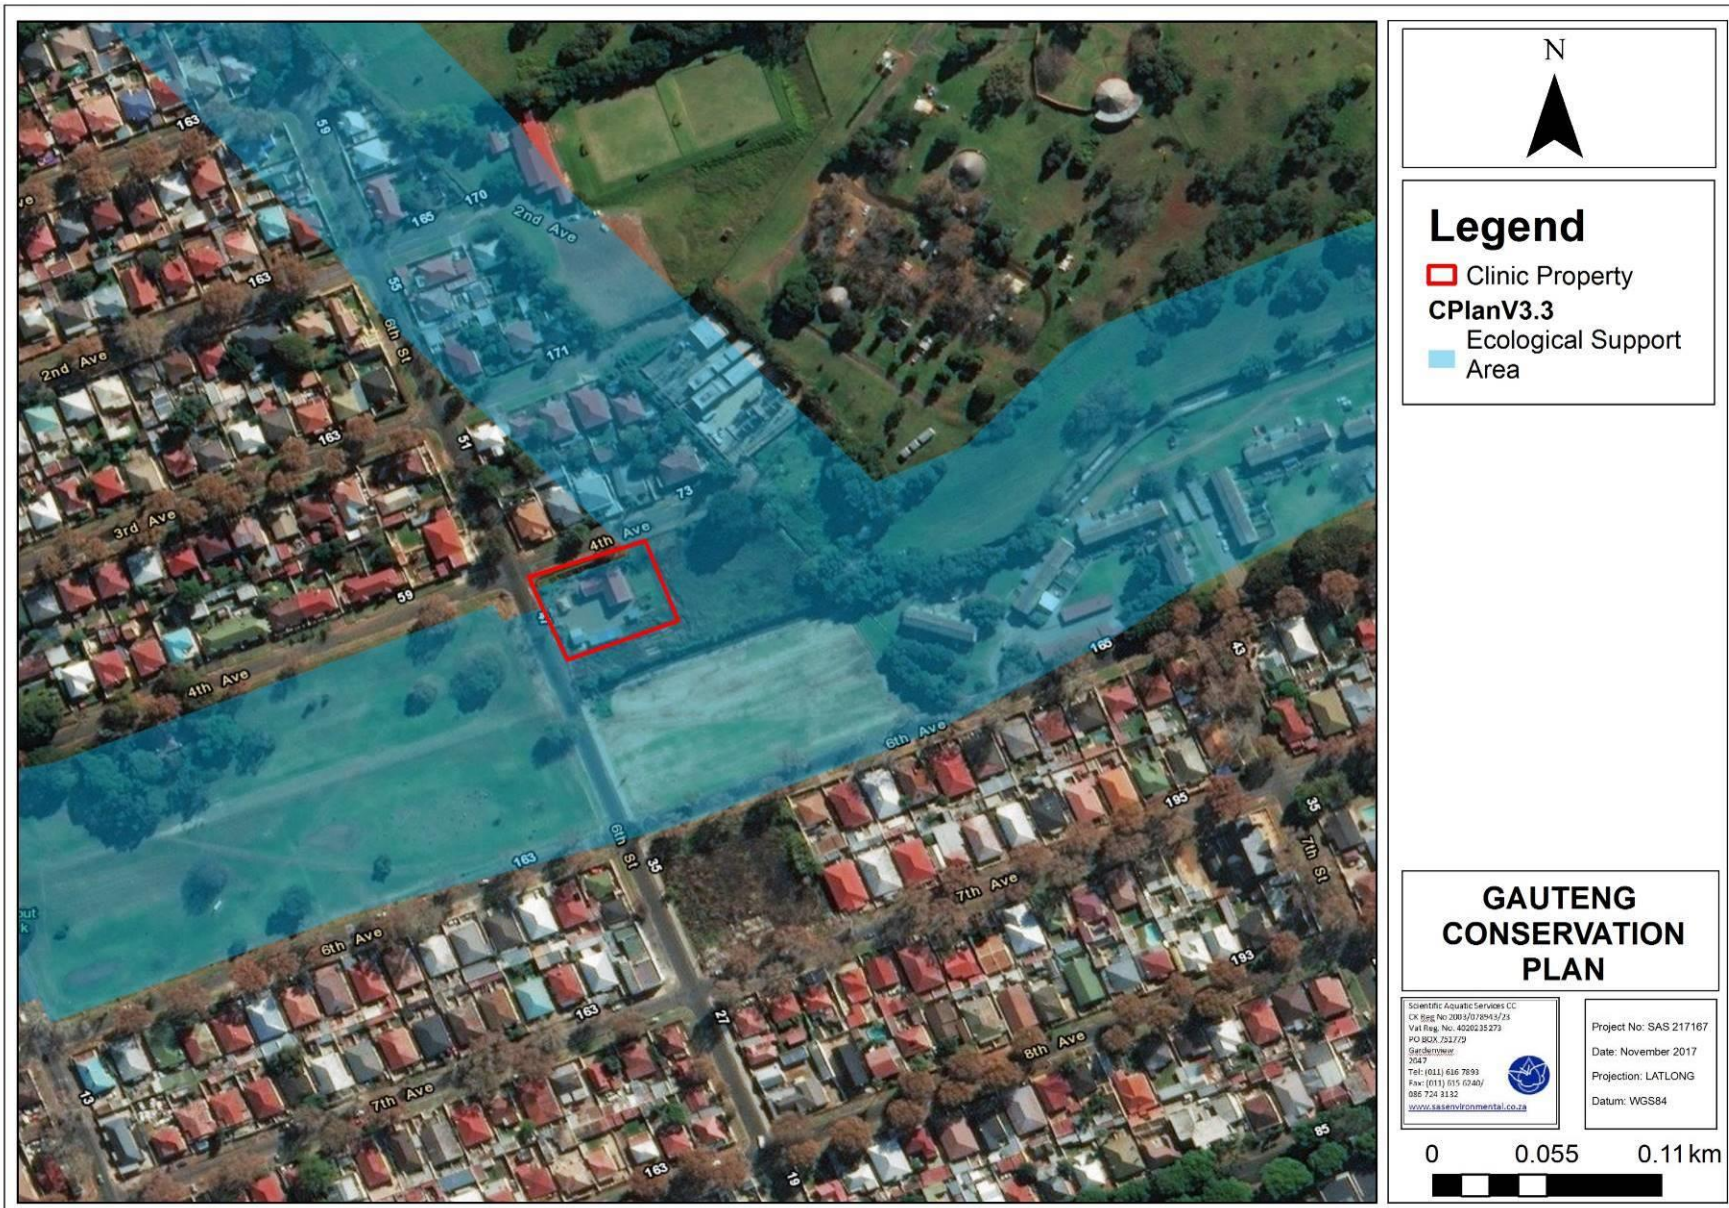
Figure A2: The Critical Biodiversity associated with the clinic and surrounding area, according to the Gauteng C-Plan (2013).

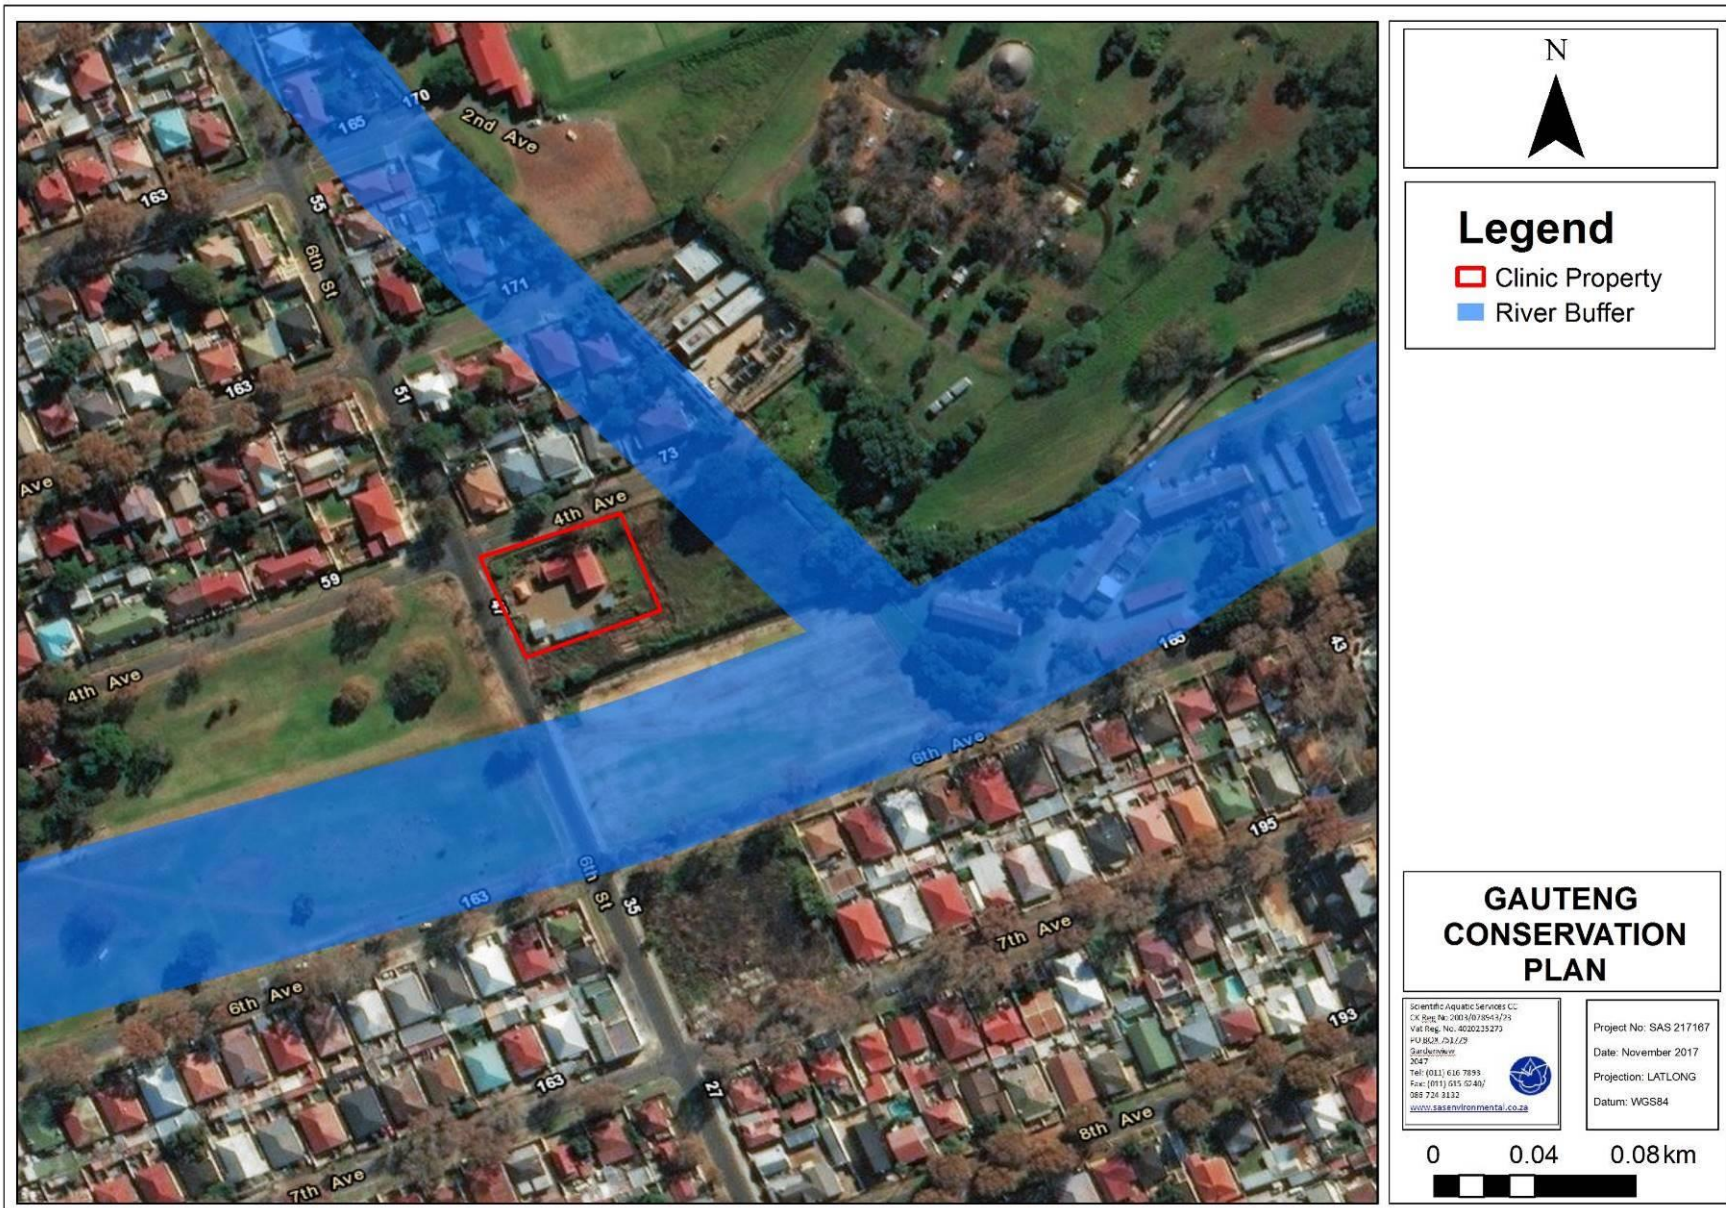
Figure A3: The River Buffer associated with the clinic and surrounding area, according to the Gauteng C-Plan (2011).
