# **DRAFT WETLAND HABITAT & TERRESTRIAL VEGETATION IMPACT ASSESSMENT**

APPLICATION FOR A SECTION 24(G) ENVIRONMENTAL AUTHOIRSATION  
FOR THE MIDWAY TRUCK STOP, ESTCOURT WITHIN INKOSI  
LANGALIBALELE LOCAL MUNICIPALITY, KWAZULU-NATAL PROVINCE

JOB NUMBER TC2101 | VERSION 1.0

29 June 2021

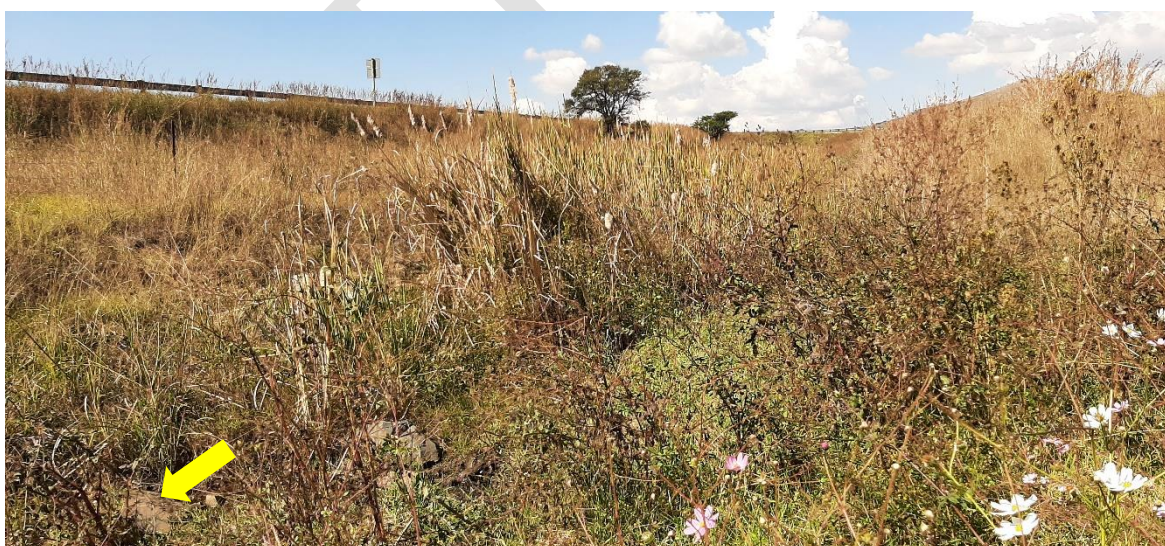
**Photo A1:** General view looking upstream of Wetland Unit CVB1. Flow directions are indicated using a yellow arrow.

Water inputs are mainly concentrated flows from upstream supplemented by stormwater from the road infrastructure. Water moves through and exits the wetland largely as concentrated flows. Soil sampling within the wetland habitat confirmed anaerobic conditions in the form of orange soil mottles with a grey soil matrix.

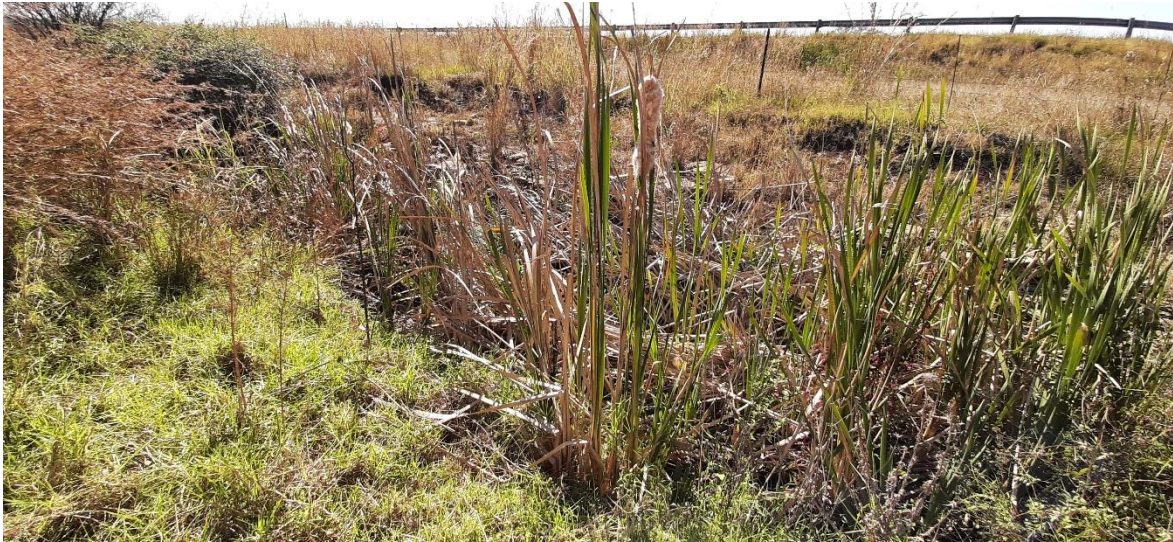
**Photo A2:** *T. capensis* (Common Bulrush) growing within the core wetland habitat.

Wetland vegetation was identified as herbaceous community comprising a mix of grasses and bulrushes. The core wetland habitat was dominated by *Typha capensis* (See photograph A2), a bulrush that only grows in wetland habitats particularly seasonally and permanently saturated areas of the wetland habitat. Outer areas were dominated by a mix of grasses and small sedges. Common species recorded include *Paspalum urvillei*, *P. notatum*, *Cyperus sphacelatus* and *Cynodon dactylon*.

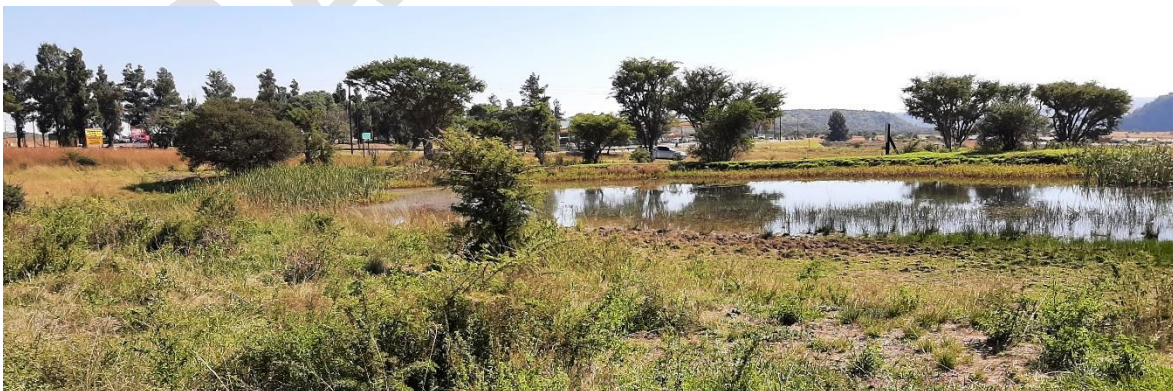
**Photo A3:** Artificial Dam (Unit AD2).

Wetland Unit CVB2 was classified as a natural occurring channelled valley bottom wetland. The wetland is situated below an in stream artificial dam (AD2) (See photograph A3). The wetland measures 320m long, 15m wide and has a longitudinal slope of 4.4%. This wetland is fed by seepage from below the dam wall (See photograph A4). Water moves through and exits the wetland as overland flow. Soil sampled from the top of the bank exhibited orange mottles within a grey soil matrix (See photograph A5).

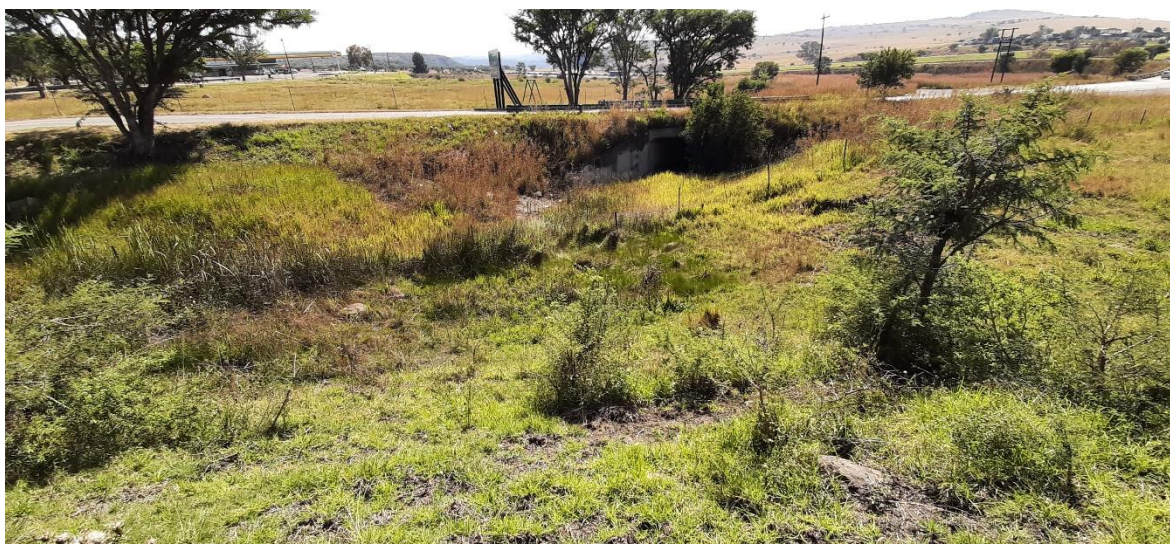
**Photo A4:** View over Wetland Unit CVB2 and towards the P170 Road (access road to the Midway Filling Station & Truck Stop). This photograph was taken from the top of the dam wall (AD2) looking downstream.

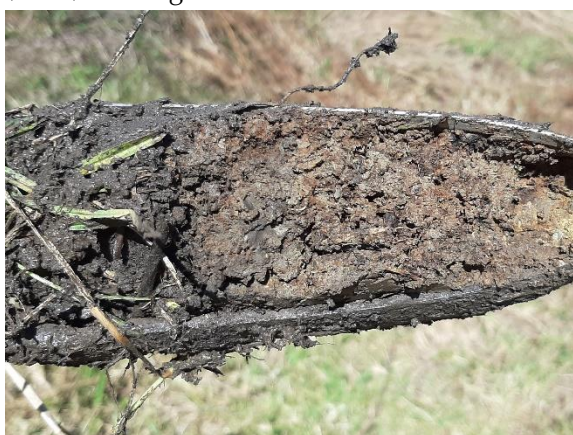
**Photo A5:** Soil sample extracted from Wetland Unit CVB2. Note high chroma orange mottles which are indicative of high soil saturation.

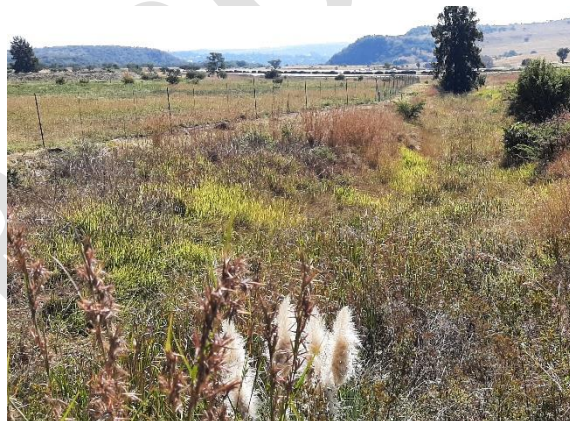
**Photo A6:** View of the wetland vegetation community occurring below the P170 Road.

Wetland vegetation was identified as herbaceous community comprising a mix of grasses, sedges and forbs (See photograph A6). Common species recorded include *Sporobolus pyramidalis*, *P. urvellei*, *P. dilatatum*, *P. notatum*, *T. capensis*, *C. congesta*, *Hyparrhenia tamba*, *C. dactylon* and *Verbena bonariensis*.

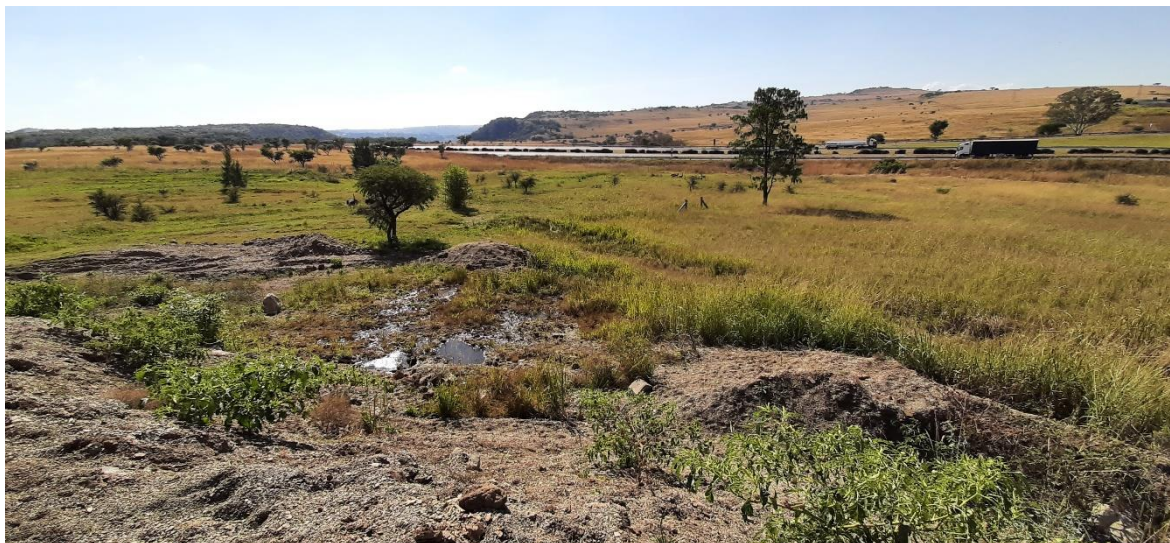
**Photo A7:** View over Wetland Unit AW1 and towards the N3 highway. The wetland area occupies the central portion of the photograph from the foreground to the N3 highway. This photograph was taken from the top of the dam wall (AD1) looking downslope.

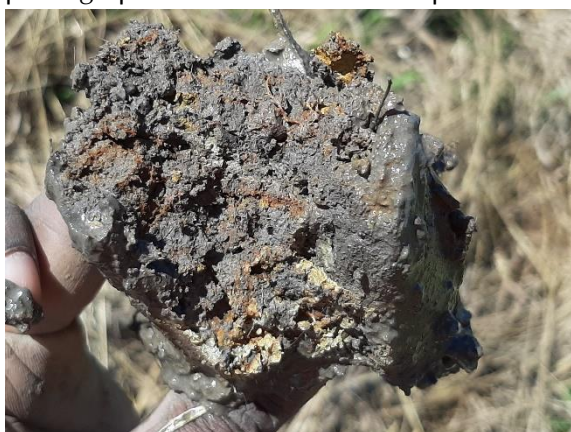
**Photo A8:** Soil sample extracted from the lower section Wetland Unit AW1. Note high chroma orange mottles within a grey soil matrix which are indicative of high soil saturation.

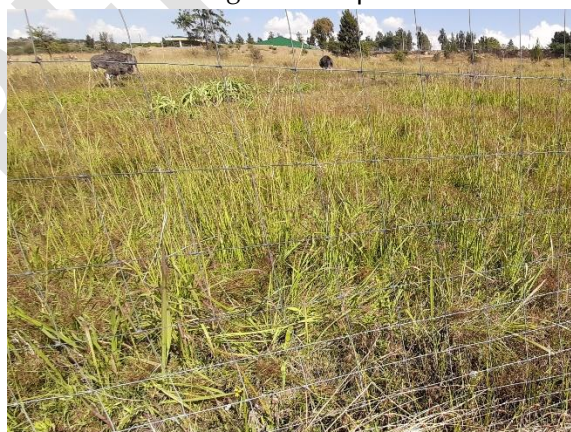
**Photo A9:** View of the vegetation community within Wetland Unit AW1.

Wetland vegetation was identified as a hygrophilous grassland comprising a mix of grasses,

sedges and forbs (See photograph A9). Common species recorded include *Aristida congesta*, *P. urvellei*, *P. dilatatum*, *P. notatum*, *Cyperus congesta*, *C. dactylon* and *Hypoxis hemerocallidea*.

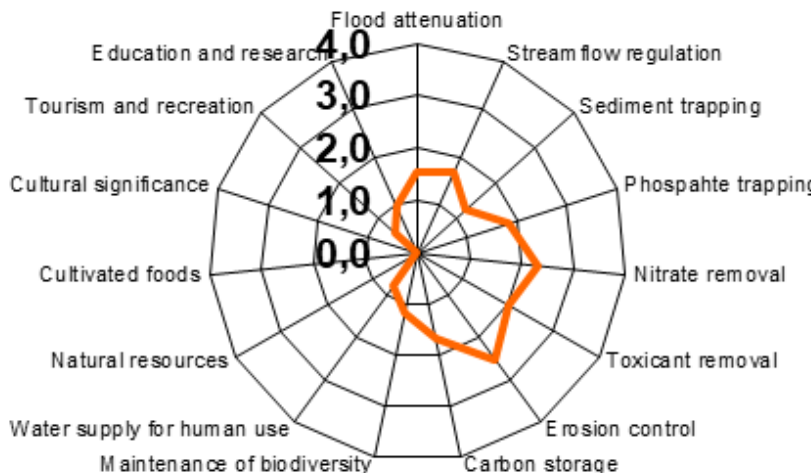
<p><b>Figure 4.2:</b> Ecosystem services scores for Wetland Unit CVB1 presented using a spider diagram.</p>

Item	Score	Impact Description / Rationale
PES	6.1 E PES Class	<b>PES: Seriously Modified</b> Wetland Unit CVB1 was evaluated as Seriously Modified owing to major catchment and within-wetland impacts. Key impacts driving the score include (i) damming on flows upstream of the catchment which has resulted in reduced water inputs, (ii) increased stormwater inputs which has resulted in increased flood peaks and channel incision, (iii) habitat infilling and transformation linked with road infrastructure development, and (iv) channel modification / straightening to make way for the N3 highway.
EIS	1.67 Moderate	<b>EIS: Moderate</b> A score of 1.67 indicated that Wetland Unit CVB1 was of moderate EIS. The score was driven largely by its ecological sensitivity. The wetland was assessed as particularly sensitive to changes in floods and changes to low flows.
Ecosystem Services	N/A	<p>The most notable ecosystem services provided by Wetland Unit CVB1 included stream flow regulation, phosphate trapping, nitrate removal, toxicant removal, erosion control and carbon storage (Figure 4.2).</p>

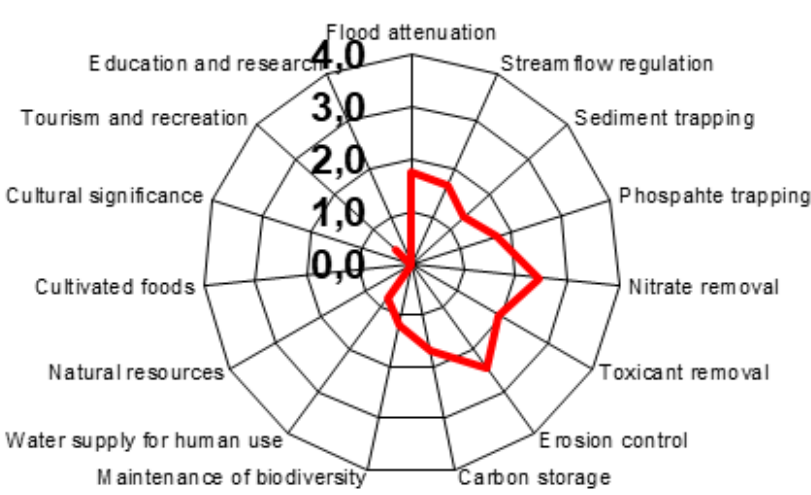
<p><b>Figure 4.3:</b> Ecosystem services scores for Wetland Unit CVB2 presented using a spider diagram.</p>

EIS	1.67 Moderate	<p><b>EIS: Moderate</b>                  Wetland Unit CVB2 scored 1.67 which indicated that it was of moderate EIS. The score was driven largely by its ecological sensitivity. The wetland was assessed as particularly sensitive to changes in floods and changes to low flows.</p>
Ecosystem Services	N/A	<p>Key ecosystem services provided by Wetland Unit CVB2 included flood attenuation, stream flow regulation, phosphate trapping, nitrate removal, toxicant removal, erosion control and carbon storage (Figure 4.3).</p>

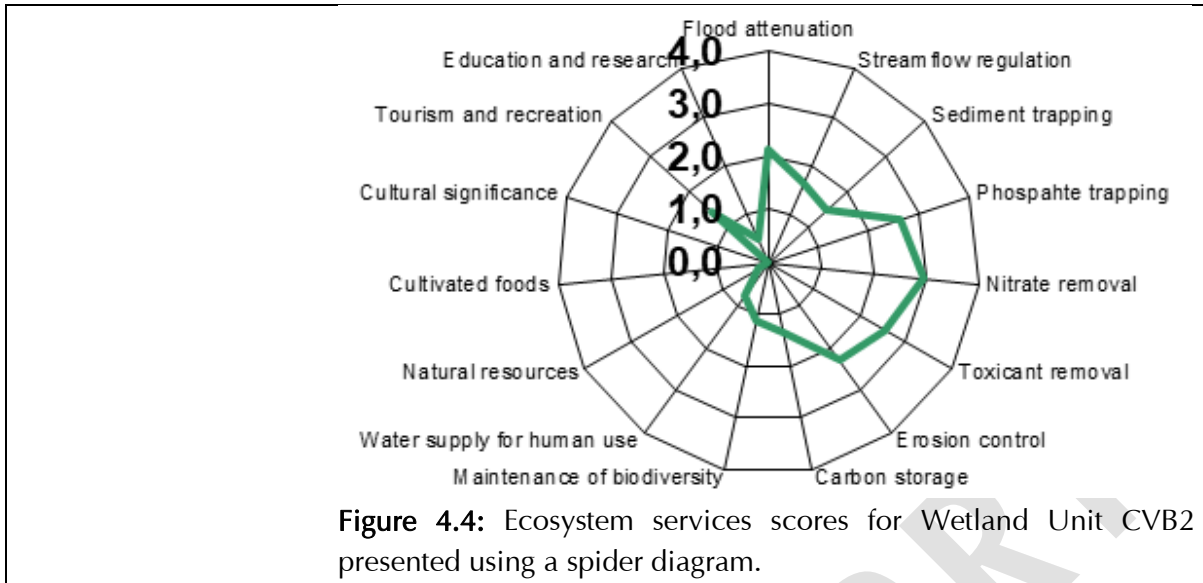
Item	Score	Impact Description / Rationale
PES	N/A	<p>The PES of Wetland Unit AW1 was not assessed because the wetland is artificial in nature. The WET-Health assessment tool used for assessing the PES of wetlands relies on the reference state of the wetland in order to assess the deviation of the wetland's health from its reference state as a way of determining its PES.</p>
EIS	1.5 Low	<p><b>EIS: Low</b>                  A score of 1.5 indicated that the artificial wetland (Unit AW1) was of low EIS and the score is largely attributed to both its ecological importance and ecological sensitivity. In addition to being sensitive to changes to low flows, the wetland harboured unique species such as Ostriches and Blesboks. It was also utilised as a feeding site by aforementioned game.</p>
Ecosystem Services	N/A	<p>Wetland Unit AW1 was assessed as notable at providing the following services; flood attenuation, streamflow regulation, phosphate trapping, nitrate removal, toxicant removal and erosion control (Figure 4.4).</p>

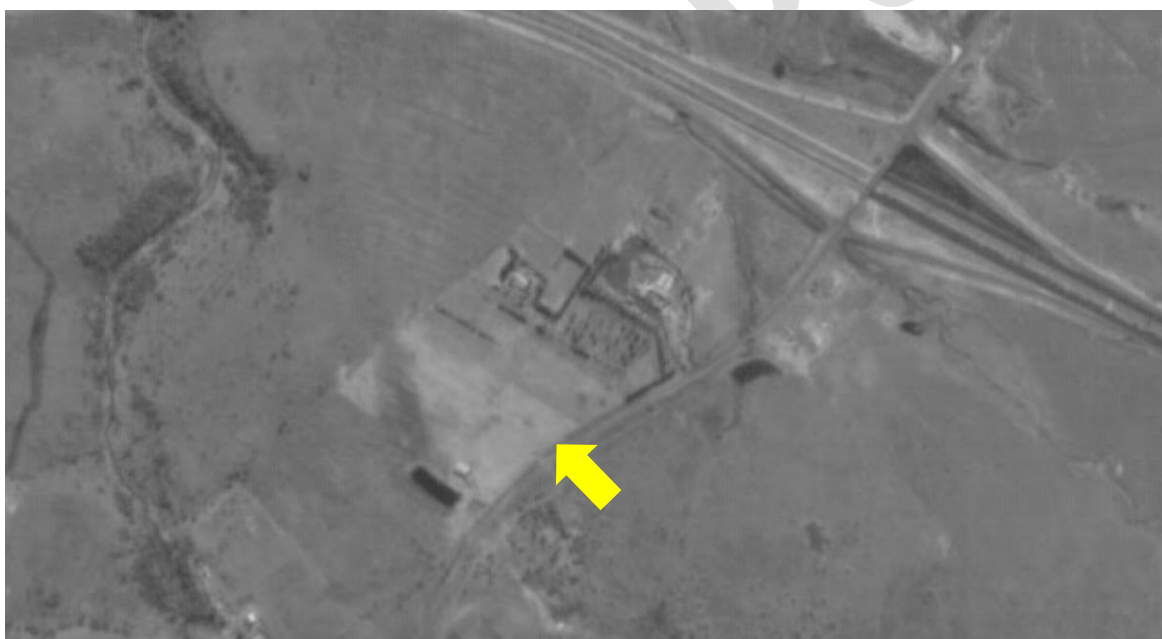
**Figure 5.1:** Historic aerial imagery of the study area with the area of interested pointed out using a yellow arrow. This photograph was taken on 17 August 2000 and it shows clear signs of cultivation, possibly pasture grass.

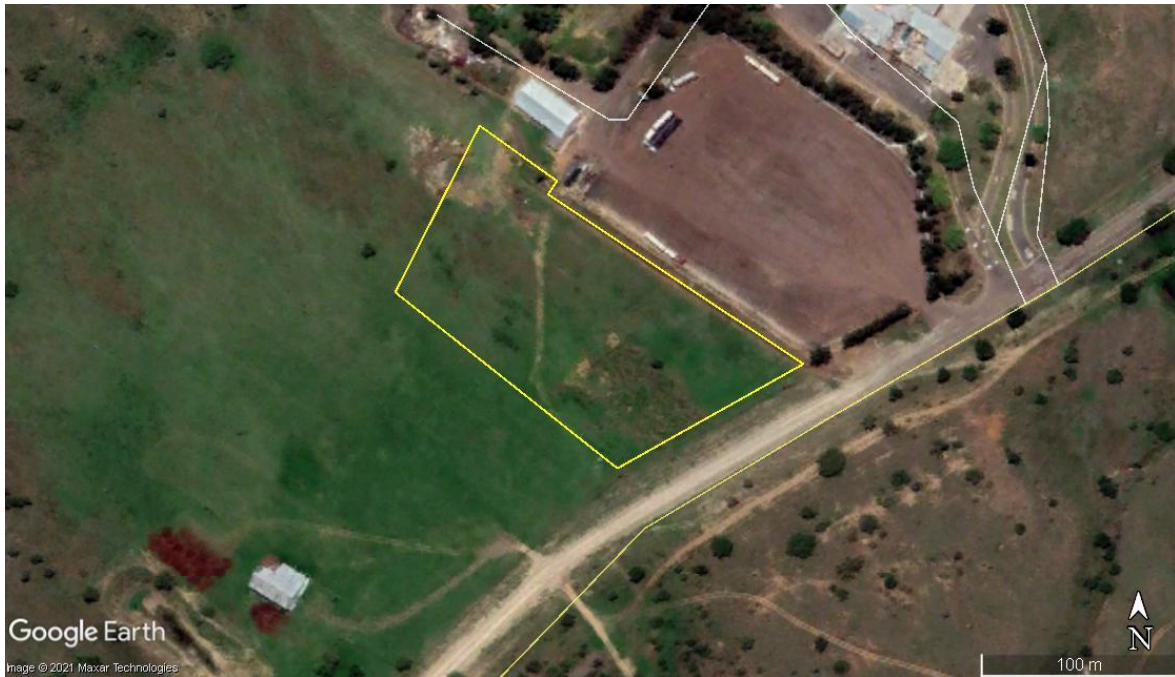
**Figure 5.2:** Google Earth aerial imagery taken in December 2019 (months before development of the site) with the truck stop footprint highlighted using a yellow polygon. Note that the site was undeveloped and the vegetation community within and around the development area was uniform.

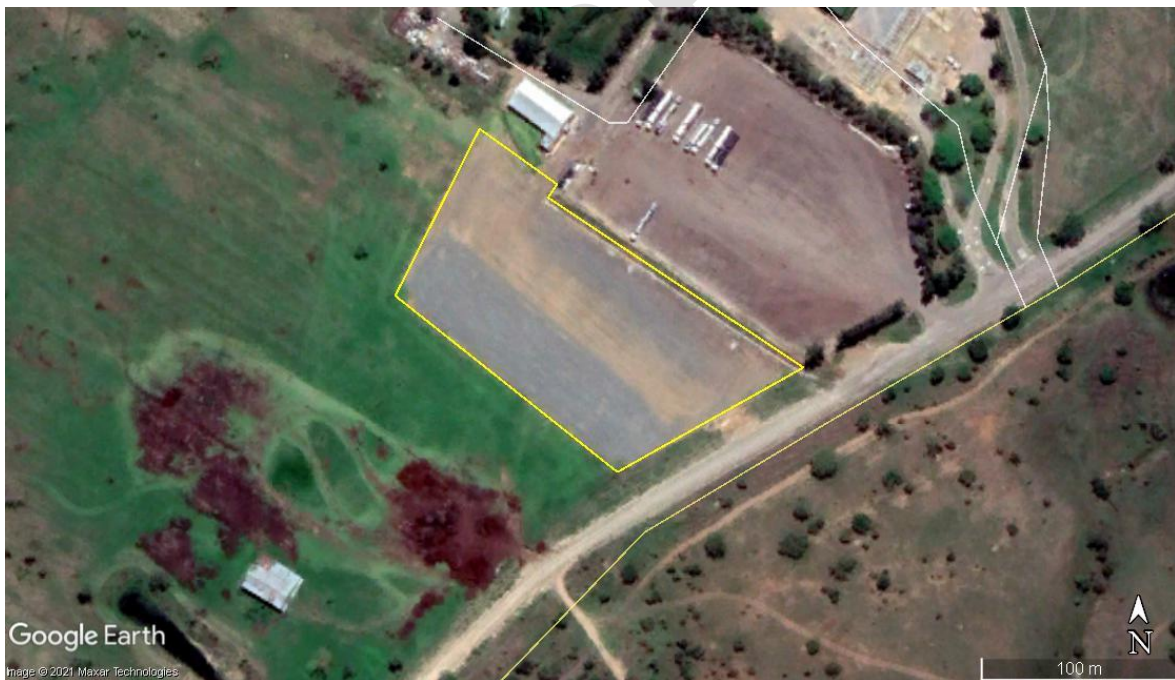
**Figure 5.3:** Google Earth imagery taken in November 2020 with the truck stop footprint highlighted using a yellow polygon. Note that the truck stop had been constructed.

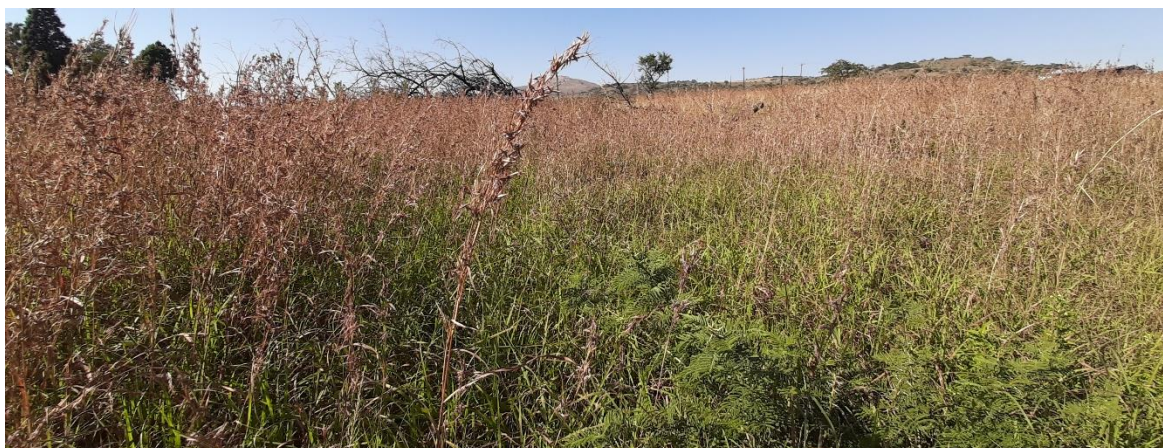
**Photo B1:** Monotypic stand of *H. tamba* found along the western boundary of the truck stop. In the foreground are a few *Acacia* saplings.

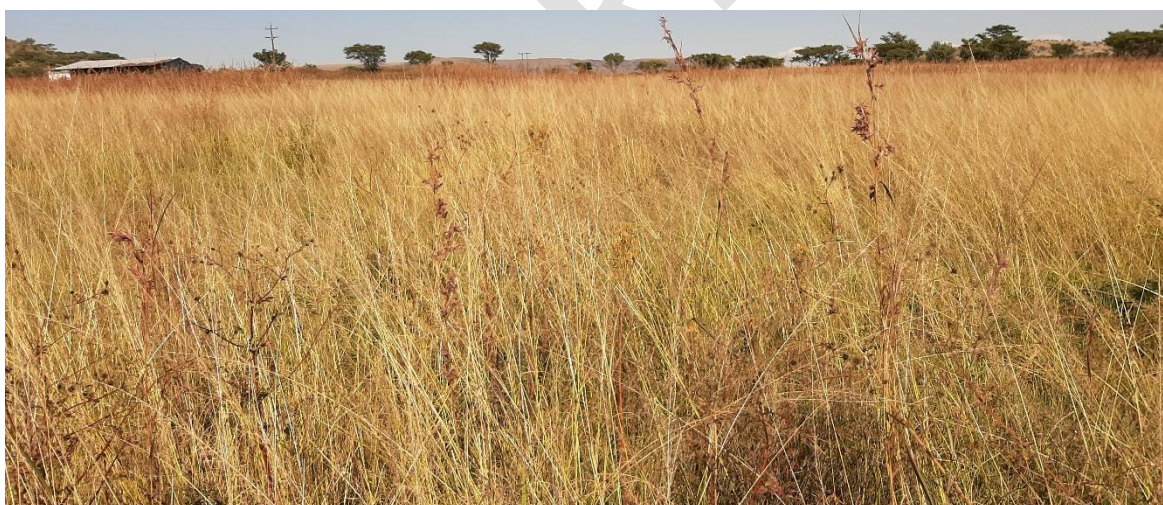
**Photo B2:** Monotypic stand of *S. pyramidalis* found along the western boundary of the truck stop. Note a few *H. tamba* species poking through in the foreground and a monotypic stand of *H. tamba* showing as a brown line in the background.

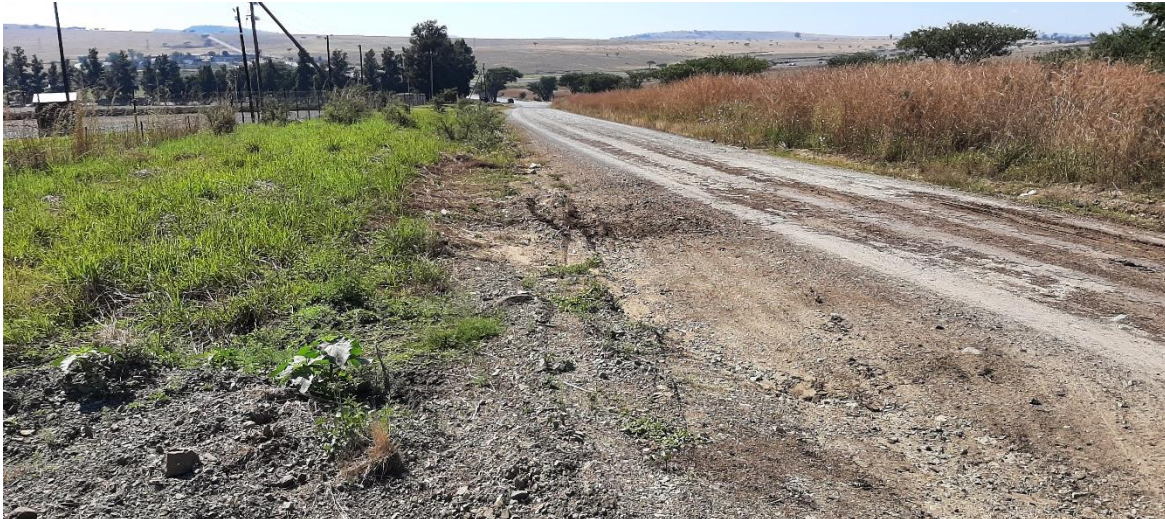
**Photo B3:** View of the road reserve. On the left is the mowed *H. tamba* mono typic stand adjoining the truck stop and on the right is the 2.3m tall monotypic stand of *H. tamba*.

Impacts to the grassland prior to construction of the truck stop were likely limited to trampling of the vegetation within footpaths. On the day of the field assessment, the grassland within the road reserve had been mowed.

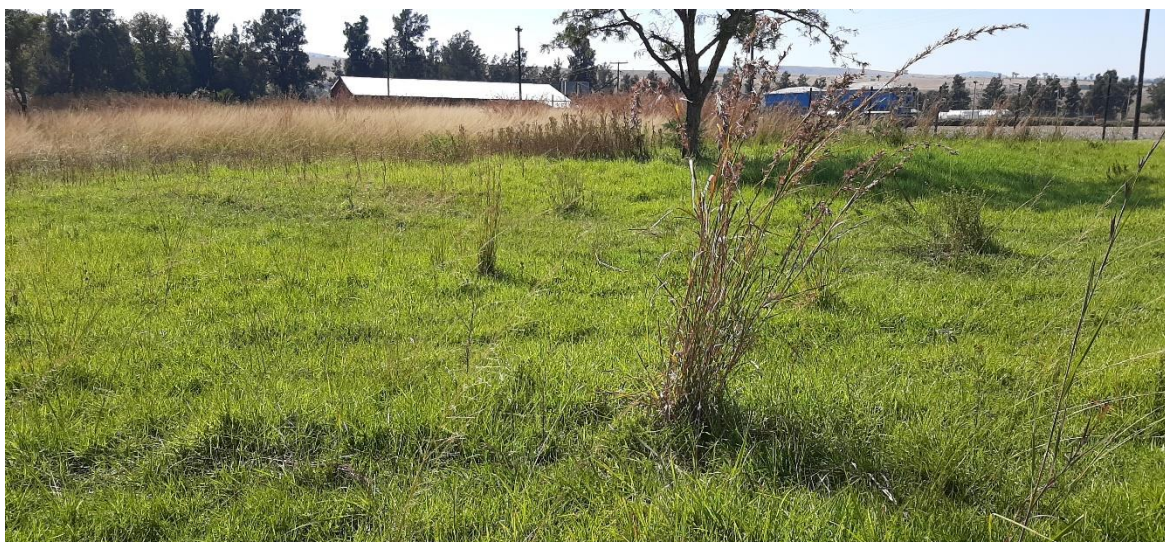
**Photo B4:** In the foreground is the Short Pasture Grassland and in the background in the Tall Secondary Grassland in the left corner and truck stop in the corner to the right-hand side.

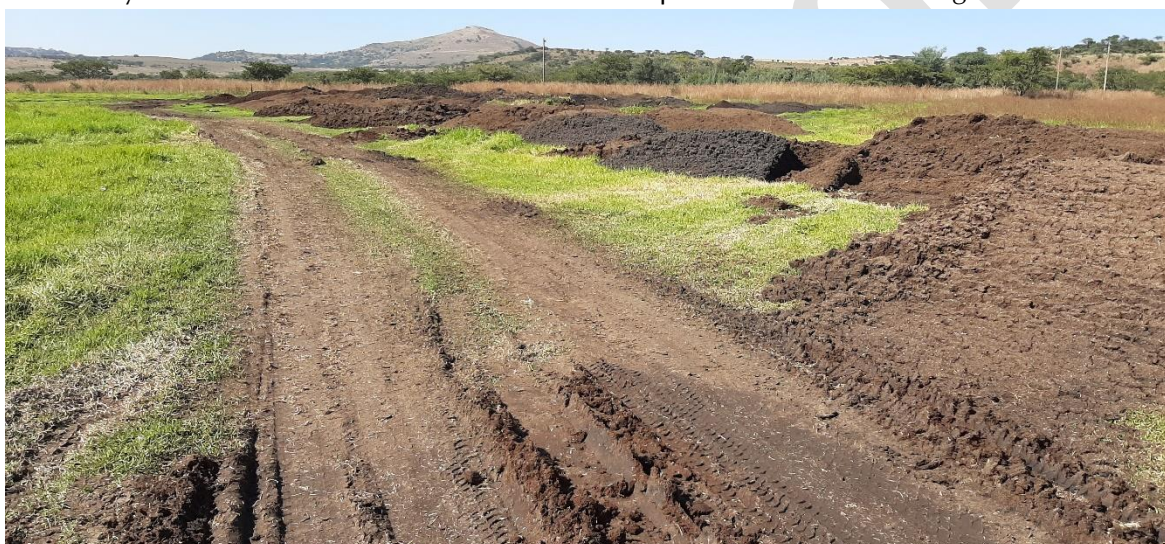
**Photo B5:** Recorded stockpiles within the Short Pasture Grassland adjoining the truck stop.

Impacts to the pastureland prior to the development of the site were likely limited to trampling within foot paths and limited dumping of rubble in the northern corner of the site.
