APPENDIX 6
PHOTOGRAPHIC DOCUMENTATION

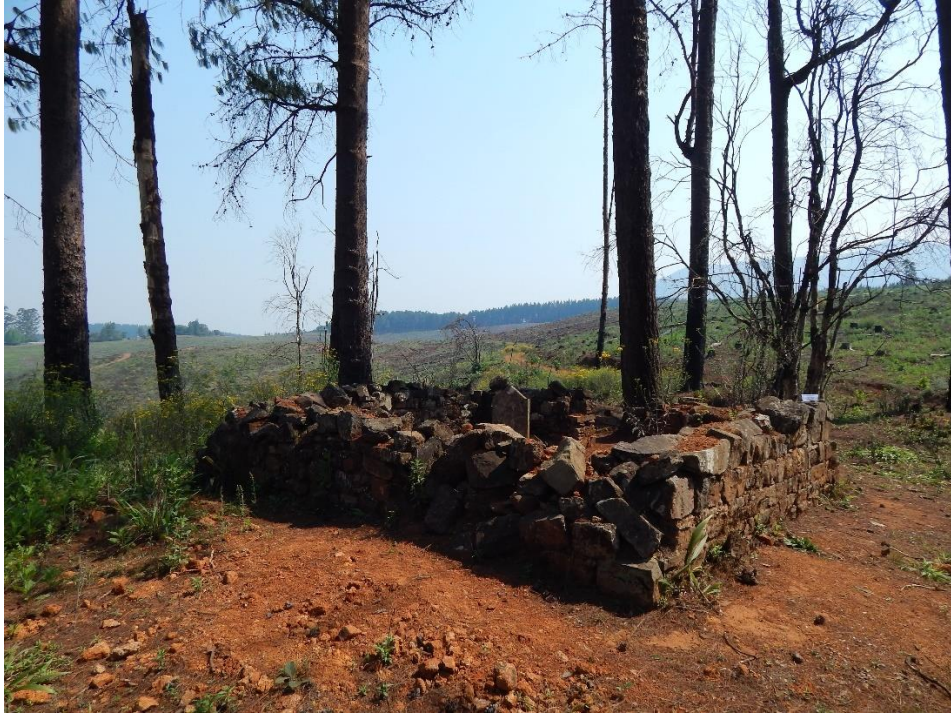
Fig. 1: The Maria Shires burial site is enclosed by a 5 x 5m stone wall, approximately 500mm wide. This structure is protected by the NHRA section 34.

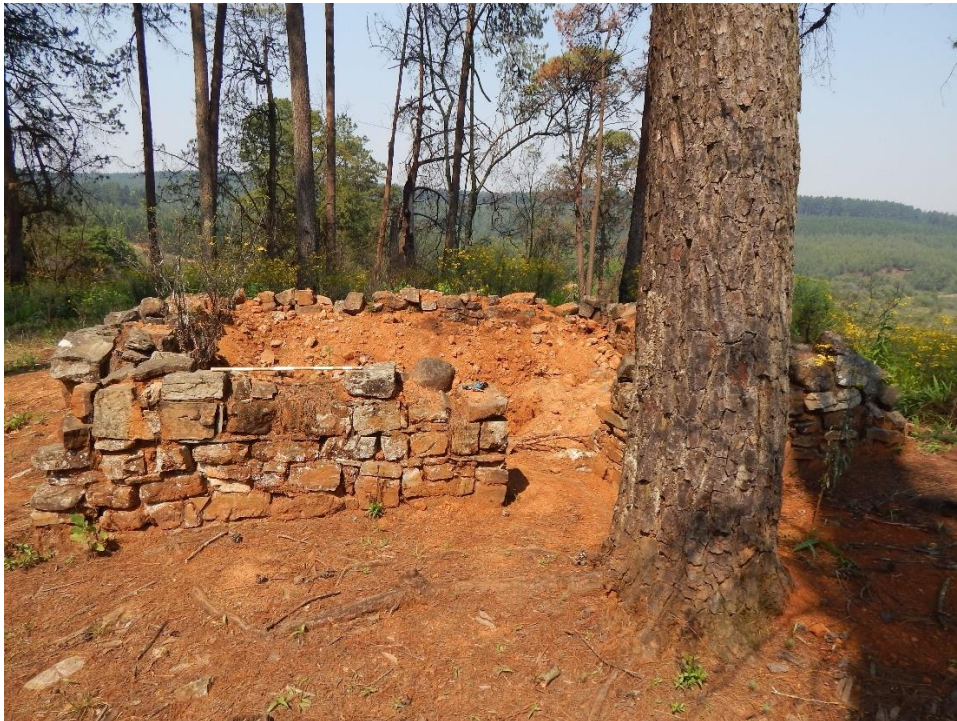
Fig. 2: The western wall where the entrance is located.

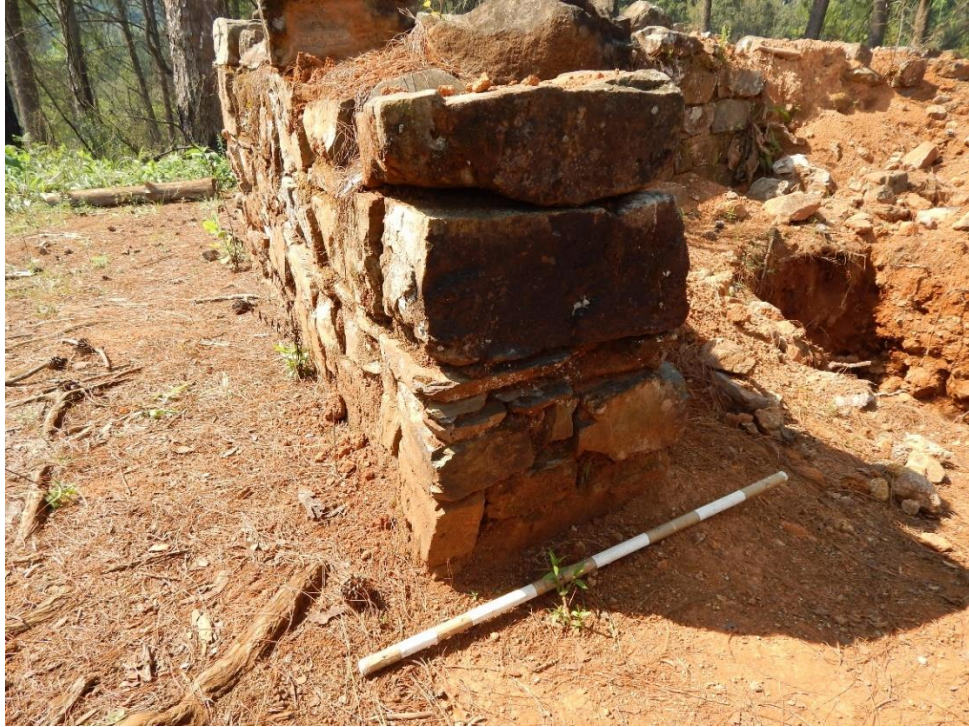
Fig. 3: The entrance to the burial site in the western wall. The wall is approximately 500mm wide.

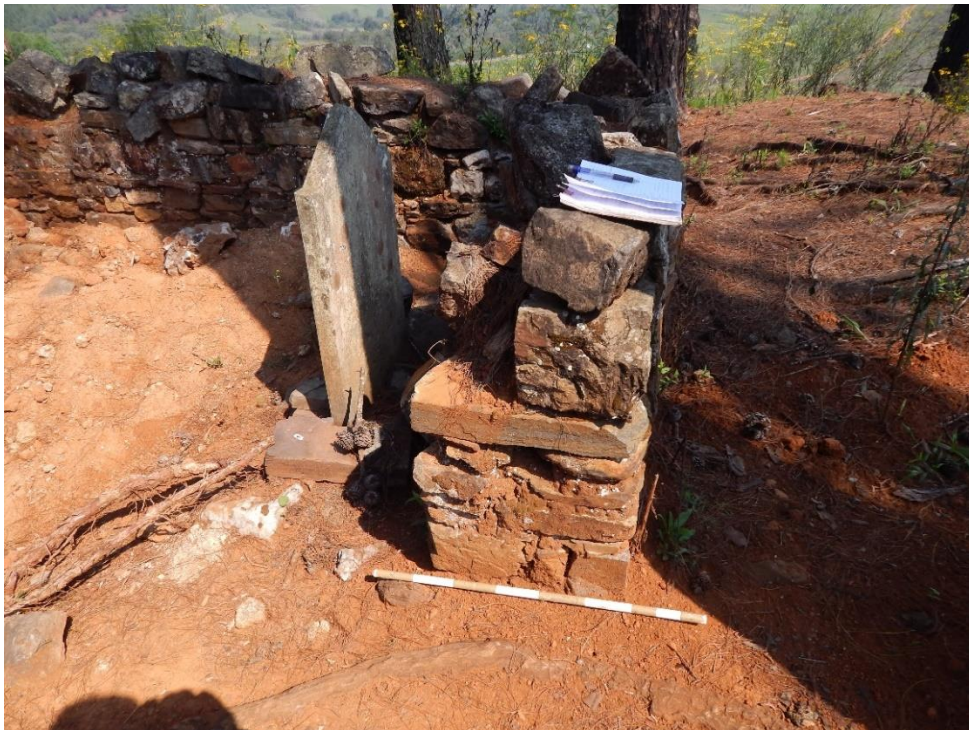
Fig. 4: The other side of the entrance. The headstone of Maria Shires' grave is visible to the left.

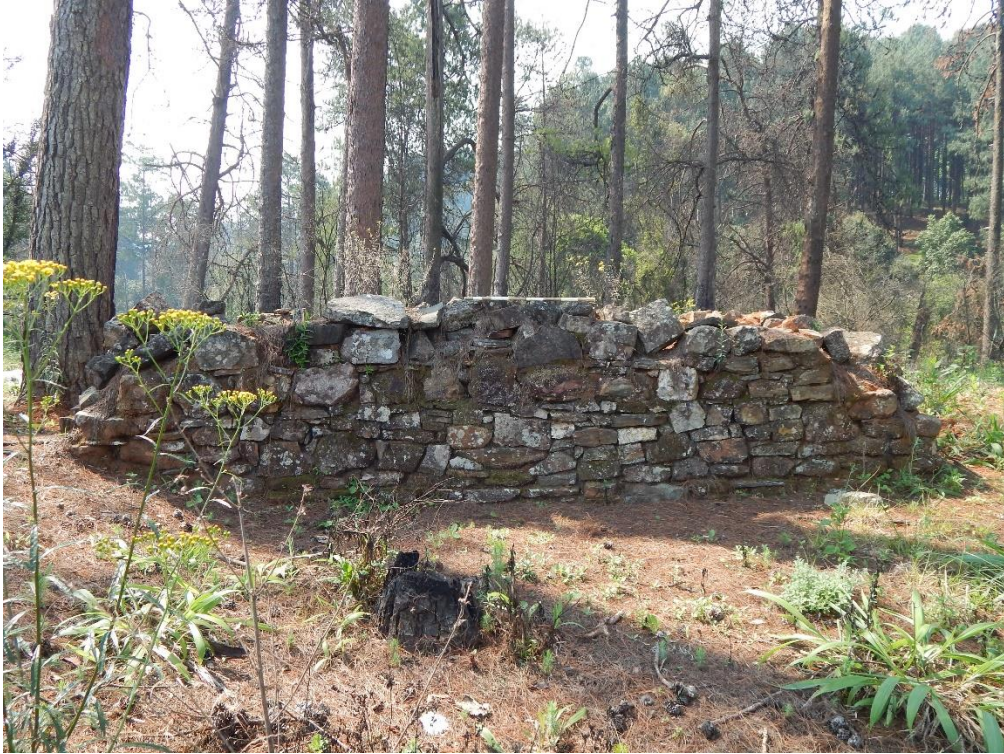
Fig. 5: The southern wall. Some damage occurred in this section, especially on the south-western and south-eastern corners.

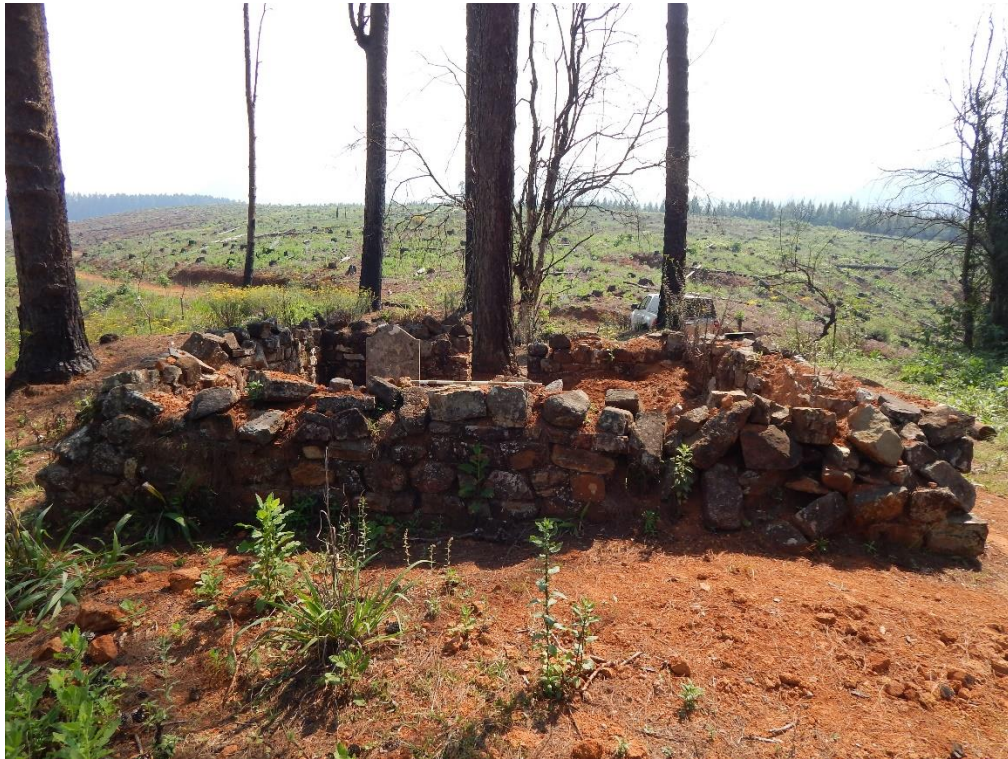
Fig. 6: The eastern wall has been damaged, mostly at the top. It is not clear if the damage happened simultaneously with the desecration of the graves in 2021.

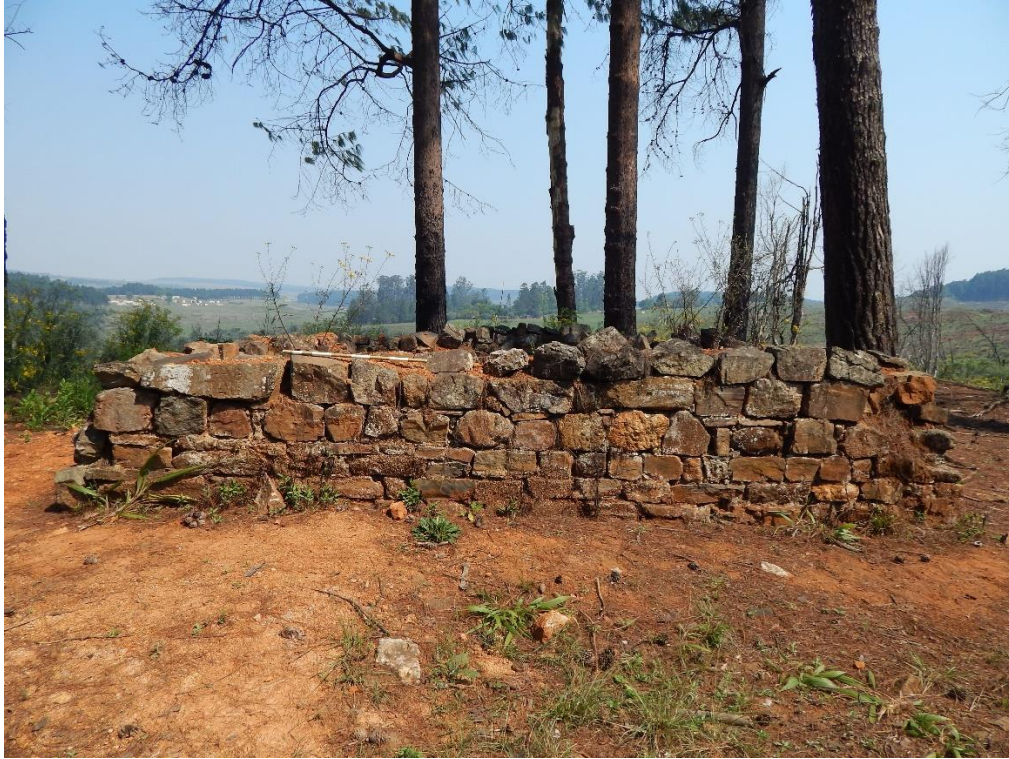
Fig. 7: The northern wall of the stone enclosure.

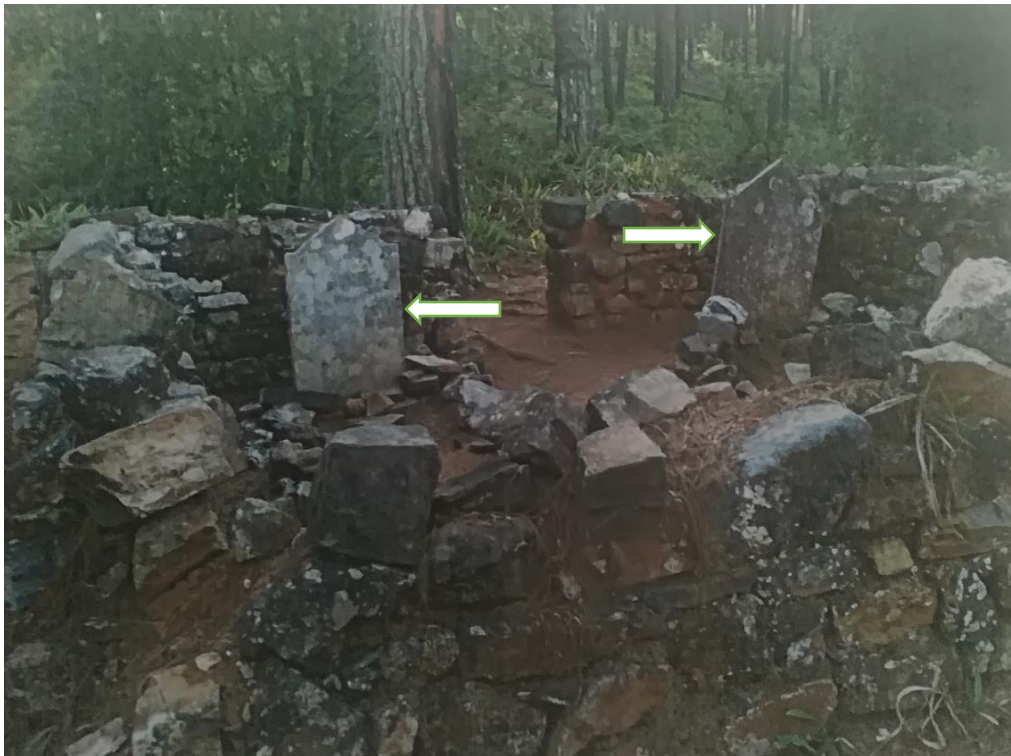
Fig. 8: The original position of the graves within the stone enclosure, before the desecration took place. The grave of Maria Shires is on the left (see arrow) and the grave of William Bowman on the right (see arrow).

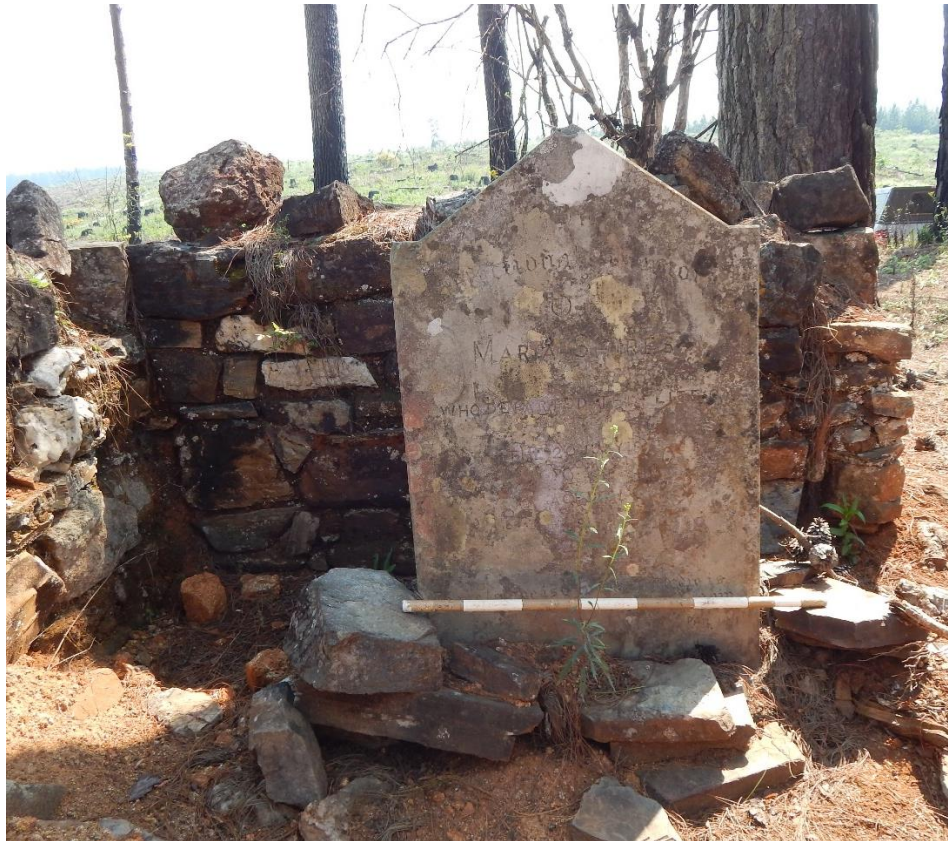
Fig. 9: The Maria Shires headstone, which is still in its original position.

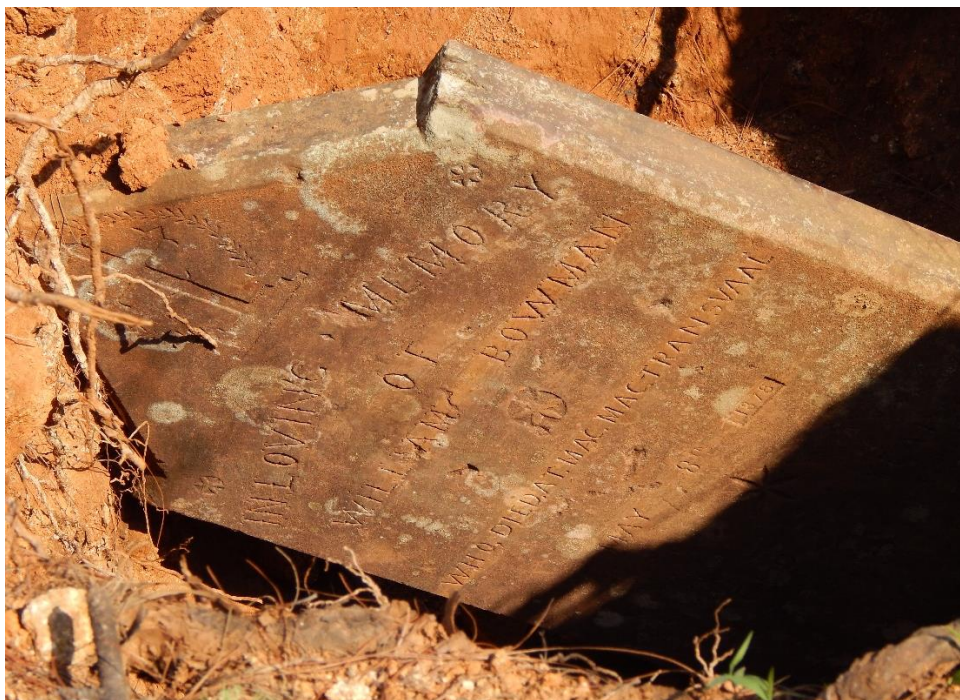
Fig. 10: The headstone of William Bowman's grave, which has been removed from its original position.

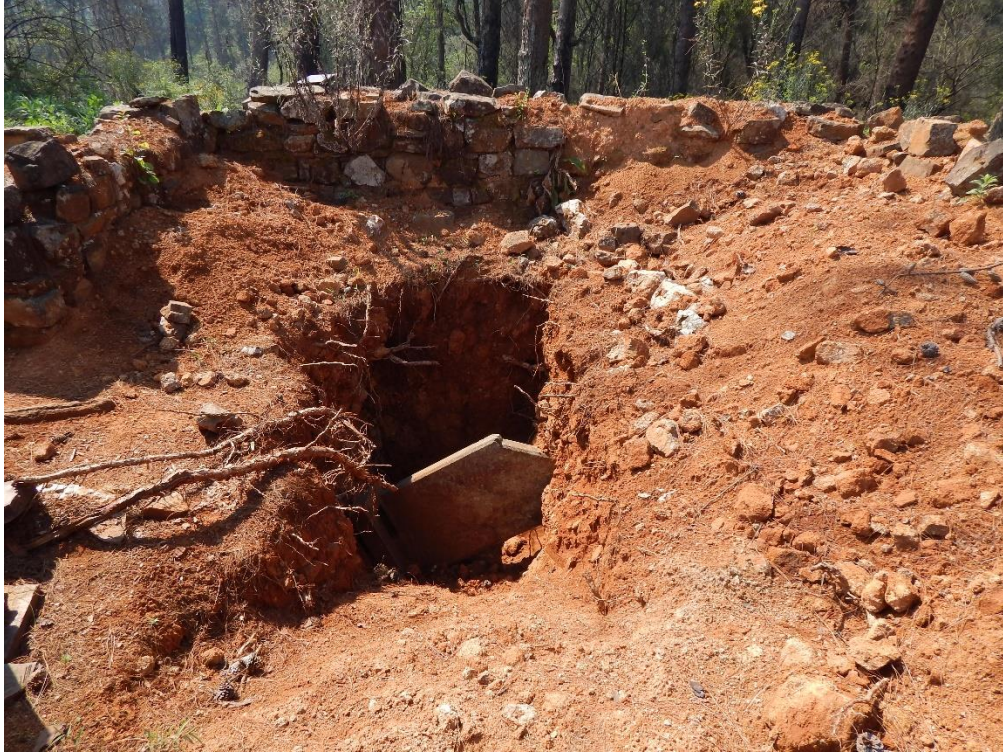
Fig. 11: The extent of the damage (vandalism), is visible in this image. The excavated soil has been piled up on the inside of the stone enclosure. The excavated area is clearly visible.

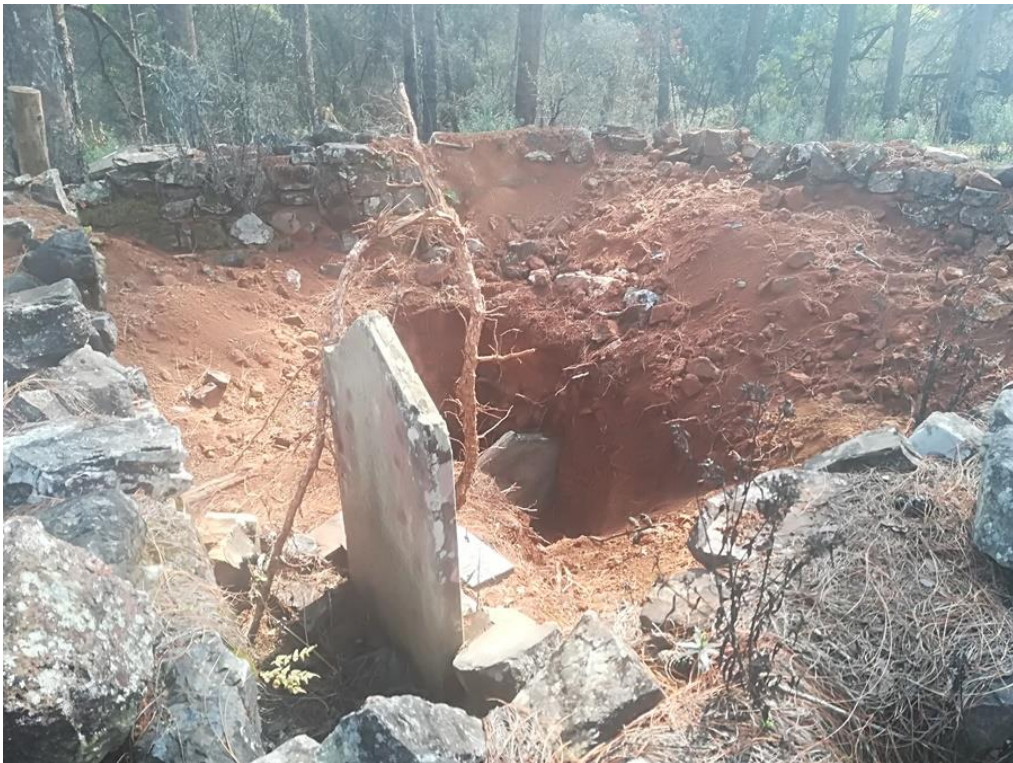
Fig. 12: The Shires headstone is visible in the foreground, with the excavated area, and the Bowman headstone, visible in the trench.

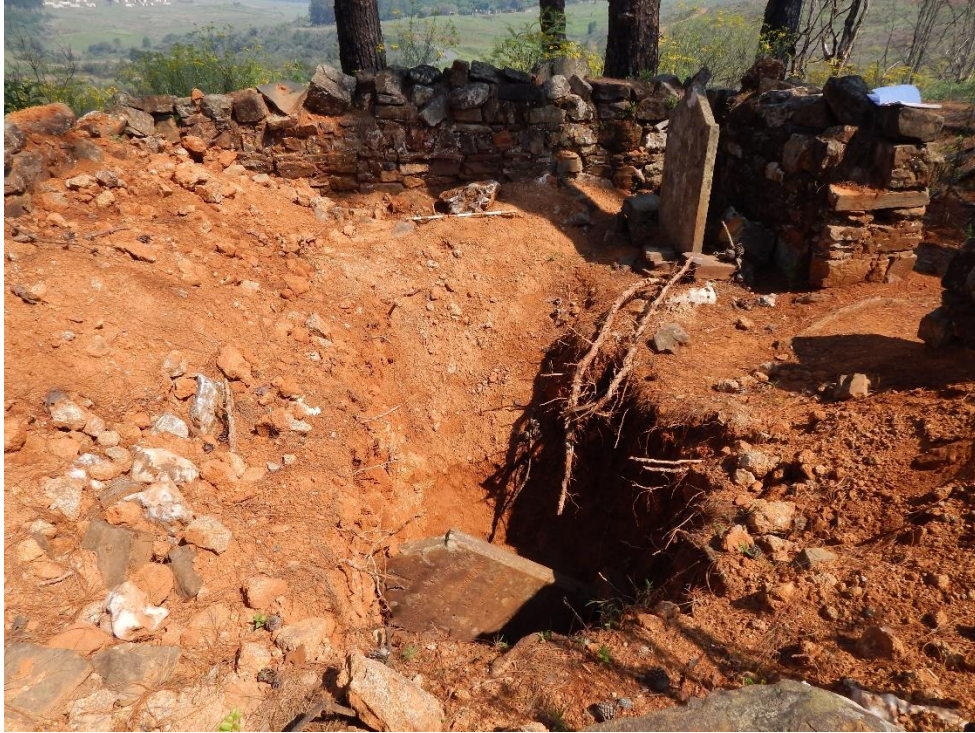
Fig. 13: Most of the excavated soil was piled up against the eastern wall.

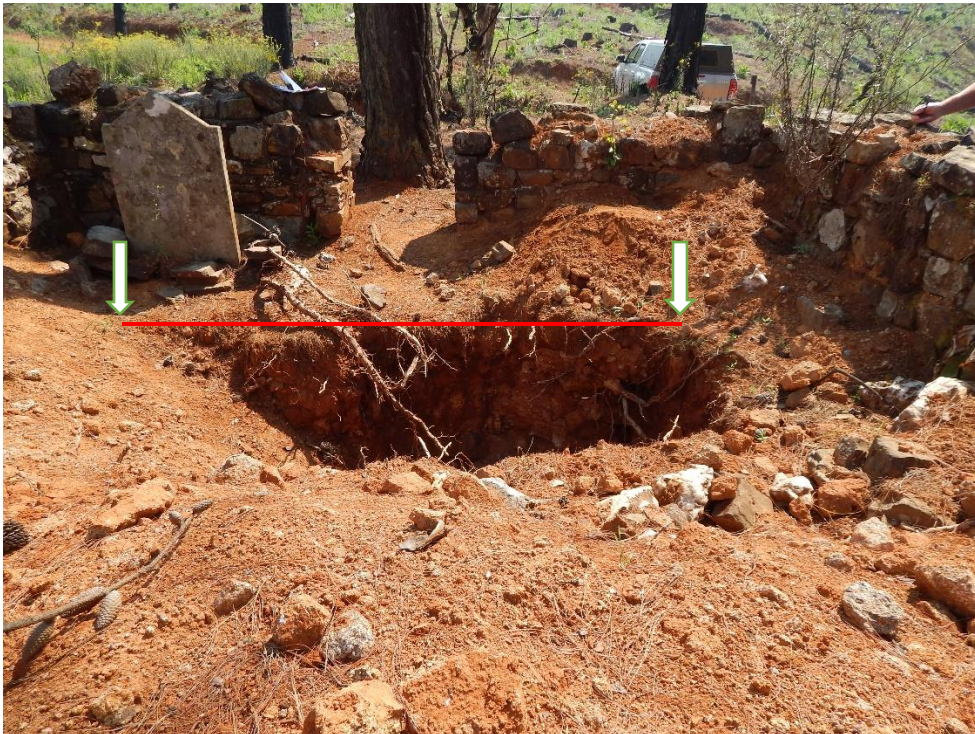
Fig. 14: The extent of the excavated trench is visible in this image. It seems as if the vandals dug into the Bowman as well as the Shires graves in an attempt to find possible treasure (see line and arrow). The excavated soil was piled up on the sides, and has subsequently fallen partly into the trench.
