Ten Bosch: Wetland and Riparian Zone Identification and Description

July 2016

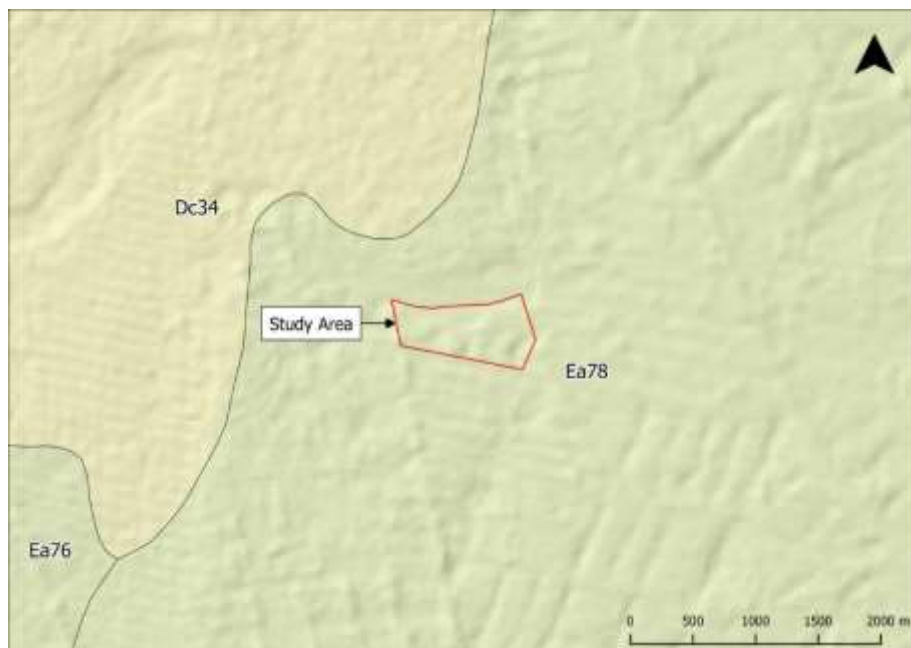
Figure 4: Study area in relation to the land types in the vicinity

The study area falls entirely within land type Ea78 (Figure 4). The geology is described as “Basalt of the Letaba Formation, Karoo Sequence”, while the soils are described as “One or more of: vertic, melanic, red structured diagnostic horizons, undifferentiated” (Land Type Survey Staff, 1972–2006).

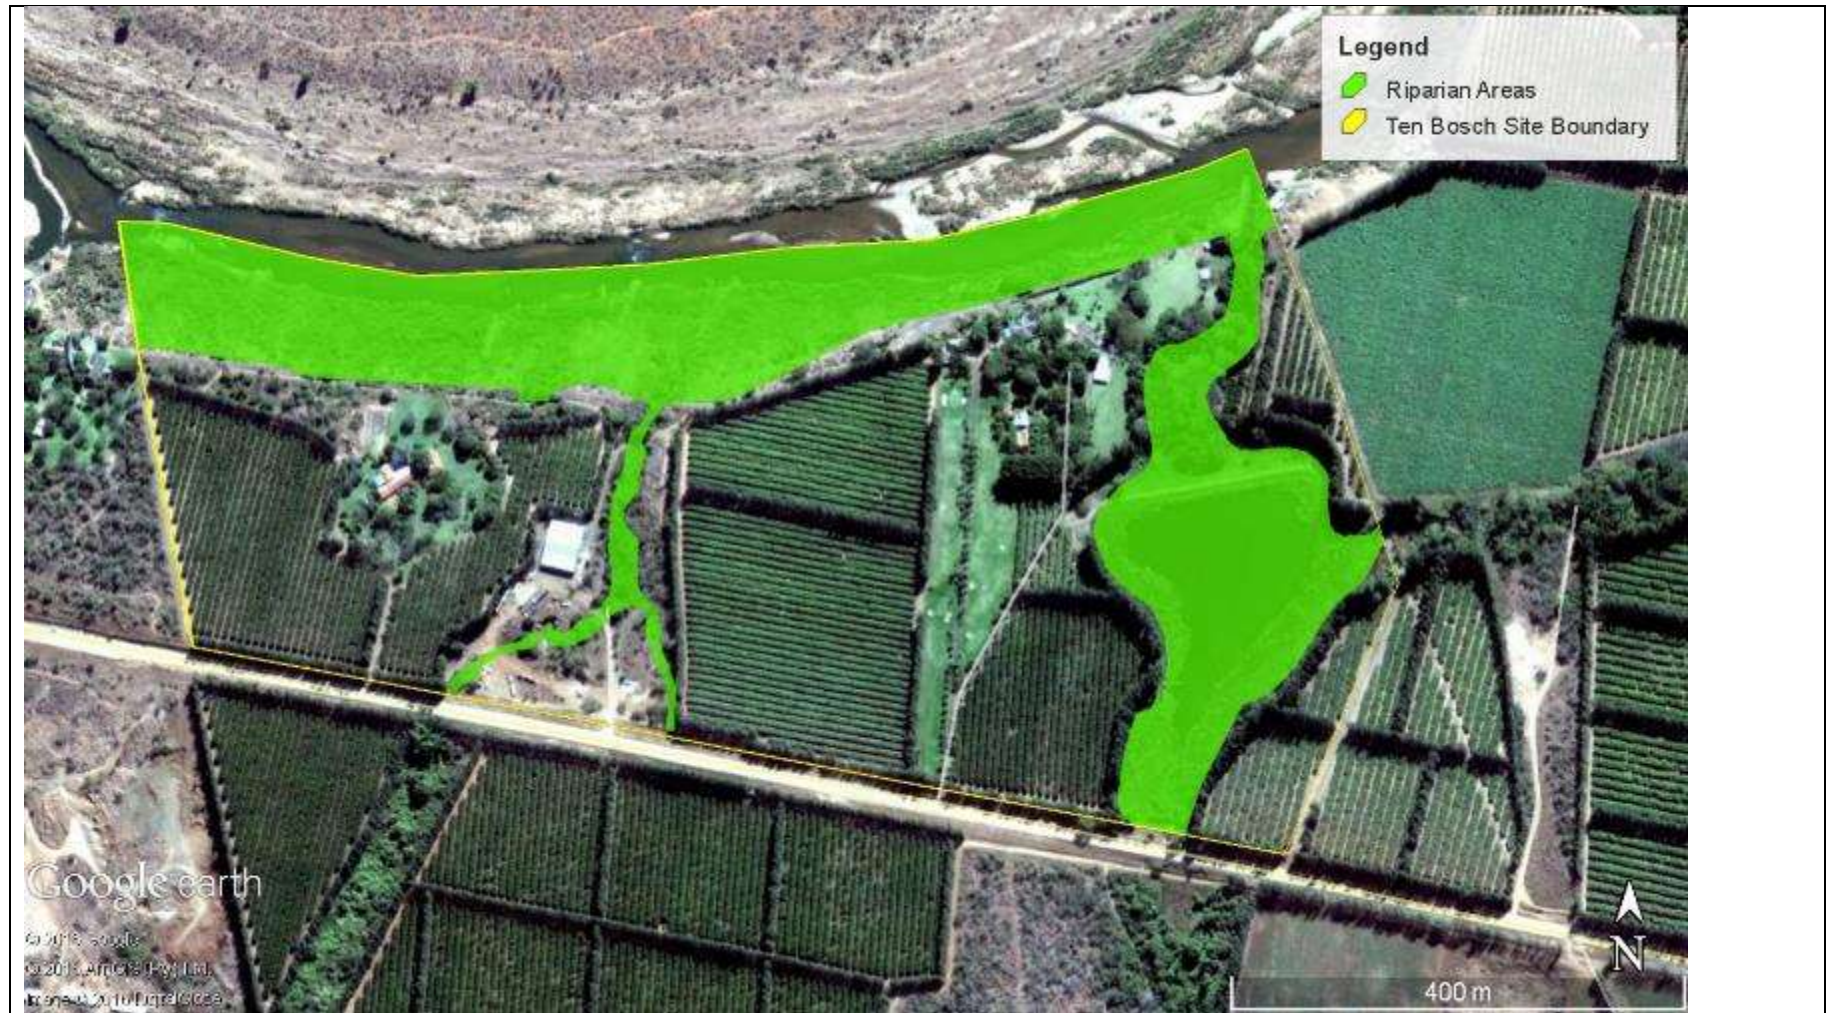
Figure 8: Delineated riparian areas on the Ten Bosch study area adjacent to the Crocodile River

The riparian areas identified in the study area were delineated in accordance with the guidelines for delineating the boundaries of a wetland, set out by the Department of Water Affairs and Forestry (DWAFF) (DWAFF, 2005). These delineated riparian areas are demarcated and indicated as per the map shown in Figure 8.

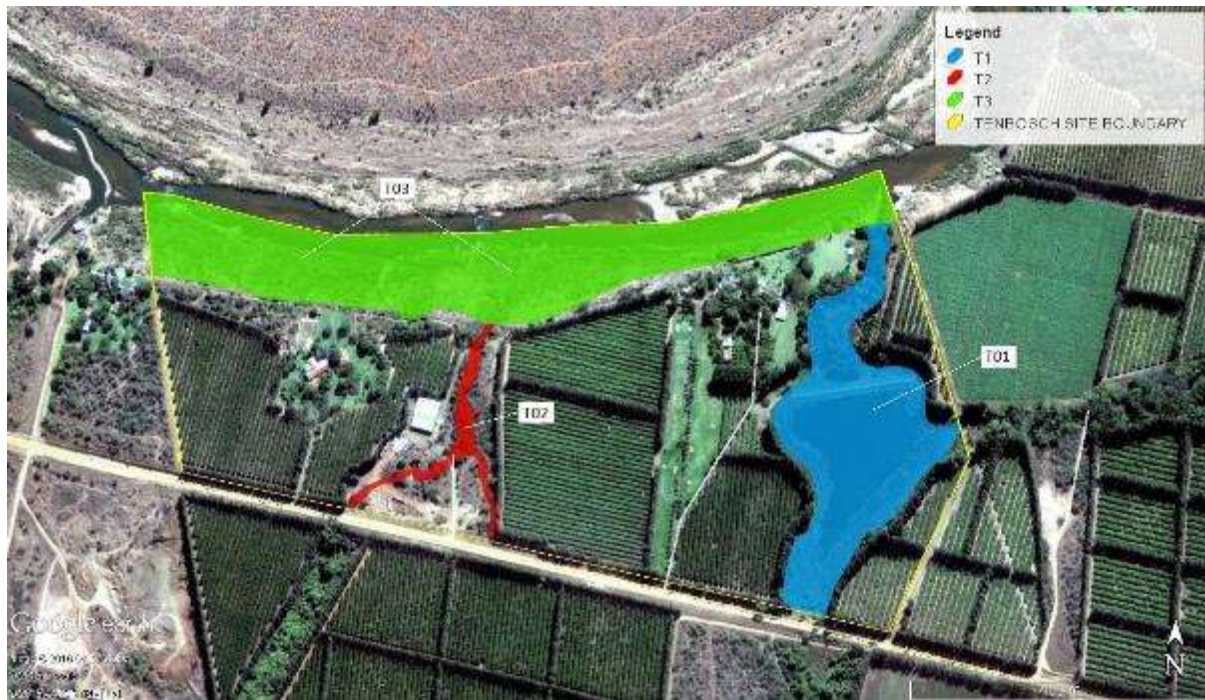
Figure 9: Identified Riparian areas for the purpose of this study

3 water courses were identified and can be described as riverine areas. There are wetland areas which form part of these riparian areas. These wetland areas occur around the dam and upstream of road crossings and weirs. The delineated riparian areas are demarcated and indicated as per the map showed in Figure 9.

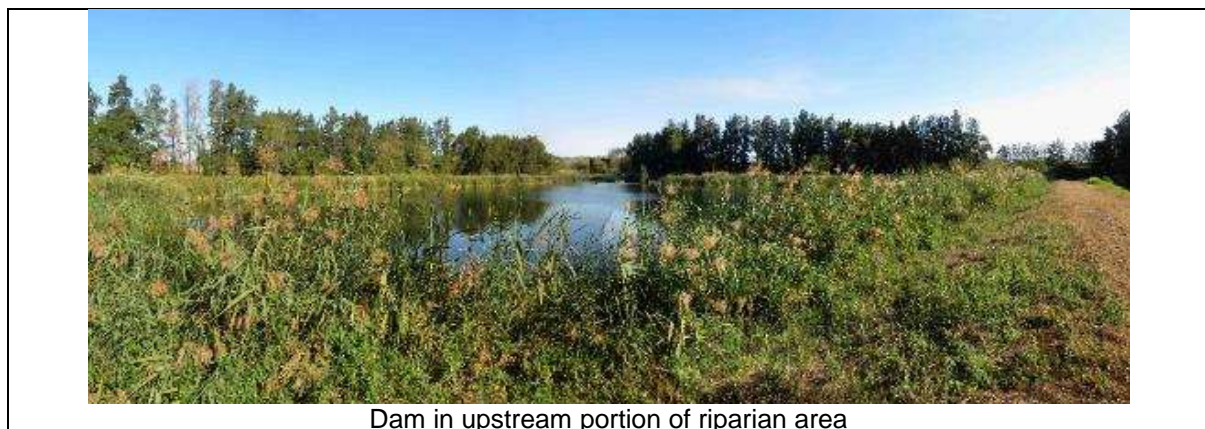
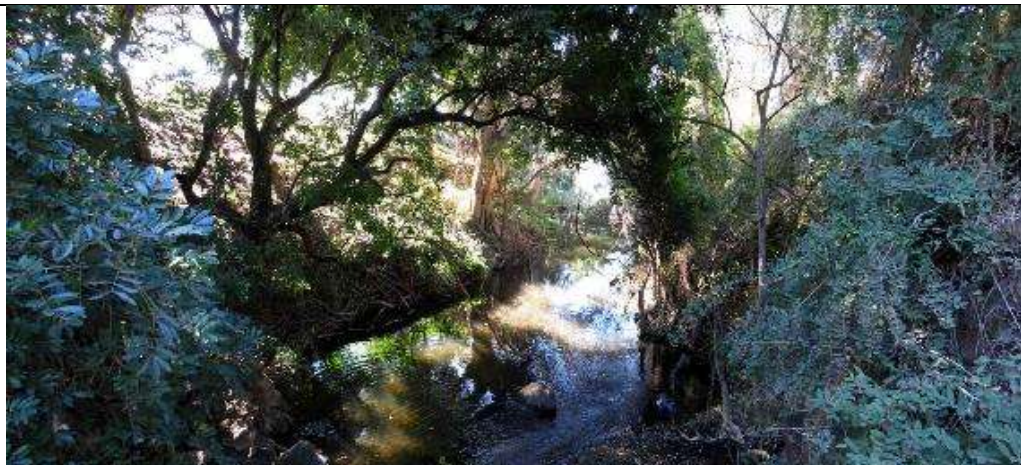
Figure 10: Views of Site T01 Riparian Area

This site is located at 25°23'09.51 S, 31°53'31.57 E. The riparian zone extends upstream from the edge of the property and downstream where it joins the Crocodile River (Figure 10 and Figure 11).

Dam in upstream portion of riparian area

Riparian forest in lower downstream portion of river

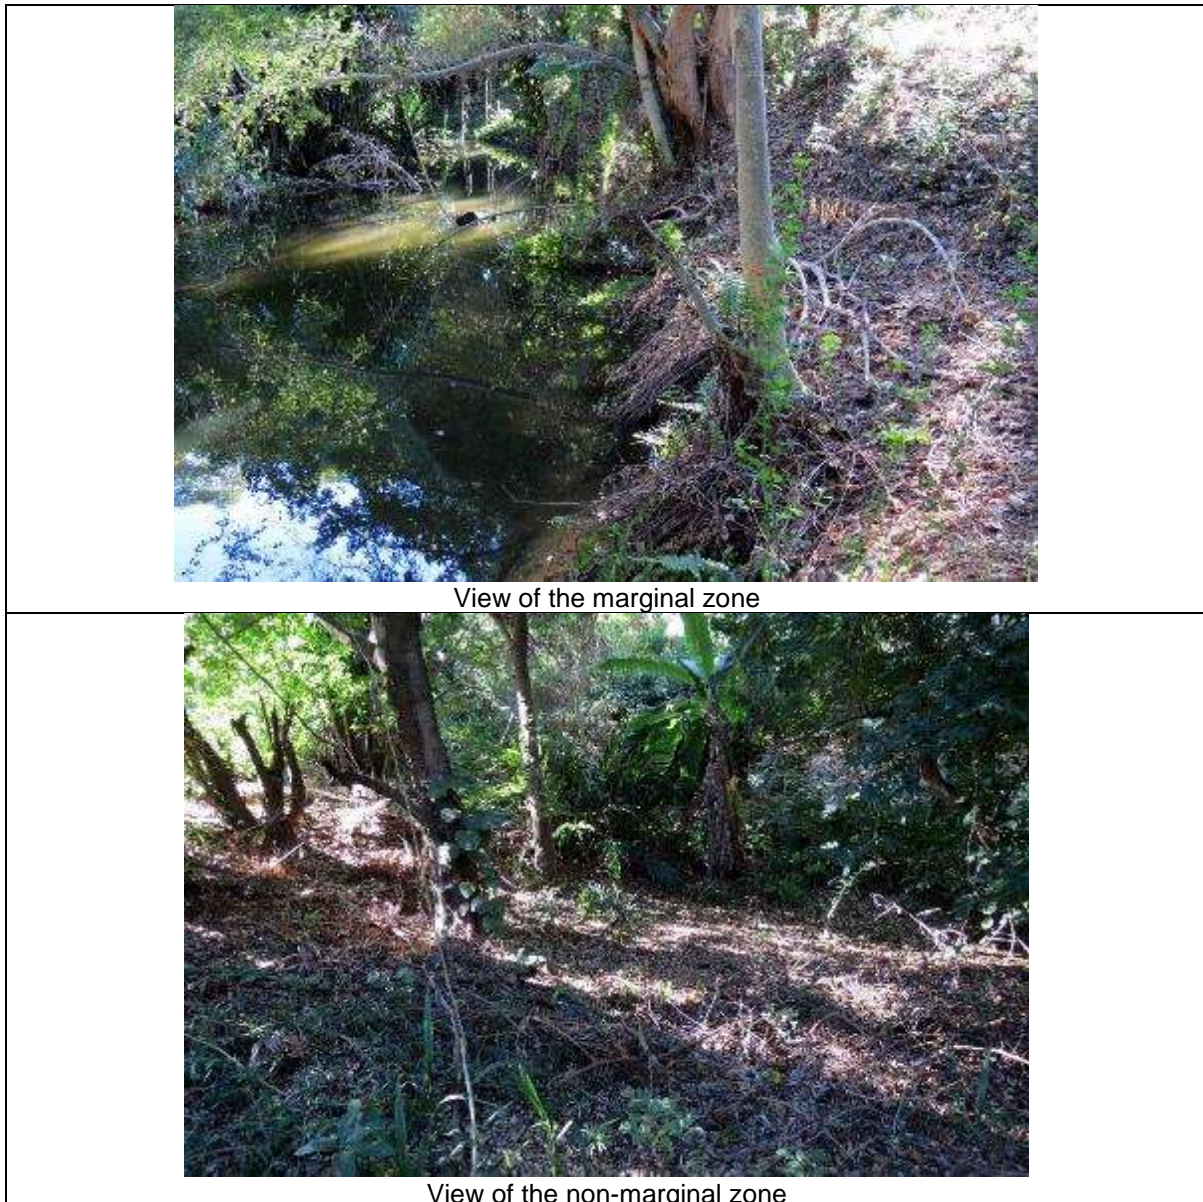
Figure 12: Photos of selected VEGRAI site

A reed and tree dominated state exists along the edges of the dam. Downstream of the dam the dominant vegetation is mostly trees and herbs. The substrate consists mainly of soil material and rocky habitat in places. The banks are steep in places. The following woody species occur: *Bridelia micrantha*, *Acacia xanthophloea*, *Philenoptera violacea*, *Phyllanthus reticulatus*, *Ficus sycomorus*, *Syzygium cordatum*, *Celtis africana*, *Sclerocarya birrea* subsp. *caffra*, *Bridelia micrantha*, *Rauvolfia caffra*, *Grewia monticola*, *Bridelia cathartica*, *Phyllanthus reticulatus*, *Gymnosporia senegalensis*, *Pluchea dioscoridis* and *Gymnanthemum coloratum*, etc. Understory plants such as: *Setaria megaphylla*, *Hypoestes forskoolii*, *Cucumis zeyheri*, *Jasminum fluminense*, and *Panicum maximum* occur. Some exotic

vegetation such as: *Melia azedarach*, *Solanum mauritianum*, *Lantana camara*, *Ageratum conyzoides*, etc. were also found.

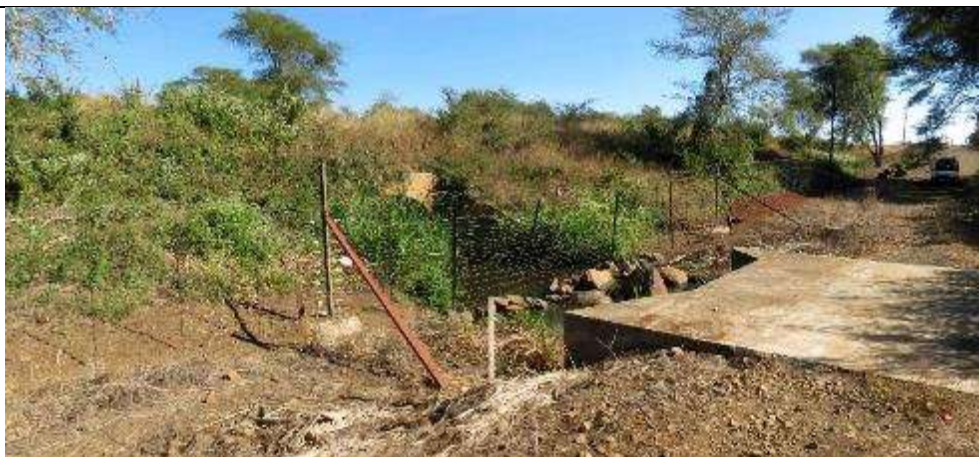
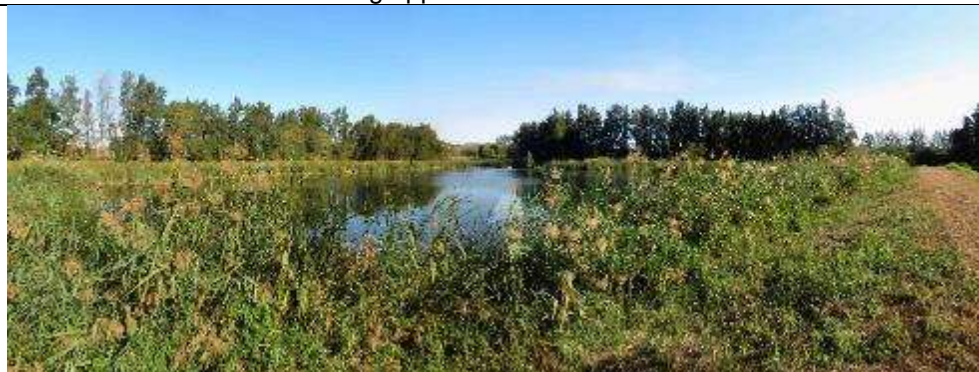
Figure 13: Activities that contribute towards the degradation of the T01 riparian zones integrity

The Riparian Index of Habitat Integrity (RIHI) is a C/D (57.7%). The main impacts are the road crossings, orchard footprint (extending into riparian areas in places), a dam that destroyed approximately 71% of the original riparian area, felling of riparian vegetation, a weir in the active channel and the extensive presence of exotic vegetation (Figure 13). Water quality is degraded further as a result of agriculture, human settlement, and a golf course adjacent to the riparian area. Due to the influence of the dam, less alluvial material is released to the downstream areas which has resulted in the degradation of the riverbank, referred to as bed-armouring. The result of this can be seen in bank collapse and undercutting of the bank which is taking place. There is also extensive vegetation clearing in the riparian areas' catchment which reduces the vegetation roughness coefficient (Figure 13).

One culvert connecting upper stream area with lower stream area

Dam in drainage line

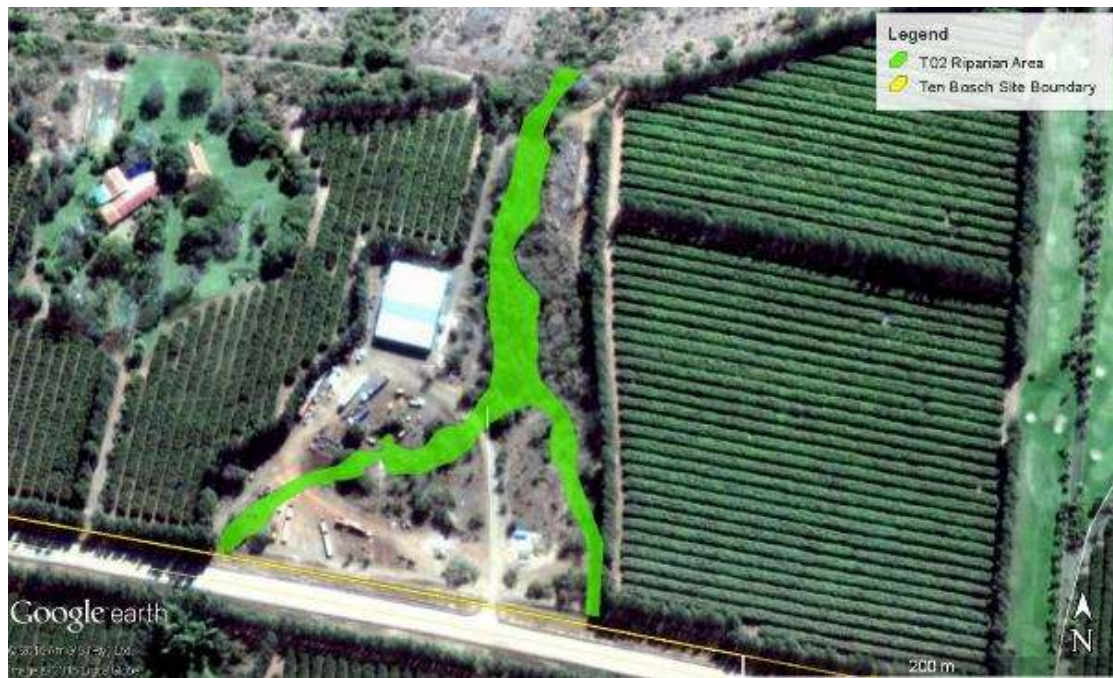
Figure 15: Google image of the T02 delineated riparian zone

This site is located at 25°23'11.64 S, 31°53'12.68 E (Figure 14). The riparian zone extends from the edge of the property upstream to where it joins with the Crocodile River downstream (Figure 15 and Figure 16).

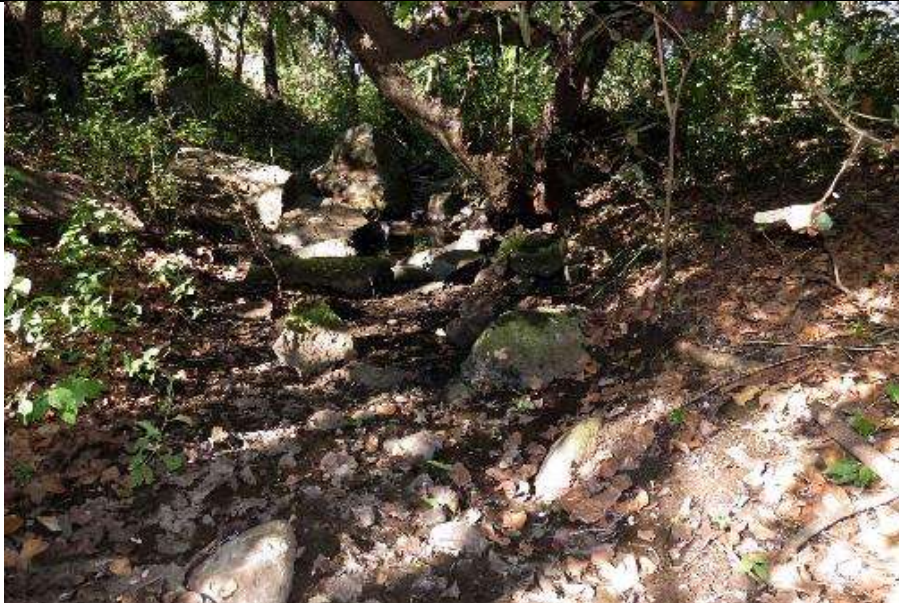
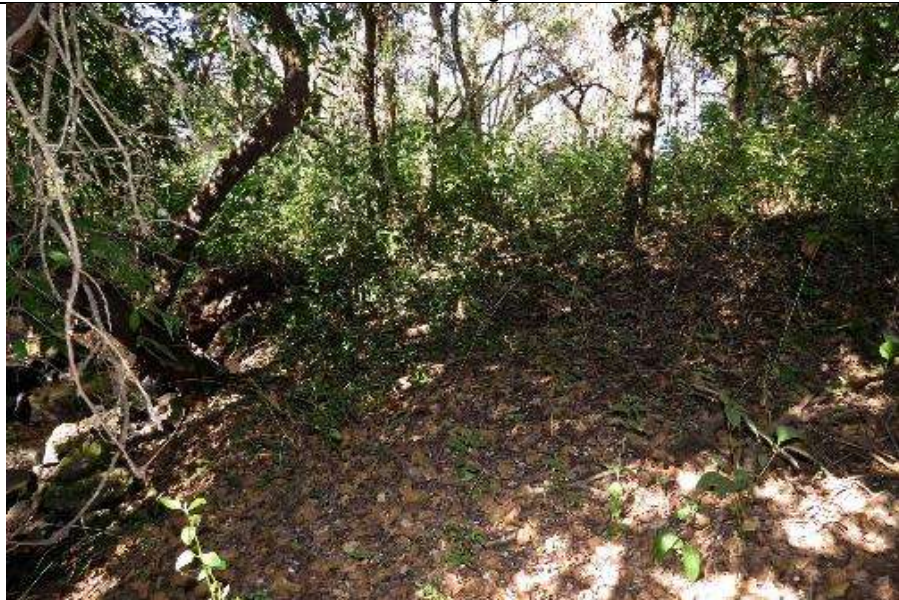
Figure 16: Photos of selected marginal and non-marginal zones of the T02 riparian

A tree and grass-dominated state occurs upstream of the road-crossing. In this area the groundcover and some shrubs have been felled to clear the space. The substrate consists mainly of soil and rocky material. The downstream section is dominated by a woodier component. Upstream of the lower road crossing the dominant vegetation consists of grass and sedges. The following woody species occur: *Rhoicissus tridentata* subsp. *cuneifolia*, *Bridelia micrantha*, *Acacia nigrescens*, *Acacia xanthophloea*, *Philenoptera violacea*, *Phyllanthus reticulatus*, *Ficus sycomorus*, *Ziziphus mucronata*, *Syzygium cordatum*, *Celtis africana*, *Sclerocarya birrea* subsp. *caffra*, *Rauvolfia caffra*, *Grewia monticola*, *Grewia flavescens*, *Phyllanthus reticulatus*, *Gymnosporia senegalensis*, *Pluchea dioscoridis* and *Gymnanthemum coloratum*, etc. Understory plants such as *Setaria megaphylla* and *Panicum maximum* are present. Some exotic vegetation such as, *Melia azedarach*, *Solanum mauritianum*, *Lantana camara*, *Ageratum conyzoides*, etc. were also found. The climber *Ipomoea purpurea* occurs abundantly and has a smothering effect on the vegetation.

View of the marginal zone

View of the non-marginal zone

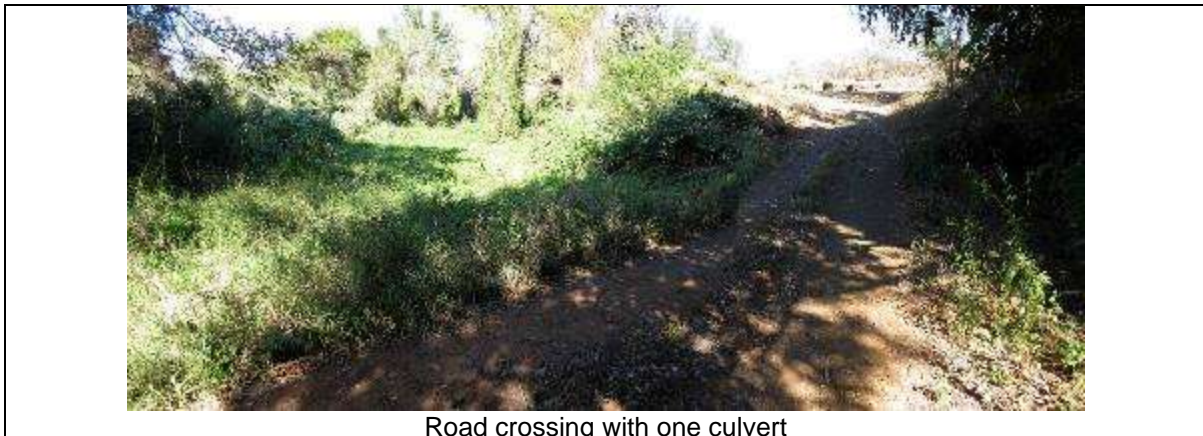
Figure 17: Impacts that result in the degradation of the wetland area

The Riparian Index of Habitat Integrity (RIHI) is a D (53.8%). The main impacts are roads traversing the riparian zone, dumping, agriculture, vegetation clearing and further water quality problems (due to the presence of orchards, exotic infestation and the damming effect of a road crossing with only one culvert) (Figure 17).

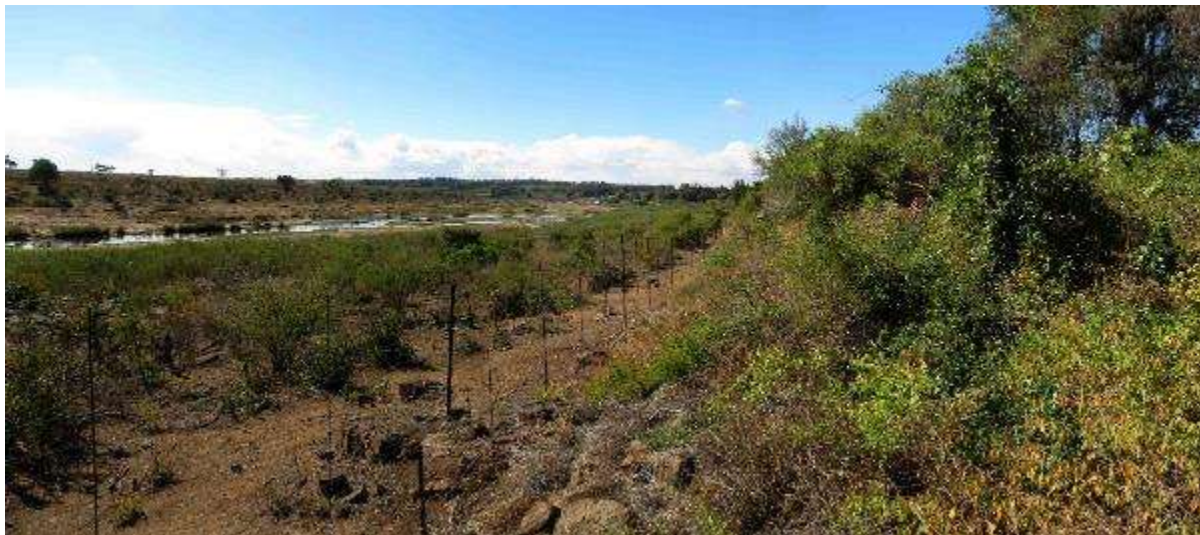
Figure 18: Panoramic view of the riparian area T03

The Crocodile River site is located at 25°31'50.21 S, 31°23'01.25 E. A panoramic view of the study area can be seen in Figure 18. Figure 19 is a Google aerial photo indicating the extent of this riparian zone.

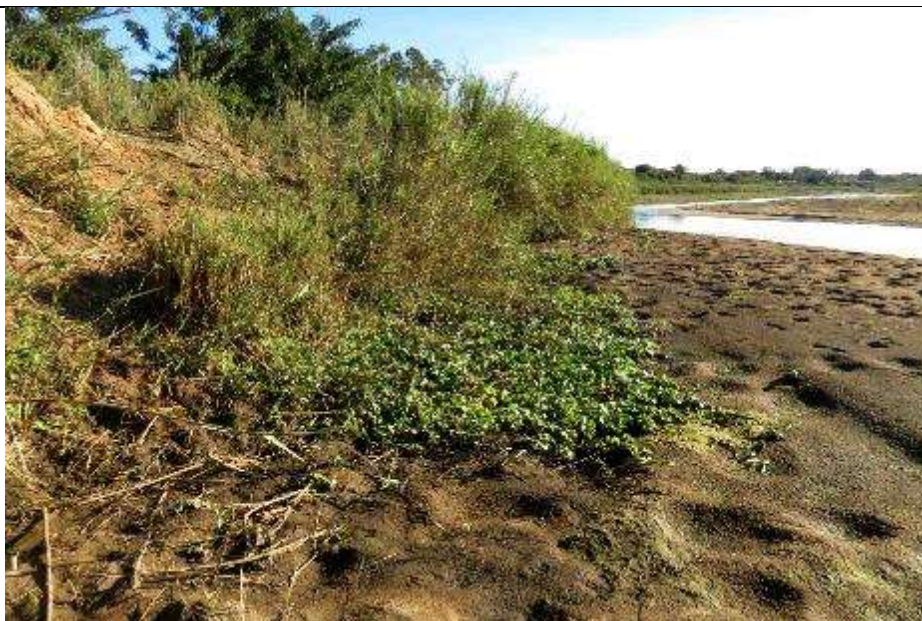
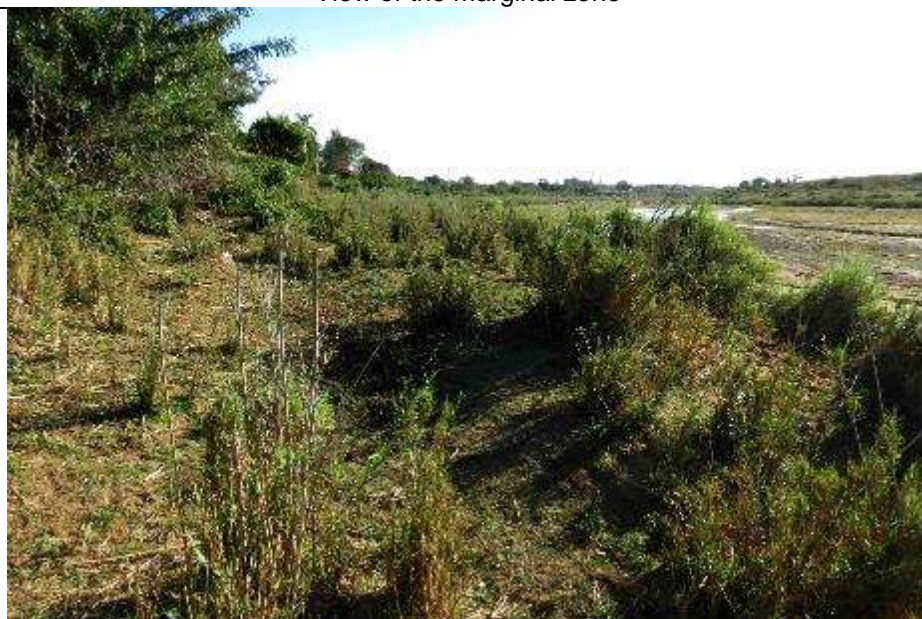
Figure 20: Photos of selected VEGRAI site

Reeds with scattered trees and shrub species are the dominate vegetation type. Continuous grazing and trampling has resulted in the reeds and trees being stunted. The woody species are obviously recovering after major flood destruction in the not-too-distant past. The substrate consists mainly of alluvial material and rocky dykes crossing the riverine area. The following woody species are dominant: *Dichrostachys cinerea*, *Gymnosporia senegalensis*, *Ziziphus mucronata*, *Lippia javanica*, *Bridelia micrantha*, *Acacia nigrescens*, *Philenoptera violacea*, *Phyllanthus reticulatus*, *Pluchea dioscoridis*, *Gomphocarpus physocarpus*, *Asparagus cooperi*, etc. Grass species such as *Cynodon dactylon*, *Setaria sphacelata* and *Panicum maximum*, are also present. *Cyperus sexangularis* and *Schoenoplectus* spp. are the dominant sedges. Some exotic vegetation such as, *Centella asiatica*, *Spathodea campanulata*, *Melia azedarach*, *Solanum mauritianum*, *Lantana camara*, *Parthenium hysterophorus*, *Ageratum conyzoides*, etc. were also identified.

View of the marginal zone

View of the non-marginal zone

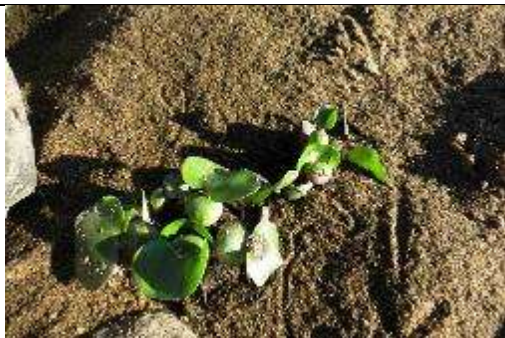
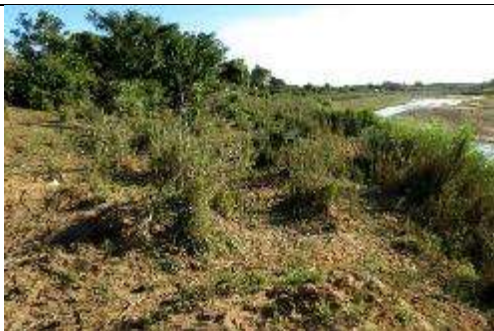
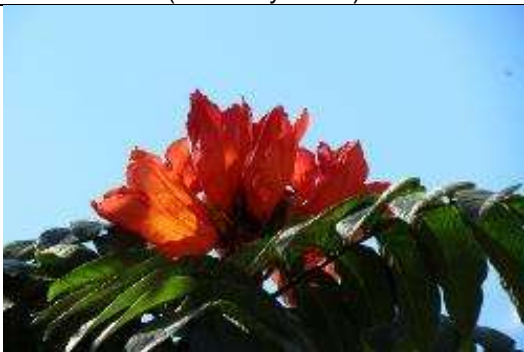
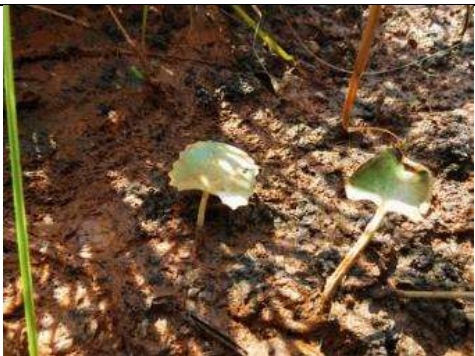
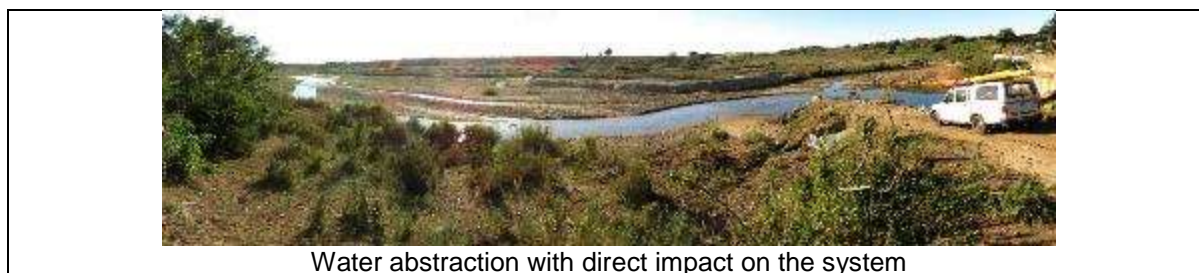
Figure 21: Impacts identified in the Crocodile River Riparian zone

The Riparian Index of Habitat Integrity (RIHI) is a C/D (57.9%), with the main impacts being flood events, grazing and trampling, water abstraction and the presence of exotic species. The exotic tree *Spathodea campanulata*, a tall tree native to the dry tropical forests of tropical Africa. It has been nominated as among the top 100 of the “World’s Worst” invaders (Figure 21).

<p>The exotic <i>Eichhornia crassipes</i> (Water hyacinth)</p>

<p>Grazing and trampling</p>

<p><i>Spathodea campanulata</i> (Fountain Tree)</p>

<p><i>Centella asiatica</i></p>

Water abstraction with direct impact on the system
