DRAFT SECTION 24G REPORT

Proposed Rectification in Terms of Section 24G of National Environmental Management Act (NEMA, Act 107 of 1998) for the Unlawful Activities on the Rem of Erf 196, Portion 1 of Erf 196, Rem of Erf 197 and Erf 198, Ashburton, KwaZulu-Natal

GDE PROJECT NO.: GDE324

REFERENCE NO.: DC22/S24G/0003/2023

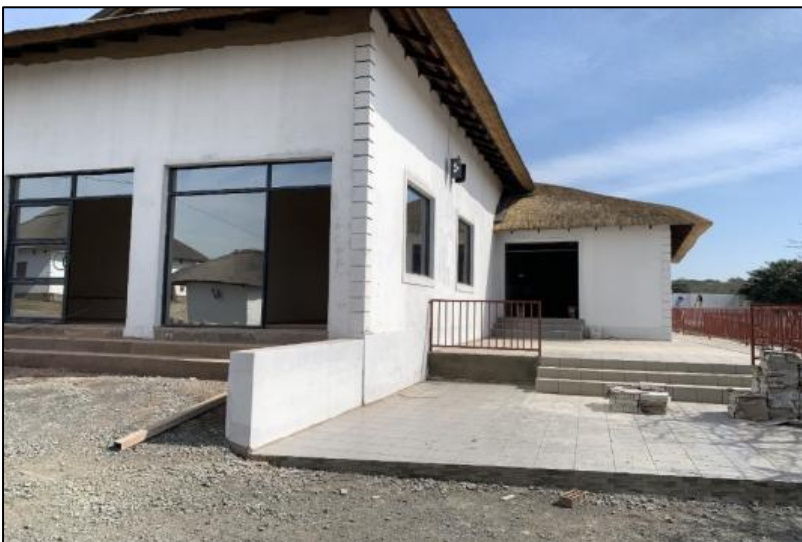
Plate 2: View of the buildings being constructed.

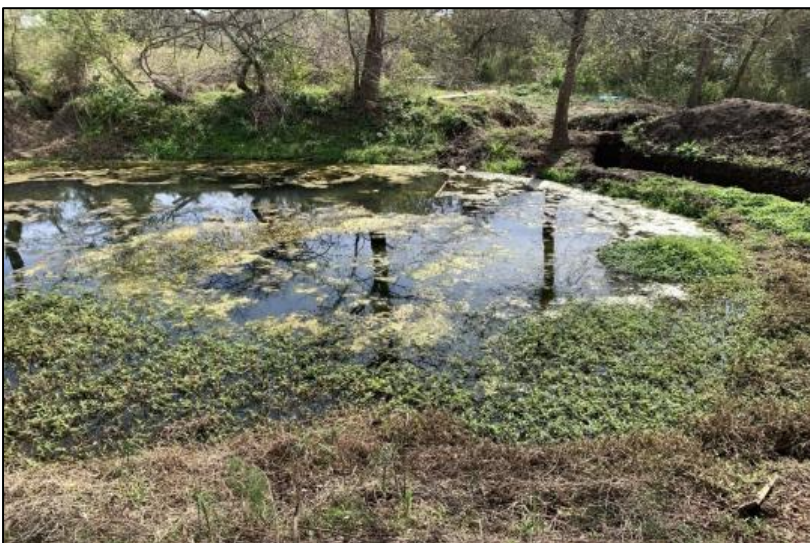
Plate 3: View of the infilled watercourse.

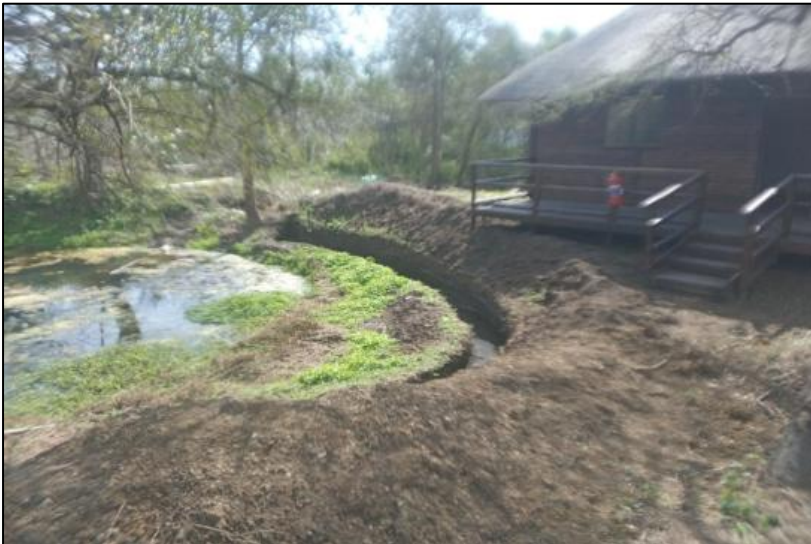
Plate 5: View of the infilled watercourse and location of an accommodation unit.

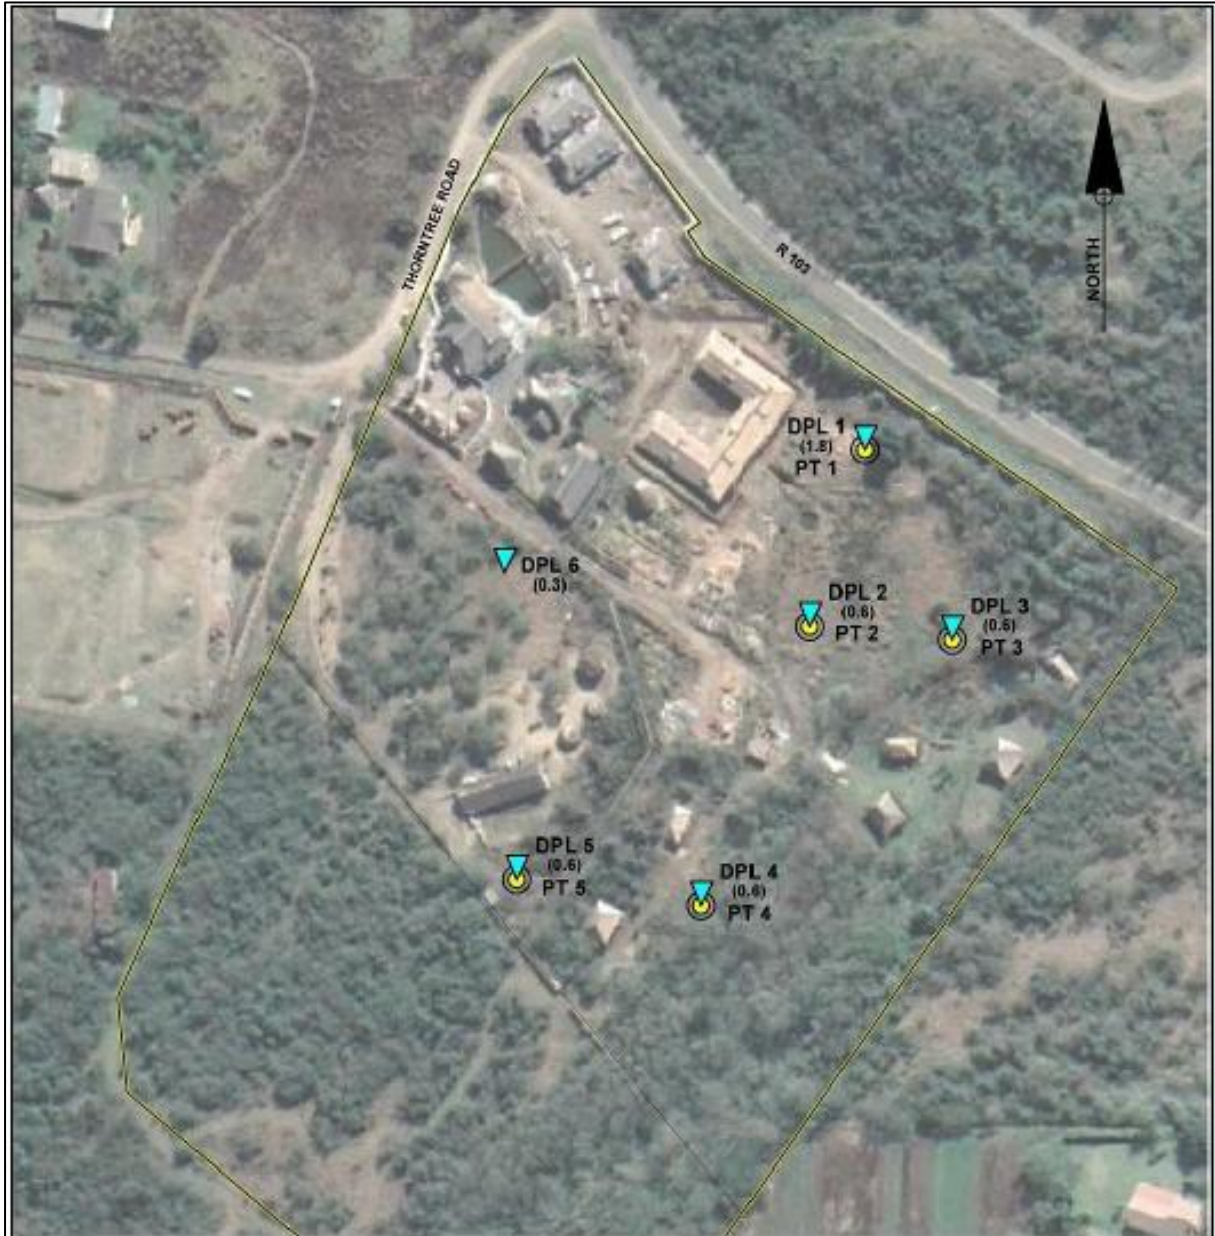
- Six Percolation Tests (PT)
- Six Dynamic Cone Penetrometer (DPL) tests

Figure 4: Location of the Percolation Tests and Dynamic Cone Penetrometer Tests (Source: Gondwana GeoSolutions).

The geology of the site consists of bedrock that is very shallow, on average 0.6 m in the range of zero to 1.8 m below existing ground level. It is overlain by a mantle of soils comprising dark greyish brown clayey sands and very thinly developed residual soils consisting of yellowish-brown silty sand.

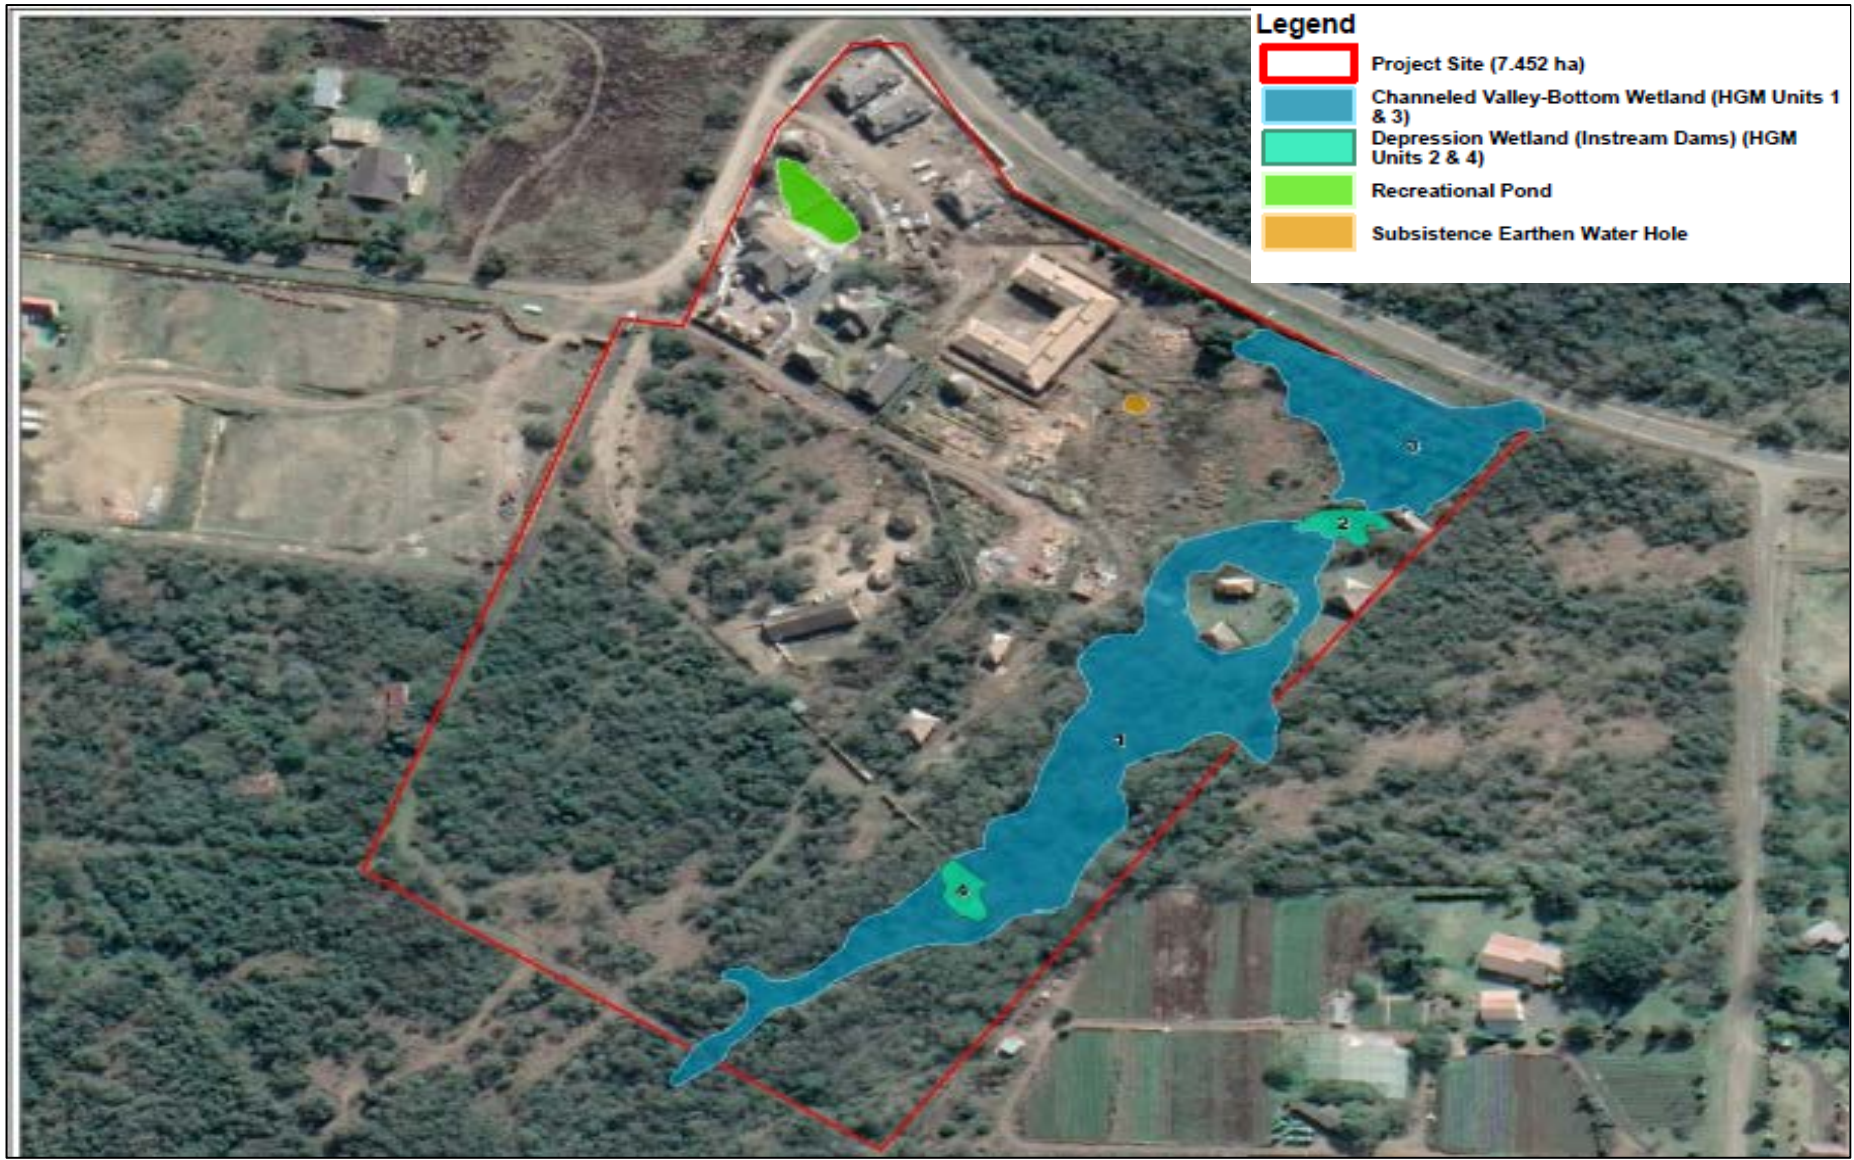
HGM Units 2 – 4 scored a **Class D (Low)**. These wetlands are not considered to be ecologically important and sensitive at any scale. The biodiversity of these wetlands is not usually sensitive to flow and habitat modifications. Although, the wetlands do play a slight role in managing the quantity and quality of water on-site to some degree.

HGM Unit 1 scored a **Class C (Moderate)**. This wetland is considered to be ecologically important and sensitive at a provincial or local scale. The biodiversity of this wetland is not usually sensitive to flow and habitat modifications. The wetland does play a small role in managing the quantity and quality of water on-site to some degree.

Figure 5: Retrospective Wetland Delineation Map (Source: Kinvig & Associates).

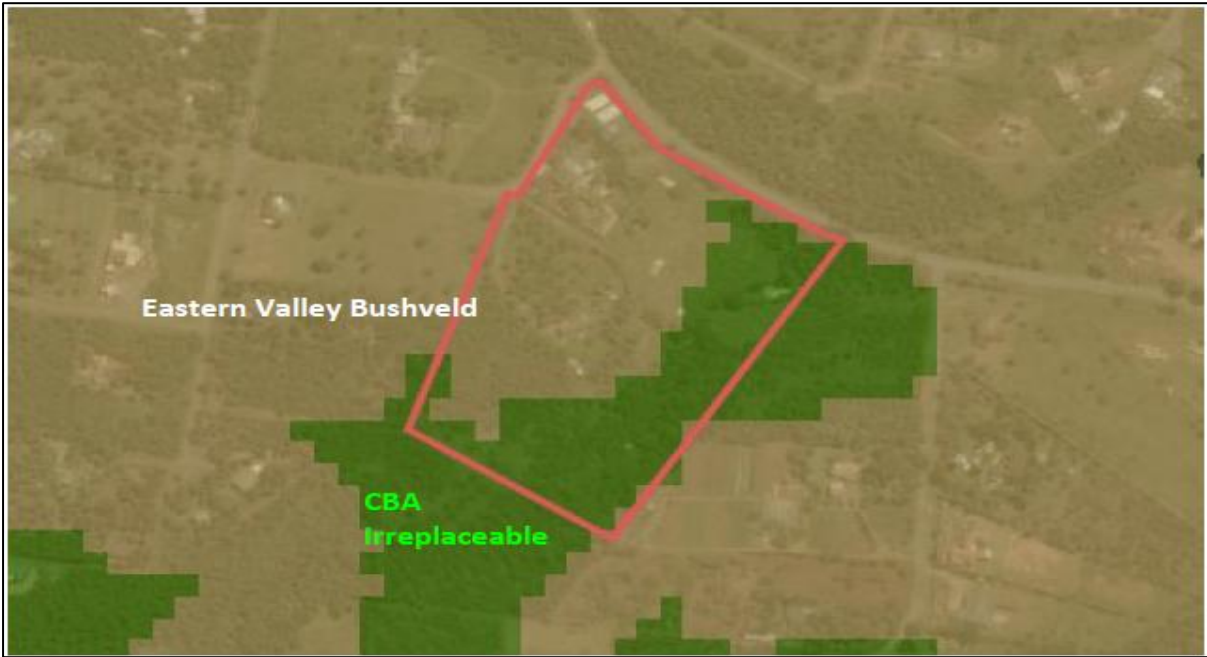
The assessed area sites were *Irreversibly Modified* in parts where buildings, roads and gardens have been constructed, and *Highly Modified* in other areas where vegetation clearing has occurred, with drains, roads and / or new accommodation units under construction. The 4.7 ha of indigenous vegetation in Area A was diverse with key species representative of Eastern Valley Bushveld. The area indicated as CBA Irreplaceable was located within area A. The National Screening Tool indicated a *Medium* Sensitivity for plant species in a small portion of the property with the remaining area identified as *Low*.

Figure 9: Critical Biodiversity Area of the Site (Peter le Roux).

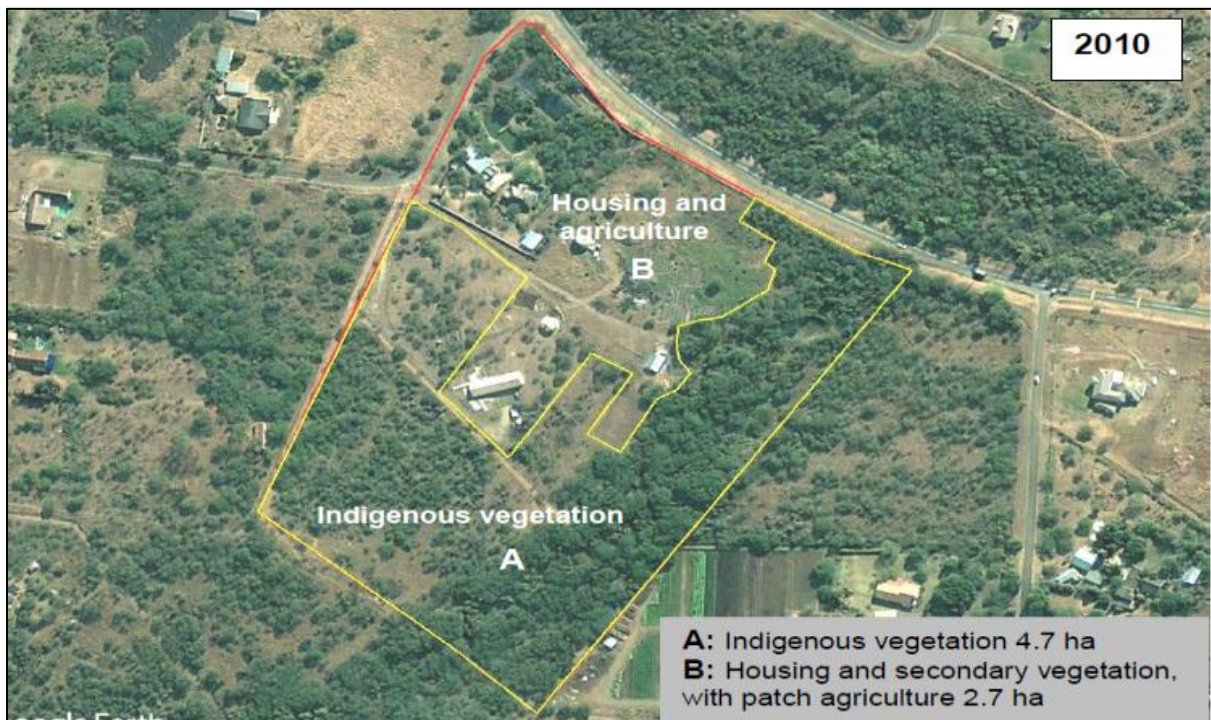
The biodiversity specialist has classified the vegetation types of the site into two areas: **Area A** – 4.7 ha Indigenous Vegetation and **Area B** – 2.7 ha Housing and Agriculture (**Figure 10**), with some Hotel rooms/chalets being constructed in the Indigenous Vegetation depicted in Area A, which also forms part of the CBA Irreplaceable Area (**Figure 11**).

Figure 10: Classification of vegetation types of the site (Source: Peter le Roux).

The EAP is of the opinion that given the abovementioned positive and negative impacts associated with the unlawful activities on site, the preferred option is for the Hotel to remain with the implementation of the recommendations provided by the specialists. The negative impacts will not be as far reaching and long-term as the benefits associated with the current state of the site. It is recommended that the Applicant remove the structures (Hotel accommodation) that are located in the 0.26 ha cleared area (**Figure 10**) (refer to **Appendix D1** for the Biodiversity Assessment).

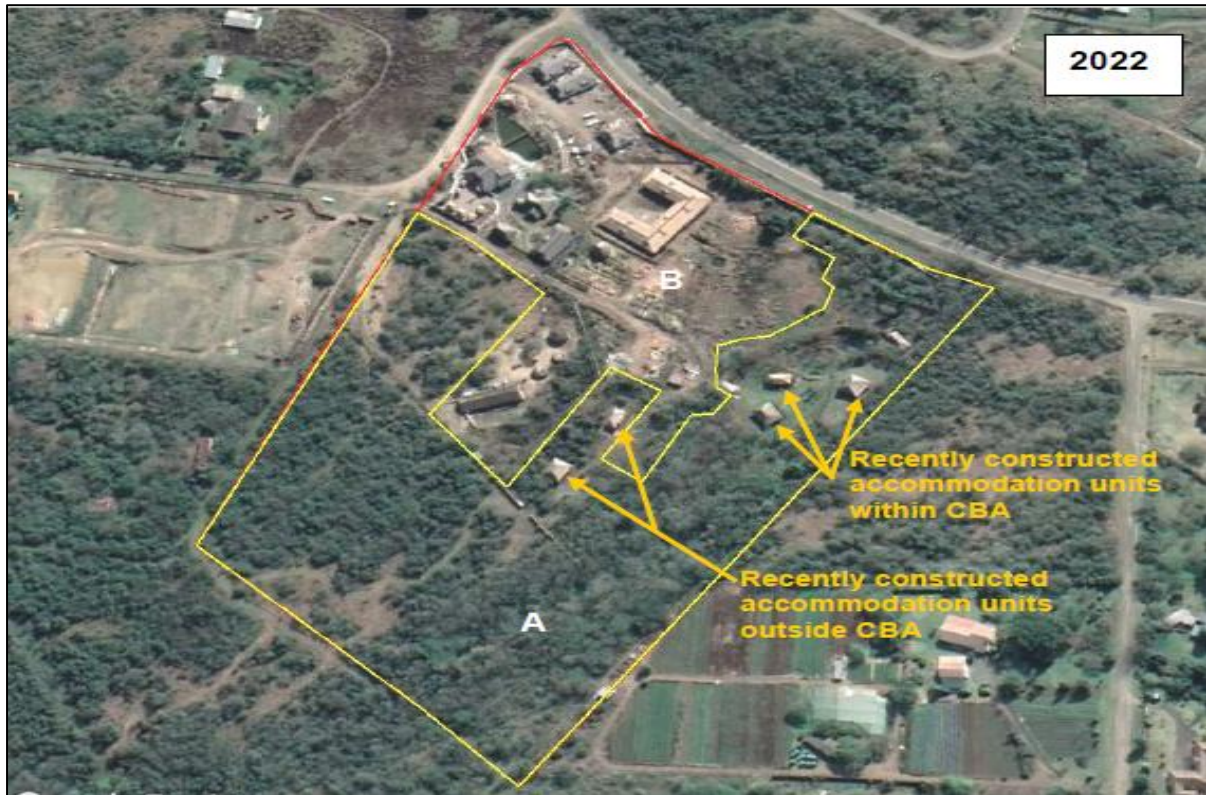
Figure 11: Google Earth Imagery showing the change in vegetation due to construction on the Thorntree Property (Source: Peter le Roux).
