## **Unlawful Construction and Infilling of a Watercourse on the Remainder of Portion 274 of the Farm Tiegerpoort 371 JR**

### **Environmental Impact Report**

**GDARD Reference Number: S24G/03/22-23/0577**

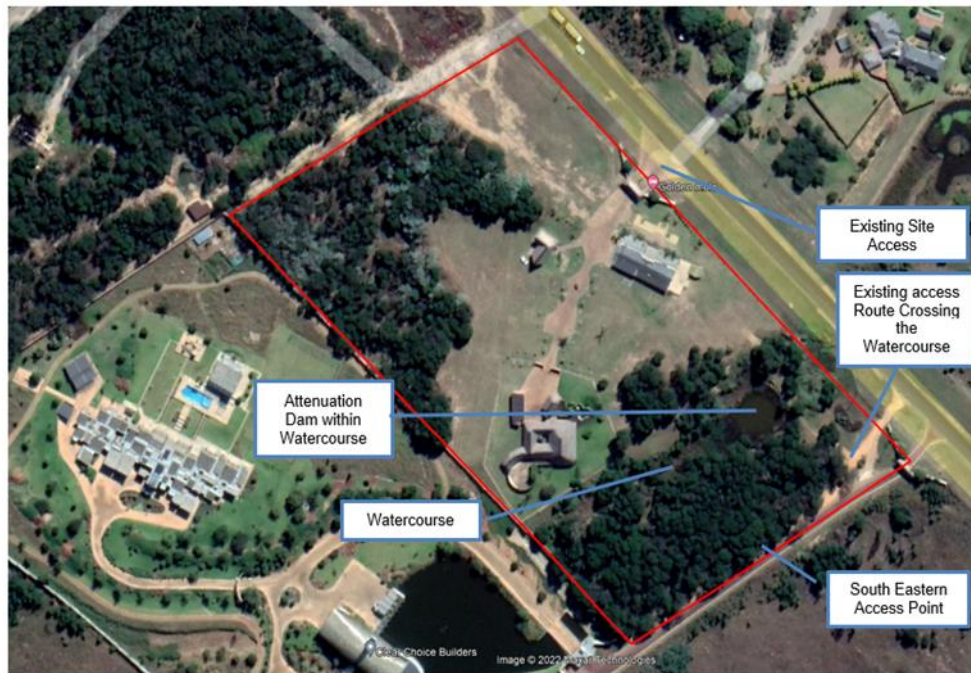
Figure 2-2 Google Earth Image (2019) showing the access points in relation to the site

This is the gravel road to the south east of the property. The new access road will join an existing road (developed prior to 1998). The existing road is a narrow width gravel road, approximately 4m wide which

traversed the watercourse. (Figure 2-2). In order to make use of the existing access road, access to the site will have to be via the south eastern boundary.

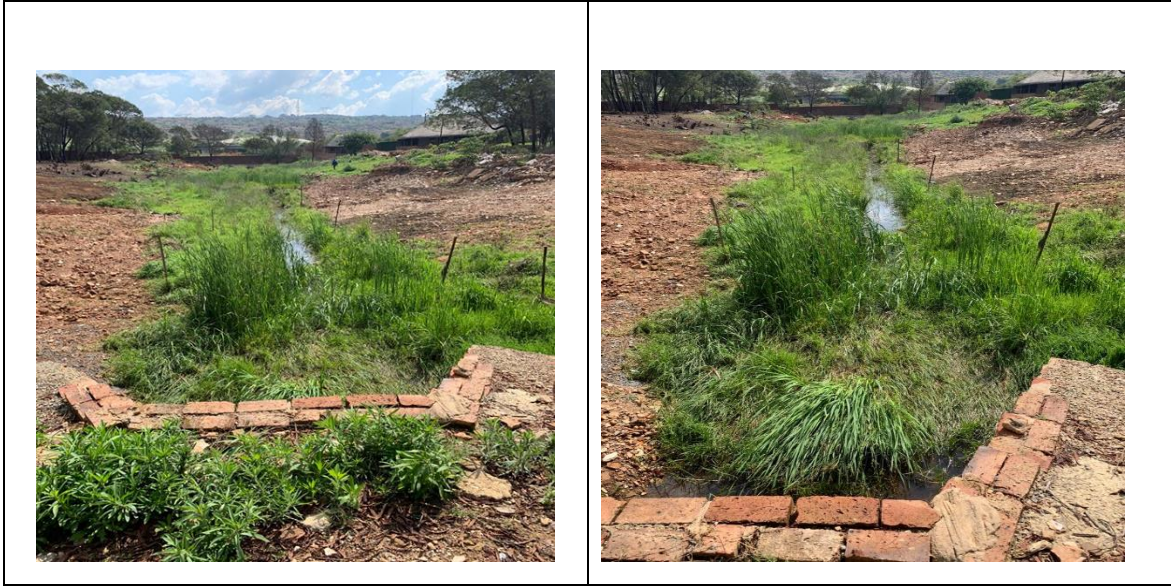
In compliance with the above instruction Ms Sethole removed the building rubble that was stockpiled within the riparian area. The building rubble was removed and stockpiled out of the floodline. Refer to **Figure 2-5** and **Figure 2-6**.

**Figure 2-5: Building rubble removed from the floodline**

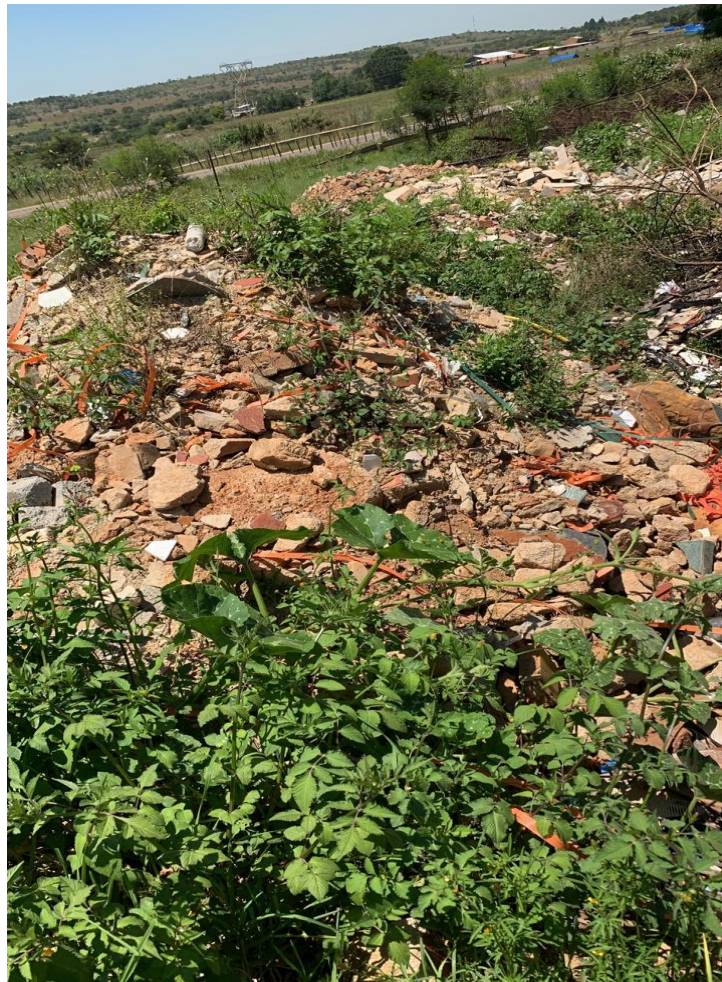
**Figure 2-6: Building rubble stockpiled on site (out of the floodline) west of Graham Road**

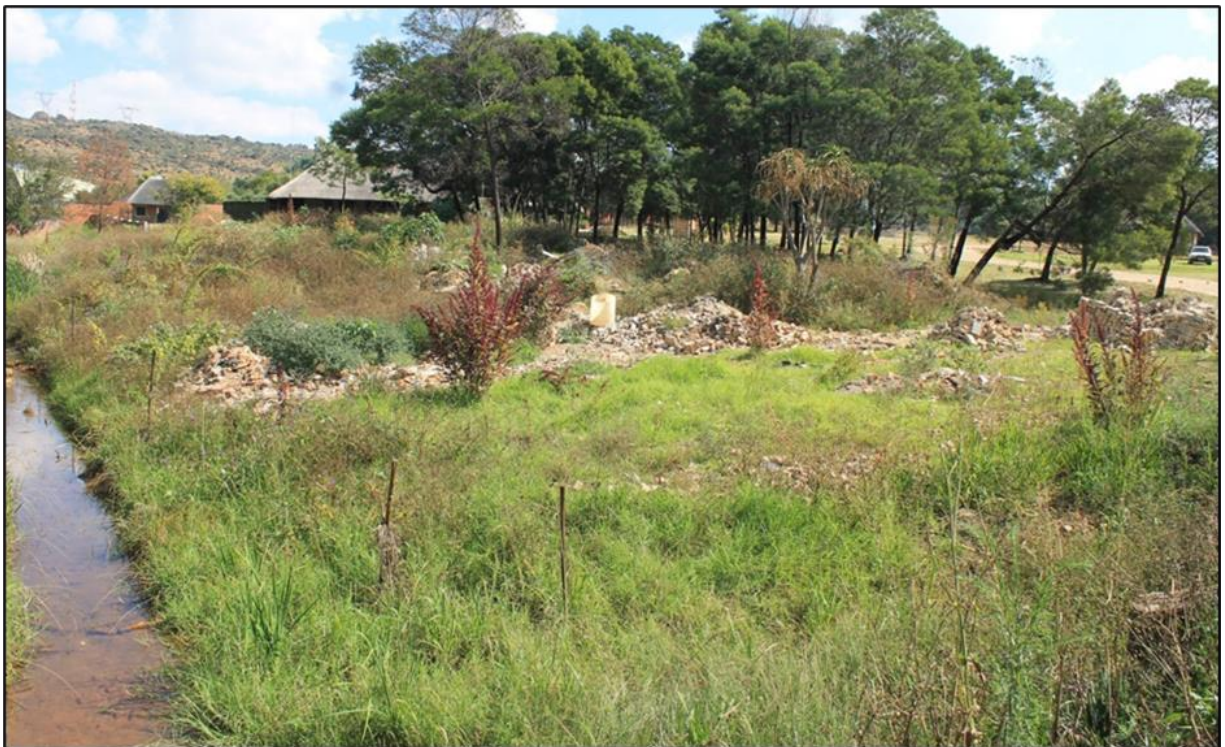
Figure 4-7: The right riverbank facing upstream (TBA, 2022)

The project area is already disturbed with alien invasive plant species dominating the riparian area (**Figure 4-6**), such as A) *Solanum mauritianum*, D) *Manihot grahamii*, E) *Ipomoea purpurea*, F) *Bidens Pilosa*, G) *Agave americana*, and *Acacia mearnsii* (known as Black wattle, **Figure 4-8**). However, there were few scattered indigenous plant species such as B) *Crassula ovata*, C) *Typha capensis*, H) *Leonotis leonurus* and I) *Aloidendron barberae*. The delineated riparian area for the project area is presented in **Figure 4-9**.

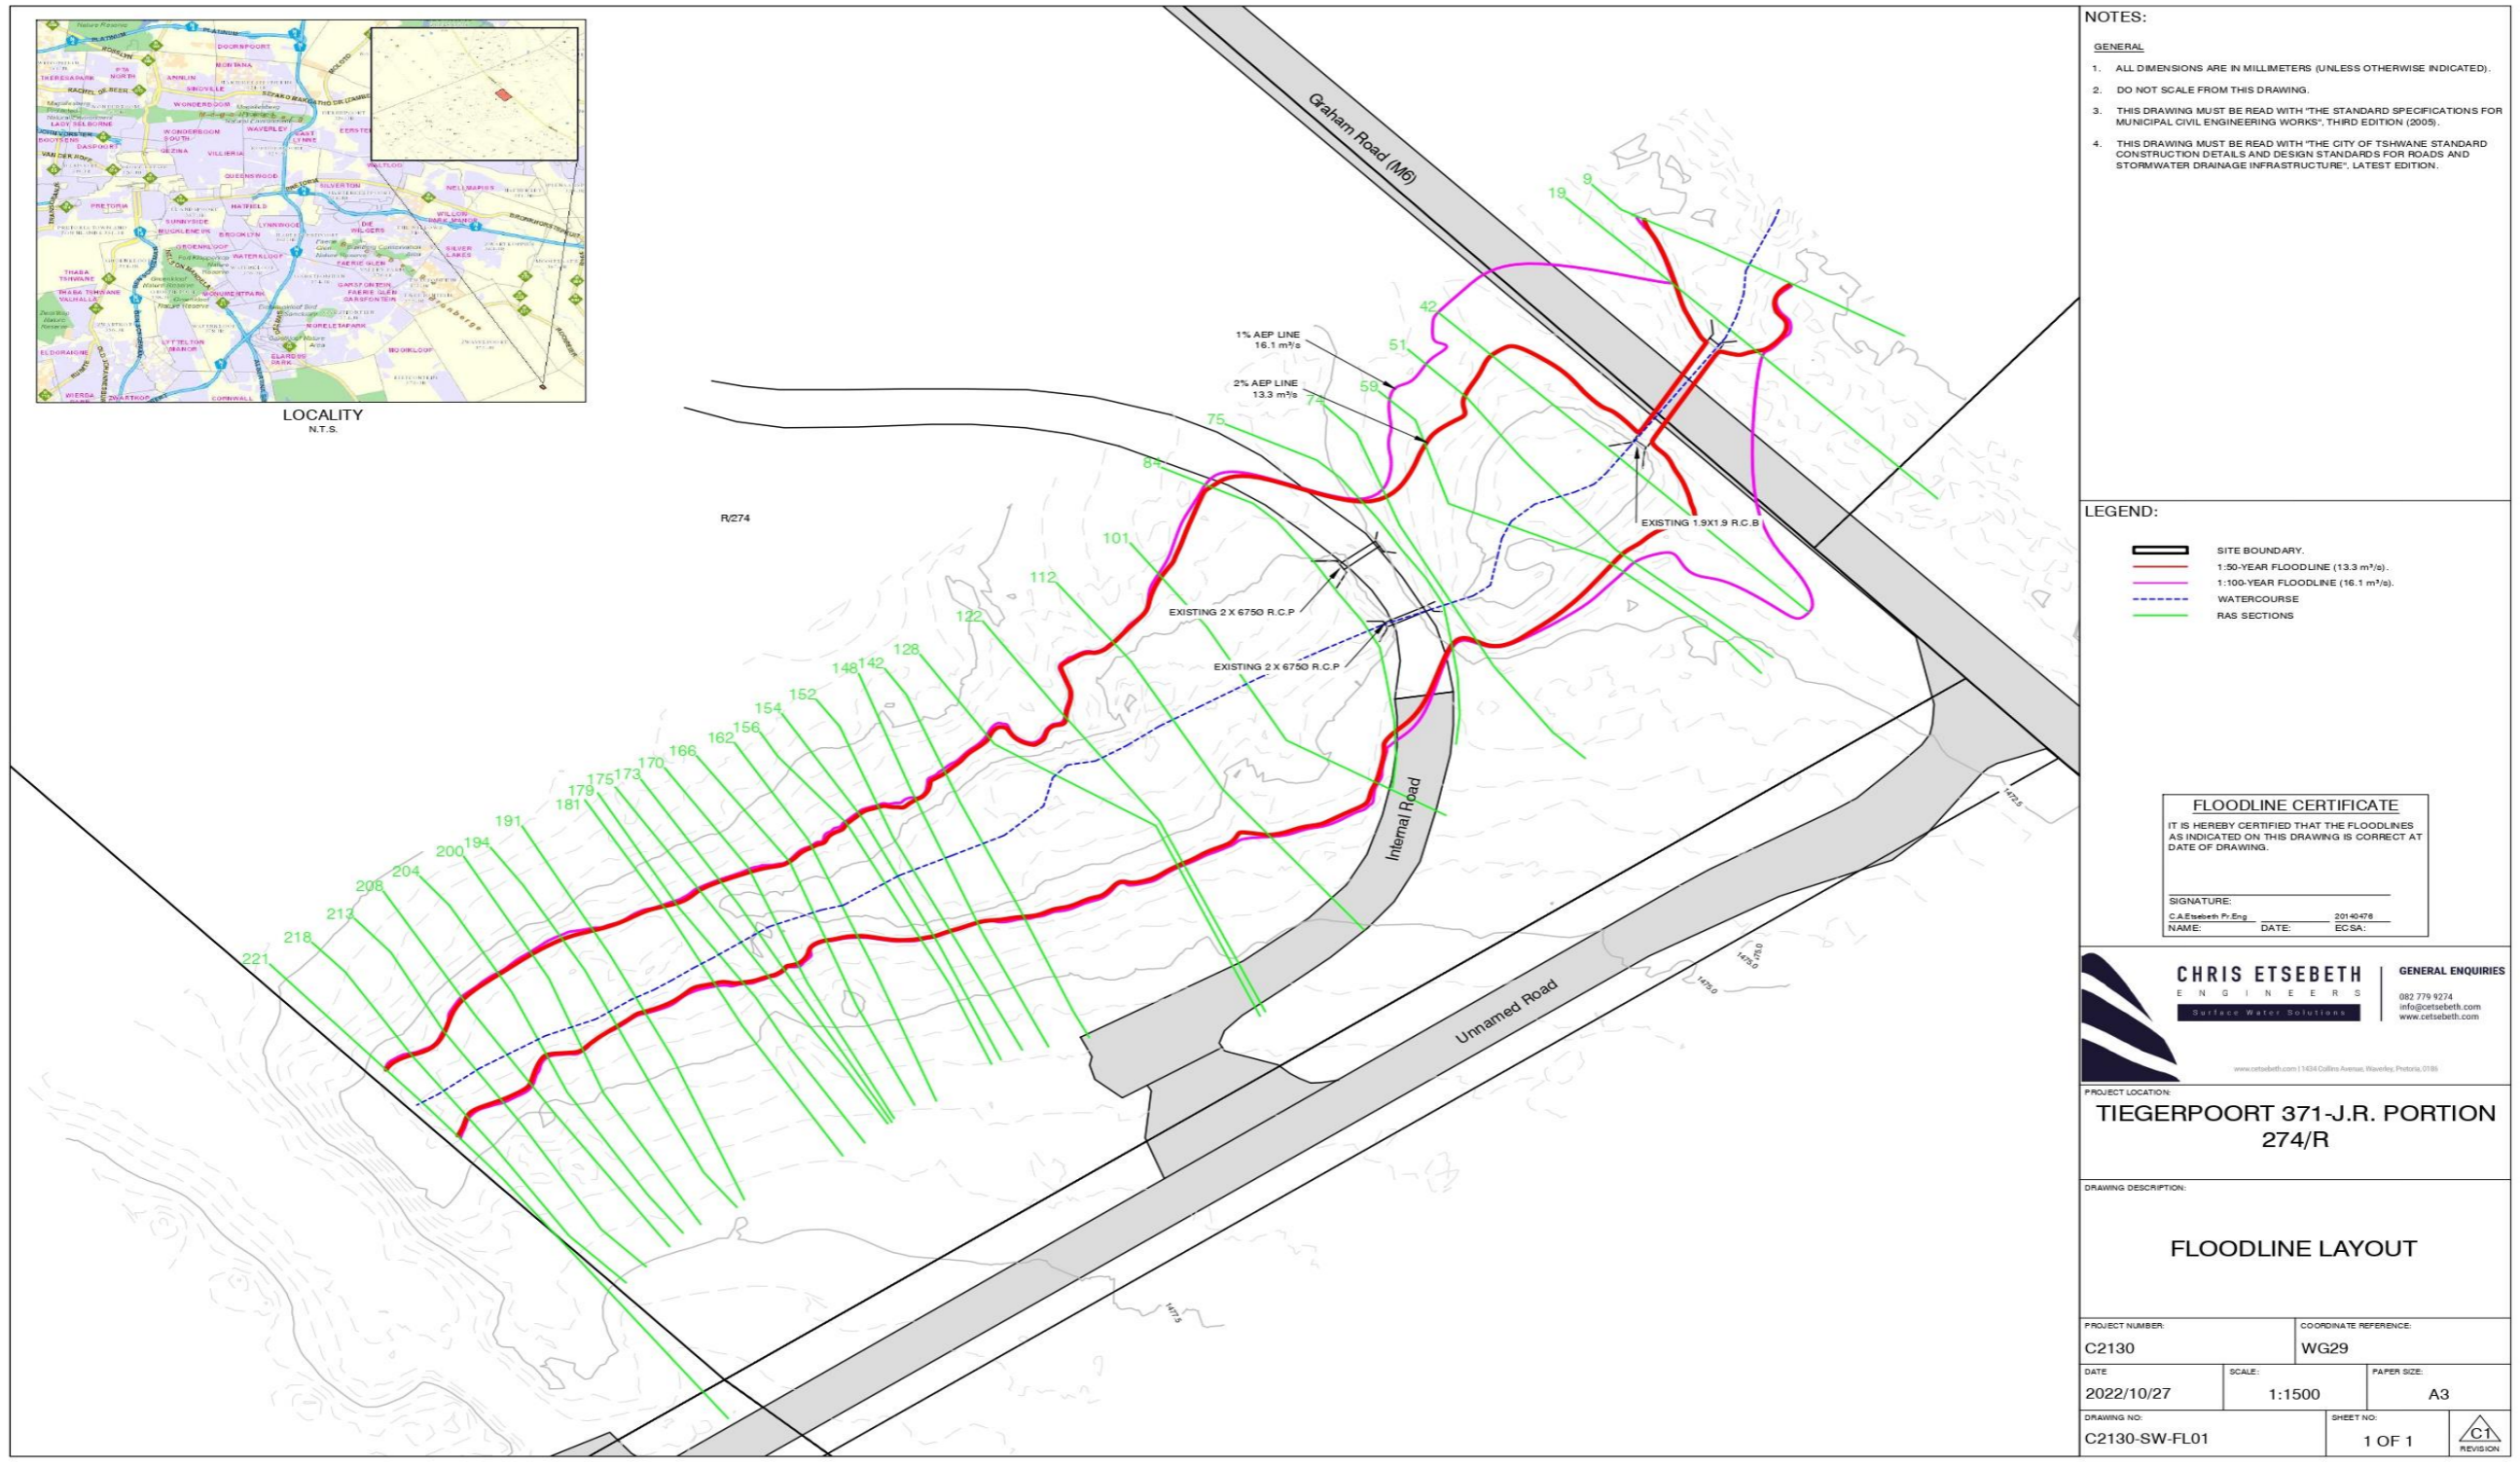
Figure 4-12: Floodline layout (Chris Etsebeth Engineers (Pty) Ltd, 2022)

A Floodline assessment was undertaken by Chris Etsebeth Engineers (Pty) Ltd for the project area. The project area falls within the 1: 50 year and 1: 100 year floodline. **(Figure 4-12)**.

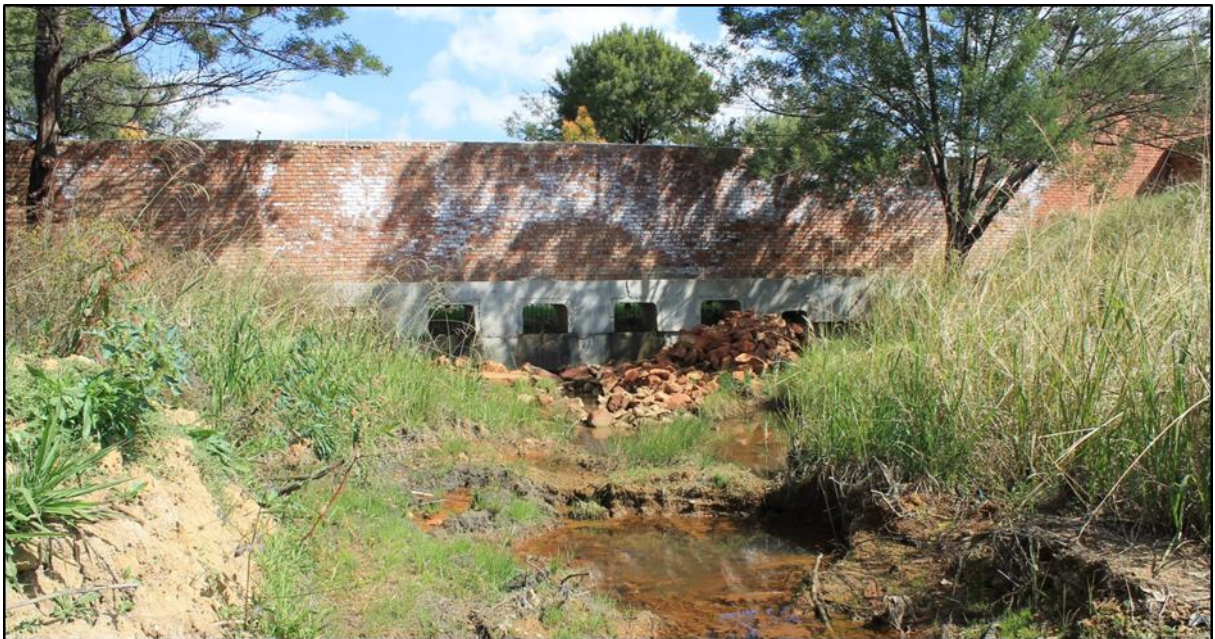
According to the IHIA results (Table 4-2), the instream habitat integrity of the assessed tributary reach was rated as largely modified (class D). This status was attributed to inundation (numerous impoundments within the tributary), bank erosion that resulted in bed and channel modification through sedimentation and subsequent flow modification. The riparian habitat integrity was also rated as largely modified (class D), with the highest impact score being exotic vegetation which has encroached into the riparian zones, competing with indigenous vegetation and altered the riparian zone from natural (pre-urbanized) conditions. An overall large loss of natural habitat, biota and basic ecosystem functions has occurred within the assessed reach.

**Figure 4-17: Instream Wall and Rock dump on site**

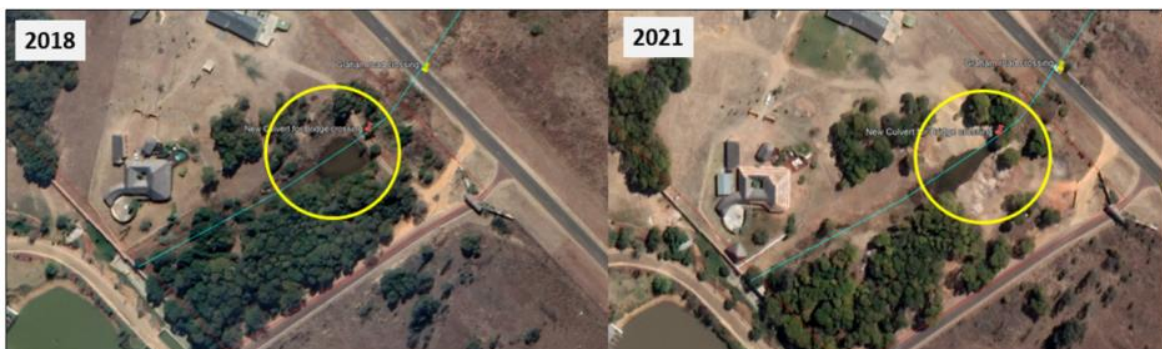
An Aquatic Biodiversity S24 Study and Impact Assessment was undertaken by the Biodiversity Company. According to the Biodiversity Impact Assessment, as part of the scope of work, [Section 24(G)] for the culvert crossing that have been built as well as the other developments that have taken place on the project area, such as the road, infilling the attenuation dam, placing rocks south east of the site at the boundary wall, storage of building waste on site for levelling of the river banks. The potential state the area cleared as well as the areas where construction had occurred before these impacts had to be determined, historical Google Earth Images were compiled and can be seen in **Figure 5-1** in order to assist in the determination. It is evident that a large portion of the areas cleared, especially in relation to the road construction and bank alteration had occurred on areas that had been impacted historically by the attenuation pond and clearance of trees.

**Figure 5-1: Comparison between the historic image before the majority of the impacts/changes occurred and most recent satellite image for the project area. The 2018 image: illustrate an instream dam; 2021 image: illustrate infilled of the instream dam (Google Earth, 2021) (TBC, 2022)**

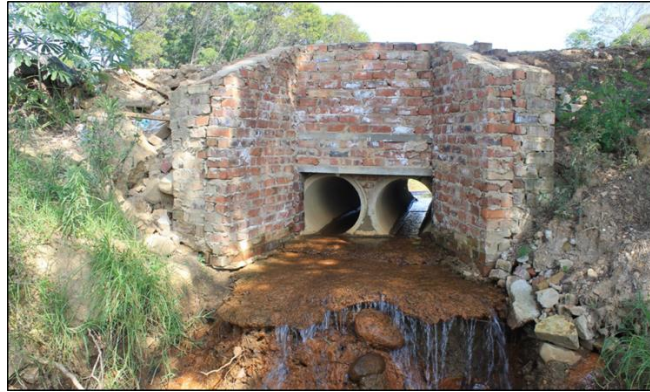
**Figure 5-2: The newly constructed culvert crossing (TBC, 2022)**

The construction phase of the culvert crossing was poorly executed with many expected risks during construction having occurred on a large scale, with little to no rehabilitation having occurred. However, with

low water levels experienced on site, the water was still flowing past the newly constructed culvert crossing. Which then suggests that the newly constructed culvert does cater for low flow conditions of the tributary and the movement of aquatic biota such as *Enteromius paludinosus* and *Pseudocrenilabrus philander*. The second old culvert will then serve as an alternative flow path for high flow conditions **Figure 5-2** and **Figure 5-3**.

Impacts from the unauthorised instream culvert crossing were noted at the time of the survey. The identified current impacts were the increase in sediment inputs, siltation, erosion and the major impact being the alteration to flow volumes due to changes in drainage patterns by the constructed culvert crossing. These impacts including the operational impacts could be lowered with the application of mitigation and rehabilitation. The vegetation on site is tolerant and no protected trees or SCC flora are likely to have occurred recently within the site. The numerous category 1b invasives must be controlled according to an Invasive Alien Plant Management Plan, in line with NEM:BA legislation. There is evidence of large modification to the tributary and therefore the ascribed mitigation and rehabilitation must be enforced. The risks for decommissioning have been considered in the specialist report if the application is rejected. It should be noted that there are more risks posed by decommissioning phase when compared to the risks posed by the operation phase.
