BRYPAAL SOLAR POWER (PV) PROJECT NOVEMBER 2017

Topography Specialist Report

Remainder of Portion 4 of the
farm Brypaal No. 134

Project Name	EIA for the proposed development of a 100 MW PV Solar Facility on the farm Brypaal, Northern Cape Province.
Report Title	Topography Specialist Report
DEA Reference	14/12/16/3/3/2/1019
Report Status	Final

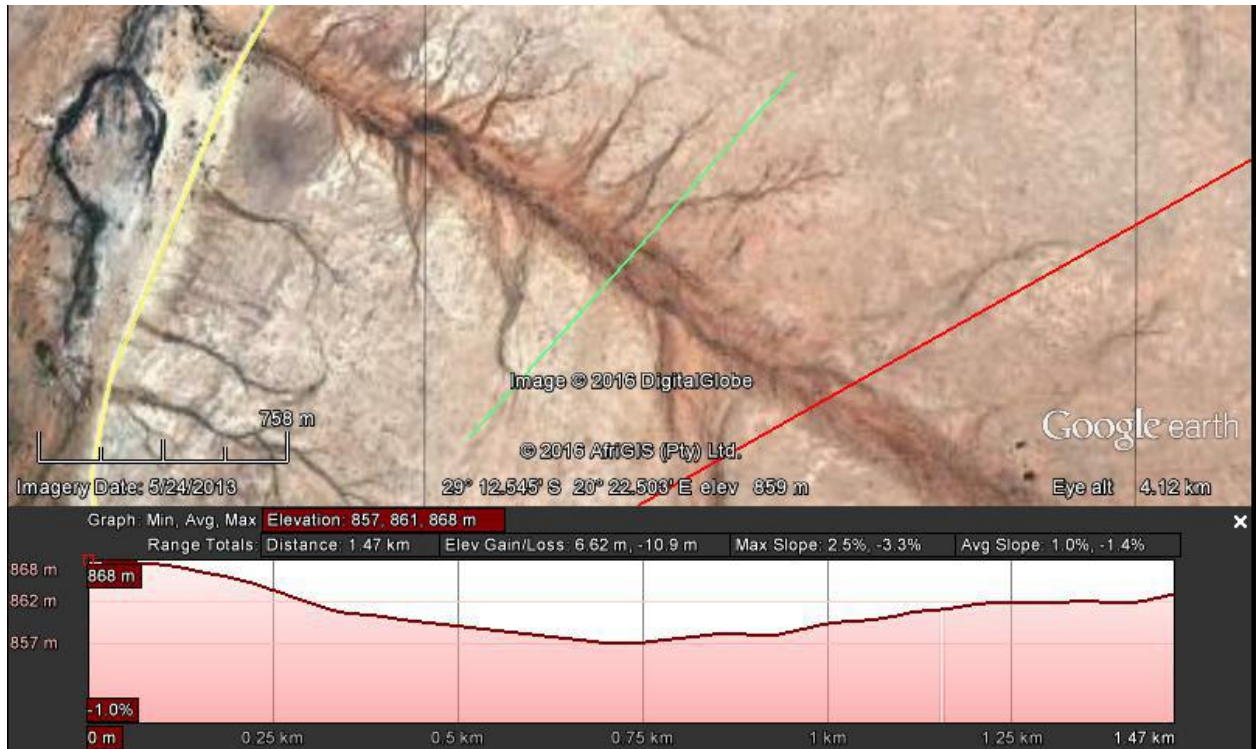
SLOPE PROFILE DRY STREAM 1(A):

AVERAGE SLOPE: 1.0%, -1.4%

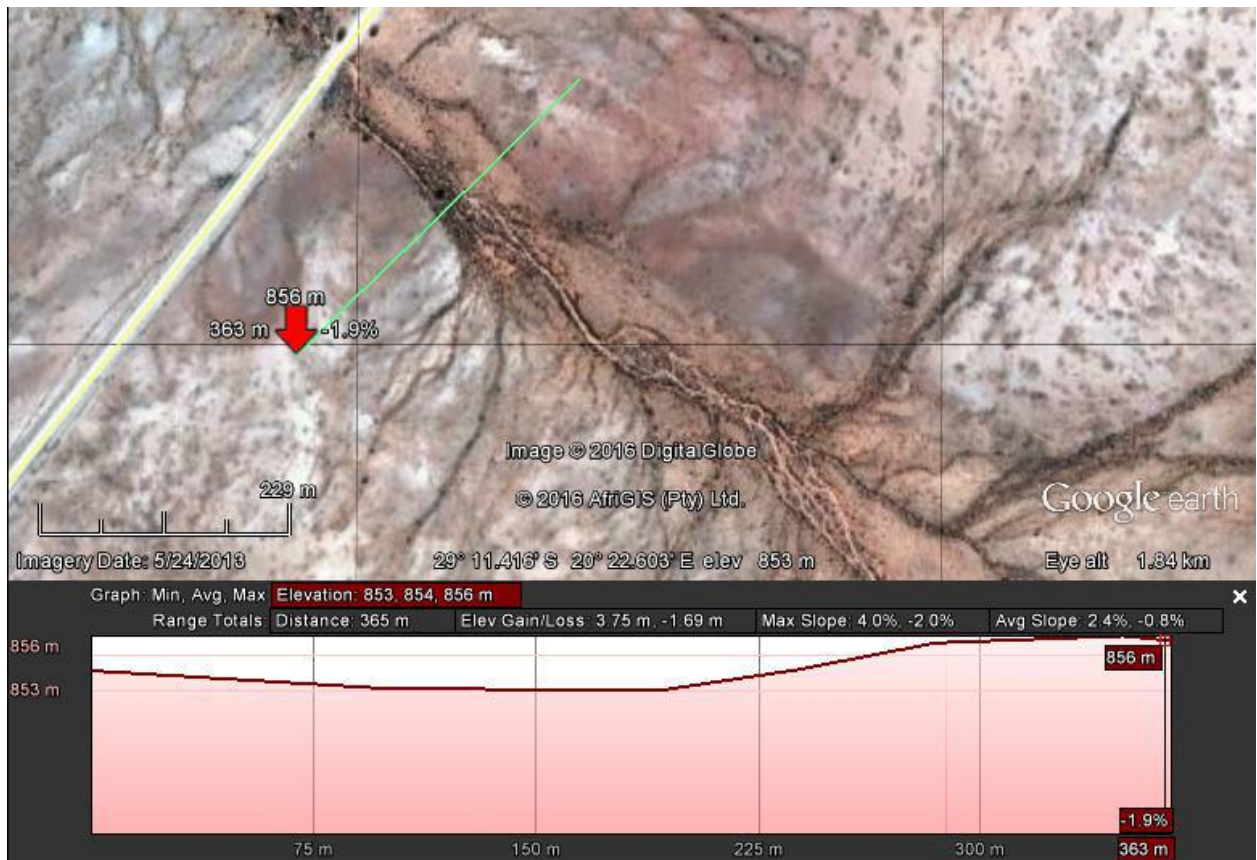
SLOPE PROFILE DRY STREAM 2(C):

AVERAGE SLOPE: 2.4%, -0.8%
