# Tutuka Power Station Ash Disposal Facility - Hydrogeological Assessment

## Final Report

**Eskom Holdings SOC Ltd**

**GCS Project Number: 19-0217**

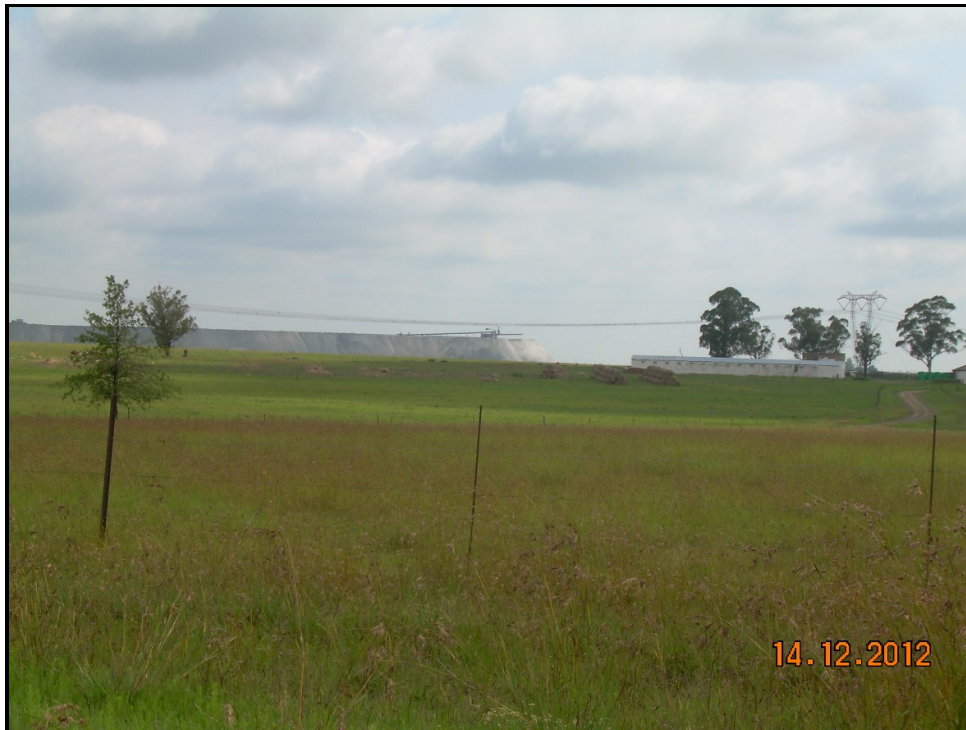
**Figure 1.** Tutuka Ash Disposal Facility at the back of figure 1.

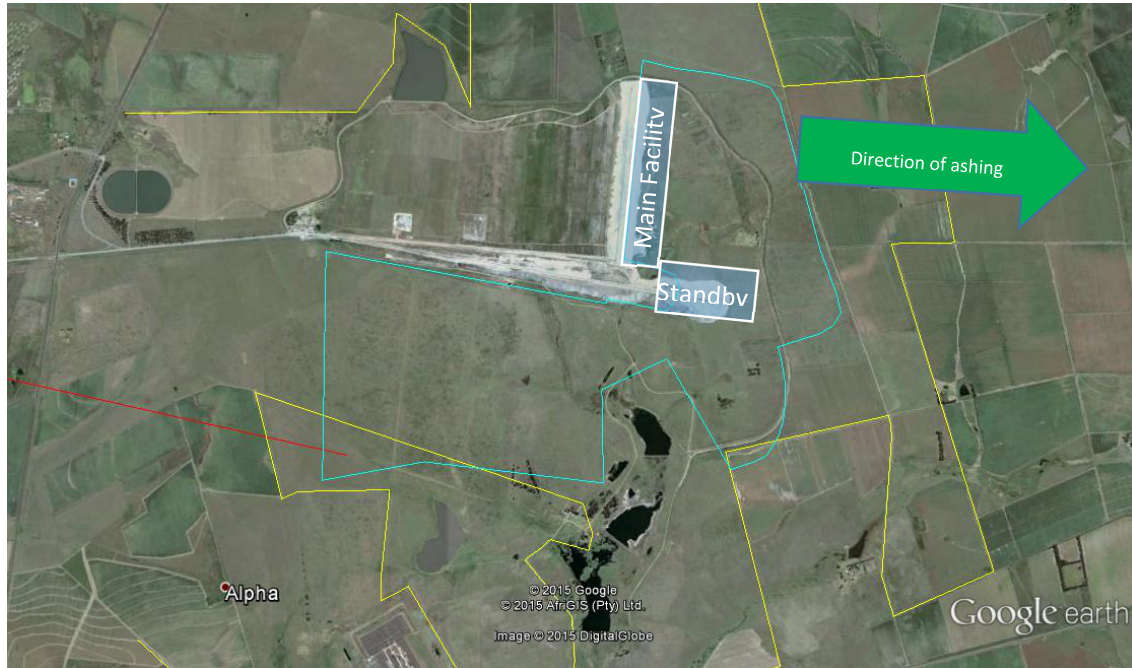
**Figure 2.** Google image of the area that forms part of this exemption application.

To make this report comprehensive a short summary of the impacts that were identified during the Environmental Impact Assessment (EIA) are provided below, with a specific focus on the 54 hectare area where Eskom proposes to dispose of the ash without the liner installation. Current disposal (faces visible on the photo) occurs just before the newly proposed alternative (blue outline in figure 2). The ashing philosophy and strategy is such that the disposal continues in an easterly direction. The Google image below indicates the area for which the exemption application is being made (white outline, Figure 2).

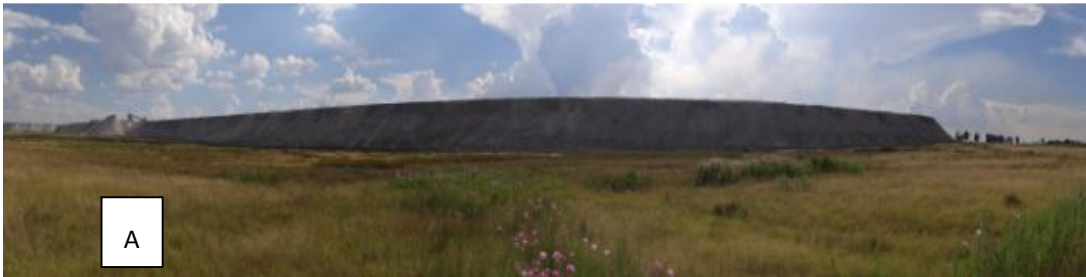
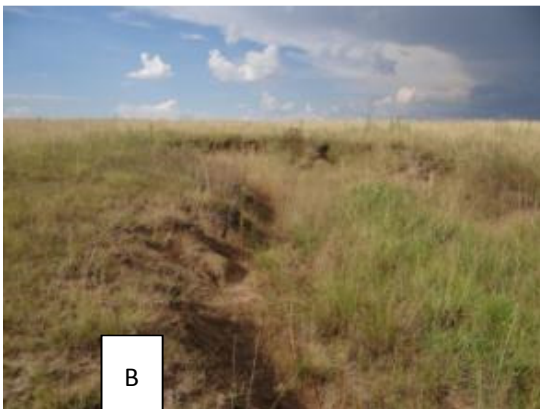
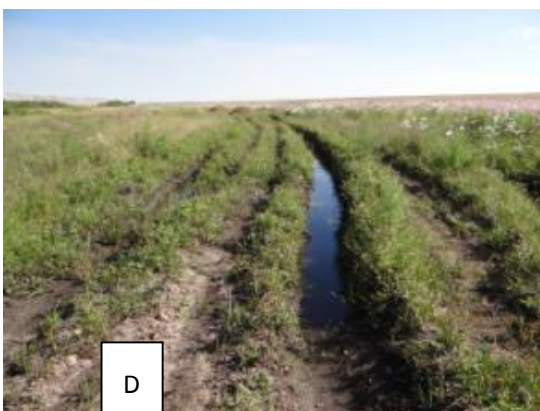
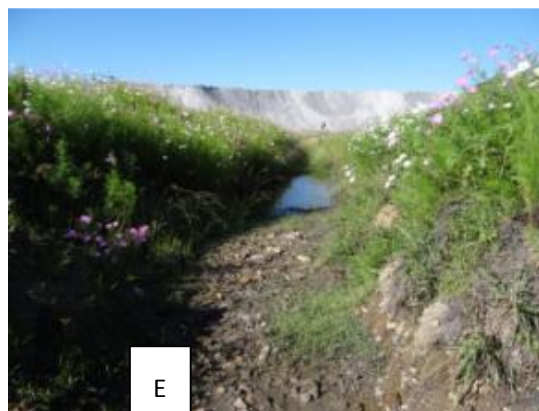
**Figure 6:** Site Wetland 6 upstream of the Ash Disposal Facility within Alternative A showing (A) panoramic view of the area, (B-E) extensive trenching and (F-G) clearing activities

Figures 6 below show some images of Alternative A (Photos A, F and G includes areas under this application).

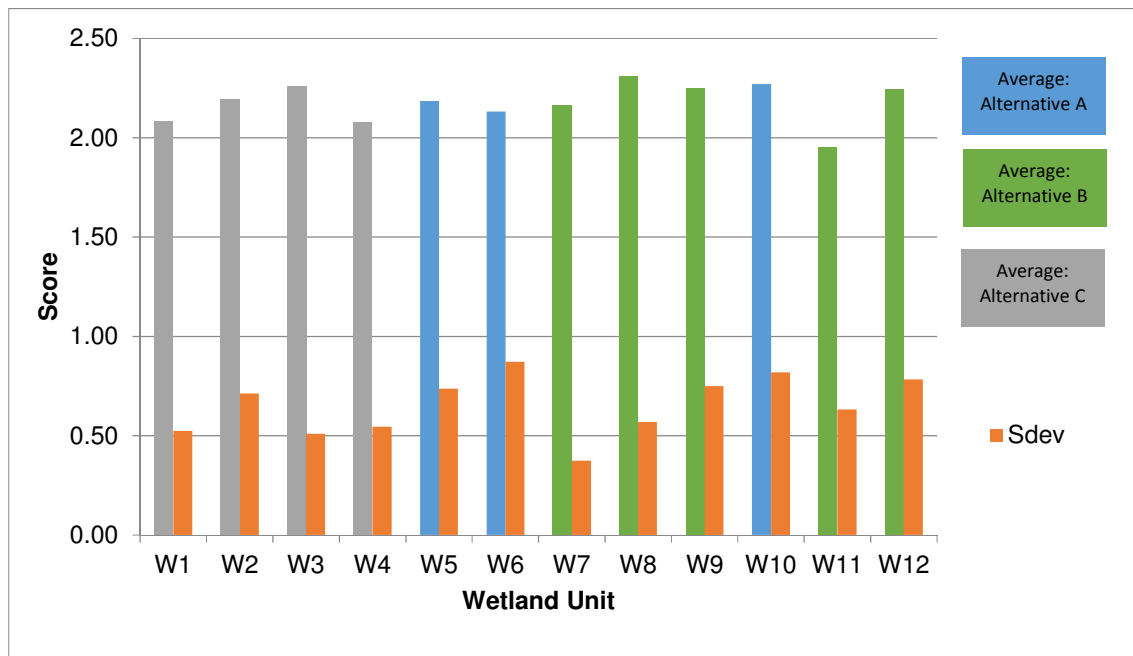
**Figure 8.** Average overall Ecosystem Service scores per wetland unit

Figure 8 indicates the current functional assessment scores for the wetlands on site. This score refers to the number and variety of ecosystem functions (bullet points above) at each wetland. It is clear that Wetland 6 (the proposed area for unlined ashing) are at the lower end of wetland functionality in comparison to the other wetlands.

Wetland 6 retains little hydrological integrity and mainly functions as a pollution control facility at the moment (Figure 8).

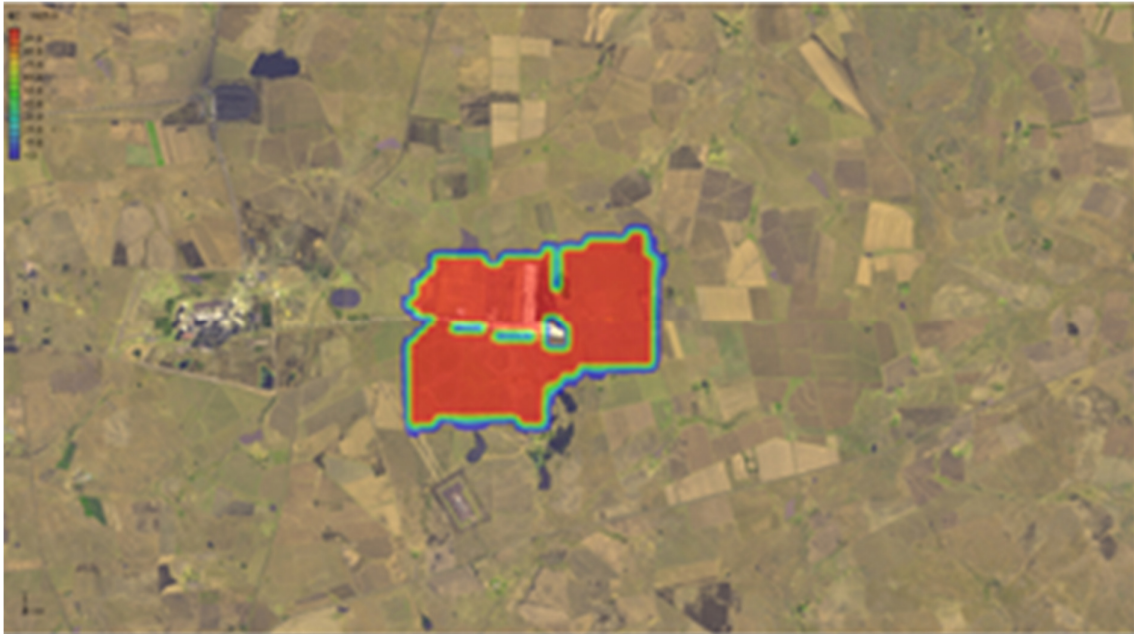
**Figure 11.** Modelled impact on groundwater plume five years after deposition starts. Assuming impact on the entire footprint without lining (SLR, 2013).

The numerical model results suggest that the movement of leachate away from the ash disposal facility as a groundwater plume should take place relatively slowly, with plume extents being generally less than 1 km from the ash disposal facility after 100 years.
