30 June 2022  
05 December 2022 - revised

**Umzinto SAPS and Magistrates Court  
Erf 123 and 124, Umzinto, KwaZulu Natal**

**BUILT ENVIRONMENT HERITAGE SCREENING**

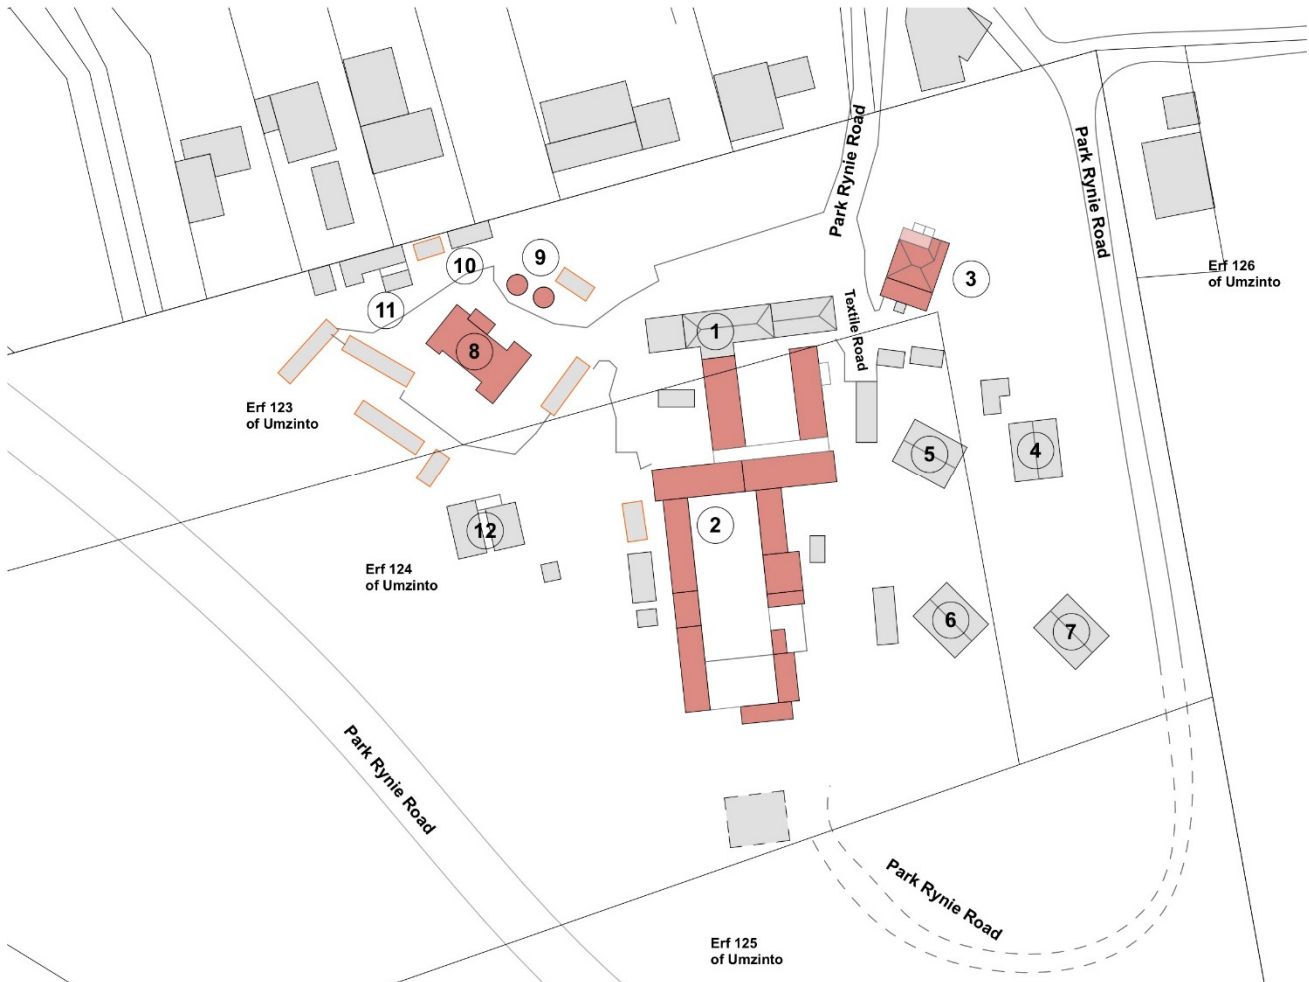
### Inventory of Structures

Structures over 60years old : red  
Structures younger than 60 years :grey  
Temporary structures : unmarked grey  
Demolished structure : unmarked grey, dashed line

1. Magistrates Court Building
2. The Old Prison
3. SAPS Crime Prevention Unit (old house at entrance)
4. Dwelling and outbuilding
5. Dwelling and outbuilding
6. Dwelling and outbuilding
7. Dwelling and outbuilding
8. SAPS Offices (old house)
9. Rodavels storerooms
10. SAPS Office
11. SAPS gun store room
12. SAPS Child Protection

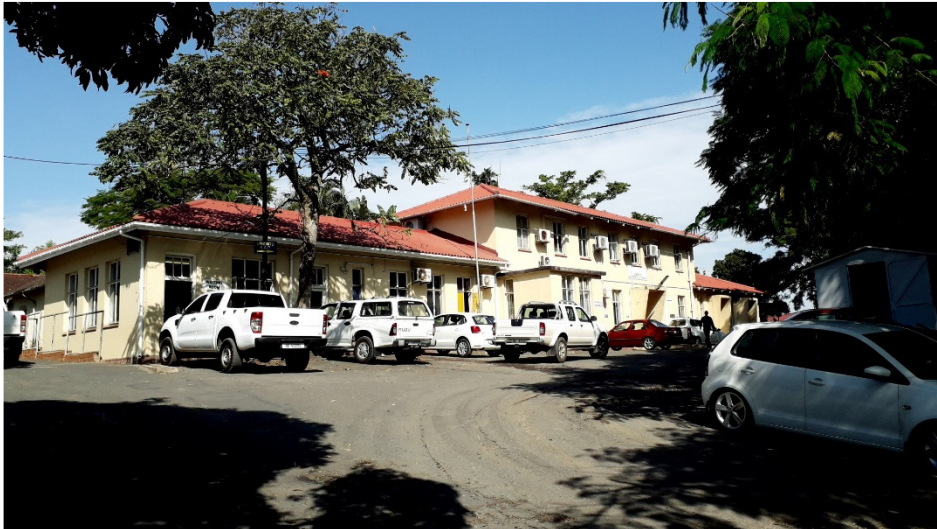
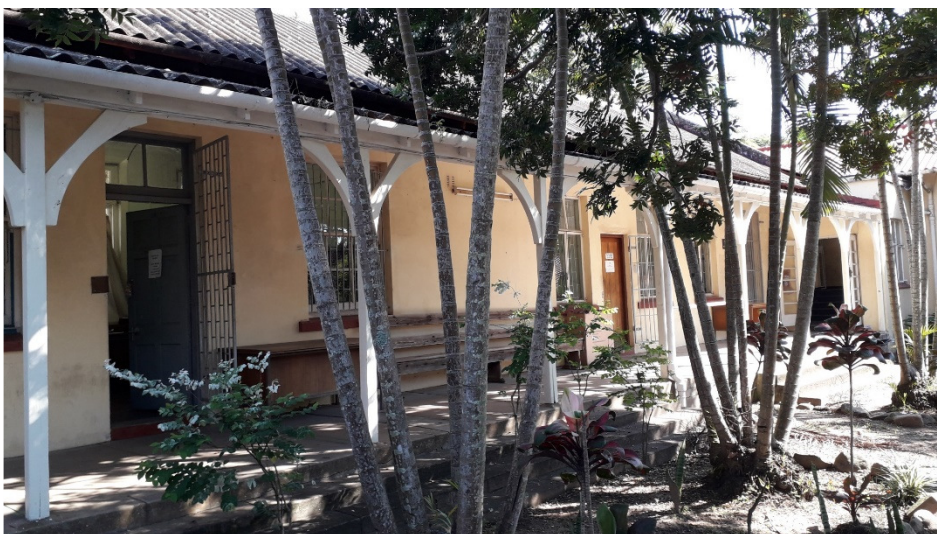
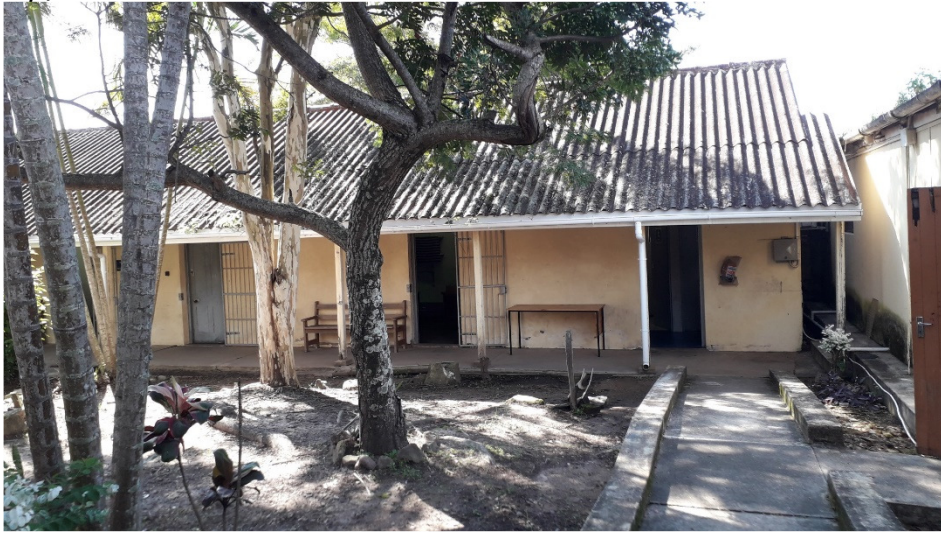
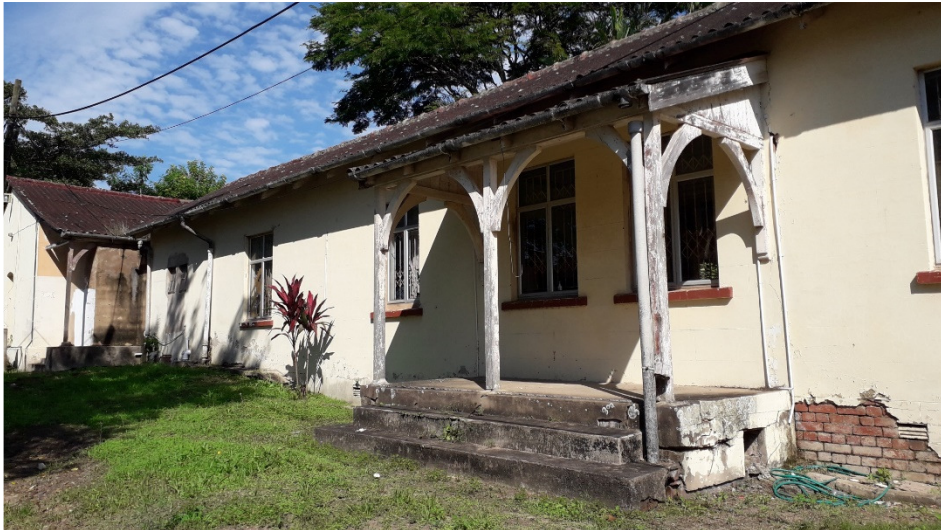
## 1. Magistrates Court Building

The magistrates court complex consists of three linked structures, the front structure that houses the main entrance hall is a double storey block with flanking single storey wings. Construction date is estimated to be in the 1960's. An older structure may have been incorporated into the complex in the 1960s upgrade. It is plastered and painted masonry construction with sheet roof material. The entrances are framed with concrete “eye-lid” coverings, commonly used on government buildings in the 1960s. The rooms have high ceilings and windows and doors have fanlights. The courts and offices are accessed off an internal passage that runs the length of the building. The roof sheeting and storm water goods appear to be recently replaced, but missing in places.

Behind the double-storey block are two single-storey buildings with verandas opening onto a garden courtyard. They are estimated to have been constructed between 1920 and 1940. The upper block has high ceilings and a separate veranda roof with timber posts and brackets (equal to the school specification in schools built in 1920-30s). The lower block has an extended roof veranda facing the courtyard. The remains of an entrance portico is on the East side with timber posts. The blocks have been linked to the main magistrates court block via the entrance hall and stairway.

The Magistrates Court complex (Bldg 1) is of **medium local heritage significance** due to its age, the incorporation of older court buildings in the complex and their prominent position on the site. It has the potential to be refurbished under its current or administrative use.

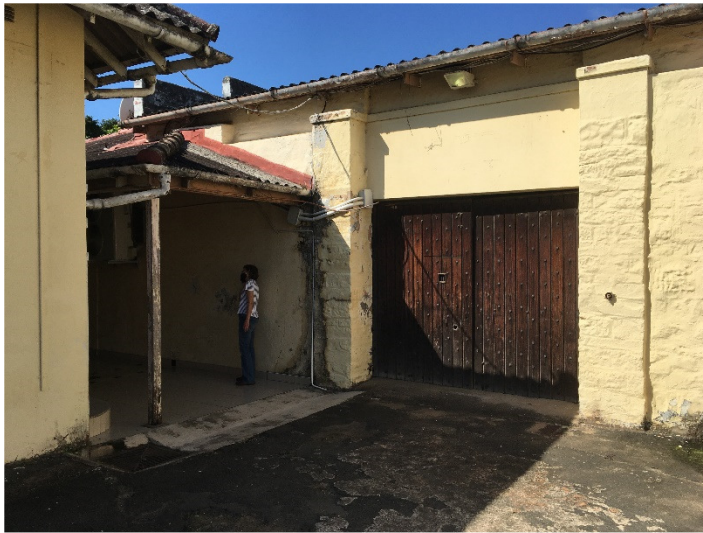
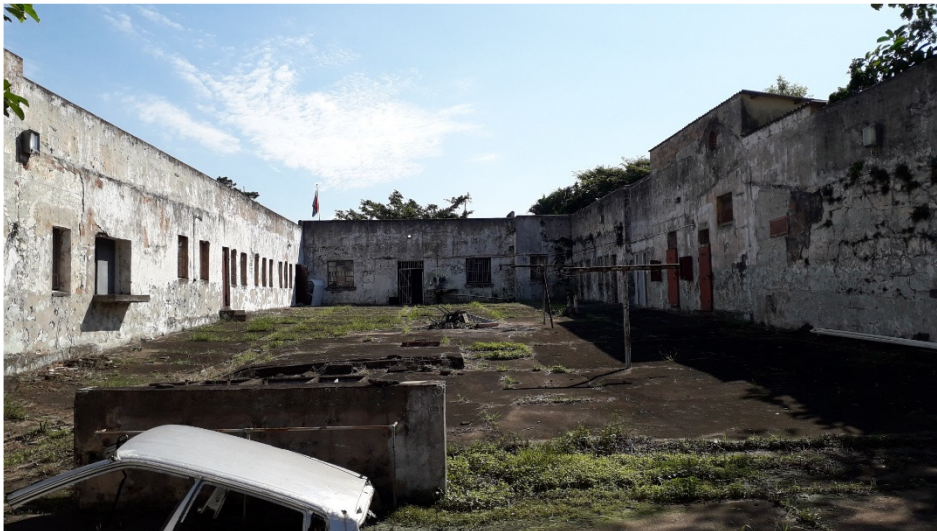
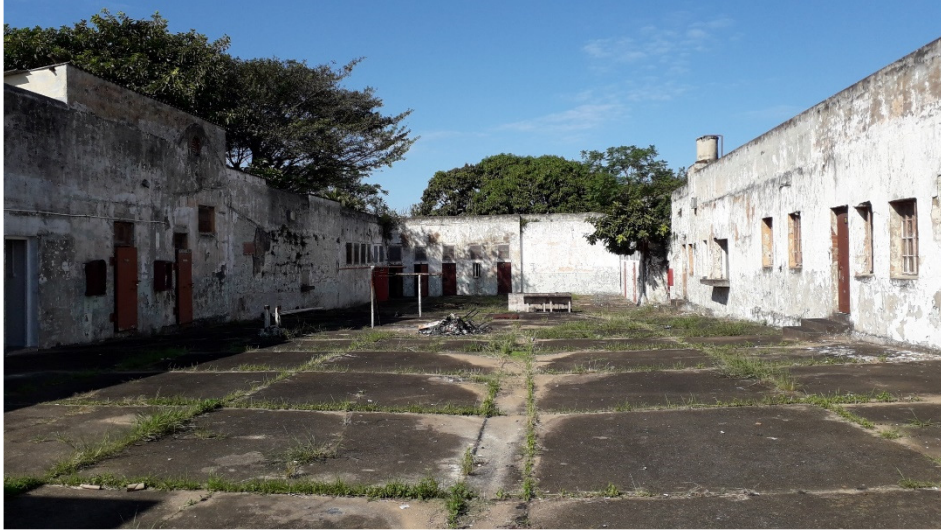
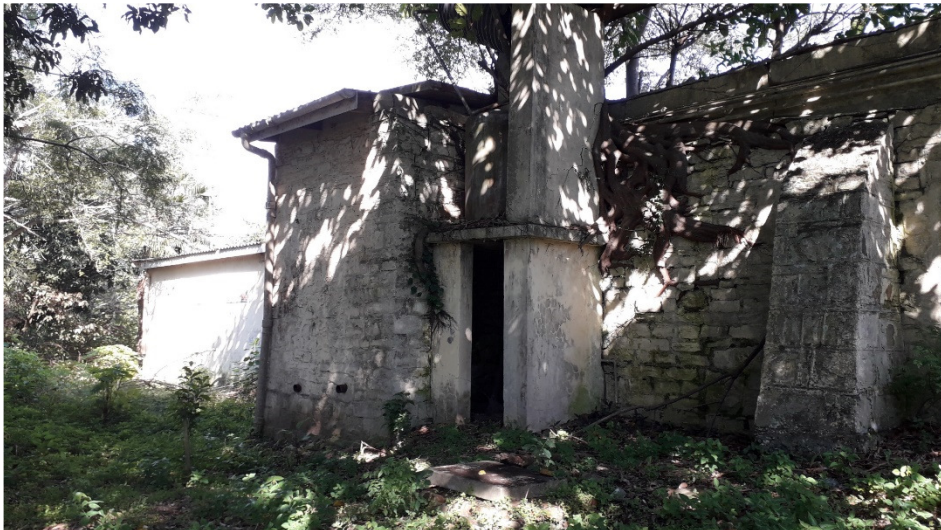
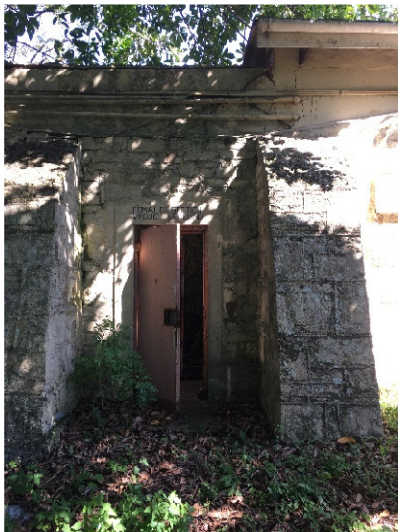
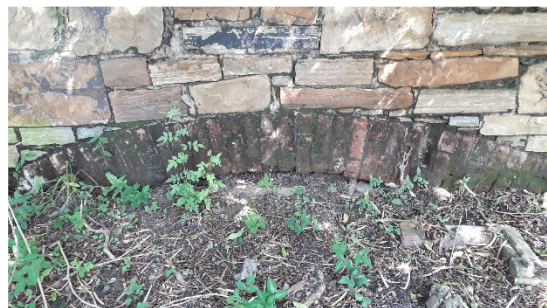
## 2. The Old Prison

The old prison structure covers an area of approx..1700sqm, measuring 55x30m, It is a rectangular plan of cells and rooms around an open courtyard in the centre. The East side was the female cells with a small open courtyard. The original structure is constructed of stone, but there is evidence of clay brick additions and extensions. Most of the building has been plastered or whitewashed. A portion of the East elevation shows the original stone. An arched structure below ground floor is visible on the East elevation, this needs further investigation. The original reinforced entrance gate is still in place. Windows are steel frame. The North end has been converted to a conference facility, most alterations are light-weight and removable.

The walls have suffered damage from trees and roots that have been allowed to grow into the structure.

The Old Prison building (bldg. 2) is of **high local heritage significance**, due to its age, its service to the community, its design and materials. It has the potential to be repurposed as a public or private facility.

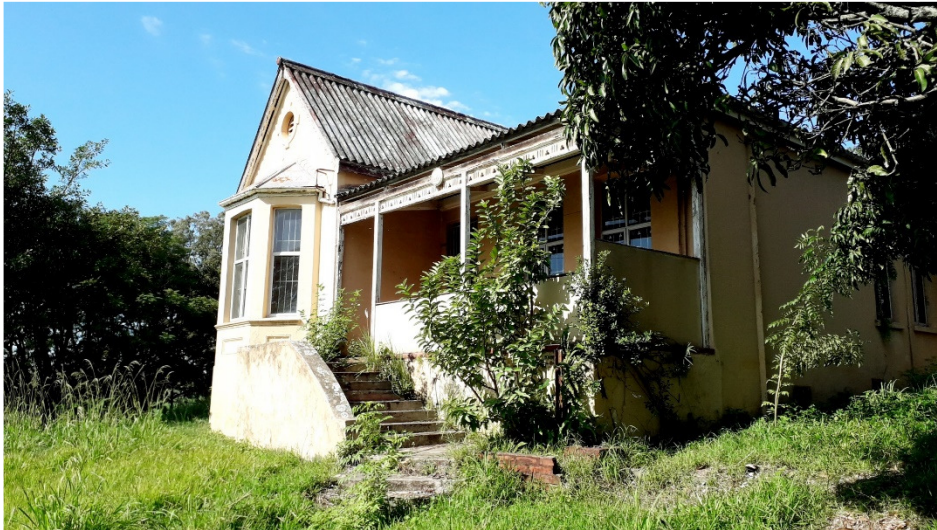
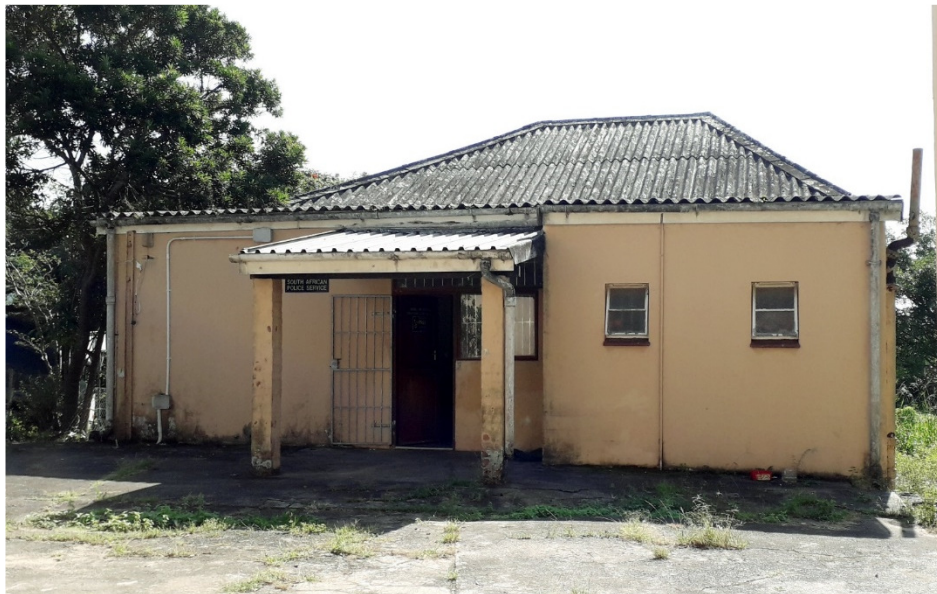
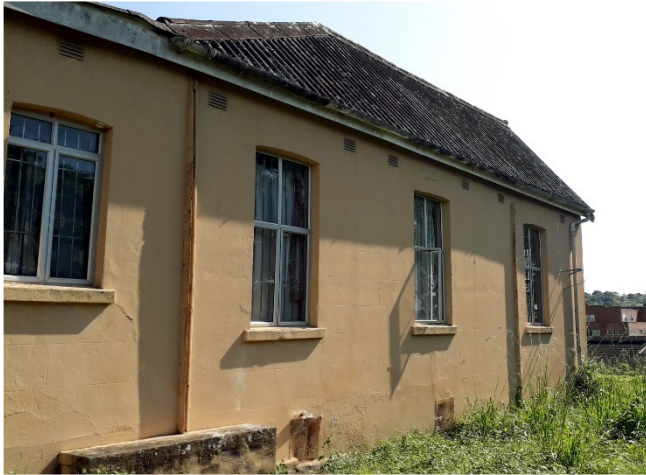
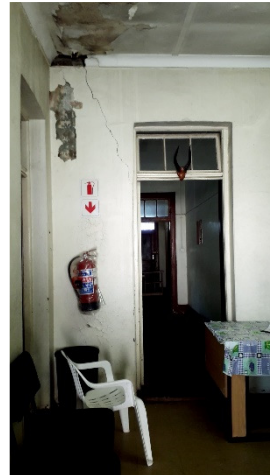
3. SAPS Crime prevention Unit (old house at entrance)

The old house on the left at the top of the driveway is a single storey house and a typical example of a “Natal gabled-veranda-house”. It has an asymmetrical gable with bay window and a circular roof vent centred in the gable, a timber veranda with decorative filigree. The timber barge-boards on the gable are scalloped. Plaster detail on the gable, around the roof vent and below the bay window. The house is plastered and painted with ruled jointing detail. The roof material is asbestos sheeting. Timber windows have been replaced with aluminium frames. Floors are suspended timber. The internal and external walls show structural cracks.

The old houses (Bldgs 3 and 8) are needing major upgrades due to the age of the structures and their lack of maintenance over the past years. Structural assessments are recommended to inform planning decisions. The internal layouts of these buildings were for residential use and do not suit the current use.

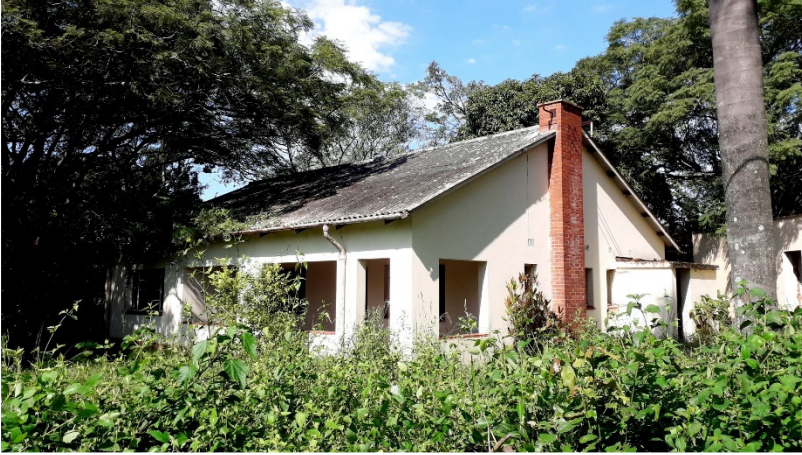
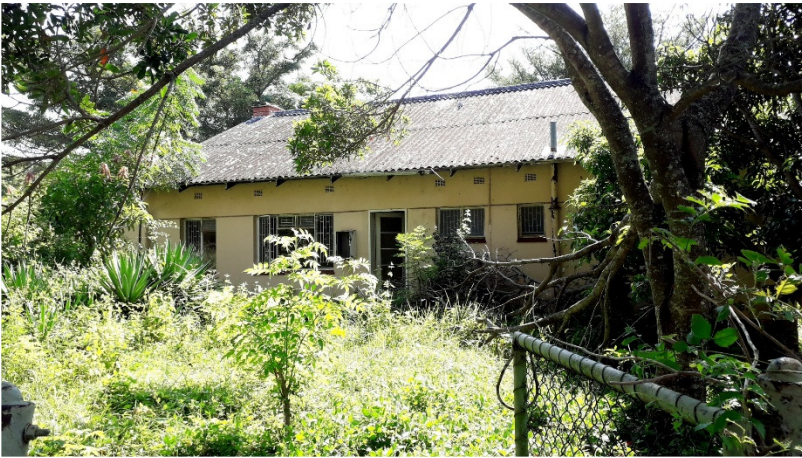
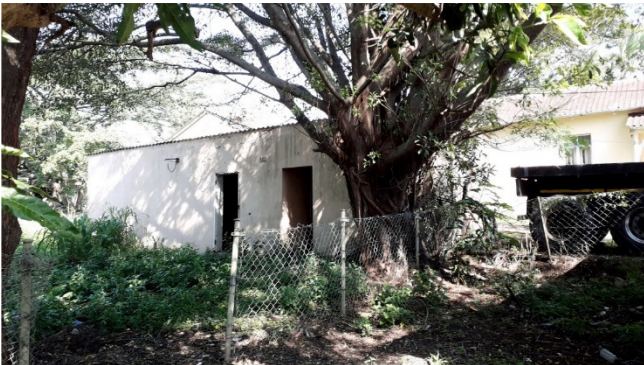
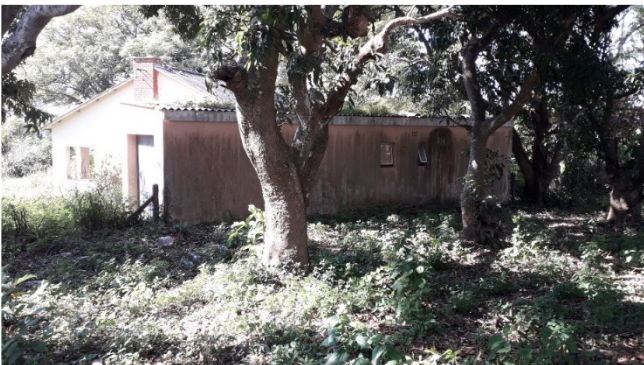
4. Dwellings and outbuildings (bldgs. 4-7)

Four houses, built between 1954 and 1967 are located on the Eastern side of the site. They have asbestos roofs and are of masonry construction. Each house has a garage outbuilding.

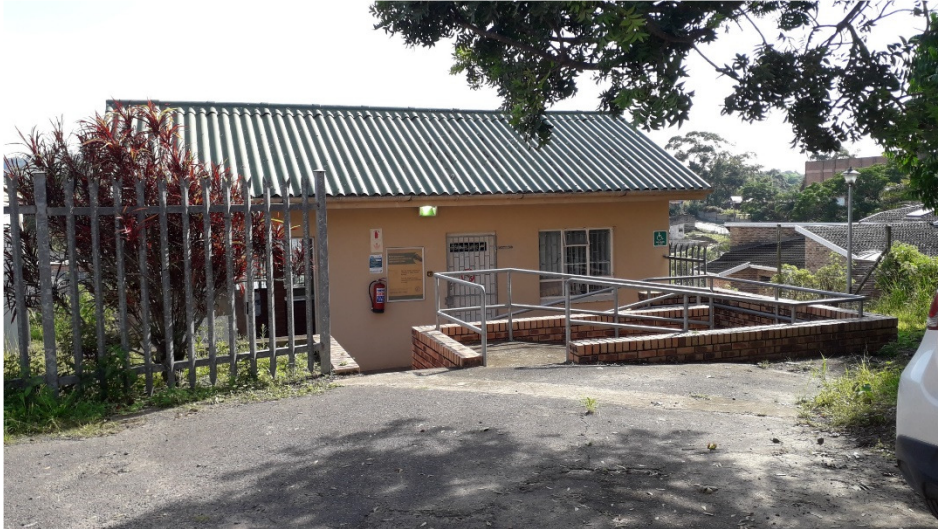
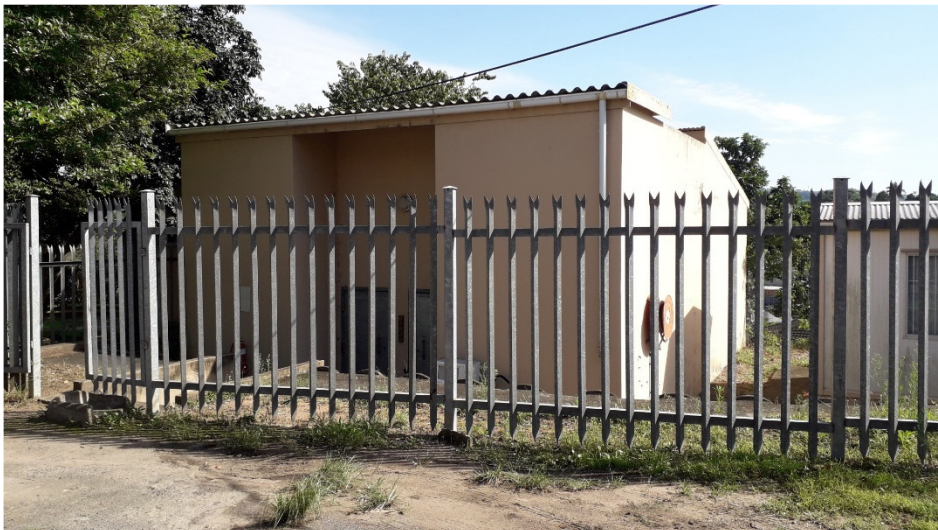
Buildings of recent construction, estimated to be 20-30 years old. Asbestos roof, masonry construction.

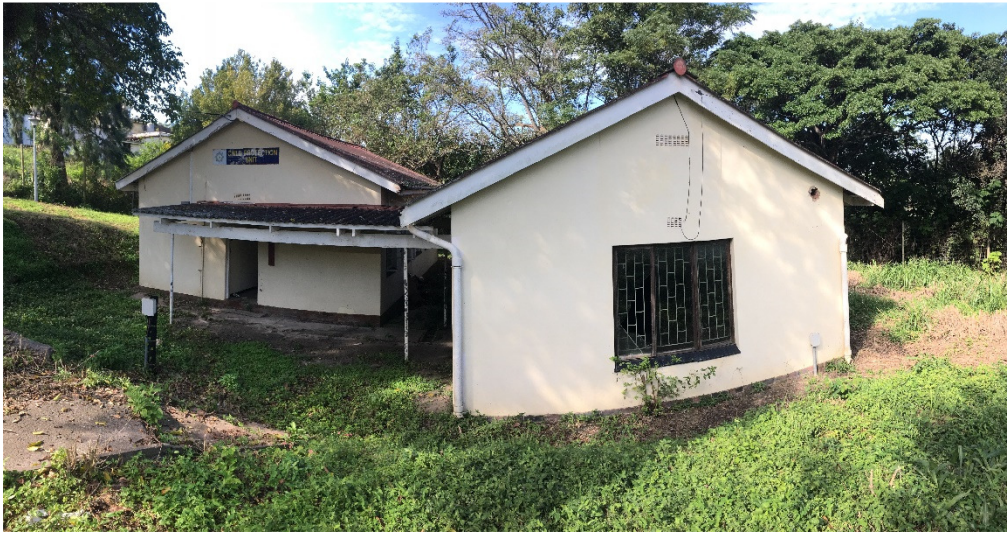
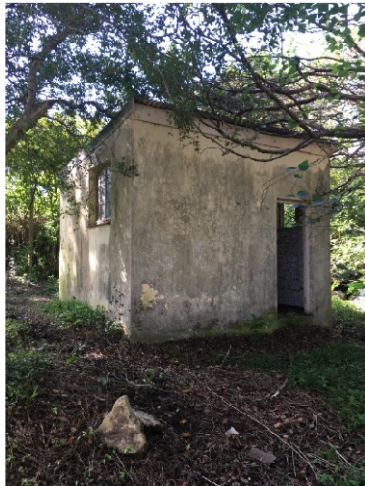
## 12. SAPS Child Protection

The child protection unit consists of buildings of recent construction, estimated to be 20-30 years old. Asbestos roof, masonry construction.
