# Umbila Emoyeni Phase One Wind Farm Terrestrial, Avifaunal and Freshwater Walkdown

## Bethal, Mpumalanga

April 2023

Report Name	Umbila Emoyeni Phase One Wind Farm – Walkdown Report
Reference	Umbila Wind Farm
Submitted to

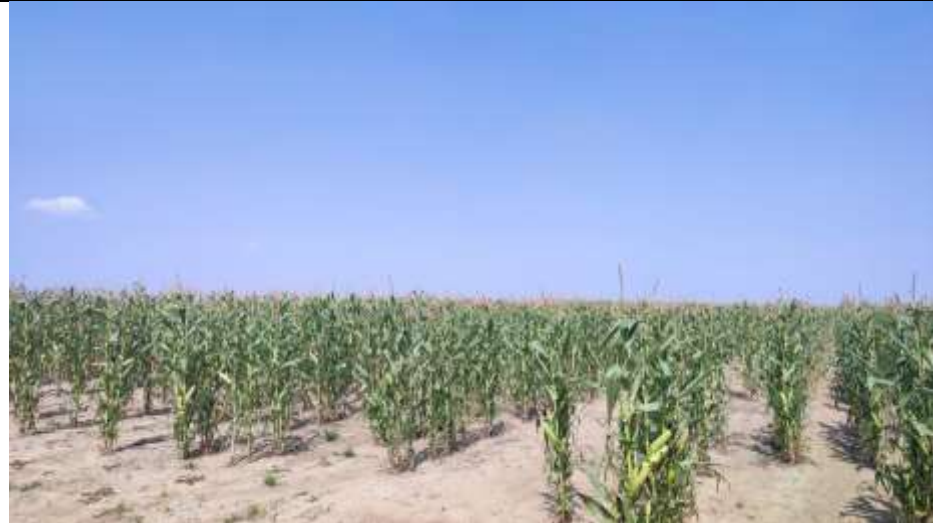
**T15**

Findings: No specific ecological constraints were recorded.

Location: Located in maize fields (low sensitivity)

Sensitivity area: Classified as low sensitivity area.

Habitat suitable to Highveld Golden Moles are present, though no signs of mole activity was recorded.

Recommendation: Move Turbine position 39m north onto the road crossing between the agricultural lands, for easier access.

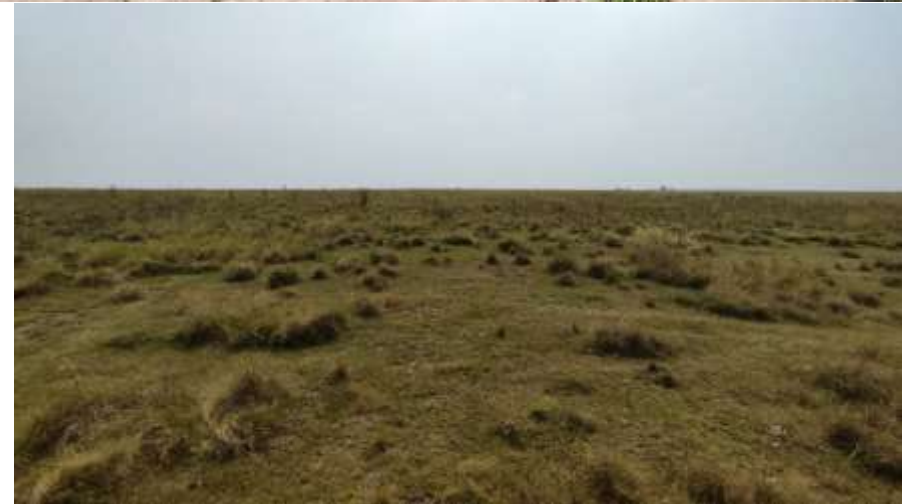
**T7**

Findings: No specific ecological constraints were recorded.

Location: Located in previously designated medium sensitivity area.

Sensitivity area: Classified as moderate sensitivity area.

The substrate of this area is not suitable to Golden Moles, no mole activity was recorded.

Recommendation: No changes to placement area required.

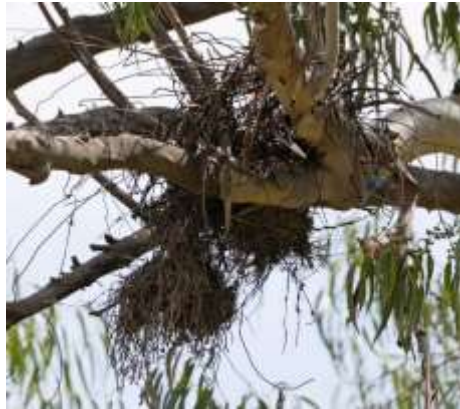
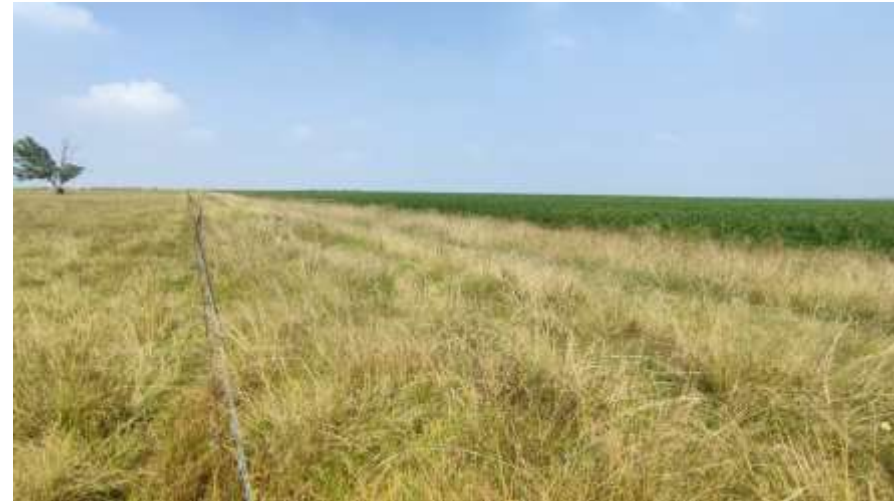
T6

Findings: No specific ecological constraints were recorded. A clump of alien trees is located 150 m from the Turbine location with one old and abandoned bird nest.

Location: Located in previously designated low sensitivity area.

Sensitivity area: Classified as low sensitivity area.

Habitat suitable to Highveld Golden Moles are present, though no signs of mole activity was recorded.

Recommendation: Keep Turbine on the road next to the fence line.

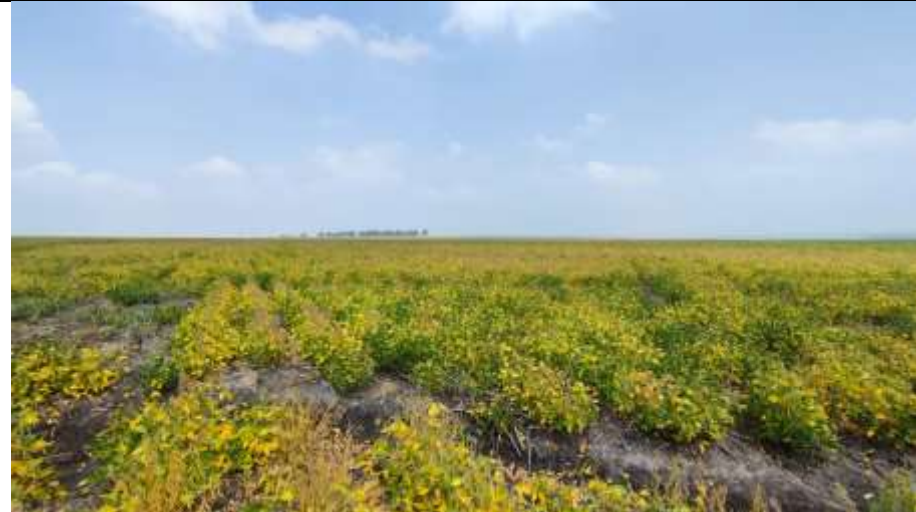
**T13**

Findings: No specific ecological constraints were recorded.

Location: Located in previously designated low sensitivity area. (Soya lands)

Sensitivity area: Classified as low sensitivity area.

Habitat suitable to Highveld Golden Moles are present, though no signs of mole activity was recorded.

Recommendation: Move Turbine towards the nearest road 133m east of Soya lands. Do not place the Turbine on the other side of the road.

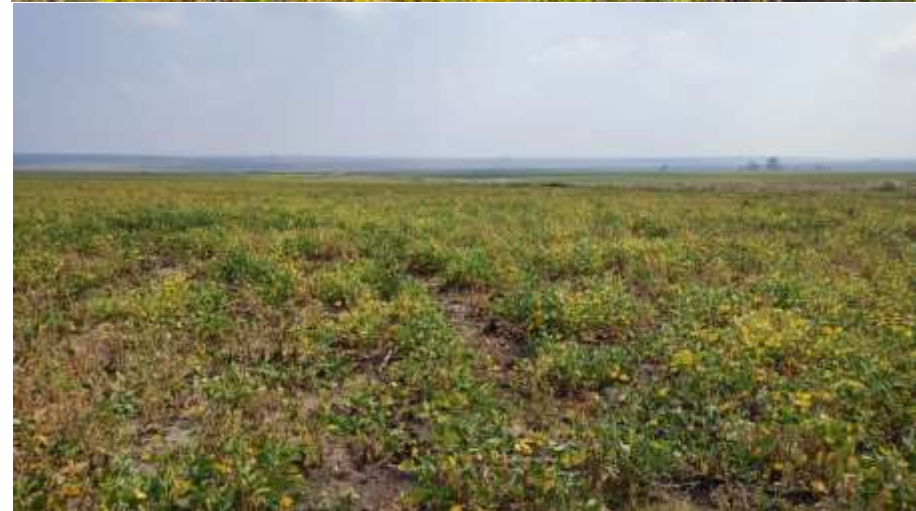
**T10**

Findings: No specific ecological constraints were recorded.

Location: Located in previously designated low sensitivity area. (Soya lands)

Sensitivity area: Classified as low sensitivity area.

Habitat suitable to Highveld Golden Moles are present, though no signs of mole activity was recorded.

Recommendation: Move Turbine to the nearest road crossing 109m south-east of Soya lands.

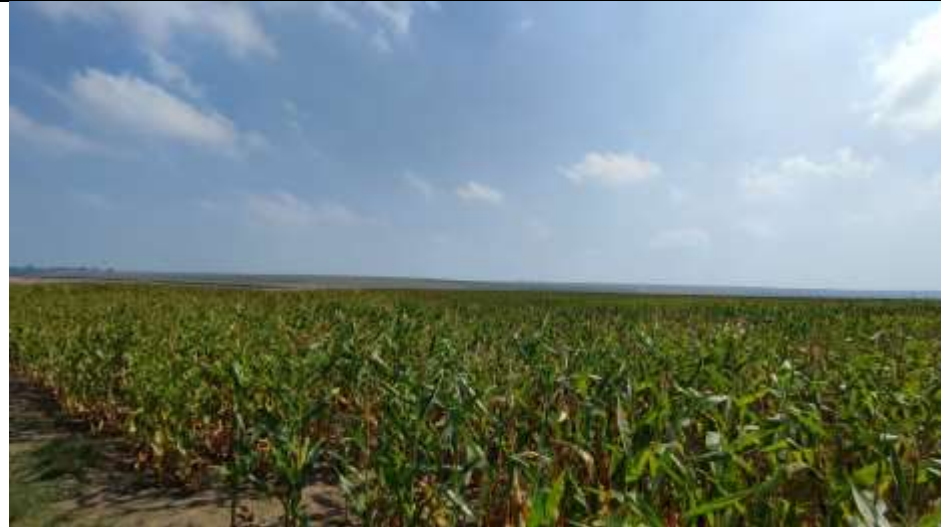
**T17**

Findings: No specific ecological constraints were recorded.

Location: Located in previously designated low sensitivity area. (Mielie lands)

Sensitivity area: Classified as low sensitivity area.

Habitat suitable to Highveld Golden Moles are present, though no signs of mole activity was recorded.

Recommendation: Move Turbine 43m South to the nearest road crossing next to mielie lands.

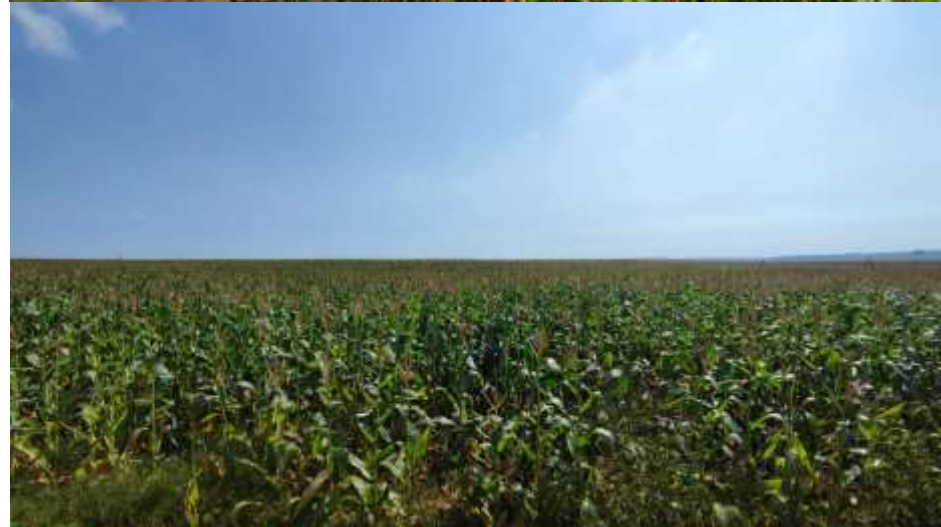
**T14**

Findings: No specific ecological constraints were recorded.

Location: Located in previously designated low sensitivity area. (Mielie lands)

Sensitivity area: Classified as low sensitivity area.

Habitat suitable to Highveld Golden Moles are present, though no signs of mole activity was recorded.

Recommendation: Move Turbine south to the nearest road crossing 162m SW, next to mielie lands. It will be easier to access the turbine.

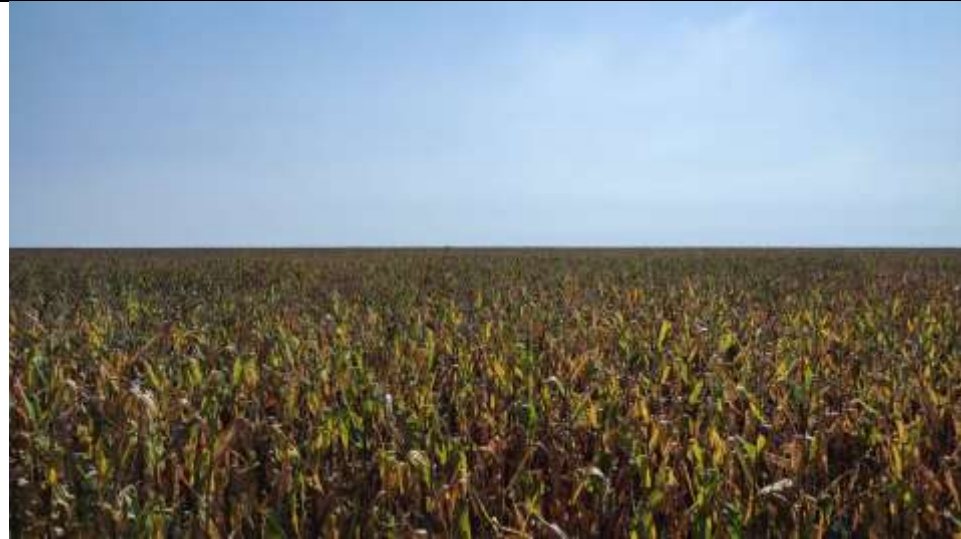
**T20**

Findings: No specific ecological constraints were recorded.

Location: Located in previously designated low sensitivity area. (Mielie lands)

Sensitivity area: Classified as low sensitivity area.

Habitat suitable to Highveld Golden Moles are present, though no signs of mole activity was recorded.

Recommendation: Move Turbine 70m south into the old cultivated land next to the road, access will be easier.

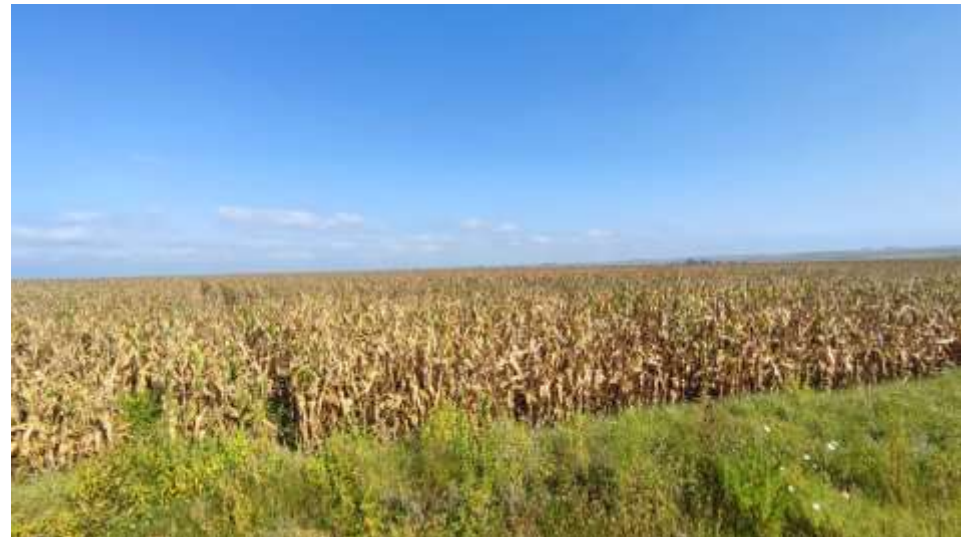
**T24**

Findings: No specific ecological constraints were recorded.

Location: Located in previously designated low sensitivity area. (Mielie lands)

Sensitivity area: Classified as low sensitivity area.

Habitat suitable to Highveld Golden Moles are present, though no signs of mole activity was recorded.

Recommendation: Position remain unchanged.

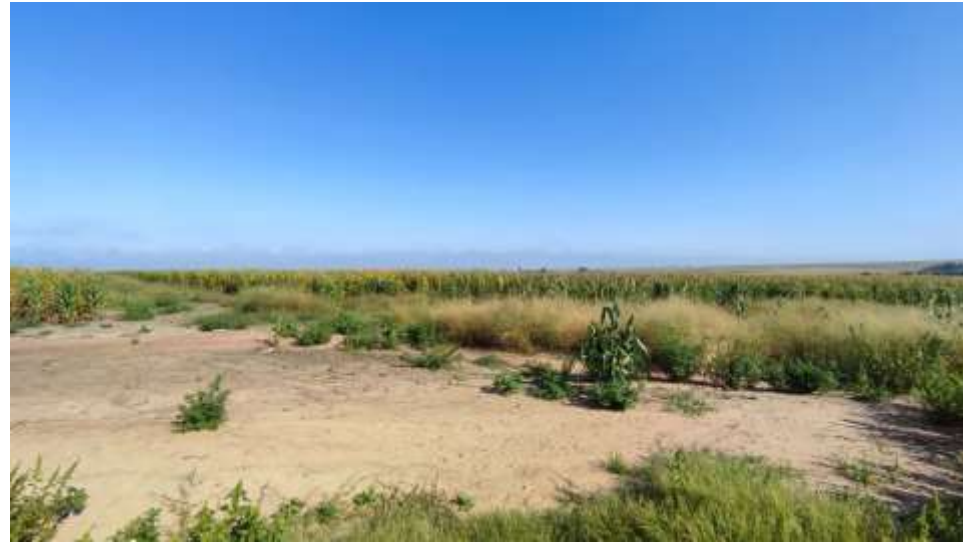
**T9**

Findings: No specific ecological constraints were recorded.

Location: Located in previously designated low sensitivity area. (Mielie lands)

Sensitivity area: Classified as low sensitivity area.

Habitat suitable to Highveld Golden Moles are present, though no signs of mole activity was recorded.

Recommendation: Move Turbine 45m east into the road next to the natural veld. Access will be easier.

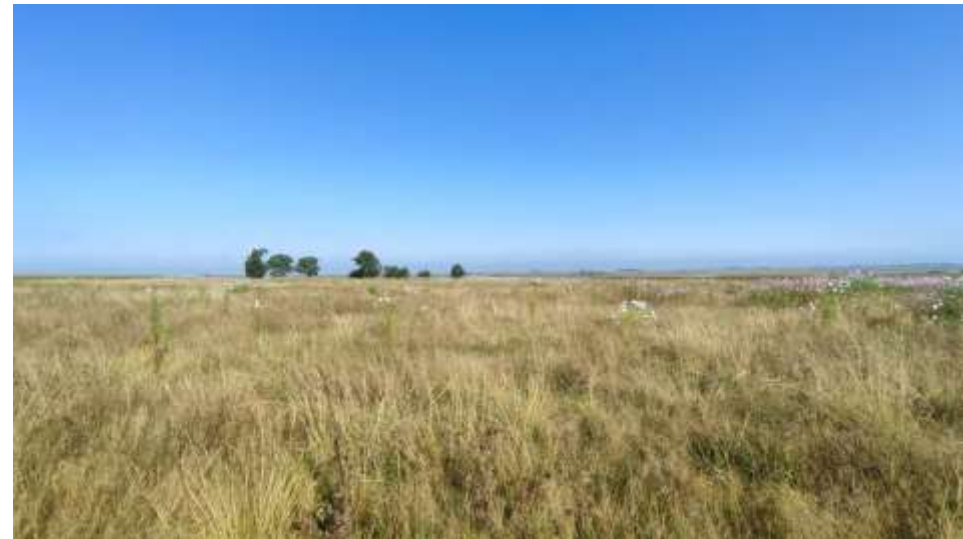
**T2**

Findings: No specific ecological constraints were recorded. There is a clump of alien trees 270 m from the point, but no priority species was recorded.

Location: Located in previously designated low sensitivity area. (Old cultivated lands)

Sensitivity area: Classified as low sensitivity area.

Habitat suitable to Highveld Golden Moles are present, though no signs of mole activity was recorded.

Recommendation: Position remains unchanged.

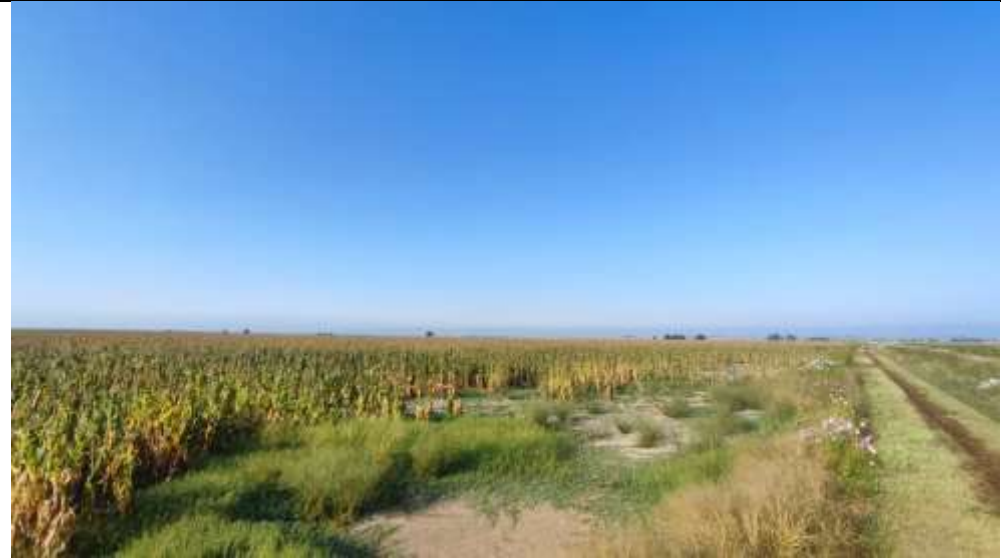
**T21**

Findings: No specific ecological constraints were recorded.

Habitat suitable to Highveld Golden Moles are present, though no signs of mole activity was recorded.

Recommendation: Position remains unchanged.

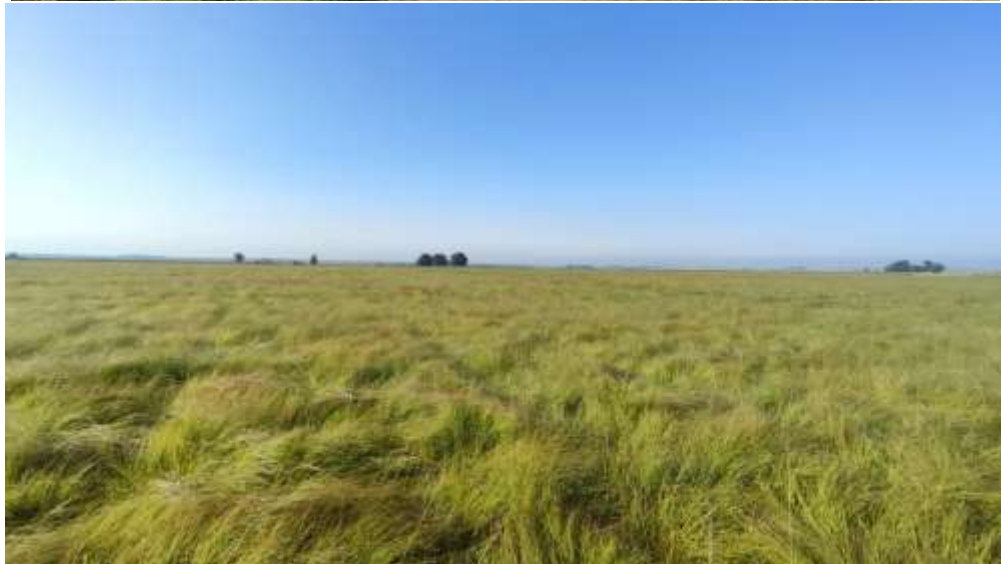
T16

Findings: No specific ecological constraints were recorded.

Habitat suitable to Highveld Golden Moles are present, though no signs of mole activity was recorded.

Recommendation: Position remains unchanged.

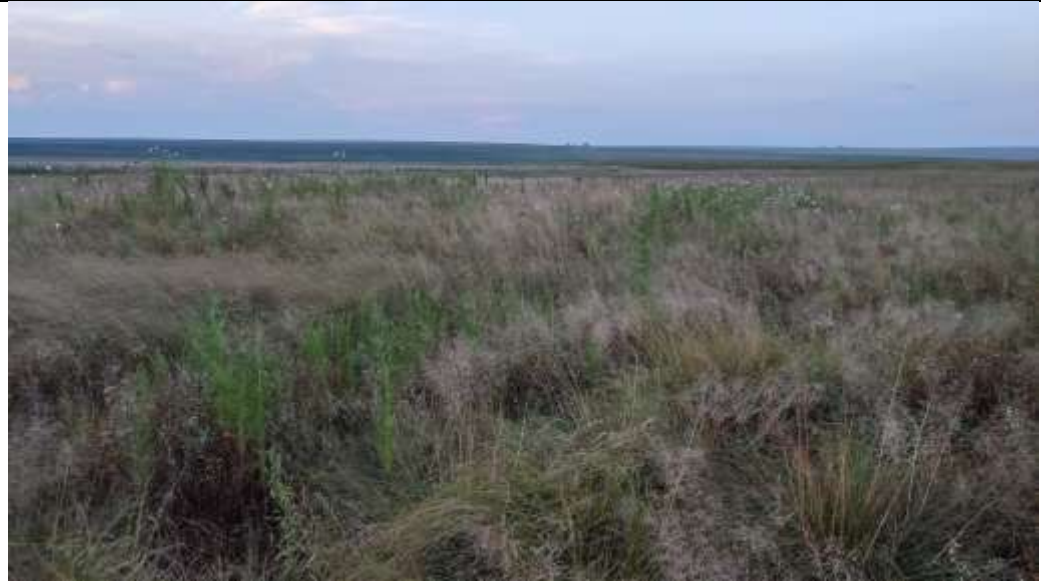
Findings: No specific ecological constraints were recorded.

Habitat suitable to Highveld Golden Moles are present, though no signs of mole activity was recorded.

Recommendation: No changes to placement area required. Relocation (rescue) of the single protected plant.

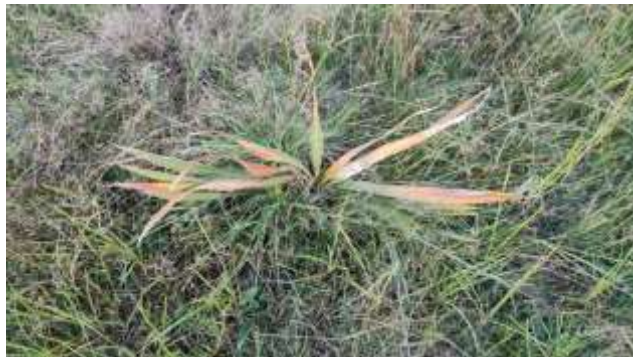
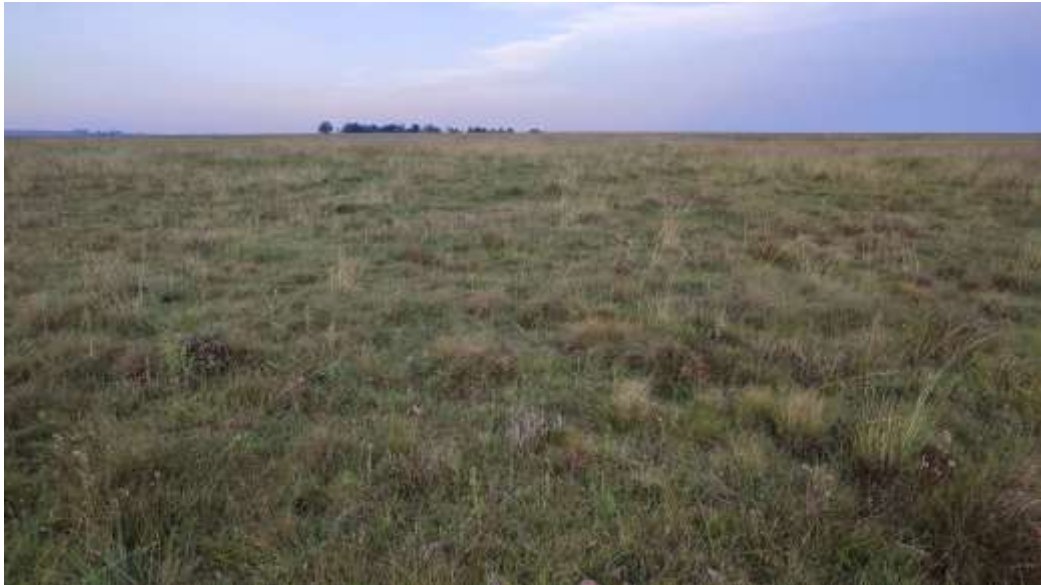
T18

Location: Located in previously designated medium sensitivity area.

Sensitivity area: Classified as moderate sensitivity area. One (1) *Boophone disticha* (Protected) is present within the area.

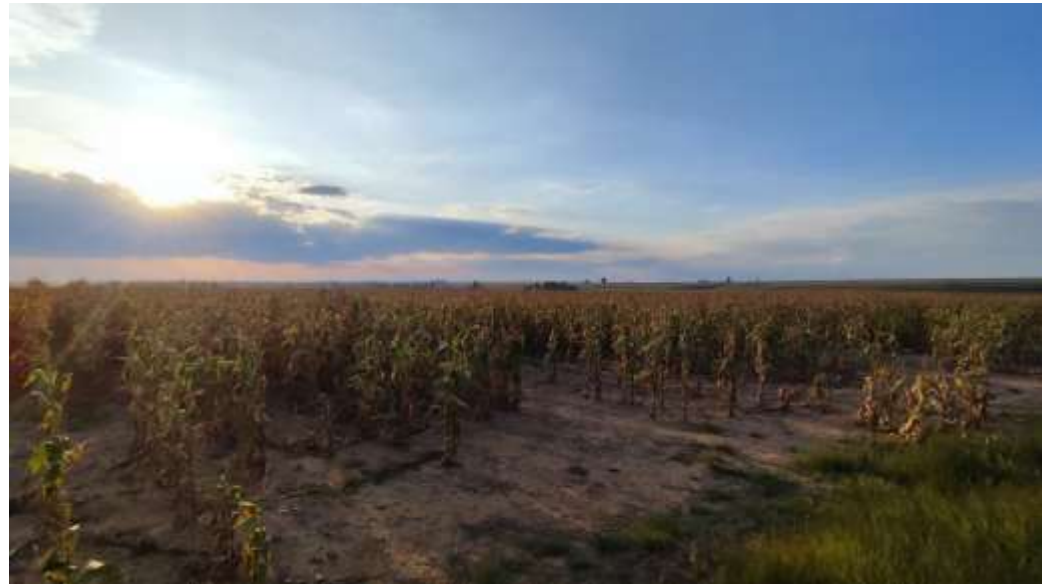
T1

Findings: No specific ecological constraints were recorded. One species of conservation concern, a Blue Korhaan (Globally listed as Near-Threatened) was heard calling from approximately 500 m North East from the turbine point.

Habitat suitable to Highveld Golden Moles are present, though no signs of mole activity was recorded.

Recommendation: Position remains unchanged.

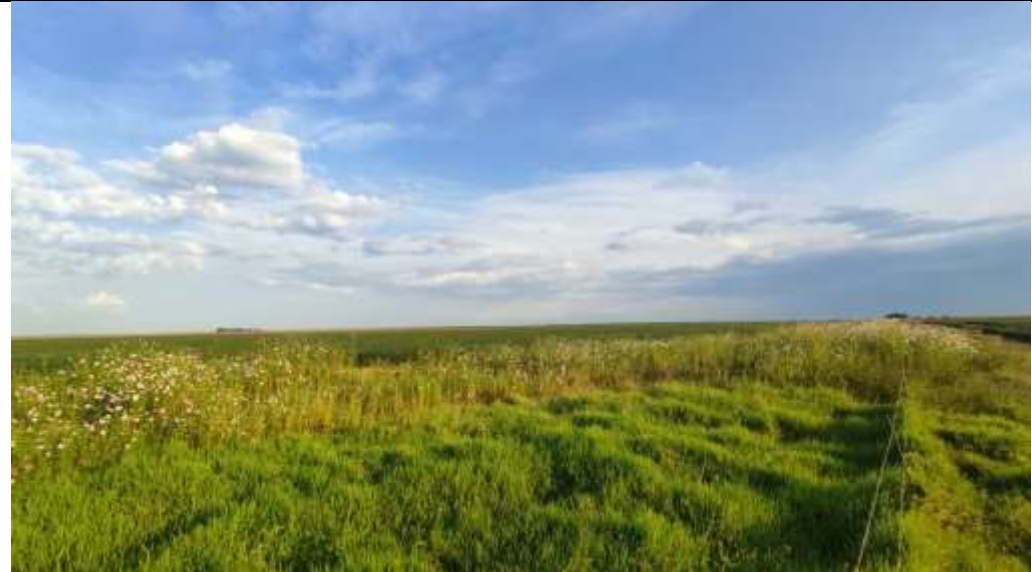
T8

Findings: No specific ecological constraints were recorded.

Habitat suitable to Highveld Golden Moles are present, though no signs of mole activity was recorded.

Recommendation: Move Turbine to the nearest road 20m east of Soya lands.

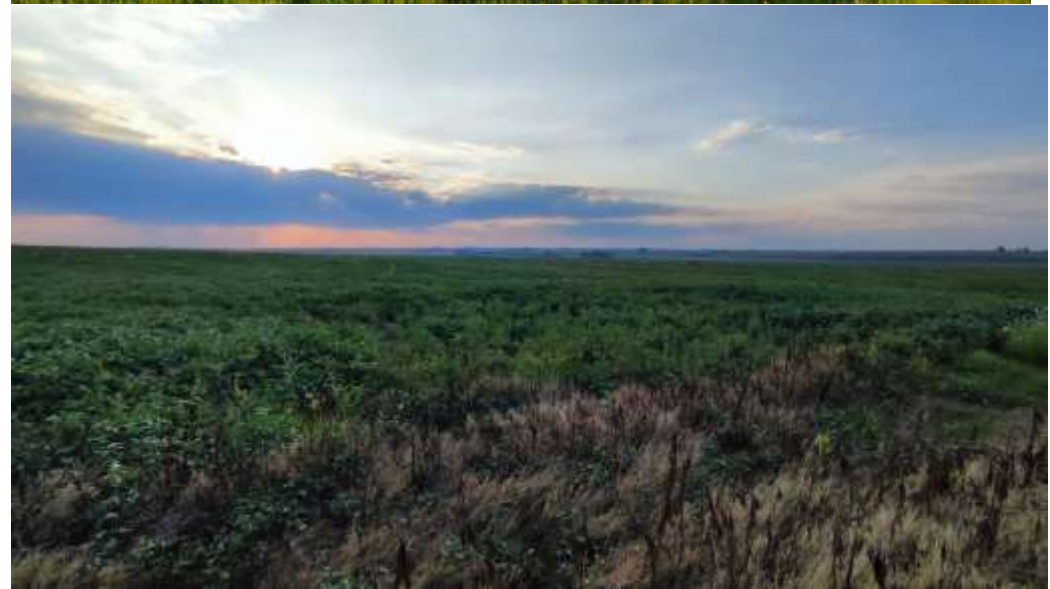
Findings: No specific ecological constraints were recorded.

Location: Located in previously designated low sensitivity area. (Mielie lands)

Habitat suitable to Highveld Golden Moles are present, though no signs of mole activity was recorded.

Recommendation: Position remains unchanged.

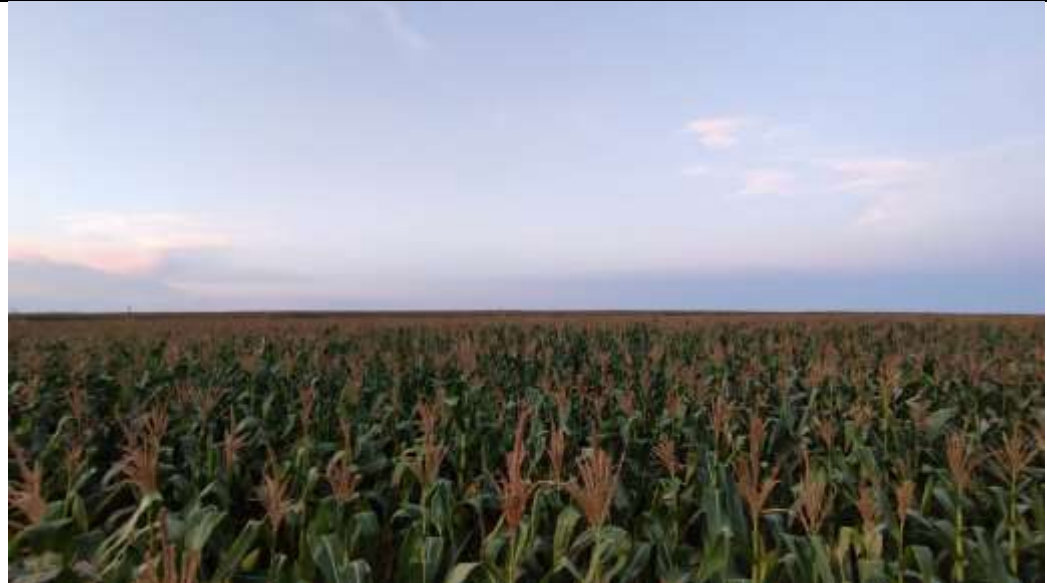
Findings: No specific ecological constraints were recorded.

Location: Located in previously designated low sensitivity area. (Mielie lands)

Habitat suitable to Highveld Golden Moles are present, though no signs of mole activity was recorded.

Recommendation: Position remains unchanged.

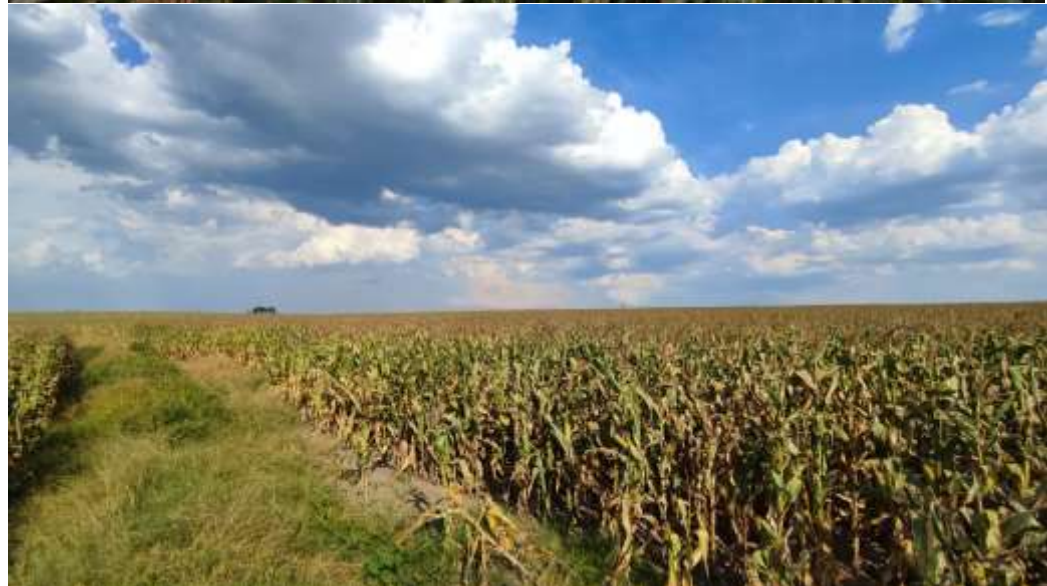
**T19**

Findings: No specific ecological constraints were recorded.  
Location: Located in previously designated low sensitivity area. (Planted pasture)  
Sensitivity area: Classified as low sensitivity area.  
Habitat suitable to Highveld Golden Moles are present, though no signs of mole activity was recorded.  
Recommendation: Position remains unchanged.

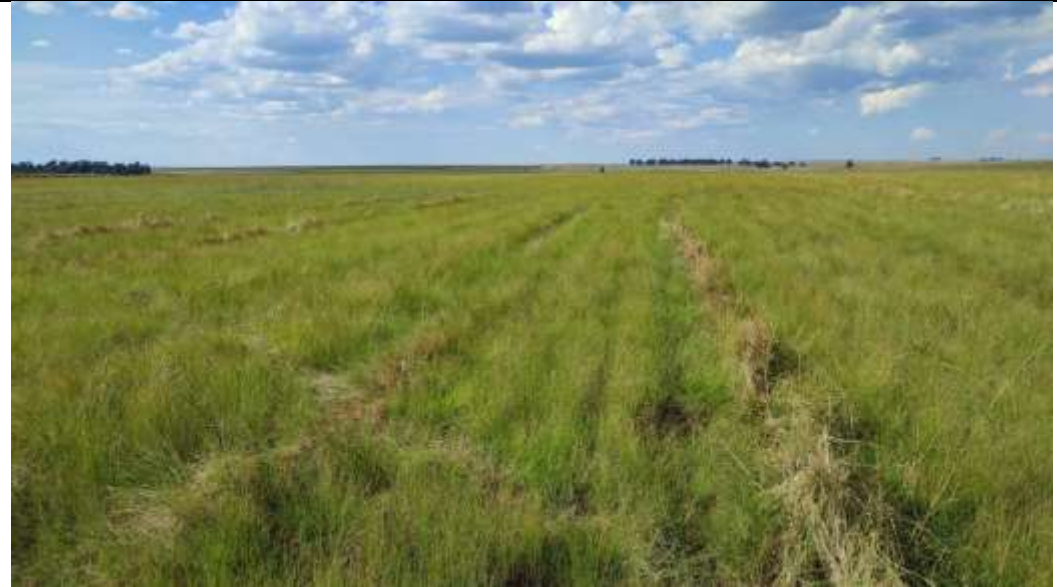
**Batching  
plant,  
Construction  
compound,  
Turn in line  
and MTS**

Findings: No specific ecological constraints were recorded.  
Location: Located in previously designated low and medium sensitivity area (Soya lands, undulating grasslands and old lands)  
Sensitivity area: Classified as low – medium sensitivity area.  
Habitat suitable to Highveld Golden Moles are present, though no signs of mole activity was recorded.  
Recommendation: Position to remain unchanged.

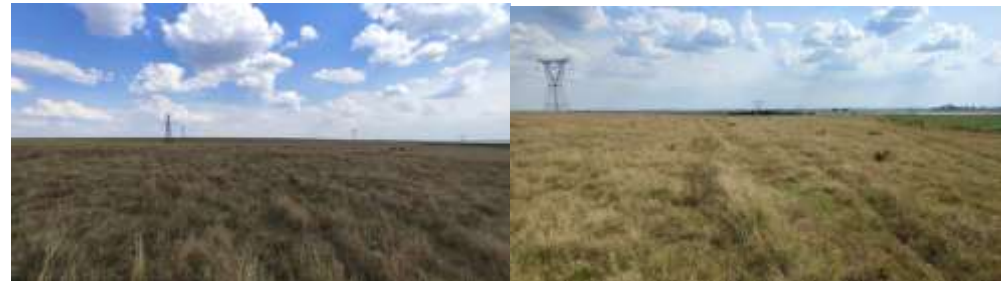
T4

Findings: No specific ecological constraints were recorded. There is a clump of alien trees located 335 m from the turbine position but no priority species birds of prey were recorded.

Habitat suitable to Highveld Golden Moles are present, though no signs of mole activity was recorded.

Recommendation: Position remains unchanged.

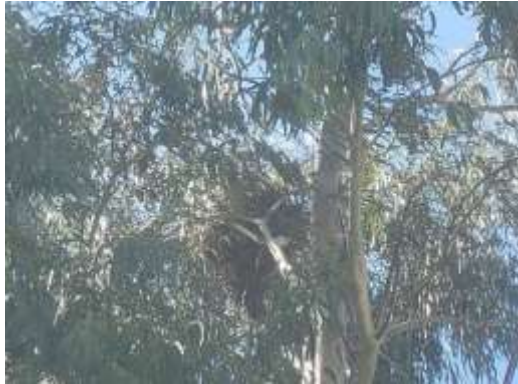
**Collector site, OM 1 and OM 1,5**

Findings: No specific ecological constraints were recorded.

One nest was recorded 40 m north of the collector site in an alien tree and one Black-winged Kite was recorded perched in a dead tree nearby.

Location: Located in previously designated low and medium sensitivity area (Mielie lands, Soya lands and undulating grasslands)

Habitat suitable to Highveld Golden Moles are present, though no signs of mole activity was recorded.

Recommendation: Position to remain unchanged.

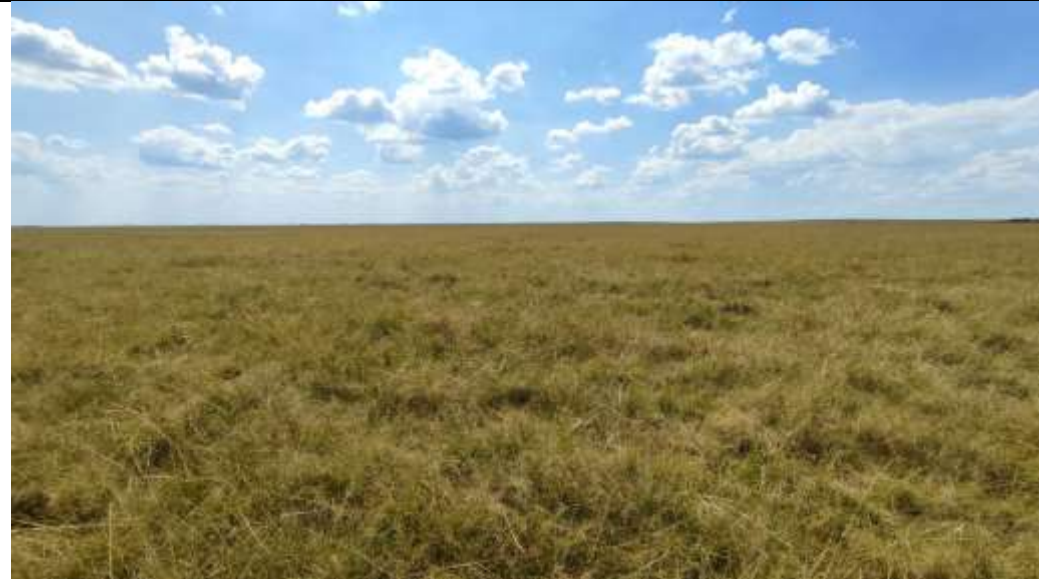
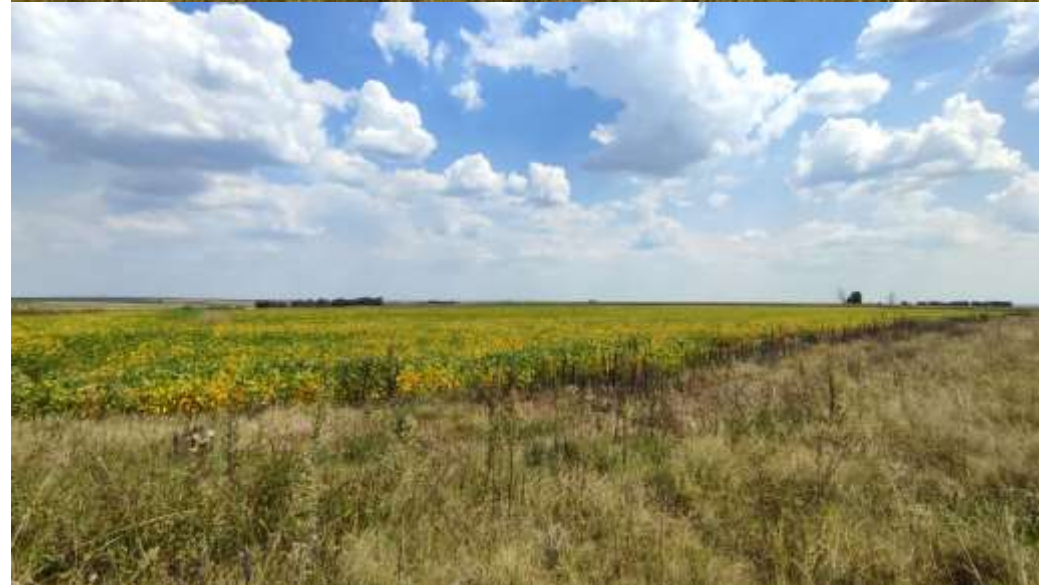
T22

Findings: No specific ecological constraints were recorded.

Habitat suitable to Highveld Golden Moles are present, though no signs of mole activity was recorded.

Recommendation: Position remains unchanged. The position of the collector site could also be moved 100 m south in case the nest recorded is active.

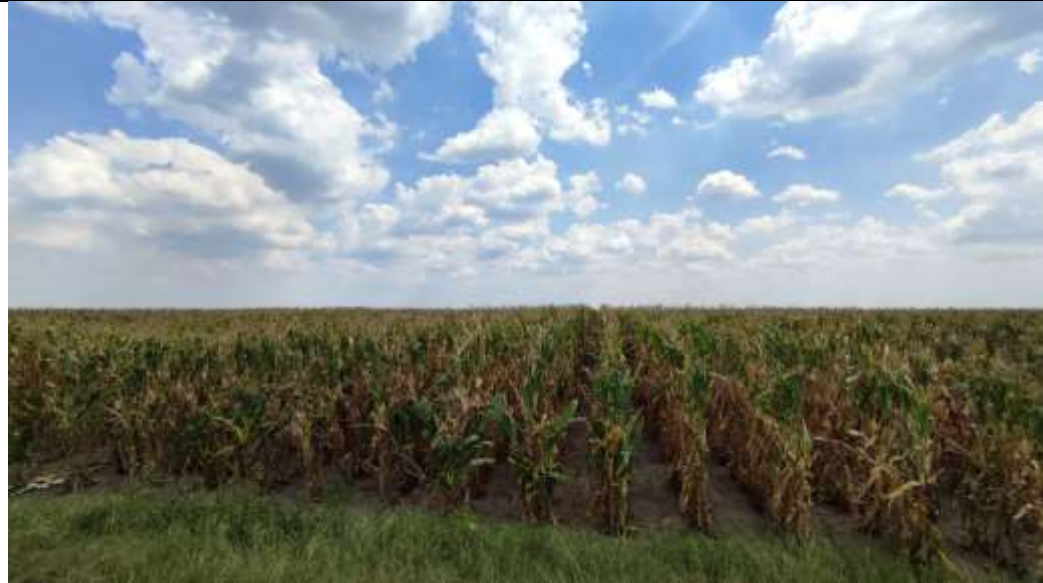
T5

Findings: No specific ecological constraints were recorded. A clump of alien trees is located 330 m away from turbine point but no priority species were recorded.

Habitat suitable to Highveld Golden Moles are present, though no signs of mole activity was recorded.

Recommendation: Position remains unchanged.

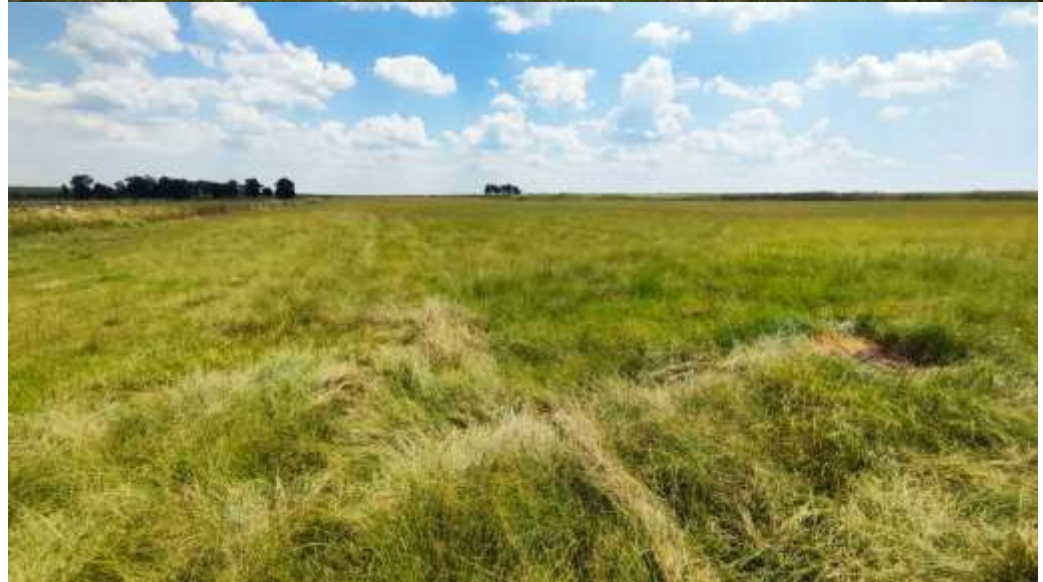
Findings: No specific ecological constraints were recorded.

A clump of alien trees is located 50 m west of powerline, but no priority species were recorded. The powerline does cross a stream and bird flappers are recommended.

Location: Located in previously designated low to very high sensitivity area (Soya lands, Mielie lands, undulating grasslands, old lands and wetlands). Location of pylons not on wetlands, only the cables traverse the wetlands and therefore wetland damage will likely be minimum. Construction phase must avoid any wetland damage.

Sensitivity of area: Classified as a low – very high sensitivity. *Crinum bulbispermum* (Protected) is present within the area. The position of the *Crinum bulbispermum* plants is underneath the powerline but not in the footprint of the pylon. No disturbance to the area where the plants occur is foreseen, however the position of the plants is noted for thoroughness.

Recommendation: Positions of pylons to remain unchanged.

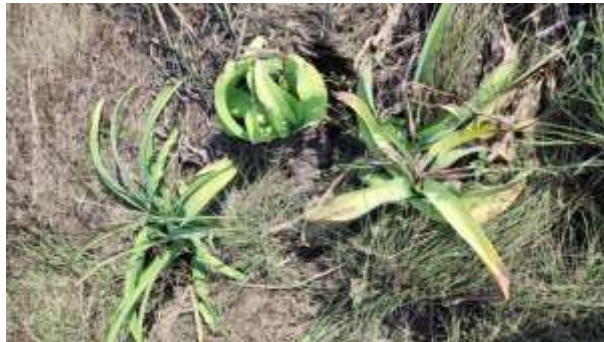
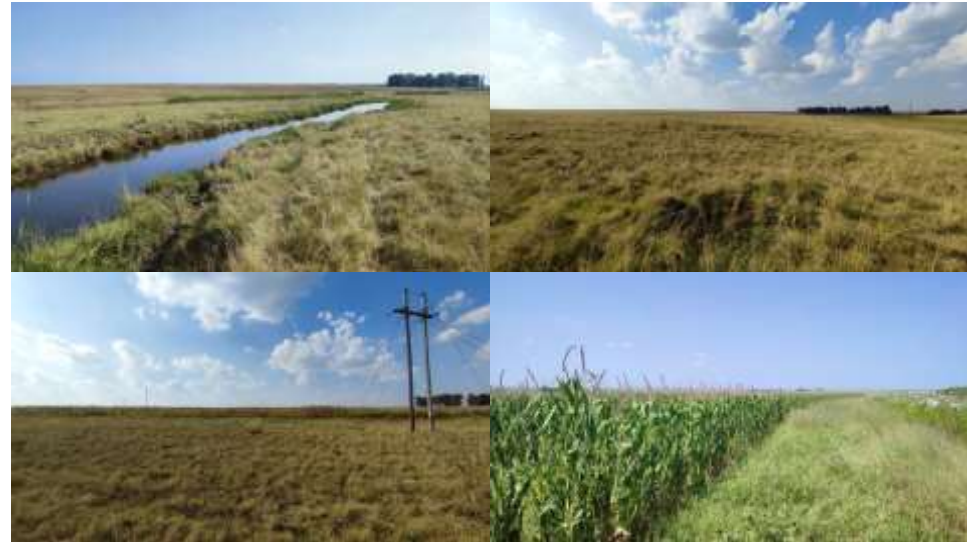
**Pylons 1-11  
From  
collectors to  
MTS**

Habitat suitable to Highveld Golden Moles are present, though no signs of mole activity was recorded.
