**PROPOSED EXTENSIONS AT NGWENYA LODGE NEAR KRUGER
NATIONAL PARK, MPUMALANGA PROVINCE**

*ON PORTIONS 68, 78, 79, 80 and 82 FARM, 162 JU, LOCATED IN THE EHLANZENI
DISTRICT MUNICIPALITY, MPUMALANGA PROVINCE*

VISUAL IMPACT ASSESSMENT

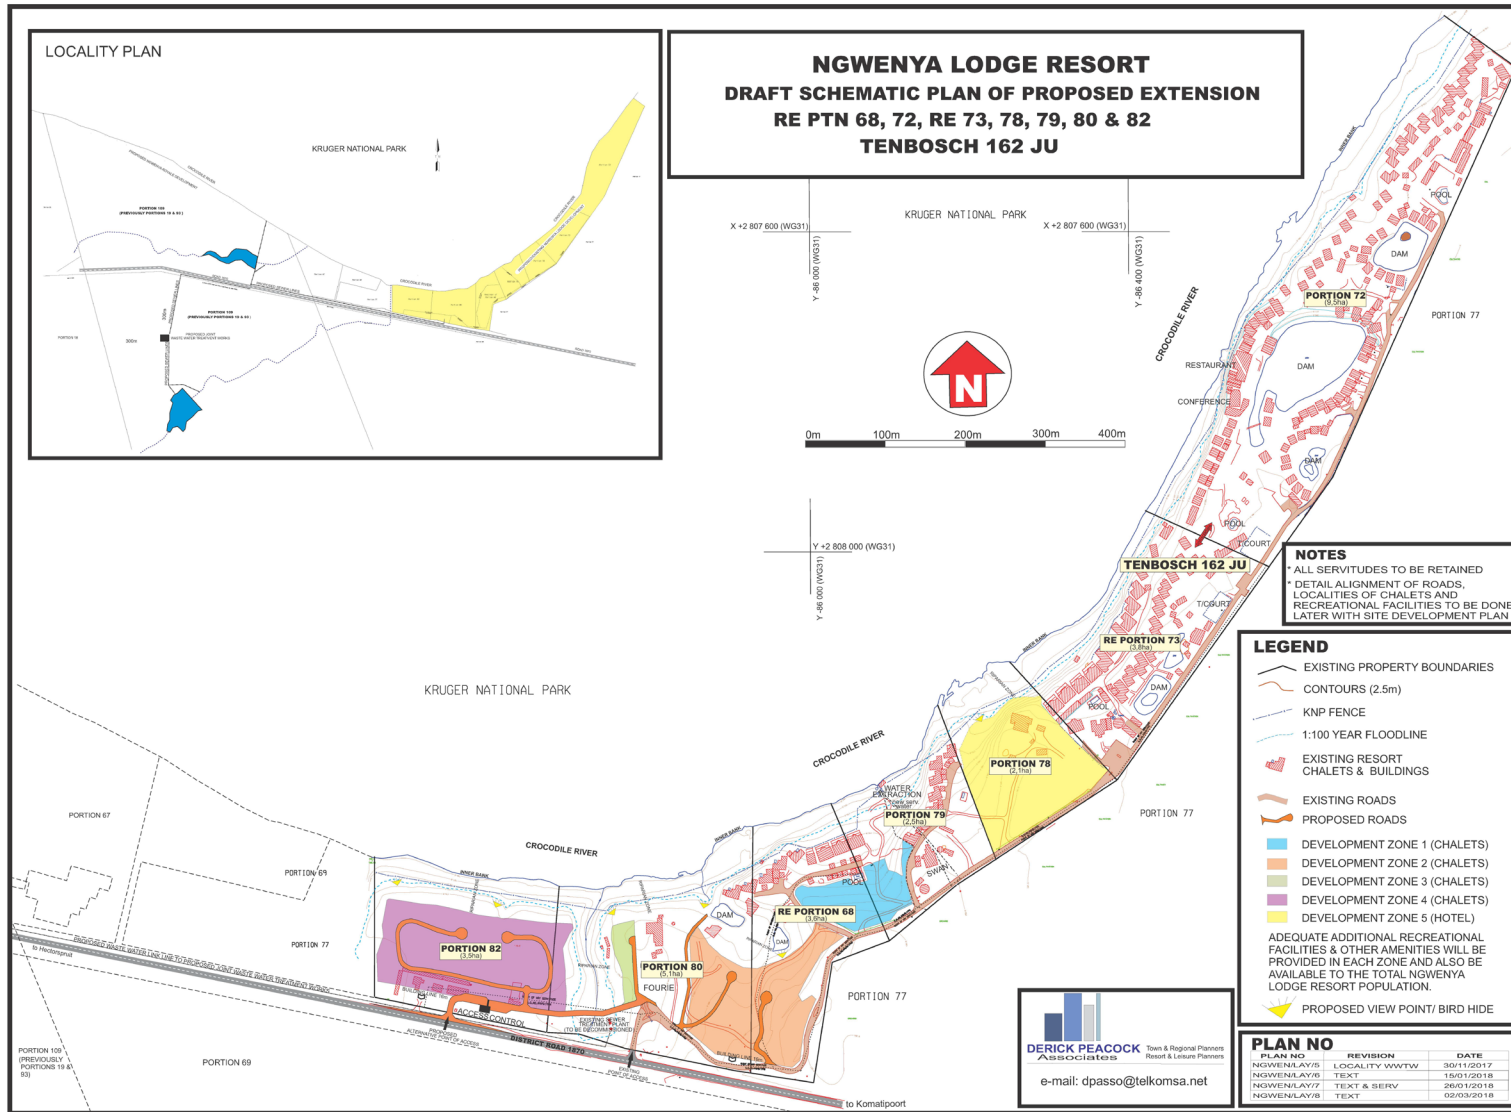
Figure 1: Lodge layout

The proposed expansion will consist 5 Development Zones, where Development Zones 1 to 4 will consist of the construction of chalets and Development Zone 5 will comprise of the safari lodge.

The total footprint of the proposed expansion will not exceed 20 hectares.

Refer to **Figure 1**.

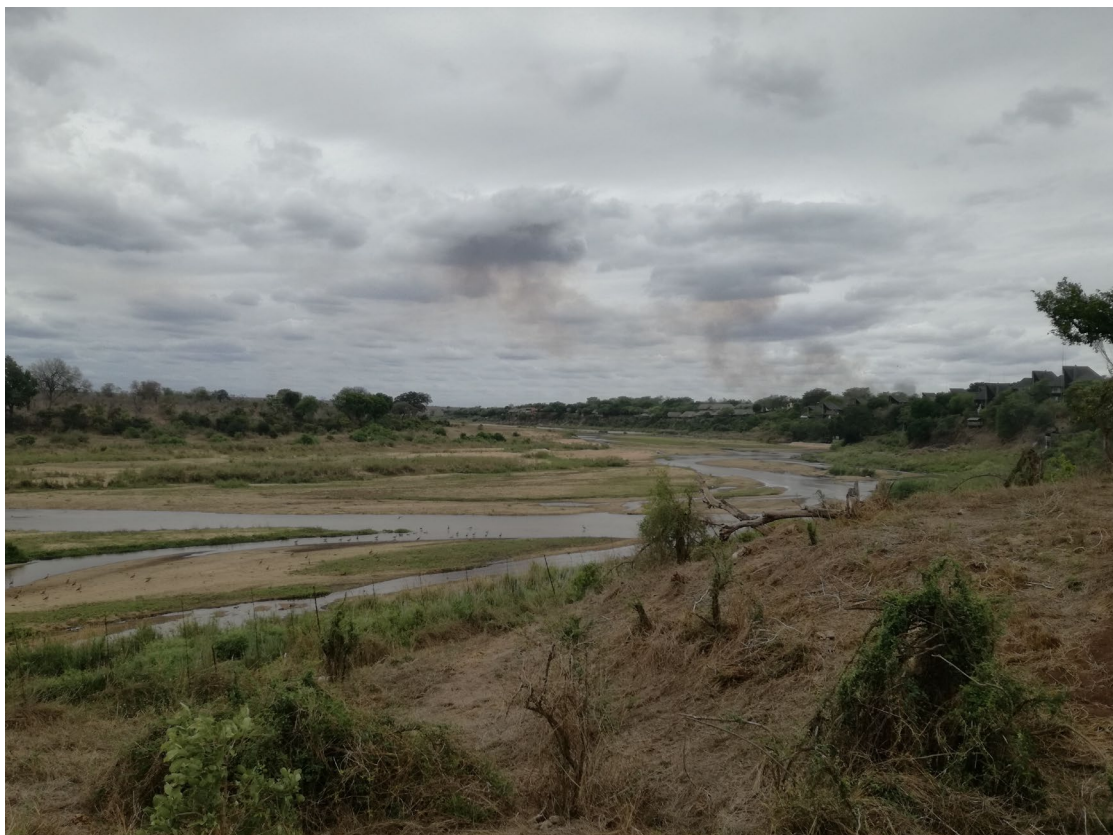
Figure 2: Surface hydrology of the site (Crocodile River)

Surface hydrology within the study area is dominated by the Crocodile River system, located north of the proposed site. Additionally, one (1) drainage line and various dams are located within the proposed study area.

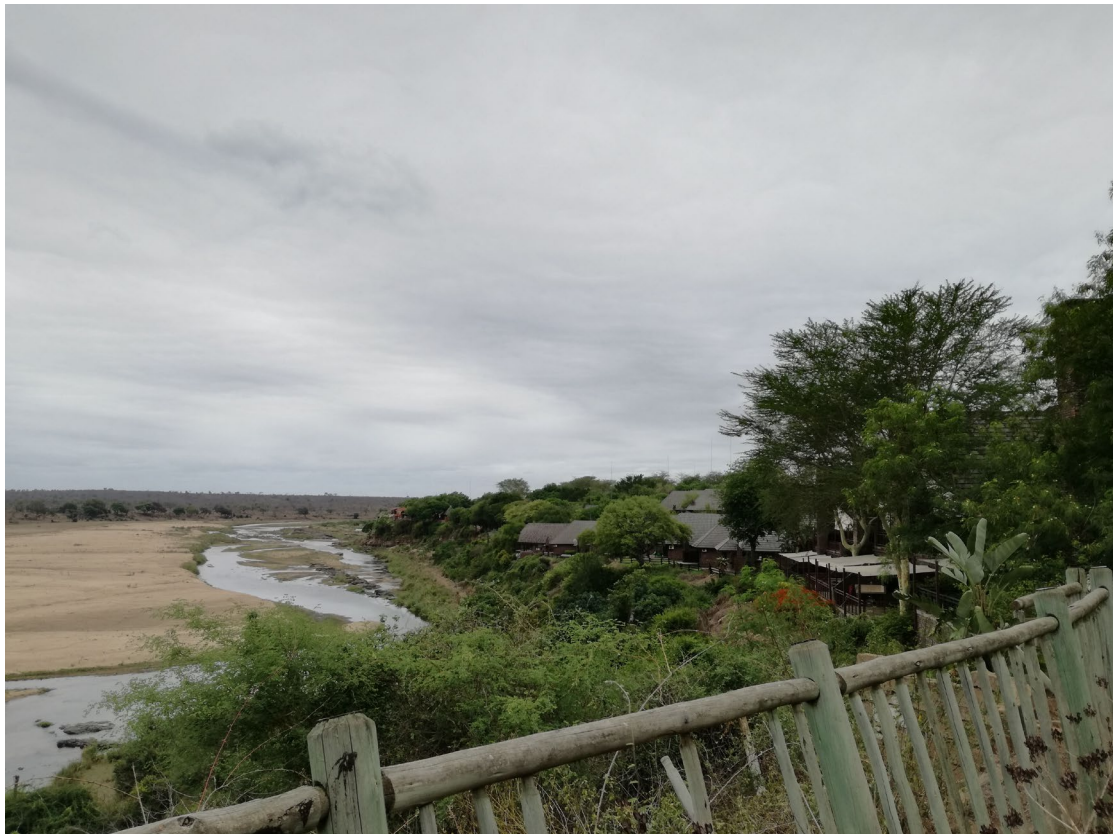
Figure 3: Topography of the site and surrounds

The topography within the study area comprises of fairly flat plains with open tree savanna. The mean annual precipitation is 634 mm.

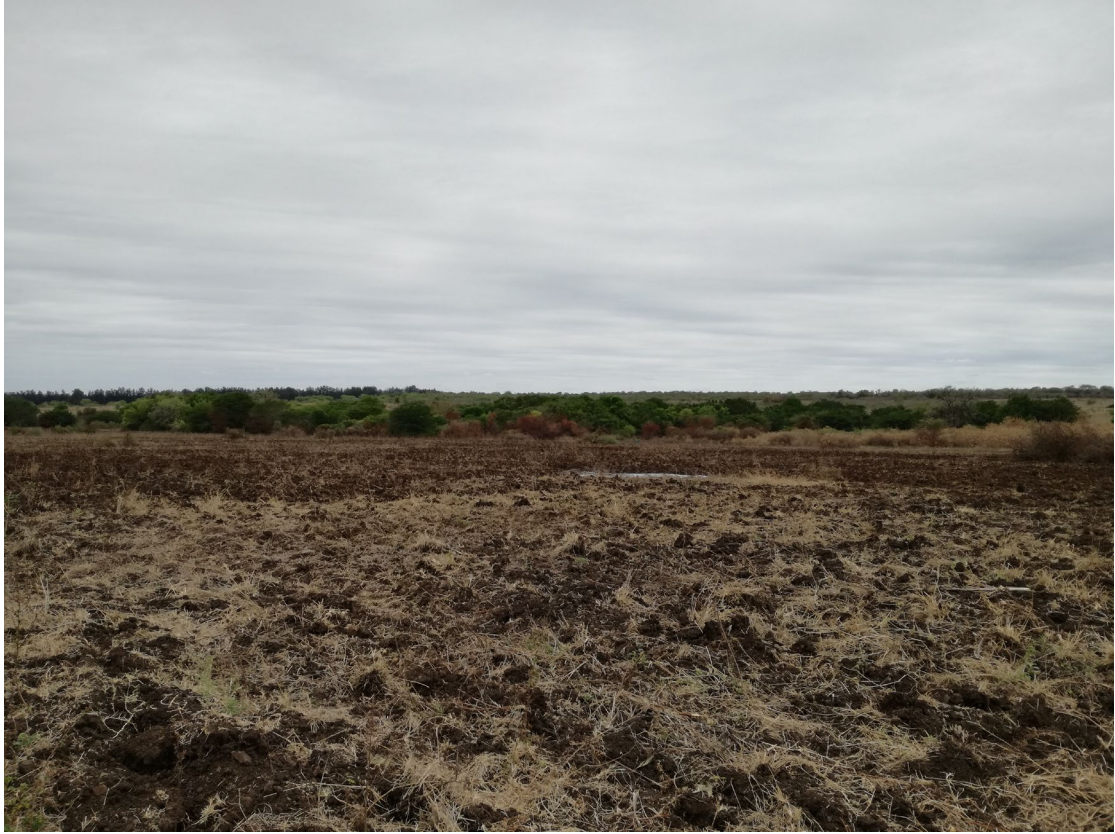
Figure 4: Typical land cover and land use of the area

Land cover within the study area is characterised by a moderately developed shrub layer and a dense herbaceous layer. Land use is deemed predominately cultivation.

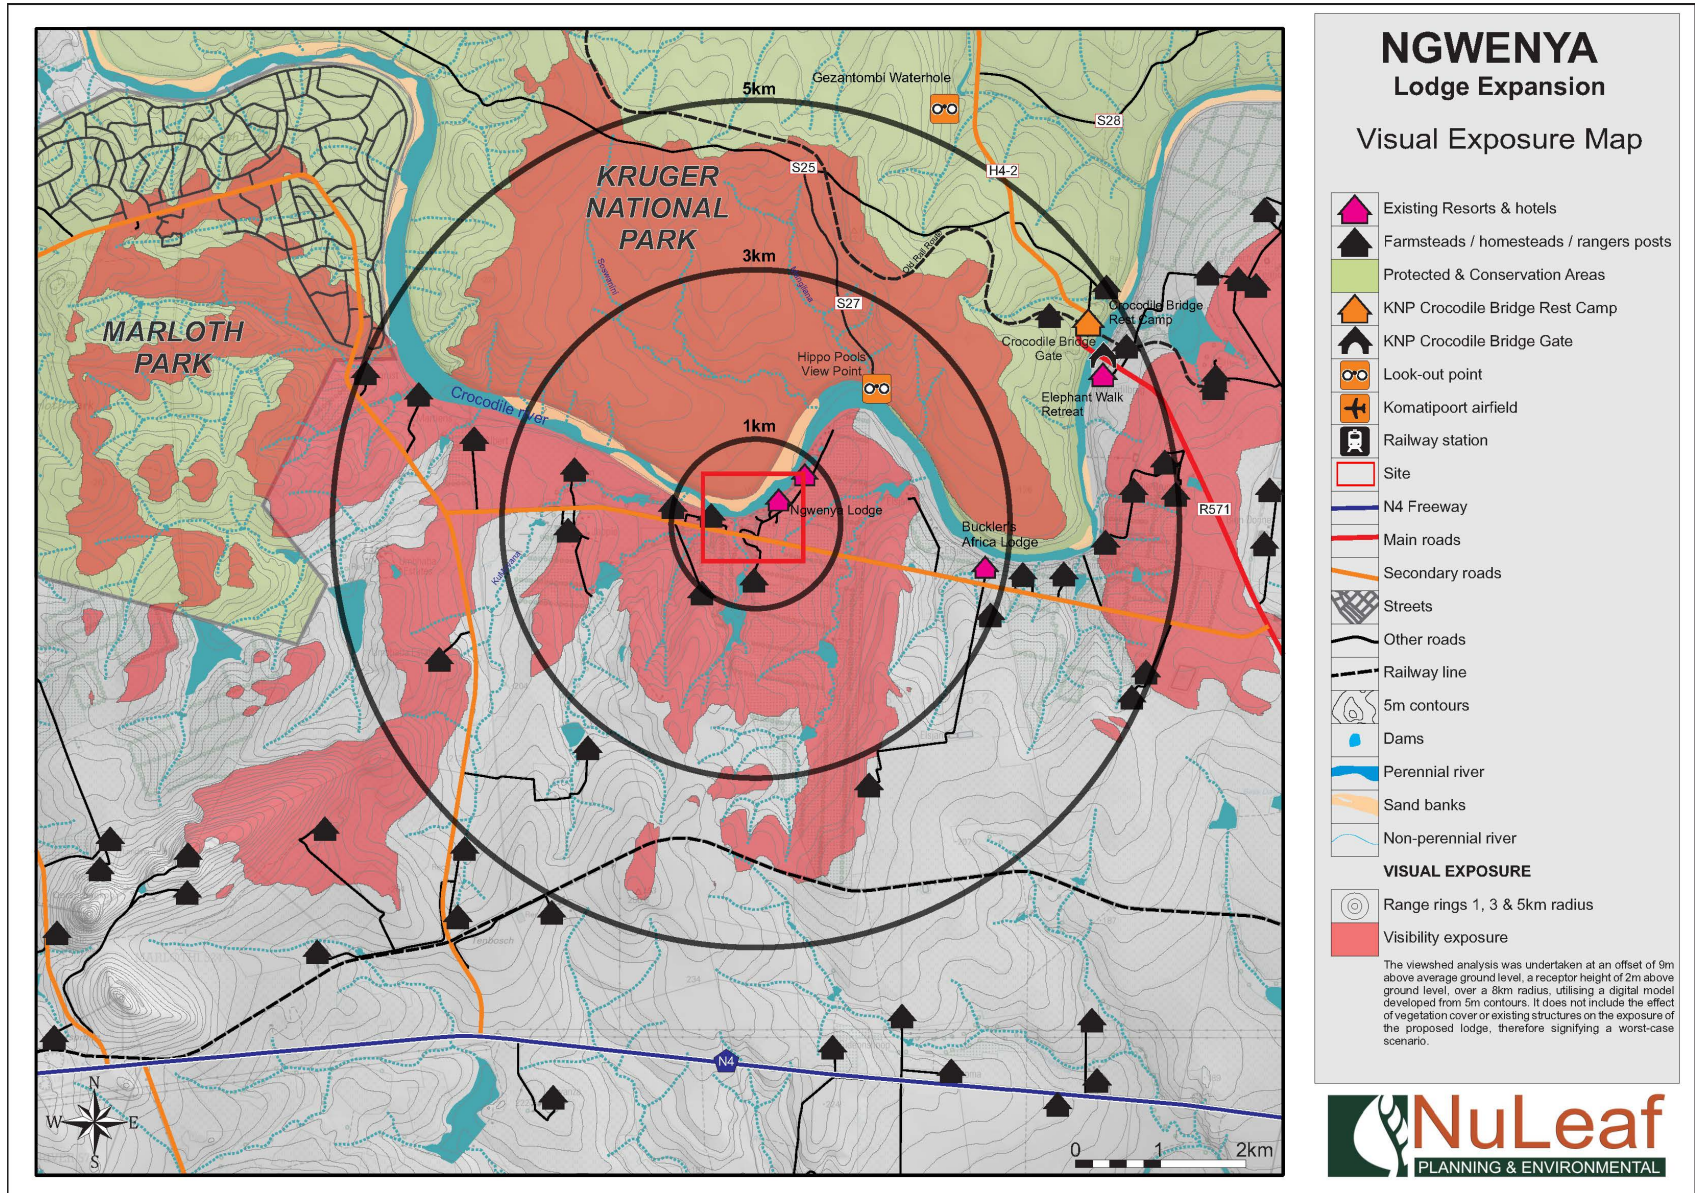
Map 2: Potential visual exposure of the proposed Ngwenya Expansion

In order to understand the potential visual exposure of the proposed development, a viewshed analysis was undertaken, a transmitter (development) offset of 9m above average ground level (i.e. the approximate height of a three storey building). This was done in order to determine the general visual exposure of the area under investigation, simulating the proposed structures associated with the development. A receptor height of 2m above average ground level was used. Refer to **Map 2**.

The analysis does not include the potential shielding effect (i.e. VAC) of the existing environment, and does not take into consideration the limitations of the human eye, therefore signifying a worst-case scenario.

Potential visual exposure is concentrated on the site itself and within the area in the immediate vicinity thereof. Potential visual exposure within 1km from the site is high, with no visually non-exposed areas. Sensitive visual receptors in this area include mainly the existing Ngwenya Lodge users, portions of the Kruger National Park (KNP) several farmsteads, as well as, a local road (D1870) and a fruit package plant. The close proximity of the proposed development to the Crocodile River effectively means that visual exposure of the proposed development along its banks is guaranteed.

The extent of potential visual exposure is significant between 1km and 3km from the site. Within this zone, visually exposed areas are, located mostly to the north, north east, north west and south. Visually screened areas lie near Bucklers Africa Lodge to the south east and to the south west of the site. Sensitive visual receptors such as farmsteads, uses of local roads and Ngwenya Lodge are likely to be affected. A large portion of the Kruger National Park, located to the north of the site, will also be visually affected. The tourist road S27 and Hippo Pools View point is located in this area of the KNP, which thereby drastically increases the likelihood of visual receptors occurring in this area.

Between 3km and 5km from the site, potential visual exposure decreases in extent. These visually exposed areas lie mostly to the north, north west, and to a lesser extent to the west, south west and east. Roads, farmsteads and users of tourist roads in the Kruger National Park (S25) have been identified as potential sensitive visual receptors. A few lodges and homesteads located along the Crocodile River to the west of the development are also likely to be affected.

Beyond 5km from the site, potential visual exposure is very limited, with visually exposed areas lying to the north west and east of the site. The population of Marloth Park and farmsteads have been identified as potential sensitive visual receptors, however, it is highly unlikely that this visual exposure will take place.

The results of the viewshed analysis and potential observer proximity for the proposed expansion of the existing Ngwenya Lodge is shown on **Map 2**.

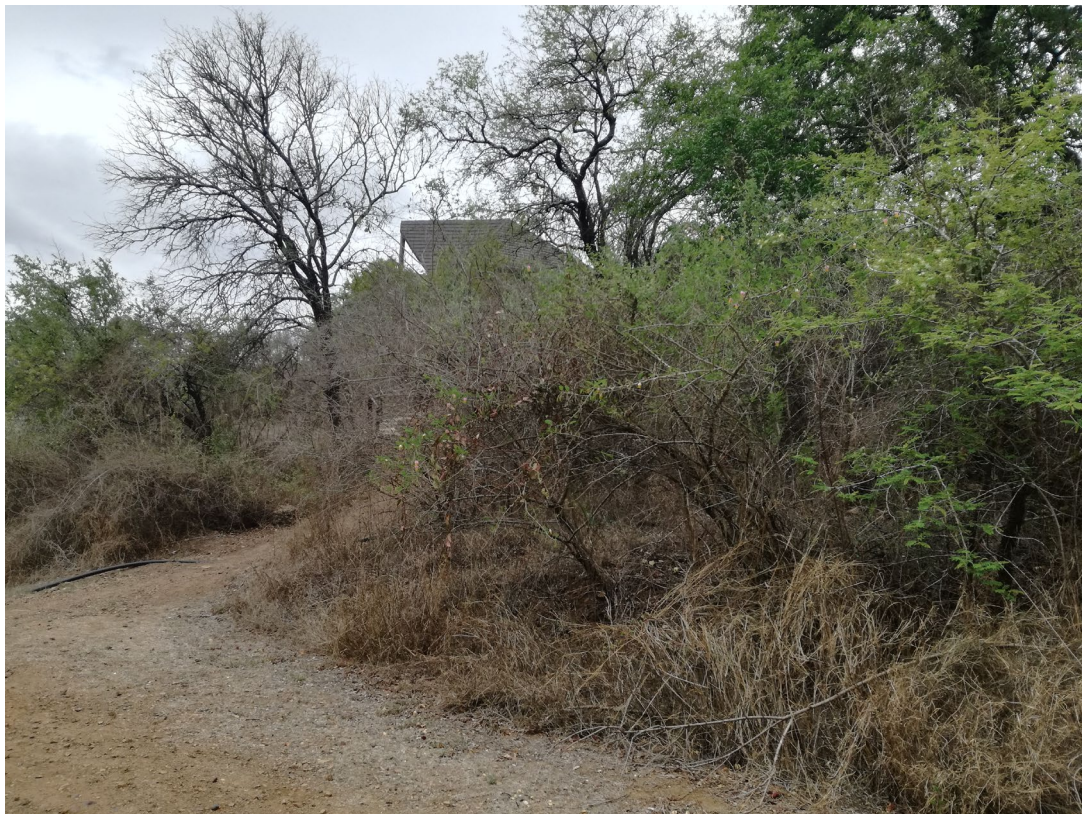
Overall, the Visual Absorption Capacity (VAC) of the site and surrounds is *low*, due mainly to the nature of the vegetation and development, as well as the presence of the existing Ngwenya Lodge (i.e. cleared bushveld vegetation and high roof pitches). Where the natural vegetation has been cleared due to previous site disturbances/development, or where vegetation has been heavily grazed, VAC is low. However, where the natural bushveld vegetation is still mainly intact, VAC is moderate.

Figure 8: Moderate VAC of the natural bush

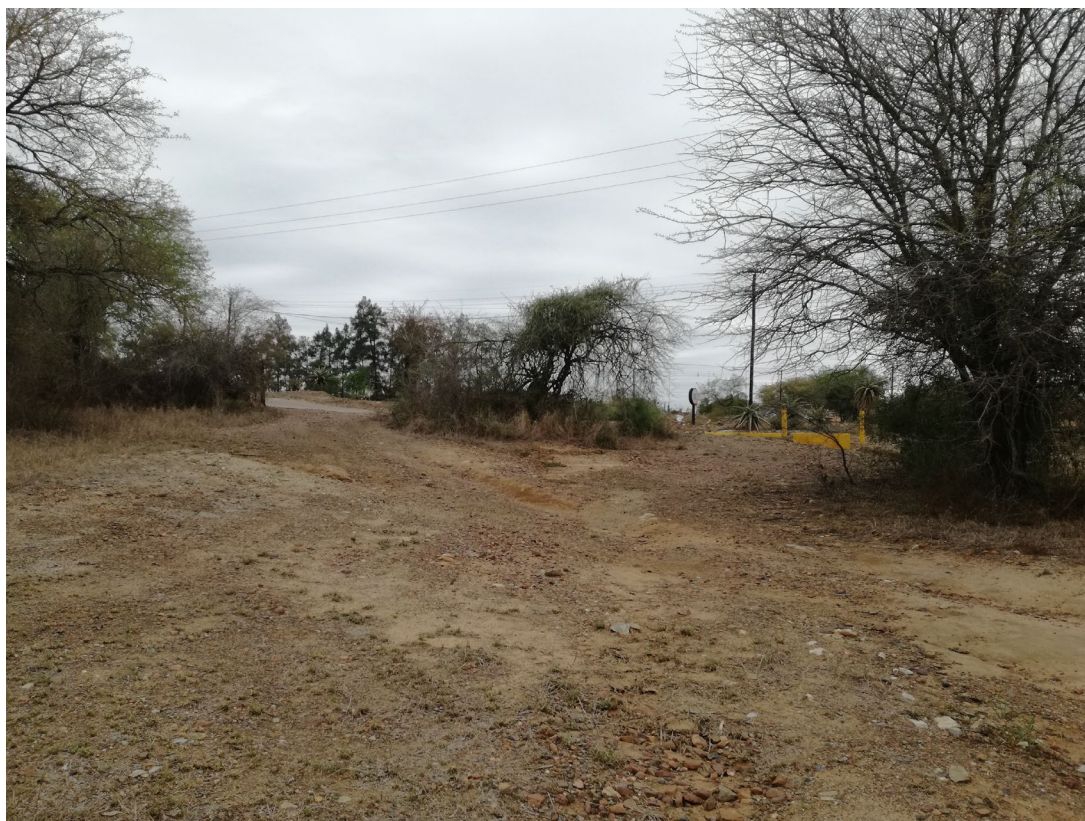
Figure 9: Low VAC of the cleared area

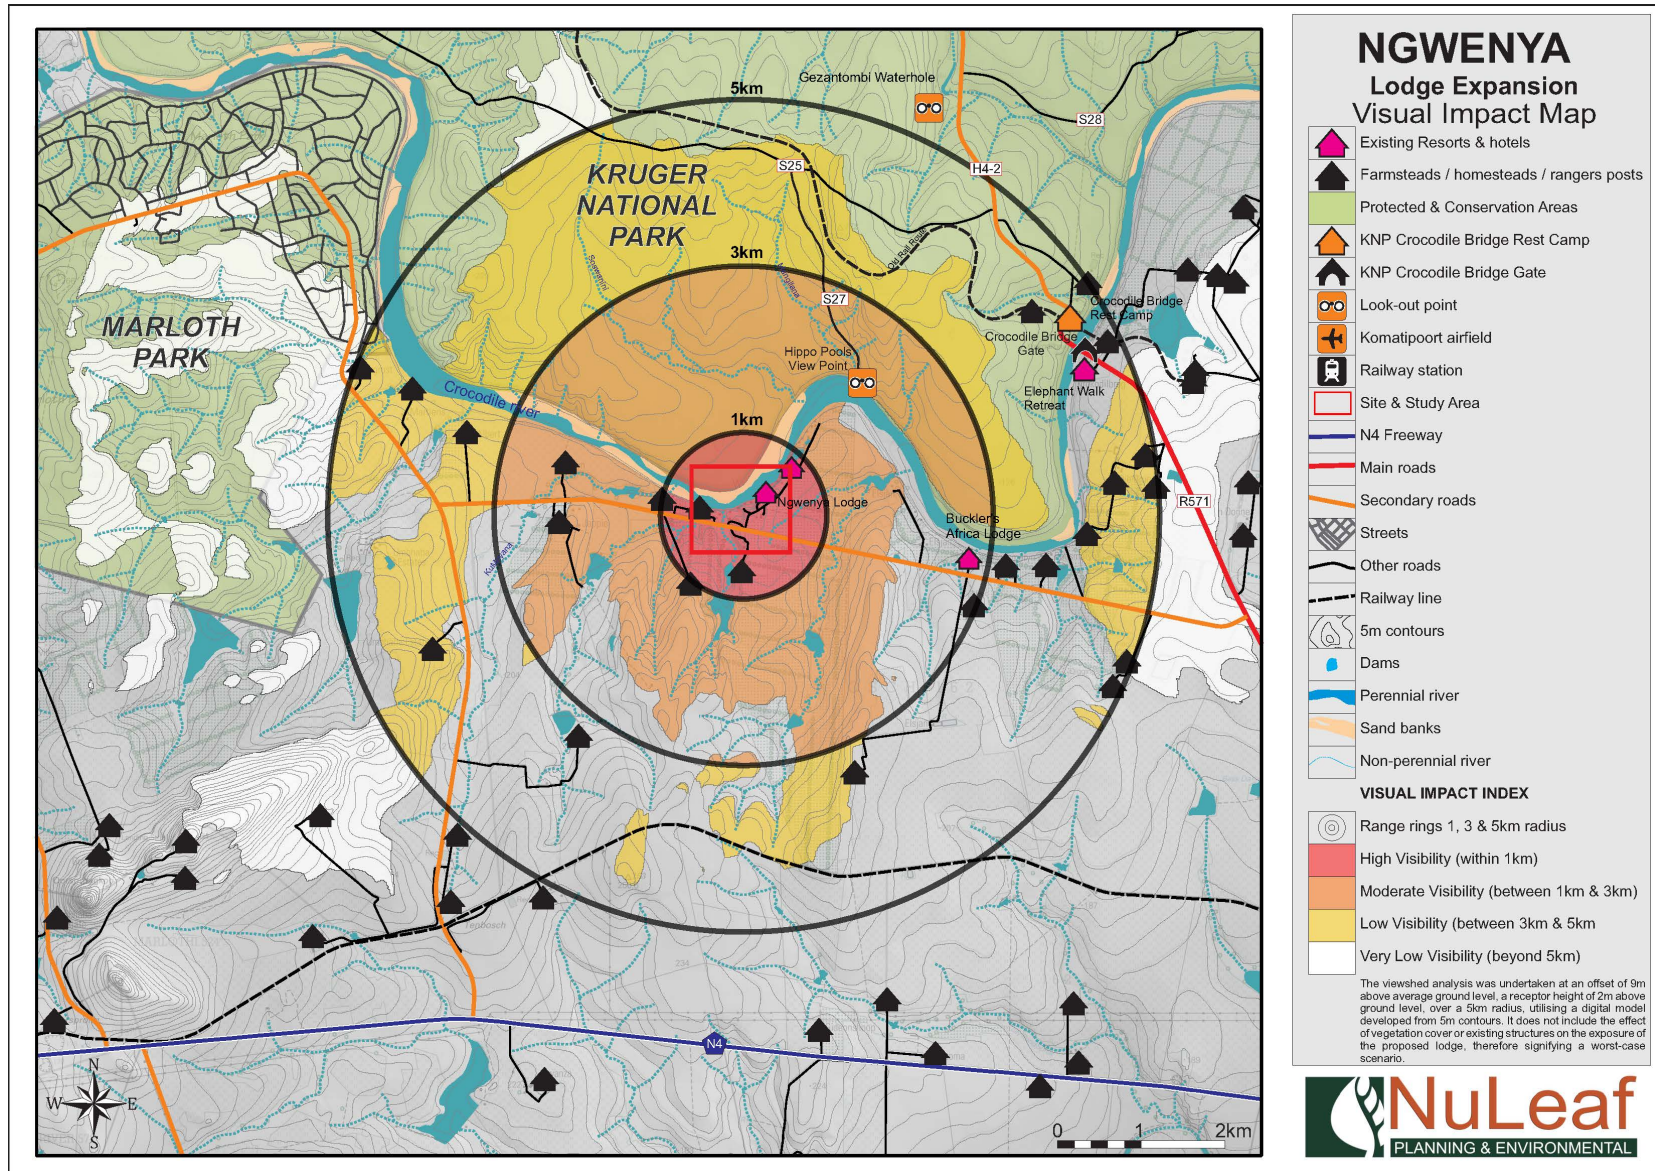
Map 3: Visual Impact Index

Sensitive visual receptors at this distance possibly include residents on the periphery of Marloth Park, as well as residents of farmsteads/lodges to the south east of Crocodile Bridge Gate into the KNP.

The Crocodile Bridge Gate and Rest Camp will however not be visually impacted upon by this development in any of the zones.
