# David Styles

## Vegetation Surveys, Advice and Consulting

### ASSESSMENT OF VEGETATION WITHIN AND SURROUNDING THE FOOTPRINT OF A PROPOSED PEDESTRIAN BRIDGE AT BURBREEZE, TONGAAT

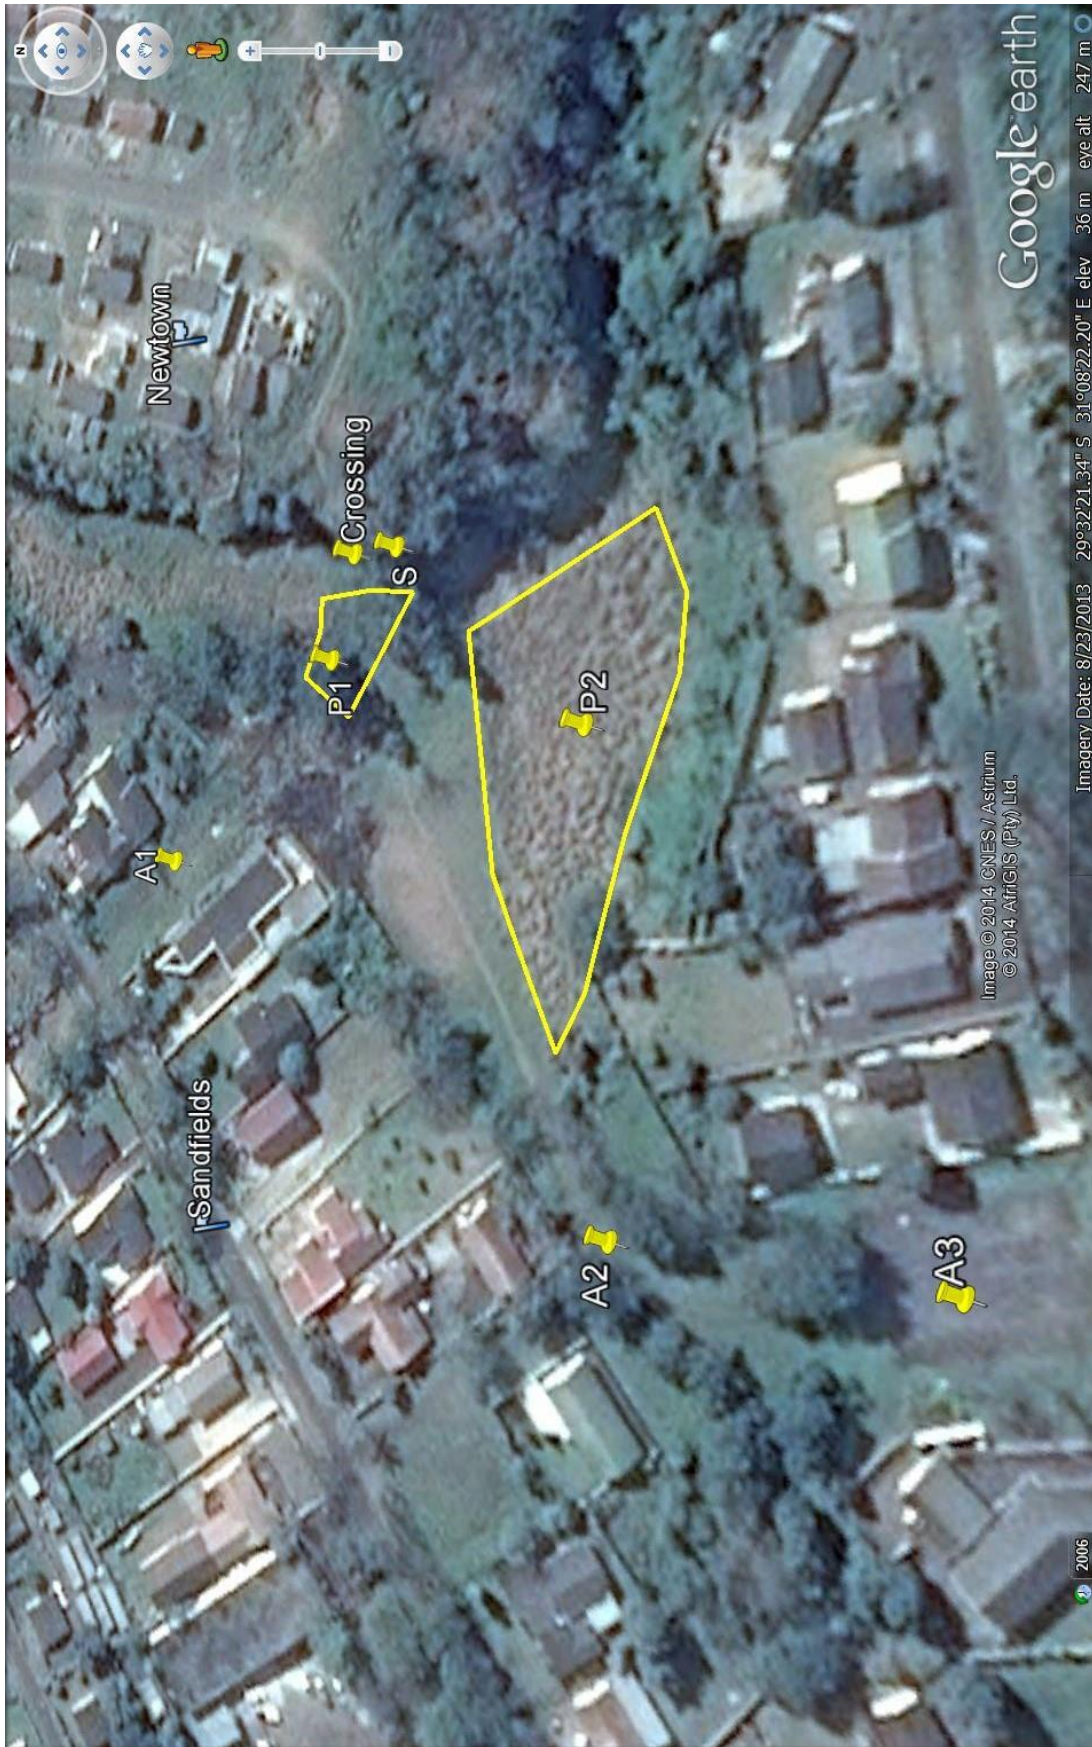
APPENDIX 1: Vegetation map

**Crossing** – The GPS point provided for the proposed bridge crossing. There appears already to be informal crossing of the small river at this point, by passage over a pipeline.

**A1** – Some of the current pedestrian traffic over the river appears to pass through here, which is alleged by a neighbor to be private property, which has a fence at the bottom that has been cut. This is likely to increase if the bridge is built, unless a relatively indestructible feature such as wall be built to prevent this.

**A2** – Most of the traffic proceeds over the river in this direction, towards a small park/playground that appears to have fallen into disuse, possibly partly because of the traffic that now occurs through it. This park is shown at point A3.

**S** – This is a lone indigenous trees, *Syzygium cordatum* (Umdoni) close to the crossing. A small number of other indigenous trees mentioned in the report are further away and are probably safe from construction. Almost all the other tree growth evident in the aerial photography comprises alien species, mainly *Eucalyptus grandis* (Saligna Gum) and to a lesser extent *Melia azedarach* (Syringa).

**P1** – Polygon containing two patches of the indigenous reed *Phragmites mauritianus*, some of the alien reed *Pennisetum purpureum* (Napier Fodder) and some other grassy growth.

**P2** – Polygon containing a large amount of the alien reed *Pennisetum purpureum*.

- Relocation of the *Phragmites mauritianus* reeds if in the construction footprint, to other suitable habitat along the river banks. This should preferably be on the western/Sandfields side of the river as vegetation on the banks is less transformed than on the eastern/Newtown side. This would need to be undertaken with due care by a horticulturist or other suitably qualified person, if this is to be successful.

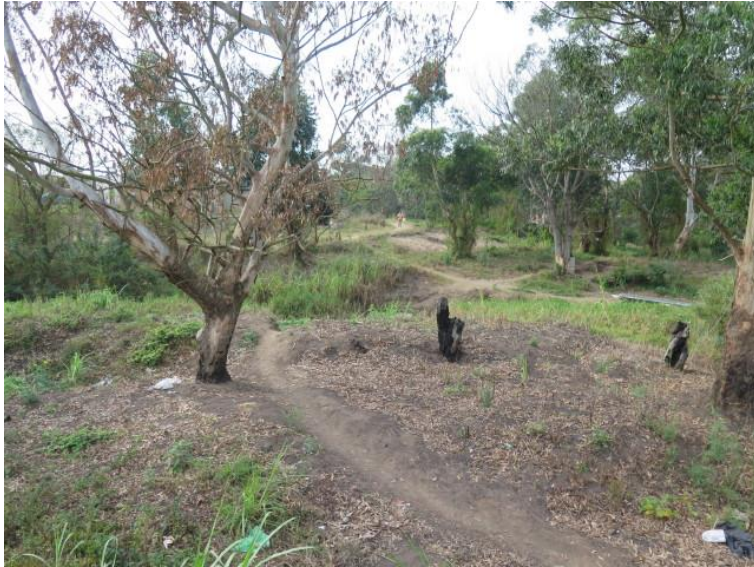
**Top:** View of the crossing, together with the informal path that takes pedestrians over the small river. Trees in the vicinity are nearly all alien eucalypts.

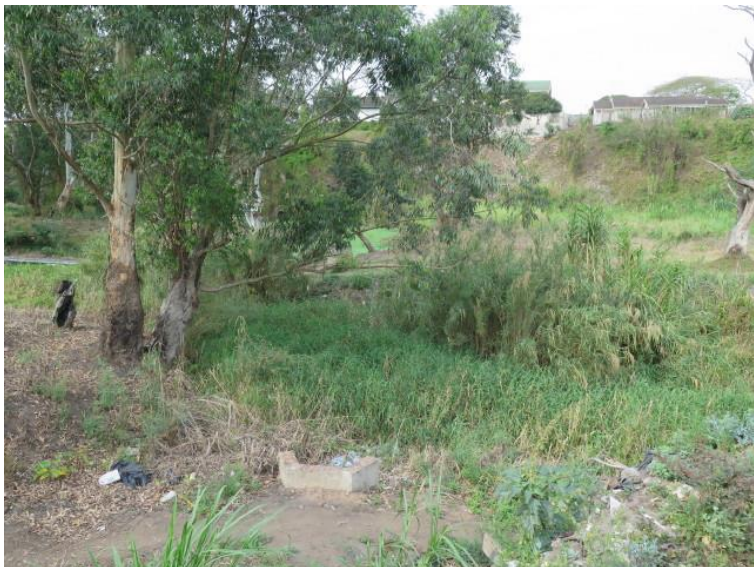
**Middle:** Patch of the indigenous reed *Phragmites mauritianus*, with a few examples of the alien reed *Pennisetum purpureum* (Napier Fodder), nested in other grassy growth.

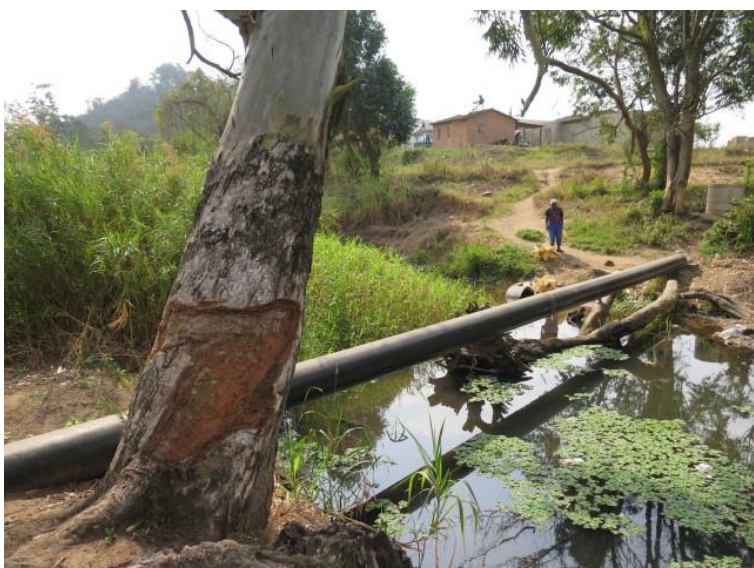
**Bottom:** View of the pipeline across the river, on which some pedestrians precariously cross, with another patch of *Phragmites mauritianus* to the left.

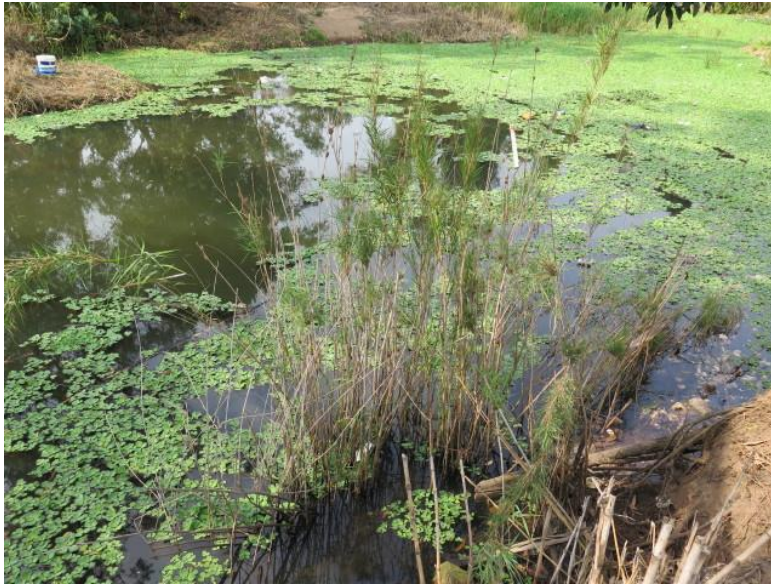
**Top:** View of into the river, with some *Phragmites mauritianus* reeds and large numbers of the alien floating aquatic *Pistia striatiodes* floating on the water.

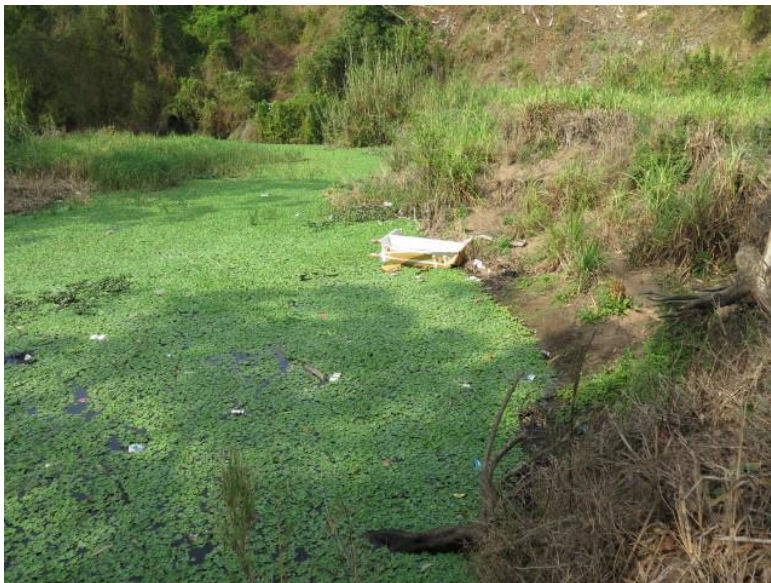
**Middle:** Another view showing the dense infestation and disturbance on the river banks.

- Destruction of alien plants during and post-construction would also be beneficial. If such mitigation was to be set in place it is also necessary to advise a radius around the proposed bridge around which this could occur. A distance of 30 metres each side of and back from the river banks would seem reasonable, but given that rivers are dynamic systems and there will be pedestrian movement in an area in which there is already much alien vegetation, invasion will readily resume if a control effort is not sustained.

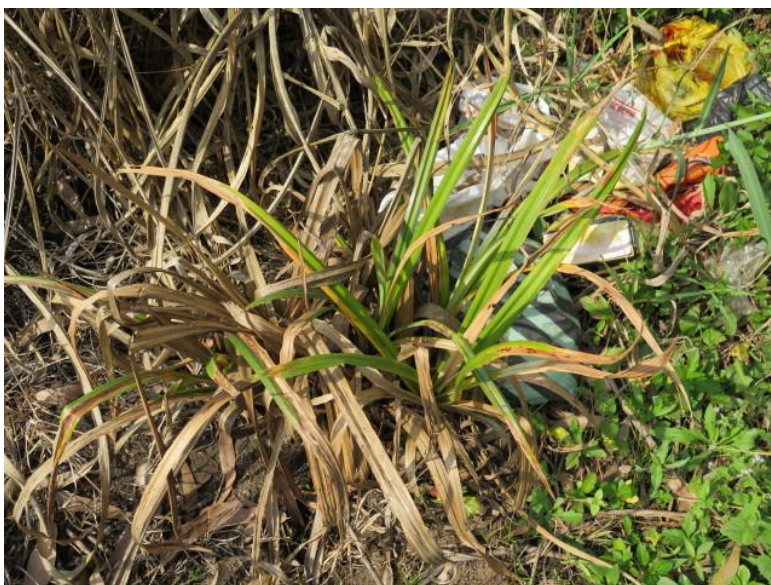
**Bottom:** A small number of *Cyperus dives* plants occur at or within 30 metres of the crossing, close to the river banks. Most are in poor condition or have been burned. This also shows some of the litter that is found on the banks.

- Finally, it will benefit the vegetation and the river if the refuse and litter that have been dumped is removed, including from the park through which pedestrians walk, but a long-term solution also requires a change mind-set from residents both the Newtown and Sandfields sides. Ideally a solution to the degradation seen will require involvement of either the municipality, or the communities, or both the municipality and the communities in a continuing effort to keep the river and its surrounds clean. If this could be achieved on a stipend basis, this could also create income for some residents of Newtown, in which there appears to be a high rate of unemployment.

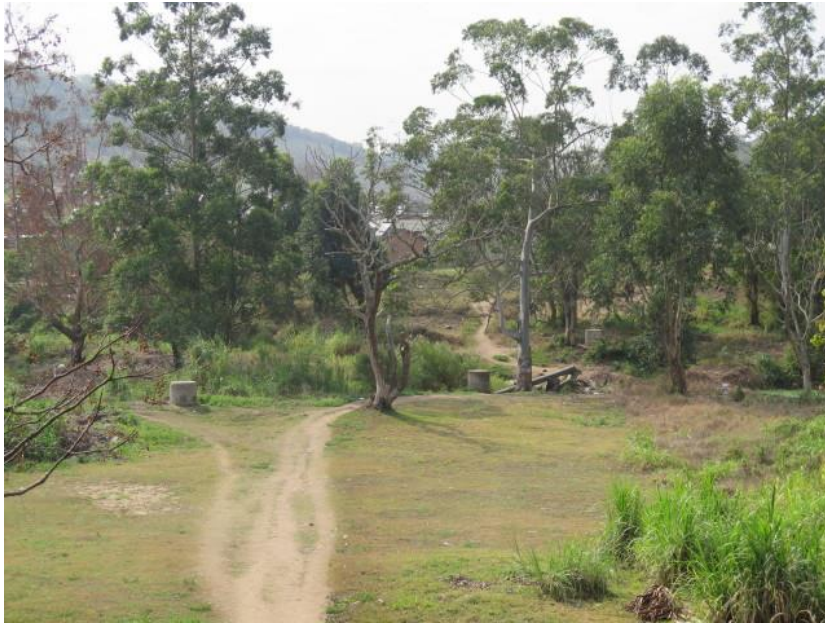
**Top:** Wider view of the proposed crossing point and the current path.

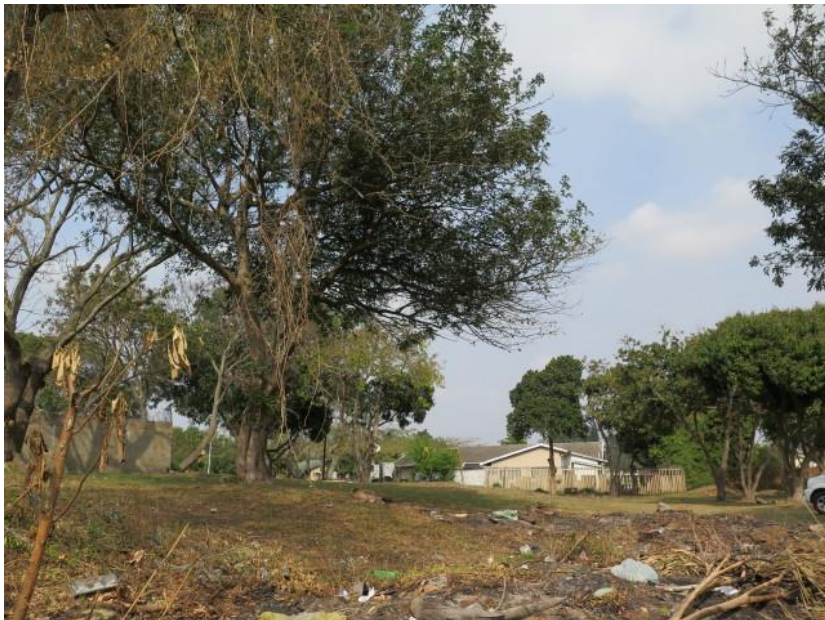
**Left:** View of the pedestrian path looking towards the small park/playground which appears now in disuse, with litter and refuse in the foreground.
