## **CHAPTER THREE: DESCRIPTION OF THE AFFECTED ENVIRONMENT**

The proposed development will entail the establishment and operation of a composting and fertiliser processing plant (including associated infrastructure) of approximately 10.5 hectares on Farm 715 Division Uitenhage which is approximately 377 hectares in total extent. The process entails firstly, composting the poultry litter in windrows for a period of two to four months using an aerobic process on an area of about 10ha. Thereafter the composted litter (now referred to as fertiliser) can either be sold directly to users in bagged or bulk form; or be processed further (pelletised) before being sold. The applicant proposes a phased approach to the bagging, bulk storage; and further processing of the fertiliser. In the short term the fertiliser will be stored in a roofed structure (storage and collection area of the fertiliser processing plant) both in bagged and bulk form for distribution to users. However in the medium to long term, the roofed structure will be expanded to provide for the processing and pelletising of the fertiliser, before it is bagged or stored in bulk. Once fully developed, the footprint of the roof

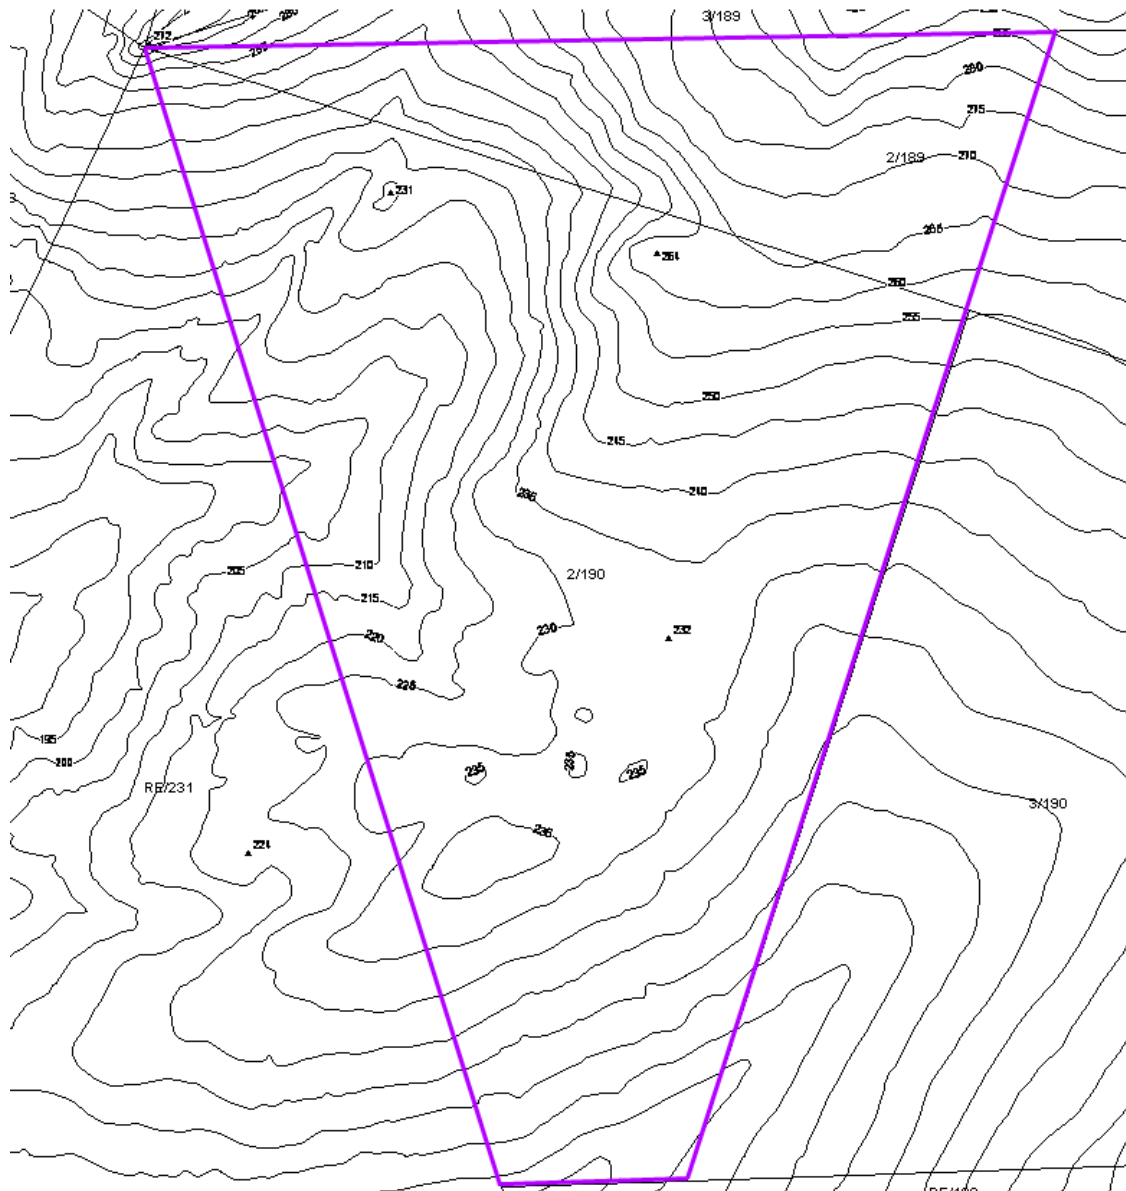
Map 3.3: Topography of the study area (5m contours)

The topography of the landscape within the study area (Farm 715 Division Uitenhage) is generally flat, sloping gently from the north east to the south west. The elevation of the area ranges from approximately 290 meters (above sea level) in the north eastern corner of the property to approximately 190 meters (above sea level) in the south western corner (See Map 3.3). The central portion of the site is relatively flat (at ca. 230 msl), while in the north there are a few gently sloped valleys.

The site lies between the Coega and Sundays Rivers, and falls within the M30A catchment which drains into the Coega River system. Surface runoff from the site is likely dictated by the topography of the site. Therefore it is presumed the northern portion of the site would drain to the south west, towards the Coega River. From the flat central portion southwards it appears the site drains to the south east, towards a non-perennial stream that cuts across the south eastern corner of the site, also eventuating in the Coega River system.

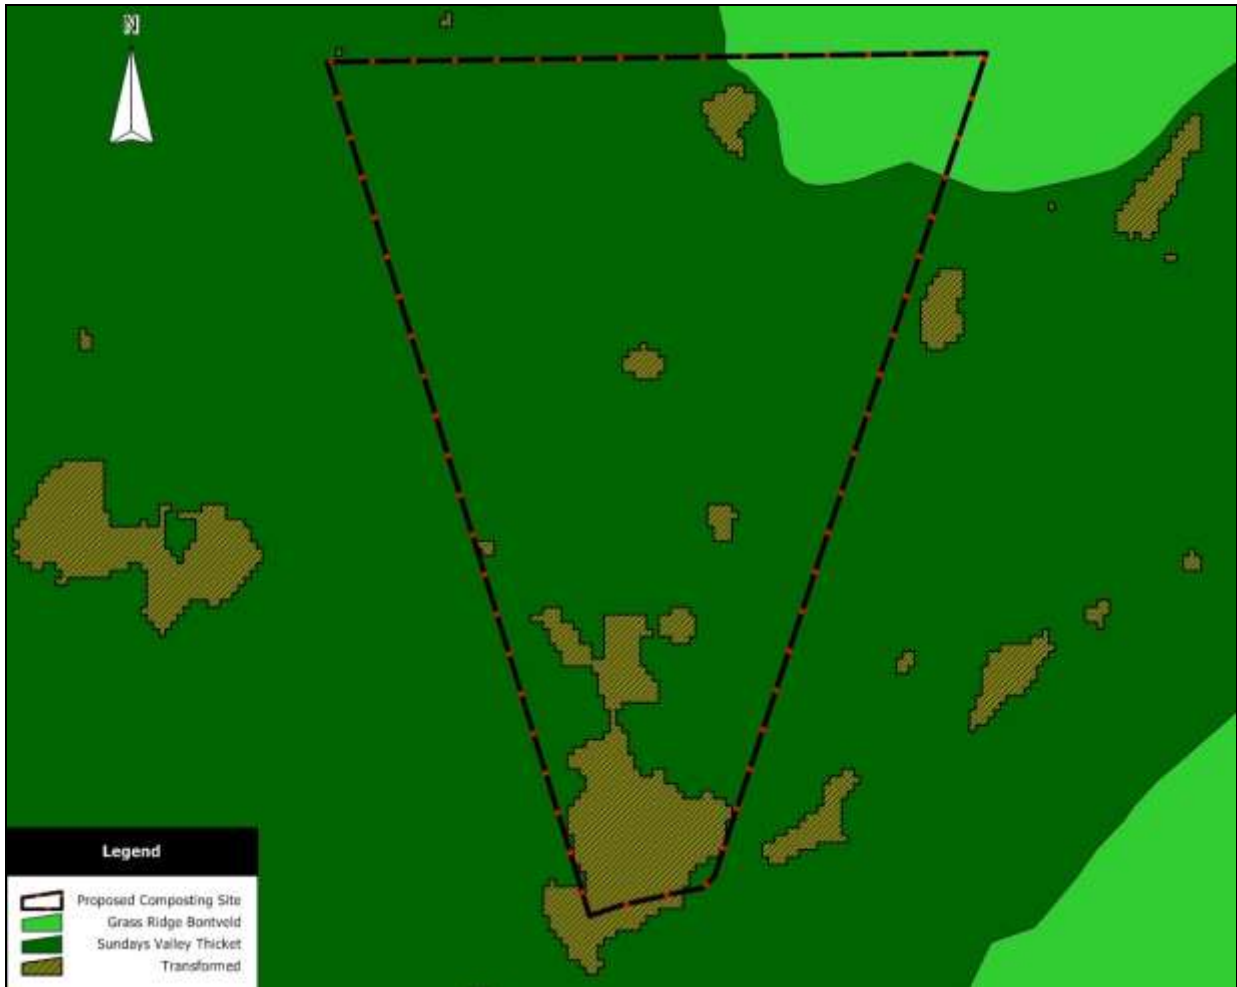
Map 3.7: STEP Mapping for the affected area.

**STEP** (Subtropical Thicket Ecosystem Programme) (Pierce & Mader 2006.) - According to the STEP mapping resources the site is mostly covered by Sundays Valley Thicket, with a small portion of Grass Ridge Bontveld indicated in the north eastern corner (Map 3.7). Both of these vegetation types are classified as *currently not vulnerable*. According to the STEP Conservation Priority Map Guideline document this classification means that these areas can tolerate some disturbance from developments but that developments should preferably take place on sites that have undergone impacts, rather than on pristine sites. The STEP Transformation maps further show that most of the southern portion of the site is currently transformed.
