**ASHA Consulting (Pty) Ltd**  
40 Brassie Street  
Lakeside  
7945

19 February 2020

### **PROPOSED POWERLINE RISIVILLE/MCKAY FEEDER LINE UPGRADE: HERITAGE SCREENING**

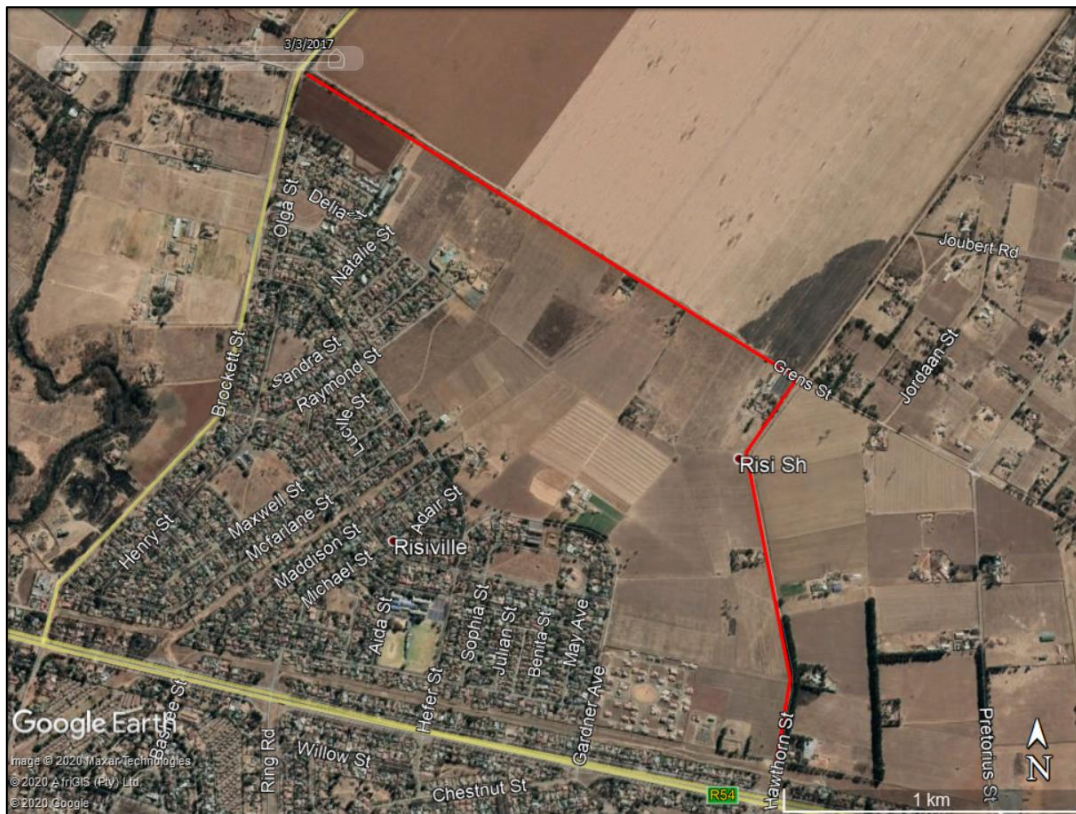
**Figure 2:** Aerial view of the study area showing the alignment of the powerline proposed for an upgrade.

Thank you for providing project information with regards to the proposed upgrading of the Risiville/Mckay Feeder Line near Vereeniging from a capacity of 11kV to 22kV (Figures 1 & 2). The proposal is to reuse the same alignment along Hawthorn Street but then switch to the northern side of Grens Street for the west-east section of the route (the existing powerline is on the southern side of this road). The total length of the proposed upgrade is 3.3 km. Along Hawthorn Street the new poles will be placed in the same foundation holes utilised by the existing 11kV power line, but new holes will be excavated along Grens Street. The old line would be decommissioned and removed. It is noted that the surface along the south side of Grens Street is sloping an unsuitable for the new powerline, hence the need to move it to the north side of the road.

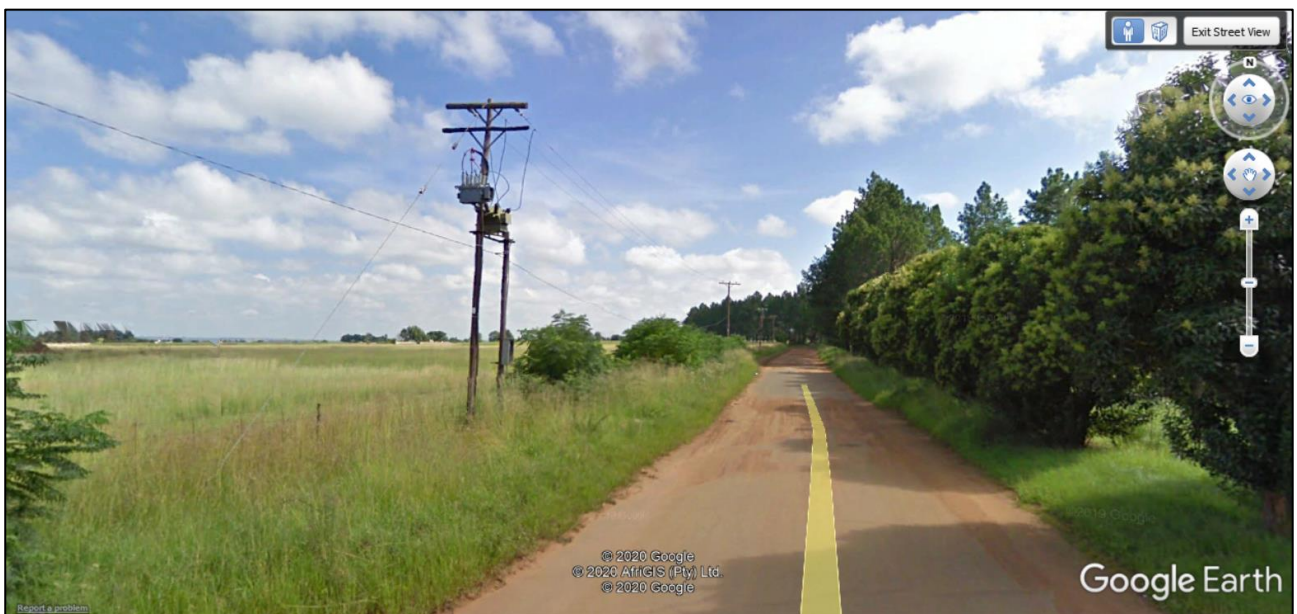
**Figure 5:** View towards the north along Hawthorn Street from the south-eastern end of the study area. The pylon in view is where the upgrade commences. Source: Google Earth Street View.

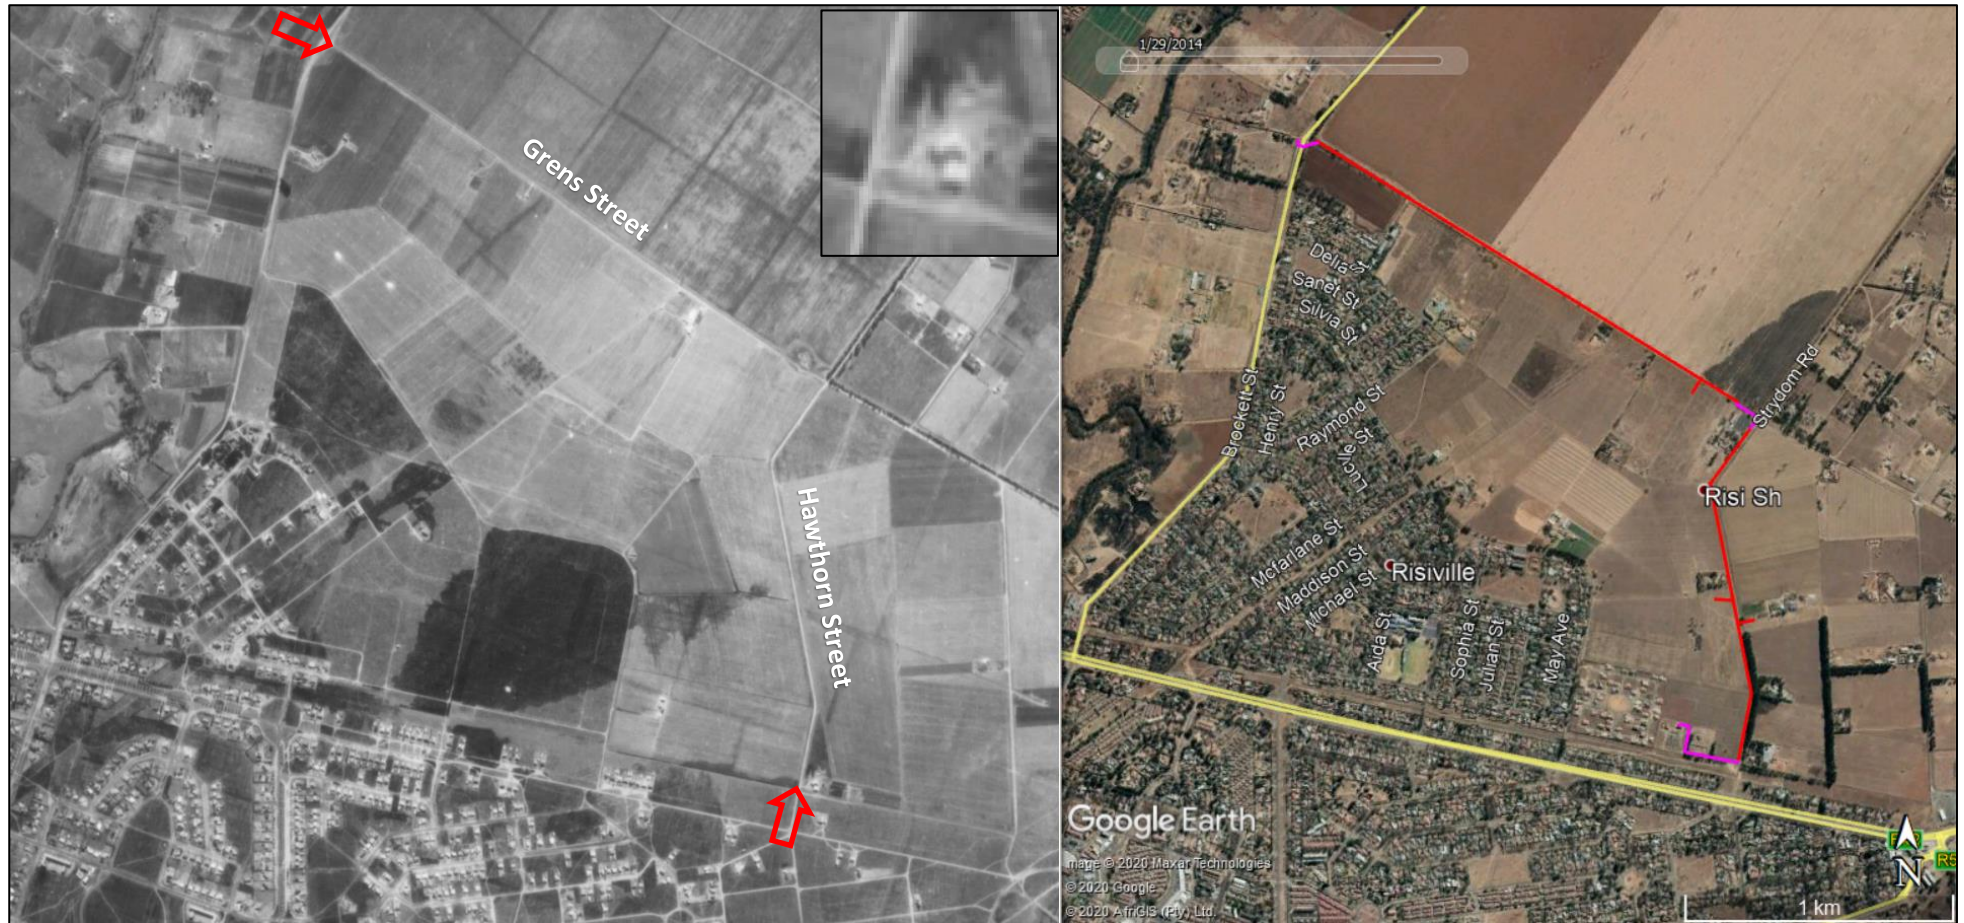
**Figure 6:** Aerial photos from 1961 (Job 438, strip 022, photograph 03212) and 2019 (Google Earth) showing the nature of the landscape 60 years ago. The inset shows the house at the southern end of Hawthorn Street.

Just one building occurs close to the route. This lies at the southern end of Hawthorn Street, on its eastern side (Figure 6). It is not possible to tell whether the house existing in 1961 is still present within the modern structure, but at the minimum the original building does appear, from its roofscape, to have been extensively modified. It will not be impacted in any way and is of no further relevance.

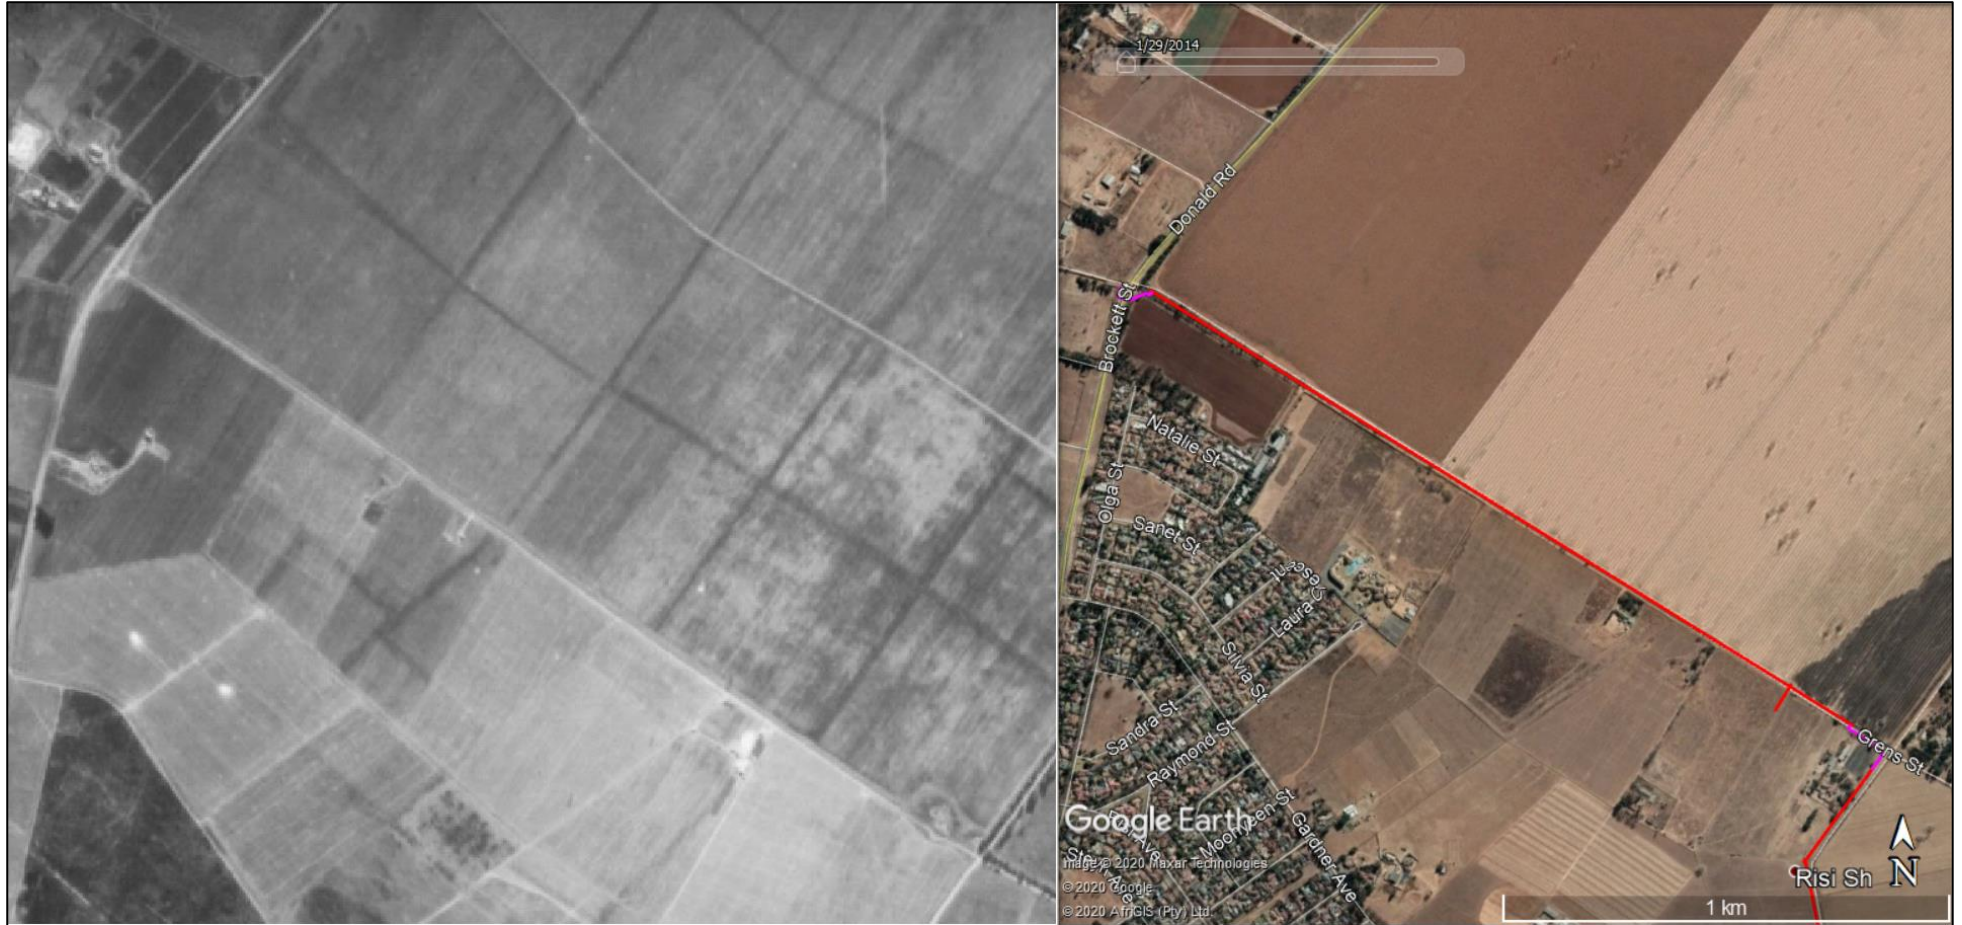
**Figure 7:** As above but focused on Grens Street and showing the tree line to be absent.

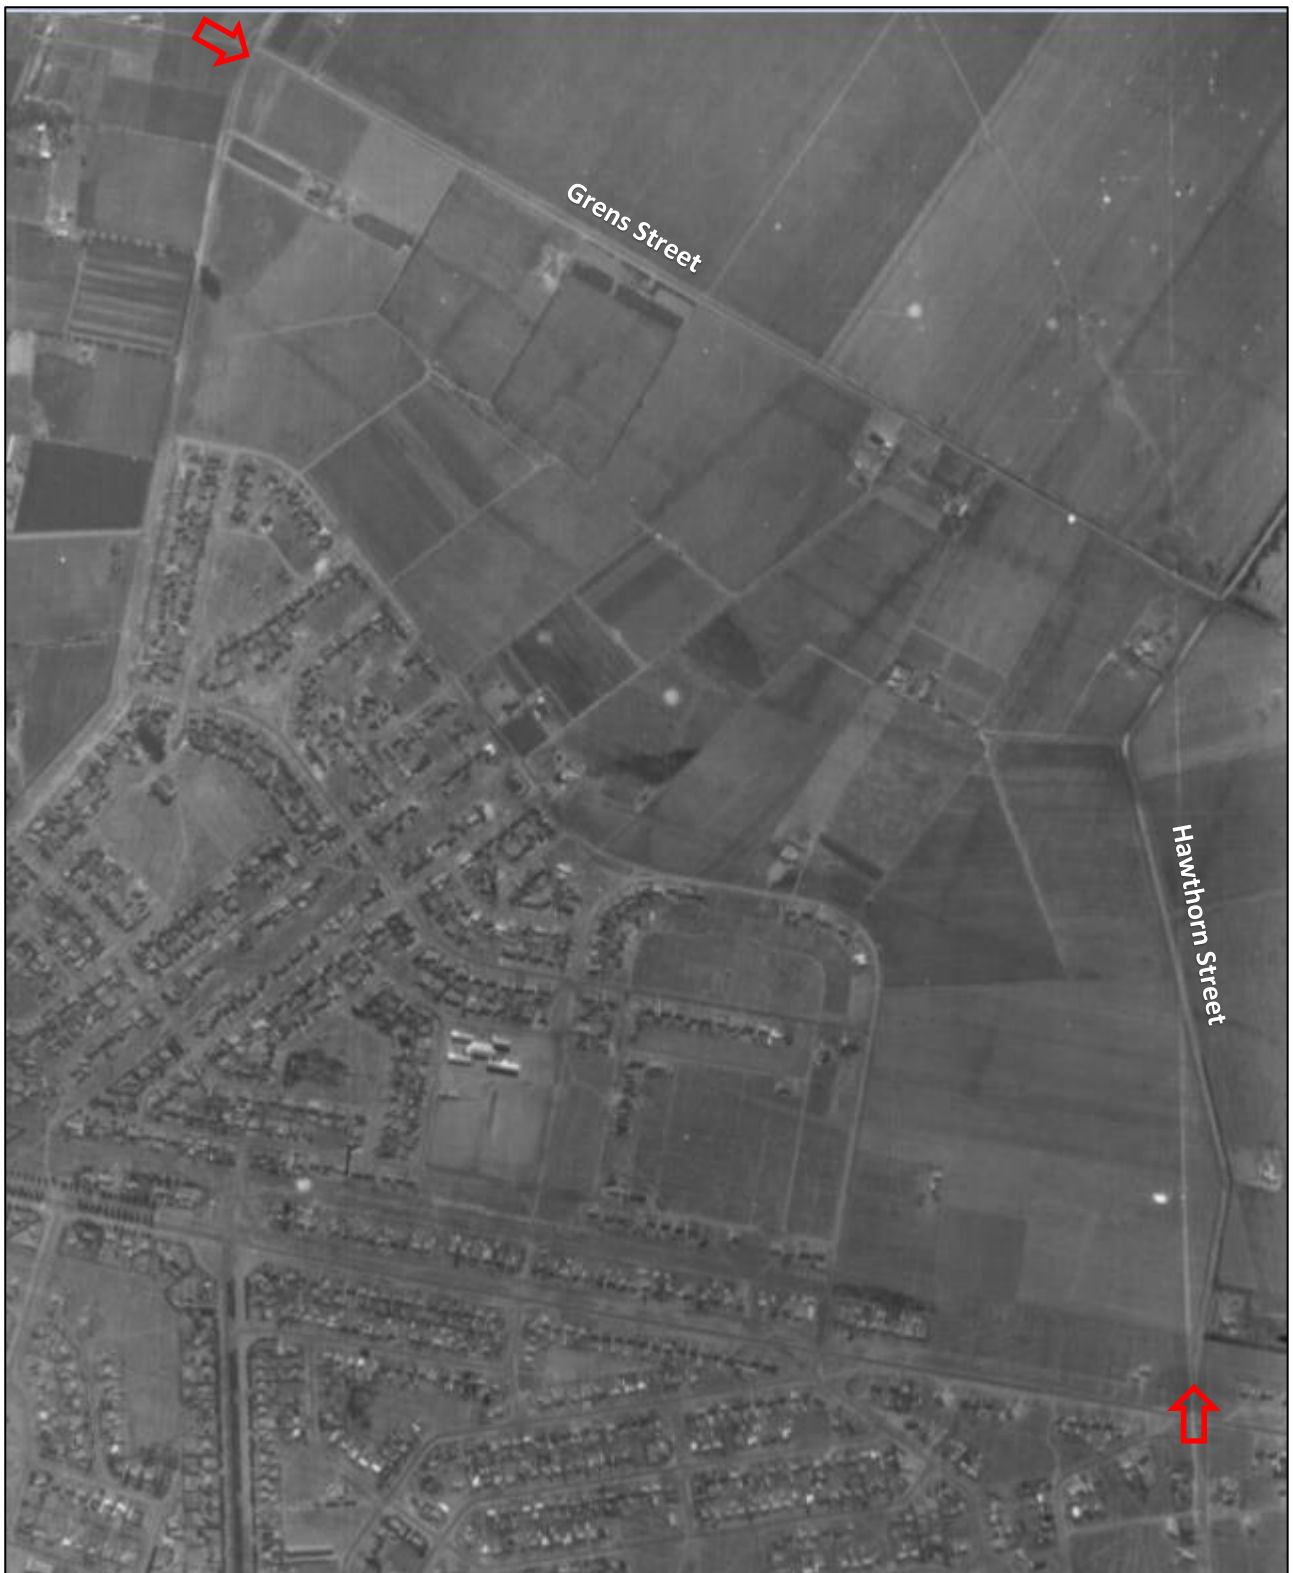
**Figure 8:** Aerial photos from 1969 (Job 653, strip022, photograph 05679) showing the tree line along Grens Street to be absent. The line along the southern end of Hawthorn Street is present but still small.

Cultural landscapes can be defined briefly as “the spatial manifestation of the relations between humans and their environment” (Marquart & Crumley 1987: 1)<sup>3</sup>. The study area is rural in nature with gravel roads, tree lines and arable lands characterizing the landscape. The edge of the urban landscape of Vereeniging is not far away to the southwest, however. The tree lines are the most visibly striking elements of the cultural landscape and the 600 m tree line along the northern side of Grens Street will be impacted. It will either need to be trimmed or else trees will be removed where necessary in order to create the necessary safety distance between the trees and the powerline. Figures 6 and 7 show that in 1961 there were no tree lines along either Grens or Hawthorn Streets. Figure 8 shows the Grens Street tree line to still be absent but the Hawthorn

Street one is just visible (i.e small, young trees). Figure 9 shows that by 1985 the Grens Street tree line was still not present but that along Hawthorn had grown up considerably. It is only the younger tree line (along Grens Street) that will be affected. While it is an integral part of the cultural landscape it should be noted that it is not an historical tree line and that other tree lines occur in the surrounding area including along Bocket Street both north and south of its Grens Street intersection.

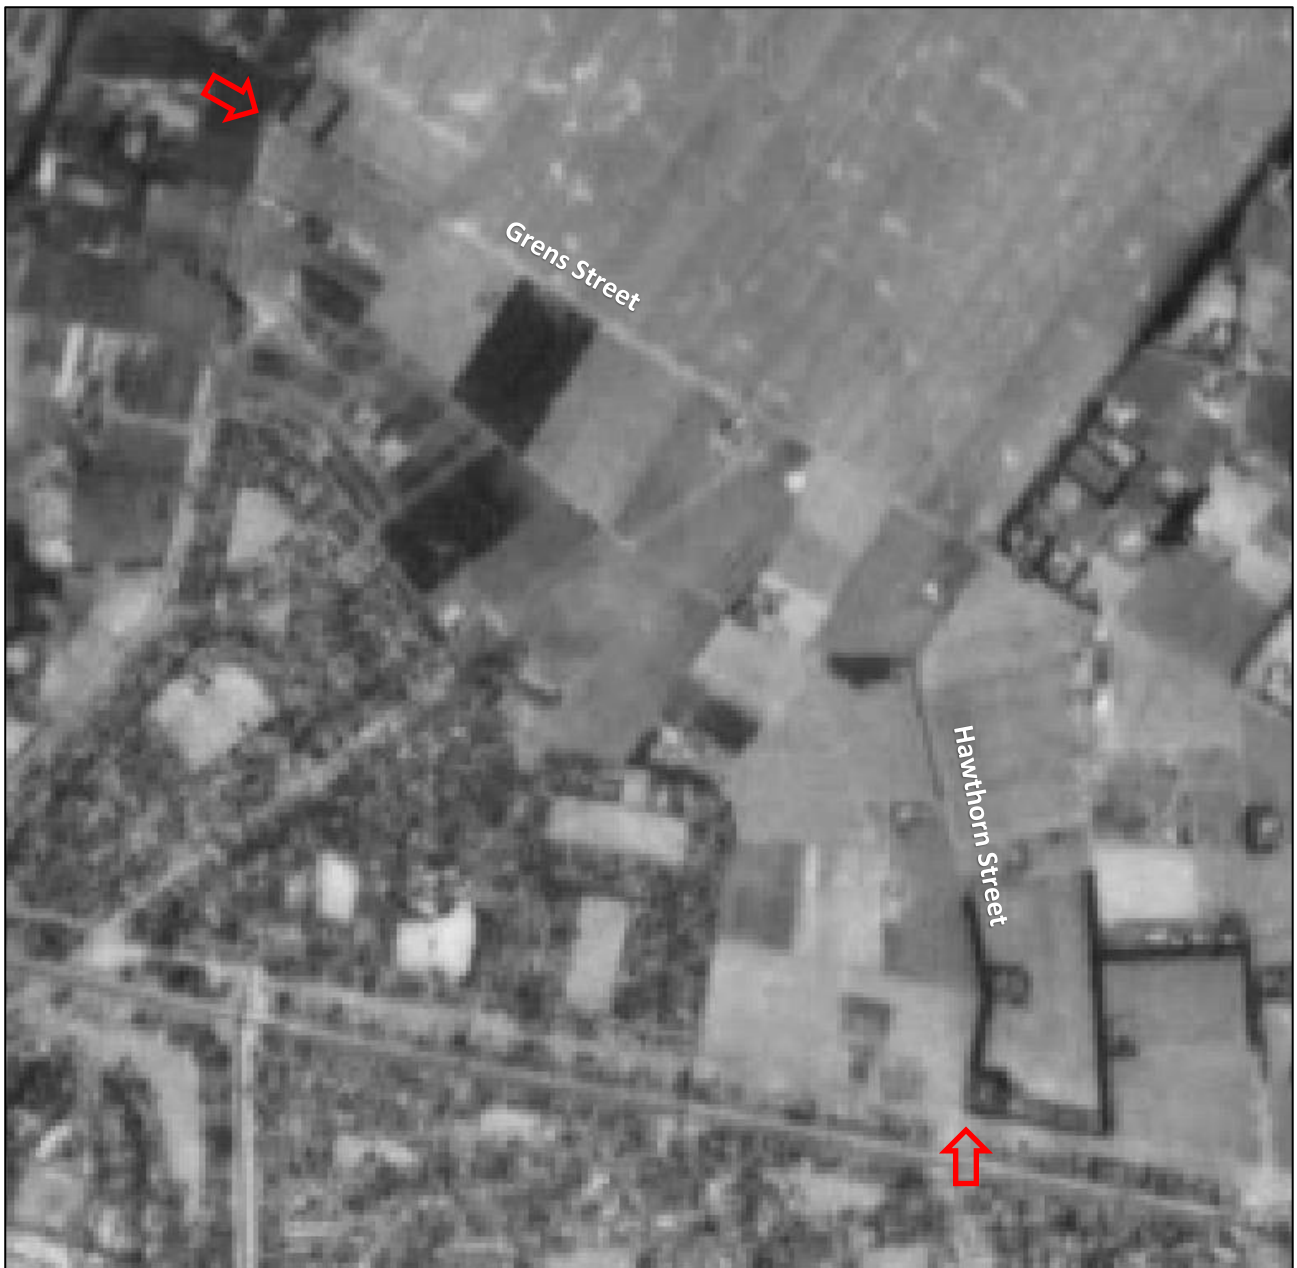
**Figure 9:** Aerial photos from 1985 (Job 881, strip 005, photograph 03071) showing the tree line along Grens Street to be absent. The line at the southern end of Hawthorn Street, however, was already present. The ends of the powerline are arrowed.
