CONVENTION FOR ASSIGNING SIGNIFICANCE RATINGS TO IMPACTS

COLESBERG ROAD UPGRADE PROJECT: PALAEOLOGICAL IMPACT ASSESSMENT

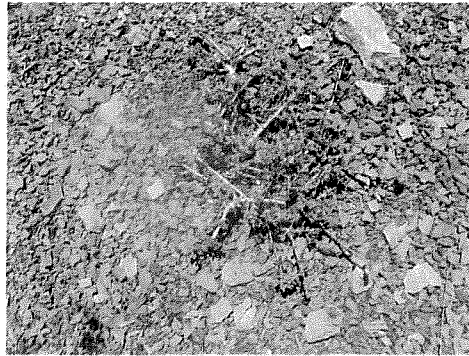
This site is situated in a plain with gentle slope from west to east. It is also an existing borrow pit which will be further expanded to the west rather than going deeper. The area to be excavated can be divided into a southern and a northern portion. The southern portion has a deeper topsoil

and a denser cover with *Sporobolus fimbriatus* (dropseed grass) and *Eriocephalus spinescens* (doringkapok) as the dominating species. The northern portion has sparse cover in a shallow, stony topsoil with *Aristida diffusa* (iron grass) and *Euryops spp.* (harpuis). The current condition of the veld is acceptable.

FIGURE 3: Borrow pit 3. Existing quarry which is going to be expanded.

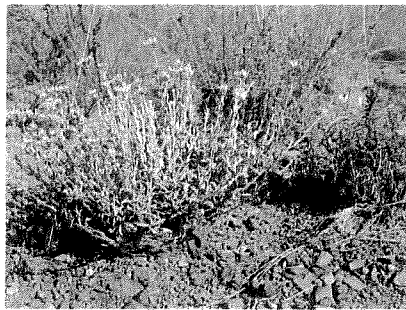
The site is currently unfenced and partially utilized by grazing animals. It is an old borrow pit which will be further mined by cutting up to two meters into the apron of the koppie, rather than digging deeper in the existing quarry. The site is situated high in the landscape, almost in a koppie (Figure 5). The slope is steep and slopes from northwest to southeast. The veld can be described as typically apron veld. The most dominating species are *Erioccephalus ericoides* (kapokbos) and *Eragrostis lehmanniana* (Lehmann's love grass). The veld is generally in a good condition.

FIGURE 5: Borrow pit 5 with *Eriocephalus ericoides*, as the dominating species in the foreground.

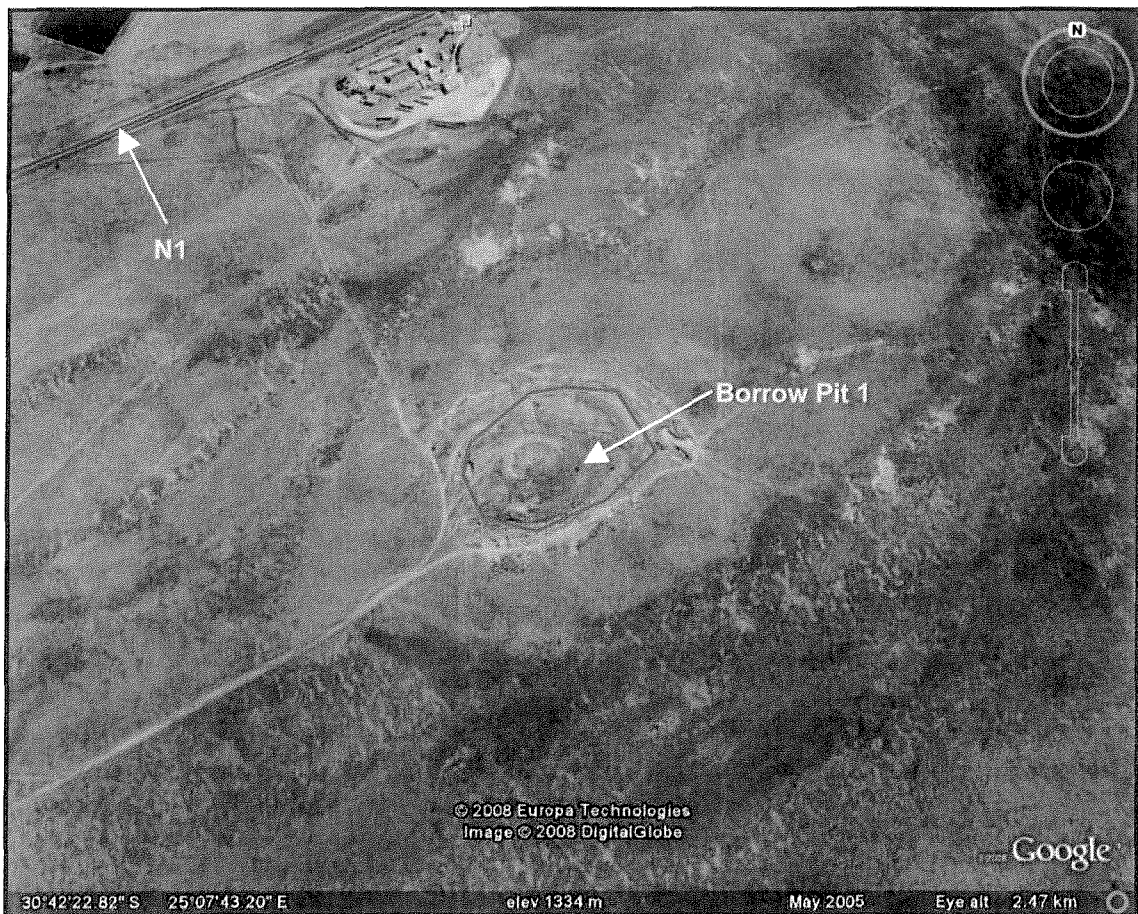
Figure 1. Aerial photograph indicating Borrow Pit 1

One weathered chunk, one broken, partially retouched and weathered Middle Stone Age (MSA) flake and one flat weathered MSA flake was documented on the proposed site. All the tools are in dolerite.

The archaeological remains have been rated as having low local significance.

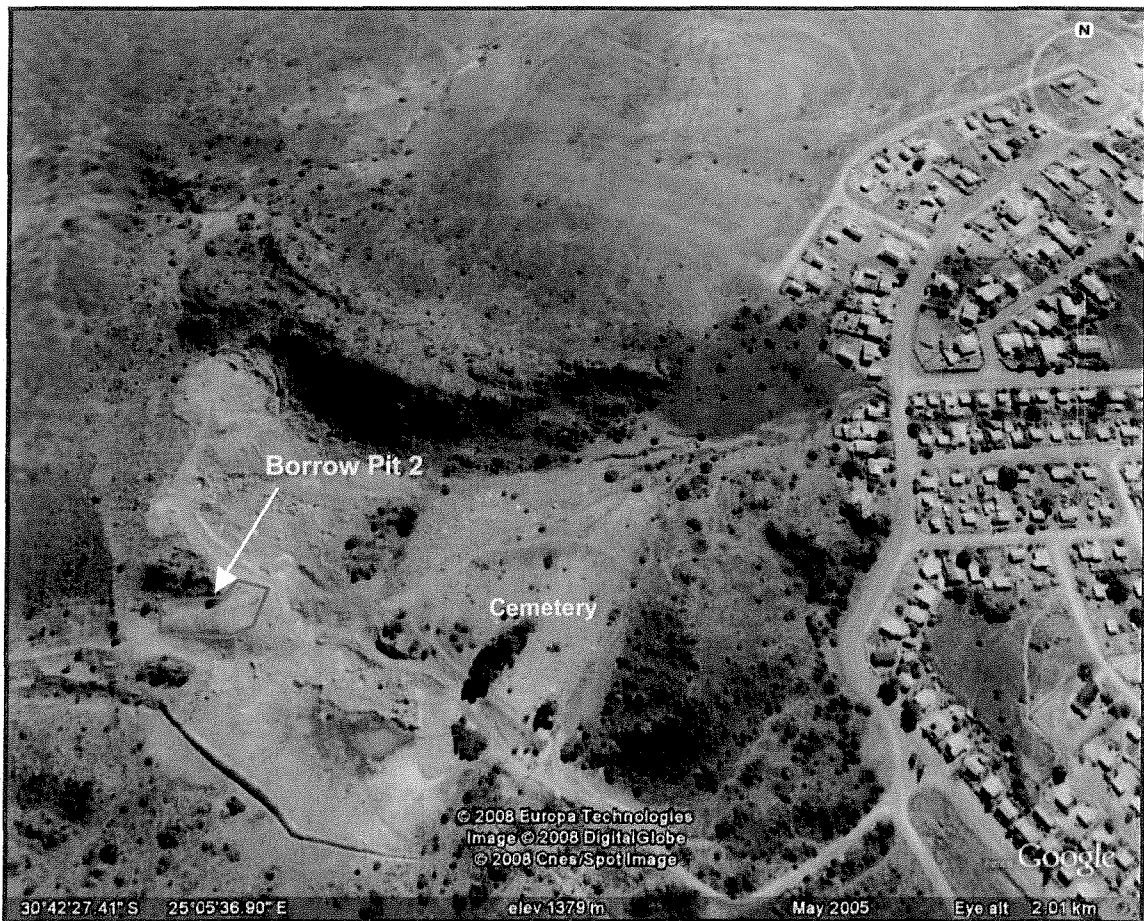
Figure 6. Aerial photograph indicating Borrow Pit 2

Three large, very weathered partially retouched dolerite MSA flakes and one broken, weathered flake were found on the proposed site.

The archaeological remains have been rated as having low local significance.

The proposed site – an existing borrow pit - is located in Colesburg, on municipal land (Remainder Erf 675). Access to the site is via the R369 to Petrusville. The proposed borrow pit is located alongside the town cemetery (Figure 6). The surrounding environment is severely degraded. The existing borrow pit has been extensively exploited (Figures 7-10). Several test pits have already been excavated on the proposed site. A small dolerite kopje and dolerite covered slopes occur immediately behind the proposed new site. Selected sub-base material from existing deposit will be exploited from the degraded south east facing slopes of the borrow pit.

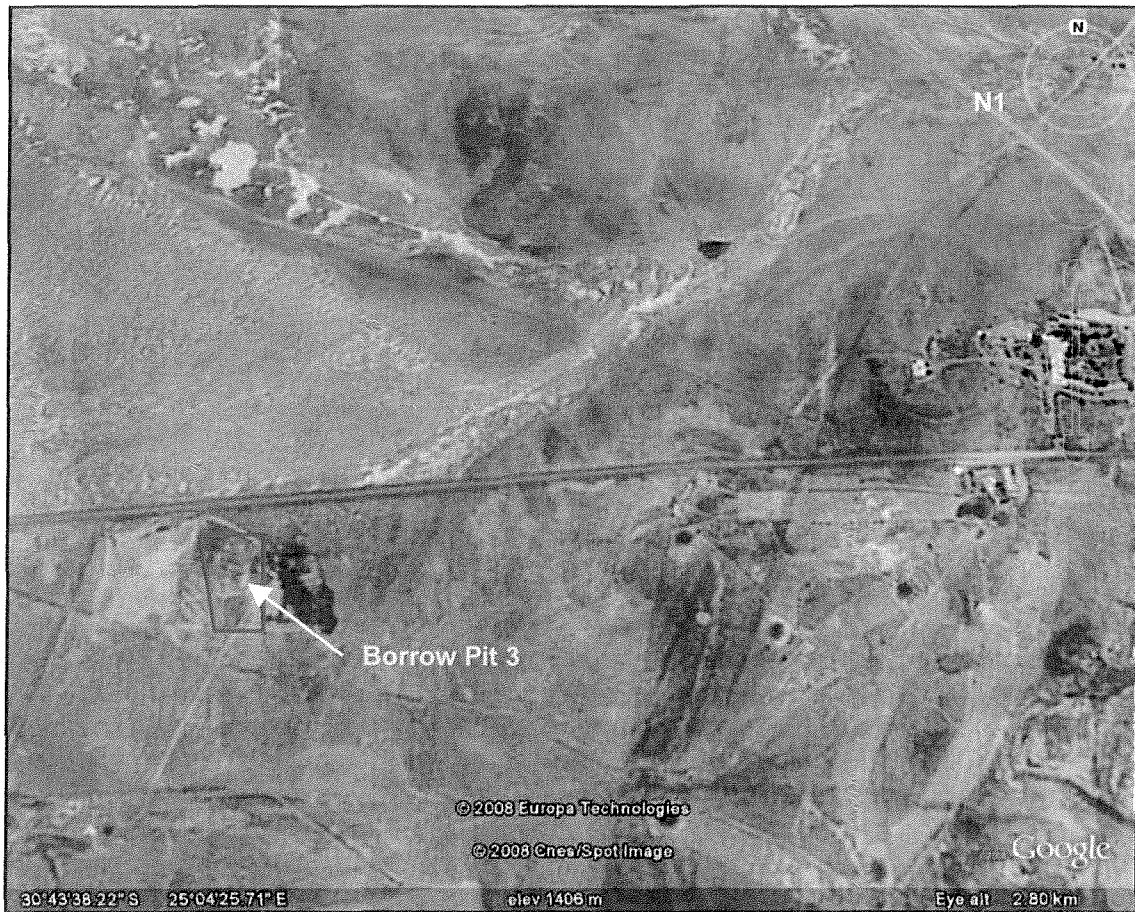
Figure 11. Aerial photograph indicating Borrow Pit 3

Three weathered MSA flakes, one weathered MSA chunk, one weathered MSA core and one flat Later Stone Age (LSA) flake were found on the proposed site. All the tools are in dolerite.

The archaeological remains have been rated as having low local significance.

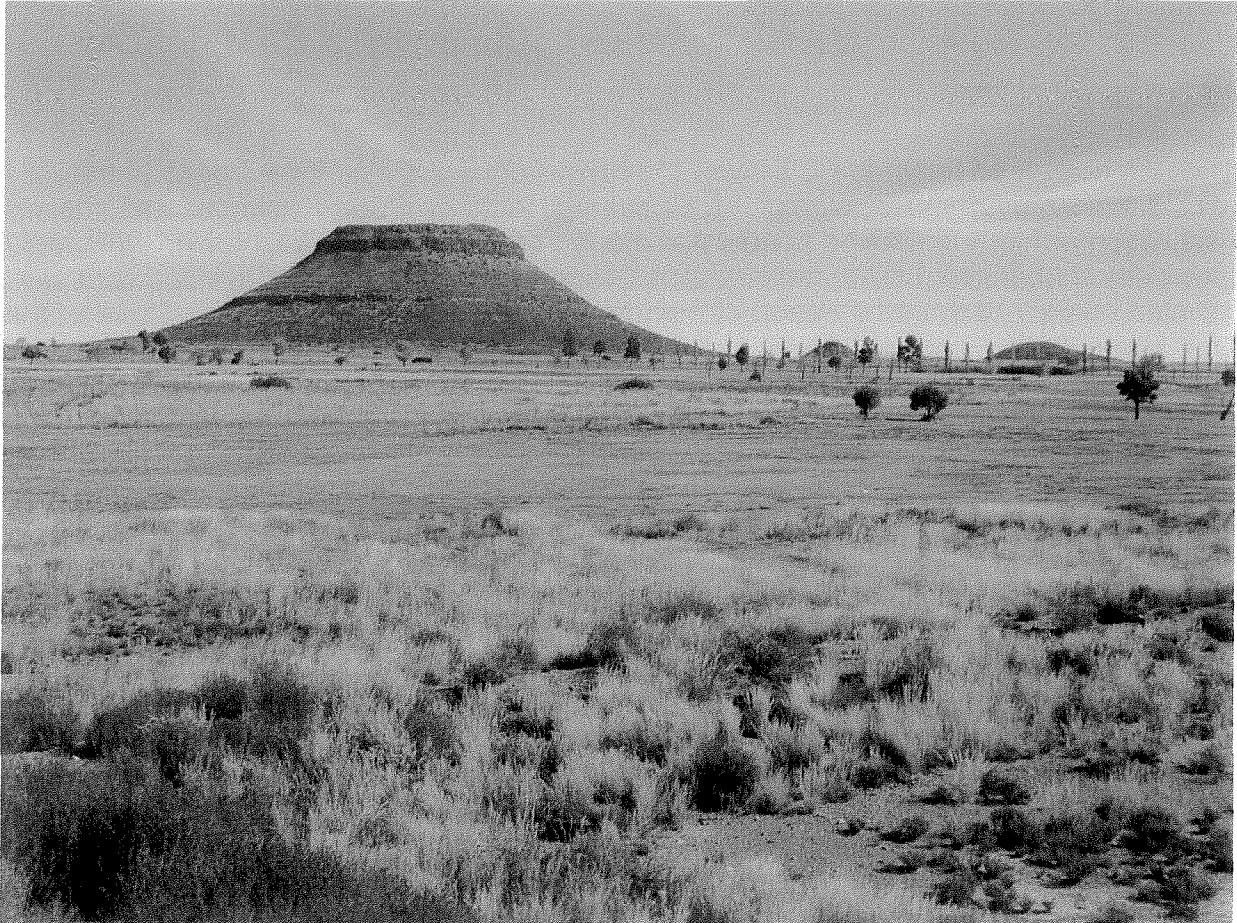
Colesberg Kop viewed from the south (N1 / N9 interchange construction site) showing lenticular channel sandstone halfway up slope and thick dolerite sill towards the crest

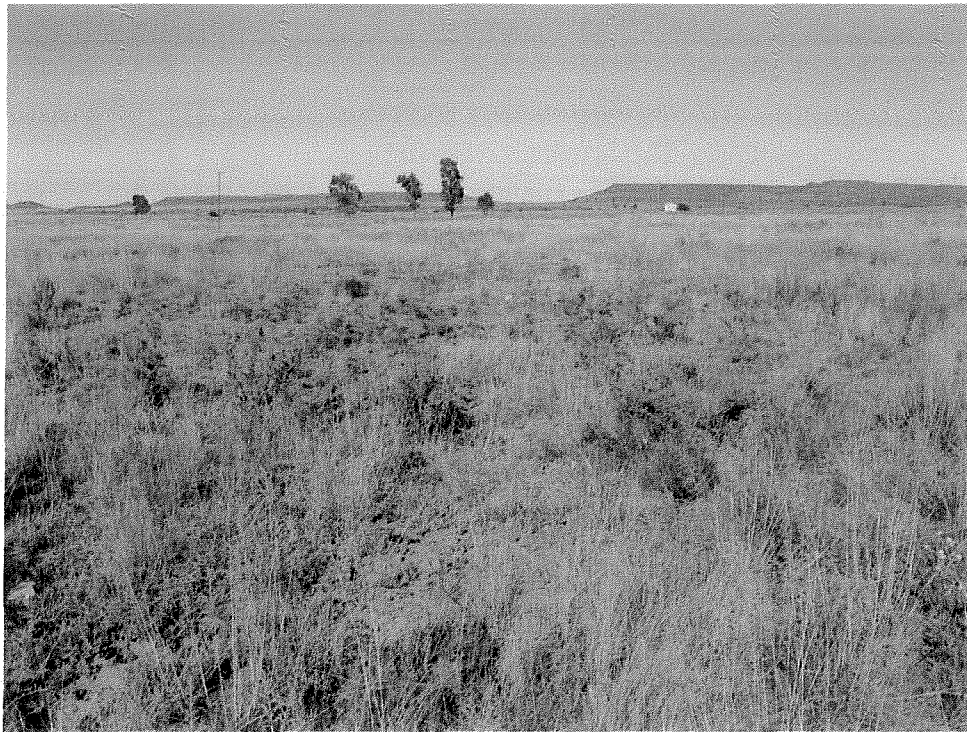
Figure 2. View looking west across construction site for new N1 / N9 intersection, Colesberg

The area of the proposed new N1/N9 interchange on the southwestern outskirts of Colesberg is largely covered with thick alluvial soil and grassy Karoo bossieveld (**Figure 2**). A few, very limited exposures of Beaufort Group bedrock were seen – for example, near the concrete wall north of the dam (30° 43' 52.5" S, 25° 04' 47.9" E), and on the northern edge of property, south of the Colesberg Country Club golf course (30° 43' 43.2" S, 25° 04' 56.2" E). Here small *in situ* outcrops and dumps of excavated rock rubble include buff to greenish-buff sandstone, crumbly grey-green mudrock, pale calcrete and ferruginous concretions ("koffieklip"), but no fossils were seen. Locally the sandstones (with vugs) and hornfelsed mudrocks reflect thermal alteration by dolerite intrusions. Alluvium exposures in deeper gullies and the margins of the shallow dam were also inspected for fossils without success.

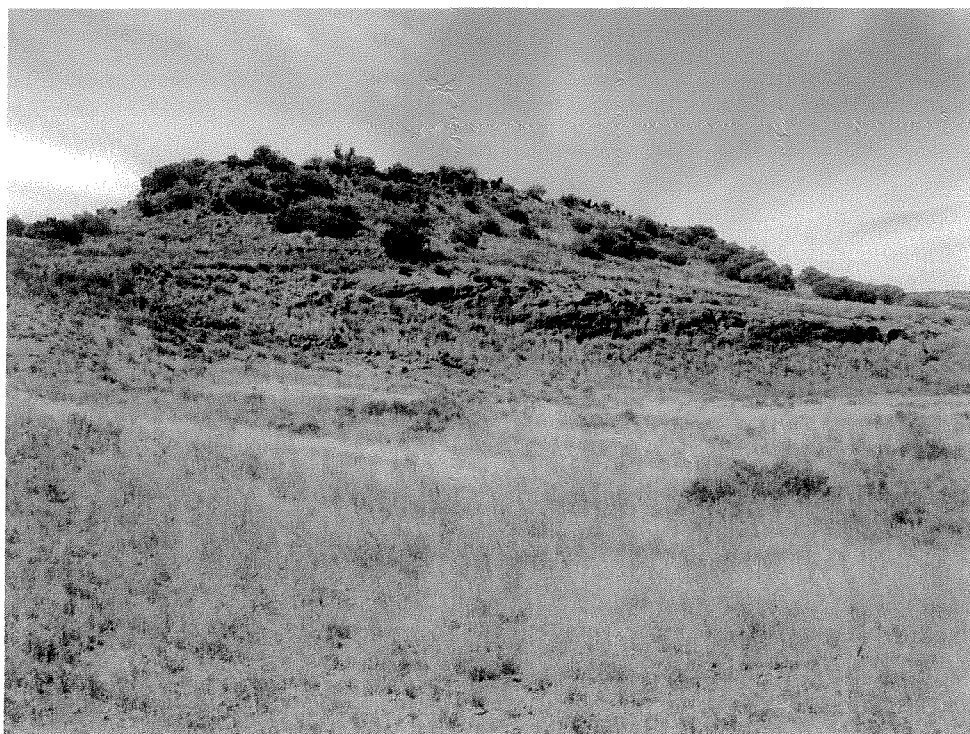
Figure 3. General view towards east of Borrow Pit 5 excavated into weathered dolerite

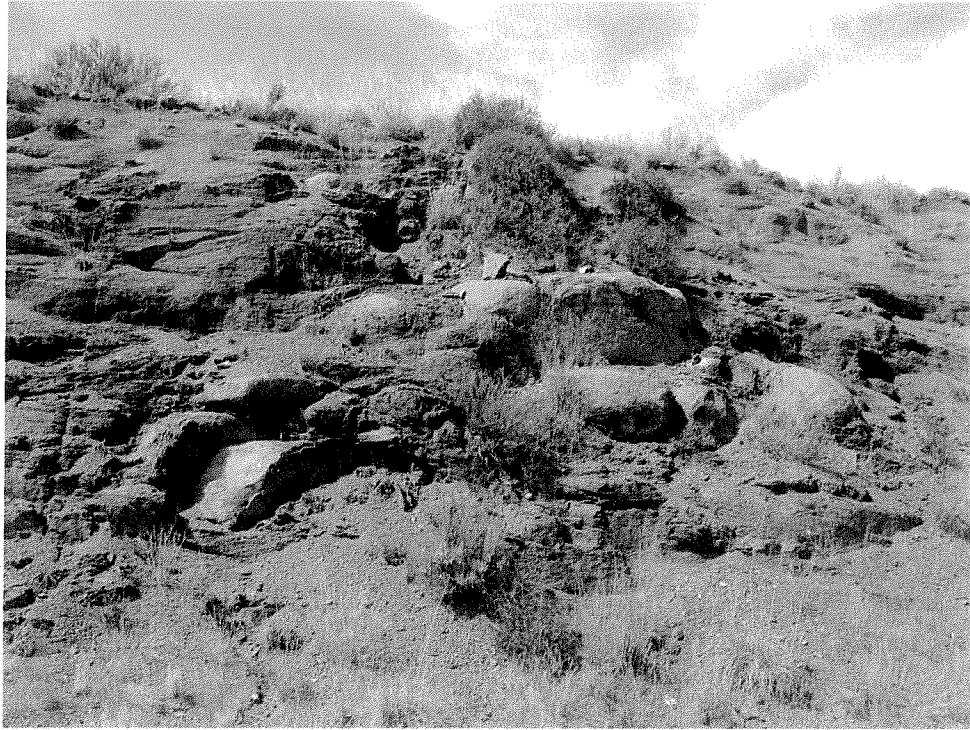
Figure 4. Roadcut along N9 adjacent to Borrow Pit No 5 showing typical dolerite weathering (eg rounded corestones)

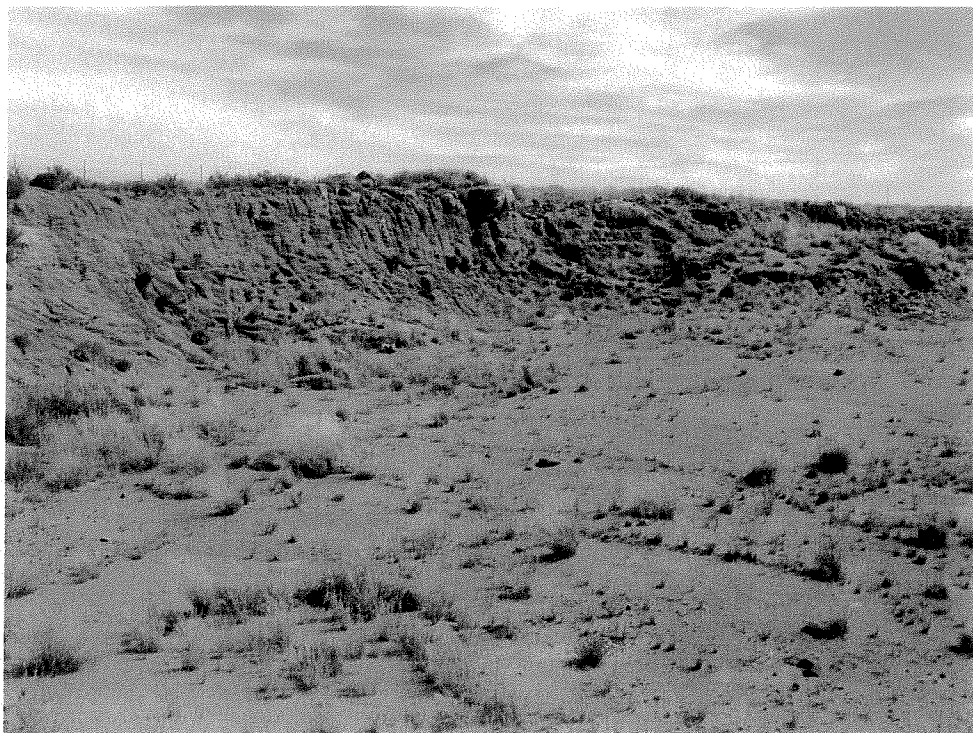
Figure 5. Borrow Pit No. 6 excavated into deeply weathered dolerite

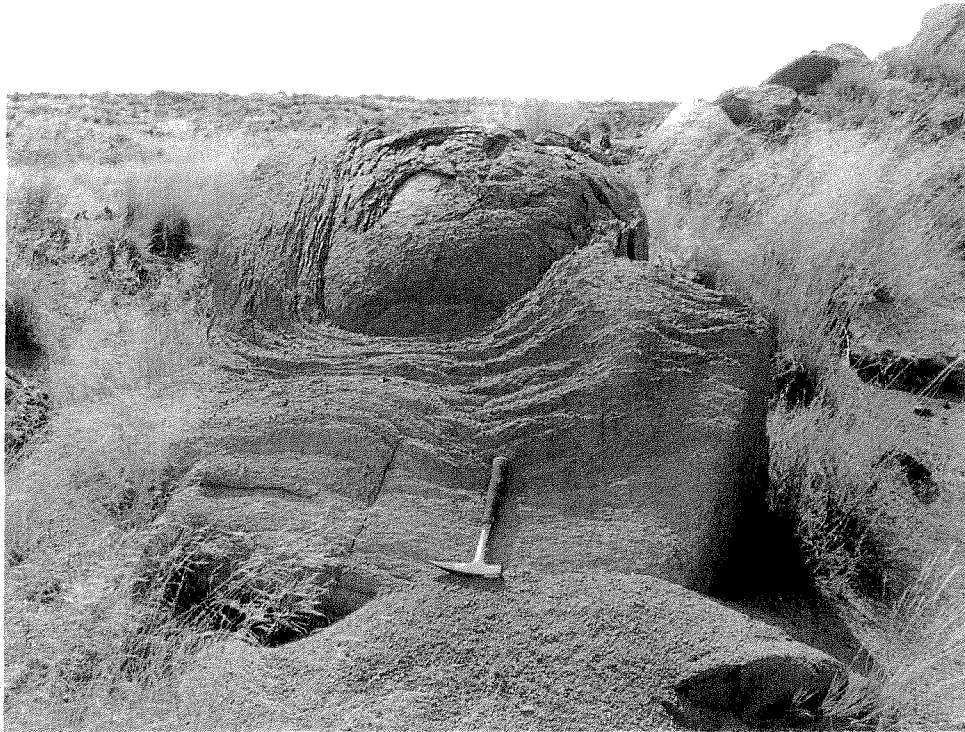
Figure 6. Classic onionskin weathering in dolerite, Borrow Pit 6

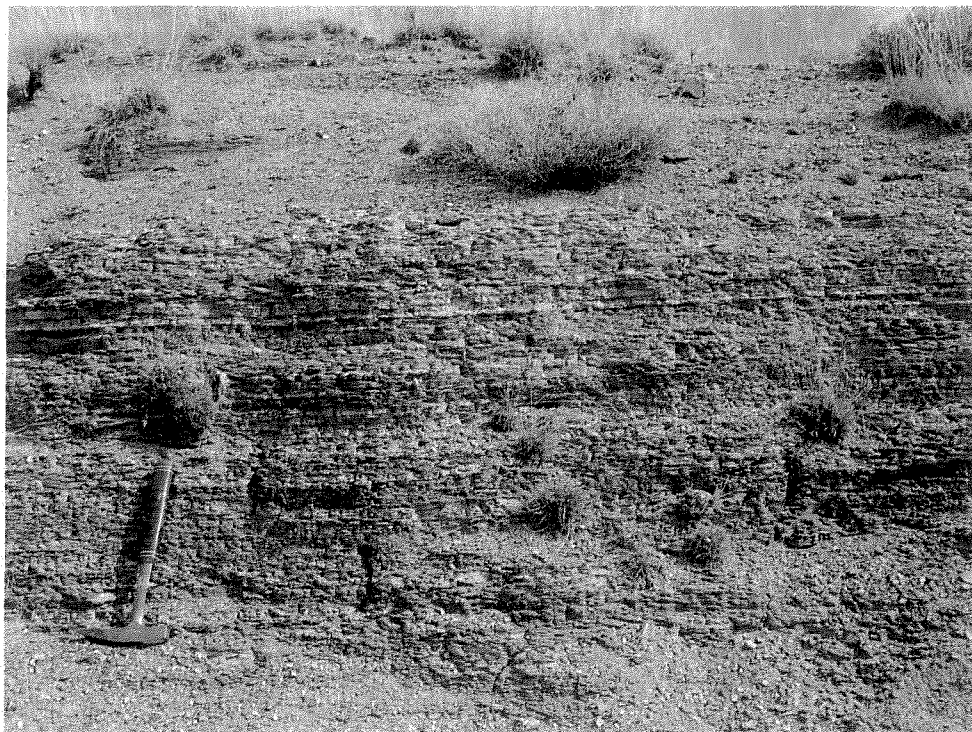
Figure 9. Thin-bedded to laminated sediments of Beaufort Group, Borrow Pit 7 – probably distal floodplain facies

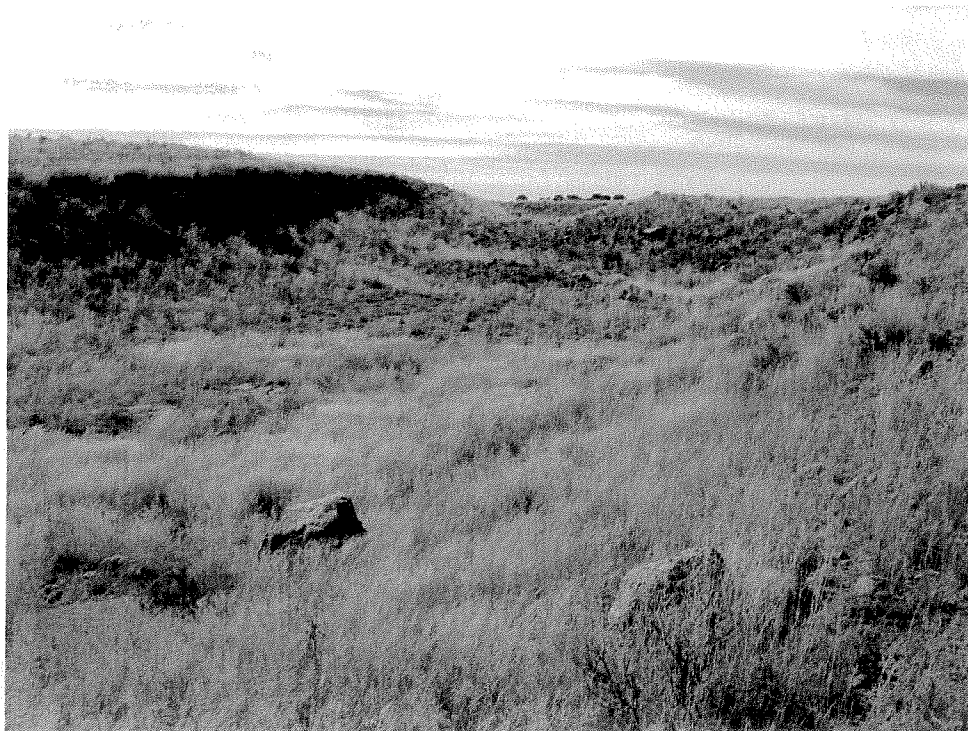
Figure 10. General view of Borrow Pit 8, excavated into dolerite, looking northwest

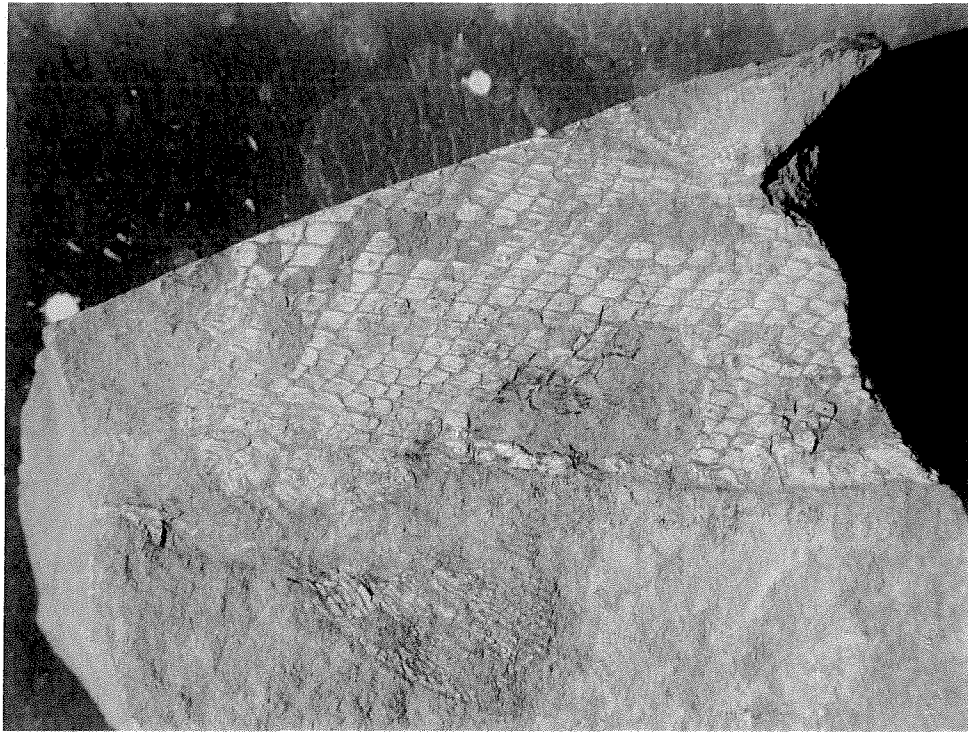
Figure 12. Palaeoniscoid fish from Beaufort Group at Suffolk Hill, Colesberg (Colesberg Museum, X1)

- well-preserved, albeit incomplete specimens **palaeoniscoid fish** from Suffolk Hill on the northern outskirts of Colesberg (**Figures 11, 12**). This *might* be related to the well-known Late Permian genus *Atherstonia*, type material of which (*A. scutata*) was collected from the Dicynodon Assemblage Zone at “the Fish River site of the Colesberg District” (Woodward 1889, Bender 2004)
