PROPOSED VLAKFONTEIN COAL MINE PROJECT

BCR Coal (Pty) Ltd

Phase 1: Desktop Assessment Terrestrial Biodiversity (Vegetation and Plant Species)

Date: July 2022

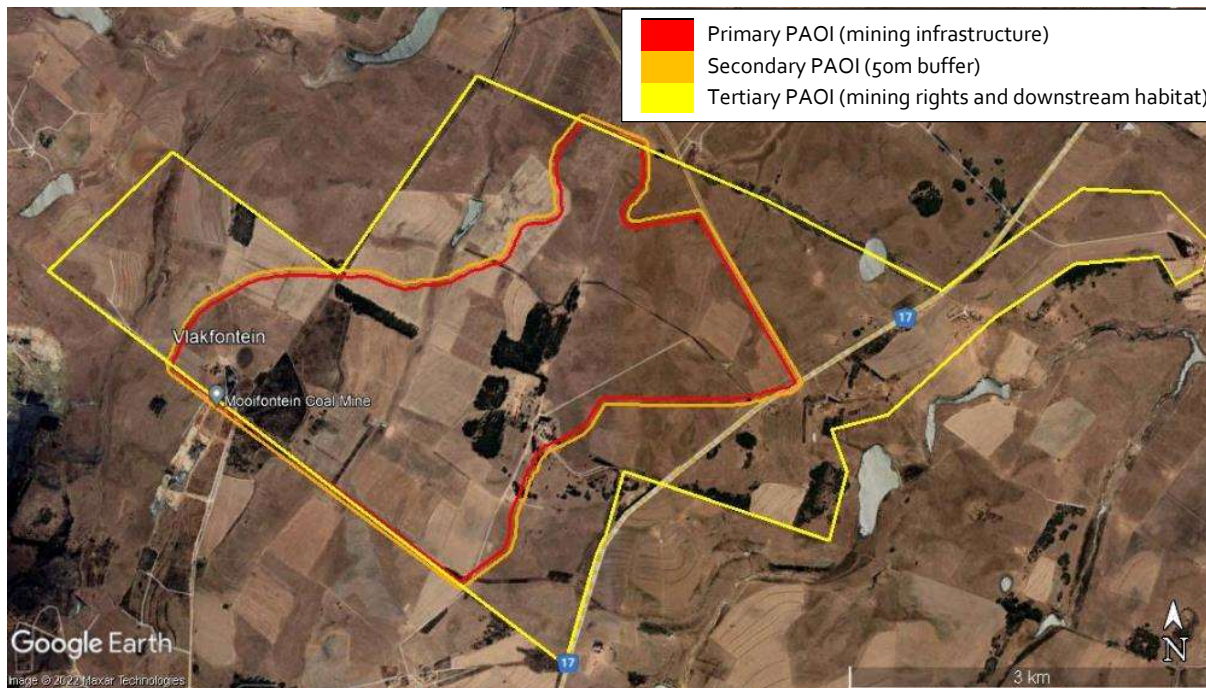
Figure 3: Project area of influence

The Project Area of Influence (PAOI) is defined as per the Species Environmental Assessment Guideline (SANBI, 2020) and was based on the development footprint and the potential extent of the impacts (e.g., edge effects) of the project activities (Figure 3).

- The mining footprint and infrastructure were regarded as the primary PAOI.
- A buffer of 50m around the mine was assessed as the secondary PAOI, where edge effects are likely to take place (e.g. an area where dust, rainwater runoff and mining activities can be expected to negatively impact on the natural vegetation). The specialist chose the 50m distance as an estimate of the extent of possible edge effects.
- The mining rights area, as well as downstream habitats were considered as the tertiary PAOI. The extent of potential impacts downstream will depend on the activity and waterflow at the time of the impact, and the area indicated in Figure 3 is only illustrative of the possible impact area.

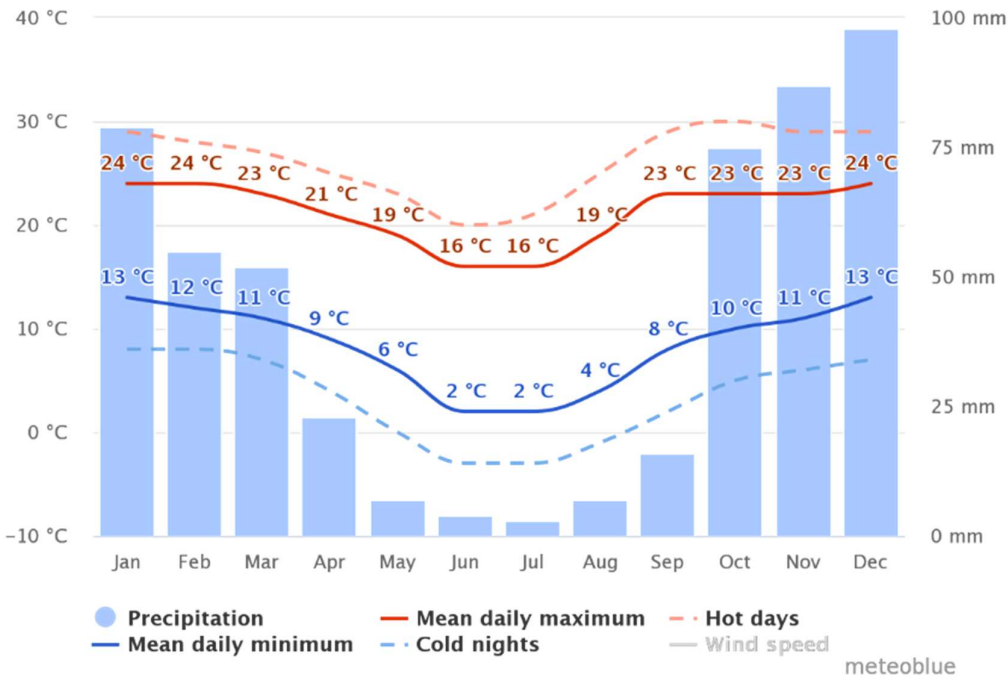
Graph 1: Average temperature and precipitation for the area (meteoblue.com)

The project falls within the summer rainfall area, with warm summers and cool, dry winters. Mean Annual precipitation (MAP) is between 650-900mm, and frost occurs in winter (Mucina and Rutherford, 2006). The graph below shows the annual average temperatures and precipitation for the Ermelo area. Most rain falls during December and January, which are also the warmest months.

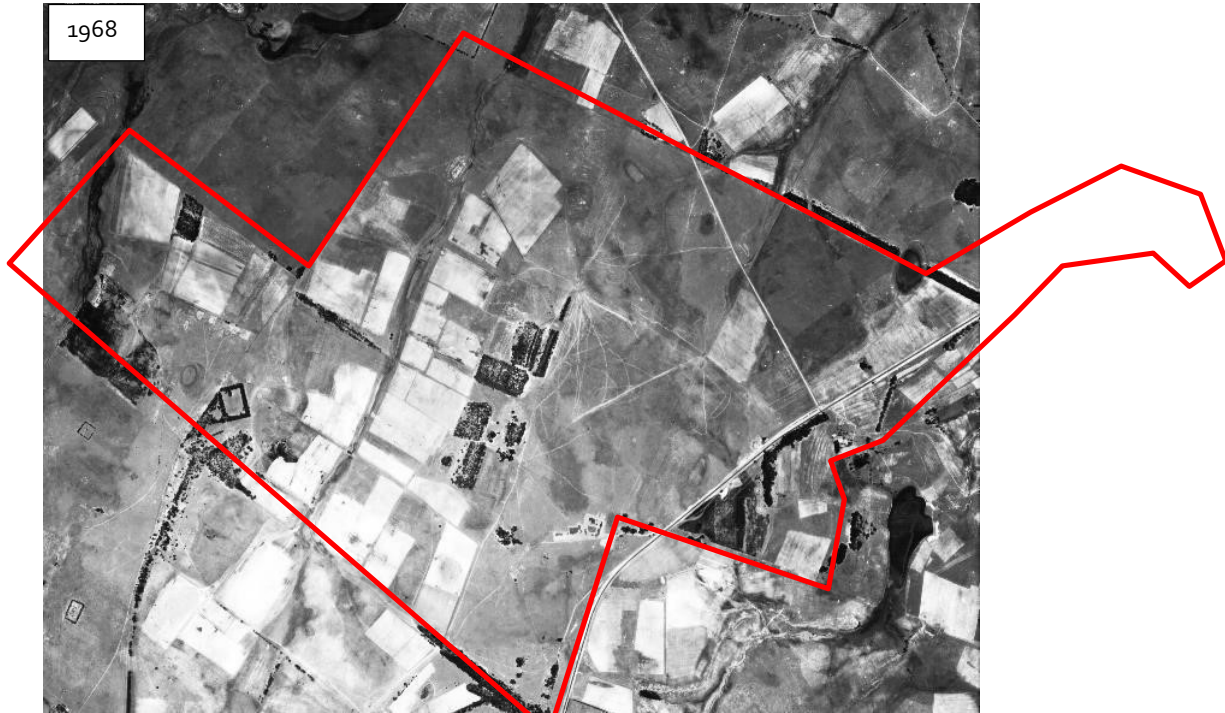
Figure 10: Aerial imagery dated 1968 (Chief Directorate National Geospatial Information Geospatial Portal)

An historical aerial image of the year 1968 indicated that the vegetation within the proposed infrastructure footprint was largely cultivated and several stands of trees, likely exotic, can be seen (Figure 10).

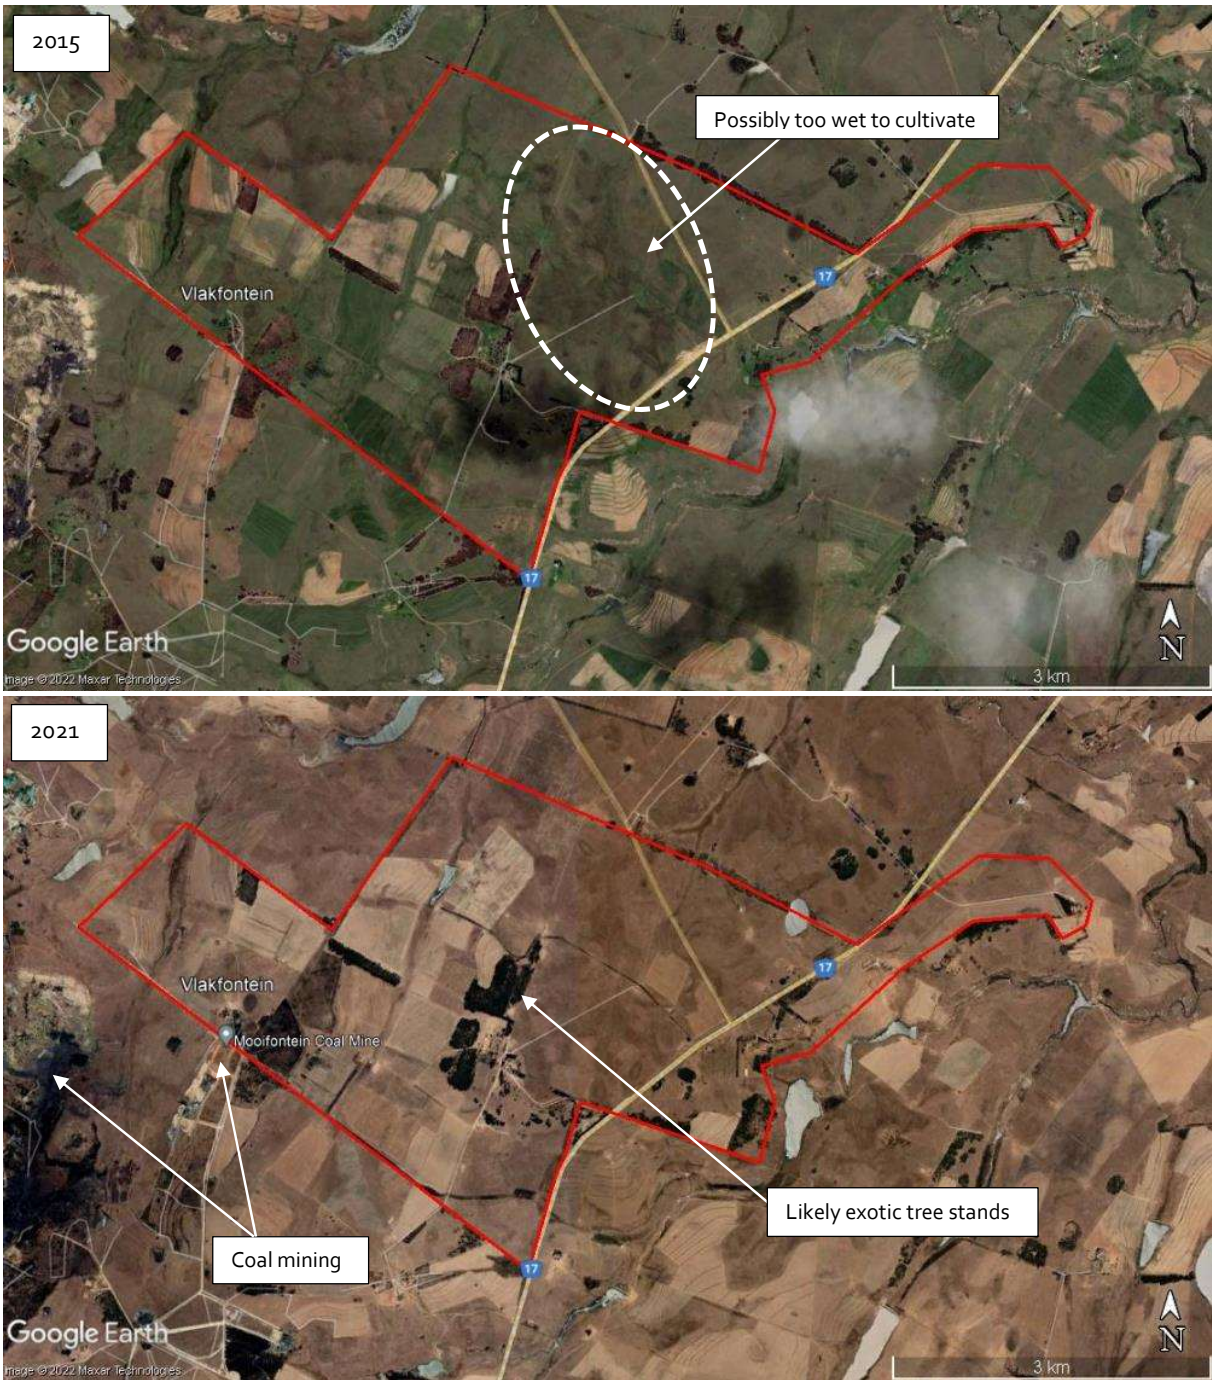
Figure 11: Google Earth satellite imagery dated 2015 (top) and 2021 (below)

Subsequent Google Earth Satellite imagery indicated the ongoing cultivation within the mining rights area (Figure 11). Some tree stands, likely the exotic *Eucalyptus*- or *Acacia* species can be seen. It seems the landowners are in the process of removing much of the exotic trees. The imagery also indicated the Mooifontein coal mine activities to the south-west of the site.

Several moist areas can be noted, and areas not cultivated over the years are likely too wet for ploughing. Remaining grasslands on the site are probably used for grazing cattle. Google Earth Satellite imagery taken from the N17 westward over the site, shows the remaining grassland on the site (Photo plate 1). The grasslands probably range from secondary to primary grasslands. The grassland and moist grasslands on the site are suitable habitat to several plant species of conservation concern.
