GIJIMA – ARBOR RAILWAY SIDING – BASIC ASSESSMENT REPORT

*ARBOR RAILWAY SIDING BASIC ASSESSMENT REPORT FOR PROPOSED OPERATIONS
OF A RAIL SIDING TO STORE, HANDLE AND RAIL COAL, MPUMALANGA PROVINCE.*

Document Name: GAB – R – Updated BAR

Volume 3 of 3 – Specialist Reports

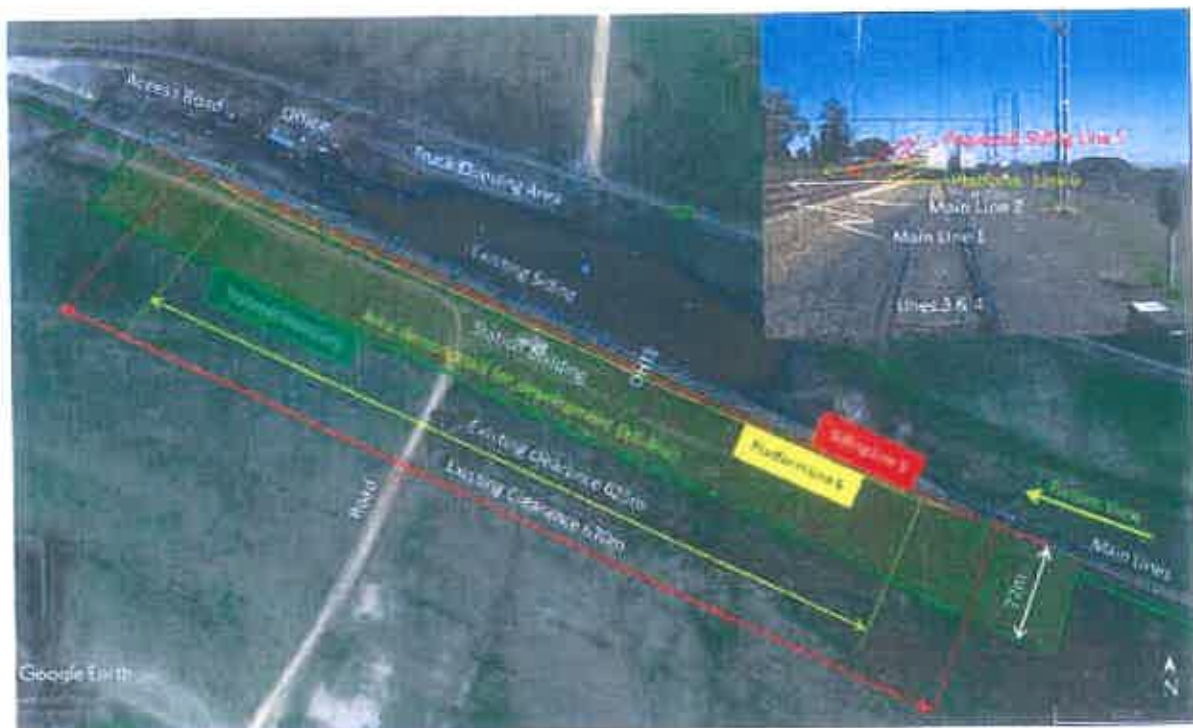
Figure 1: Proposed site for the future expansion of the existing facility

It is the intention to utilize the two lines next to the existing platform (indicated as red and yellow lines on the drawings) as the future loading lines. All the other infrastructure required to comply with the various regulations will eventually be placed within the existing Transnet boundary as shown in yellow shading on Figure 1.

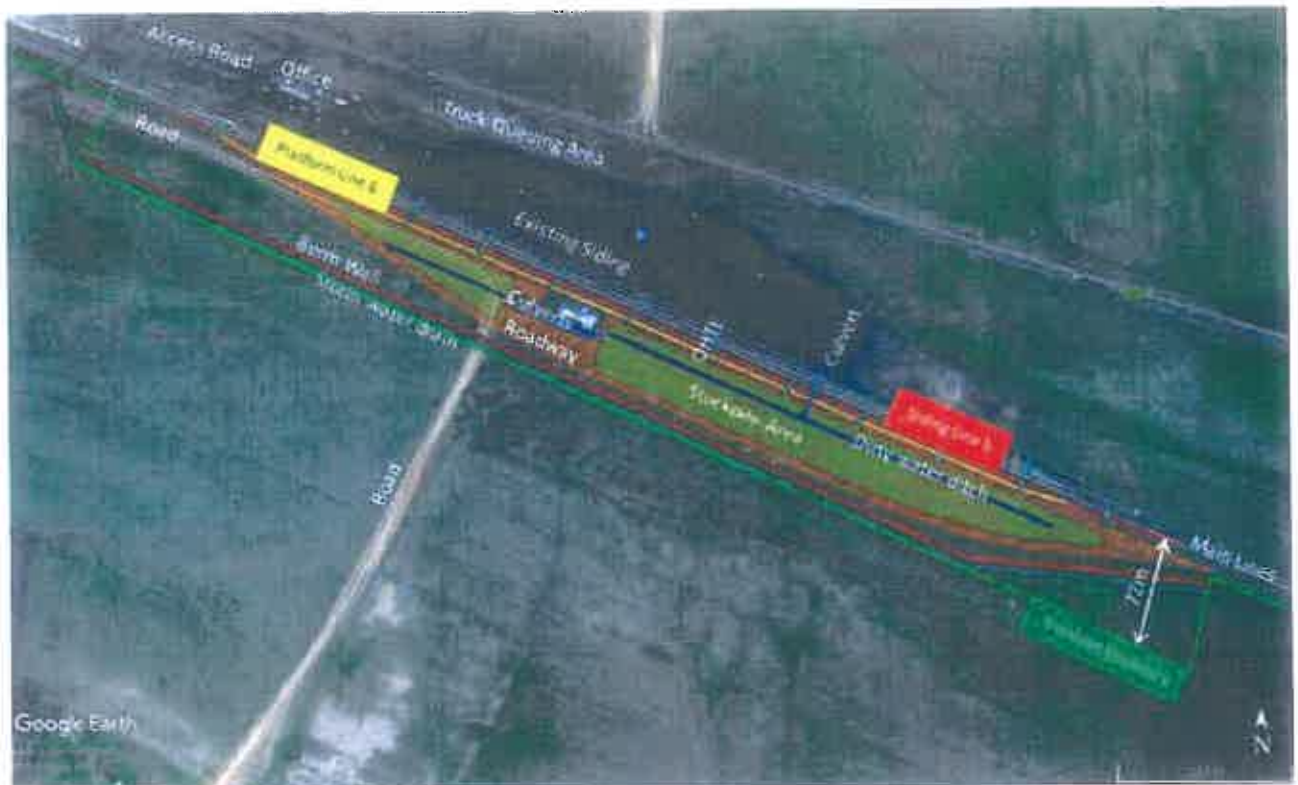
Figure 3: Layout for Phase 1

A storm water drain and berm wall will also be installed on the TFR boundary line to divert the runoff storm water away from the siding in order to separate the clean and dirty water systems.

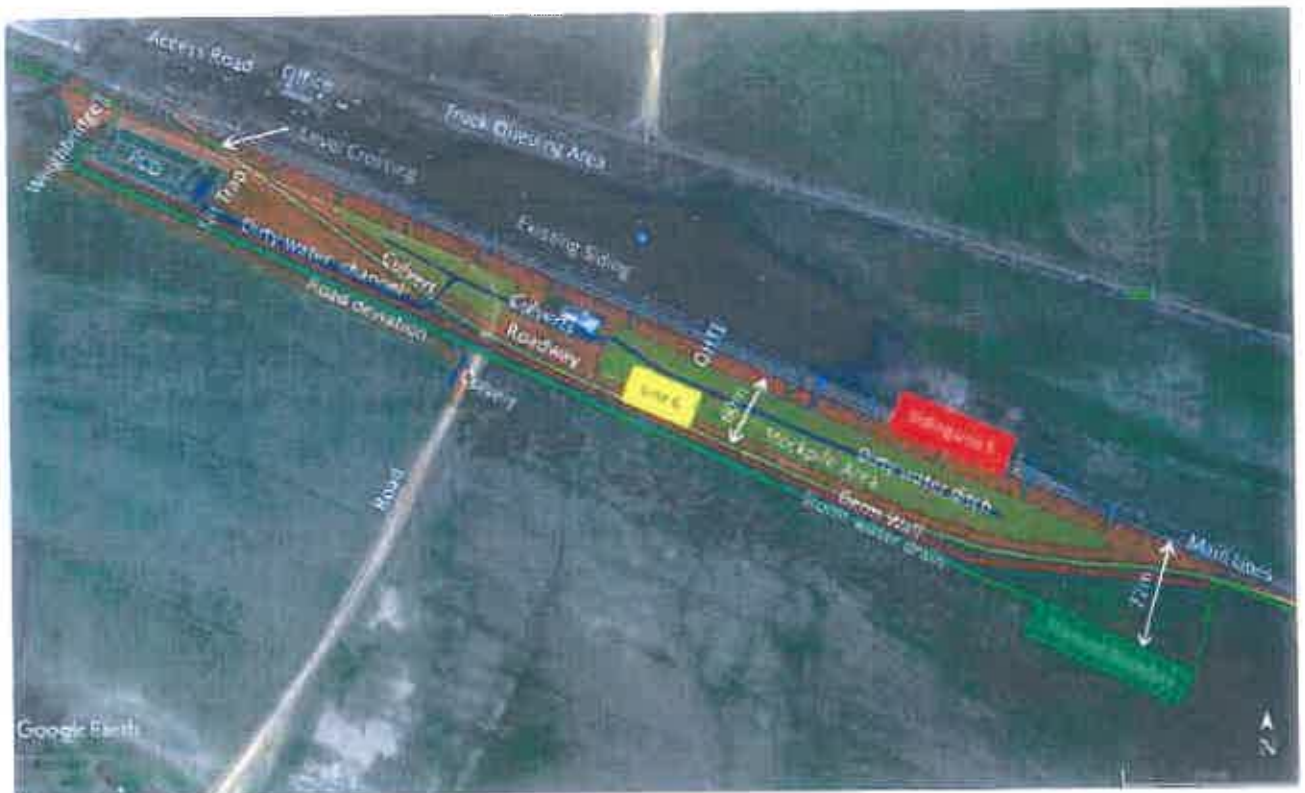
Figure 5: Layout for Phase 2

- Redirecting the contaminated water flow
- Adding a silt trap
- Adding a Pollution Control Dam (PCD)

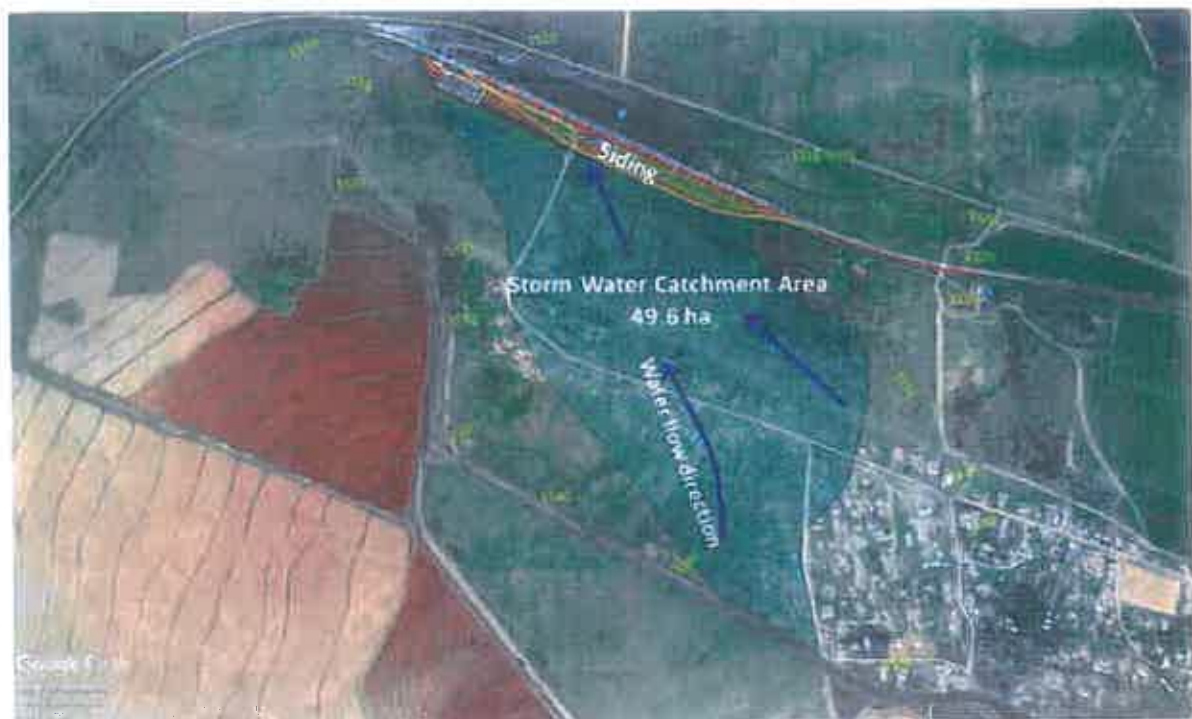
Figure 14: Storm water catchment area

The size of the catchment area according to Google Earth is about 49.6ha – see the blue shaded area on Figure 14.

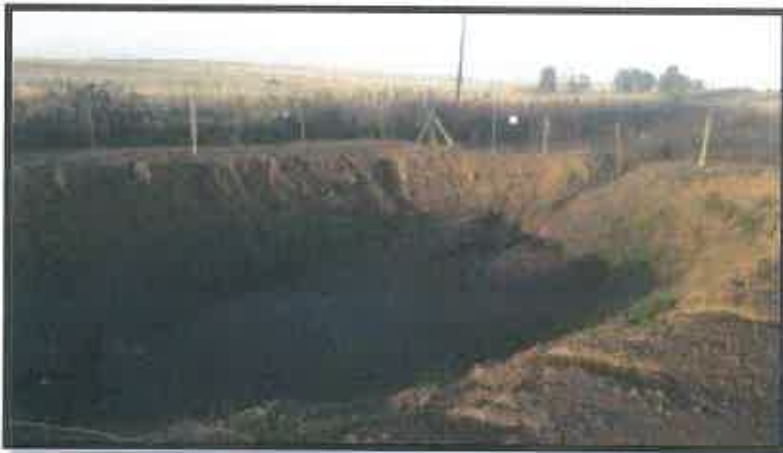
Figure 10: Slurry Control dam within Arbor siding (Image ©MYEZO).

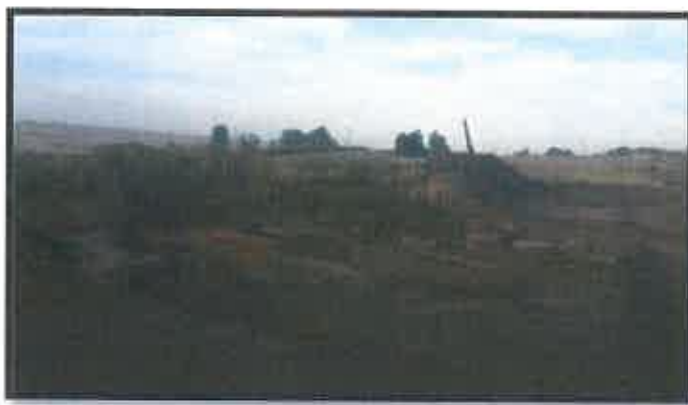
Figure 11: Transformed wetland observed within Arbor siding boundary. This wetland is completely destroyed and its delineation was determined using the soil morphology and can only happen to persist during heavy rainfalls episodes.

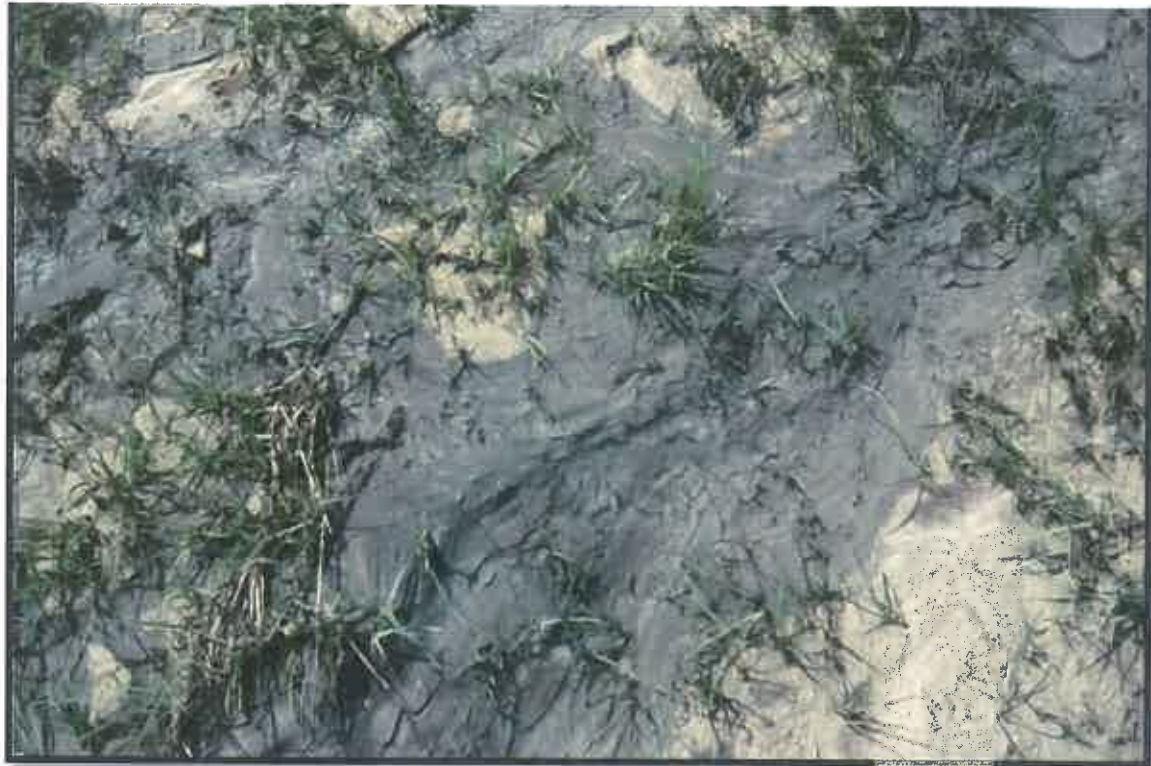
Figure 15: Coal dust residue observed in stormwater drained on the area towards NFEPA recognised ecosystem in the area.

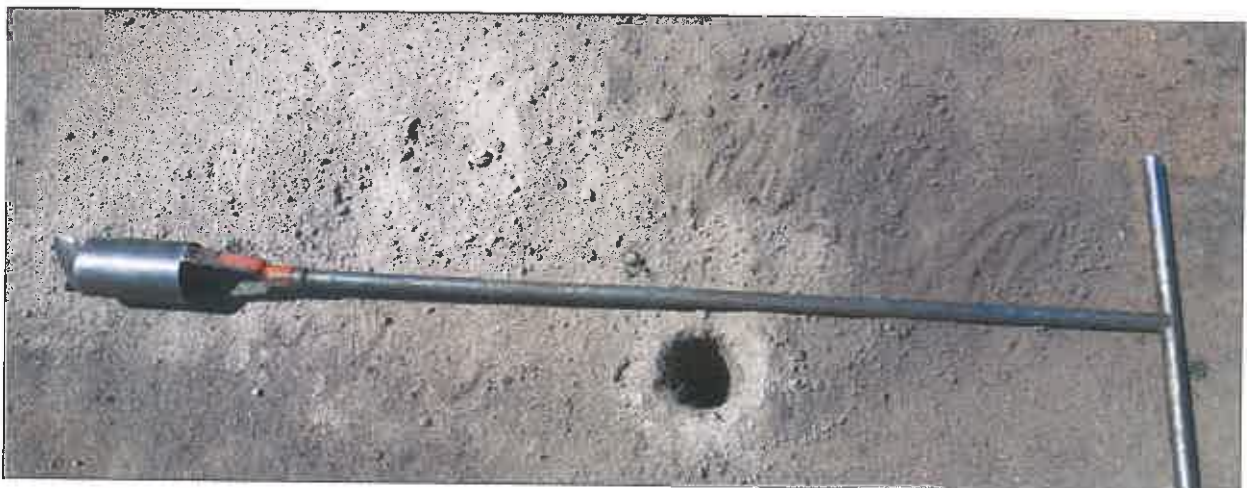
Figure 4: Thick albic / E horison of the Wasbank soil form associated with the hillslope seepage wetland within the study area

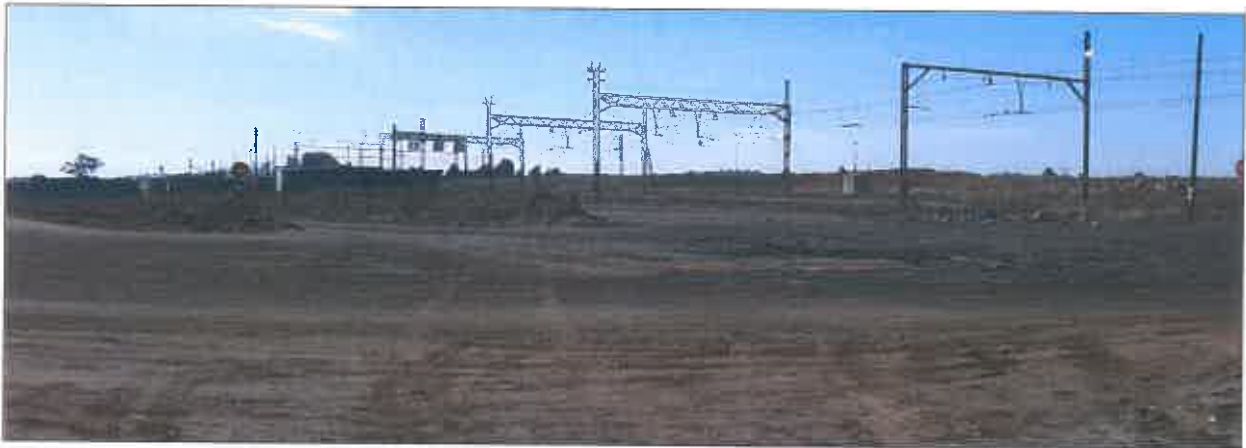
Figure 5: Siding with various anthrosols such as Grabouw 1000 and Witbank 1100

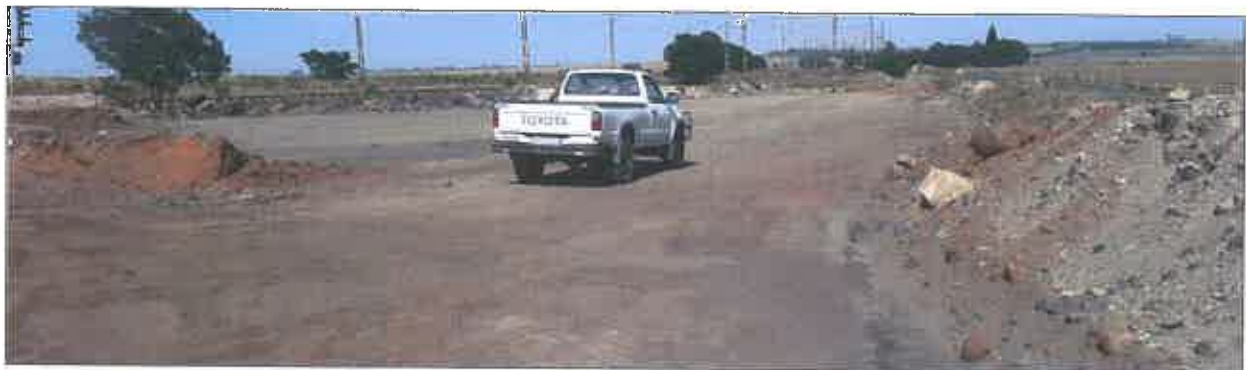
Figure 6: Section of siding towards the east siding with anthrosols Witbank 1100, Witbank 1200 and Witbank 1300

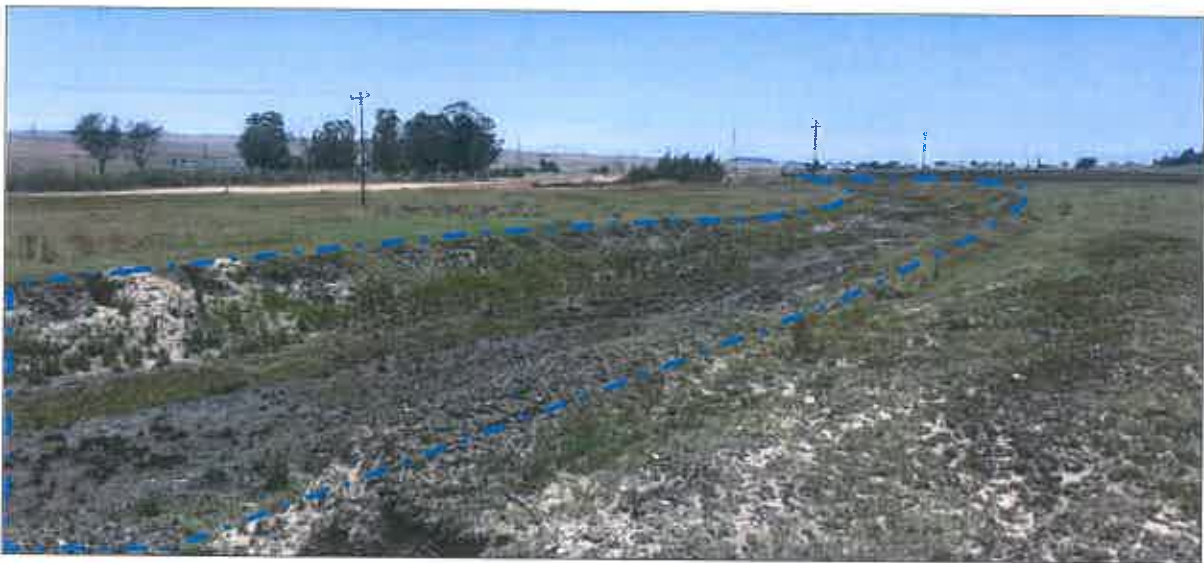
Figure 16: Old railway siding on the eastern periphery that is not in use anymore acts as an effective, large drainage canal. Note that the whole of the old siding is located within the seepage wetland
