**GIJIMA – ARBOR RAILWAY SIDING – BASIC ASSESSMENT REPORT**

**ARBOR RAILWAY SIDING BASIC ASSESSMENT REPORT FOR PROPOSED OPERATIONS  
OF A RAIL SIDING TO STORE, HANDLE AND RAIL COAL, MPUMALANGA PROVINCE**

**Document Name: GAB – R – Updated BAR**

**Volume 3 of 3 – Specialist Reports**

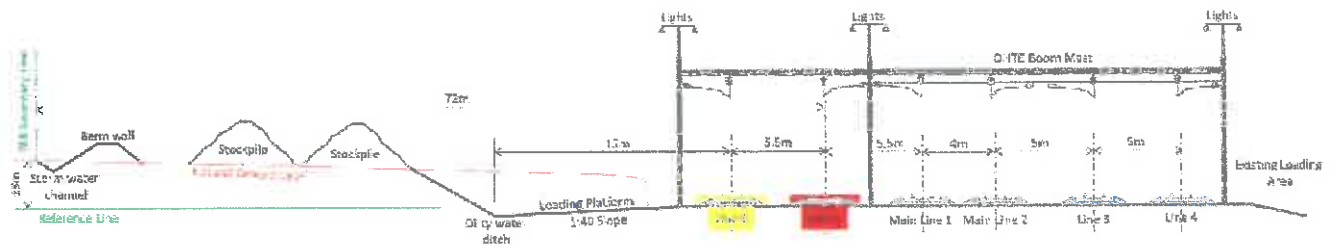
Cross-section of the siding for phase 1

Figure 4: Cross section for phase 1

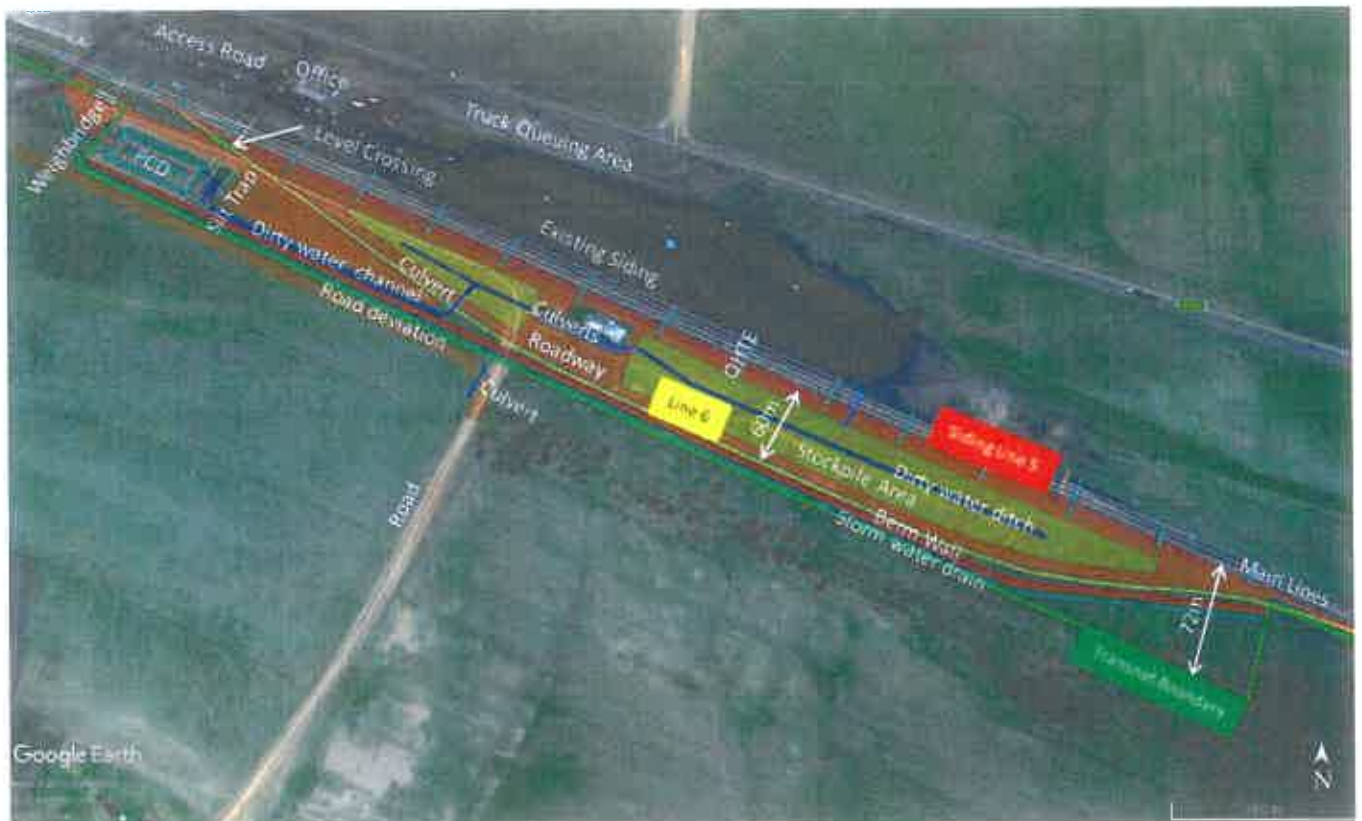
Figure 5: Layout for Phase 2

- Redirecting the contaminated water flow
- Adding a silt trap
- Adding a Pollution Control Dam (PCD)

According to the “Class C” specification for landfills subsurface drains have to be installed below the floor of the PCD for monitoring purposes. Due to the relatively small size of the PCD a single ring drain at the floor edges will suffice. Although the final ground levels for phase 2 are yet unknown it will be assumed that the outlet of the ring drain will daylight inside the storm water channel. These drains are indicated on Figure 5 by the red lines.

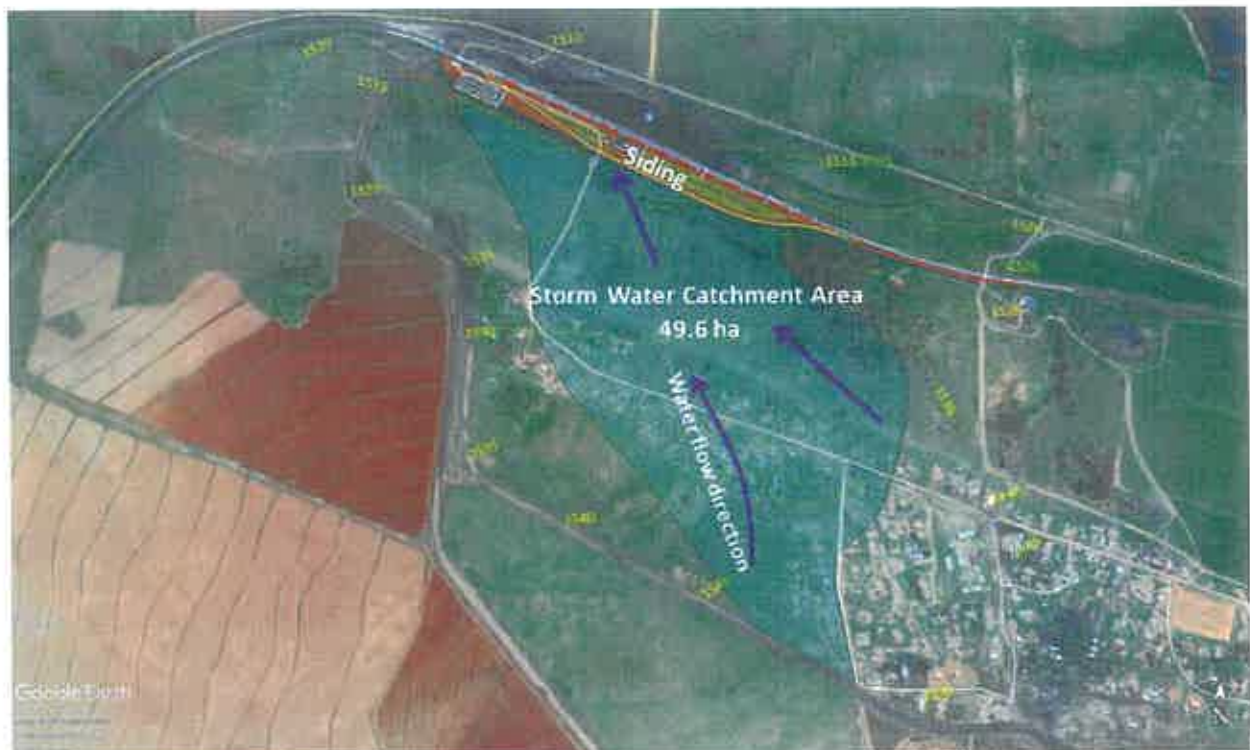
The size of the catchment area according to Google Earth is about 49.6ha – see the blue shaded area on Figure 14.

**Figure 14: Storm water catchment area**

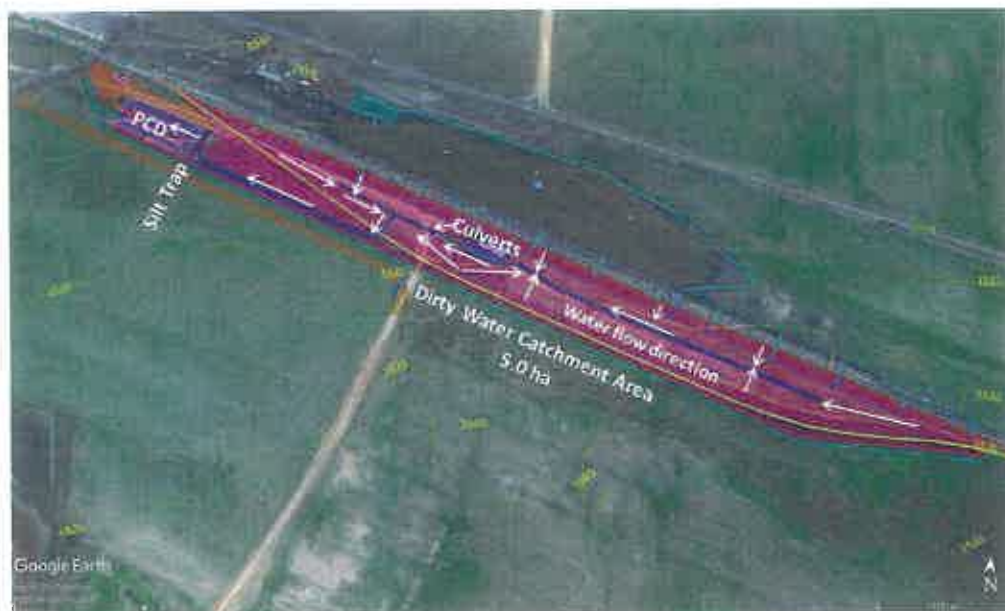
The size of the polluted area will be about 5.0ha – see purple shaded area on Figure 16.

Figure 16: Polluted area for phase 2

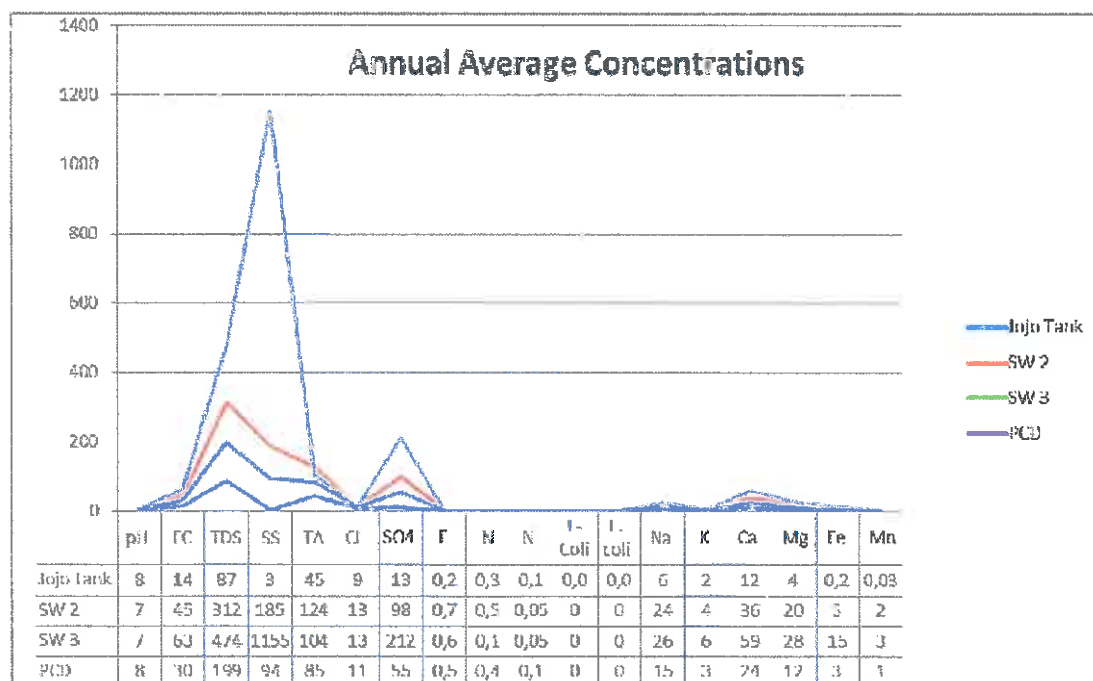
- The annual average concentration for the Jojo Tank indicates good water quality; no excessive contaminations analysed throughout the year and water quality strictly fall within the standards set for domestic usages.
- The concentration for all surface monitoring points is slightly acidic, neutral and slightly alkaline, ranging from 6 to 8. The South African Water Quality Guideline for Domestic Use shows the targeted water quality range is between 6.0 - 9.0 and 6.5 - 8.4 for Irrigational Use.
- Any form of deterioration analysed in monitoring points SW 2 and SW 3 is not associated with the ongoing activities at Arbor Siding, due to their location.

The Figure below (Figure 4-2) illustrates the comparison of all the average concentration for all the sampled surface water monitoring points.

**Figure 4-2: Annual Average Concentrations for all Surface Water Monitoring Points**

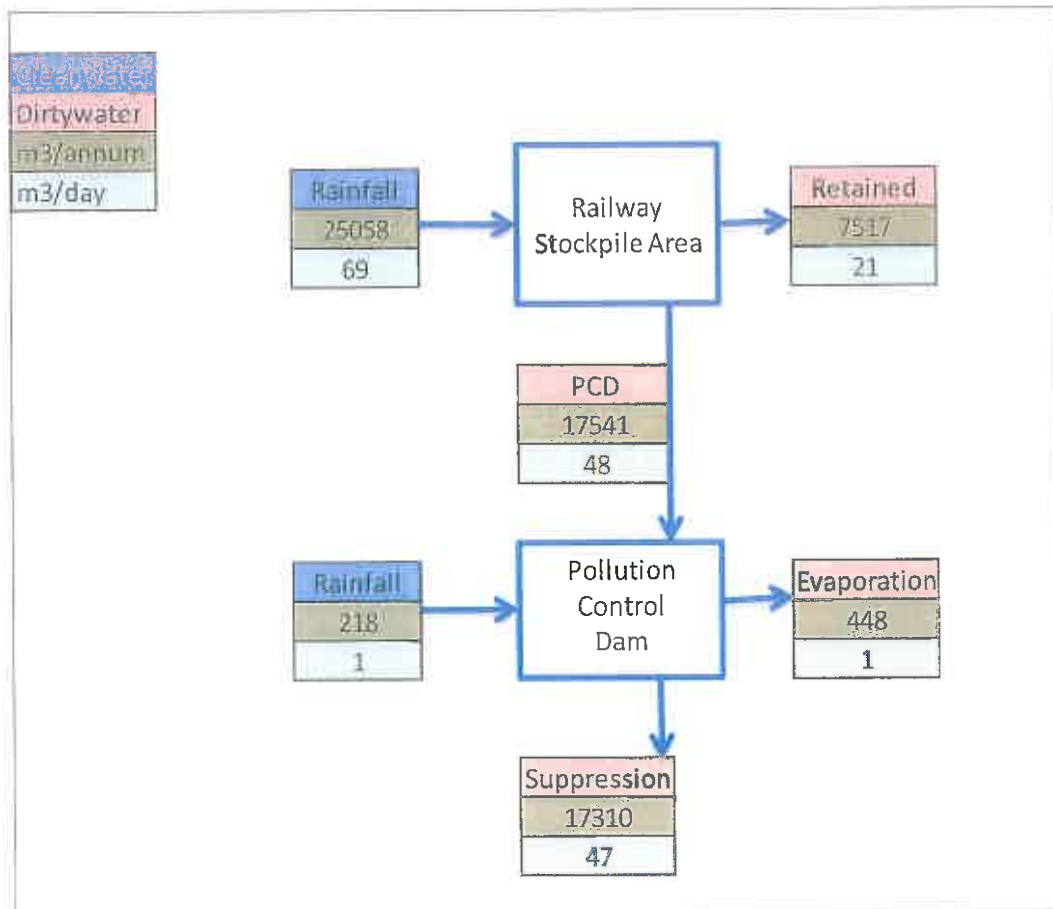
Figure 5-1: Arbor Siding Water Balance Sketch

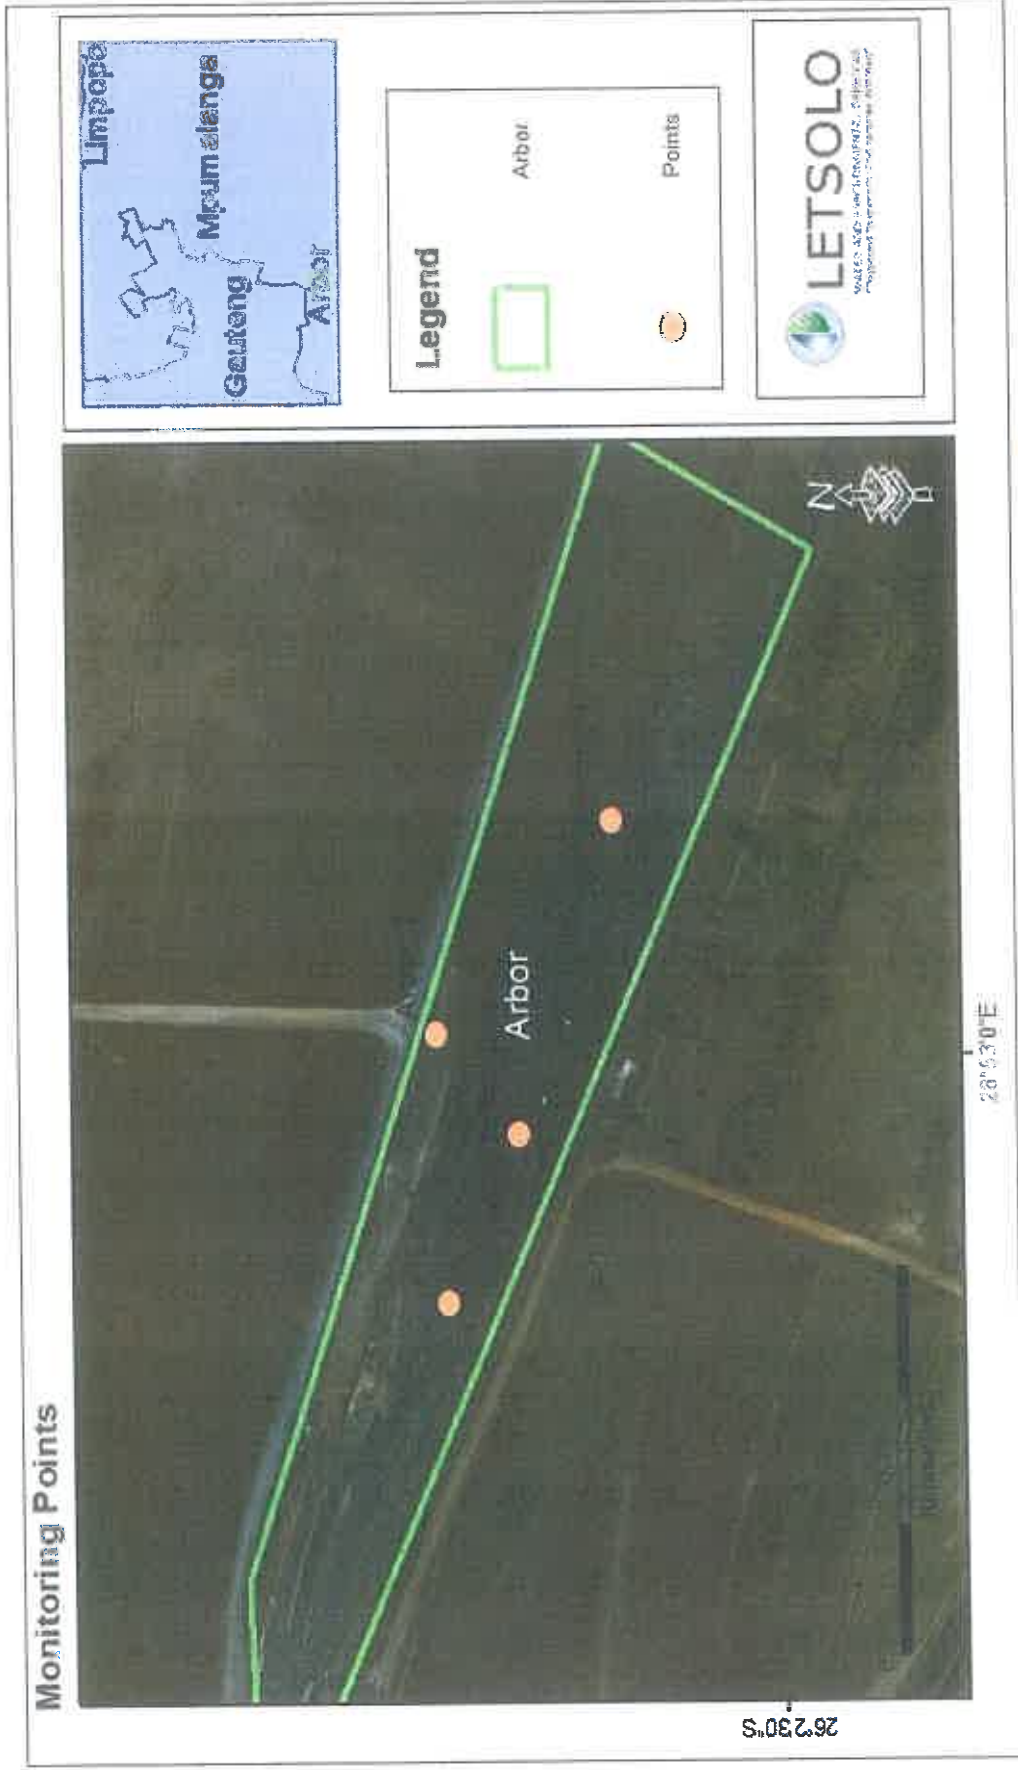
Figure 4-1: Soil Sample Points At Map of Arbor Coating Siding

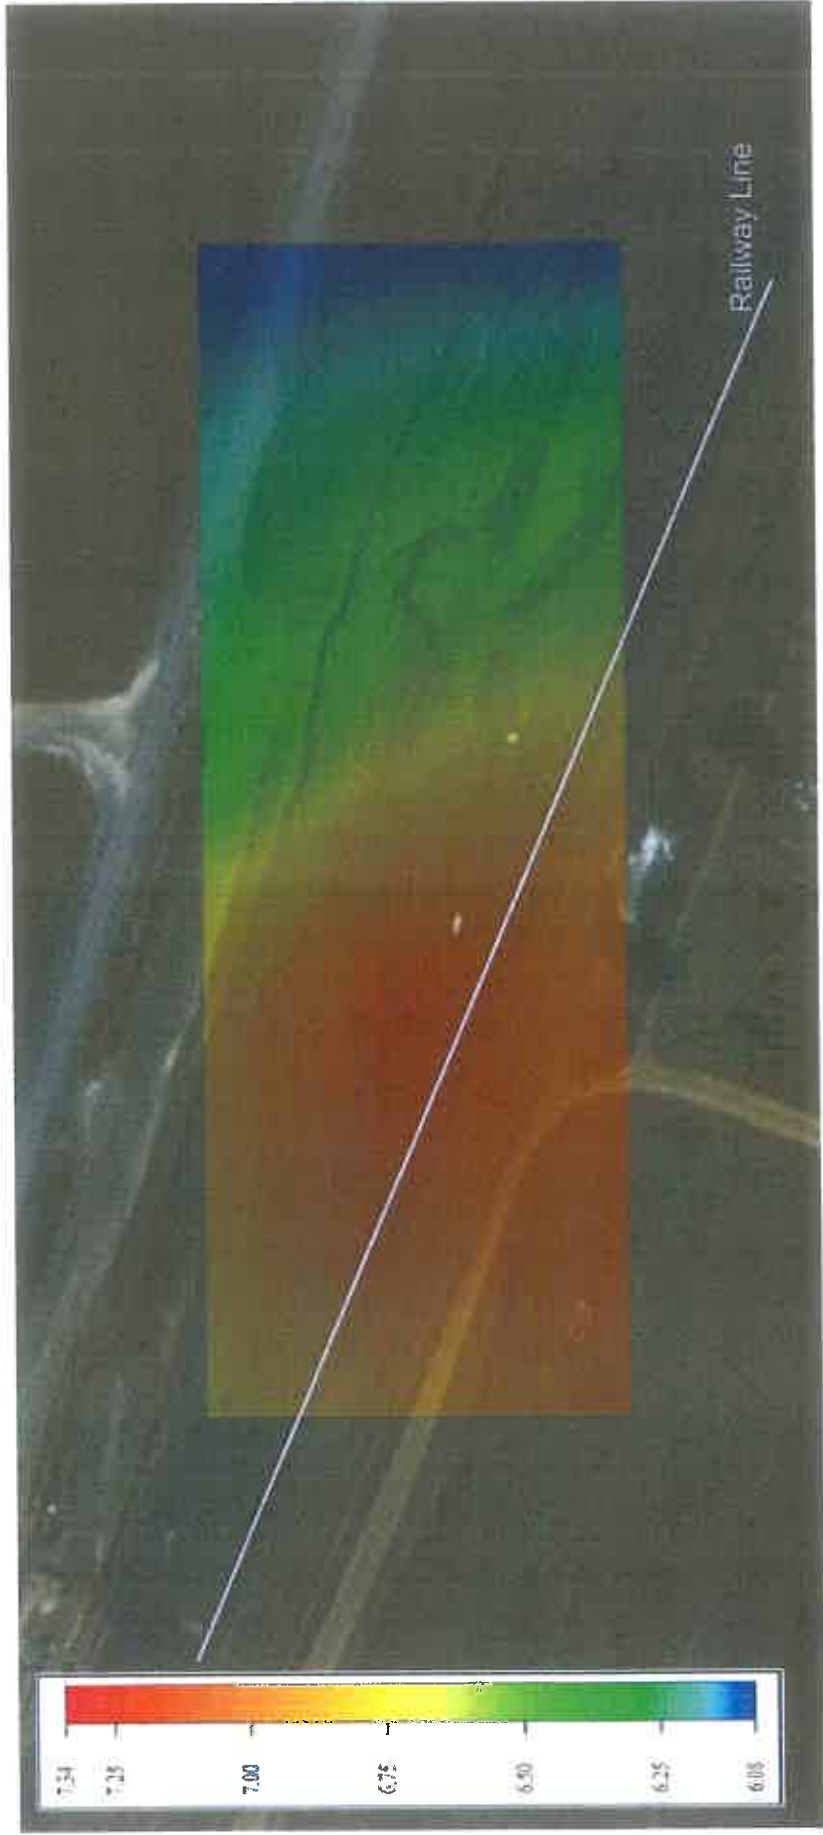
APPENDIX A : SOIL PH MAP)

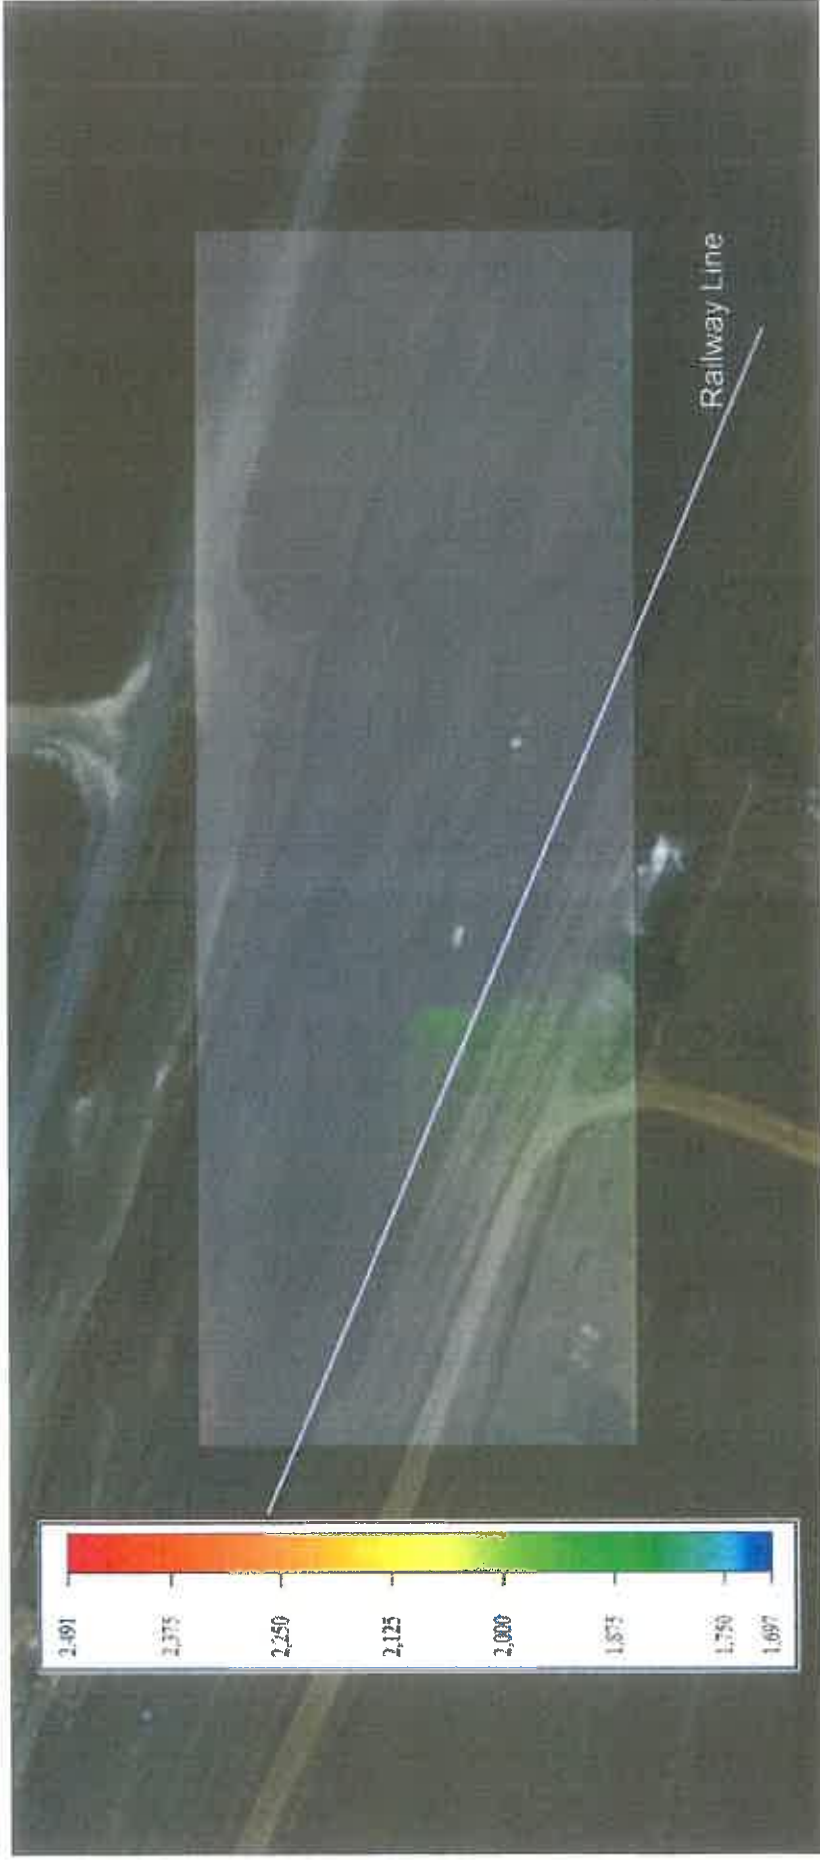
APPENDIX B : ELECTRICAL CONDUCTIVITY MAP

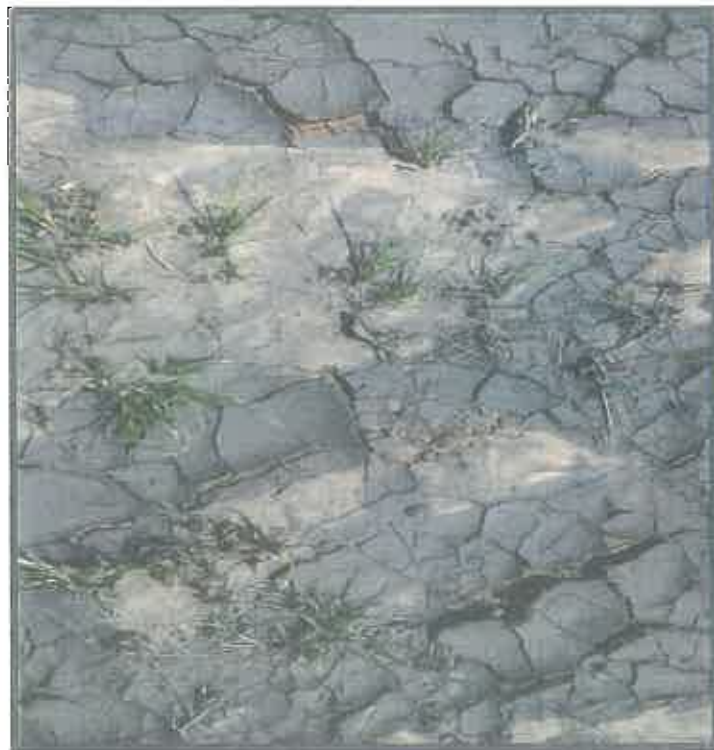
Figure 16: Dried coal dust residue stormwater.
