*GIJIMA - ARBOR SOUTHERN SIDE RAIL SIDING - BASIC ASSESSMENT REPORT*

*GIJIMA SOUTHERN SIDE SIDING SPECIALIST REPORTS THE BASIC ASSESSMENT REPORT  
FOR PROPOSED OPERATIONS OF A RAIL SIDING TO STORE, HANDLE AND RAIL COAL ON  
THE SOUTHERN SIDE*

*Document Name: GAE-R-Specialist Reports*

*Volume 3 of 3 - Specialist Reports*

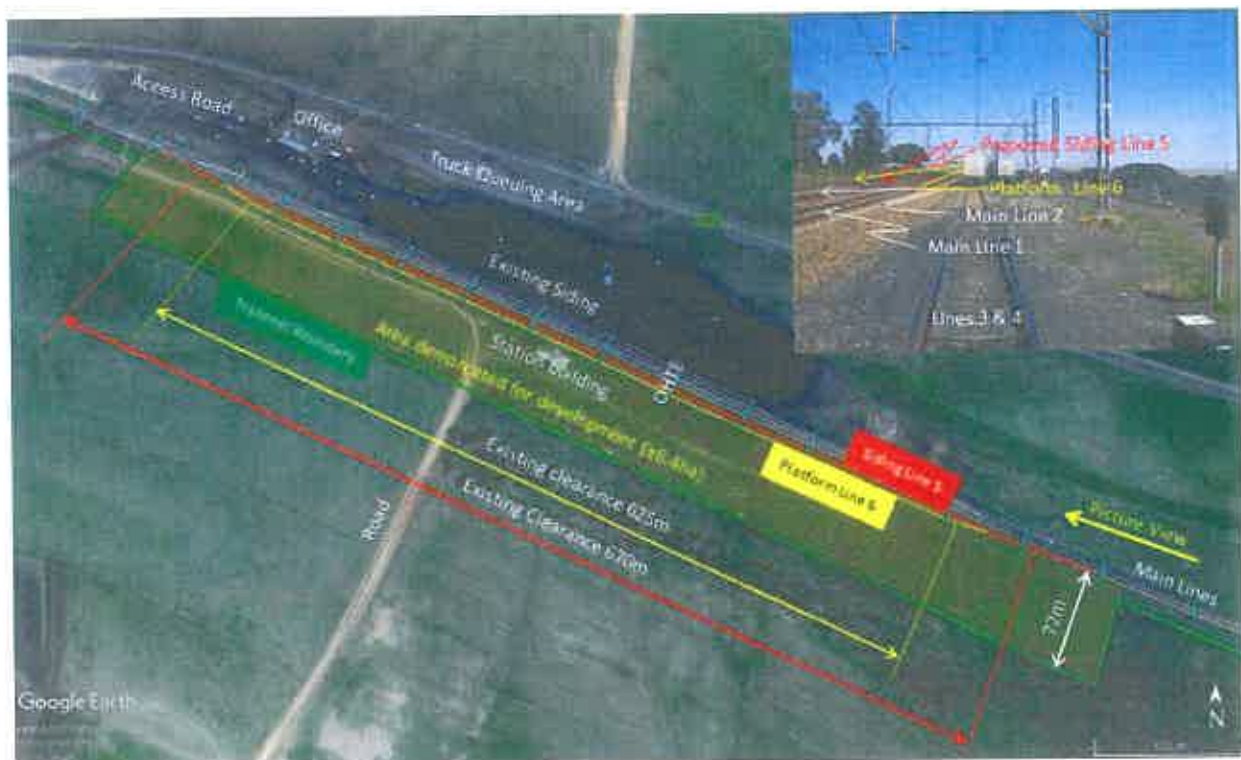
It is the intention to utilize the two lines next to the existing platform (indicated as red and yellow lines on the drawings) as the future loading lines. All the other infrastructure required to comply with the various regulations will eventually be placed within the existing Transnet boundary as shown in yellow shading on Figure 1.

**Figure 1: Proposed site for the future expansion of the existing facility**

The area in question is situated to the south of Arbor station as indicated on Figure 1 and is approximately 6.4ha in size.

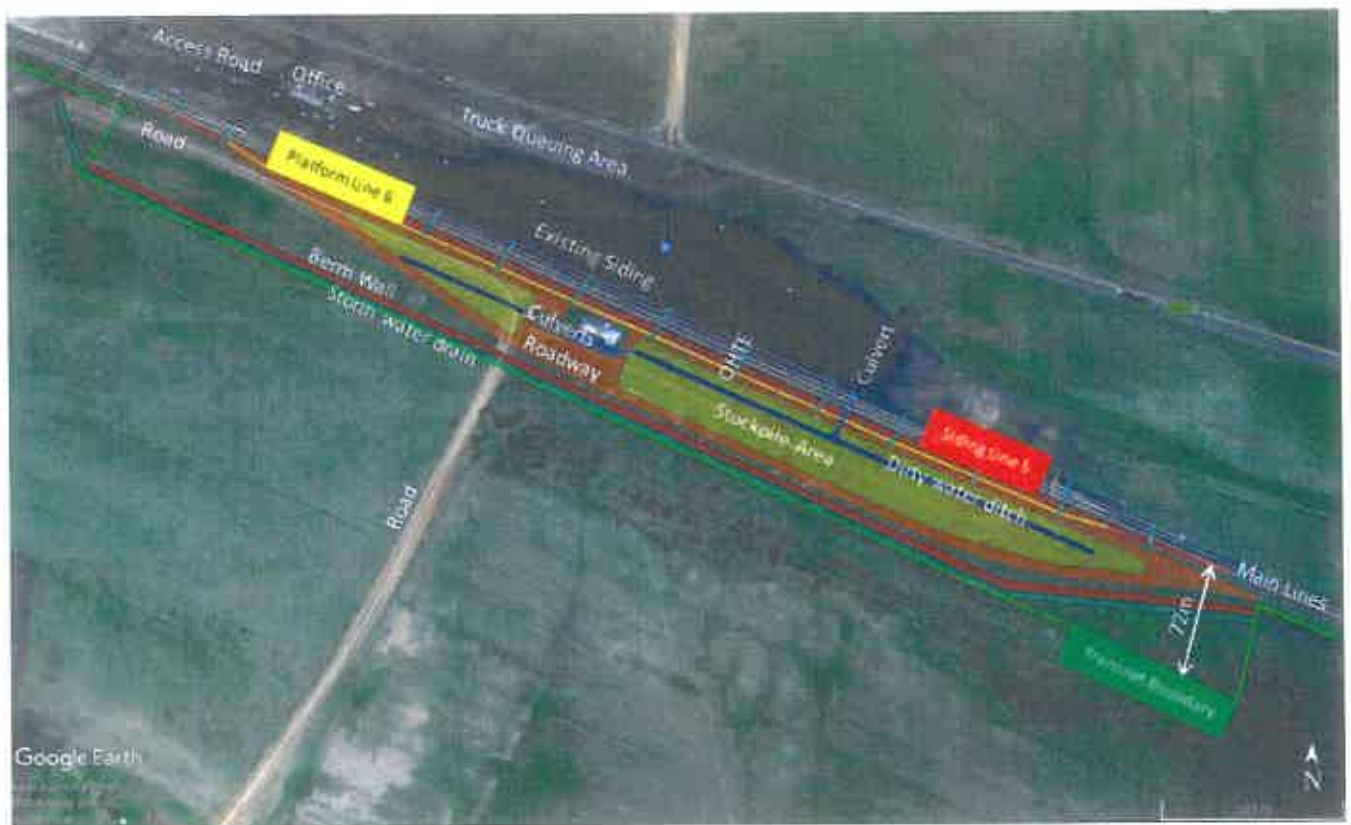
A storm water drain and berm wall will also be installed on the TFR boundary line to divert the runoff storm water away from the siding in order to separate the clean and dirty water systems.

Figure 3: Layout for Phase 1

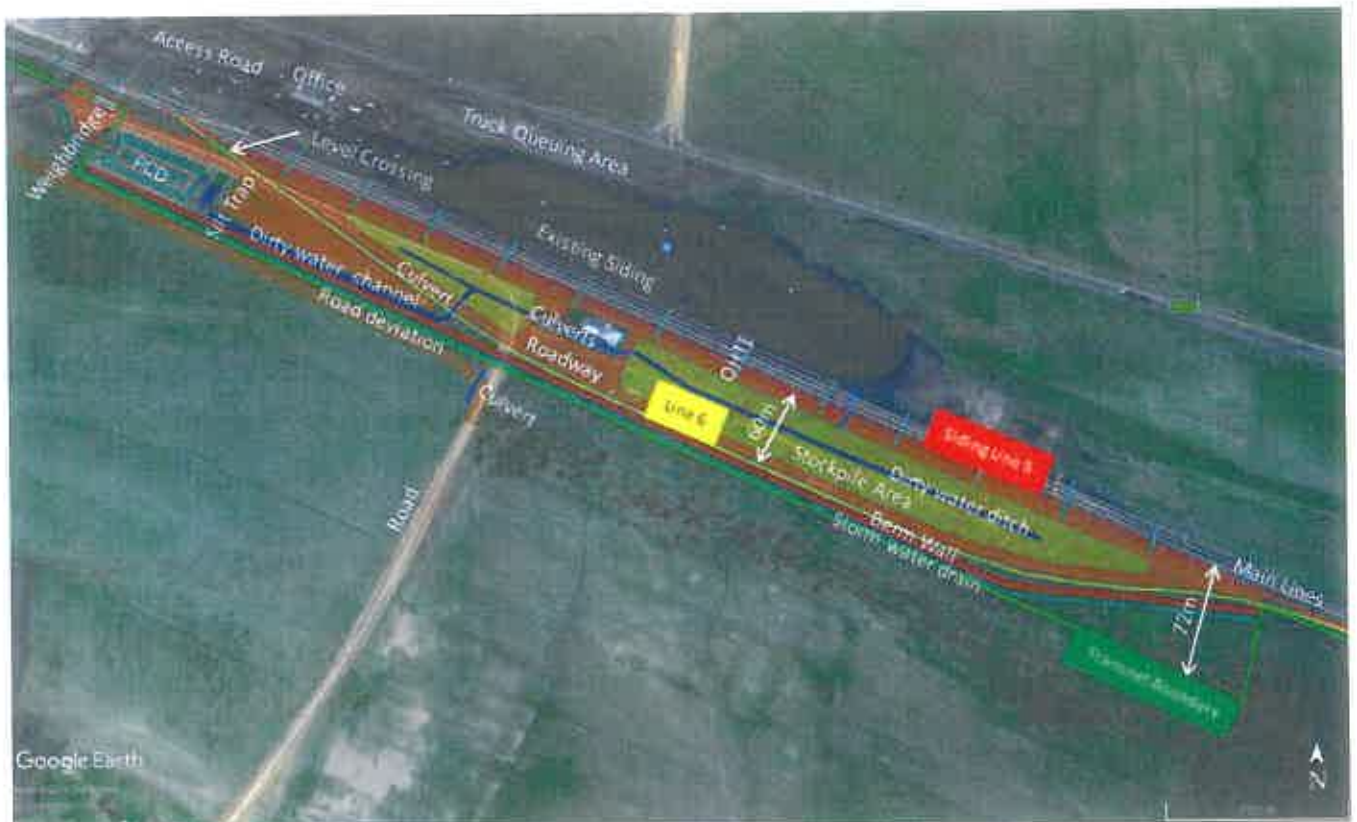
- Redirecting the contaminated water flow
- Adding a silt trap
- Adding a Pollution Control Dam (PCD)

Figure 5: Layout for Phase 2

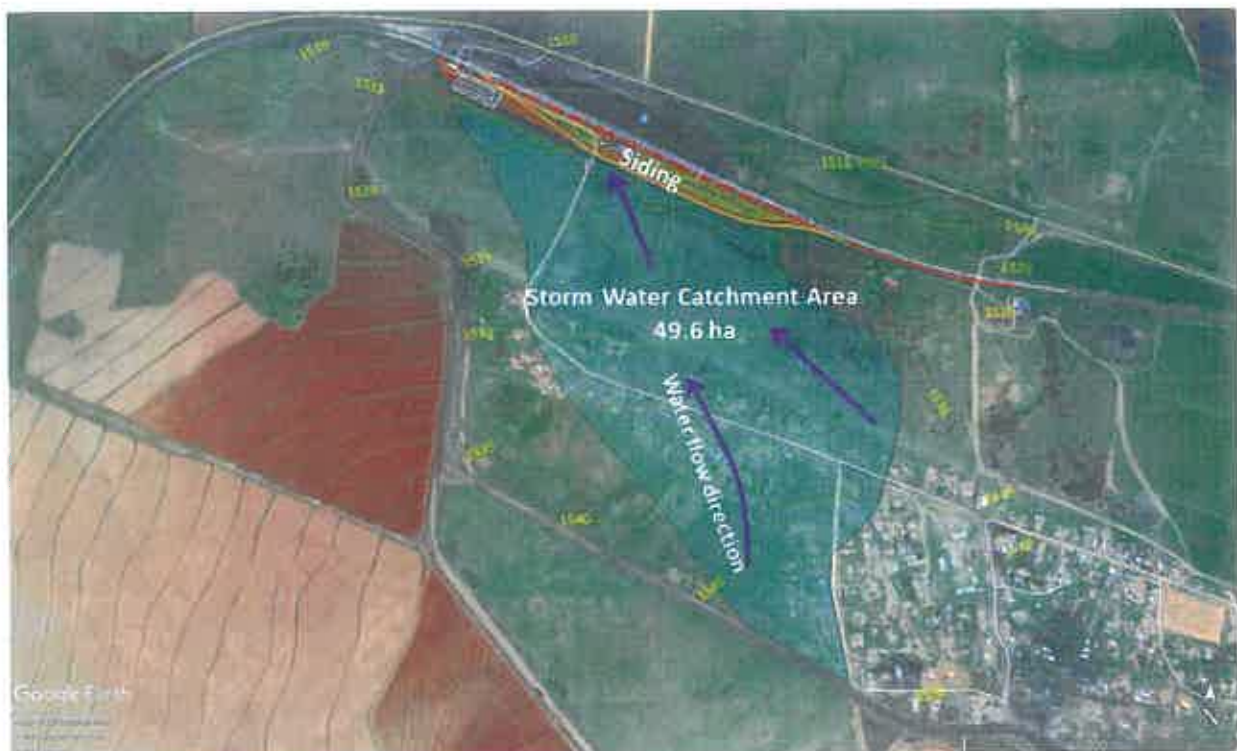
The size of the catchment area according to Google Earth is about 49.6ha – see the blue shaded area on Figure 14.

**Figure 14:** Storm water catchment area

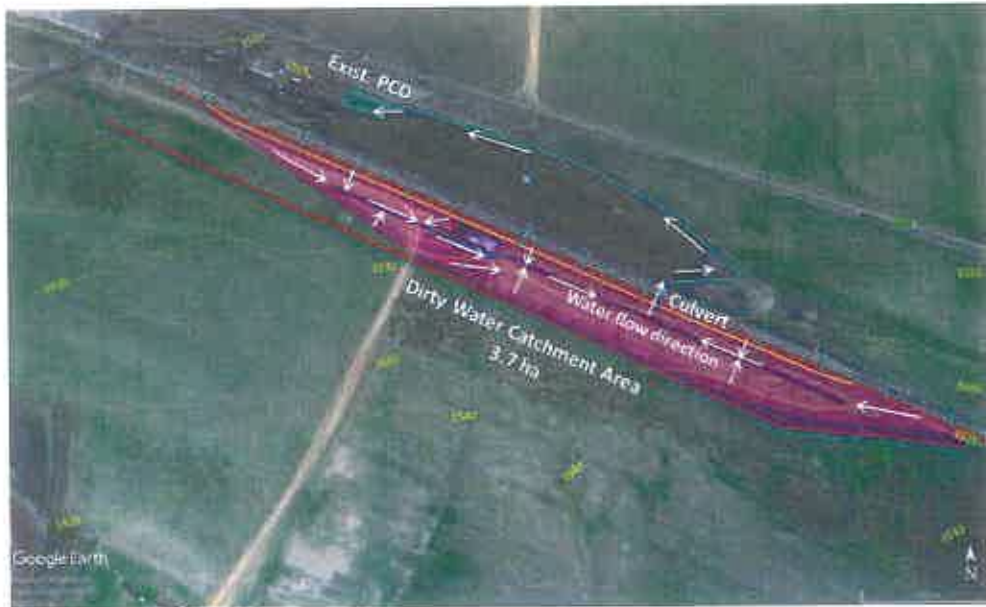
The size of the polluted area will be about 3.8ha – see purple shaded area on Figure 15.

Figure 15: Polluted area for phase 1

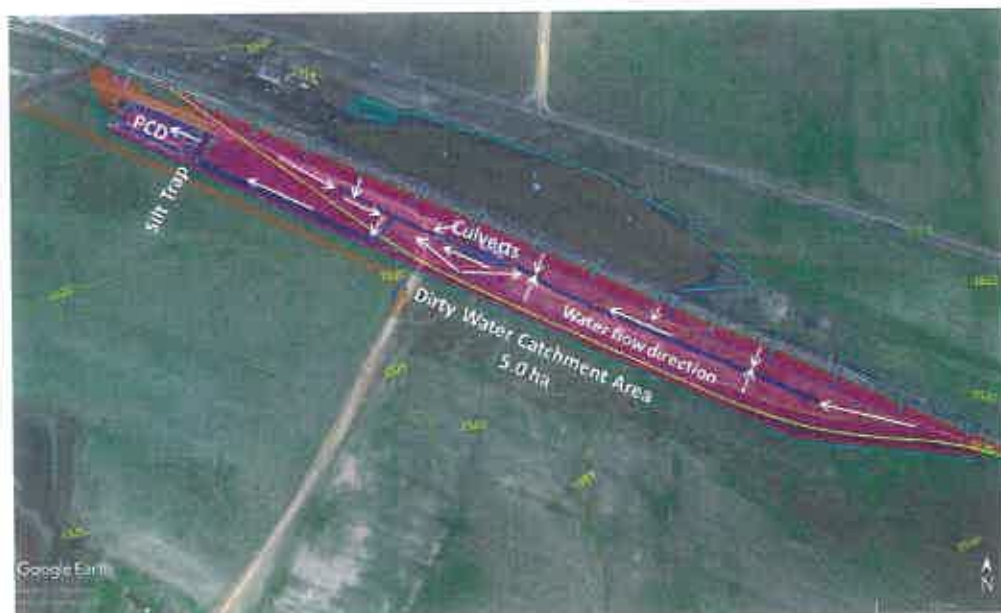
The size of the polluted area will be about 5.0ha – see purple shaded area on Figure 16.

Figure 16: Polluted area for phase 2

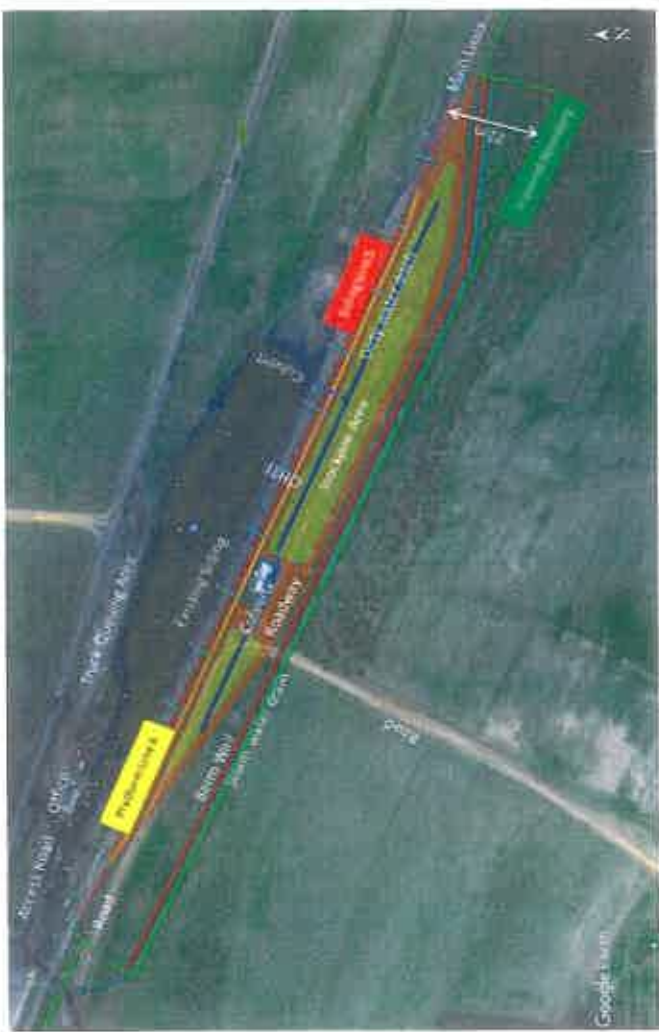
**Cross-section of the siding for phase 1**

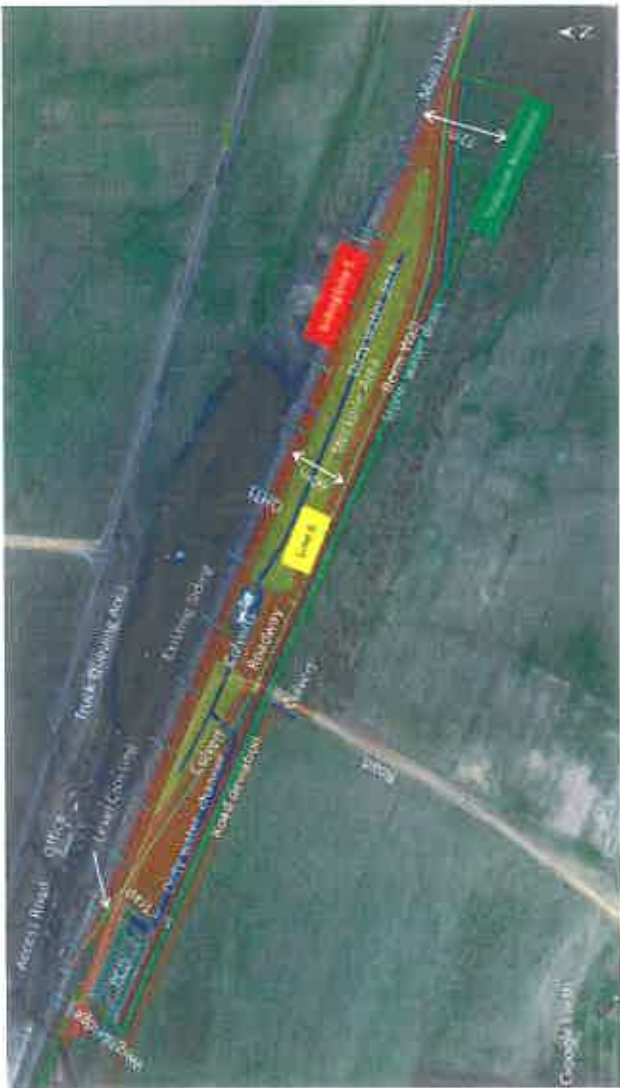
**Cross-section of the siding for phase 2**

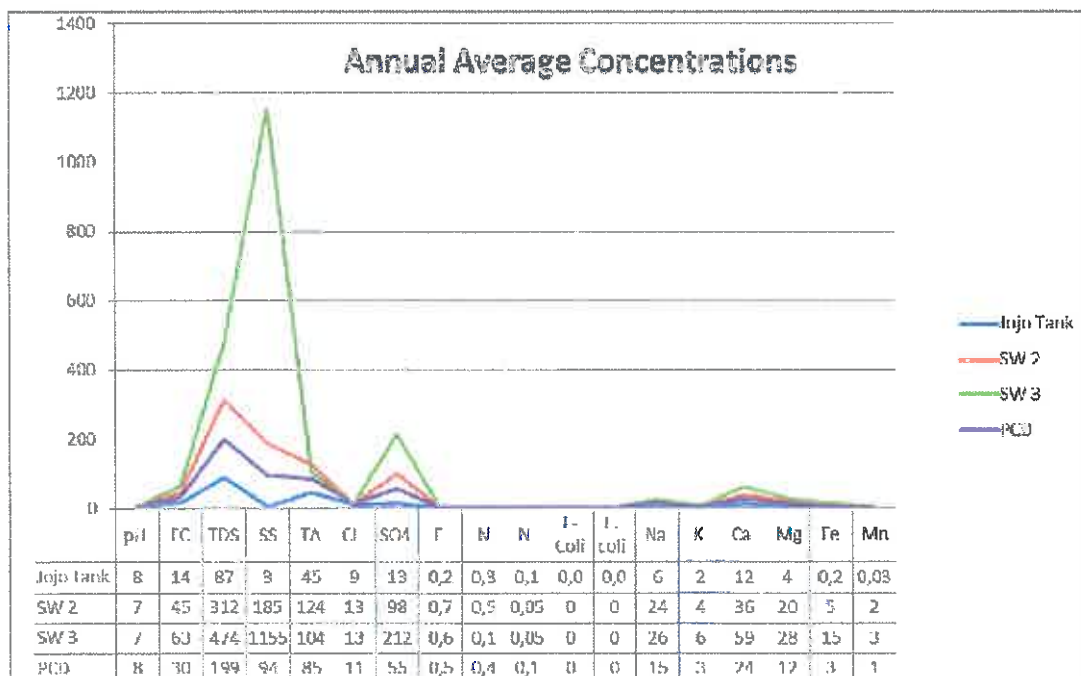
- The annual average concentration for the Jojo Tank indicates good water quality; no excessive contaminations analysed throughout the year and water quality strictly fall within the standards set for domestic usages.
- The concentration for all surface monitoring points is slightly acidic, neutral and slightly alkaline, ranging from 6 to 8. The South African Water Quality Guideline for Domestic Use shows the targeted water quality range is between 6.0 - 9.0 and 6.5 - 8.4 for Irrigational Use.
- Any form of deterioration analysed in monitoring points SW 2 and SW 3 is not associated with the ongoing activities at Arbor Siding, due to their location.

The Figure below (Figure 4-2) illustrates the comparison of all the average concentration for all the sampled surface water monitoring points.

Figure 4-2: Annual Average Concentrations for all Surface Water Monitoring Points

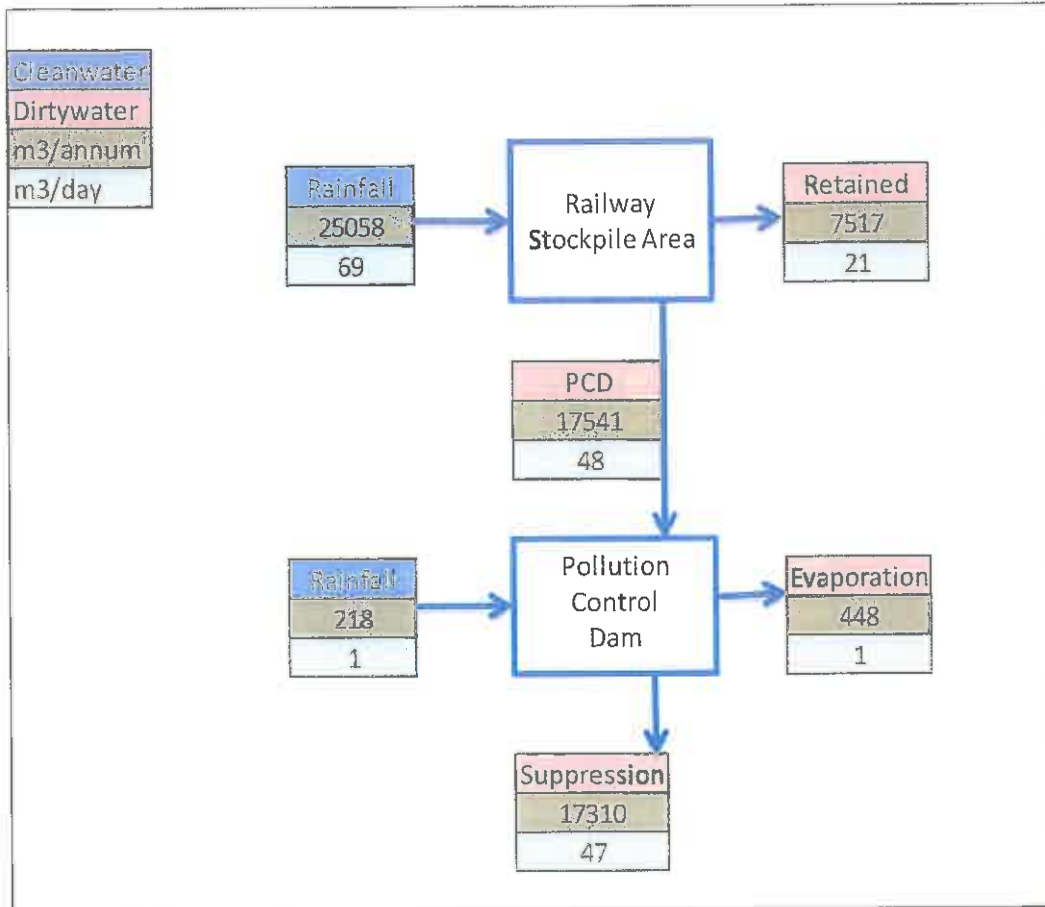
**Figure 5-1: Arbor Siding Water Balance Sketch**

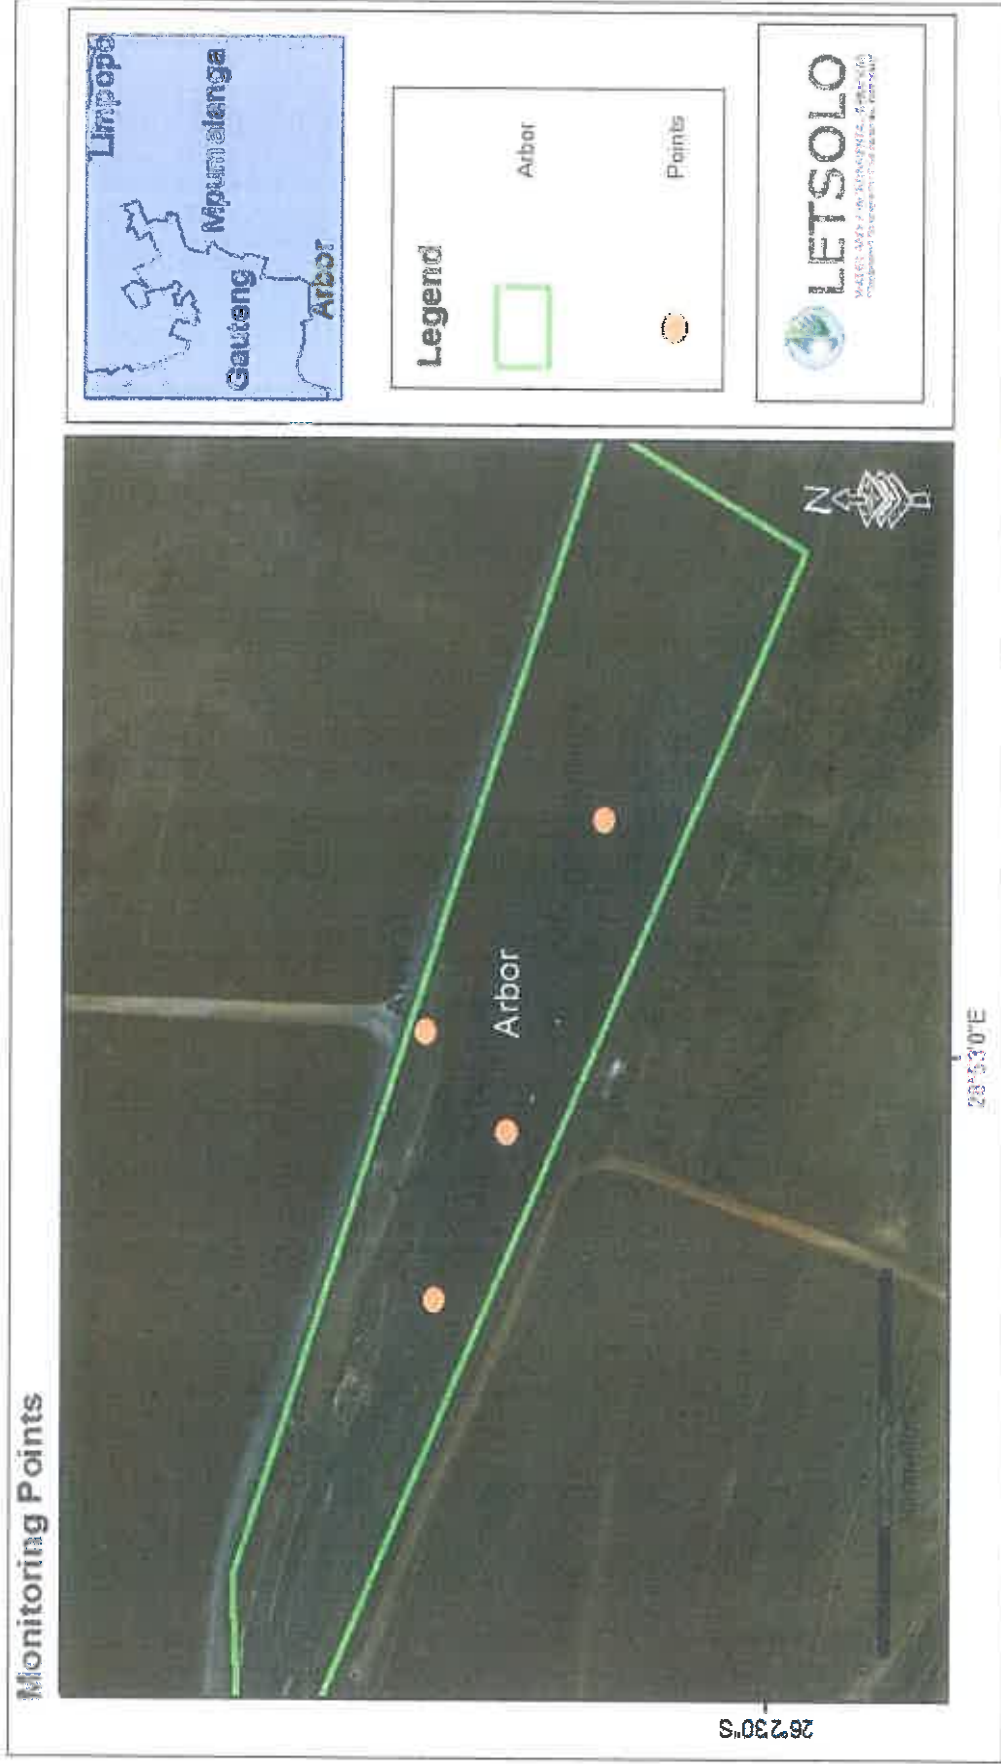
Figure 4-1: Soil Sample Points At Map of Arbor Coal Siding

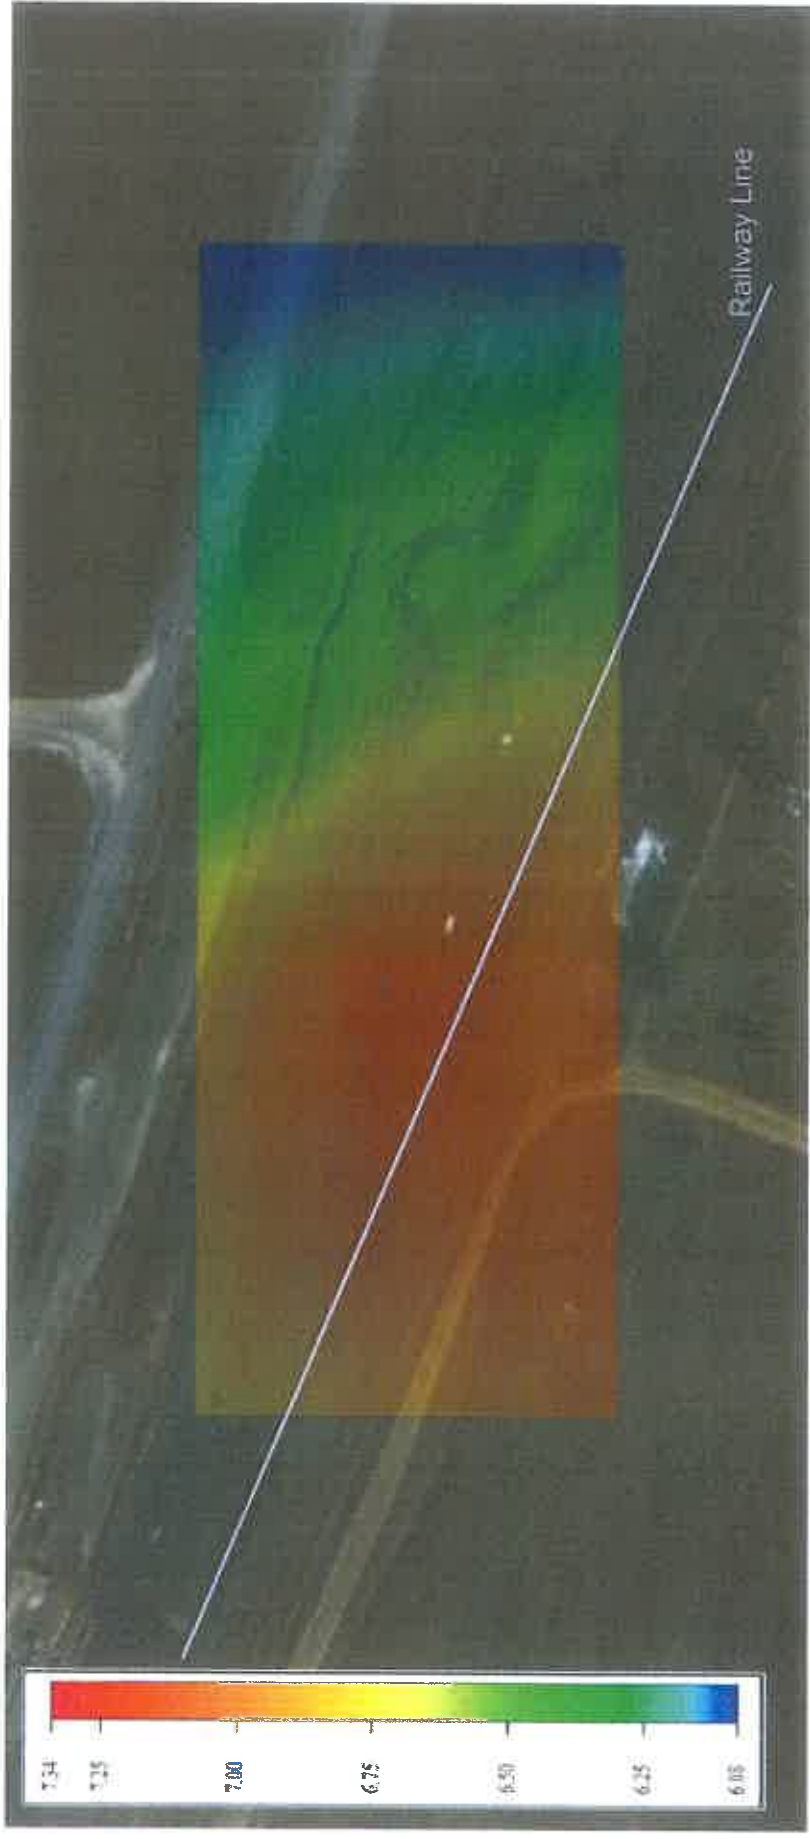
**APPENDIX A : SOIL PH MAP**

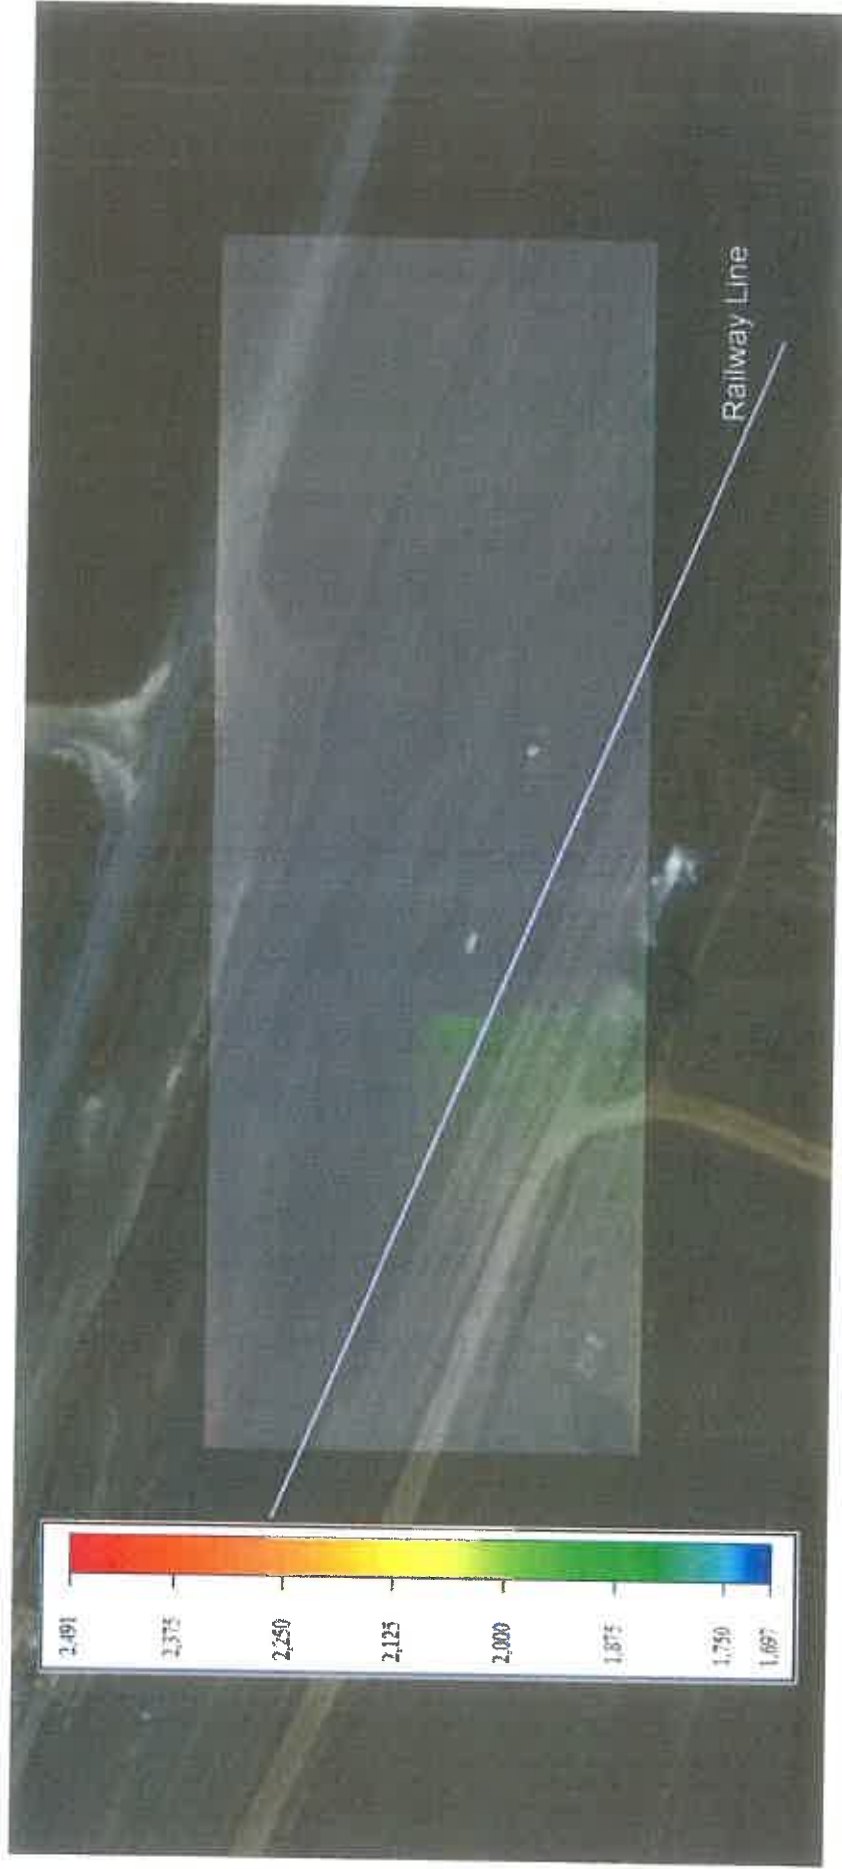
APPENDIX B : ELECTRICAL CONDUCTIVITY MAP

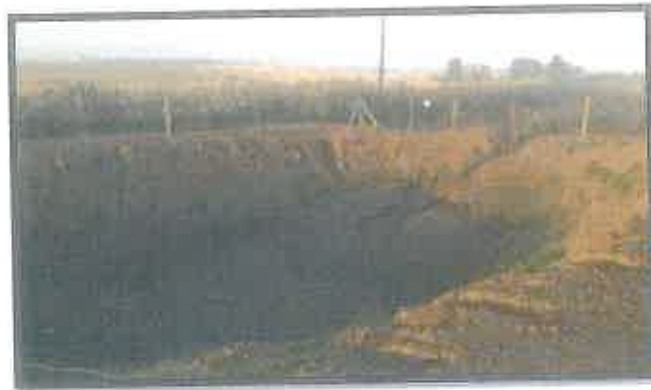
Figure 10: Control dam in site (Image ©MYEZO)

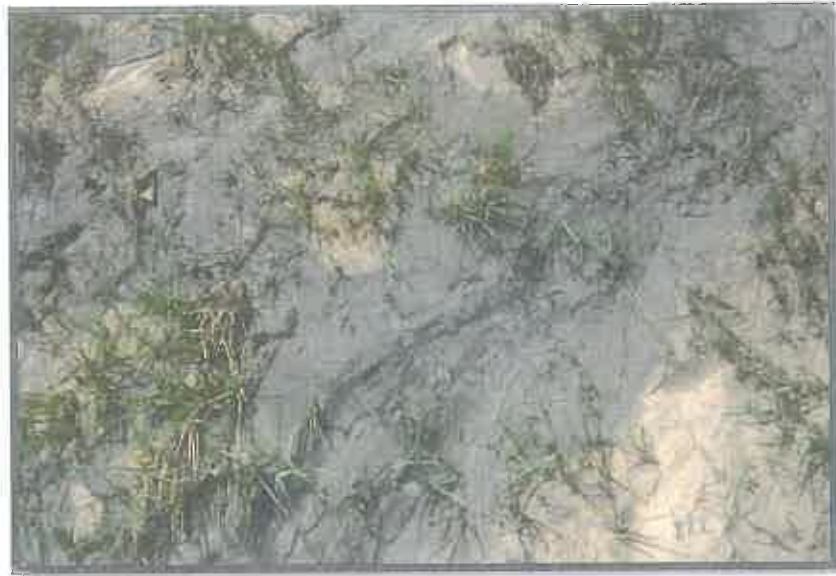
Figure 15: Coal dust residue observed in stormwater drained on the area towards NFEPA recognised ecosystem in the area.

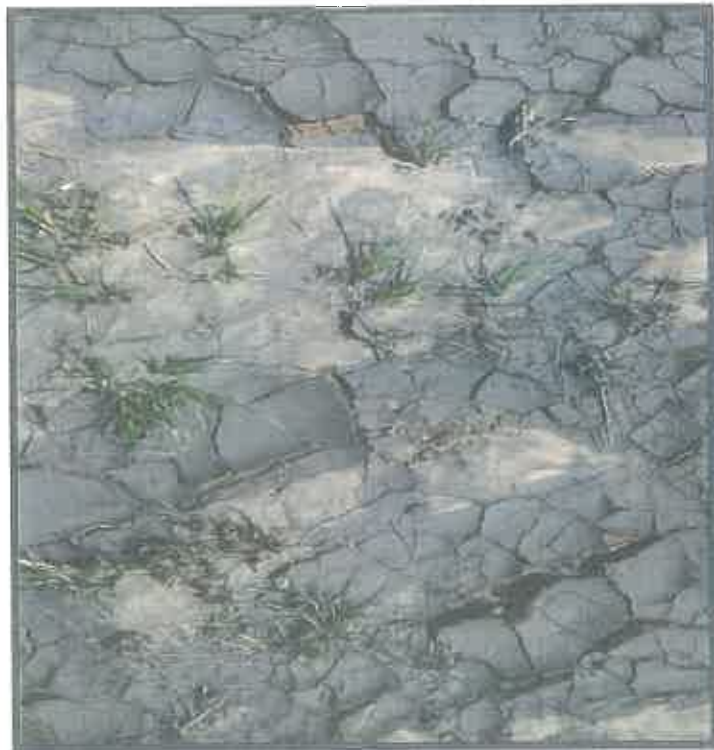
Figure 16: Dried coal dust residue stormwater.
