West Coast Resources (Pty) Ltd (WCR) is a private company owned by Trans Hex Operations (Pty) Ltd (Trans Hex), RE:CM and Calible Limited (RAC), the Government of South Africa, Dinoka Investment Holdings (Pty) Ltd and the Namaqualand Diamond Trust Fund. Trans Hex has entered into an agreement with the other shareholders of WCR to oversee and manage the operations WCR. WCR is re-establishing diamond mining operations in the Koingnaas area on the Namaqualand coast, which was previously mined by De Beers and under the existing mining environmental authorisation (EA) that was issued in terms of the National Environmental Management Act (Act No. 107 of 1998) in July 2012. As part of their operations, WCR intend to mine deposits that are located on land as well as specific deposits that extend seaward from the land potentially for several hundred metres. While some of the intended activities remain authorised in terms of the existing EA, other activities require a new EA. Myezo Environmental Management Services were appointed by WCR to undertake the Scoping and Environmental Impact Assessment (EIA). The scoping phase was been completed recently and revealed that various specialists would

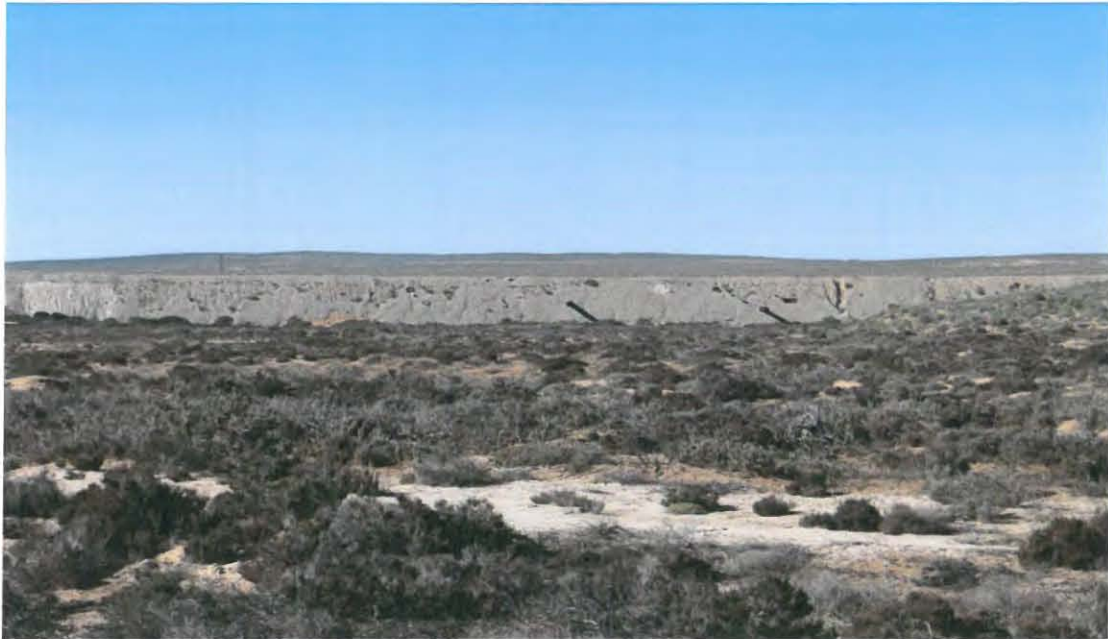
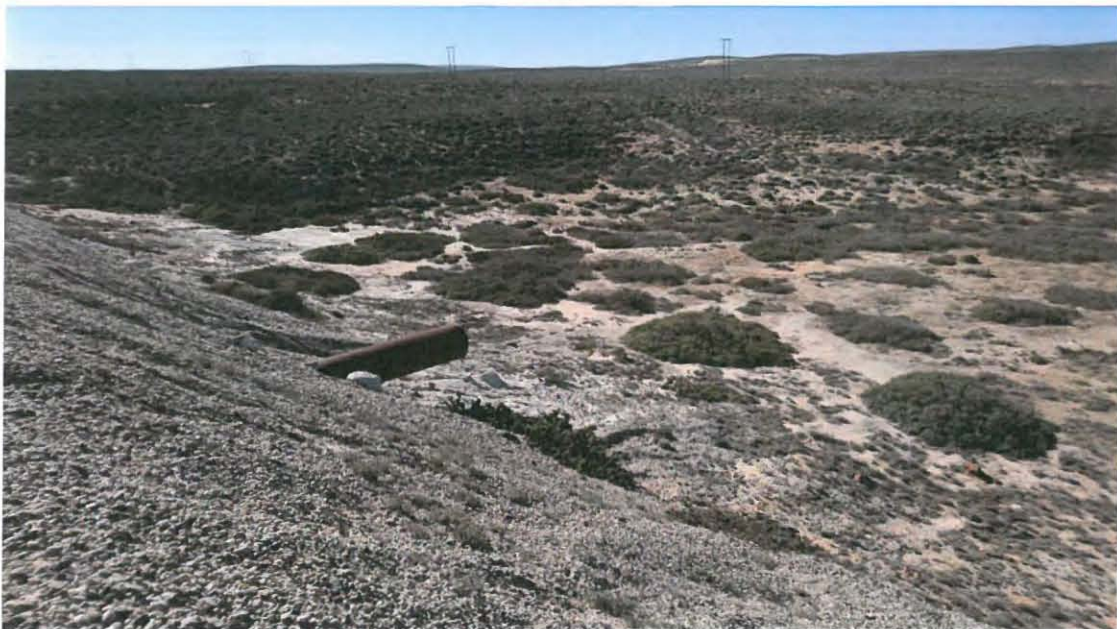
Figure 6 Photos of the main haul road situated 3 km upstream of the mouth within the restricted mining concession area of the WCR. This road prevents the river from reaching the floodplain. Photo A faces upstream and photo B shows how the intake pipe is elevated at least 1 m above the riverbed. Photos were taken on 22 June 2016.

Flow in the lower catchment and into the estuary has been severely reduced as a result of the construction of roads through the riverbed. The road connecting Hondeklip Bay with the Koingnaas mining entrance crosses the river 9 km from the mouth connecting the river on either side by a pipe with a diameter of approximately 50 cm. The pipe is not visible on the upstream side of the gravel road and it is suspected that the inlet is buried, causing the road to act as a flood attenuating, and minimally permeable barrier (Figure 5). The haul road situated 3 km upstream of the mouth within the restricted mining concession area of the WCR represents another barrier to the flow of the Swartlintjies River, preventing runoff from much of the catchment from reaching the estuary and the river from reaching the floodplain. In an attempt to connect the river to the estuary, a number of pipes have been buried in the gravel of the haul road. These pipes are, however, ineffectual as the inlets for the pipes are elevated approximately 1 m above the river bed (

Figure 6). Two smaller roads situated 1 km and 2.2 km from the mouth are no longer in use but are still in place and are further impeding the very limited flow that would otherwise reach the estuary.

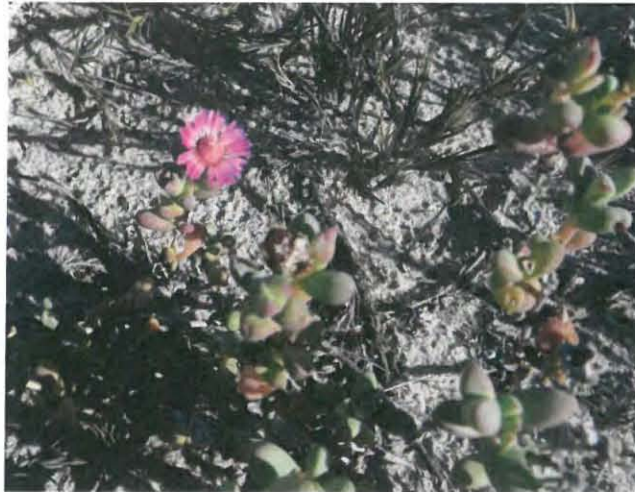
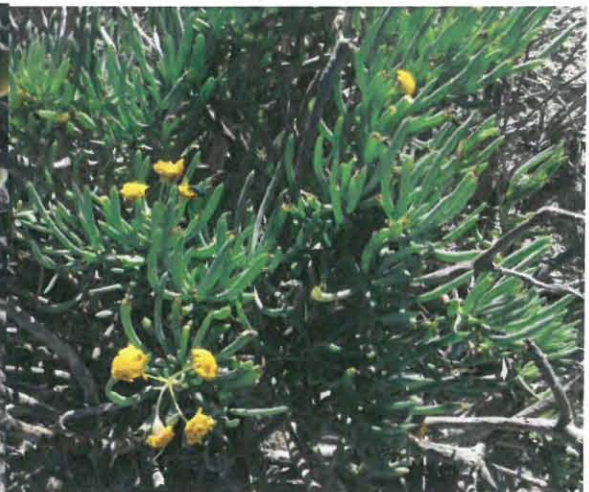
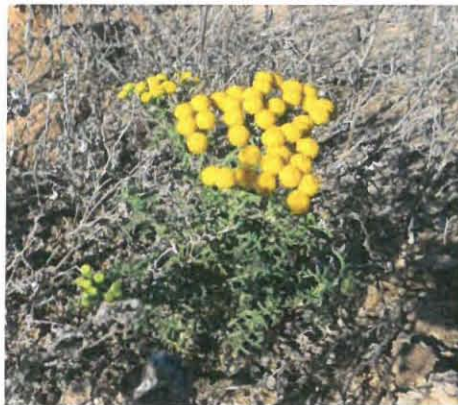
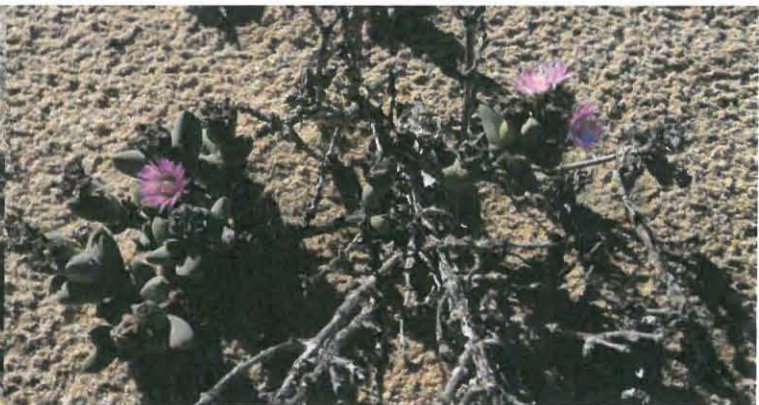
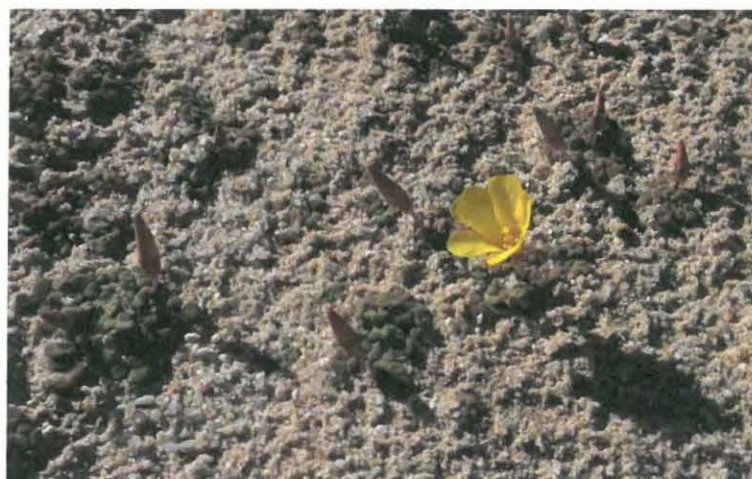
Figure 10 Photos of flowering terrestrial plants in the Swartlintjies Estuarine Functional Zone. The Photos were taken on 22 June 2016.

Amphibolia laevis

Othonna cylindrica

Oncosiphon suffruticosum

Unidentified succulent

Figure 9). The vegetation in the EFZ had come to life after the rainfall event prior to the field trip with some species being in flower (Figure 10).

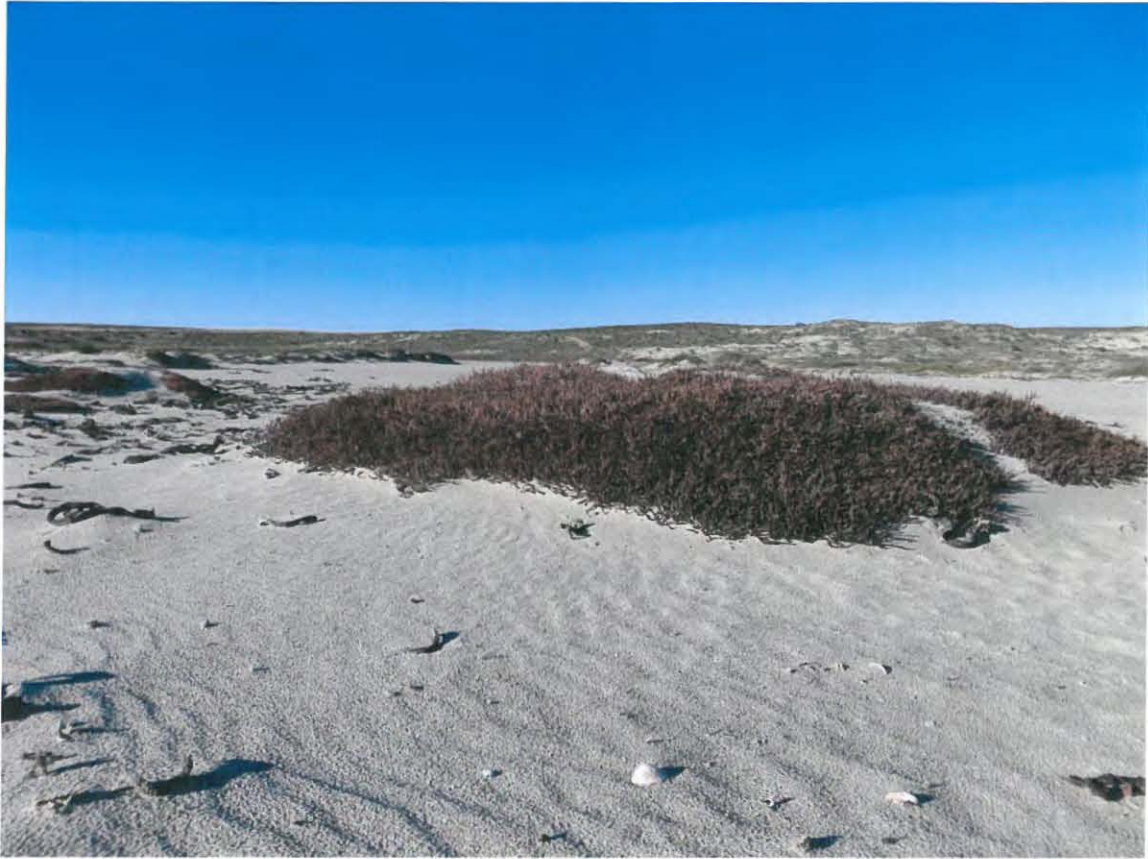
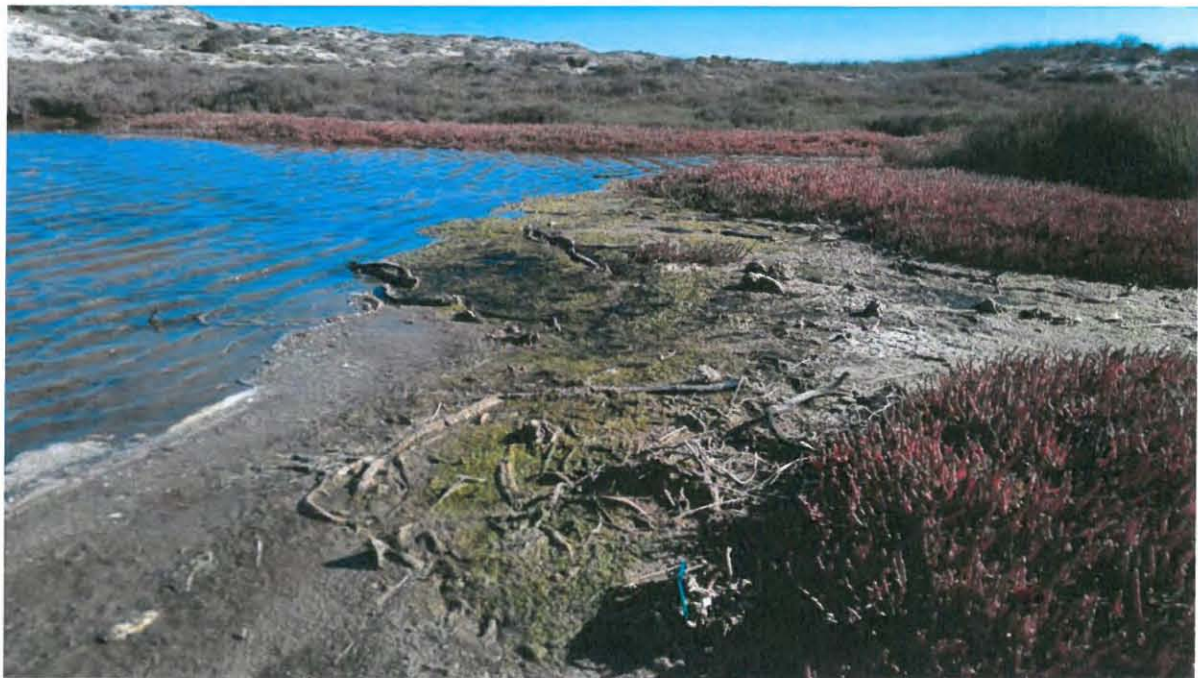
Figure 11 Patches of *Sarcocornia perennis* (A) and filamentous algae on the water's edge (B). The Photos were taken on 22 June 2016.

A

B

Seashore vegetation can be found in near the mouth on the dunes and extends as a thin band north and south of the estuary encompassing the beach and dune fields (note that this excludes Namaqualand Coastal Duneveld Vegetation type (Figure 9)). Seven species unique to this vegetation type have been identified to date (Table 3). At the estuary mouth, patches of *Sarcocornia perennis* on slightly elevated beach sand were present avoiding inundation by regular penetration of the sea during spring tide (Figure 11). Filamentous algae were growing on the edge of the water body near the mouth and further upstream (

Figure 11).
