ARCHITECTURAL ASSESSMENT OF HISTORICAL MINE MANAGEMENT OFFICE BUILDING AT VOORSPOED MINE, KROONSTAD (FREESTATE PROVINCE)

Date: June 2013

Project by: M. Naudé

The assessment of the historic mine management office building of the Voorspoed Diamond Mine, Kroonstad.

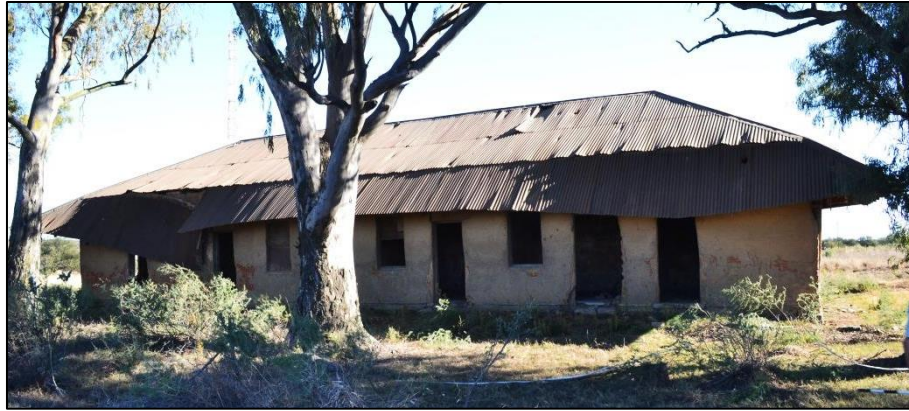
Figure 1. Eastern elevation of the mine management office building (Photograph: M. Naude 2013)

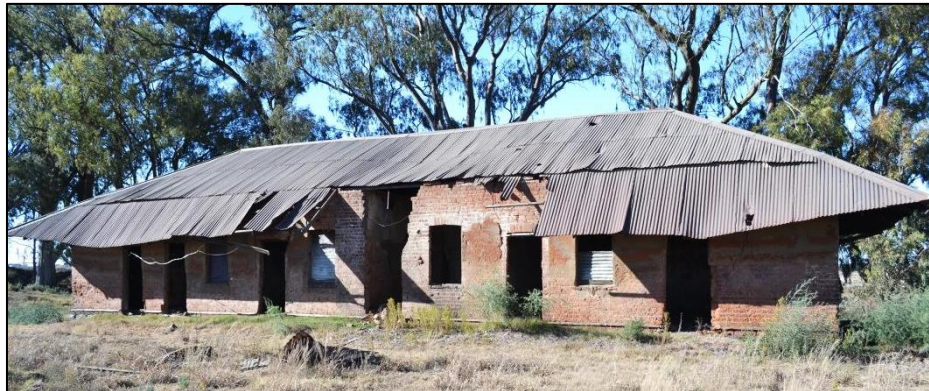
Figure 2. Western elevation of the mine management building (Photograph: M. Naude 2013)

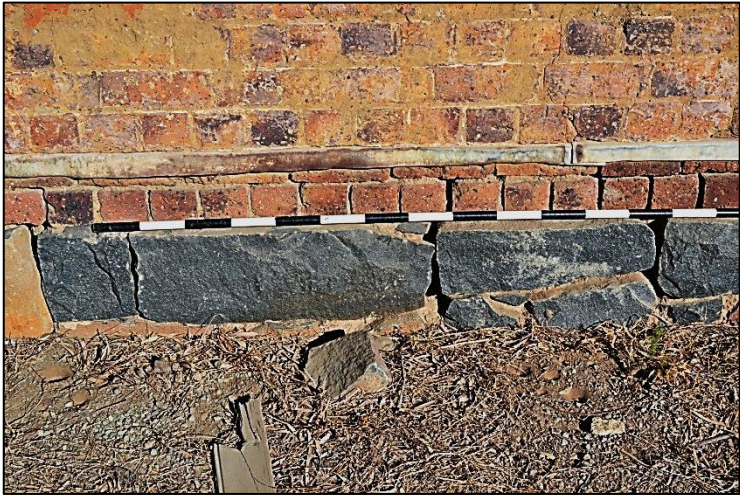
One of the exceptional elements of the building is the foundation. The foundations is constructed with neatly dresses bluish granite stone and projects above the surface to form a narrow plinth. Two rows of baked bricks were laid on top of the stone masonry foundation. The single most structural element to the foundation that attracts attention is the wide galvanized sheet iron that was installed on top of these two layers of brick as it is so wide that the exterior ends could project outwards for approximately 7cms before it was bent downwards to about 45 degrees. One of the

<p>Figure 3. Craftsmanship of the dressed stone foundation forming a plinth, with two courses of brick masonry and a well-defined damp course of galvanized sheet iron underneath the next brick courses (Photograph: M. Naude 2013)</p> <p>The unique elements of the foundation are the neatly dressed granite stone base ending in a plinth with two courses of bricks on top with an over-sized damp course of flat sheets of galvanized sheet iron projecting outwards. No effort was made to obscure the damp course but it was extended well forward (outwards) with an exposed shoulder and bent downwards to protect the top half of the (second layer of) brick masonry underneath.</p>	<p><i>Rating</i></p> <p><i>high</i></p>

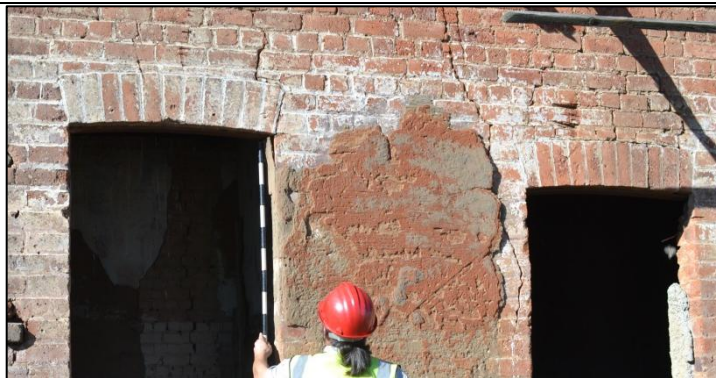
Figure 4. Slightly arched window and door lintels constructed with bricks (Photograph: M. Naude 2013)

Other elements reflecting a more refined approach to structural problems are the neatly constructed arched keystone designs of brick masonry above windows and doors. To render even more structural strength to the low arched lintels 8mm iron strips were inserted underneath the arched brick lintels.

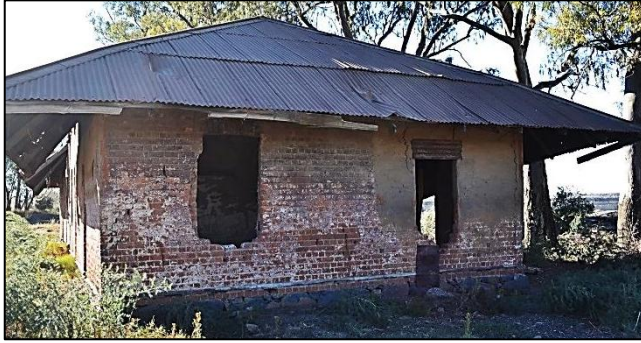
5.	<p><i>What is the state of the architectural and structural integrity of the building?</i></p> <p>The principal architectural elements of the building have remained intact in terms of the original intent of the design. However the detailing associated with this original intent had disappeared. Doors and windows have been stripped from the building; most of the ceilings and cornices have been removed and the cement floor surfaces have been removed.</p>	<p><i>Rating</i></p> <p><i>low</i></p>

Figure 5. Southern elevation with window frames removed and sections of the walls missing (Photograph: M. Naude 2013)

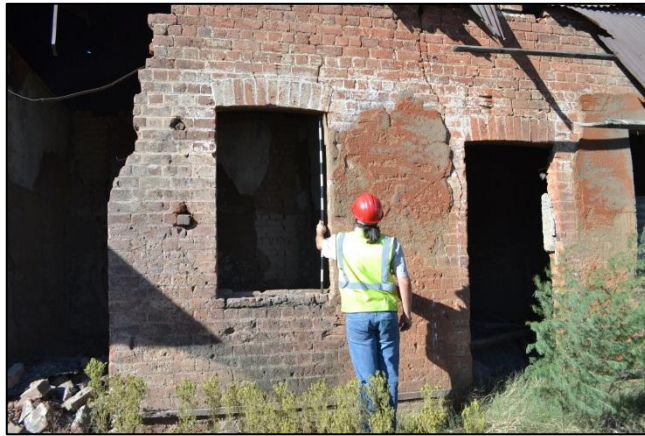
Figure 6. Door and window frames removed and complete sections of the wall from floor to ceiling height demolished (Photograph: M. Naude 2013)

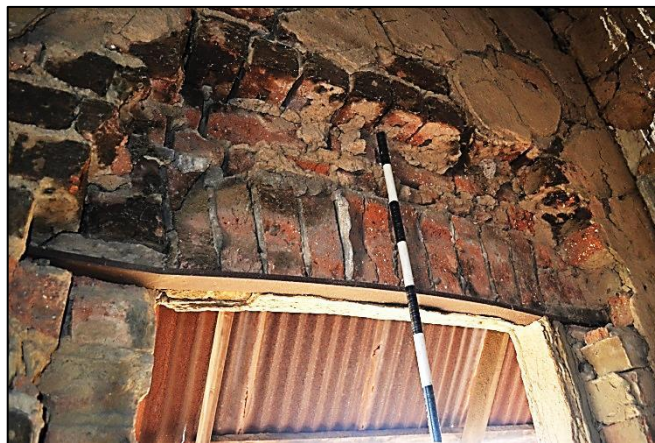
Figure 7. Arched brick masonry above the door completely demolished due to the removal of the arched iron strops supporting the window lintel (Photograph: M. Naude 2013)

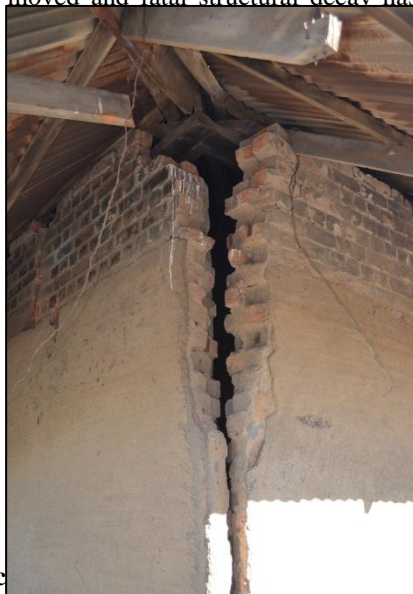
The structural integrity has deteriorated to a serious and dangerous level. Even though the foundation has remained intact, all exterior walls and the central wall have moved and fatal structural decay has set in defined by wide cracks

Figure 8. Wide crack in wall indicating outward movement (2013)

The building may be demolished and the proposed development may continue on the following conditions:

2. The building must be properly recorded prior to demolition: (a) photographically recorded and described according to standard architectural vocabulary; (b) measured drawings of the floor plan, elevations and

essential architectural elements and details; (c) the information must be compiled in a report and (d) included into the submission to the PHRA-Freestate as part of application for a demolition permit.

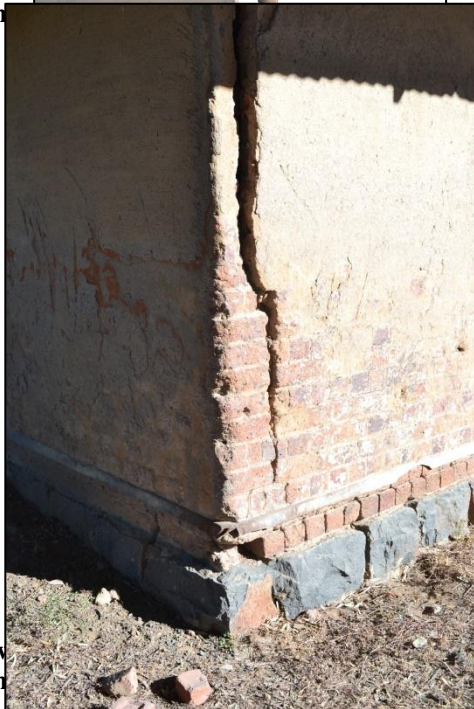
Figure 9. Outward movement of walls resulting in structural failure (2013)

The building has deteriorated to the extent that due to fatal structural disintegration and movement in the structure it would eventually cave in on itself. The building is already unstable and would self-destruct over time.
