# **AQUATIC RESOURCES ASSESSMENT**

## **Vulindlela Bridge Maintenance & Rehabilitation**

Project Reference:  
21901  
Report Date:  
April 2019  
Report Reference:  
21901\_AQU\_1

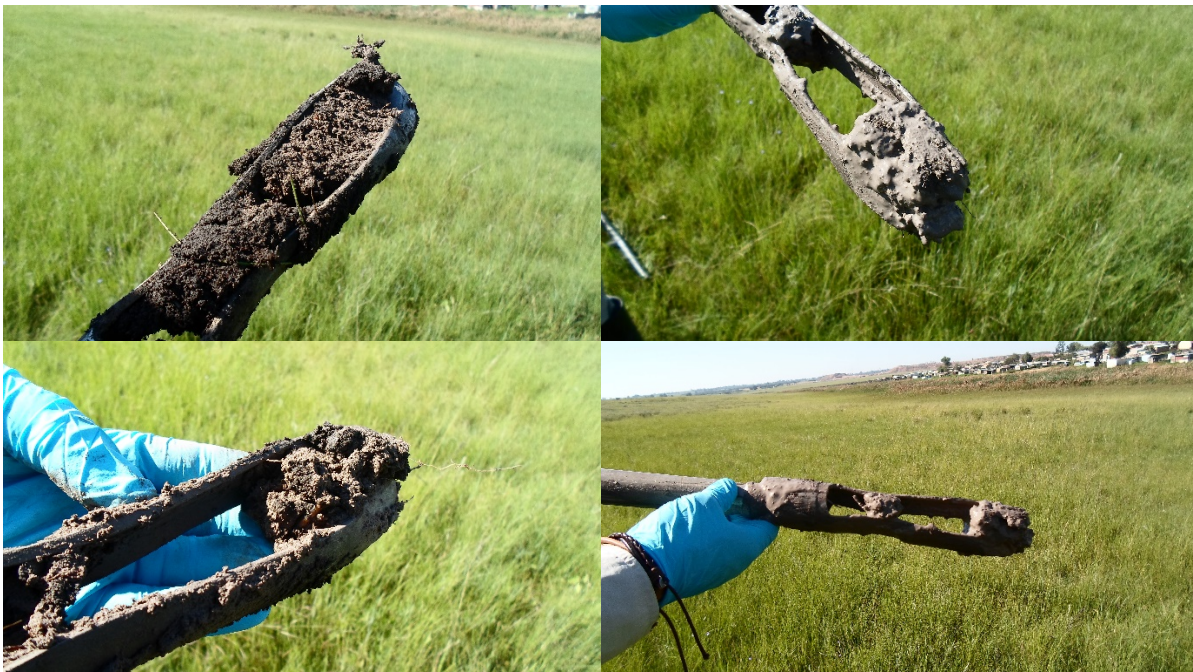
Soils were found to be of a low clay content in general. Mostly sandy soils were present especially in the top 250mm. The wetland seasonal and permanent zones reflected clayey soils. (Figure 6-1).

**Figure 6-1: Soil samples**

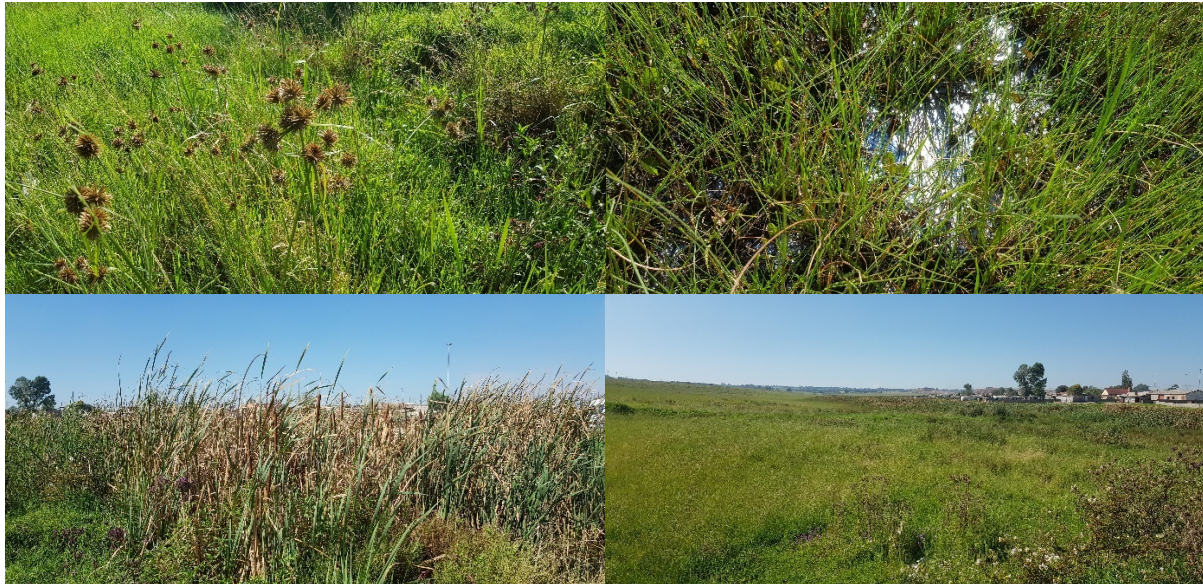
Upon the assessment of the area, the various wetland vegetation components were assessed and recorded. Dominant species were characterised as either wetland species or terrestrial species. Hydrophytic vegetation species were observed. Predominantly grass, rushes and sedge species were recorded. This unit was predominantly utilised to delineate the wetland (Figure 6-2).

Figure 6-2: Wetland vegetation
