Aquatic Biodiversity Impact Assessment – Wagt Solar Photo- Voltaic (PV) Solar Energy Facility and Associated Grid Connection Infrastructure

**Pixley ka Seme District Municipality,
Northern Cape Province**

Report Date: September 2022

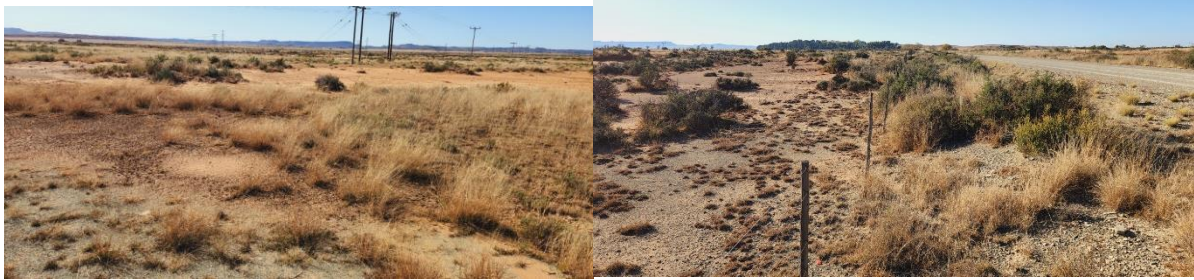
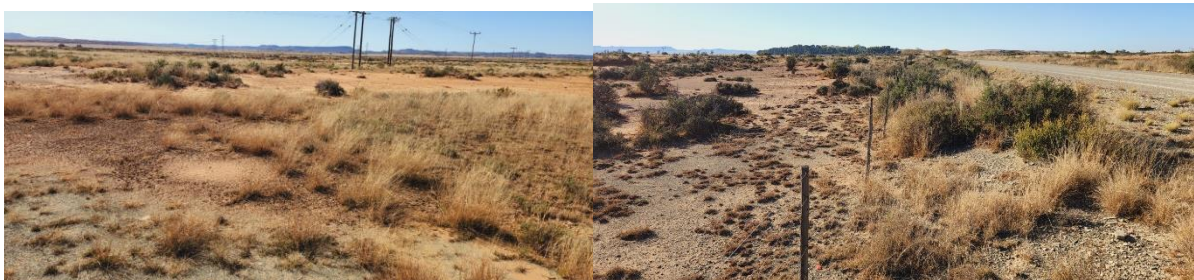
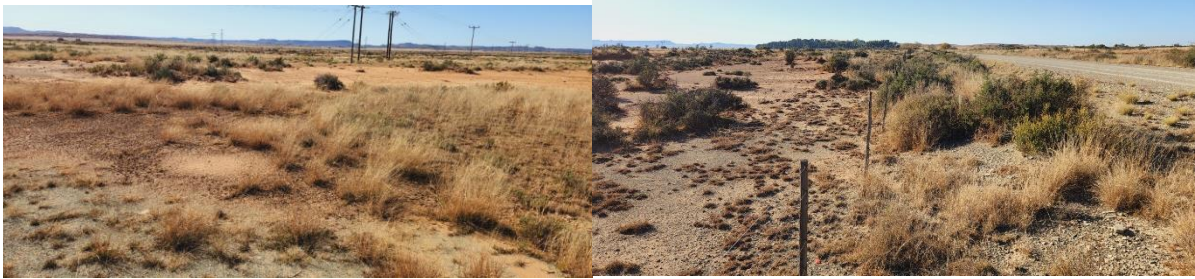
Figure 5-4 Illustration of the ephemeral habitat features of the Western tributary (June 2022)

The on-site assessment of the watercourses presented largely dry conditions, with the numerous ephemeral systems presenting no clear banks or riparian features which is typical for watercourses in an arid region (Figure 5-5 and

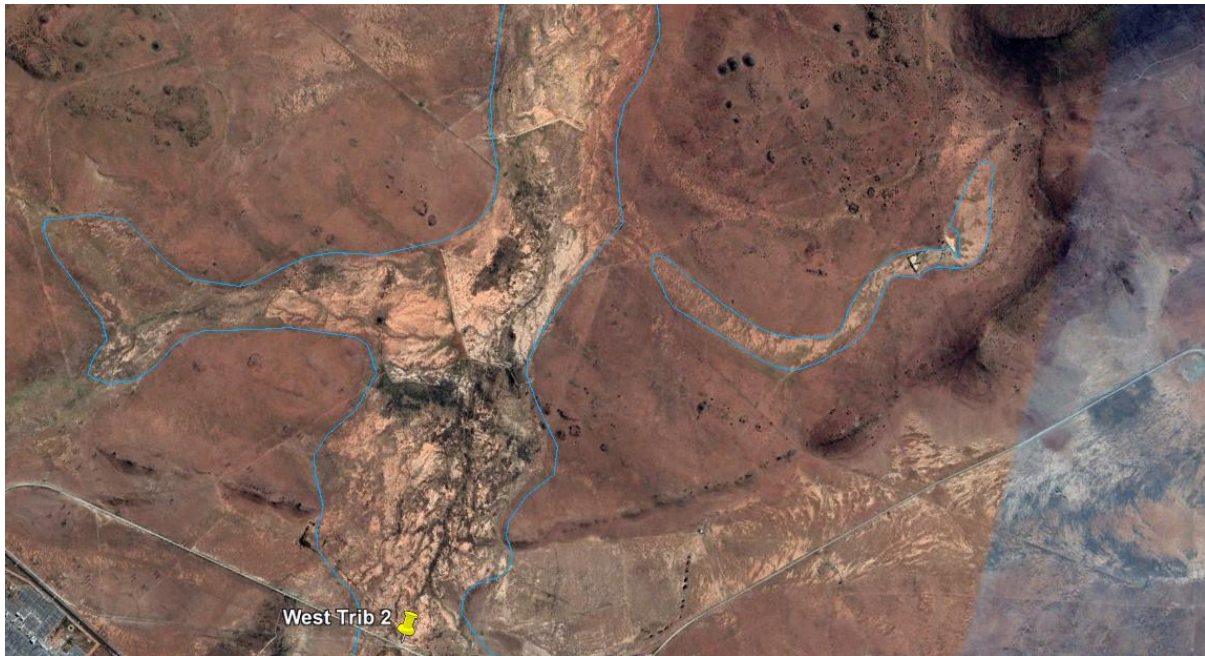
Figure 5-5 Illustration of the catchment condition of the Western tributary (Google Earth)

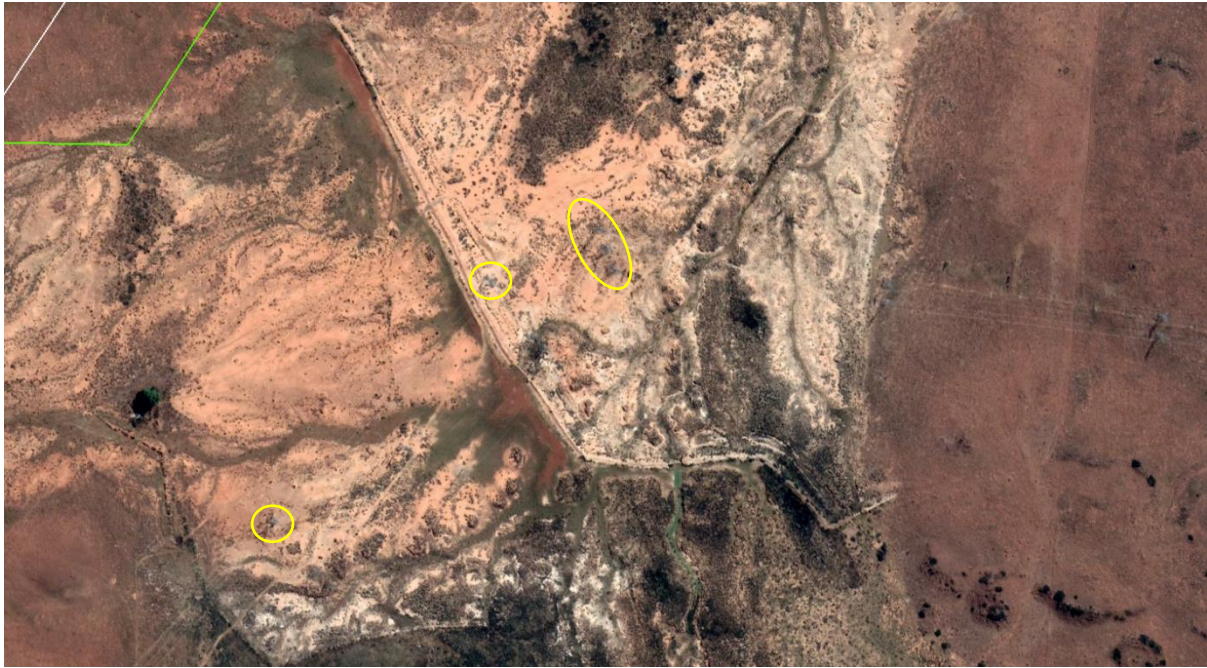
Figure 5-6 Illustration of existing instream weirs structures and powerline pylons (yellow circles) within the drainage features (Google Earth)

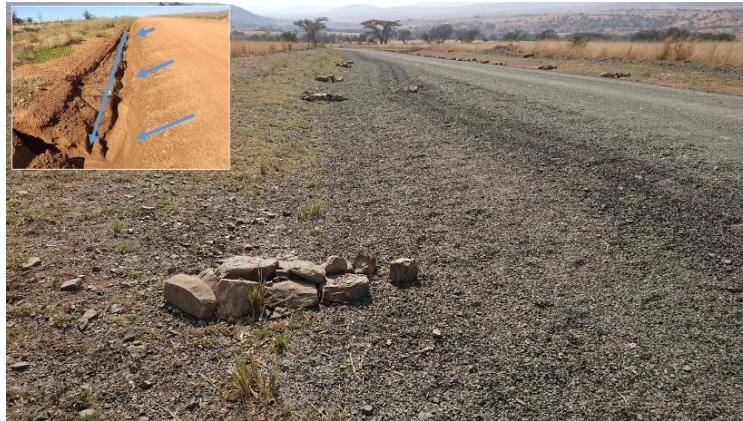
Figure 6-3 Example of road margin erosion prevention

- Energy dissipation, such as stone berms or blocks must be strategically placed along the road margins for the entire road network as surface runoff leaves the roads and enters the surrounding environment with the potential for severe erosion. The steeper the slope of the road, the more regular the berms should be spaced and can be as close as one meter apart where necessary;

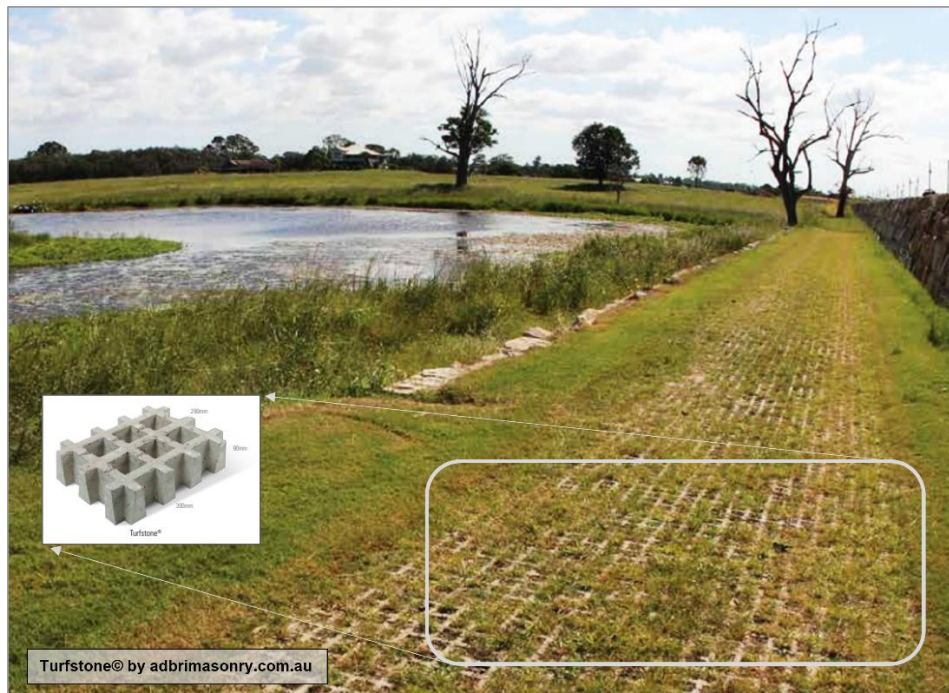
Figure 6-4 Example of permeable paving for roads and habitat maintenance

- The road margins should be hydroseeded with vigorous growing indigenous grasses that are drought tolerant to lower erosion of these key areas;
- The section of roads which will traverse the lowest lying areas/potentially wet areas or steeper slopes will be subjected to traffic from vehicles for inspections and maintenance on site with the potential for damage to habitat and erosion and thus require permeable paving. The permeable paving provides a stable platform to carry the loads of service vehicles whilst the vegetation growing through the permeable pavers compliments the surrounding vegetation, preventing erosion in these key areas;
