Water Resource Assessment for the proposed Tugela Ferry siphon rehabilitation and abstraction project

Msinga, KwaZulu-Natal

September 2018

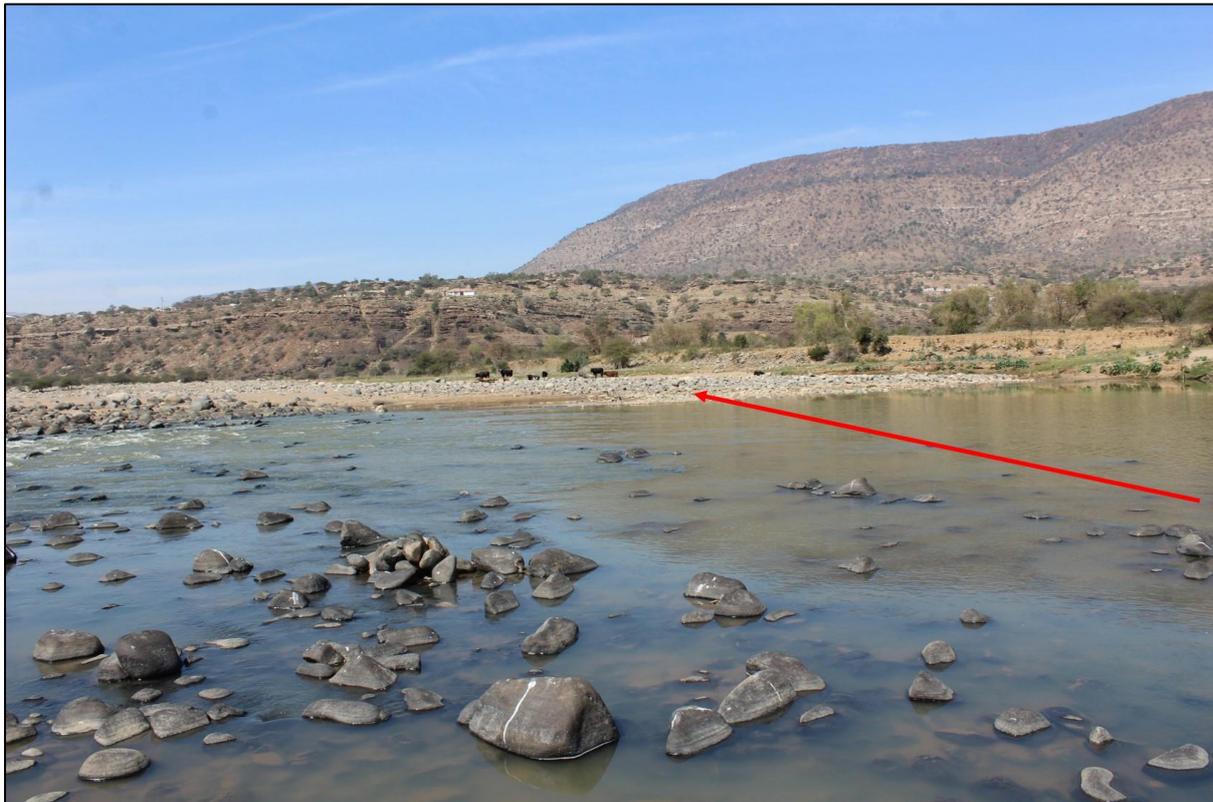
Figure 5-2: Transect Location for the RHAM (Red Line - September 2018)

In order to gain a low-level understanding of the flows and sediment regimes, the Rapid Habitat Assessment Method (RHAM) was used to establish the baseline habitat characteristics of the physical habitat at the monitoring site S2. The method was carried out according to Louw and Kleynhans (2009). The location of the cross sections as well as the overall site layout for the RHAM assessment is provided in Table 5-6 and Figure 5-2. It is noted that the RHAM site selection was largely based on the suitability for the river reach to wadable conditions.

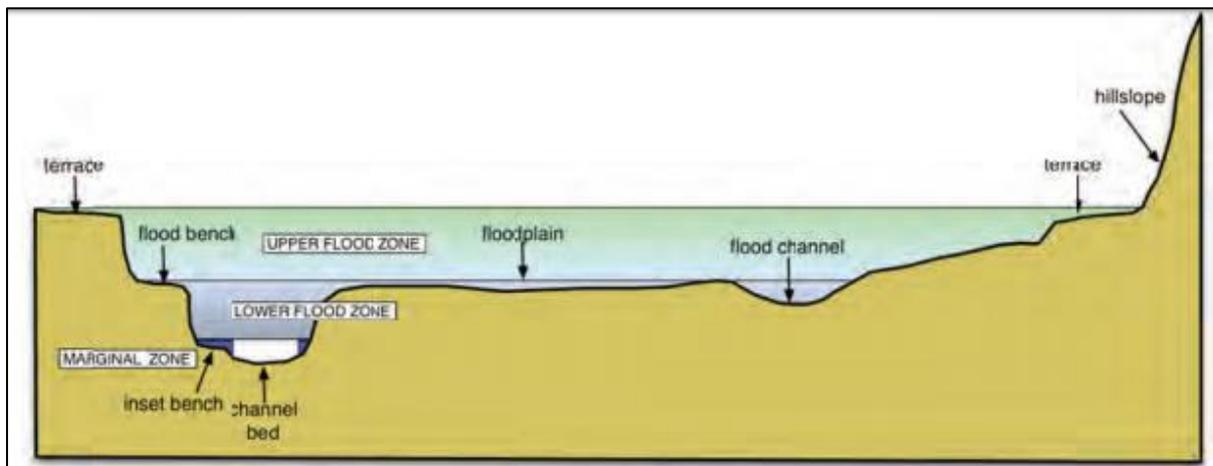
The river morphology was delineated using aerial imagery and groundtruthed during the survey. The morphological descriptions used in this assessment are based on Figure 5-3.

Figure 5-3: Channel morphological descriptions (Rowntree, 2013)

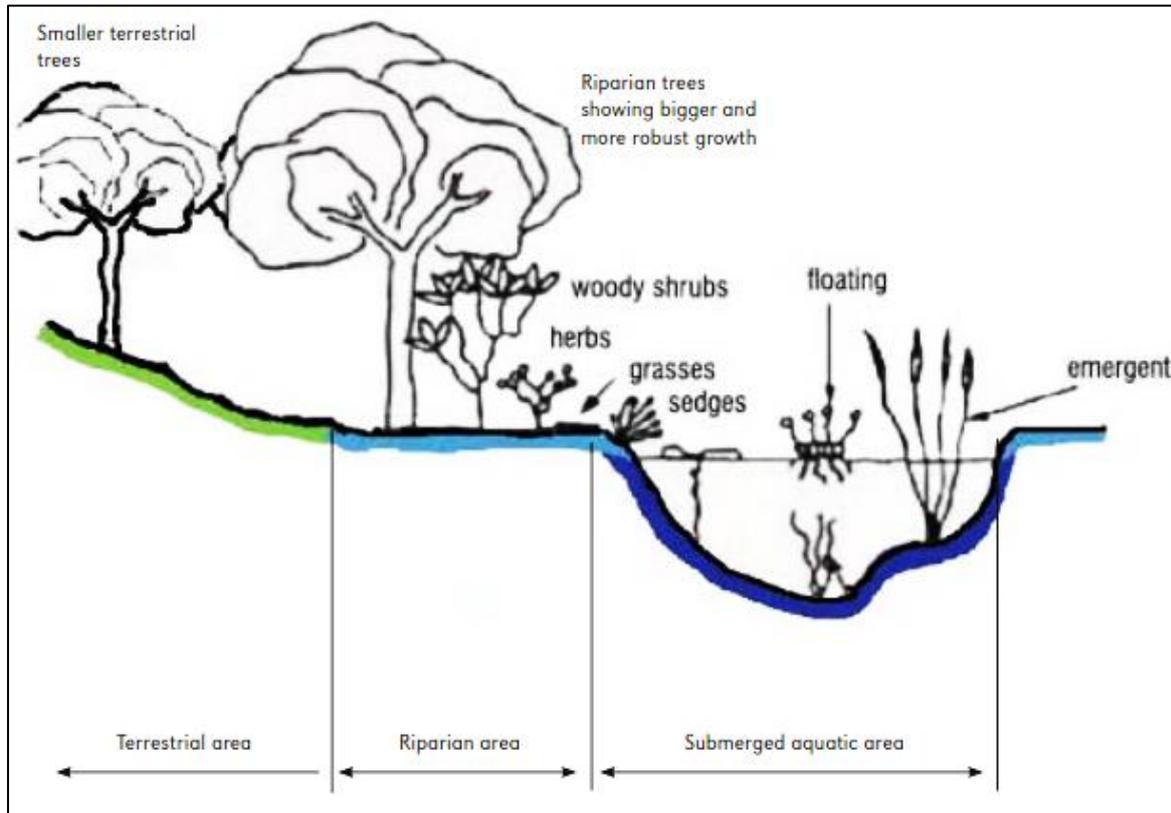
The riparian delineation was completed according to DWAF (2005a). Typical riparian cross sections and structures are provided in Figure 5-4. Indicators such as topography and vegetation were the primary indicators used to define the riparian zone. Contour data obtained from topography spatial data was also utilised to support the infield assessment.

Figure 5-4: Riparian Habitat Delineations (DWAF, 2005a)

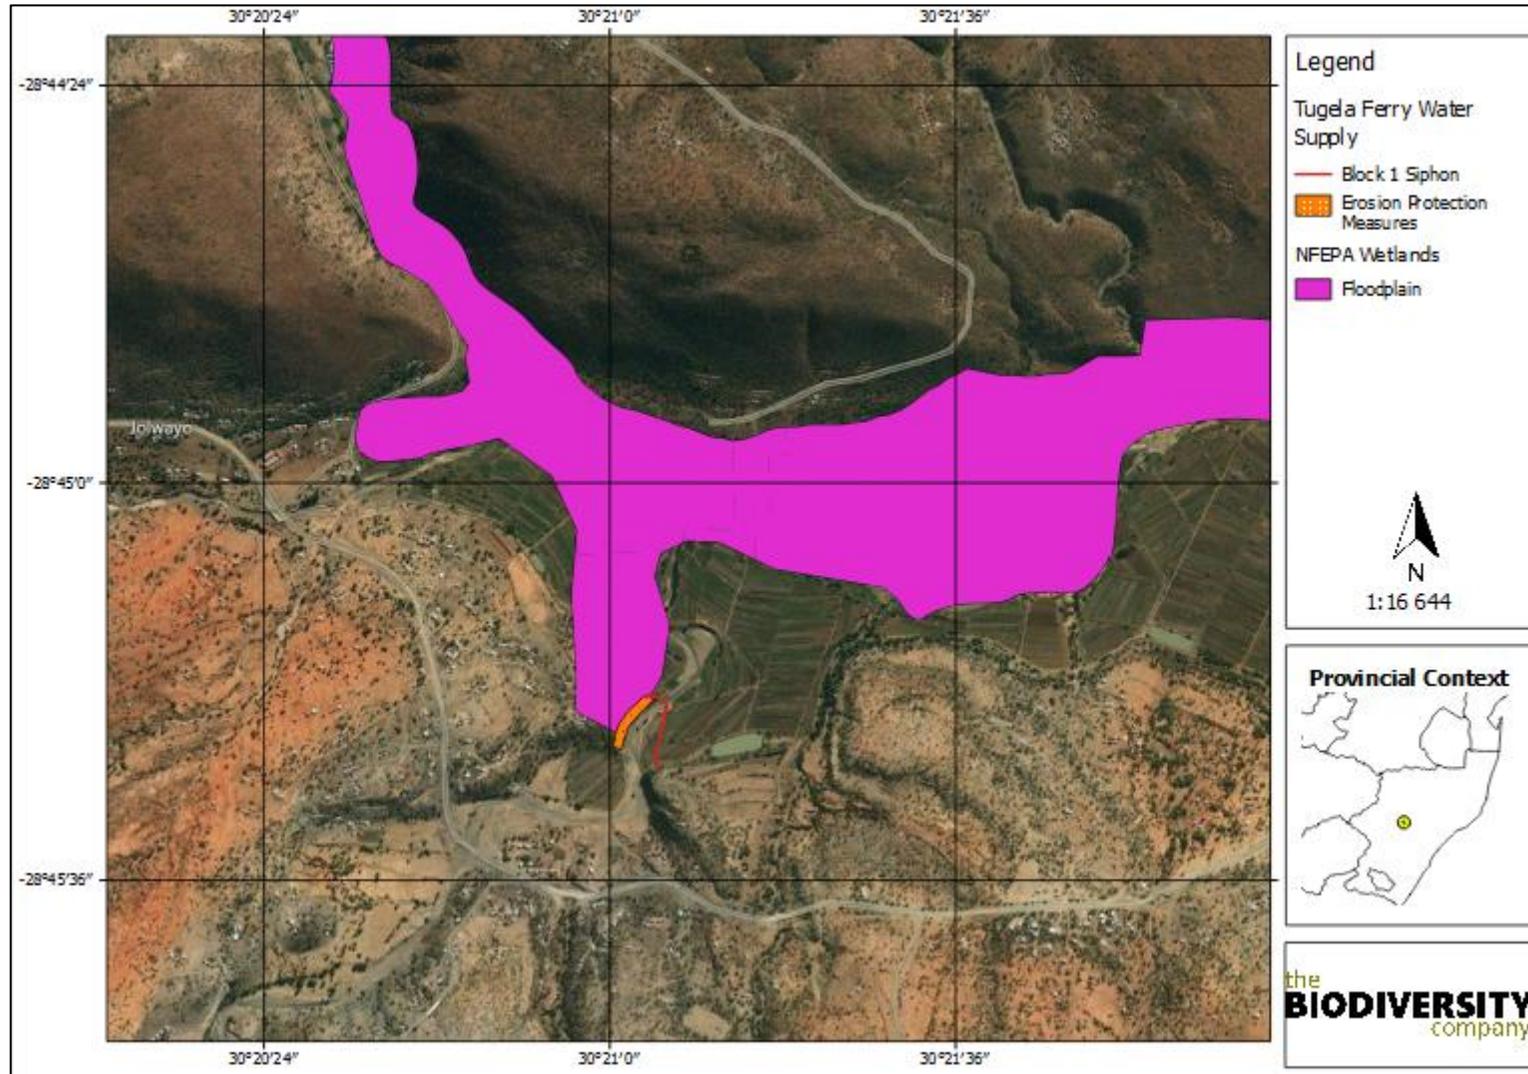
The FEPA wetland was classified as a floodplain wetland associated with the Thukela River. The wetland was classified as a natural system with a vegetation condition of AB which indicated that more than 75% of the vegetation was natural. The FEPA wetland was rated as a Rank 2 FEPA wetland and had more than two associations with other wetlands and was within 500m of a critical bird habitat.

Figure 6-1: The NFEPA wetland areas associated with the project

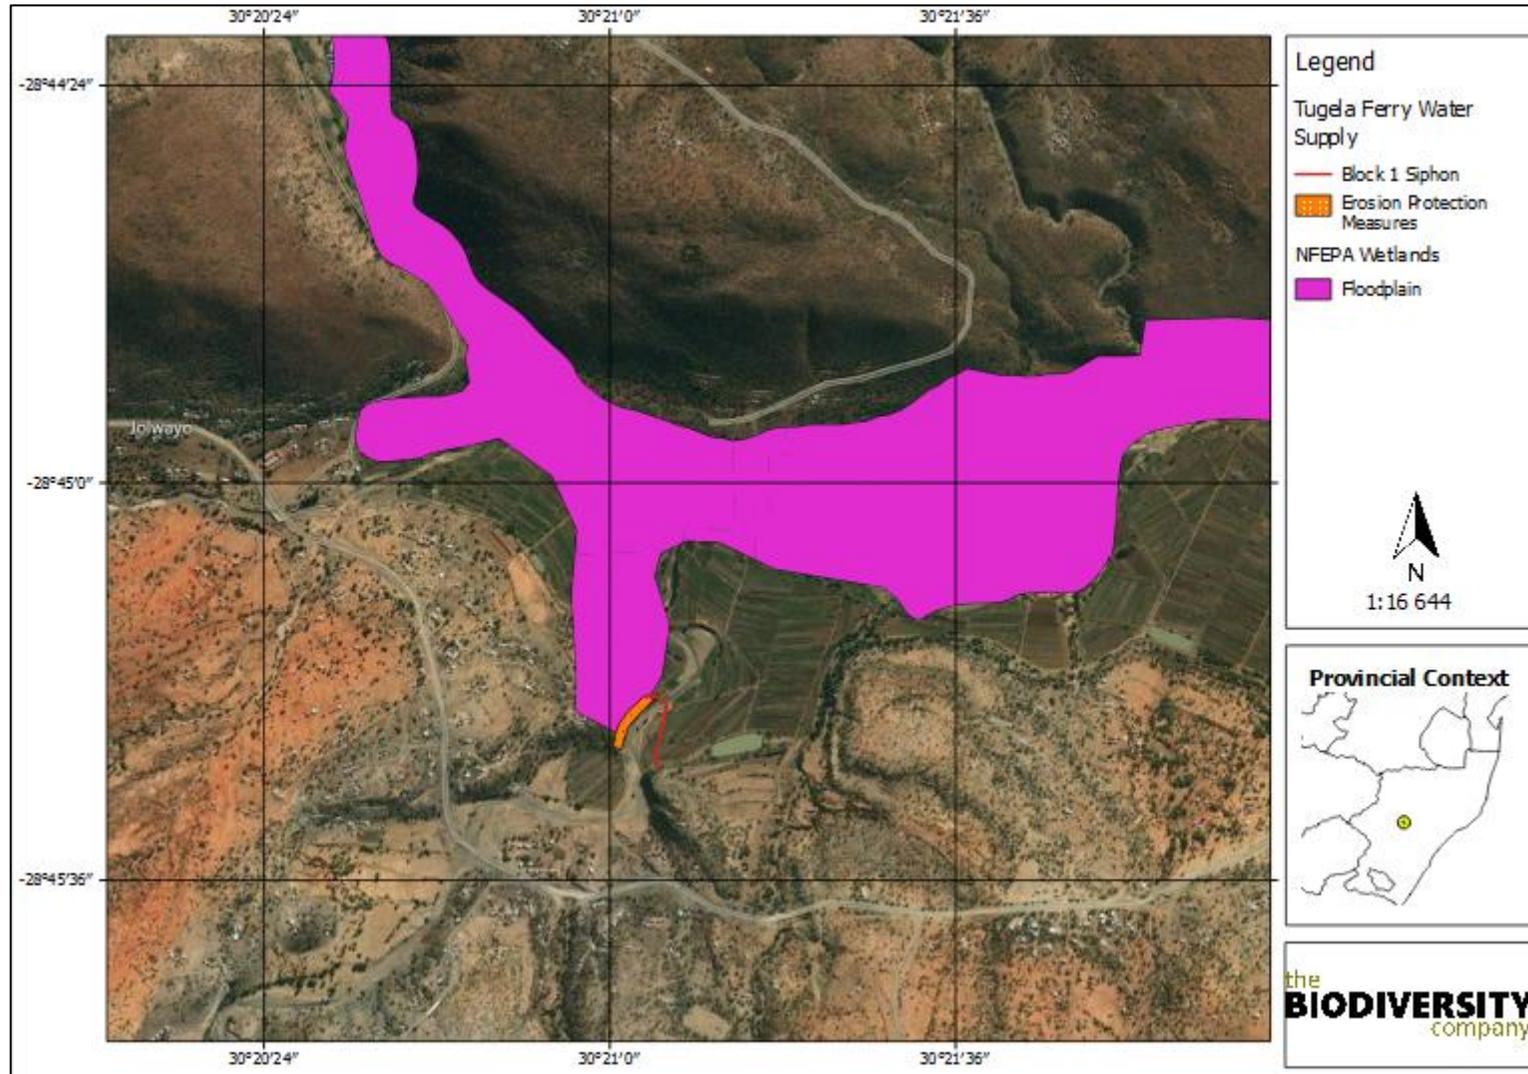
Figure 6-2: The identified wetlands at watercourse intersections associated with project

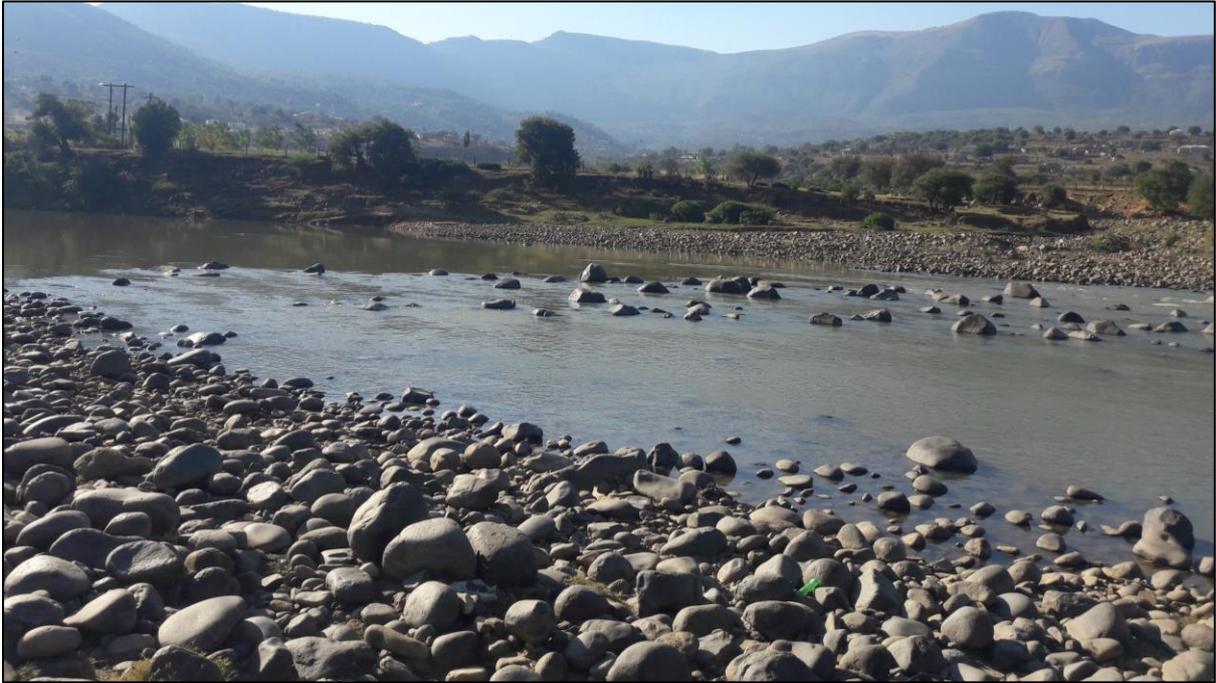
The Thukela River was determined to be a river channel with large rocks within in the channel and smaller cobble-like rocks on the banks (Figure 6-3). The river did not present indicators of wetlands and the riparian habitat was dispersed along the banks/margins of the river. The largest disturbance of the riparian zone was the establishment of rural housing areas and roads. The development of the town centre was also found to border within the riparian zone. The central characteristics of the drainage lines are illustrated in Figure 6-4.

Figure 6-3: Identified River HGM – Thukela River (September 2018)

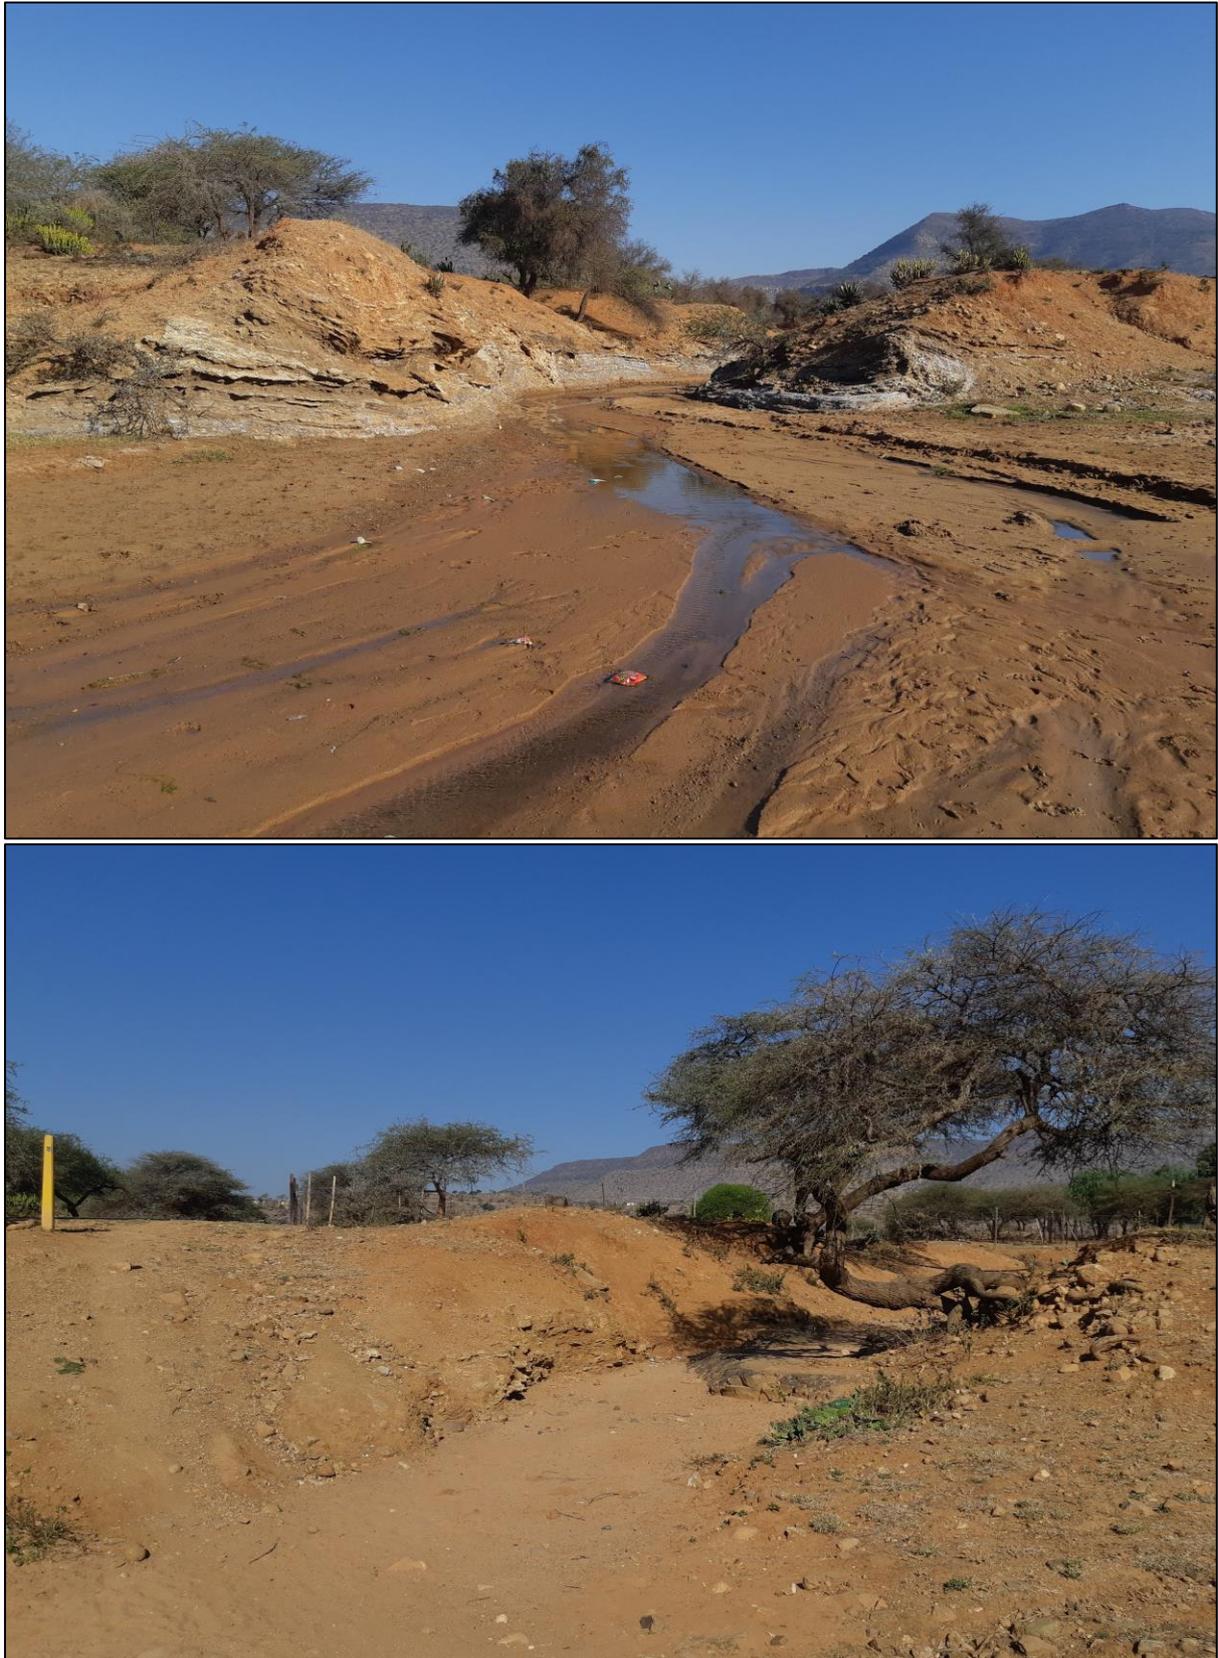
Figure 6-4: Identified drainage lines (September 2018)

The identified HGM units are not considered wetlands and as such the PES, Ecosystem Services and EIS could not be assessed.

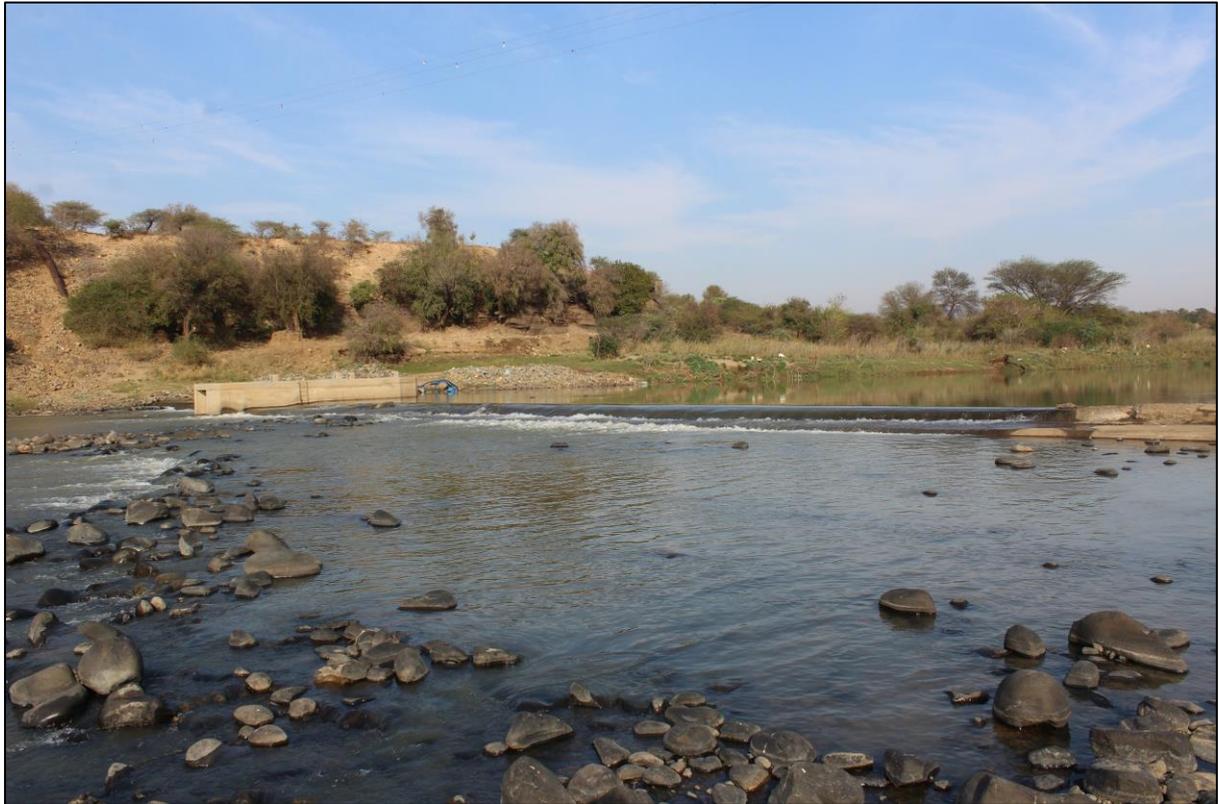
The results of the instream and riparian integrity assessment derived a class B (largely natural) status for the instream habitat of the watercourse considered in this assessment. Instream habitat impacts can largely be attributed to gauging weir impoundments compounded by sedimentation and abstraction (Figure 6-5). The riparian zone was determined to be moderately modified (class C) from reference conditions. The central factors negatively effecting the riparian zone included channel modification, vegetation removal and the presence of alien vegetation (Figure 6-6).

Figure 6-5: Impoundments used for water abstraction in the Tukhela River (S1; August 2018)

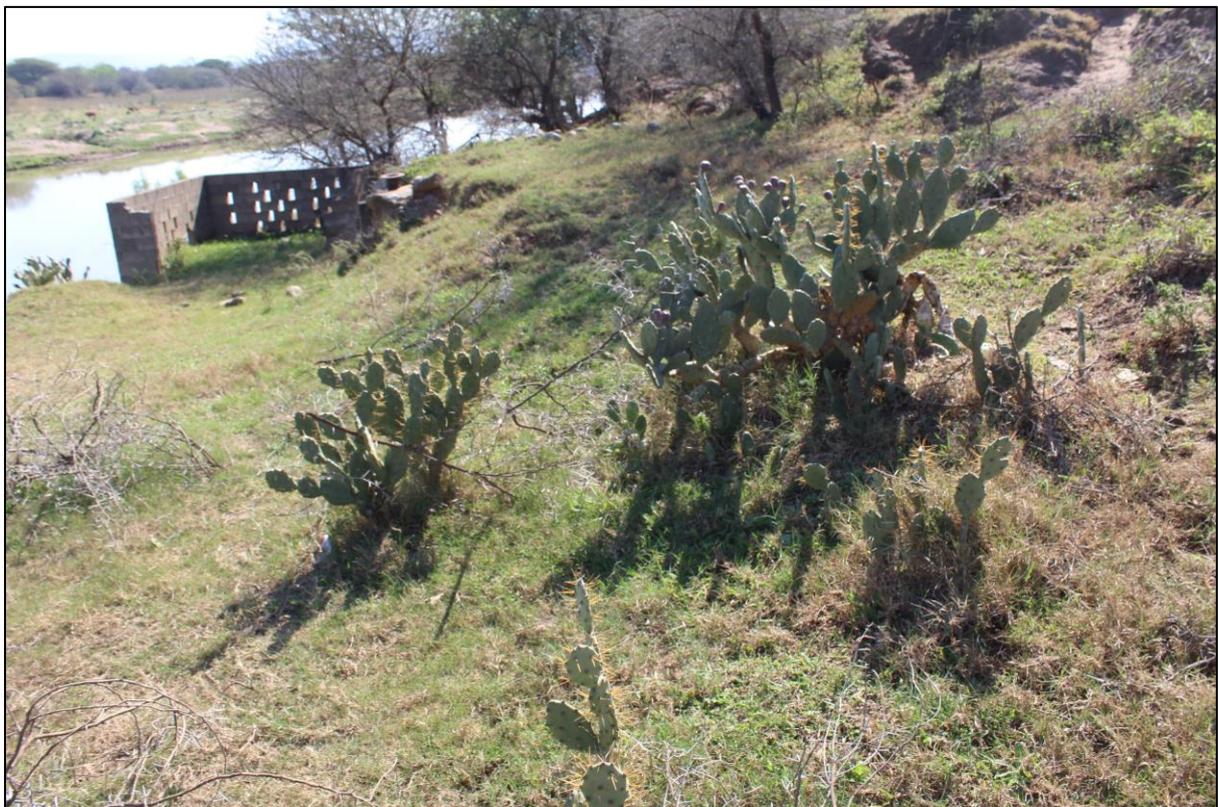
Figure 6-6: Alien vegetation in the riparian zone of the Tukhela River at the proposed abstraction point (August 2018)

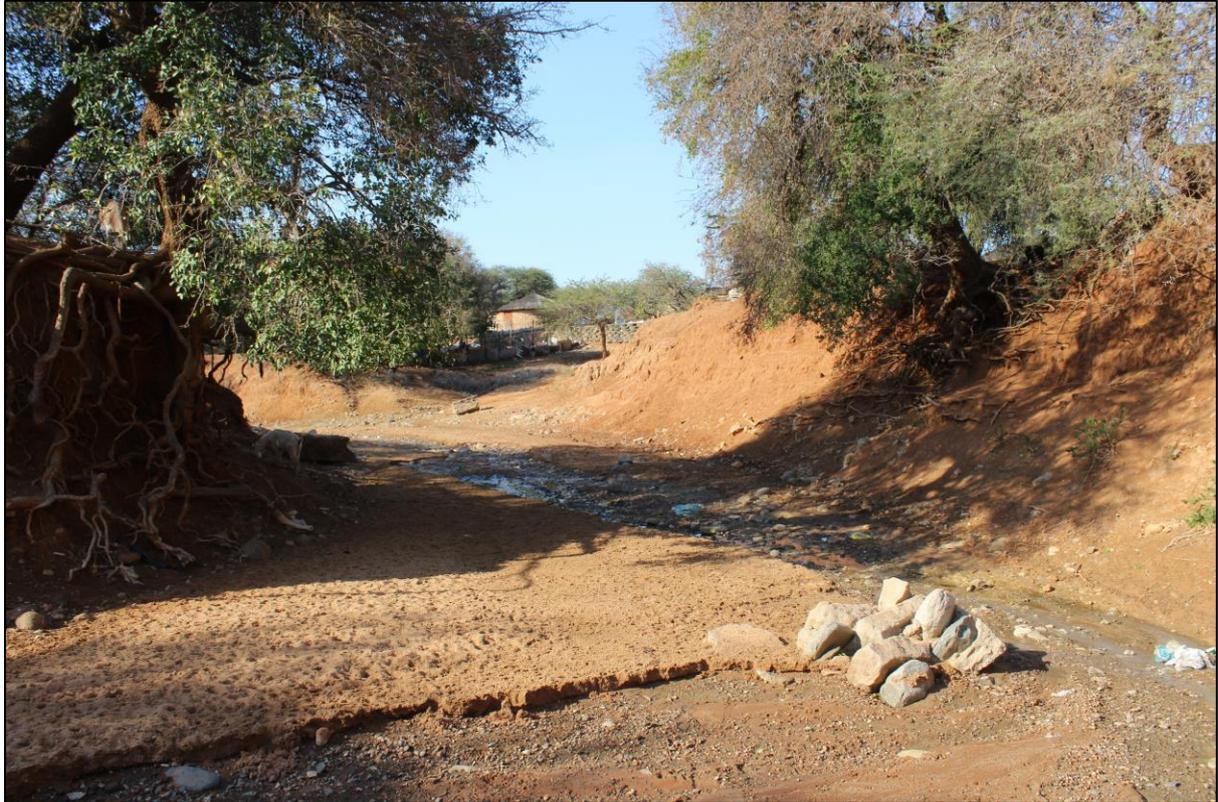
The aquatic habitats associated with the various irrigation canal crossings was largely composed of typical ephemeral drainage line habitats. Steep channels as a result of erosion in the drainage lines has significantly altered the instream and marginal habitat conditions of the various drainage lines studied (Figure 6-7). The use of irrigation canal water for domestic purposes has also resulted in some water quality modification within the drainage line systems. This instream modification was compounded by solid waste which likely was a result of direct dumping and litter picked up during runoff events (Figure 6-8).

Figure 6-7: Erosion and habitat alteration in the drainage lines associated with the proposed project (August 2018)

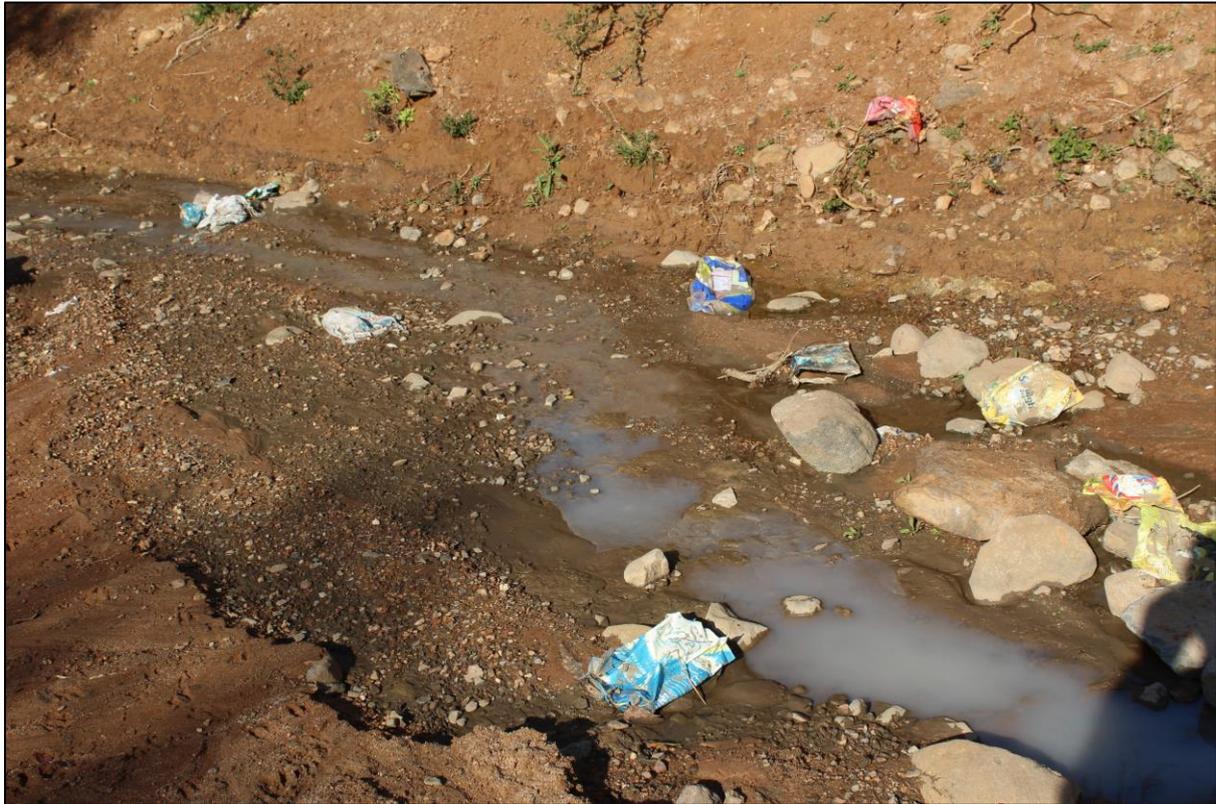
Figure 6-8: Water quality impacts stemming from the use of irrigation channel water for domestic purposes (August 2018)

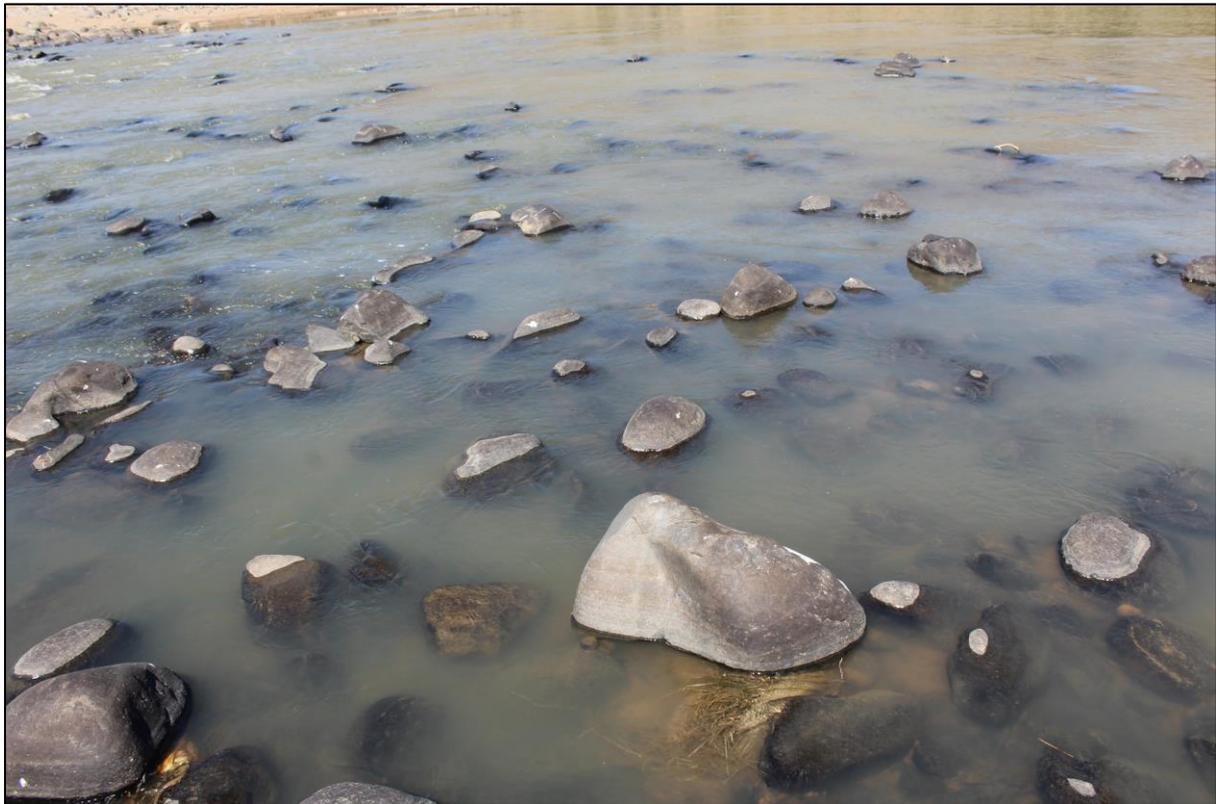
The watercourses assessed in this study were assigned a slope class E, indicating a lowland reach river system with typical lowland river features. Macroinvertebrate habitats consisted largely of marginal *Phragmites*, and submerged Pond Weed (*Potamogeton crispus*). Cobbled substrates in and out of current were also found to be abundant during the assessment. These habitats provide suitable aquatic biotopes for a wide diversity of aquatic macroinvertebrate types (Figure 6-9). Although substrates were suitable for invertebrate habitation, marginal vegetation was limited. This may reduce the overall presence of taxa belonging to the order Hemiptera. The absence of the marginal habitats was however considered to be related to natural factors.

Figure 6-9: Cobbled substrate at S2 (August 2018)

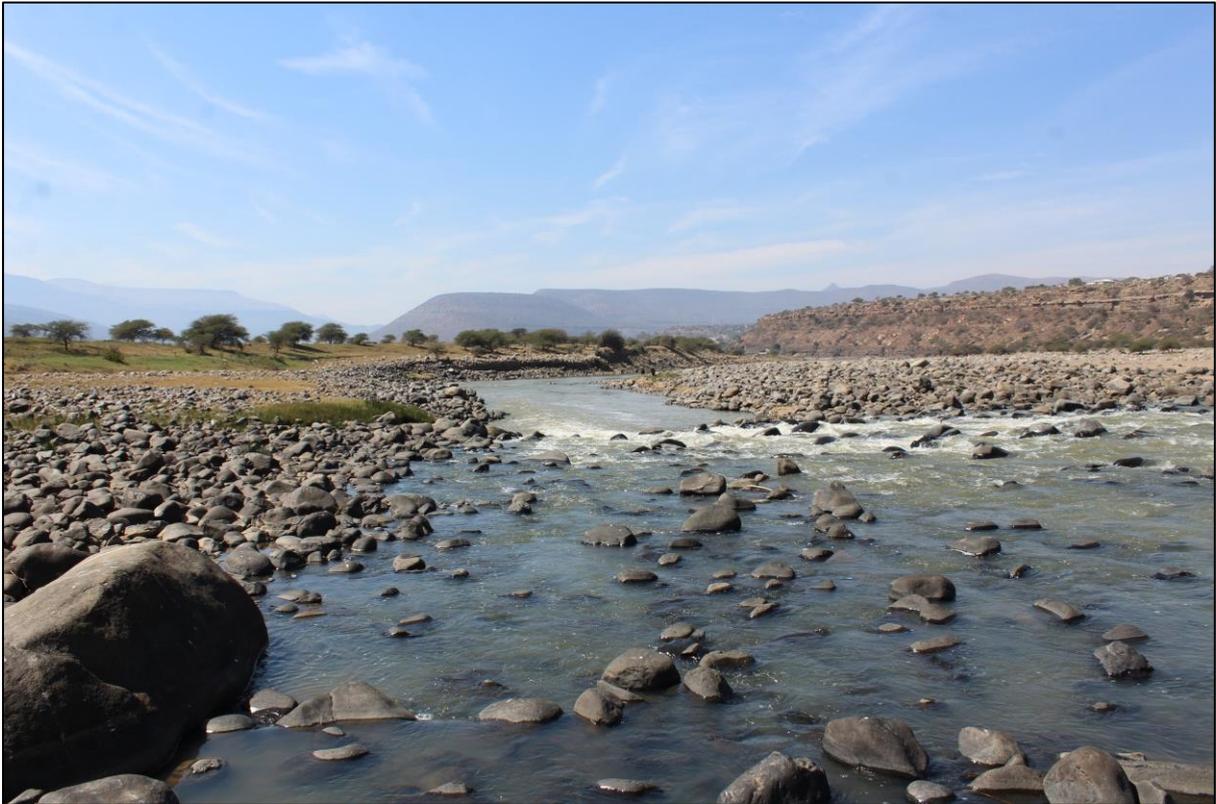
As provided in the results below, the dominant velocity depth class at the site was determined to be the fast shallow velocity depth class. Substrate consisted largely of boulders, cobbles and GSM (Figure 6-10). The river zonation (morphology) and gradient conforms to the class E geoclass (lowland river) and therefore the project area is within a depositional zone. However, cobble substrates with bedrock boulders were observed within the project area indicating that some rejuvenation may occur within the proposed project area (Figure 6-11).

Overall discharge measured at the site was 5.4 m³/s, this was within range of the established discharges in the IFR Study (DWAF, 2000).

Figure 6-10: Velocity Depth Class and Dominant Substrates at the S2 Transect (September 2018)

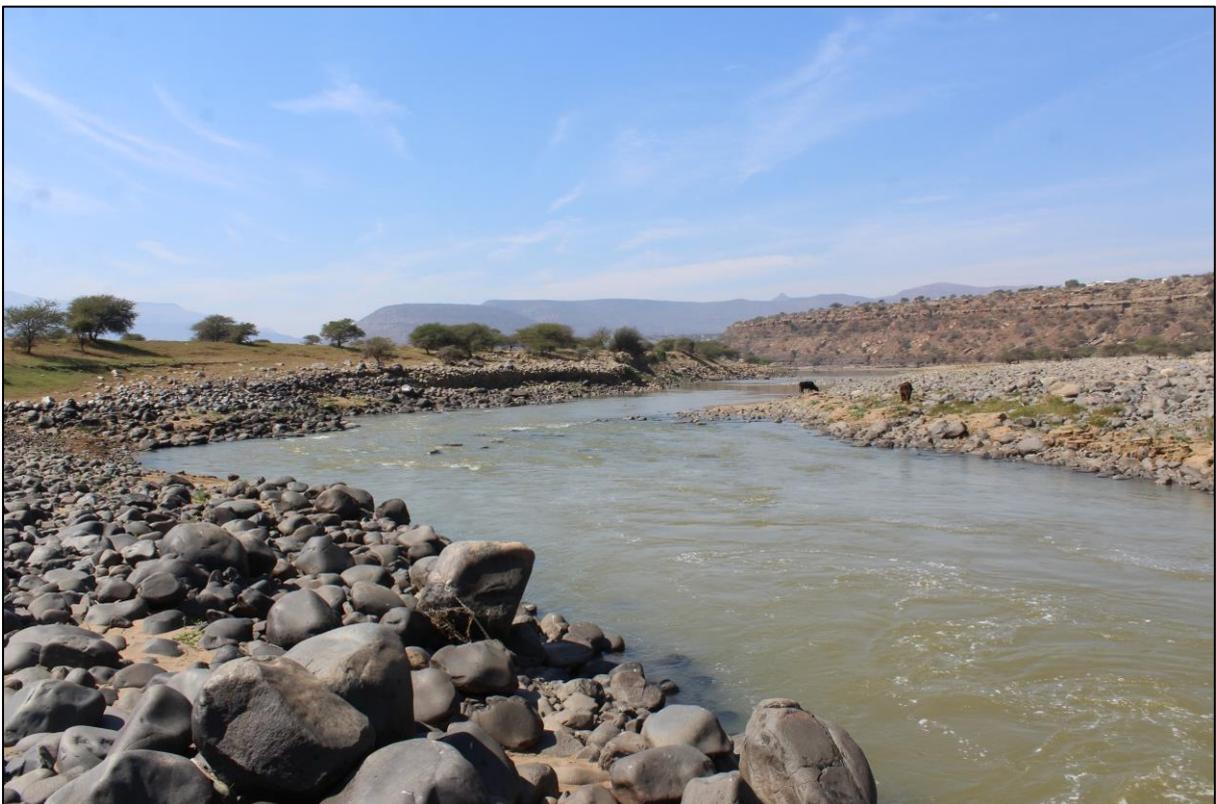
Figure 6-11: Channel Morphology Illustrating Steep Banks and Seasonal Floodplain Areas (S2, September 2018)

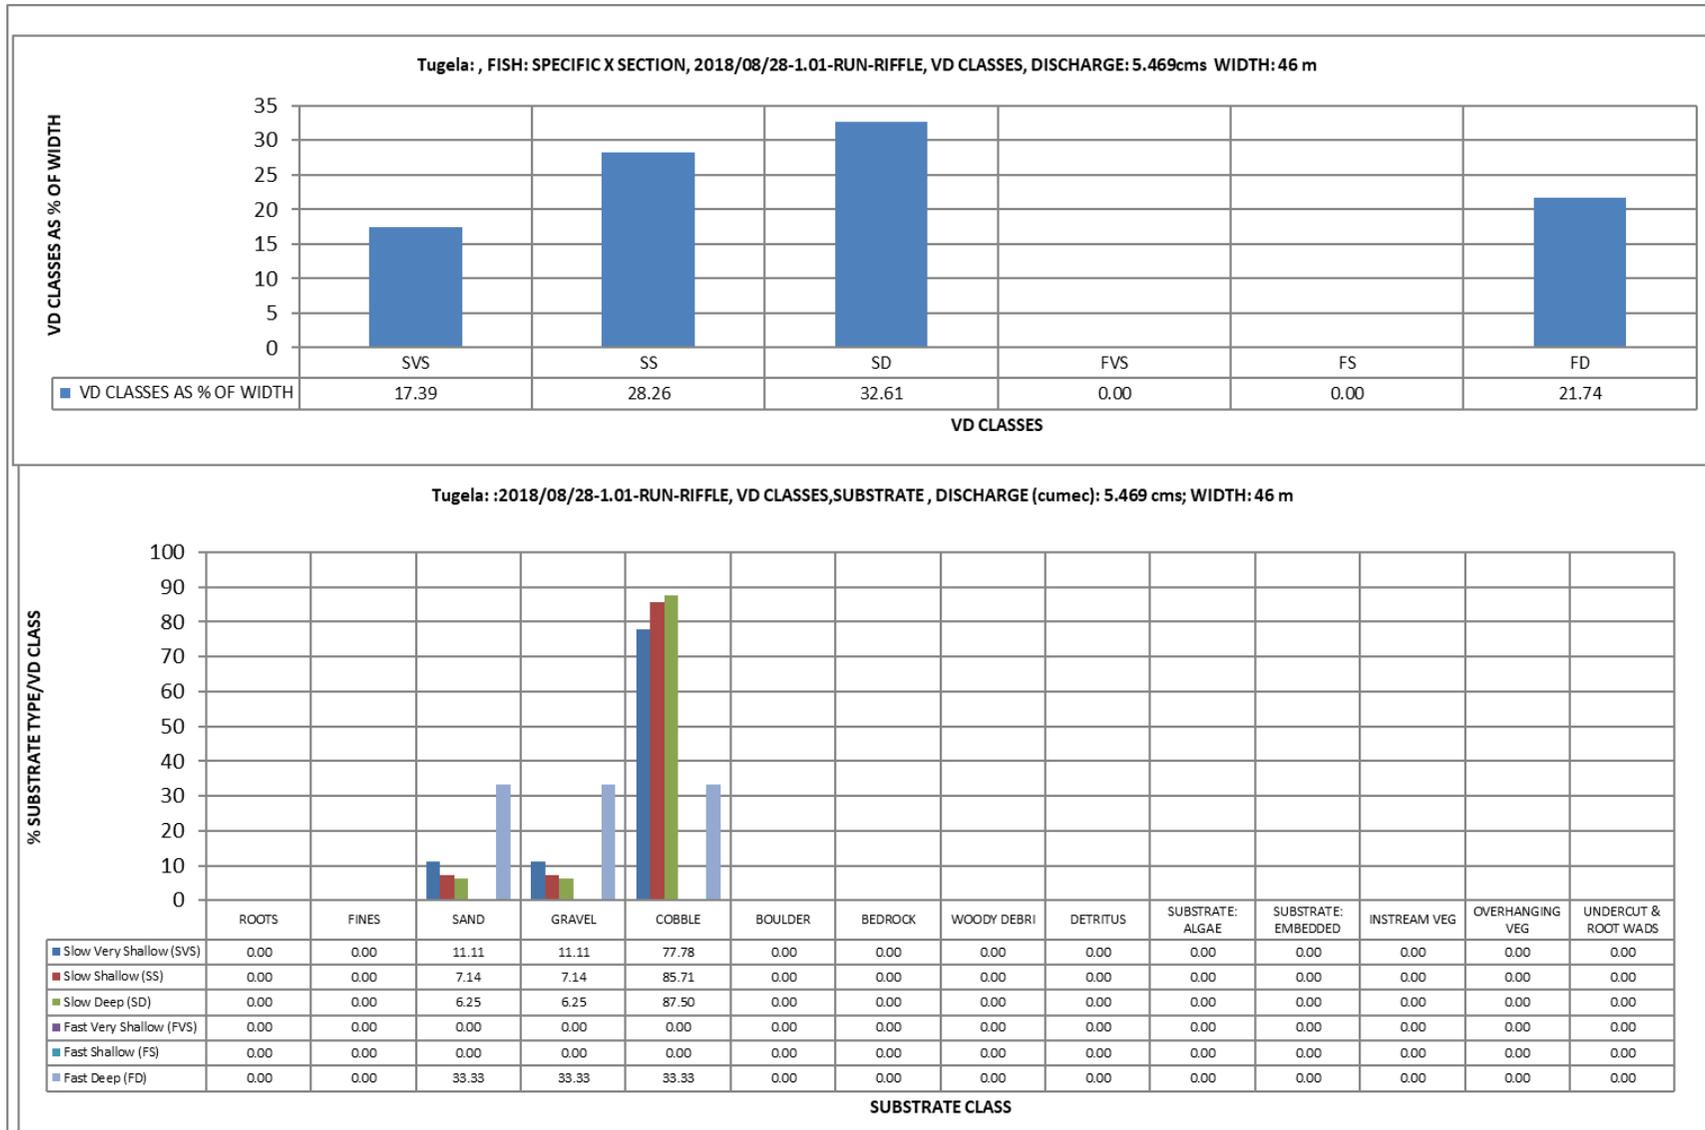
Figure 6-12: Velocity depth classes for Transect T2

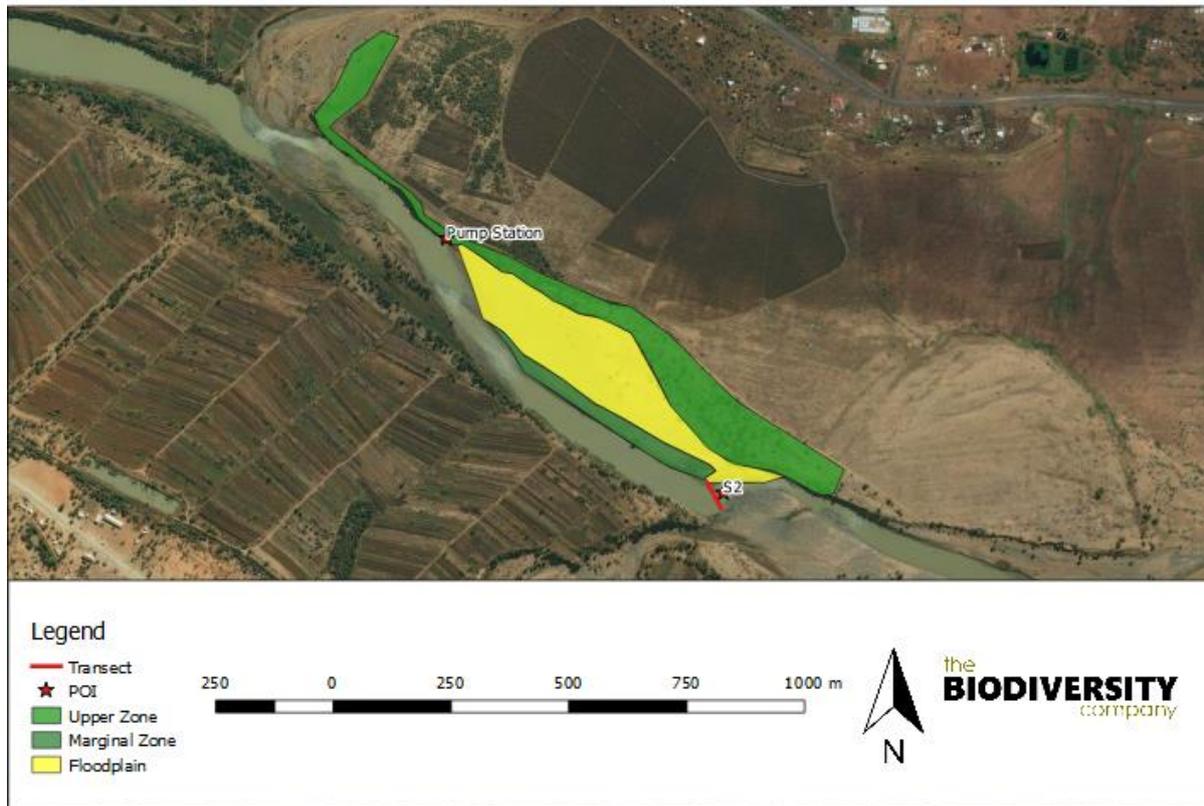
The riparian zone consisted of a river floodplain complex with limited marginal zones and an extensive floodplain zone. The upper riparian zone was confined to be macro channel and was dominated by *Vachellia* karoo. The delineation of the riparian areas in relation to the proposed project area for the perennial systems are provided in Figure 6-14. As noted above, the riparian zone of the drainage lines were limited to their immediate river banks. A standard buffer zone will be applied to these areas.

Figure 6-14: Riparian delineation for the proposed pump-station

The proposed construction footprint for the abstraction pump is located within the riparian zone. It is recommended that this permanent structure sit is moved outside the delineated riparian area. It is further recommended that the 1:100 year floodline is delineated and used as a guide for the choice of the pump station.

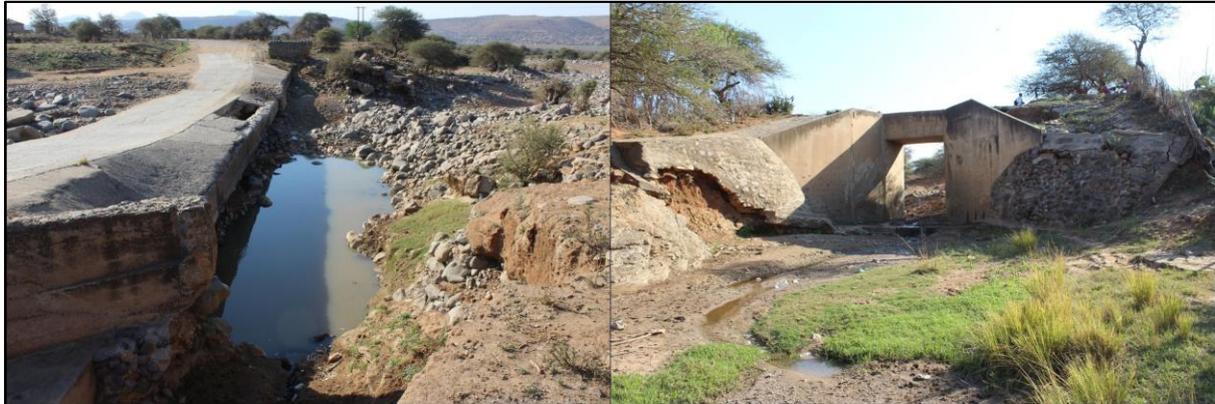
The existing pipeline crossings consist of constructed concrete structures in the form of bridges and concrete pipe crossings (Figure 7-1).

Figure 7-1: Existing watercourse infrastructure crossings (September 2018)

The proposed siphon rehabilitation will take place on existing infrastructure. Considering this, no additional river banks will be extensively modified. River bank erosion was observed within the existing banks associated with the crossing points. Short term impacts can be anticipated during the rehabilitation actions. These impacts may include the disturbance of non-perennial river banks and sedimentation. It is however anticipated that these impacts will be limited to the construction phase with the conditions stabilising and improving following the completion of the construction phase.

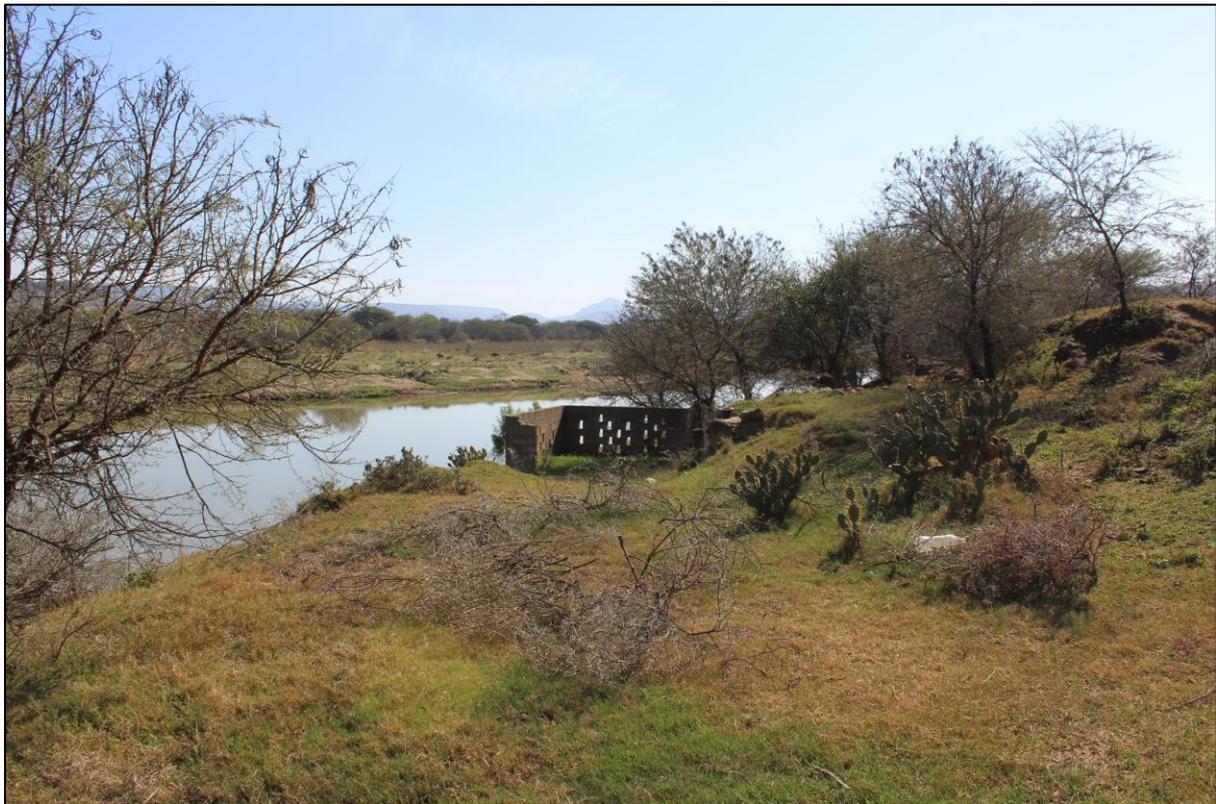
Figure 7-3: The existing frame of a pump-station that is proposed to be upgraded (September 2018)
