Water Resource Assessment for the proposed Mpungose Water Supply Scheme

Empangeni, KwaZulu-Natal

March 2019

Mpungose Water Supply Scheme

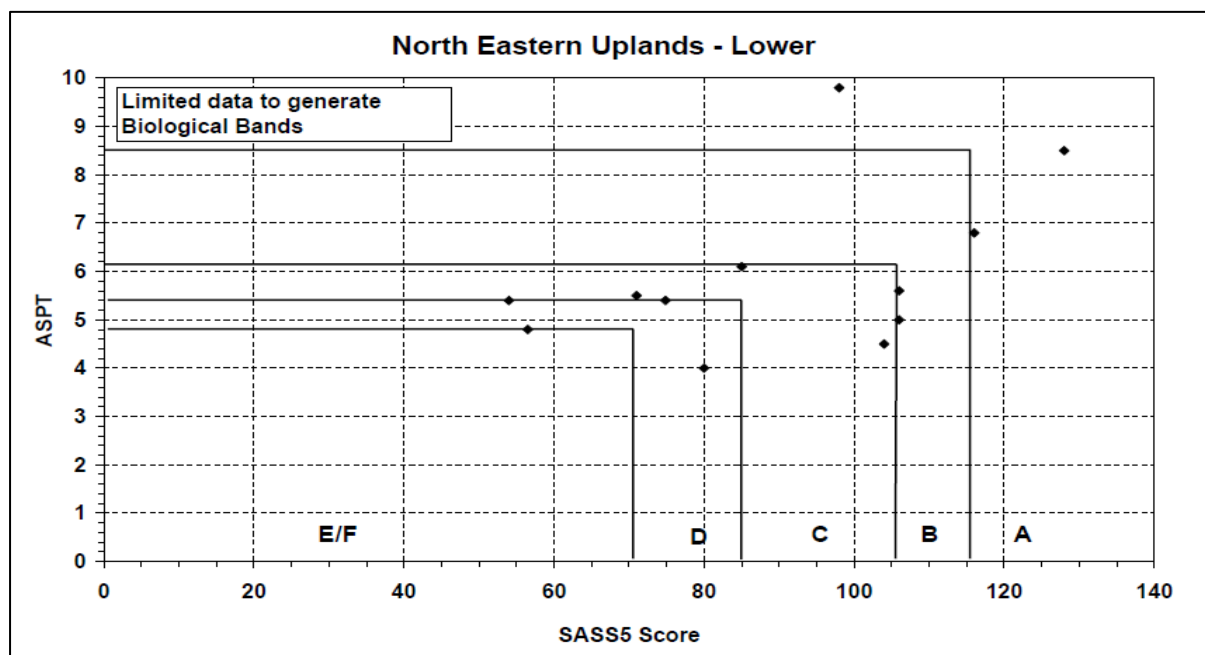
Figure 3: Biological Bands for the North Eastern Uplands - Lower Ecoregion, calculated using percentiles

All SASS5 and ASPT scores are compared with the SASS5 Data Interpretation Guidelines (Dallas, 2007) for the North Eastern Uplands - lower ecoregion (Figure 3). This method seeks to develop biological bands depicting the various ecological states and is derived from data contained within the Rivers Database and supplemented with other data not yet in the database. Ecological categories based on biological banding are presented in Table 6.

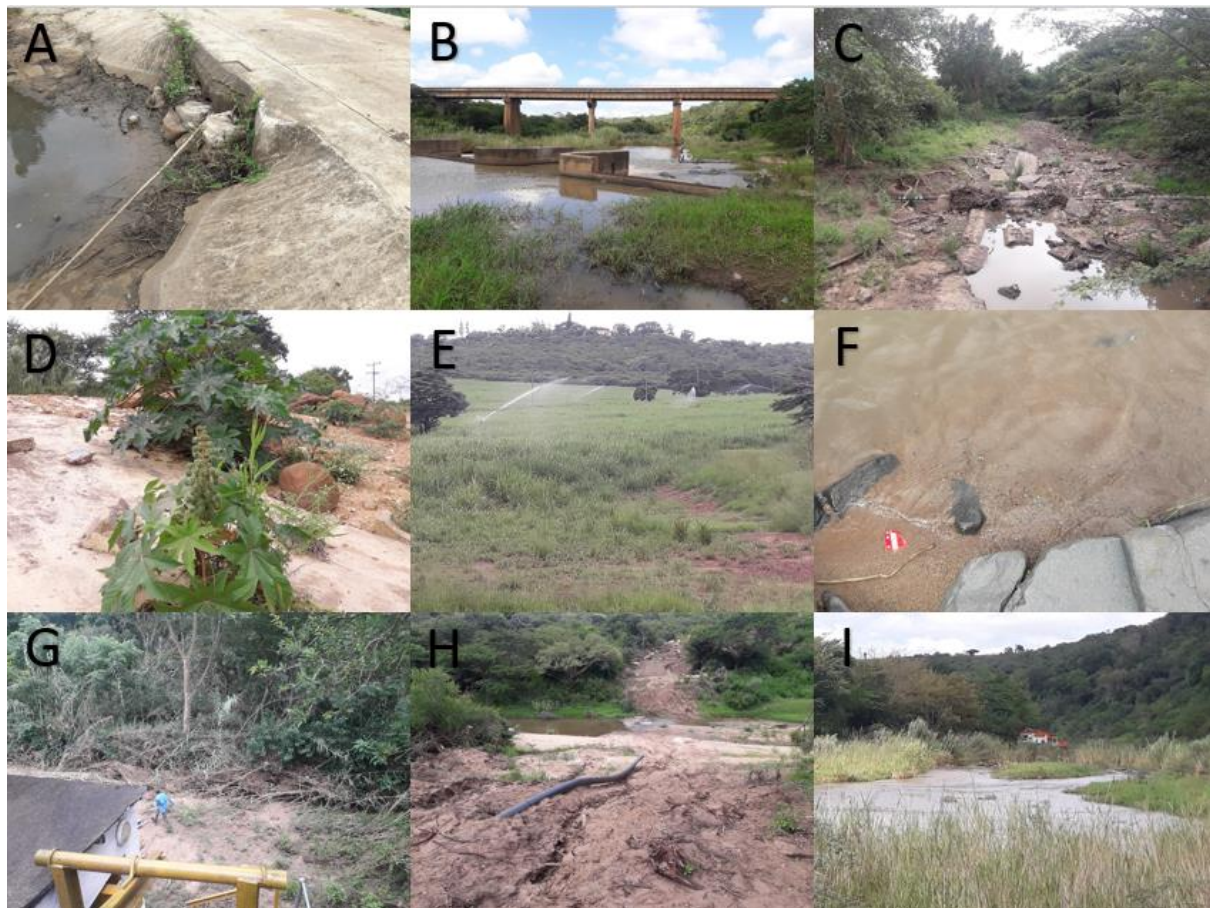
Figure 15: The impacts on the wetland’s health of the Mpungose WSS project area, A) Damming, B) Crossing structures and weirs, C) Eroded channels, D) Alien vegetation, E) irrigation, F) Sedimentation of systems, G) Water abstraction works, H) Pipeline installation and crossing activities, I Sand mining.

Road crossing (culvert or low-level crossings) have similar impacts that dams have, but at a smaller scale. The natural diffuse nature of the water-flow through wetlands is altered, as culverts cause direct flow to occur, reducing the time for infiltration and promoting erosional processes.

The impacts that affected the wetlands are shown in Figure 15.

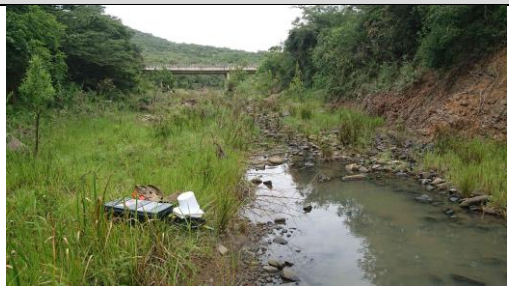
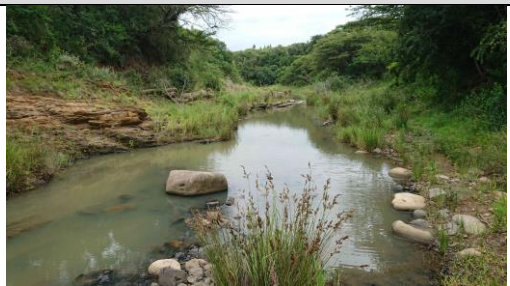
Upstream	Downstream
MTK

GPS	28°48'17.04"S 31°39'46.75"E	
Site n	Site MTK is located on the Mateku River. The site was characterised as a slow flowing river (trickle) over stone in and out of current, bedrock, gravel, sand and mud biotopes, with moderate abundances marginal vegetation present.

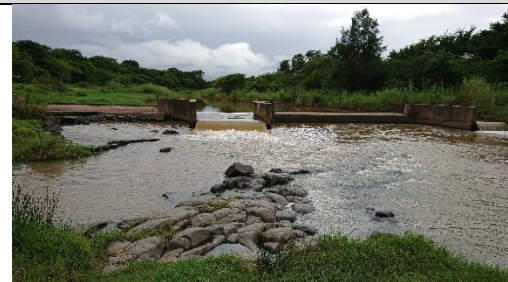
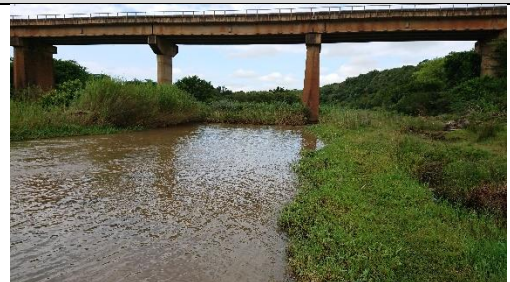
Upstream	Downstream
MLT

GPS	28°44'58.07"S 31°44'42.71"E	
Site	Site MLT is located on the Mhlataze River. The site was characterised by a diversity of flow classes over stones in and out of current, bedrock, sand, gravel and mud biotopes, with a moderate diversity of marginal vegetation. A weir influences flow and habitat at the site
