ENVIRONMENTAL IMPACT ASSESSMENT REPORT And ENVIRONMENTAL MANAGEMENT PROGRAMME REPORT

NAME OF APPLICANT: WEDBERG COMMUNAL PROPERTY ASSOCIATION

FILE REFERENCE NUMBER SAMRAD: NC-00047-PR/102

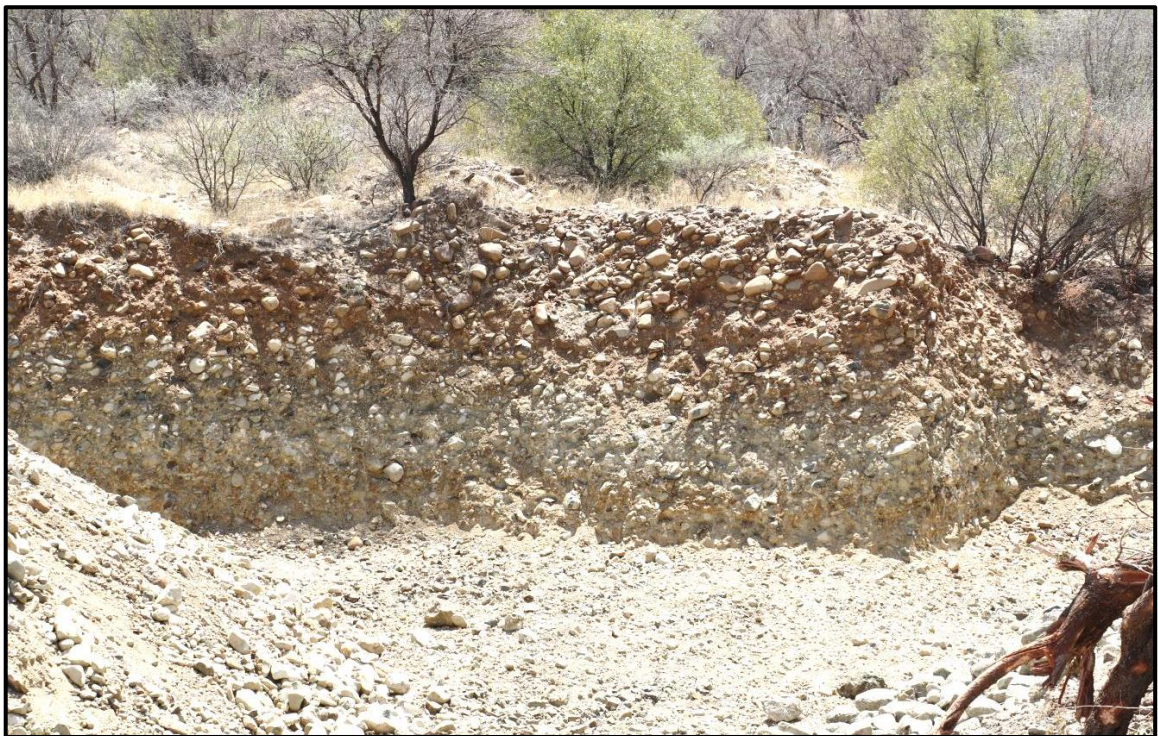
An excavated pit, indicating diamondiferous gravels

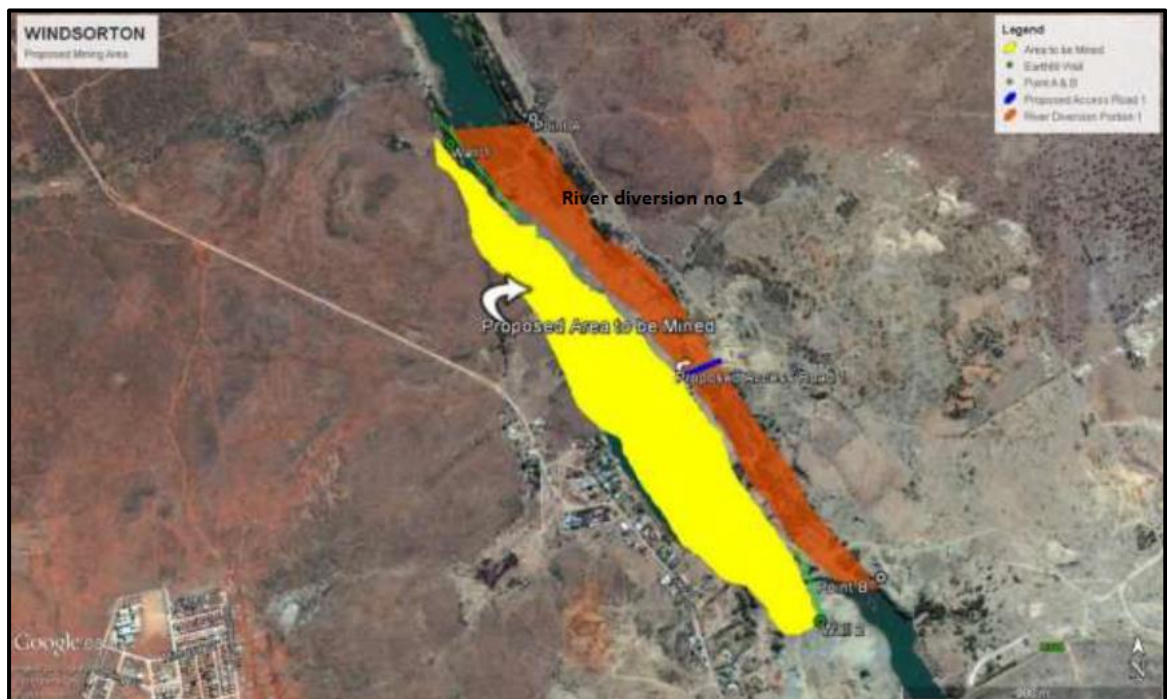
Proposed mining area at river diversion no 1

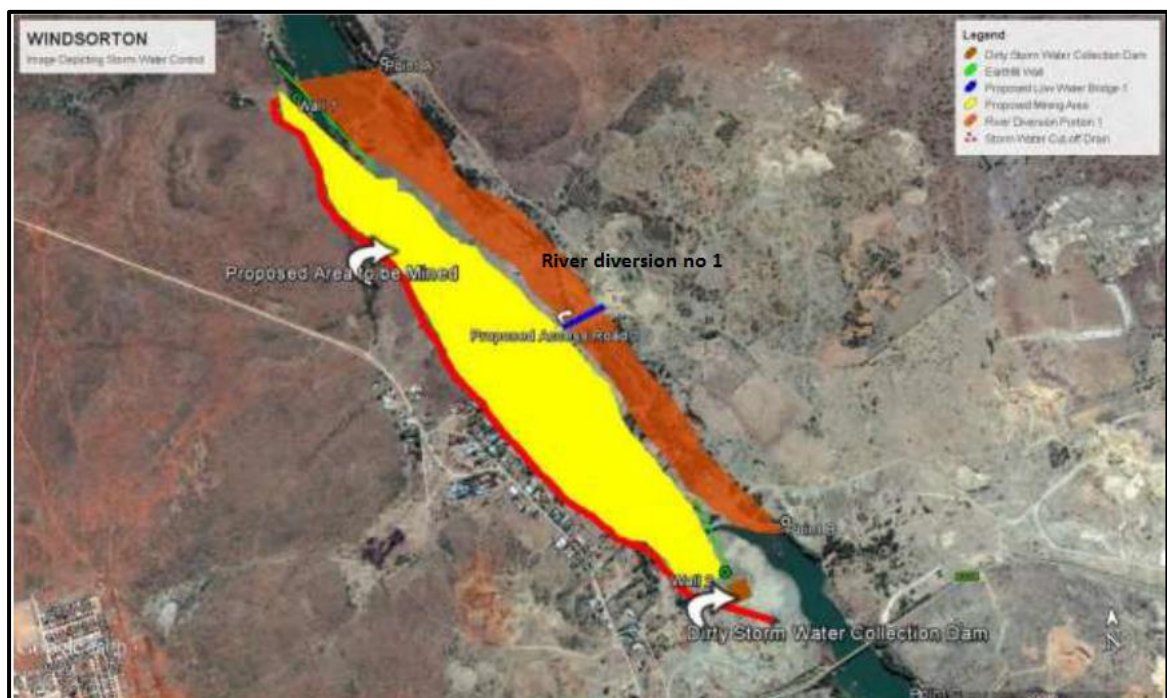
These cut-off drains will divert clean storm water runoff during a rainstorm around the proposed prospecting area following the natural contours into the Vaal River downstream:

Proposed cut-off berm at river diversion no 1

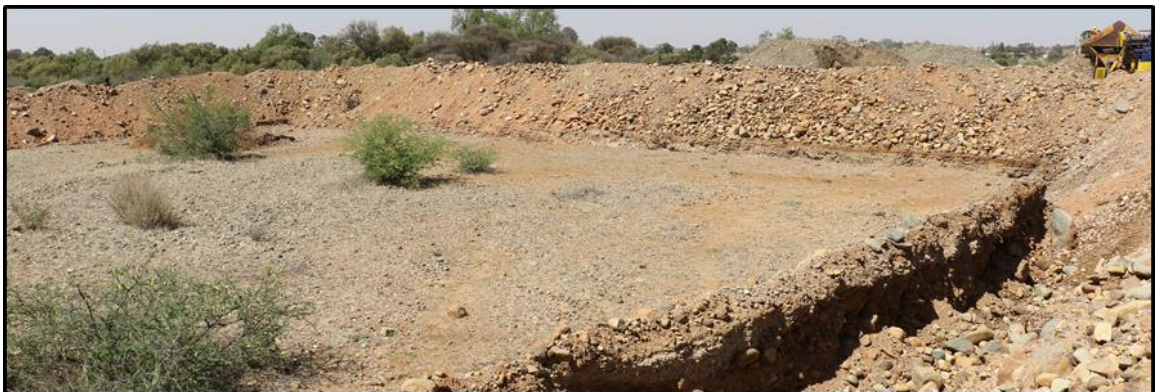
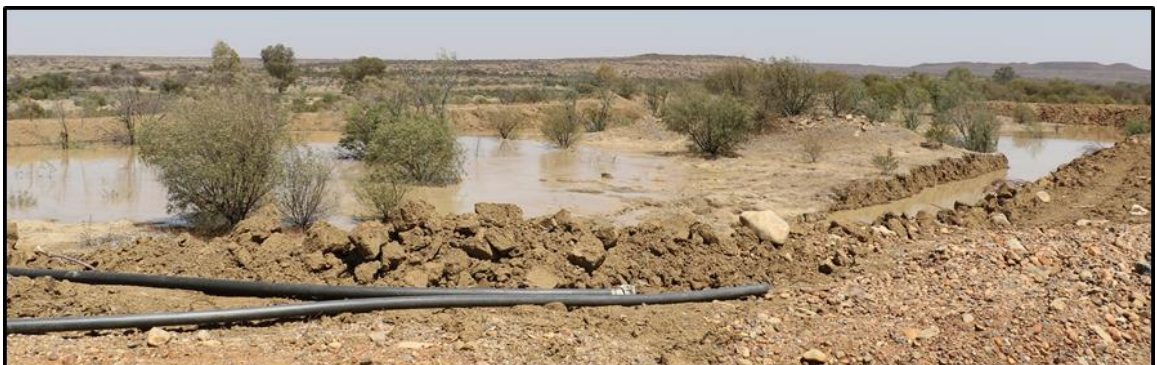
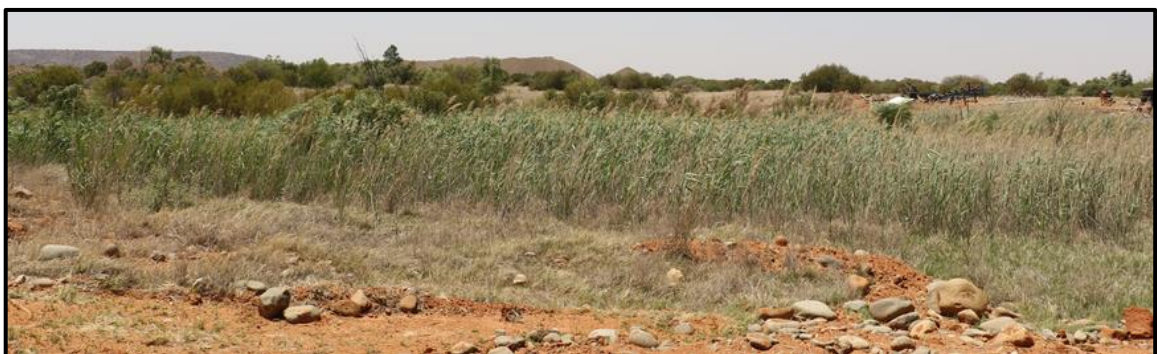
Residue from the pan plants are processed through de-watering screens where the sand is removed for beneficiation at some sites. The remaining slimes (sludge) are then pumped from the plant onto slimes dams and gravitated to the walls, providing time for settlement to take place and cleaner water to drain towards the walls. Each site has at least one active slimes dam, i.e. four slimes dams in use on the prospecting area.

Typical slimes dams found in the prospecting right area.

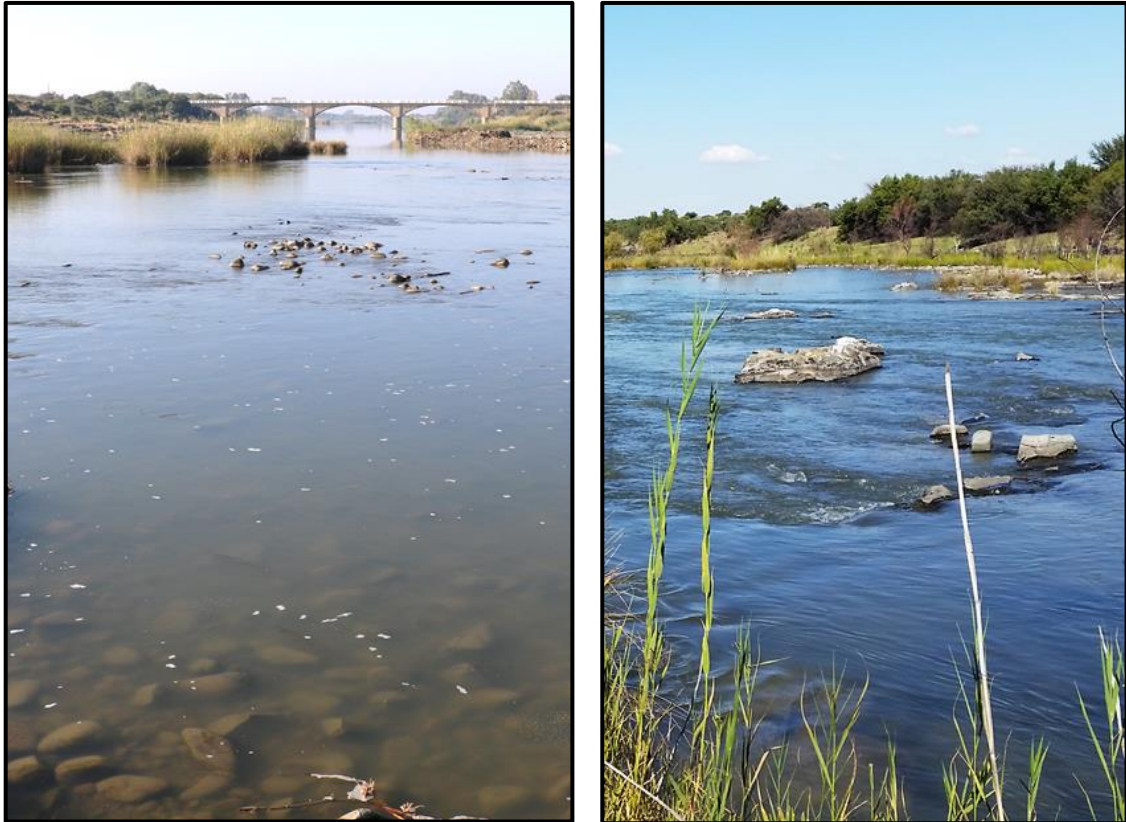
The substrate of the Vaal River mainly consist of alluvial sand-bed with cobbles (left), but bedrock protrudes the surface at places (right).

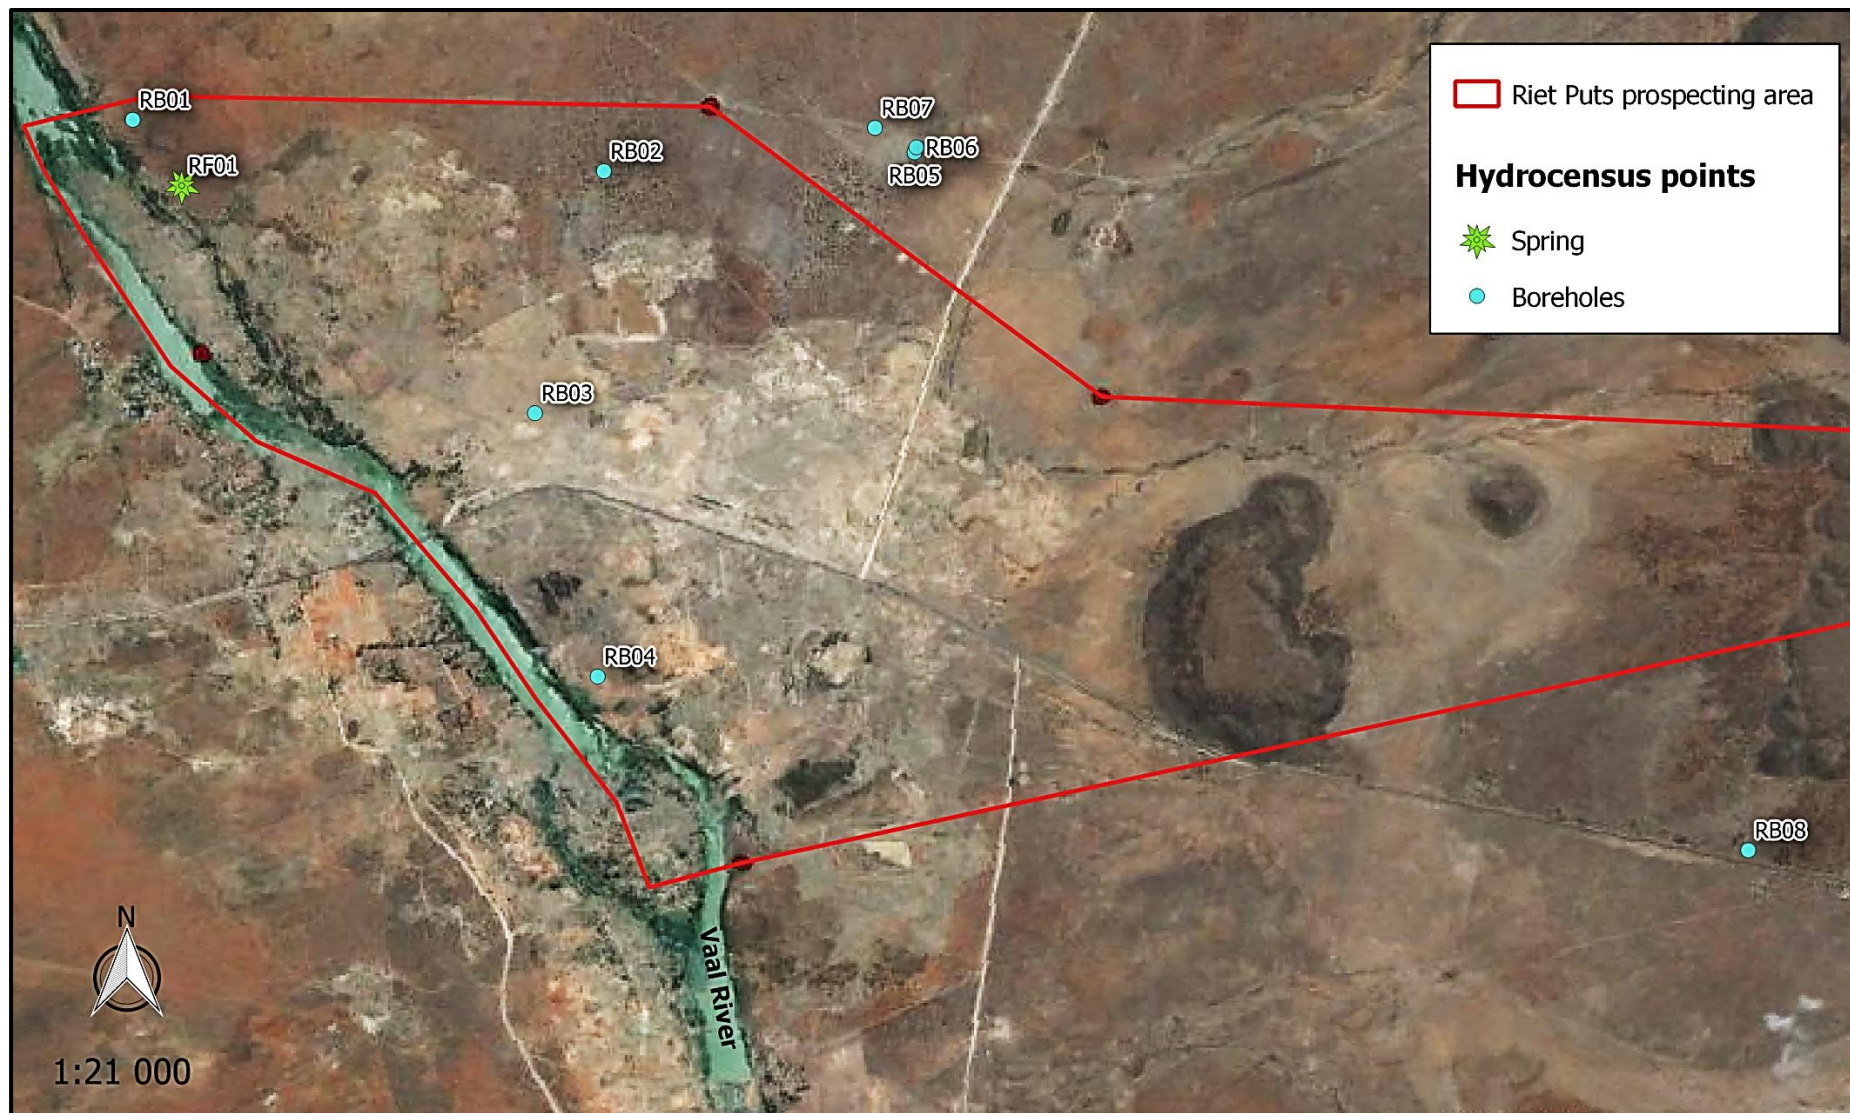
The location of hydrocensus points on and near the Riet Puts prospecting area.

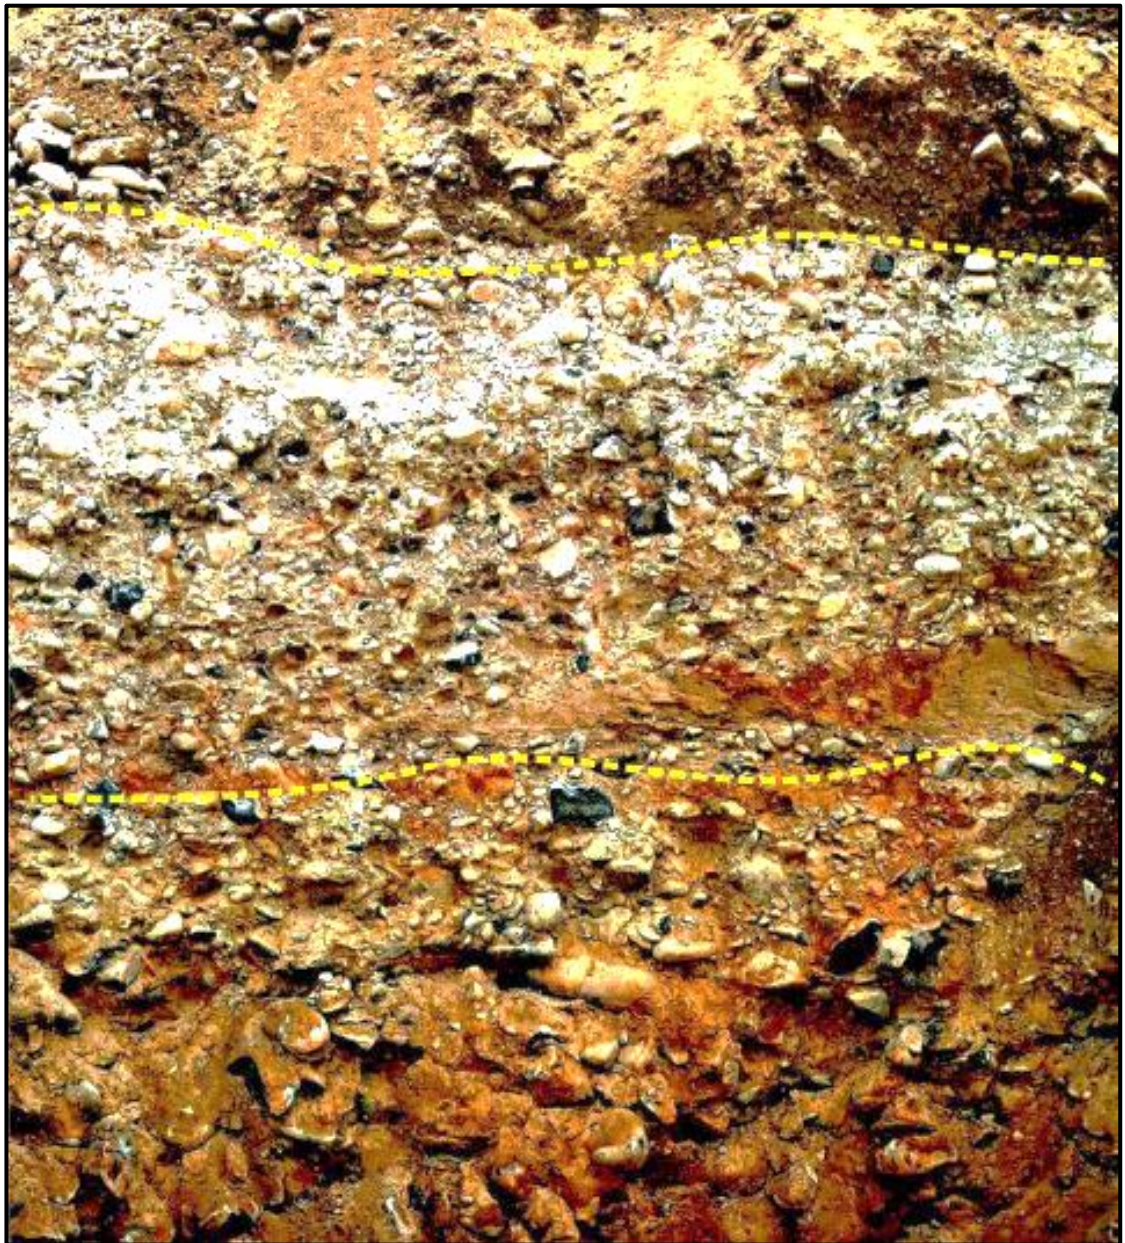
An upward fining sequence of coarse gravel within the Rietputs Formation.

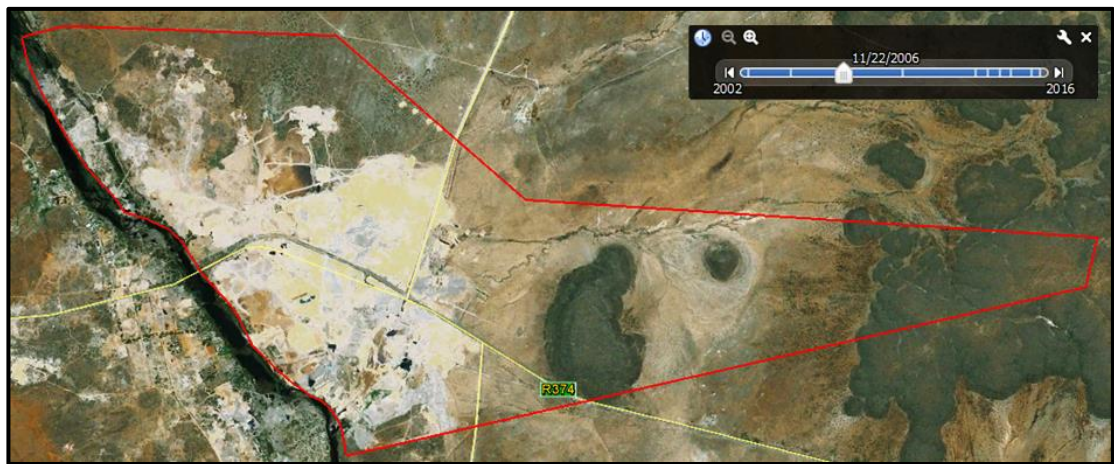
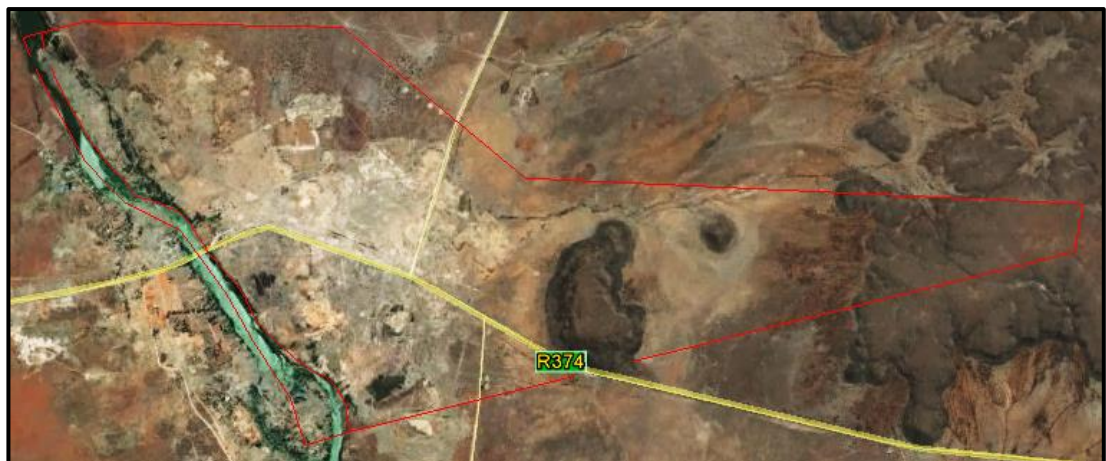
Google earth images indicating the extent of preceding disturbances on Riet Puts. The top image depicts condition of the study area in 2006 after which past mining operations were active, while the bottom image depicts the most recent conditions (2016).
