Wetland Assessment for the proposed Mantuli Road Phase 2 Project

**Nquthu Local Municipality,
KwaZulu-Natal**

September 2018

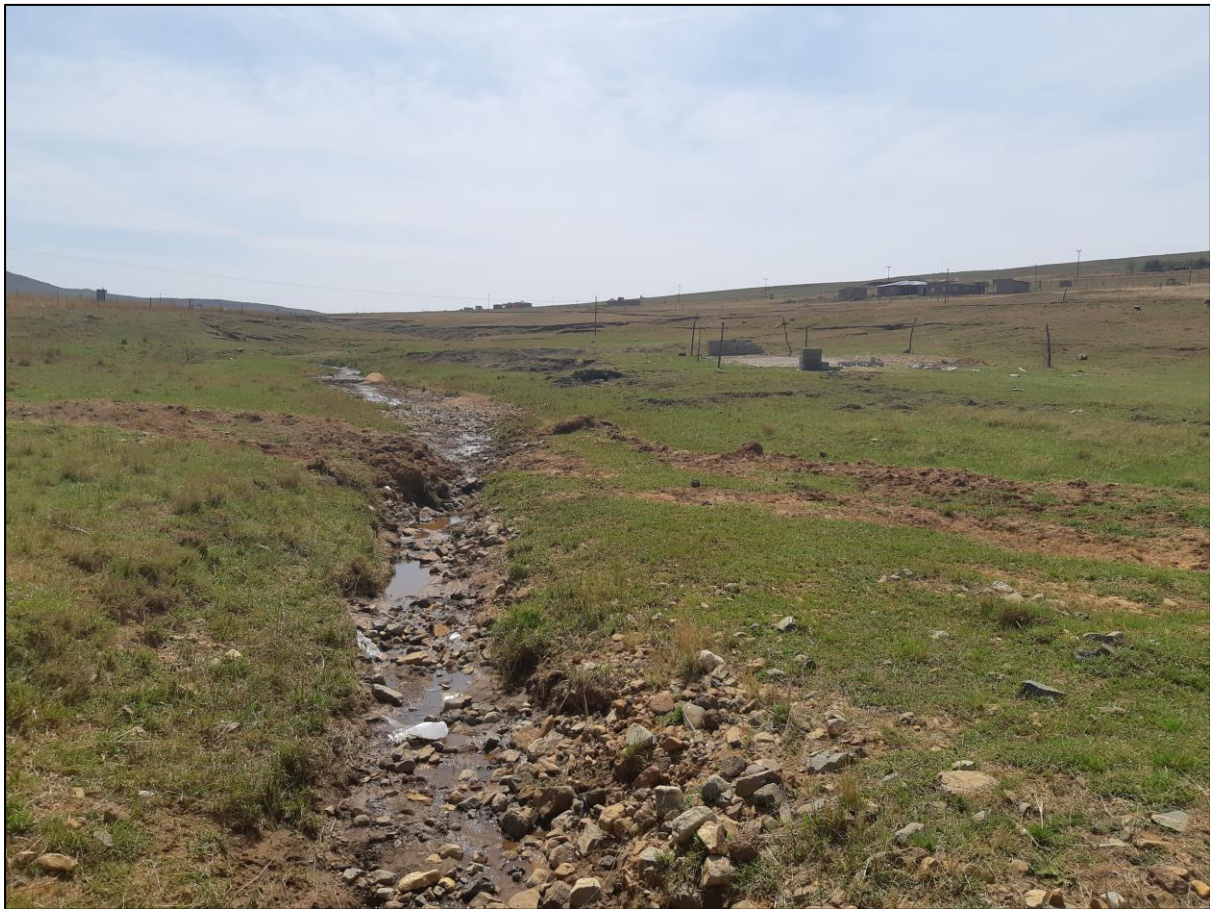
Figure 3: Identified drainage line

The wetland was determined to be in a Largely Modified (D) state as a result of the surrounding of erosion within the wetland, driving through the wetland, subsistence farming and alien invasion. Several drainage lines were identified in the project area as presented in Figure 3.

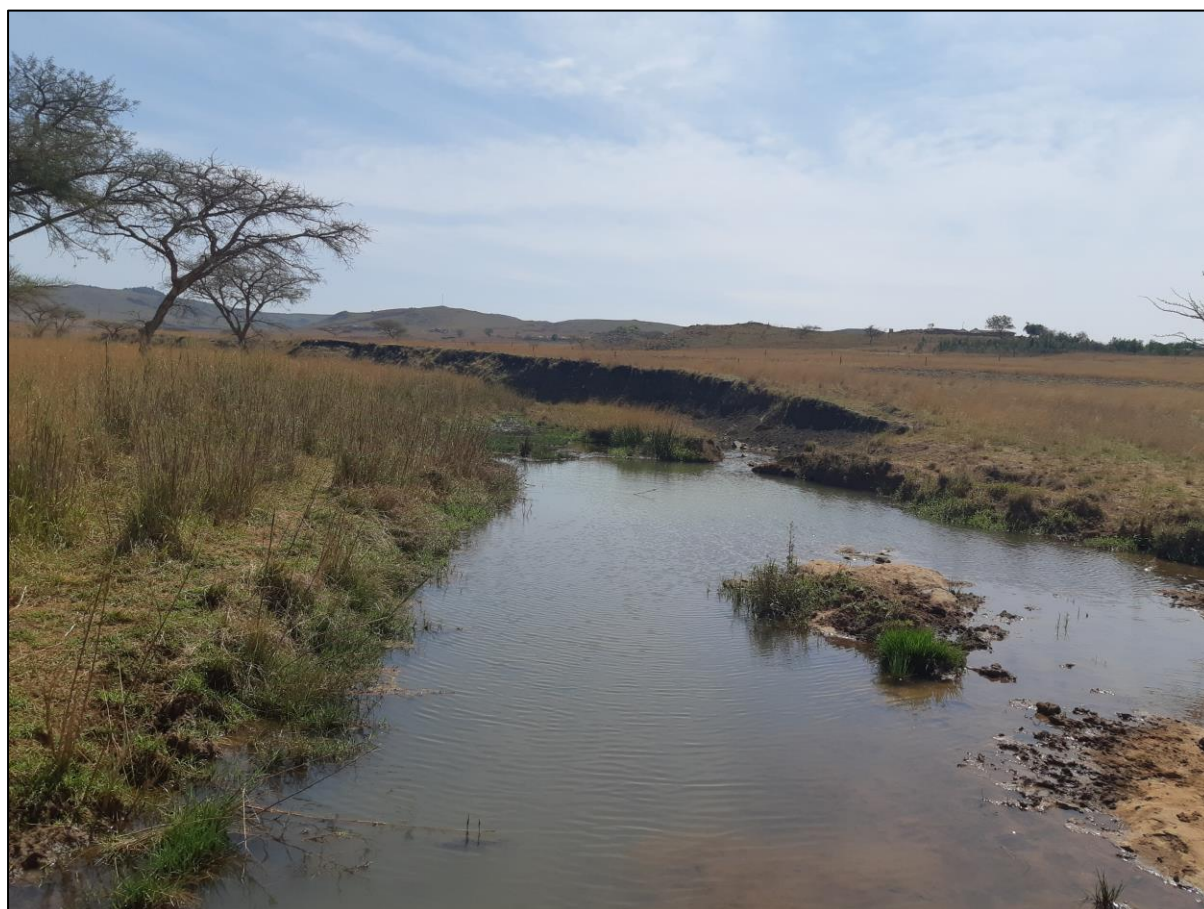
The identified wetland is shown in Figure 5. The only wetland plant that could be identified was *Juncus spp.* Some intermediate wetland plants included *Digitaria eriantha* and *Pennisetum clandestinum*. The dominant soil within the wetland was the Katspruit soil form which can be seen in Figure 6.

Figure 5: Identified Channelled valley bottom wetland (HGM 1)

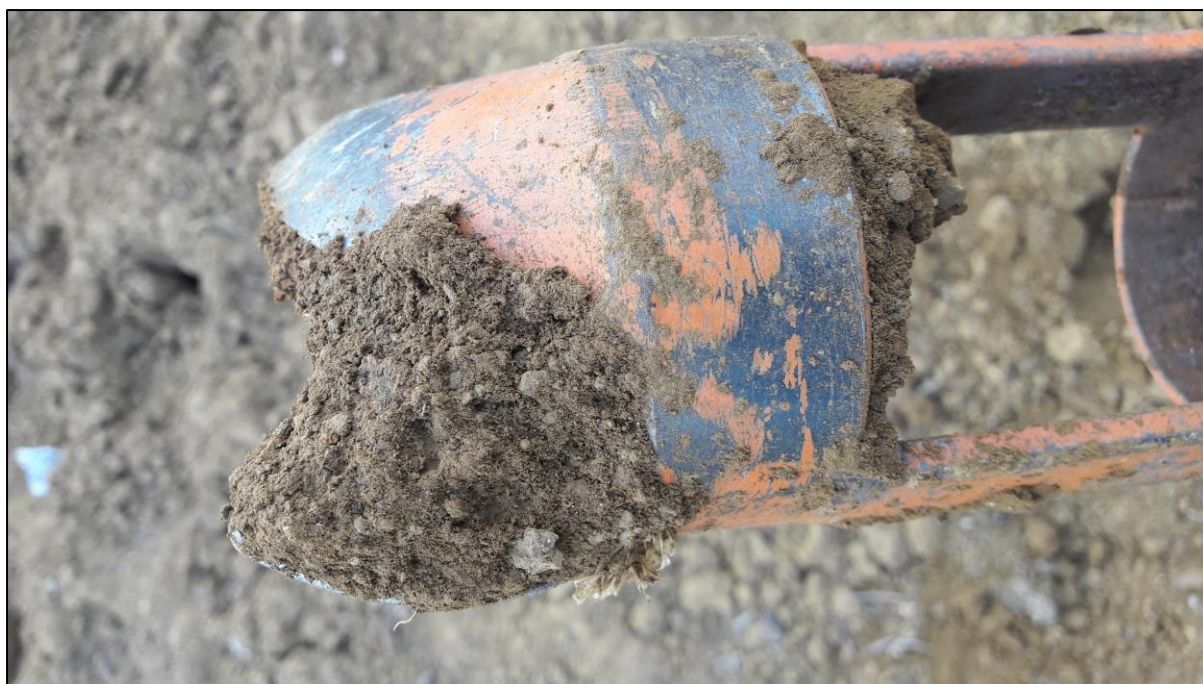
Figure 6: Katspruit soil form

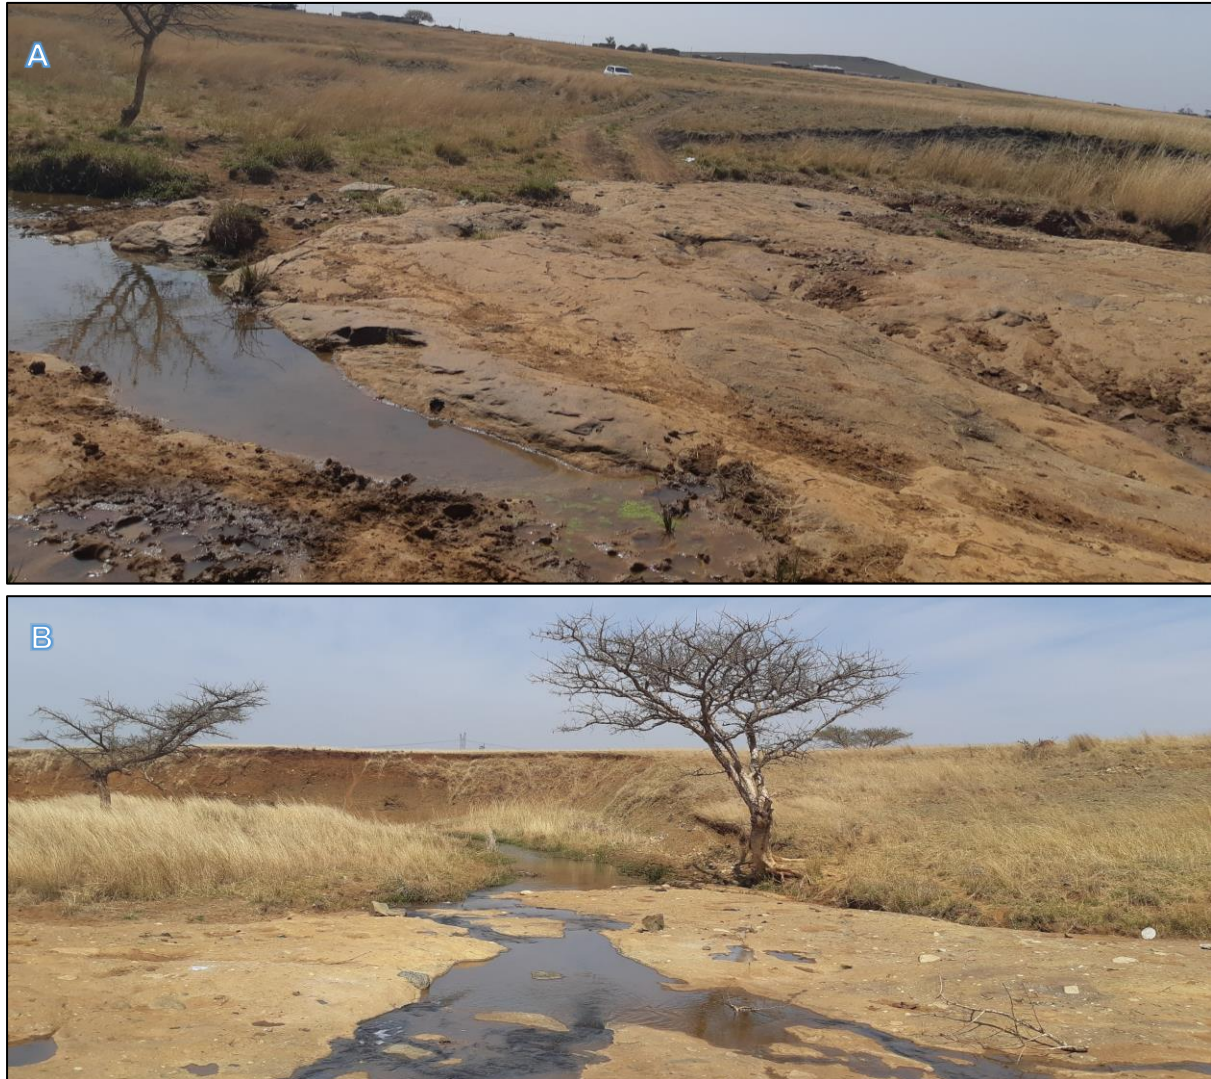
- The **hydrological** component for the HGM 1 has been altered by the current road crossings, reduced vegetative cover, and the development of roads, the increased hardened surfaces in the form of housing units and agricultural practices on the wetland edges. The hardened surfaces have altered flow volumes and intensities which enter the wetland. The current crossing had resulted in the erosion of soil and created a hardened surface (exposed bedrock) within the wetland which causes increased flow velocities and erosion of downstream areas, where flows are intensified within the wetland and erosion occurs. The reduced and altered vegetation through the subsistence farming patches has impacted on the hydrology especially in HGM 1.

- The **geomorphology** component for the HGM units assessed were determined to be Largely Modified (D) with marked increase in runoff and severe erosion occurring within the catchment.
- The **vegetation** component for the HGM unit was Largely Modified (D) respectively as a result of the low wetland plants identified within the wetland.

Figure 7: Identified impacts A) Hardened surfaces (houses) in wetland catchment and decreased vegetative cover in the catchment B) Erosion in the wetland and invasive trees

1. Re-shape and contour the banks around the causeway structure;
2. Stabilise the embankments with necessary aids (gabions, geomats etc.);
3. Revegetate the embankments and channel areas with the plants listed in Table 13. It is recommended that these plants be salvaged from the area and re-planted, or a suitable (similar) seed mix be applied to the affected areas; and
4. Ensure that water flows through the channel are dispersed and that water flow is uninterrupted.

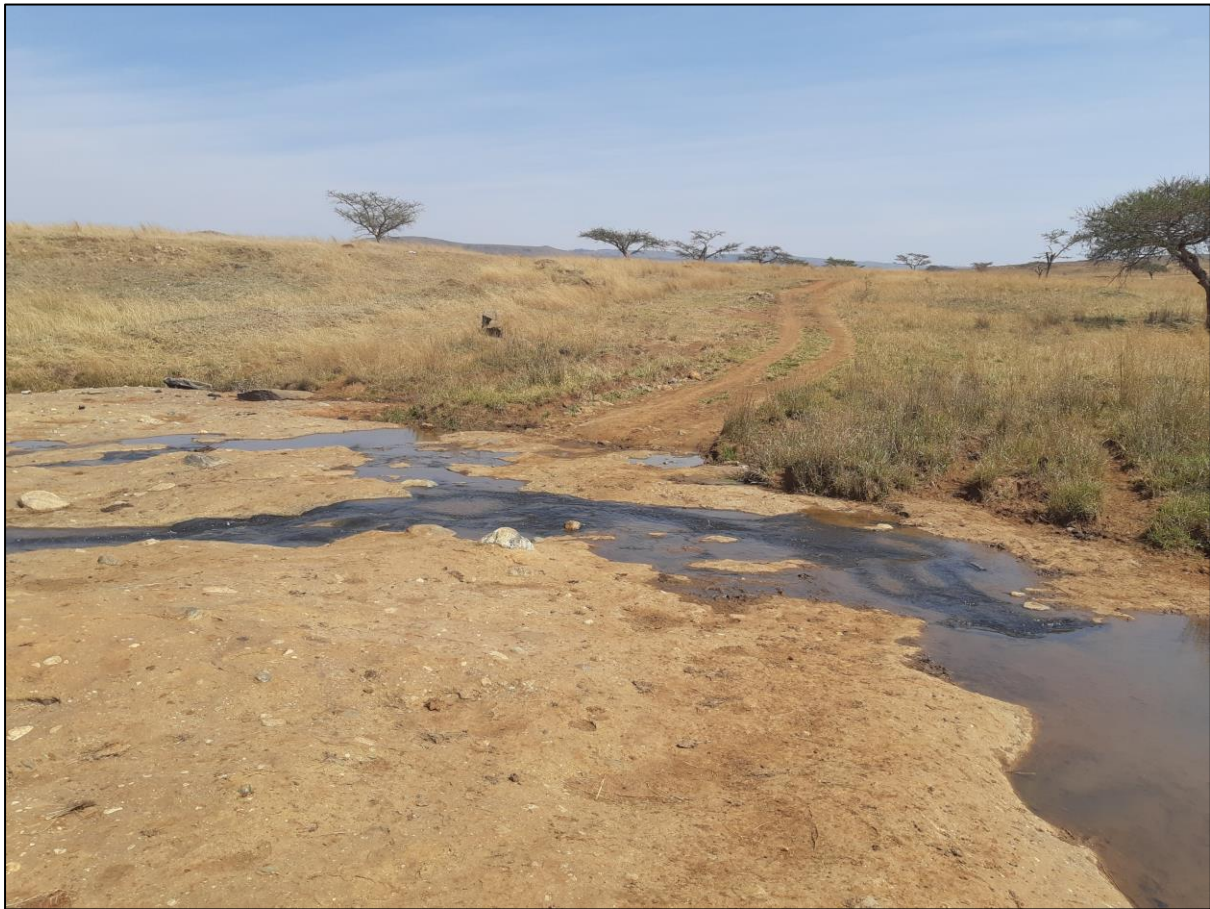
The proposed project is for the upgrade of two roads and the construction of two causeway structures. The causeway structures will be constructed within the boundaries of the channelled valley bottom (HGM 1) and a drainage line, which, as a result, will be directly impacted on. As this project entails the upgrade of infrastructure and the construction of new infrastructure, impacts associated with the area are potentially moderate to low, based on the current onsite crossings (Figure 9). Modifications to the wetland habitat is likely to occur during construction. The project will entail the cutting, reshaping, and change in hydrodynamics of the wetland. This has the potential to increase erosion and sedimentation of downstream habitats due to surface runoff during the wet season.

Figure 9: One of the crossings (Crossing 1) and the current road
