Wetland Assessment for the proposed Upgrade of Mbilane Access Road and Construction of Crossing Structures

Nquthu Local Municipality, KwaZulu-Natal

September 2018

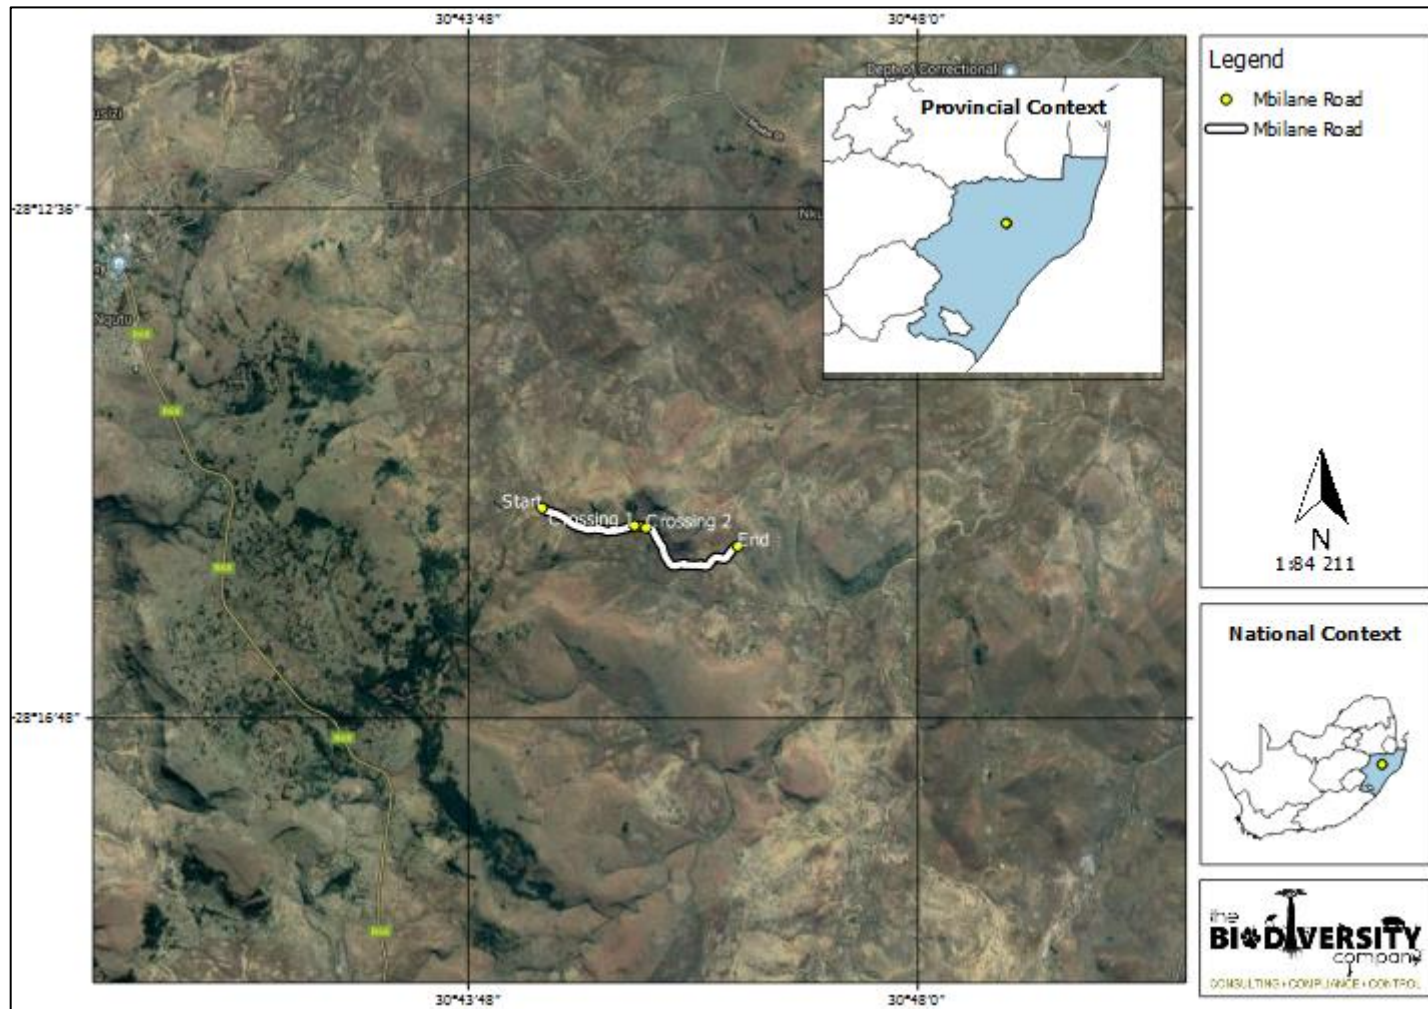
Figure 1: Local layout of the road and causeway upgrade

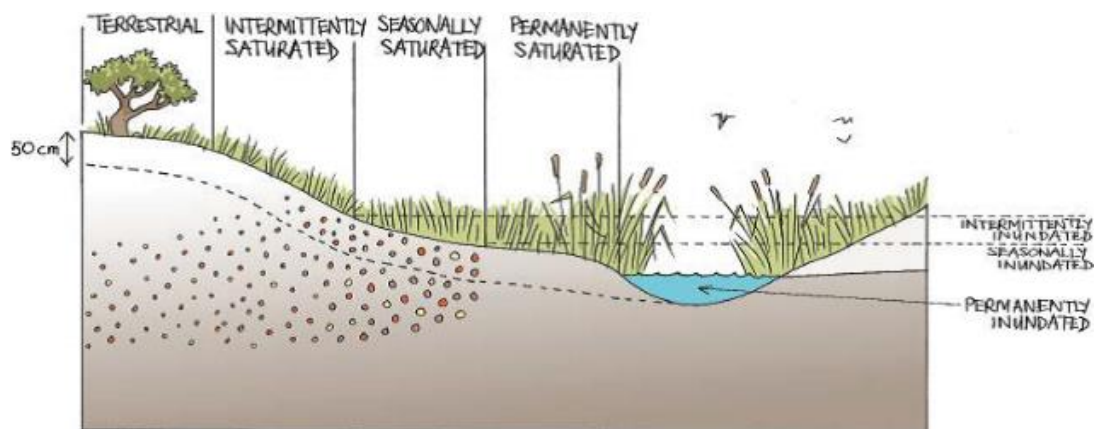
Figure 2: Cross section through a wetland, indicating how the soil wetness and vegetation indicators change (Ollis et al., 2013)

The wetland areas are delineated in accordance with the DWAF (2005) guidelines, a cross section is presented in Figure 2. The outer edges of the wetland areas were identified by considering the following four specific indicators:

Vegetation is used as the primary wetland indicator. However, in practise the soil wetness indicator tends to be the most important, and the other three indicators are used in a confirmatory role.

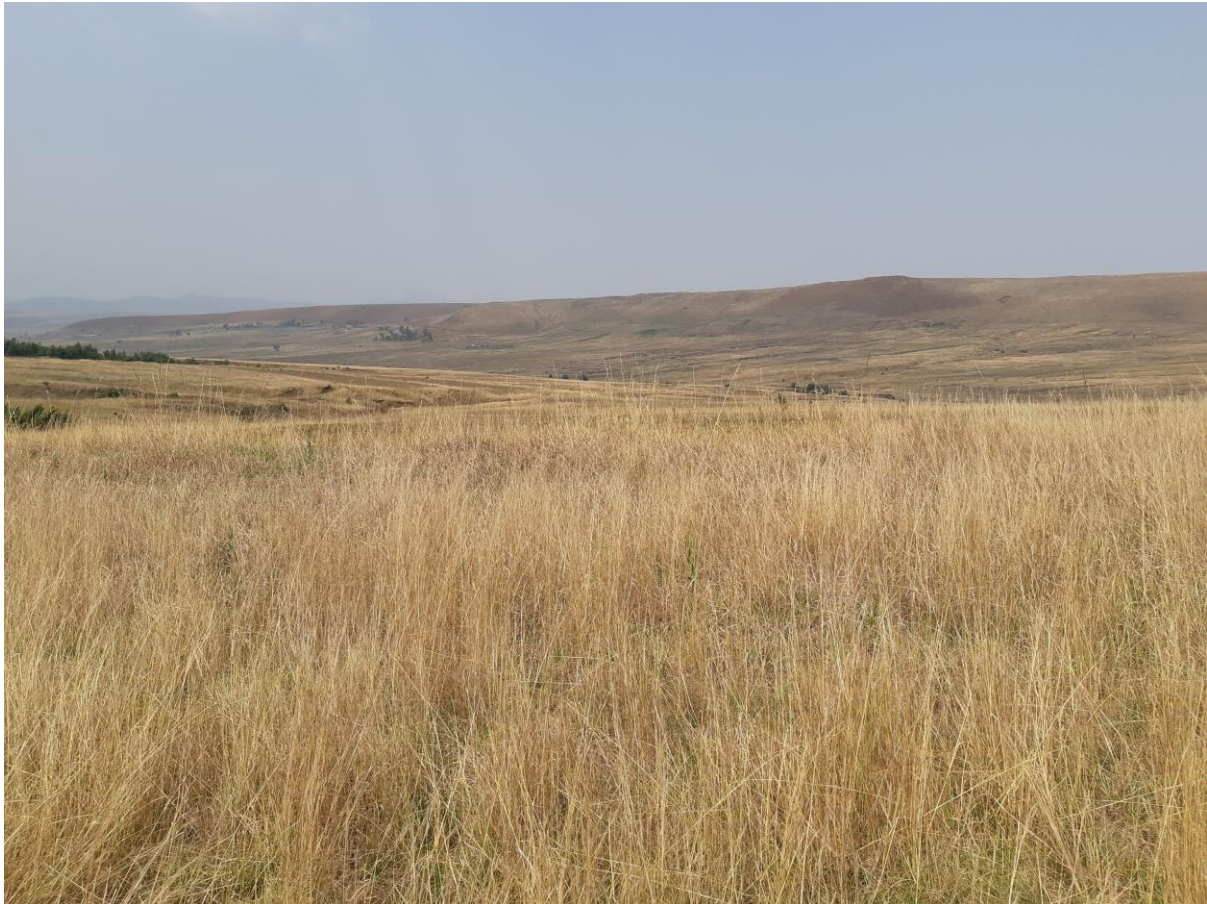
Figure 3: Identified grassland area

The vegetation within proximity to the proposed crossings was short to medium grassland. The grass species could not be identified due to the lack of flowering parts. The grassland is presented in Figure 3. The survey was conducted towards the end of the dry season with most plant species at their most dry points.

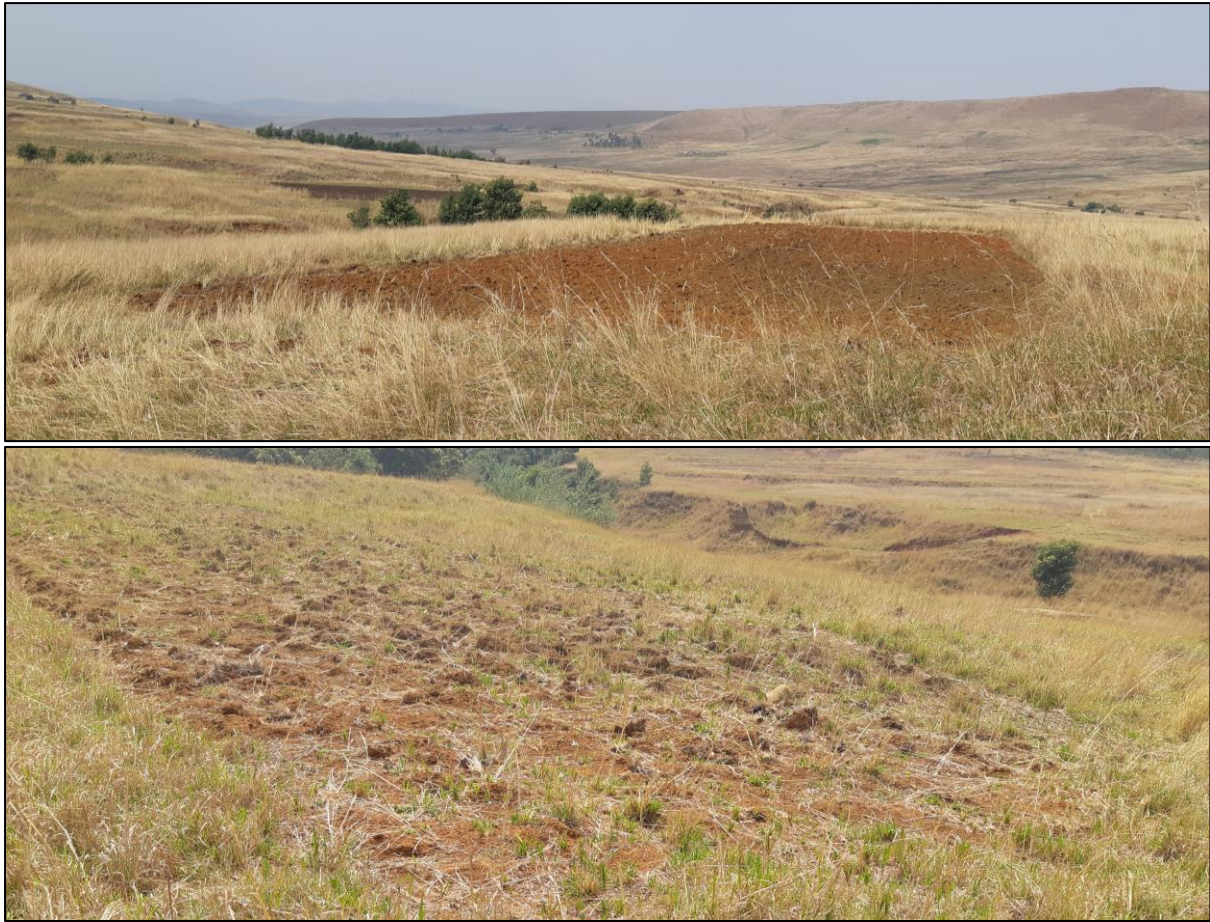
Figure 4: Areas transformed for crop cultivation

The grassland was largely monospecific and natural with several areas modified for crop cultivation (Figure 4). The area seemed densely vegetated; however, upon closer inspection large areas of bare soil were observed (Figure 5).

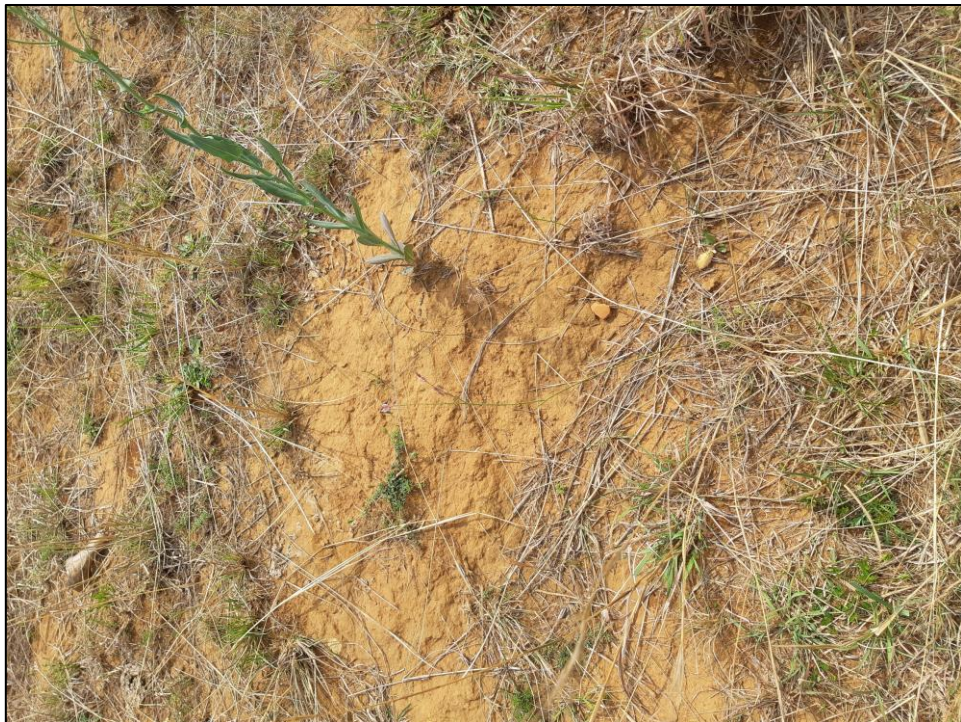
Figure 5: Areas of bare soil

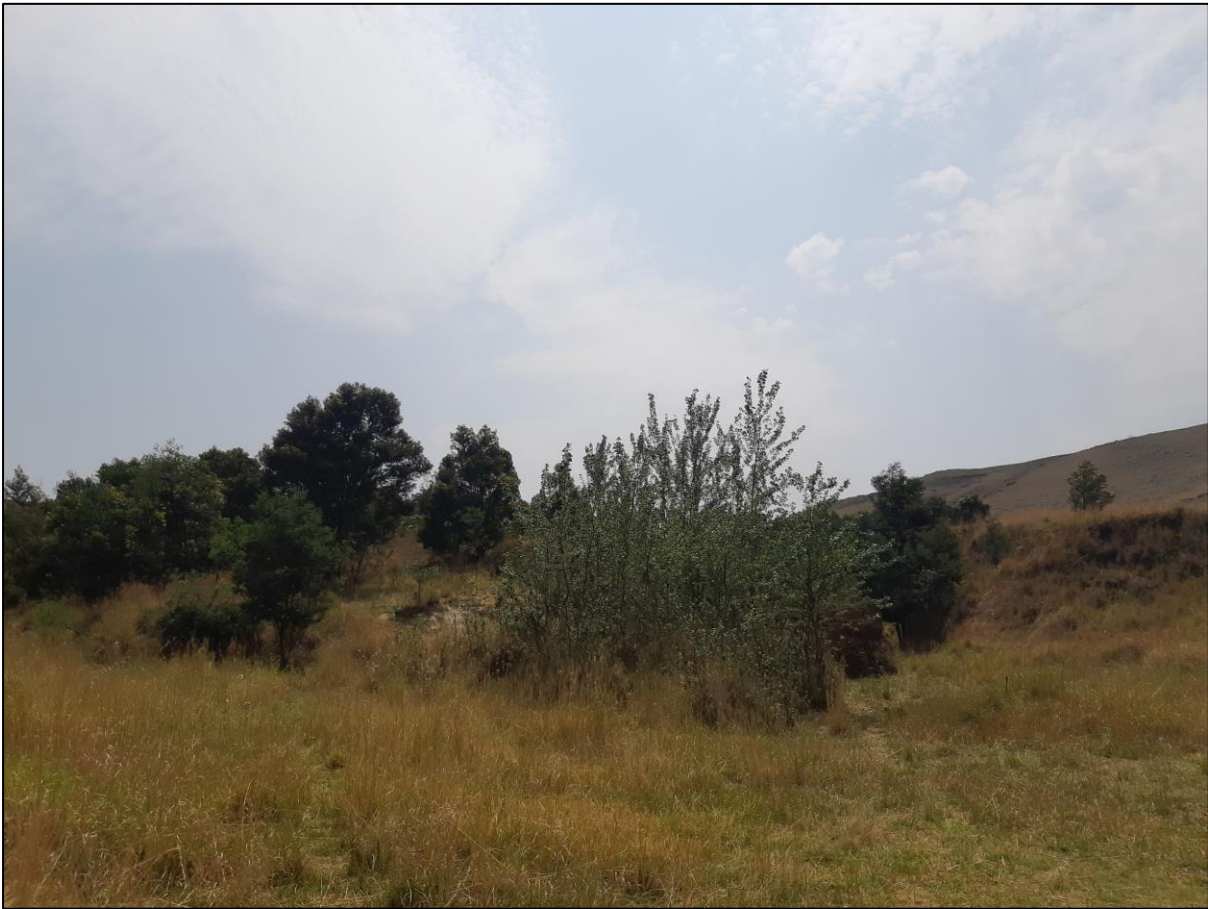
The channel area of the drainage lines was dominated by the grassland in some parts with large areas of bare soil. *Acacia mearnsii* and *Populus alba* trees were found in the channel area as seen in Figure 6.

Figure 6: Acacia mearnsii and Populus alba trees in channel area

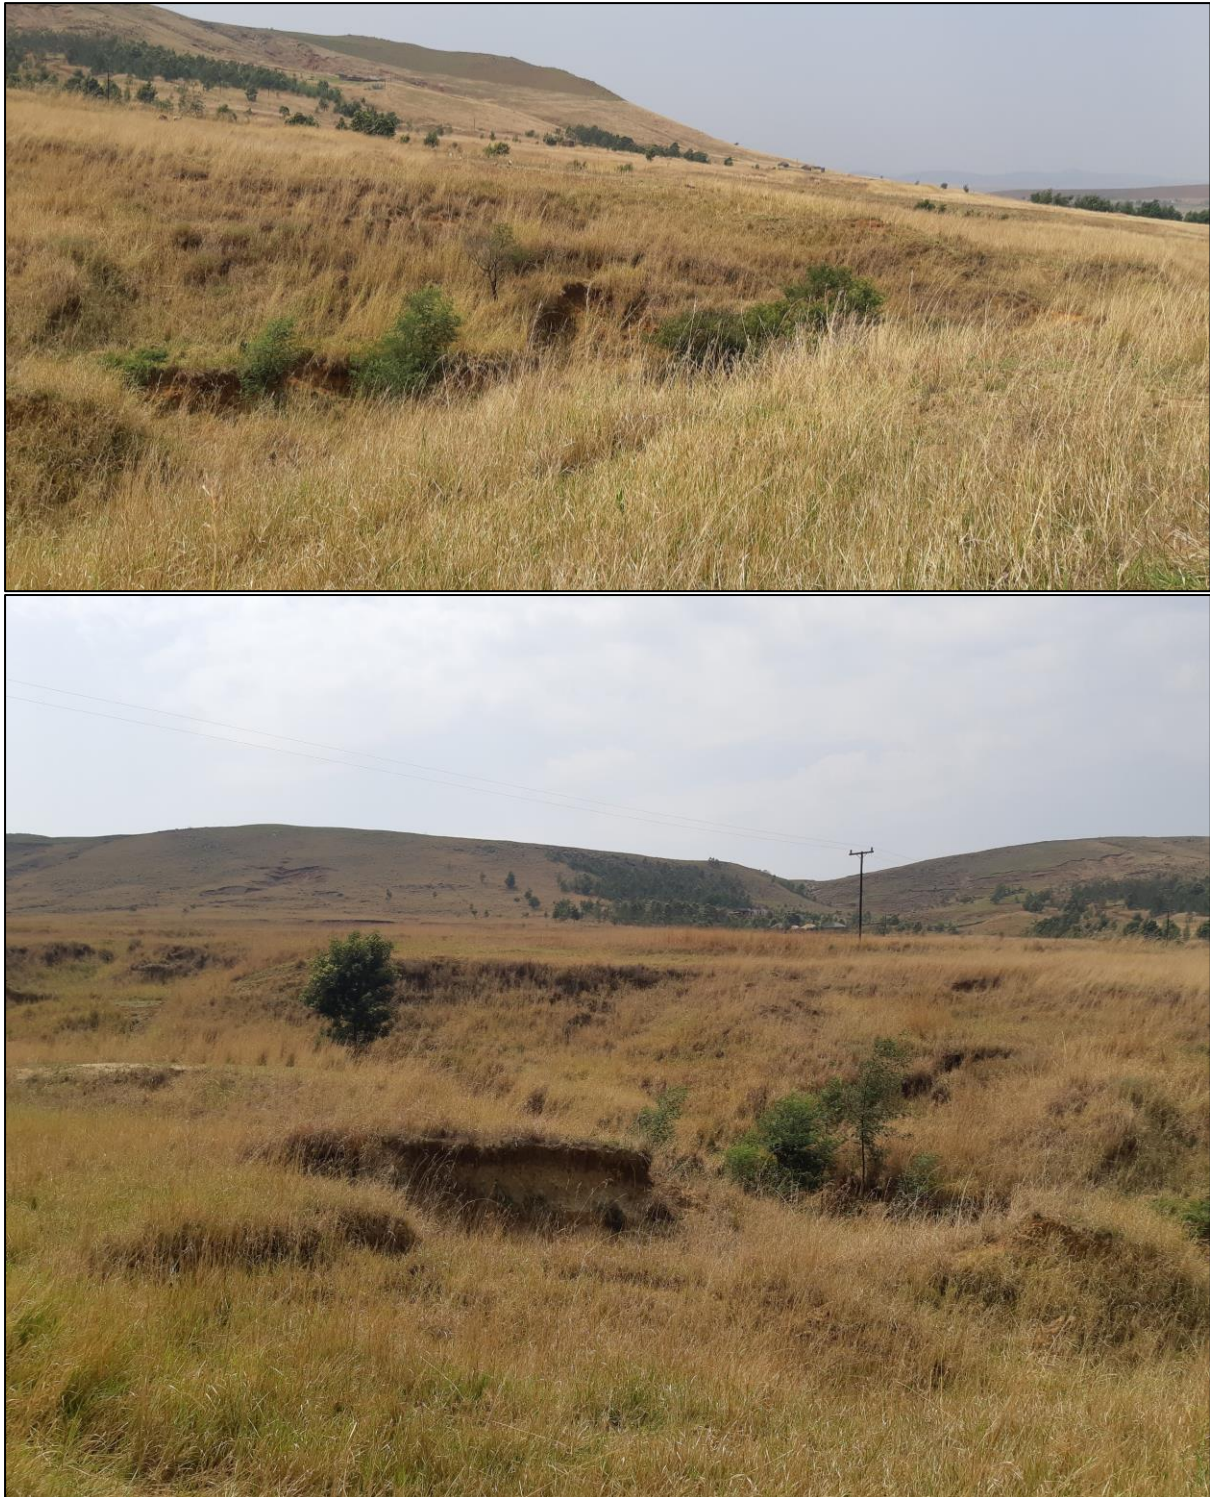
These drainage systems are ephemeral (A Section) and contain storm water and form part of a first order and sometime second order streams of rivers. These drainage lines are almost never (or very seldom) in connection with a zone of saturation and they consequently never have base flows (DWAF, 2005)

Figure 7: Identified drainage lines

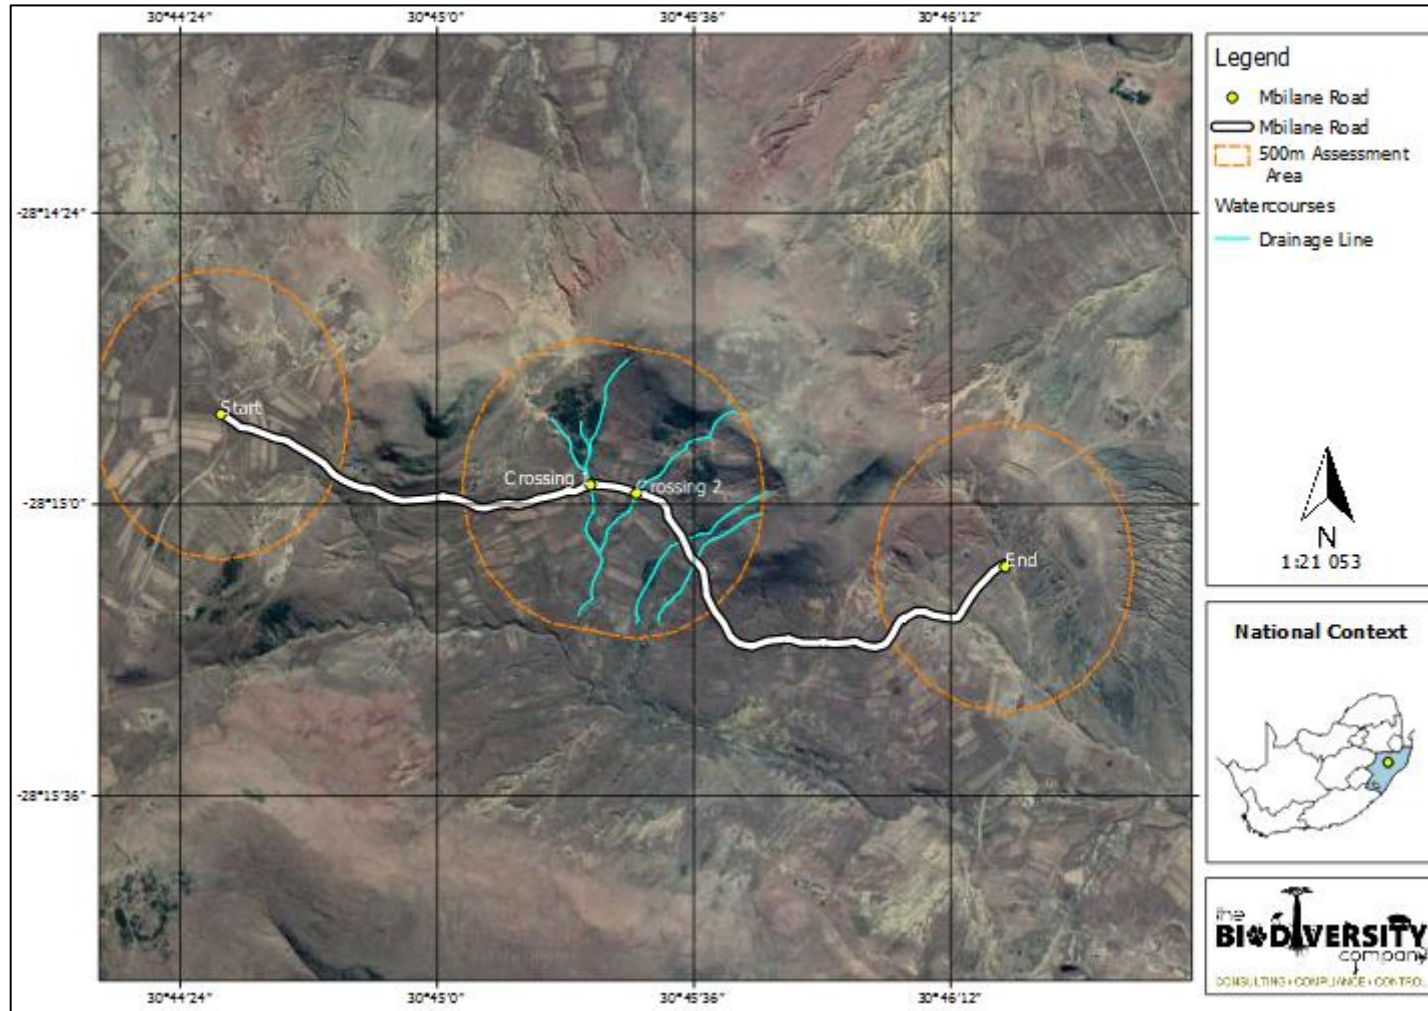
Figure 8: The delineated watercourses within 500m WULA of the assessment area

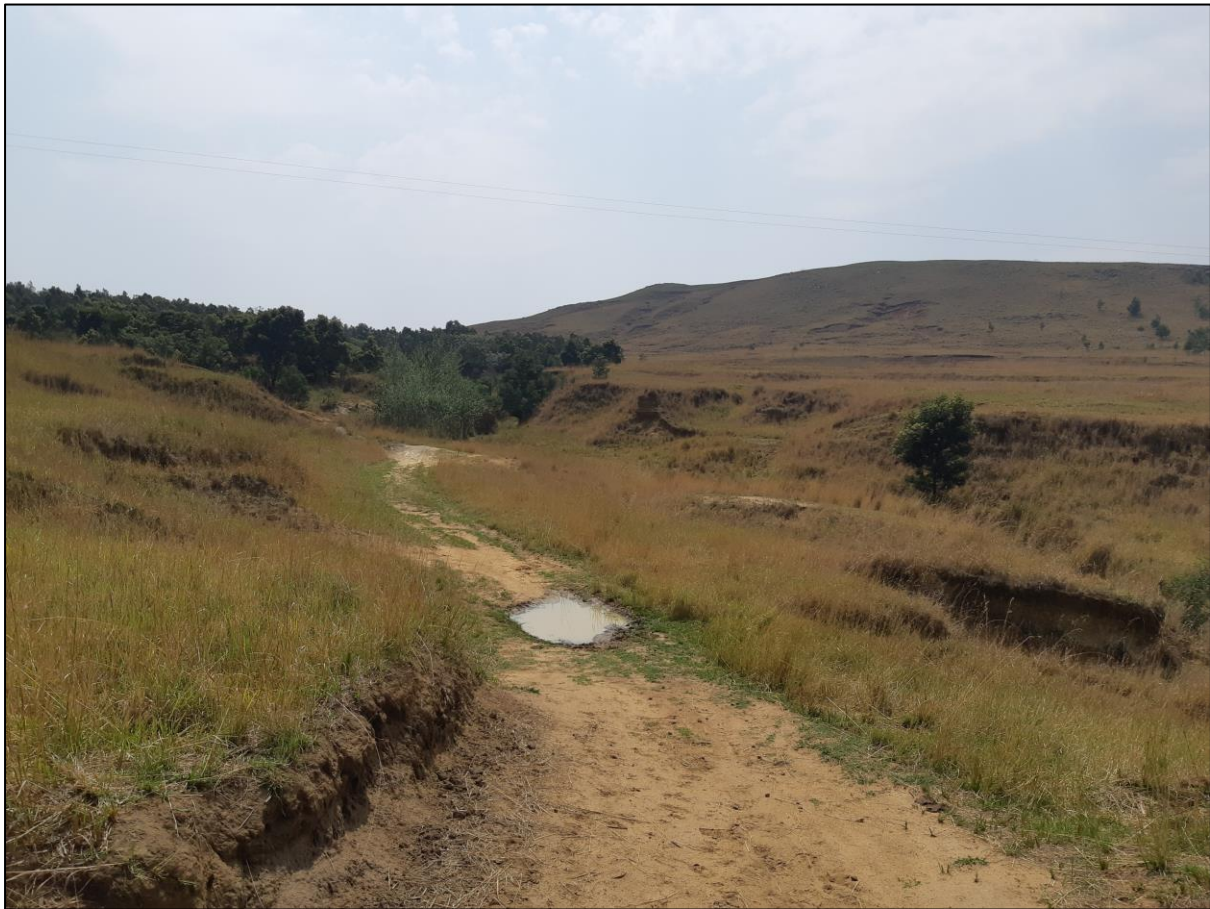
The proposed project is for the upgrade of two roads and the construction of two causeway structures. The causeway structures will be constructed within the boundaries of the drainage lines, which, as a result, will be directly impacted on. As this project entails the upgrade of infrastructure and the construction of new infrastructure, impacts associated with the area are potentially moderate to low, based on the current onsite crossings (Figure 9). Modifications to the wetland habitat is likely to occur during construction. The project will entail the cutting, reshaping, and change in hydrodynamics of the watercourses. This has the potential to increase erosion and sedimentation of downstream habitats due to surface runoff during the wet season.

Figure 9: One of the crossings (Crossing 1) and the current road

The proposed road will intersect three (3) drainage lines. The resulting disturbance of the watercourse area may require rehabilitation once the construction phase is completed. It is important that the slopes of the watercourses (drainage lines) are re-vegetated so as to mitigate impacts of erosion, sedimentation and establishment of alien plant species. Table 6 presents listed plant species which should be obtained and planted in order to address the post-construction condition of the wetland area. After the construction of the new structures, it is anticipated that a large area will be disturbed. There will be large areas of bare and disturbed soils which will be susceptible to establishment of alien invasive plant species. Therefore, the post-construction rehabilitation should follow these steps:

1. Re-shape and contour the banks around the causeway structure;
2. Stabilise the embankments with necessary aids (gabions, geomats etc.);
3. Revegetate the embankments and channel areas with the plants listed in Table 6. It is recommended that these plants be salvaged from the area and re-planted, or a suitable (similar) seed mix be applied to the affected areas; and
4. Ensure that water flows through the channel are dispersed and that water flow is uninterrupted.
