WETLAND DELINEATION STUDY

**FOR THE EXPANSION OF RAILWAY LINES AT PYRAMID SOUTH, PRETORIA, SOUTH
AFRICA.**

Contract No.	Date	Status
3424302.022S	October 2017	Draft

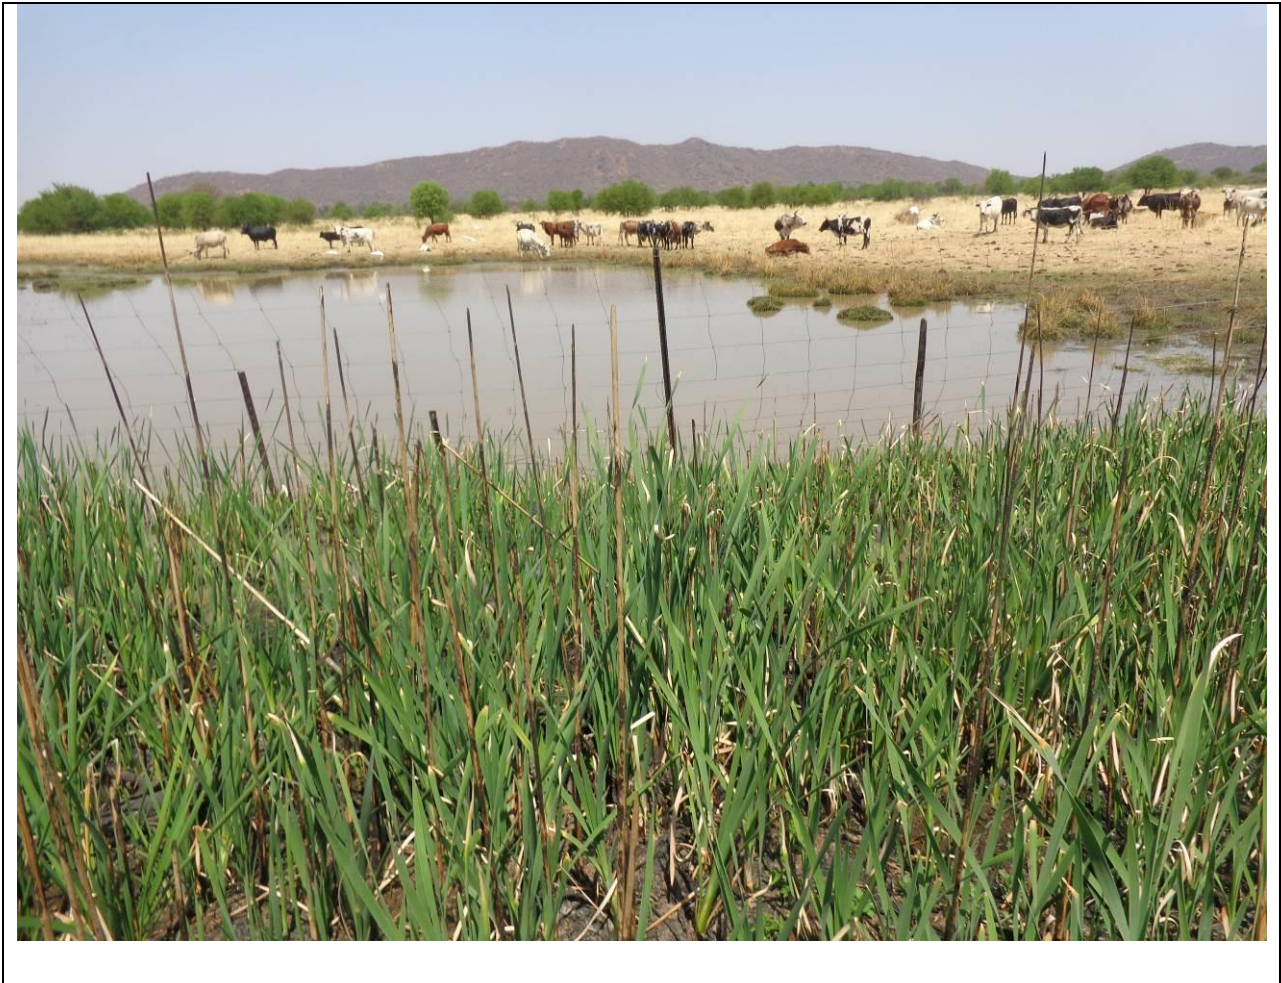
- Presence of hydromorphic soils that display characteristics resulting from prolonged saturation; and
- The presence of water loving plants (hydrophytes) (Figure 5 and Figure 6).

Figure 5: *Typha capensis* (hydrophytes) and freshwater at Pyramid South Wetland 1

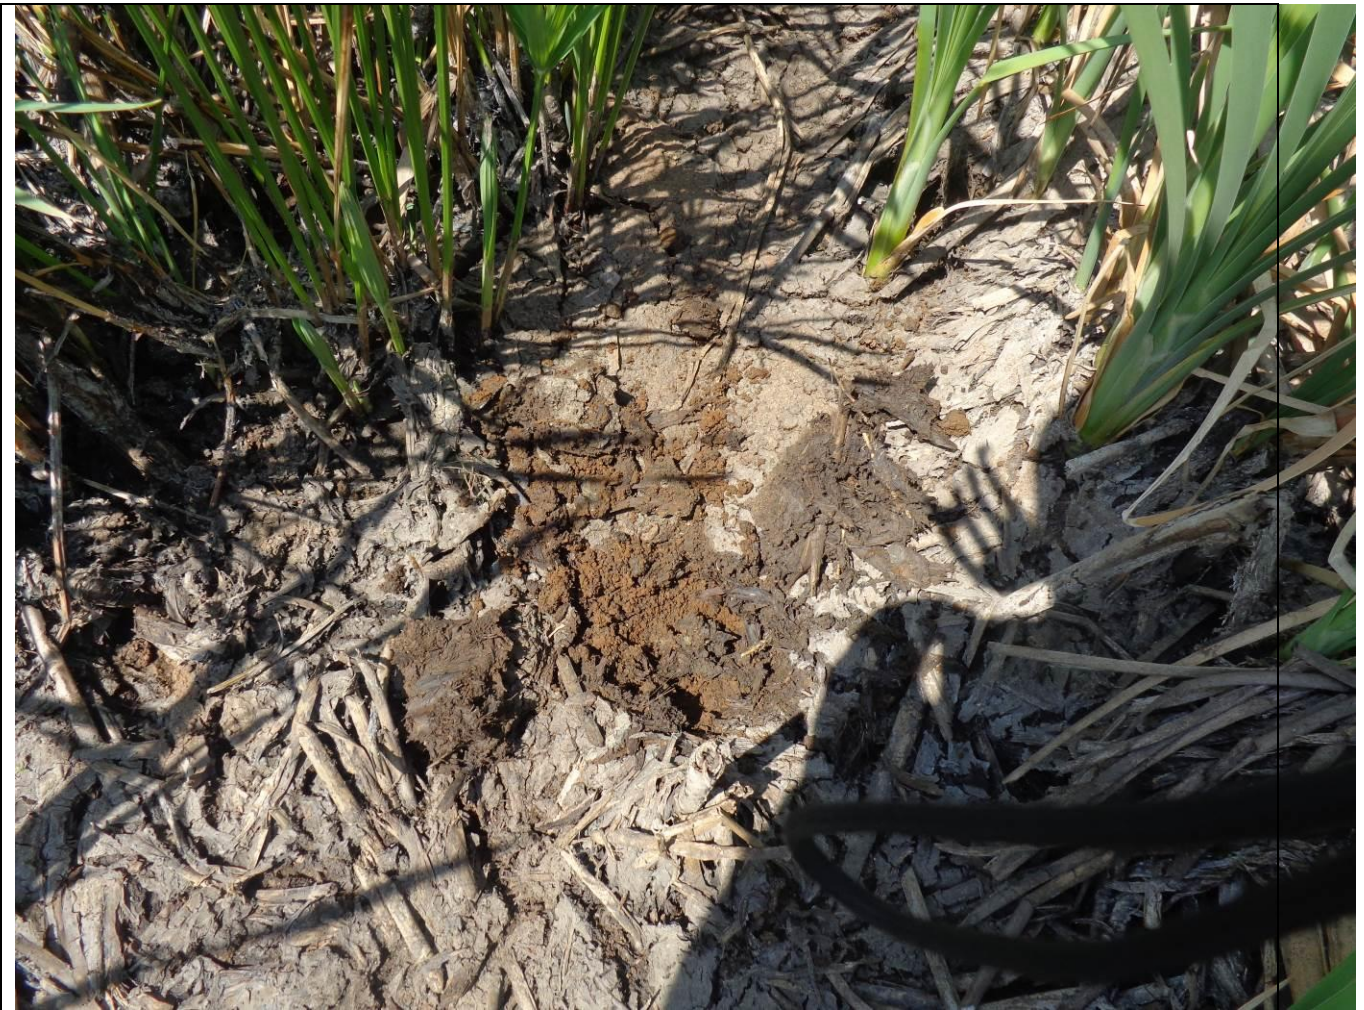
Figure 6: Hydromorphic soils at Pyramid South Wetland 1

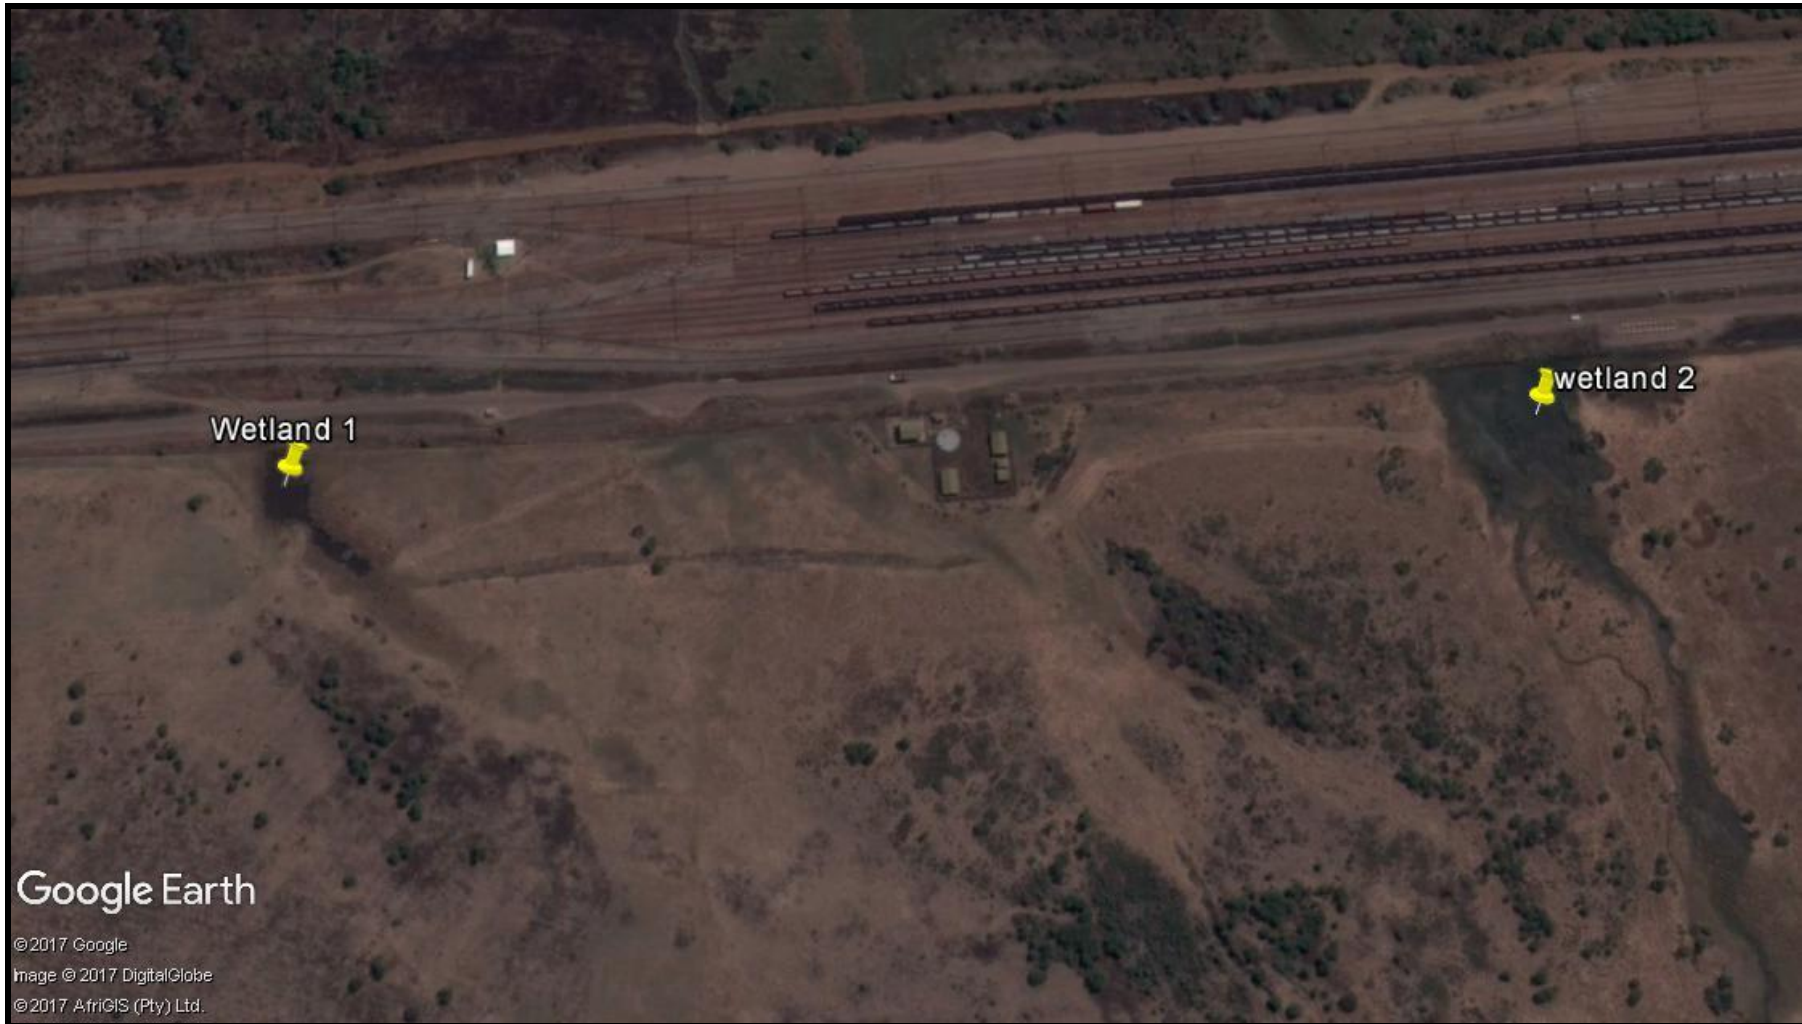
The site is well developed with extensive railway line infrastructure. On the southern part of the railway line, there are two (2) distinct wetlands as indicated by the following attributes:

Figure 7: Two distinct wetlands observed on the southern side of the proposed railway expansion site (Wetland 1 and Wetland 2)

The proposed expansion of rail infrastructure will have minimal to no impact on the 2 wetlands on site. The site is already heavily disturbed due to many years of railway infrastructure on site. Any additional water inputs will therefore be channelled offsite through these existing systems. However, due care still needs to be exercised around this area. General recommendations are listed below.

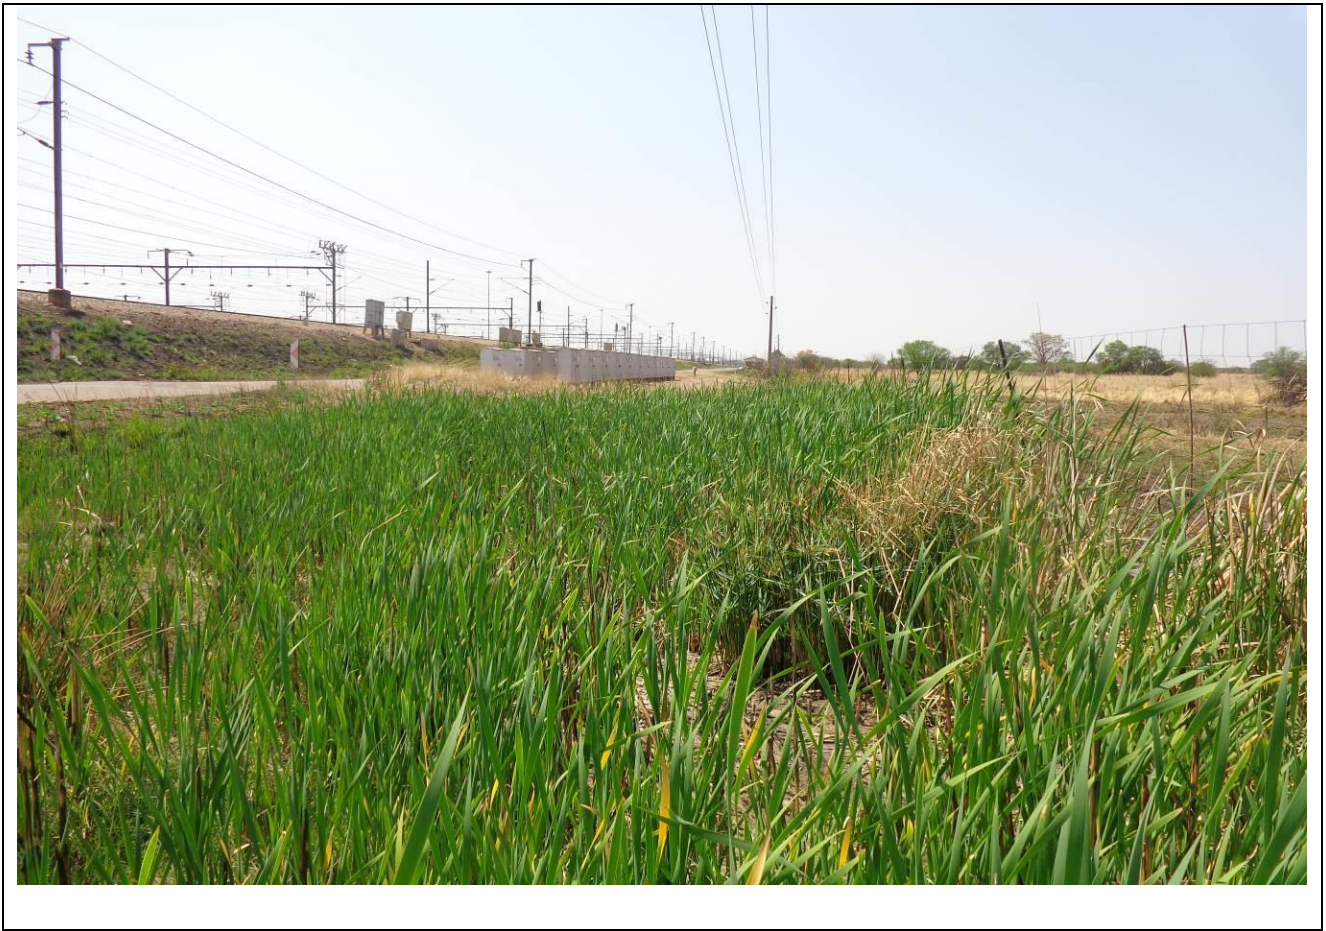
The site was characterised by vegetation lacking in species richness. The plant species identified included *typha capensis* and some *sedges*.

Figure 10: Some vegetation species identified on the Pyramid South site
