Proposed Township Development on the remainder of the farm Leeupoort No 283JS and Prt 79 of the farm Blesboklaagte No 296JS, Emalahleni, Mpumalanga

KOR-EMA-13-12-02

Wetland Delineation and Functional Assessment May 2014

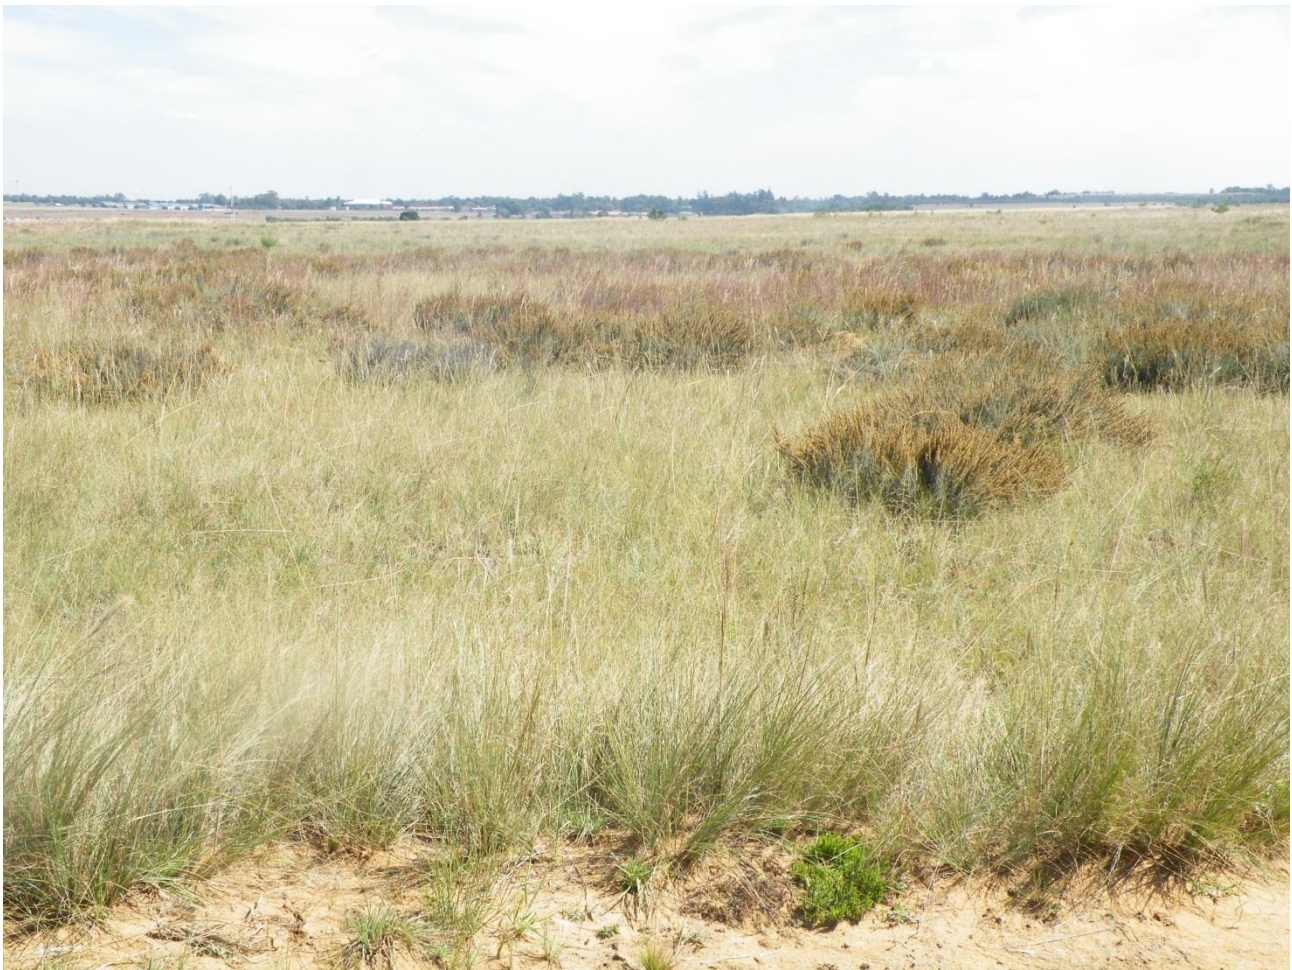
Figure 8: *Seriphium plumosum* located on the edge of the wetland and the terrestrial area.

The channelled valley bottom section of the wetland was colonised by plants such as *Typha capensis* and *Phragmites australis* with small patches of exotic woody vegetation found adjacent the channelled valley bottom area. The seepage areas had a higher density of grasses and sedges. Exotic species was found throughout the study site and especially at a high density and frequency in the quarry area. Large sections of the wetland system were fringed on the edges by *Seriphium plumosum* which is likely due to overgrazing (Figure 8). Some areas located within the seepage area in the east had a low density of vegetation and erosion gullies was prominent in this area.

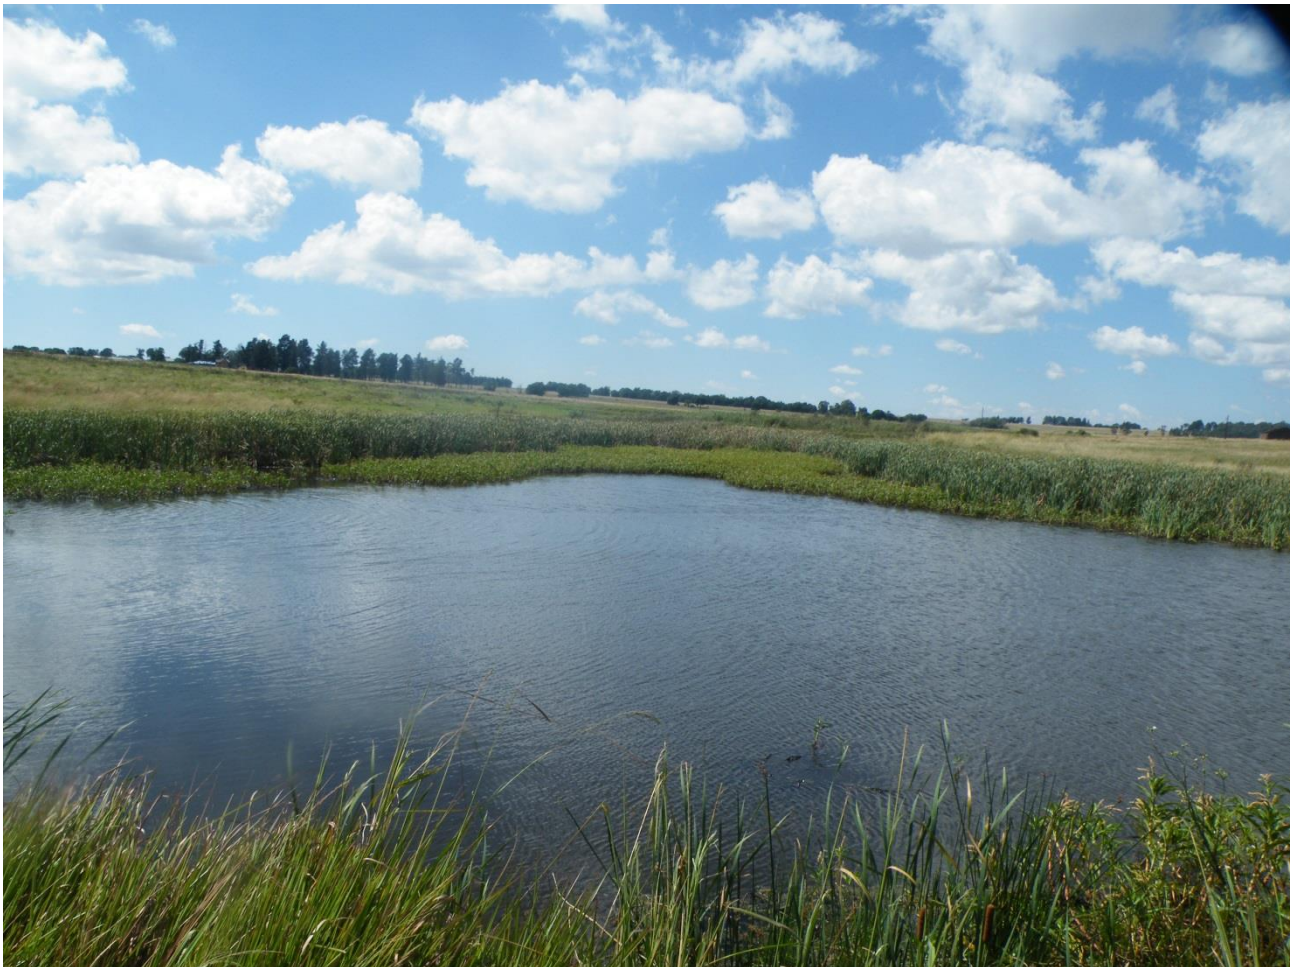
Figure 10: Damming of the channelled valley bottom.

The channelled valley bottom found on the site extends through the northern section of the study site as well as bordering the southern section of the study site. A clear channel can be seen throughout most of the wetland. The wetland has been impacted by roads, grazing and some patches of exotic woody vegetation such as *Eucalyptus sp.* and *Acacia mearnsii*. The main impact associated with this wetland is the numerous areas where the wetland has been dammed up, thus preventing the transport of sediment through the wetland as well as preventing the migration of faunal species through the wetland (Figure 10).

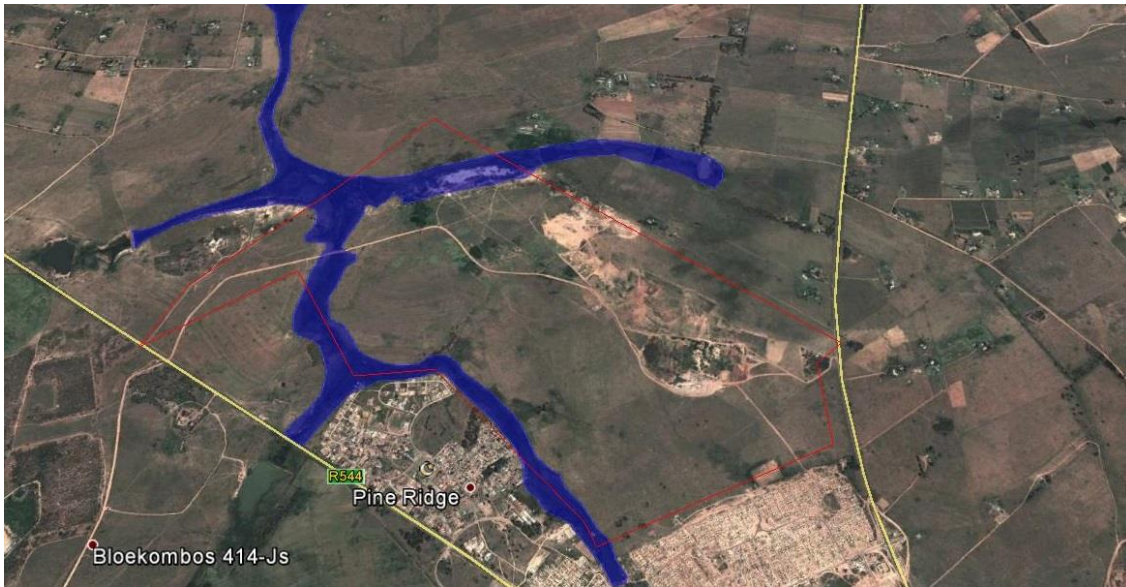
Figure 11: Channelled Valley Bottom (Blue) in relation to the study area (Red).

In the northern corner of the study site a large section of exposed soil can be seen, this area has numerous erosional gullies likely due to the upstream quarrying in the adjacent seepage wetland. The close association with the town of Pine Ridge also has an impact on the wetland by creating footpaths, dumping and fringing construction of houses. The wetland vegetation here is mostly intact with thick stands of *Phragmites australis*. Sediment was seen in the edges of the wetland suggesting that the wetland contributes to sediment trapping in conjunction with the associated seepage areas (Figure 11).

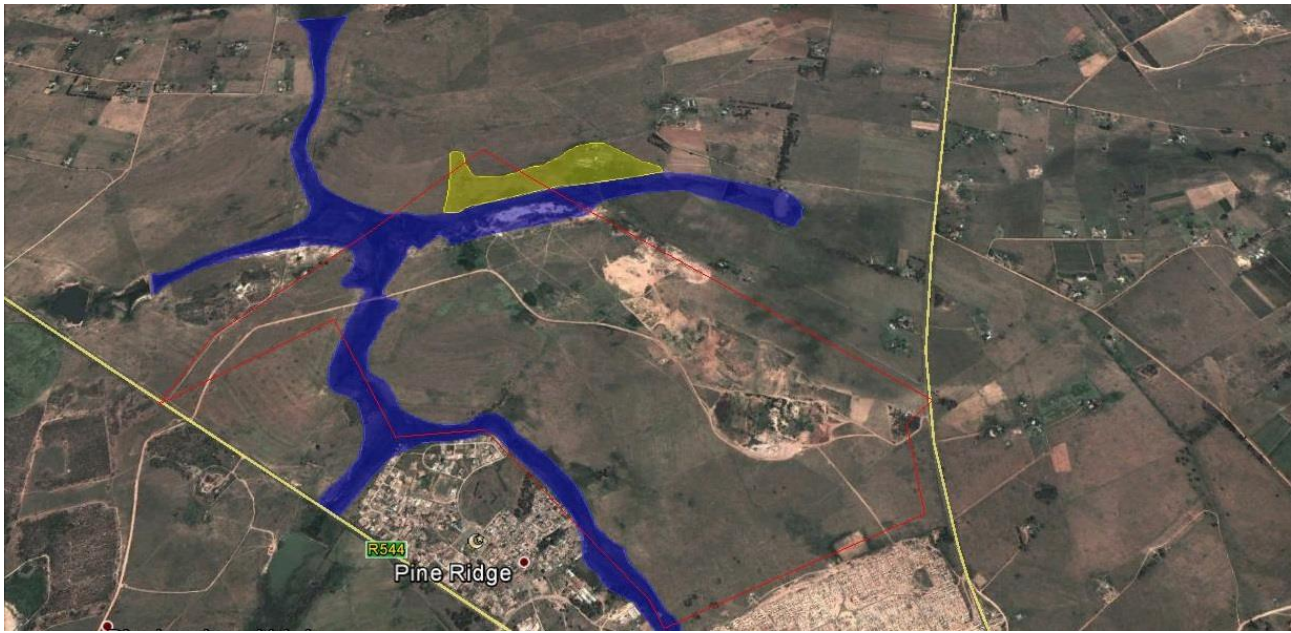
Figure 12: Seepage area (Yellow) in relation to the Channelled Valley Bottom (Blue) and the study area (Red).

The seepage area is found north of the channelled valley bottom wetland, in the northern most corner of the study site (Figure 12). The wetland is found on the foot slopes of a mountainous area. The main impact associated with this wetland is the cattle farm located on the wetland. Grazing has thus had a large impact on the area and large areas of overgrazing were recorded.

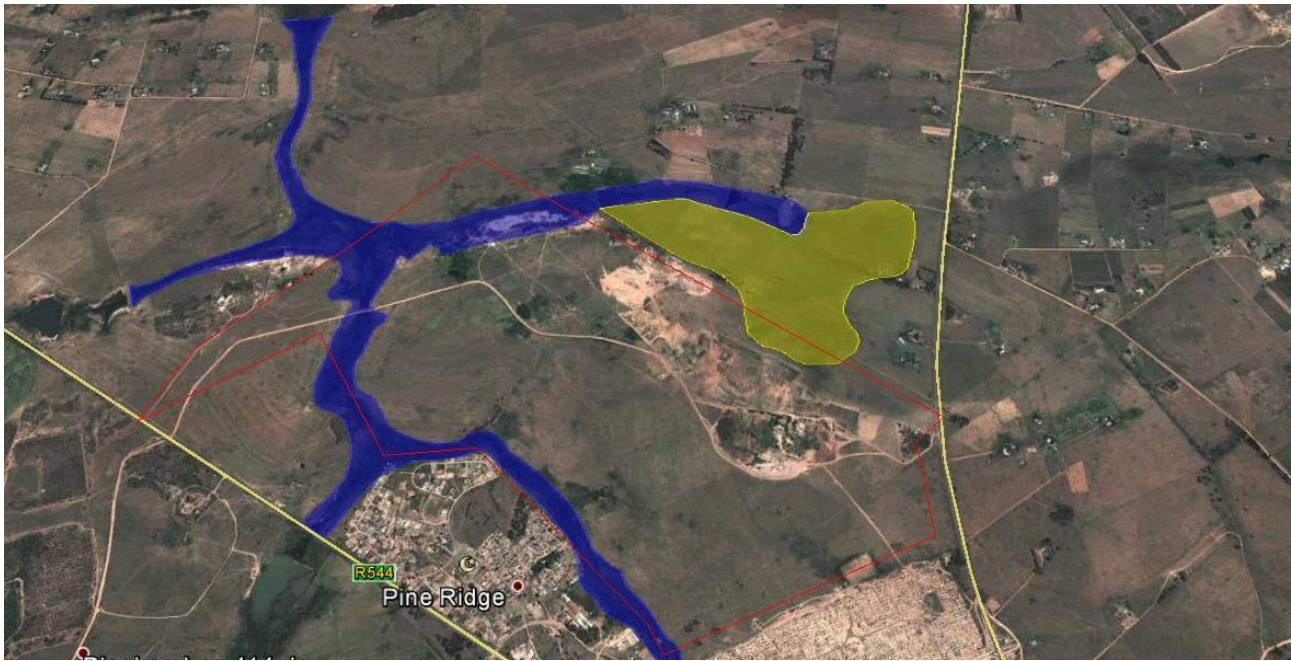
Figure 14: Seepage area (Yellow) in relation to the Channelled Valley Bottom (Blue) and the study area (Red).

This seepage area is part of a larger seepage wetland that has become degraded due to the quarrying of the area. This section of the seepage wetland is however still functional and not as impacted as the rest of the seepage area. On a small part of this seepage area is located on the study site (Figure 14).

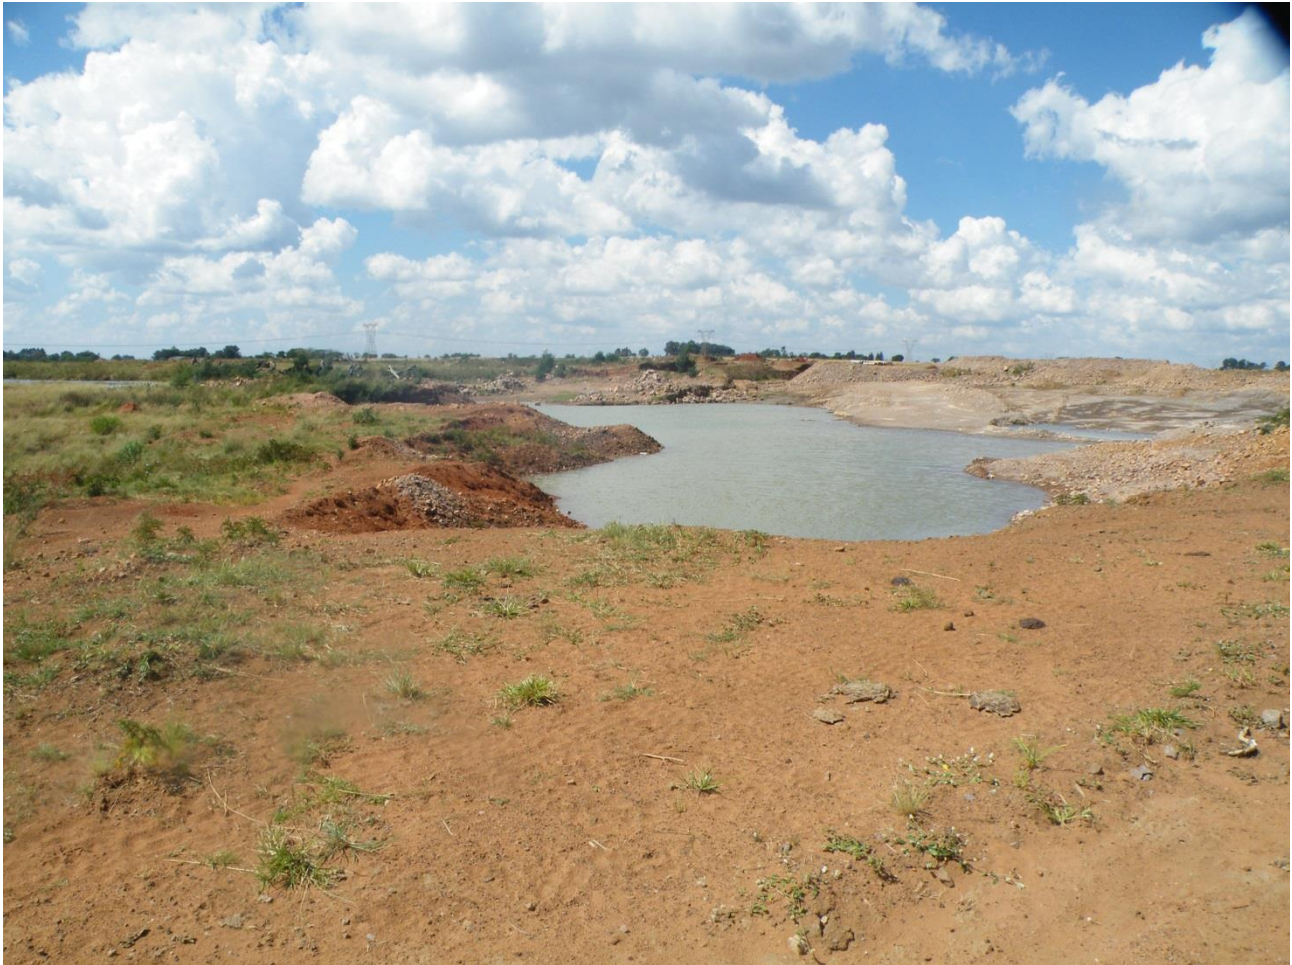
Figure 16: Quarry area located within a seepage area.

This area has been greatly impacted by quarrying and other anthropogenic activities. Large gullies and pits are located within this area. The vegetation of this area is mostly exotic with large stands of *Datura stramonium* found within the seepage area. Numerous dams have formed within this area. The area is greatly fragmented and is likely not functional as a wetland anymore. The hydrology and geomorphology has been greatly impacted. The excess sediment due to quarrying is impacting on the adjacent valley bottom wetland. Large erosional gullies were recorded in this wetland (Figure 16).

The degraded area is thus unlikely to contribute to the functionality of the adjacent wetlands to a large degree and likely does not function as a wetland anymore. However, an experienced soil specialist and a groundwater specialist should be consulted to determine the functionality of this wetland area.
