**An aquatic assessment of the proposed Seaview
Greenbushes bulk water expansion project area,
Nelson Mandela Bay Metropolitan Area, Eastern Cape**

August 2016

SRK Consulting

Project 485194

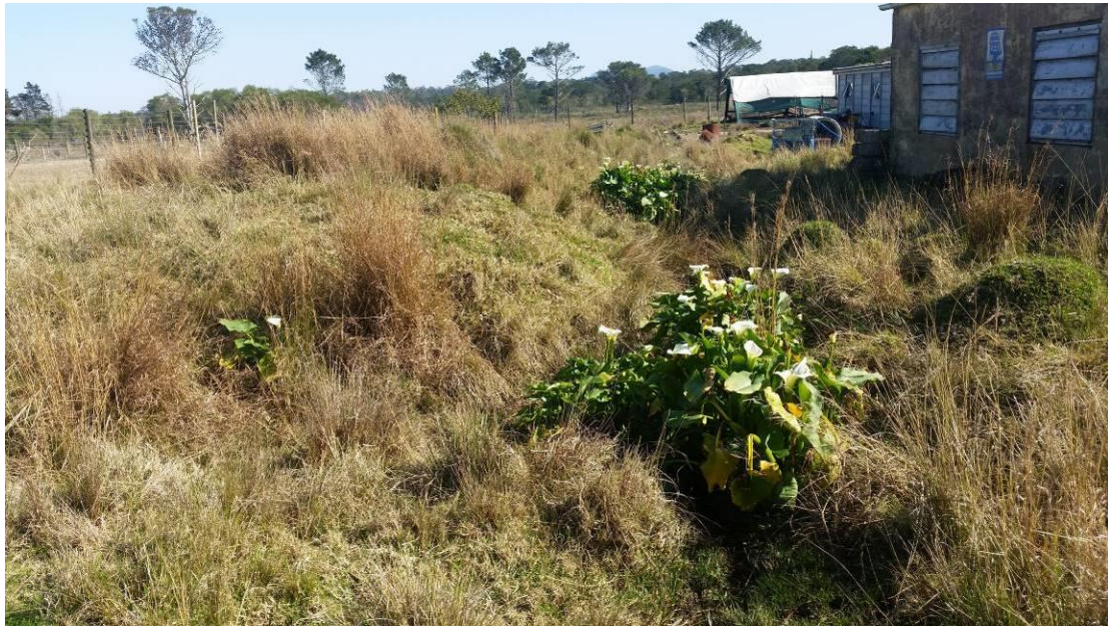
- 1) The two man-made excavated dams (Figure 9), both occurring outside the 500 m buffer, and therefore not discussed further.
- 2) A man-made trench (artificial wetland) within the 500 m buffer. Wetland plant species occur in the trench, notably *Zantedeschia aethiopica* (Figure 8). This trench often transports water westwards into two manmade dams (artificial wetlands).
- 3) South of the two dams wetland conditions prevail, considered to represent a natural wetland, though the wet conditions are enhanced by overflow of the trench and dams during high rainfall periods. Water flows in a southerly direction towards the N2 Highway where the flow is basically blocked. The dominant plant species are *Pennisetum clandestinum* (Kikuyu grass) and *Stenotaphrum secundatum* and the

Figure 8: The trench within Wetland 1, with *Zantedeschia aethiopica*

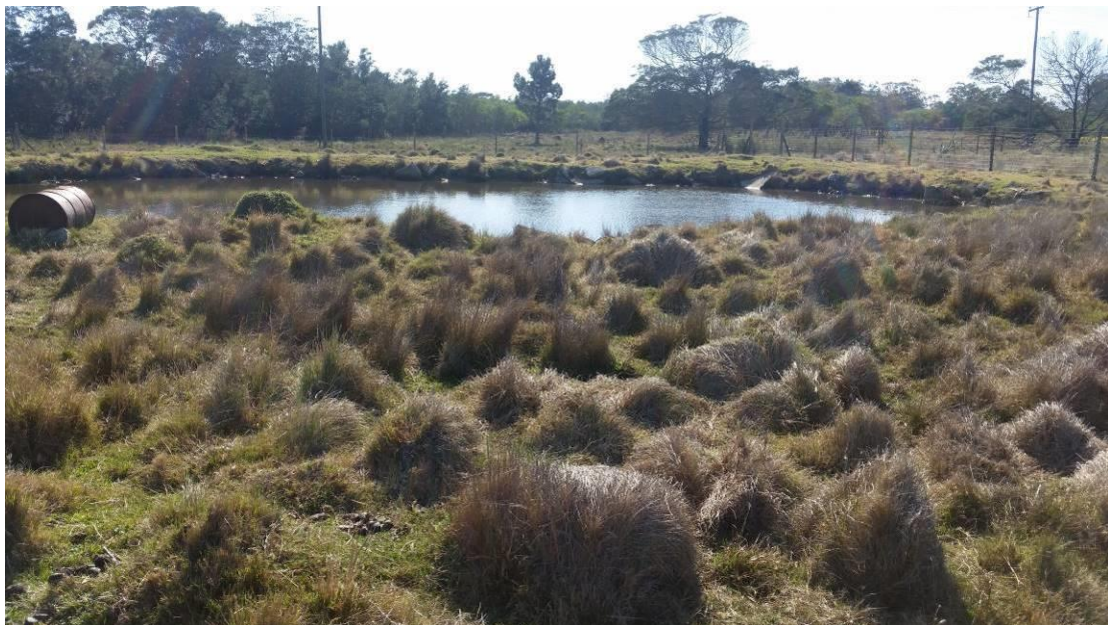
vegetation is grazed by sheep and donkeys (Figure 10). Many little ant mounds covered with grass occur throughout this wetland (Figure 9).

Figure 9: One of the dams at Wetland 1, with wetland in the foreground. Note the ant mounds covered with grass.

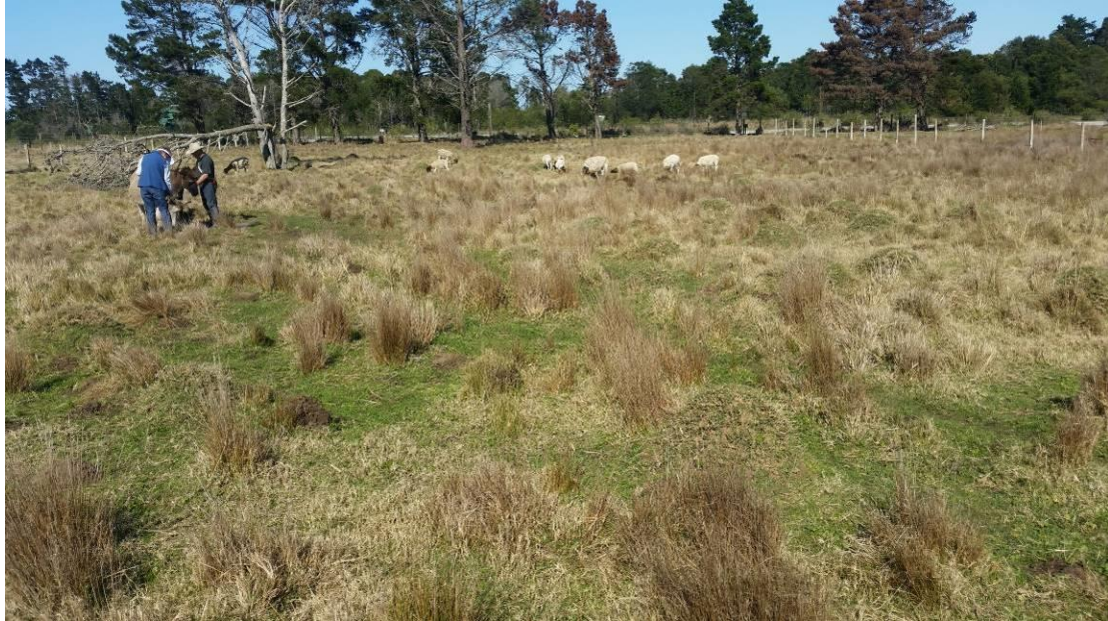
Figure 10: Natural, though disturbed, wetland at Wetland 1, grazed by sheep and donkeys.

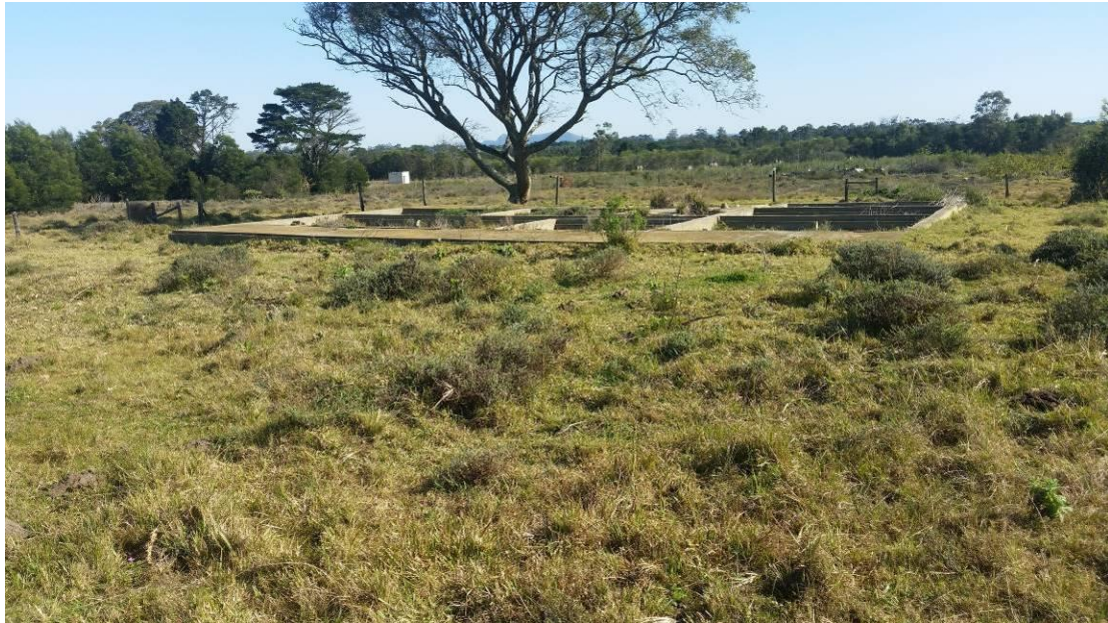
This artificial wetland is also located in the north-western part of the study site at $33^{\circ}56'45.2''\text{S}$; $25^{\circ}24'25.1''\text{E}$, just west of Seaview Rd and close to the foundation ruins of an old demolished house (Figures 6 and 11). It is indicated on both the NFEPA and NMBM GIS layers for wetlands. In the NFEPA map it is indicated as an artificial wetland. There is almost no indication that was a (man-made, artificial) wetland. The soil is sandy and the vegetation secondary and weedy but some fynbos plant species have started to re-appear. It is suggested that the wetland does not exist anymore.

Figure 11: The old foundation ruins at Wetland 2. The wetland occurred between the ruins and the bush in the background.

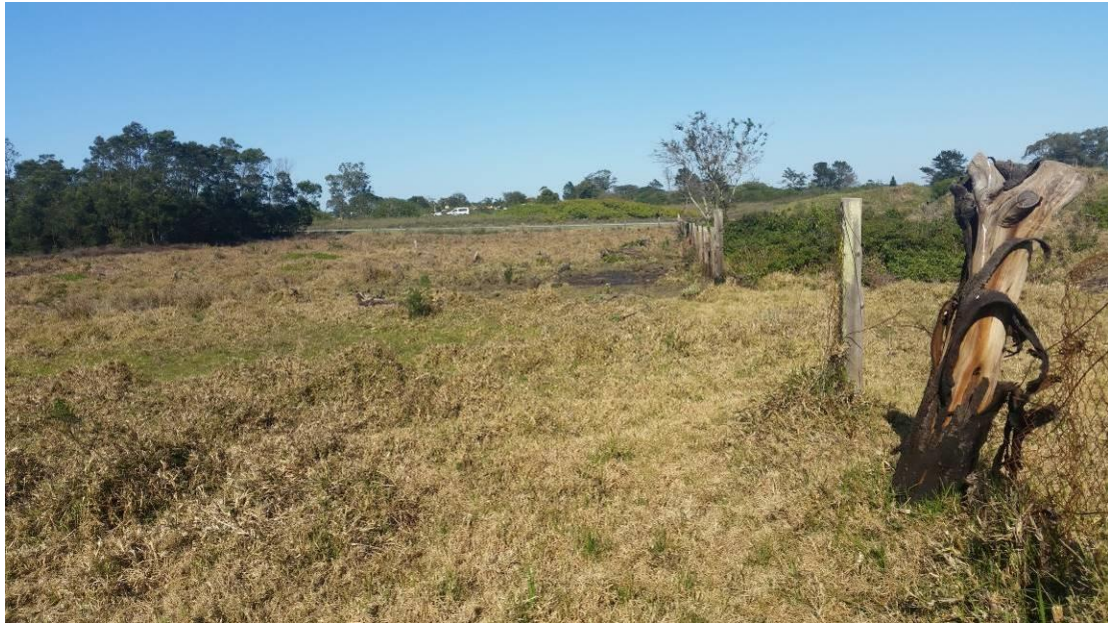
This is considered to be a natural wetland, but it is highly disturbed. It is wedged into the triangle formed by Seaview Rd, and the gravel road that leads to the Greenbushes reservoir near the N2 Highway off-ramp. Further, there are ruins of a demolished building and extensive soil dumps directly west and plantation directly east of the wetland (Figure 6). There are also stumps indicating that trees (plantation) previously occurred in the area of the wetland. However, the wetland is in a natural bottomland position in the landscape and the central part of the wetland has black sandy loam soil and surface water (Figure 12). The areas surrounding the central part have sandy soil with mottles and are very wet (but no surface water) and all slope down towards the central part. The vegetation is dominated by *Stenotaphrum secundatum* and some weedy species are present. The area is grazed by livestock. There is no obvious outlet, implying that the area could be interpreted as being a pan.

Figure 12: Wetland 3, representing a natural but disturbed pan.

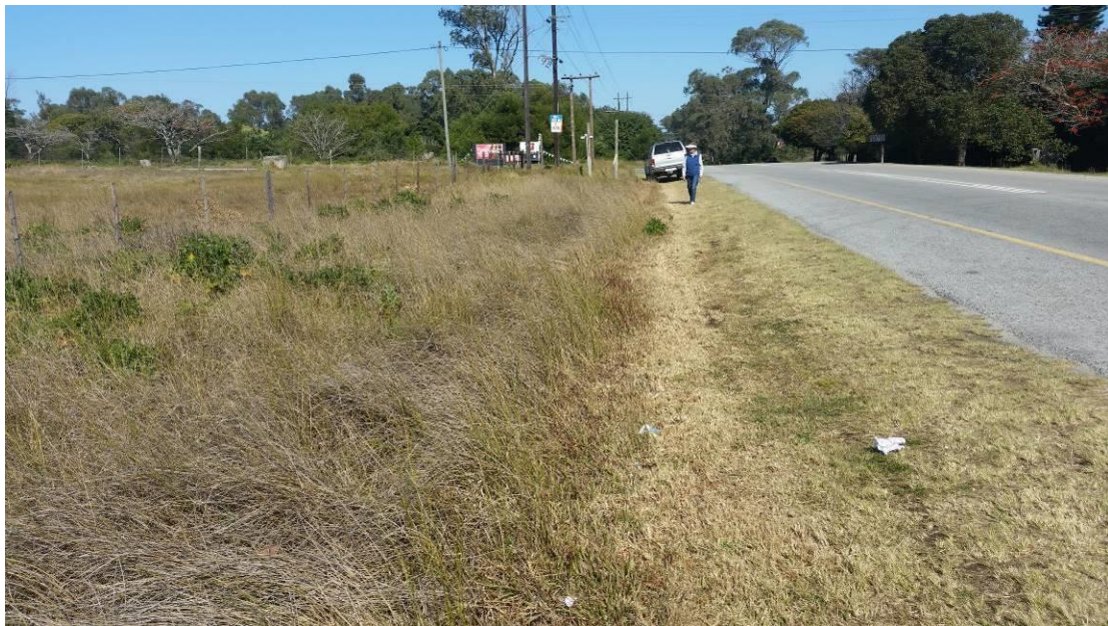
The wet conditions are caused by a damming effect of water flowing down the west-facing slope towards the slightly raised Seaview Rd. Consequently wetland vegetation, including hygrophilous grasses, sedges and *Juncus* species became established (Figure 13). Surface water and frogs occur in this habitat.

Although regarded as artificial and definitely unwanted, these wet conditions do perform limited ecological function by creating habitat conditions suitable for wetland plants and certain fauna species.

Figure 13: The wetland conditions along Seaview Road.

The proposed pipeline will transect and destroy this wet area on the road reserve. Future water flow, after construction of the pipeline may again cause unwanted wet conditions over the pipeline, and a drainage system may be needed, depending on the opinion of the design engineers.

Future water flow, after construction of the pipeline may again cause unwanted wet conditions over the pipeline, and a drainage system may be needed, depending on the opinion of the design engineers. Preferably the drainage system should allow the water to flow through a pipe, under the road, so that the water can flow further down the slope, as was probably the case before the road was constructed. This will prevent damming and the artificial wetland conditions will disappear.

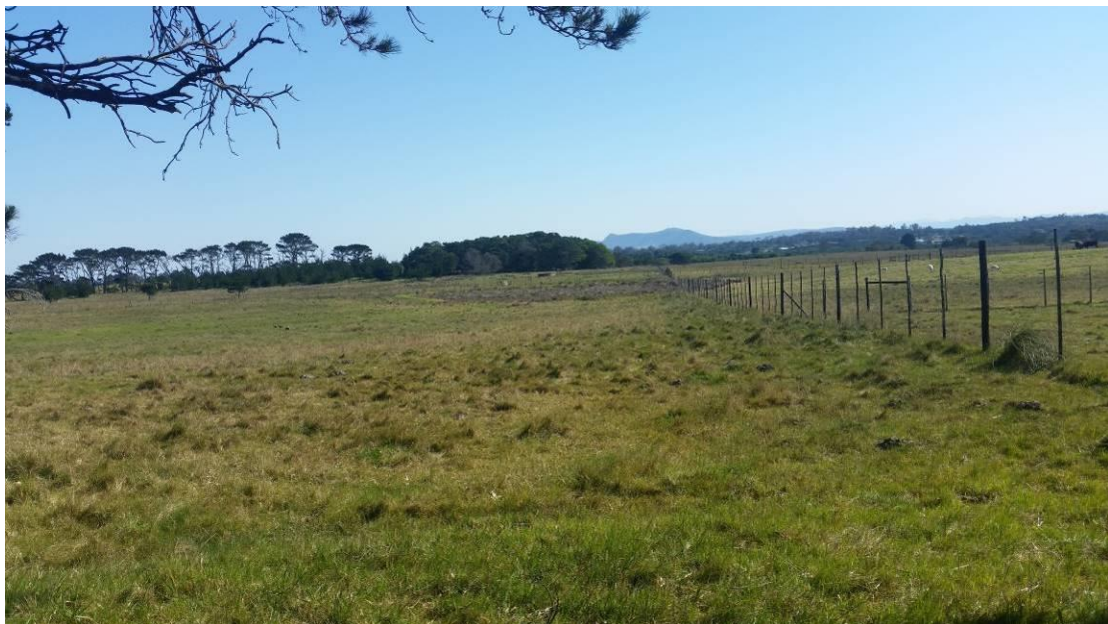
Ground-truthing indicates that the wetland is a natural pan with surface water. The farm is well-known for its livestock farming practise, and the cattle utilise the pan for drinking water. The vegetation of the entire surrounding area is therefore grazed. Note that the pan is crossed by a fence (Figure 14). It also seems that the area south of the pan, up to Seaview Rd, represents temporary (intermittent) wetland conditions (Figure 14).

The soil in the pan is saturated sandy-clay and the vegetation within the pan is mainly sedges and hygrophilous grass. The temporary zone of the wetland is moist grassland intensively grazed, and it seems that this area is an old agricultural field, therefore this zone of the wetland had been intensively modified. This area has sandy clay soil with signs of reduction (mottles).

Figure 14: The pan (Wetland 5) on farmland. Note the lower-lying inflow area stretching from the pan towards the left of the photograph.

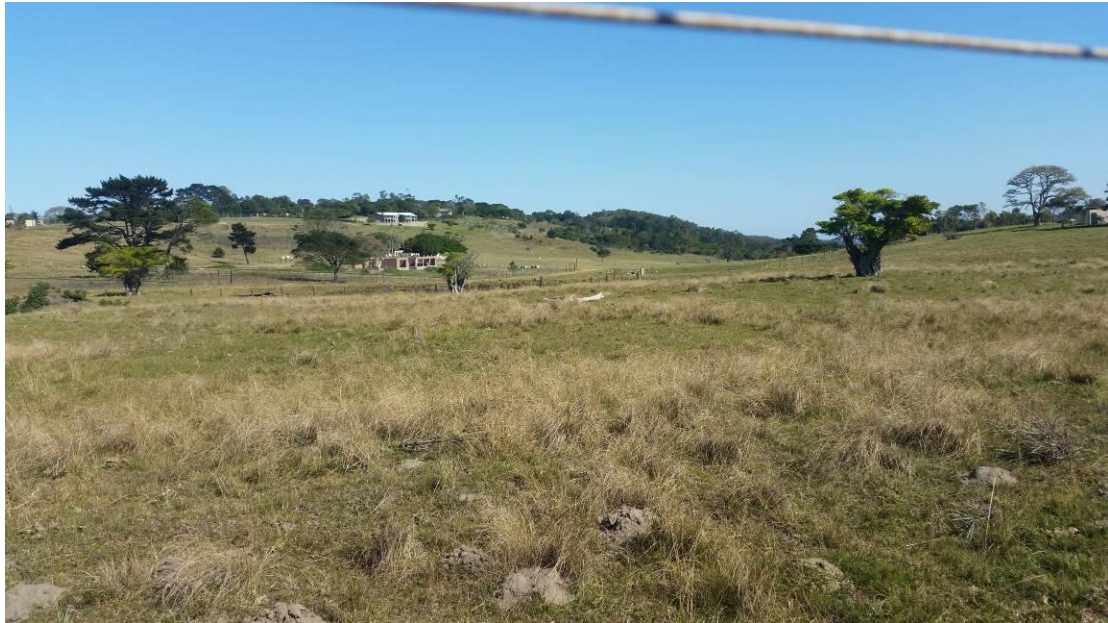
The dominant moist grassland vegetation in the small and dry catchment area above the dams shows wetland properties. This area is highly disturbed with some residential dwellings (Figure 15).The dam edges have a limited fringe of sedges. The areas surrounding the dams are all secondary grassland.

Figure 15: The catchment area of the dams as seen from Tembani Rd.

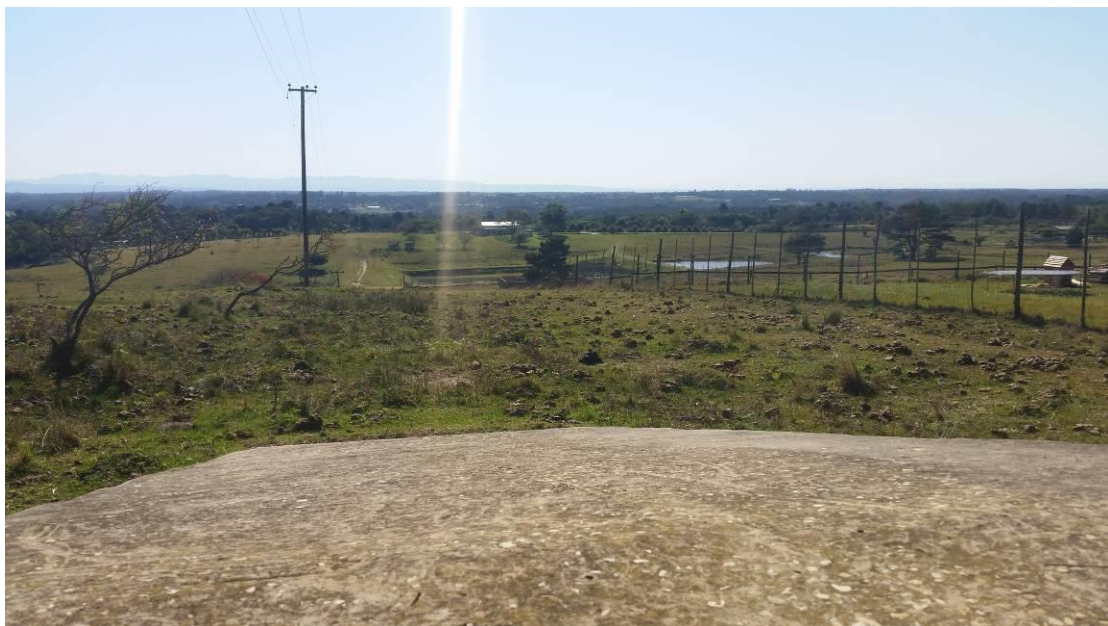
Figure 16: The series of dams in the background as seen from the gate at Spruce Rd.

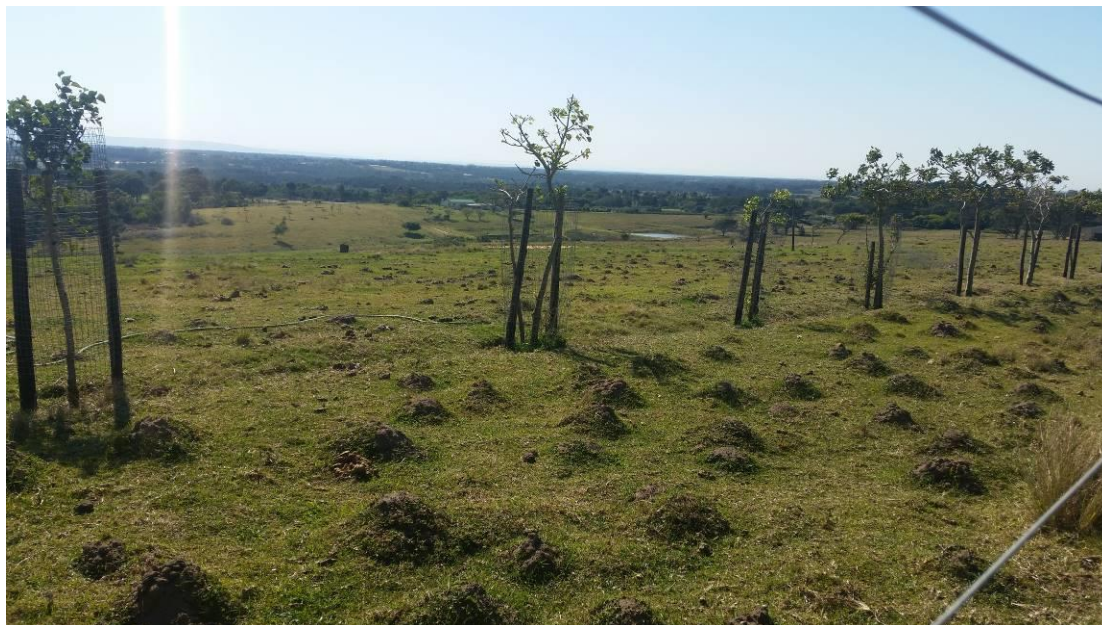
This aquatic system is indicated on both the NFEPA and NMBM GIS layers for wetlands. In the NFEPA map it is indicated as an artificial wetland. This is a small manmade dam within the same conservation area as Wetland 6. It is located on the

500 m buffer line, close to Spruce Rd at 33°58'00.8"S; 25°23'09.9"E. This dam was made in higher-lying secondary grassland, 500 m from the proposed pipeline (Figures 6 & 17).

Figure 17: The man-made dam (Wetland 7) in secondary grassland

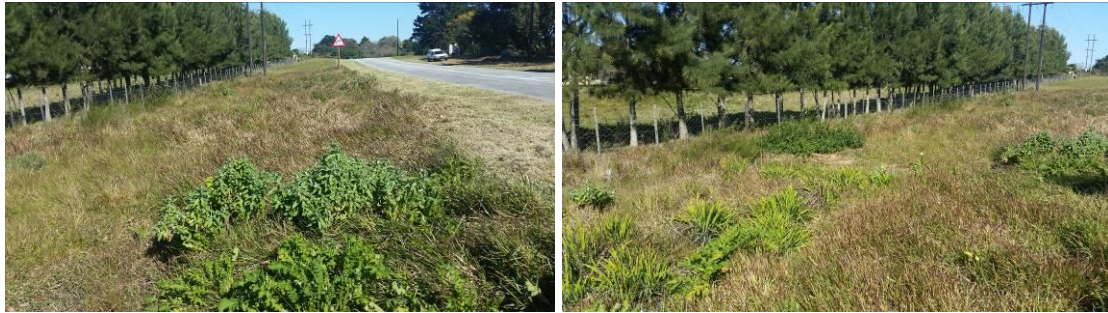
This wetland is not shown by any of the GIS layers. It is located east of Seaview Rd on farmland, at 33°58'04.5"S; 25°23'27.2"E, and stretches down the slight slope to the road reserve. Water flows from the adjacent grassland and is basically blocked by the Seaview Rd (Figures 6 & 18). The road reserve is wet with surface water. The wetland is regarded to be natural, but enhanced by the damming effect of the road. The soil is wet with definite mottles.

Figure 18: The wetland vegetation of Wetland 9 along Seaview Rd

The proposed pipeline will transect and destroy this wet area on the road reserve. Future water flow, after construction of the pipeline may again cause unwanted wet conditions over the pipeline, and a drainage system may be needed, depending on the opinion of the design engineers.

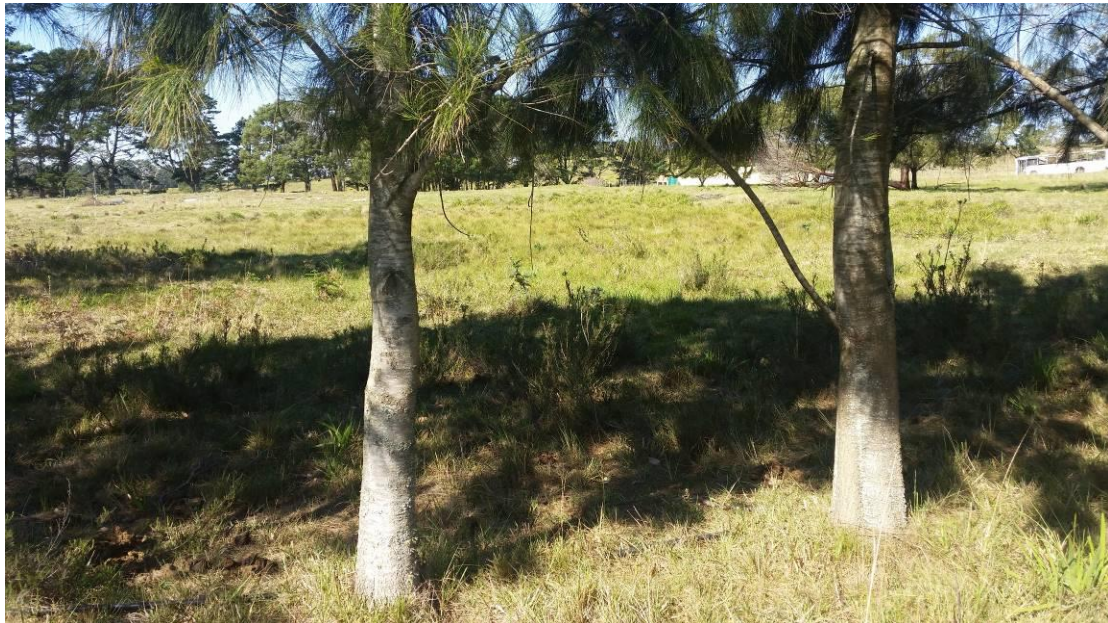
The vegetation of the lower part of this wetland is dominated by sedges and hygrophilous grasses, but higher up on the farmland is moist grassland (Figure 19).

Figure 19: The moist grassland on the farmland of Wetland 9.

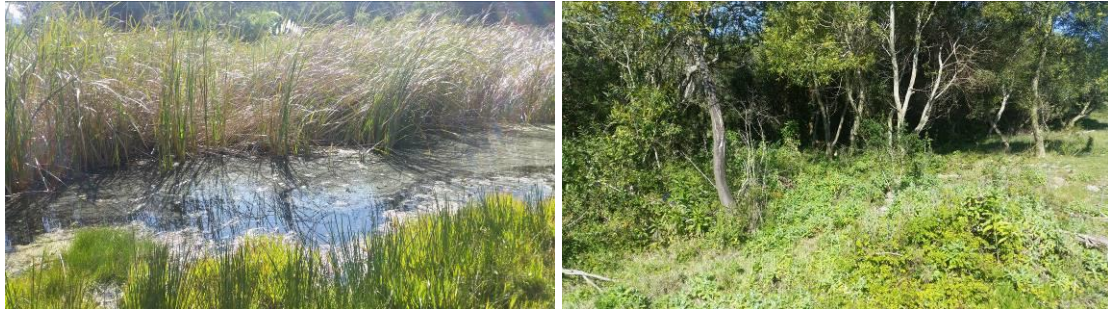
occurs in the area. A small artificial dam is present close to a residential house. The dam has water and is covered with *Typha capensis* and other sedges (Figure 20). The dam may overflow (over the dam wall and entrance road to the house) into adjacent forest.

Figure 20: The dam of Wetland 10, with *Typha capensis* and the adjacent forest.

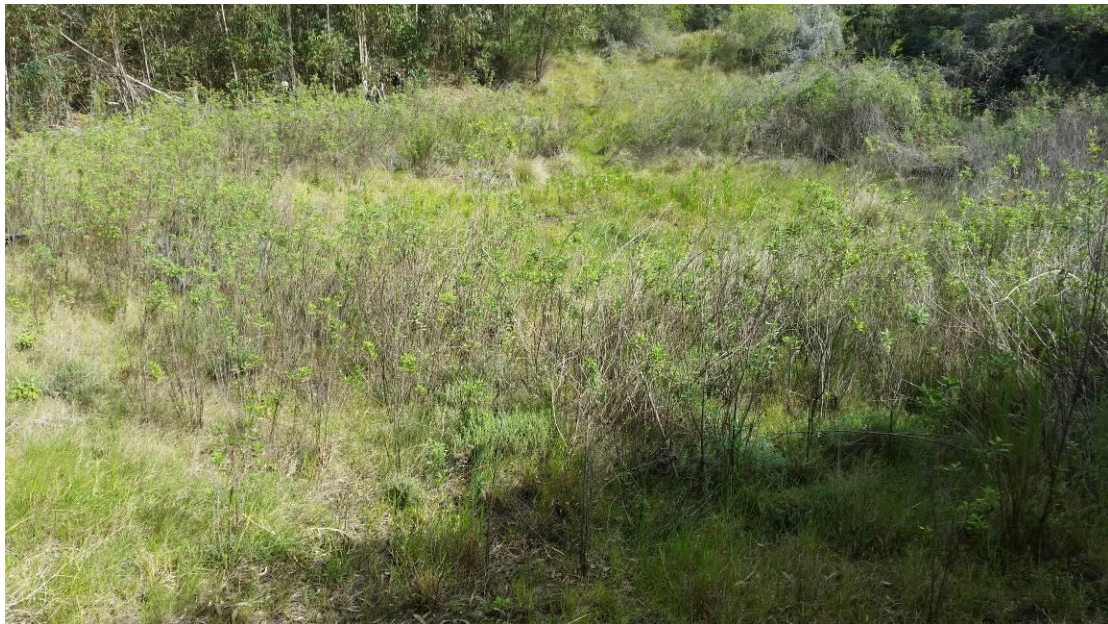
This wetland is not indicated on any of the GIS layers, though it is indicated on an aerial image provided by SRK Consulting. It is located at 33°59'31.7"S; 25°22'06.5"E. This wetland is a small natural pan of 15-18 m in diameter, hidden by indigenous forest (Figure 21), though on its eastern side is an *Eucalyptus* plantation (Figure 22). The pan is about 40 m from the pipeline servitude and about 90 m to Seaview Road. The pan floor is 10 m wide with wet clay-loam soil and covered with hygrophilous grass and sedges. At the time of the survey there was no surface water. The banks are quite steep, about 4 m wide and covered with sparse shrubs.

Figure 21: The natural pan (Wetland 11) in the forest.

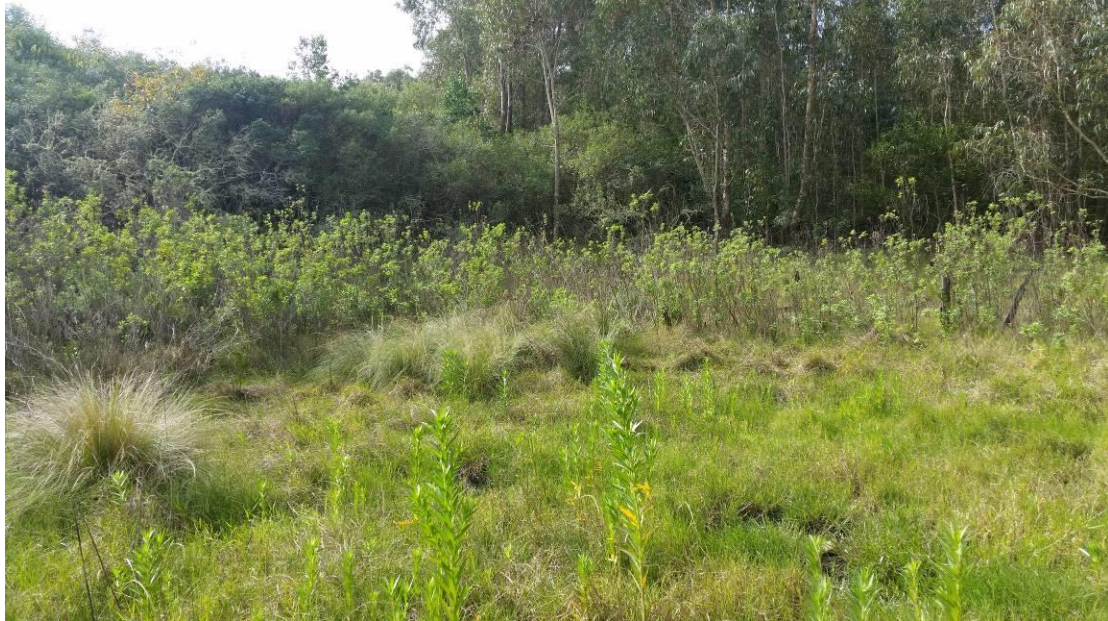
Figure 22: The pan fringed by indigenous forest and *Eucalyptus*.

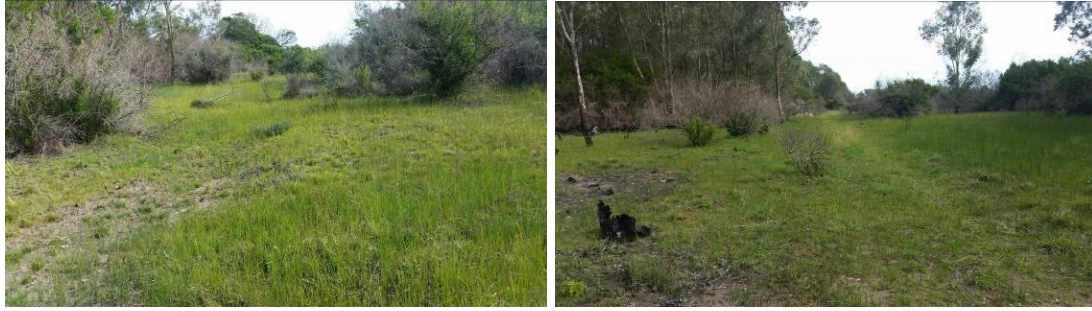
This northeast-southwest stretching low-lying wetland is currently dry but is located in a low valley without a channel (Figure 7) and is regarded as a potential wetland. This wetland does not occur on the existing databases but was indicated on the aerial photograph provided by SRK Consulting. The wetland is 200 m long and the width varies from 13 to 35 m. The central part of the wetland is at about 33°59'37.1"S; 25°21'59.9"E. The vegetation is short, moist grassland with several sedge species present (Figure 23). The soil is clay-loam, with signs of mottles. On the north-western side the wetland is bordered by indigenous forest and on the south-eastern side by a *Eucalyptus* plantation.

This wetland runs parallel to the proposed pipelines and is about 40 m from the pipeline servitude. Between the pipeline servitude and the wetland is a 40 m wide *Eucalyptus* plantation.

Figure 23: The natural Wetland 12 between natural forest and *Eucalyptus* plantation

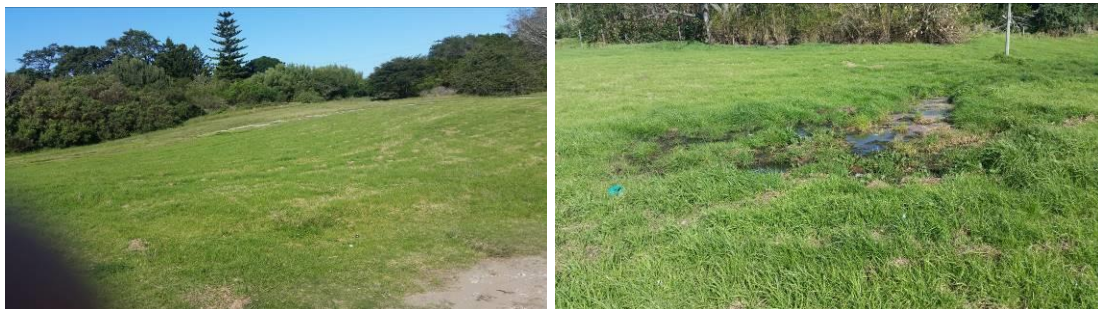
This was a small wetland close to the gate of the Daleside chicken farm at 33°59'44.0"S; 25°22'10.9"E (Figure 7). The wetland was transformed into a Kikuyu grass-covered parking area for visitors to the chicken farm. A small part of the Kikuyu-lawn is currently quite wet with some surface water (Figure 24).

Figure 24: The Kikuyu lawn (Wetland 15) at the parking lot of the Daleside chicken farm.

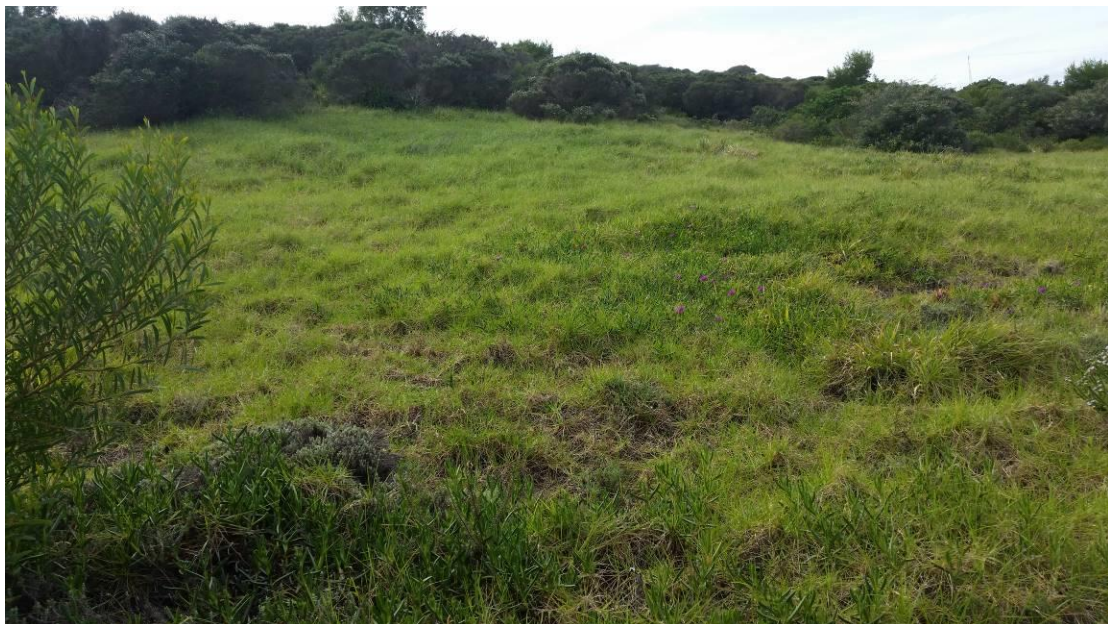
This potential wetland located at 33°59'43.5"S; 25°20'53.0"E, and indicated on the NMBM GIS wetland layer (Figure 7) was found to be a cleared area in the bush, now planted with Kikuyu grass, and no wetland occurs here (Figure 25). This location will therefore not be discussed further.

Figure 25: Area of potential Wetland 19 is Kikuyu grass on a cleared area in the bush.

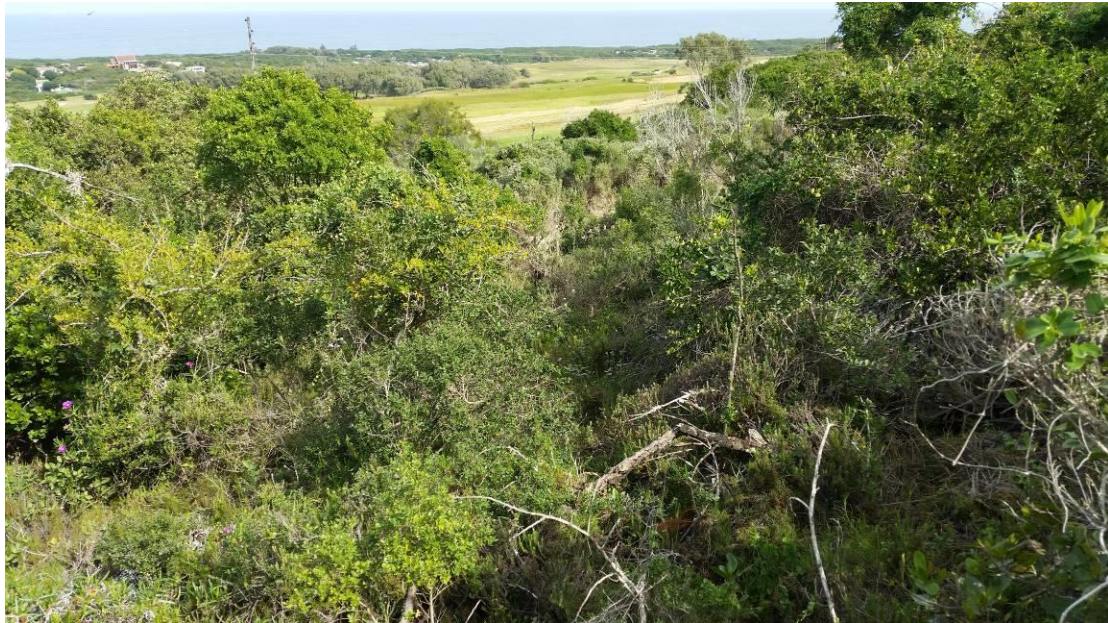
bush and no wetland occurs here (Figure 26). This location will therefore not be discussed further.

Figure 26: Dense bush in the area of potential Wetland 20.

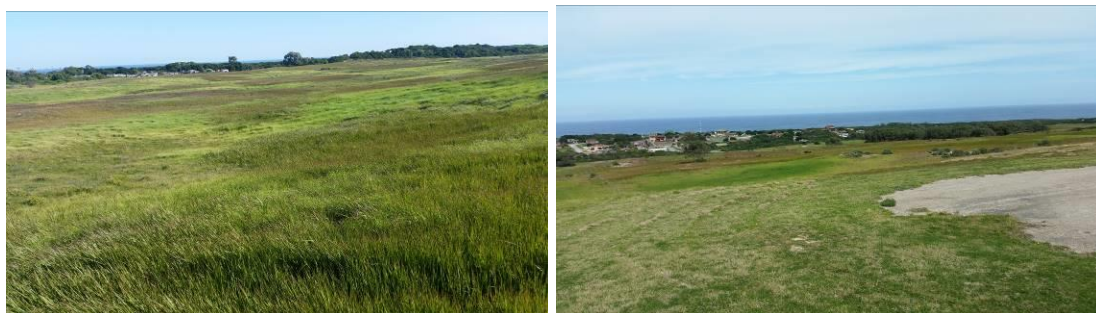
The bush in this area was cleared (date unknown) and secondary grassland / planted pasture established (Figure 27). Large areas are covered by this planted pasture grass, (which is often mowed) while large areas are covered by the grass *Imperata cylindrica*, which is mostly associated with the drier outside edge of wetlands. In this case the *Imperata cylindrica* is however not restricted to lower-lying areas, but often occur over the dune crests. It should be noted that a linear a low-lying area that could be a drainage line, is present in the southern part of the site parallel to Seaview Road This is discussed under Wetland 22.

Figure 27: The undulating cleared area of potential Wetland 21. Note the darker patches of *Imperata cylindrica*.

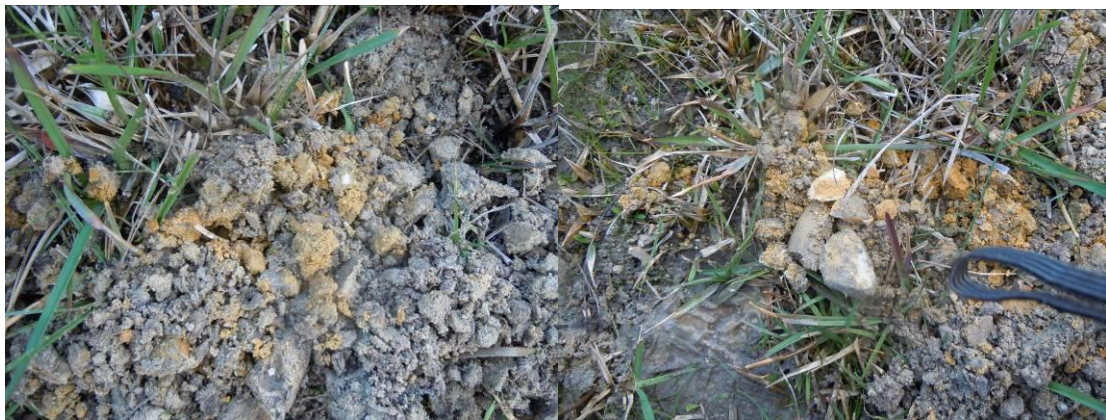
At least one soil sample was taken with a soil auger at all wetlands except Wetlands 6 and 7, where access was not possible. In general the soils were wet to moist, sandy to loamy and often with signs of wetness (Figure 13). The soil sample was made to confirm wetland conditions, rather than to indicate zonation.

Figure 13: An example of a soil sample taken with a soil auger
