PROJECT: MALUTI

**REHABILITATION PLAN FOR THE MALUTI WETLAND PROJECT, FREE STATE:
PLANNING YEAR 2014**

**AS PART OF THE
WORKING FOR WETLANDS PROGRAMME
FOR THE
SOUTH AFRICAN NATIONAL BIODIVERSITY INSTITUTE**

Prepared by: Aurecon South Africa (Pty) Ltd
P O Box 494
Cape Town
8000
South Africa
Tel: 021 526 6022
Fax: 021 526 9500
Email: franci.gresse@aurecongroup.com

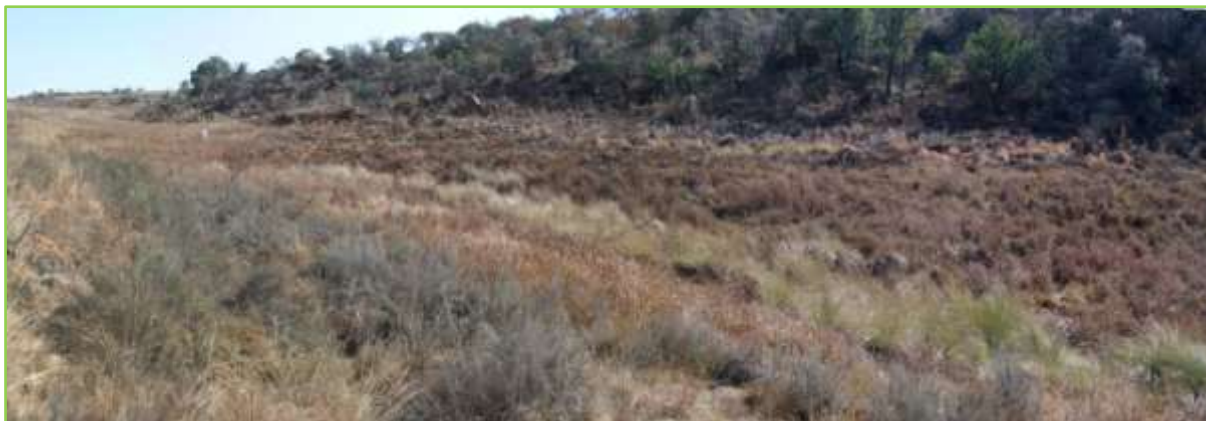
Plate A: A large, seasonal wetland identifiable by the characteristic flora. This wetland contained no surface water at the time of the photograph.

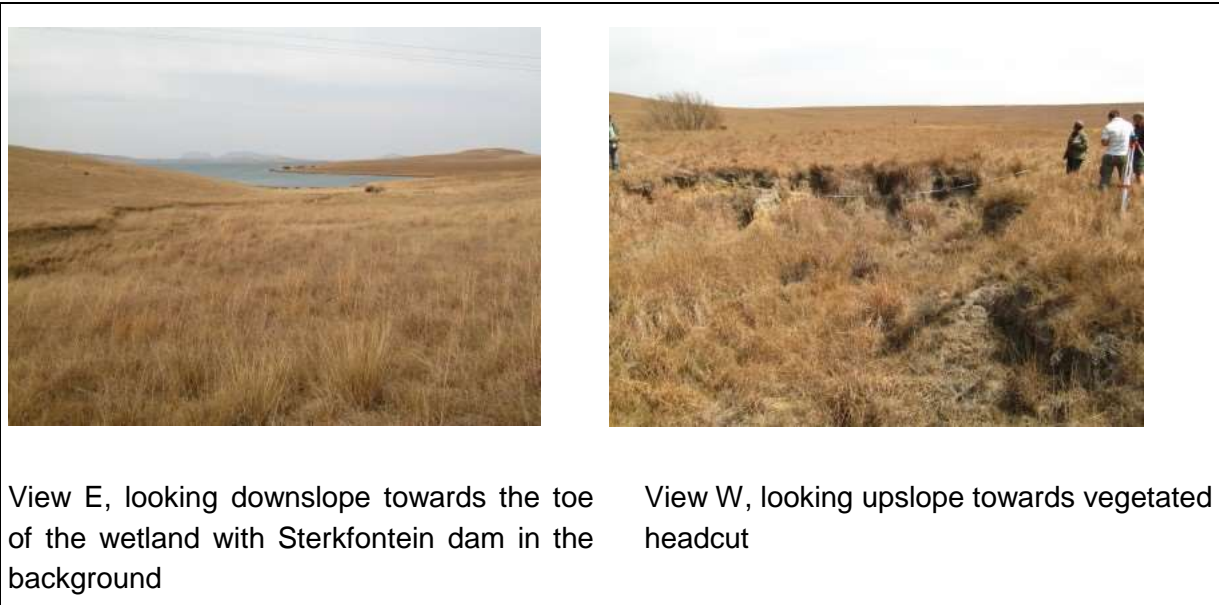
View SE, looking downstream from the head of the erosion gully towards the vegetated gully downstream

View NW, looking upslope towards intact section of unchannelled wetland in the north-east

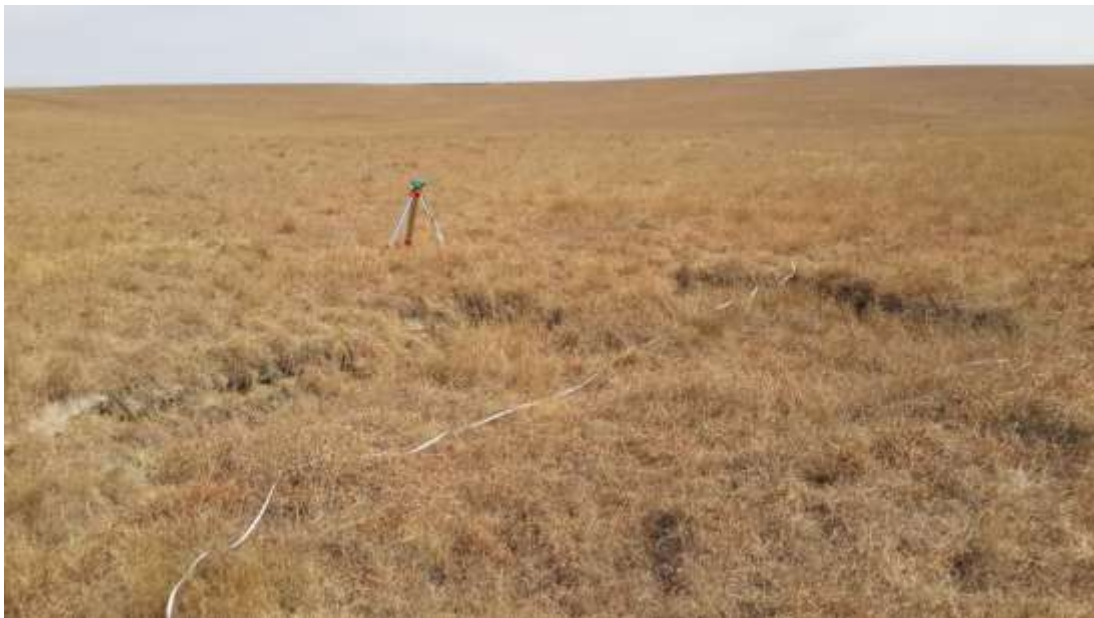
Figure 7: Intervention site C81D-01-201-00 looking upstream.

Designer	Danie Louw
Design Date	October 2013
Intervention Description	Earthworks, Sloping 1:4 and MAC-MAT-R
Rehabilitation Objective	Deactivate small head cut
Latitude (D°M'S")	28°24'21.89 S"
Longitude (D°M'S")	28°58'20.34 E"
Engineering Drawings	C81D-01-201-00

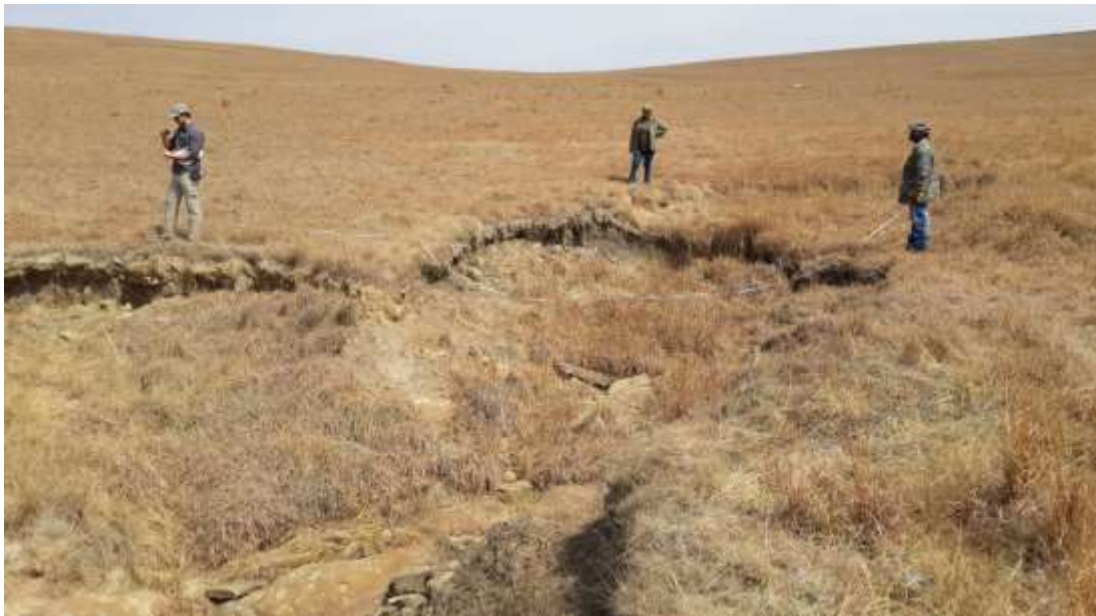
Figure 8: Intervention site C81D-01-202-00 looking upstream

Designer	Danie Louw
Design Date	October 2013
Intervention Description	Gabion drop inlet structure and Earth berms
Rehabilitation Objective	Deactivate head cut
Latitude (D°M'S")	28°24'24.07 S"
Longitude (D°M'S")	28°58'19.57 E"
Engineering Drawings	C81D-01-202-00

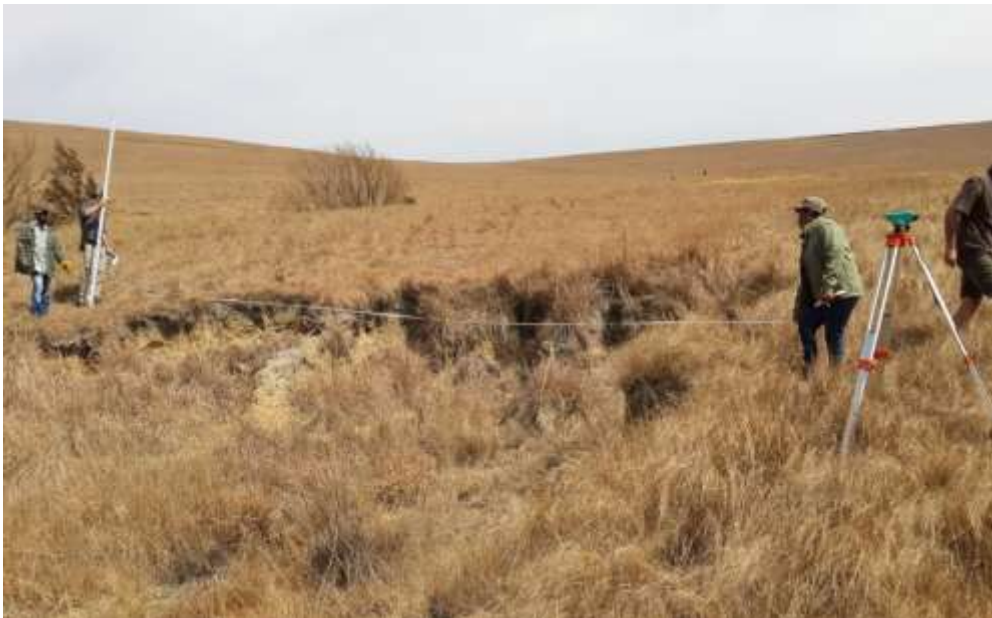
Designer	Danie Louw
Design Date	October 2013
Intervention Description	Earthworks, Sloping 1:4 and MAC-MAT-R
Rehabilitation Objective	Deactivate medium head cut
Latitude (D°M'S")	28°24'22.90 S"
Longitude (D°M'S")	28°58'23.02 E"
Engineering Drawings	C81D-01-203-00

Figure 9: Earthen diversion berm, C81D-01-203-00 looking upstream.

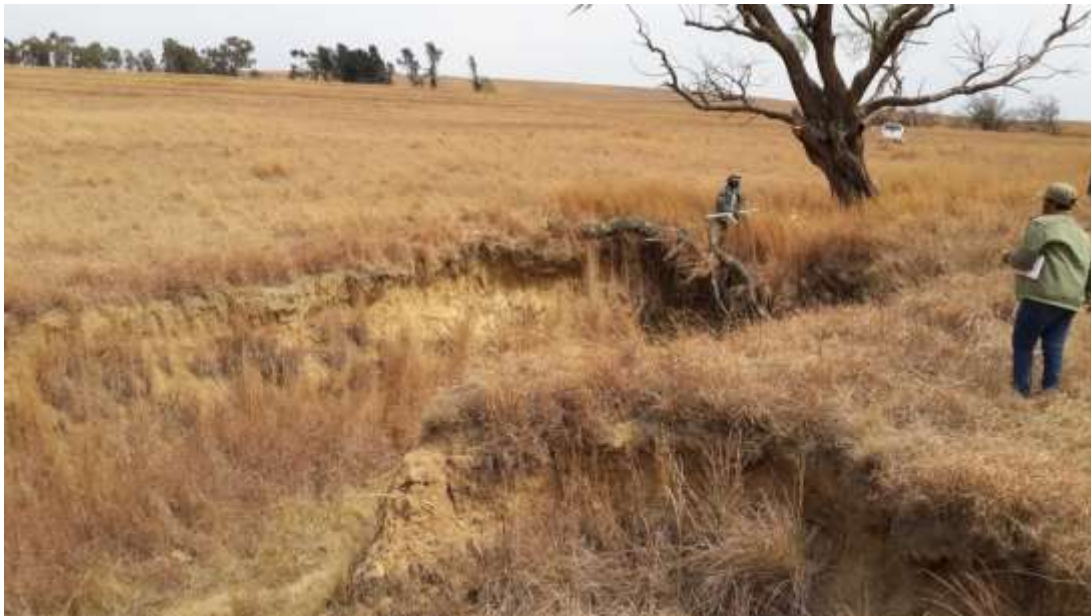
Figure 10: Intervention site C81D-01-204-00 looking upstream.

Designer	Danie Louw
Design Date	October 2013
Intervention Description	Gabion drop inlet structure
Rehabilitation Objective	Deactivate large Head cut
Latitude (D°M'S")	28°24'26.38 S"
Longitude (D°M'S")	28°58'34.00 E"
Engineering Drawings	C81D-01-204-00

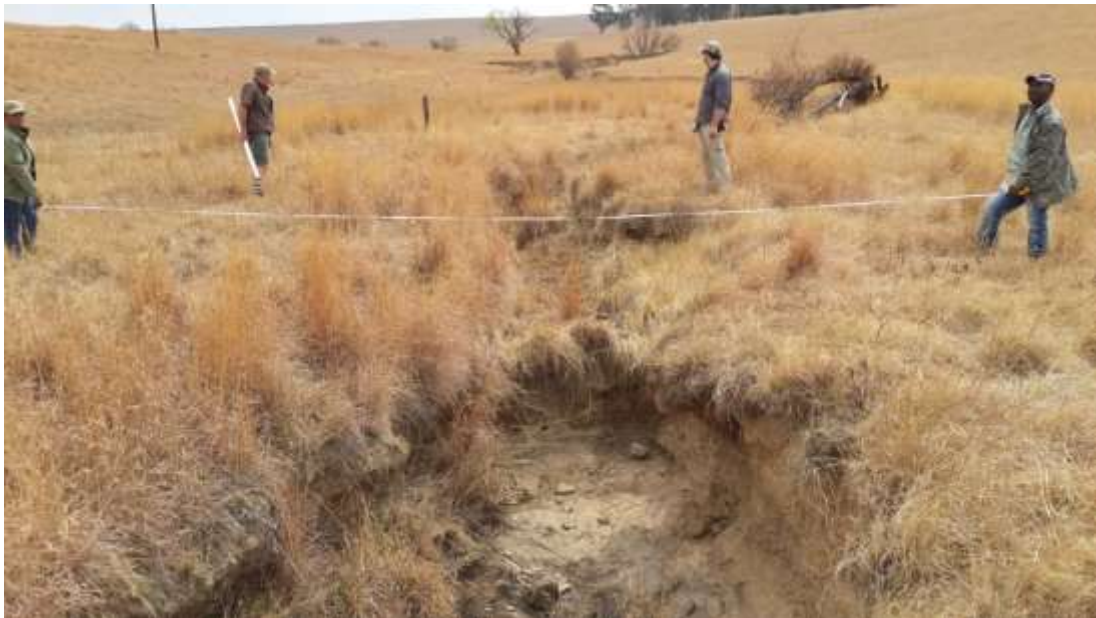
Designer	Danie Louw
Design Date	October 2013
Intervention Description	Concrete Weir
Rehabilitation Objective	To raise the water level in the channel and activate adjacent wetland areas
Latitude (D°M'S")	28°24'29.42 S"
Longitude (D°M'S")	28°58'40.39 E"
Engineering Drawings	C81D-01-205-00

Figure 11: Concrete weir, C81D-01-205-00 looking upstream.

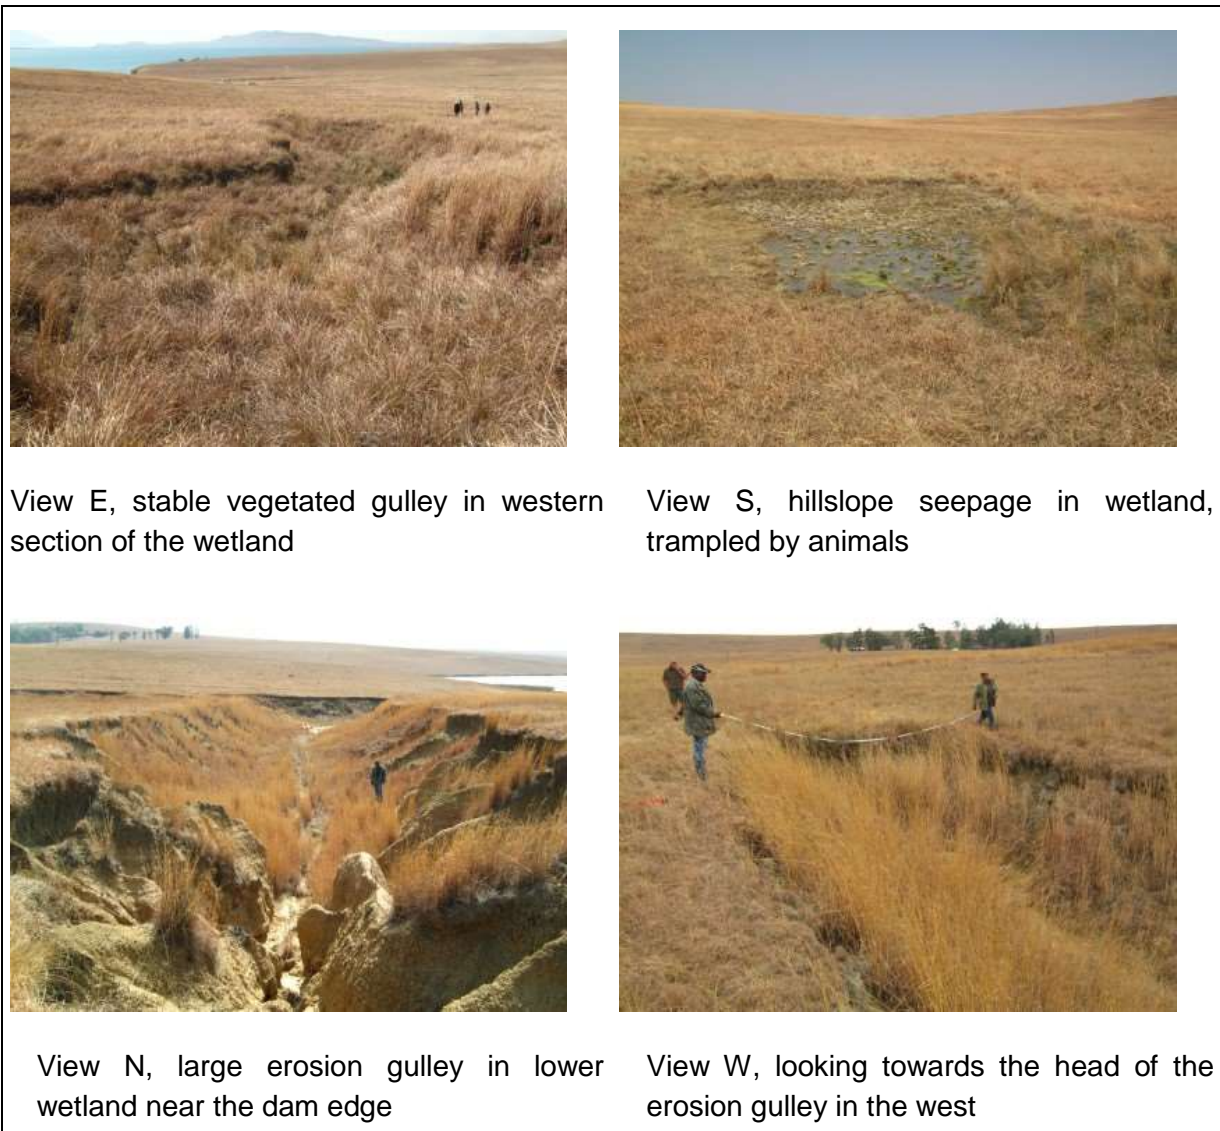
Figure 13: Site Photos of the Escol 2 wetland

The main aims of the rehabilitation work in the Escol 2 wetland would be to deactivate headcuts and secure intact wetland habitat in the upper wetland and to prevent further erosion caused by vehicles traversing the wetland via existing dirt tracks while facilitating their crossing the wetland system.

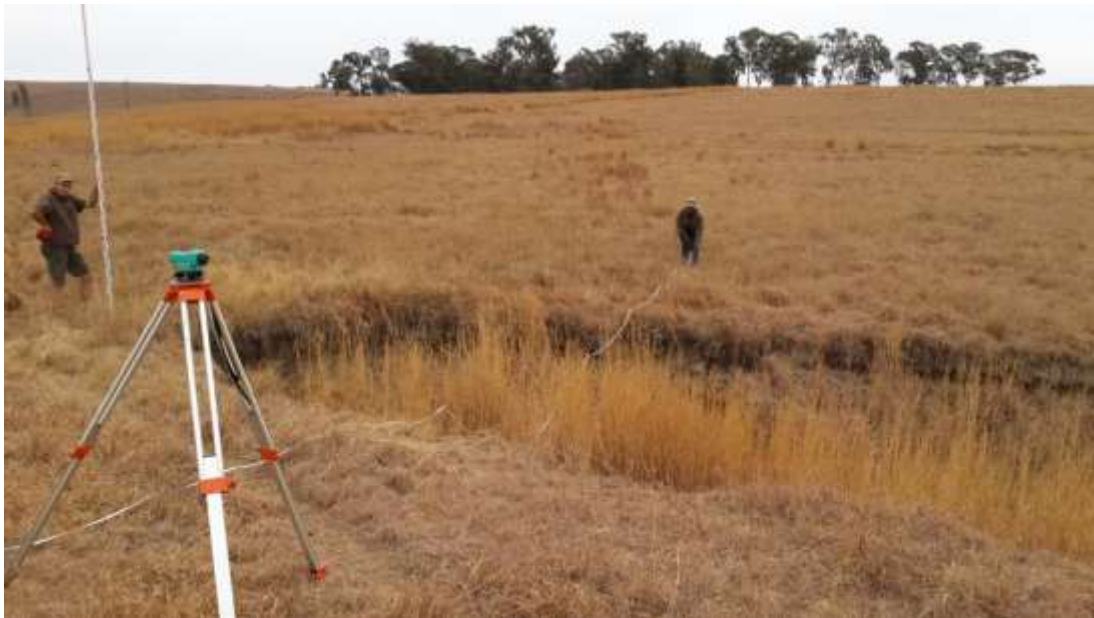
Figure 15: Intervention site C81D-02-201-00 looking upstream from the left bank.

Designer	Danie Louw
Design Date	October 2013
Intervention Description	Gabion drop inlet
Rehabilitation Objective	Deactivate large Head cut
Latitude (D°M'S")	28°24'43.25 S"
Longitude (D°M'S")	28°58'45.63 E"
Engineering Drawings	C81D-02-201-00

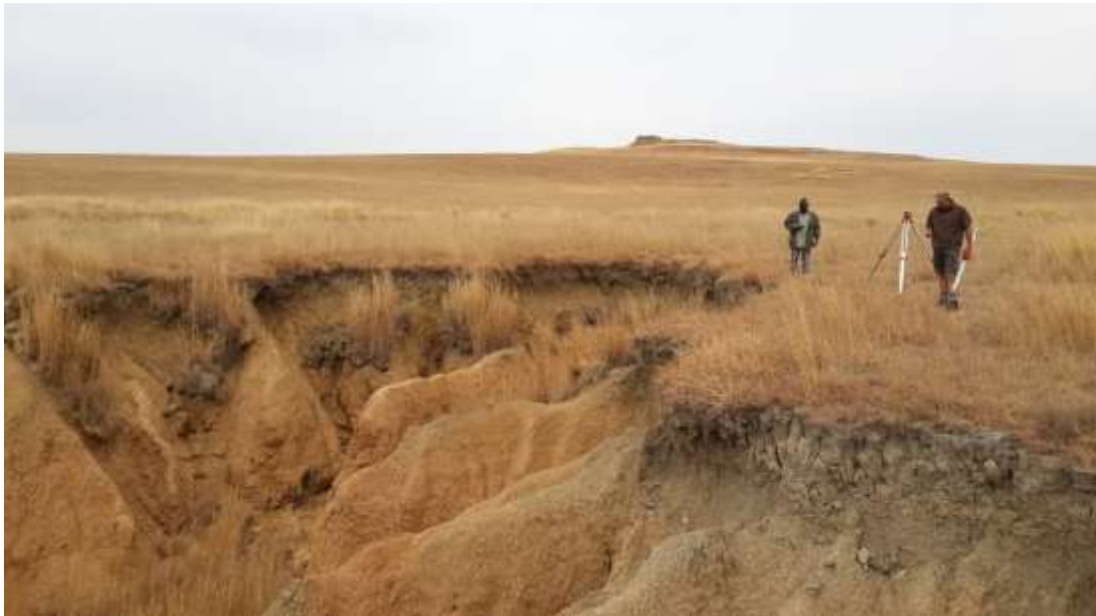
Figure 16: Intervention site C81D-02-202-00 looking upstream from the left bank.

Designer	Danie Louw
Design Date	October 2013
Intervention Description	Earth berm to divert water away from the head cut
Rehabilitation Objective	Deactivate large Head cut
Latitude (D°M'S")	28°24'42.93 S"
Longitude (D°M'S")	28°58'49.83 E"
Engineering Drawings	C81D-02-202-00

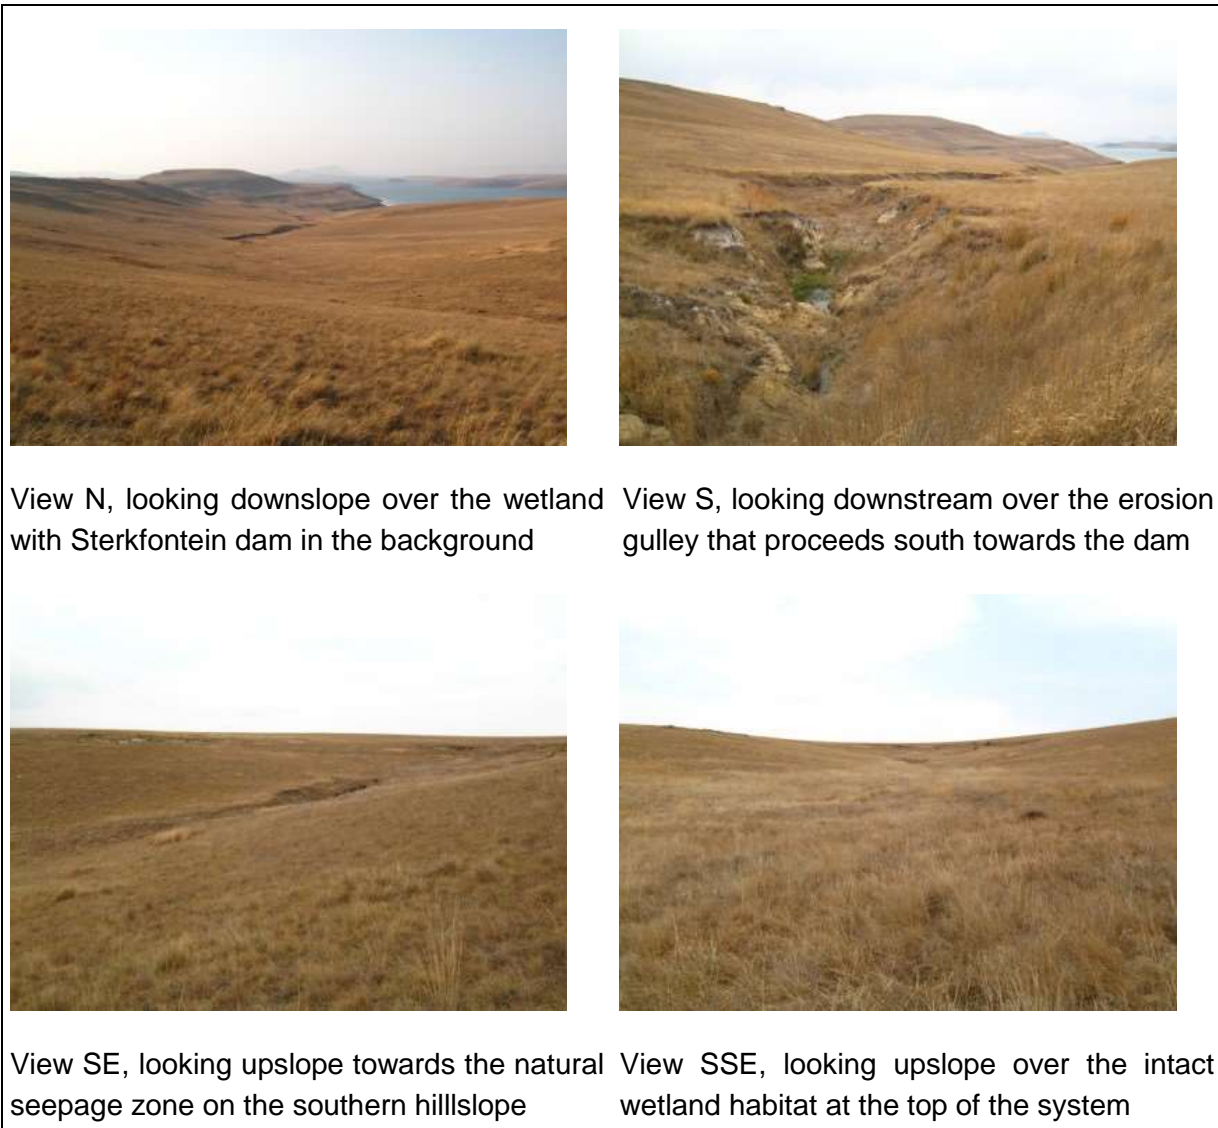
Figure 17: Site Photos of the Sterkfontein 1 wetland

The aim of rehabilitation in this wetland would be to deactivate the large active headcuts in order to secure intact wetland habitat in the upper wetland.

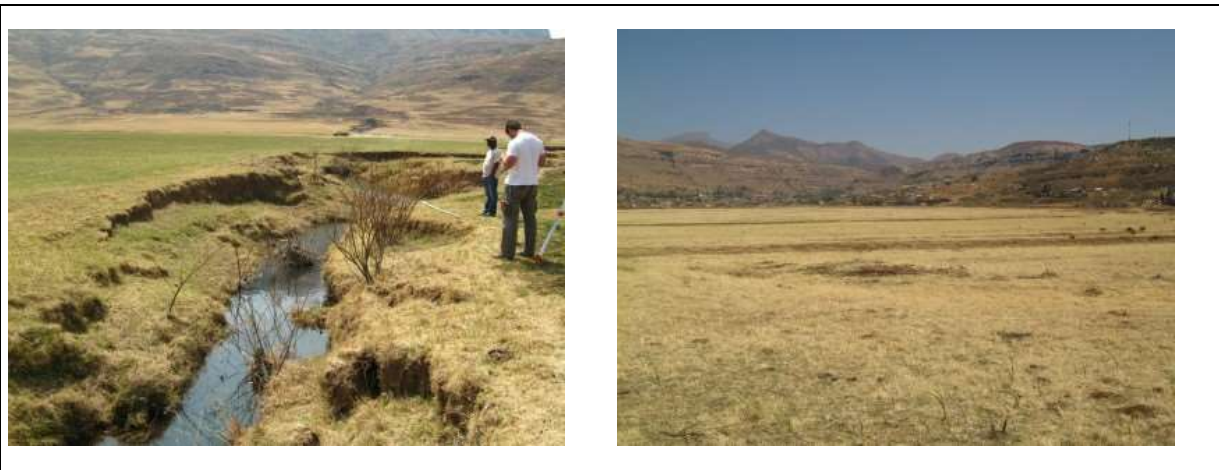
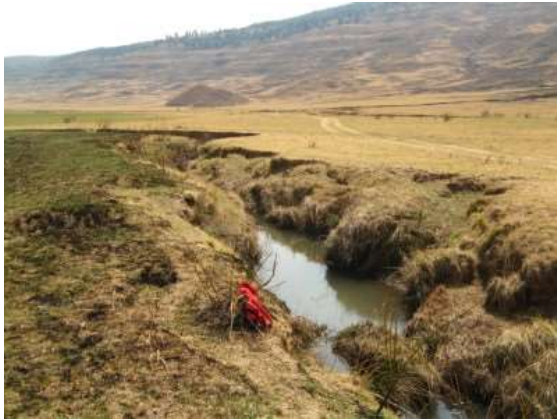
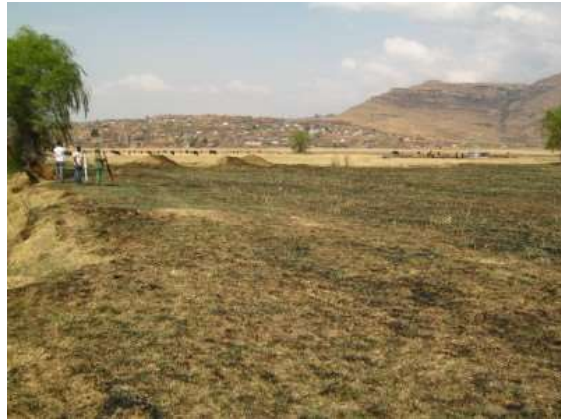
View NE, incised channel looking downstream at site for proposed intervention (weir)
 View SW, looking upslope over the broader floodplain that has been cultivated

View NW, looking upstream from proposed intervention on the main channel

View SE, looking downstream adjacent to the main channel at an area of the floodplain that has been burnt and extensively grazed by livestock

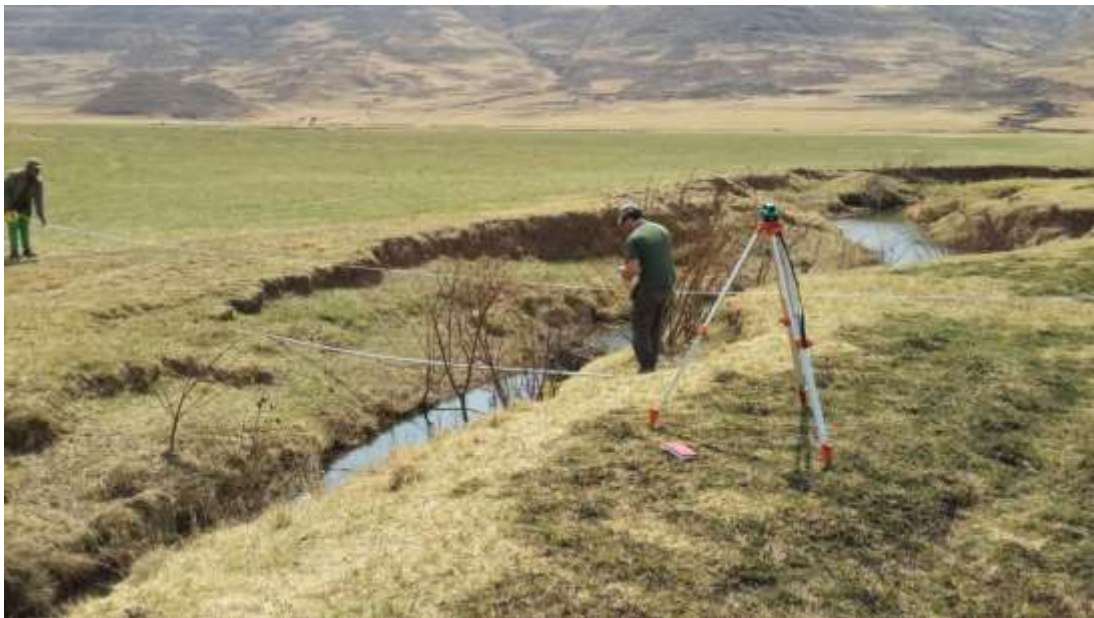
Figure 22: Intervention site C81F-02-205-00 looking down-stream from the right bank.

Designer	Danie Louw
Design Date	October 2013
Intervention Description	Concrete Weir
Rehabilitation Objective	To raise the water level in the channel and rewet adjacent wetland areas
Latitude (D°M'S")	28°33'26.21 S"
Longitude (D°M'S")	28°44'36.39 E"
Engineering Drawings	C81F-02-205-00

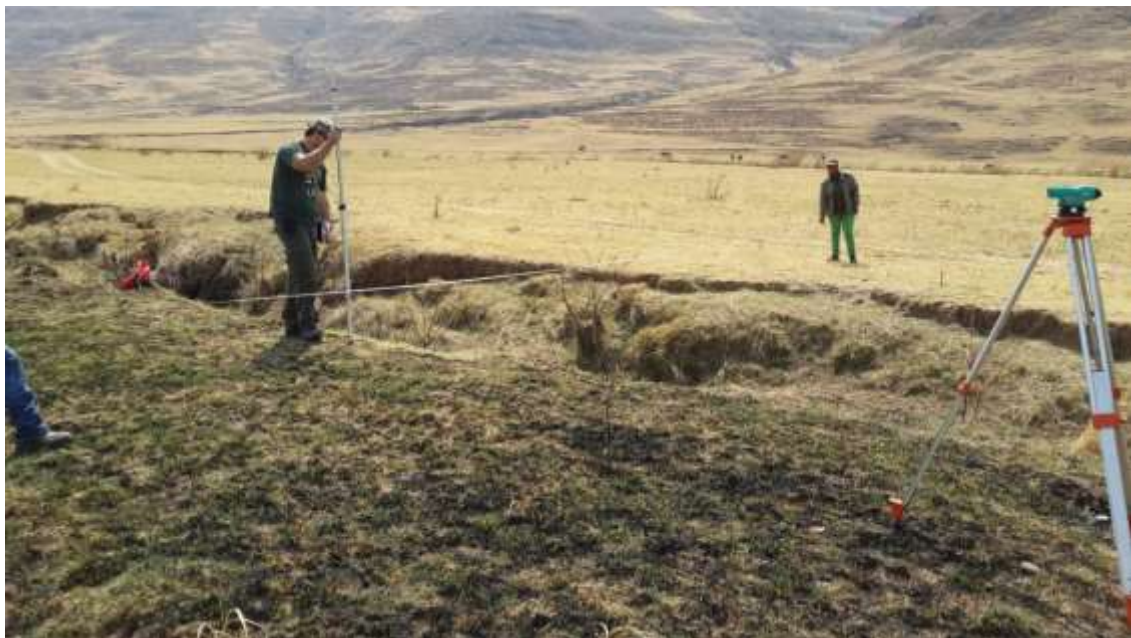
Figure 23: Intervention site C81F-02-206-00 looking upstream from the right bank.

Designer	Danie Louw
Design Date	October 2013
Intervention Description	Concrete Weir
Rehabilitation Objective	To raise the water level in the incised channel, re-wet adjacent wetland areas and support upstream structures
Latitude (D°M'S")	28°33'24.05 S"
Longitude (D°M'S")	28°44'45.41 E"
Engineering Drawings	C81F-02-206-00

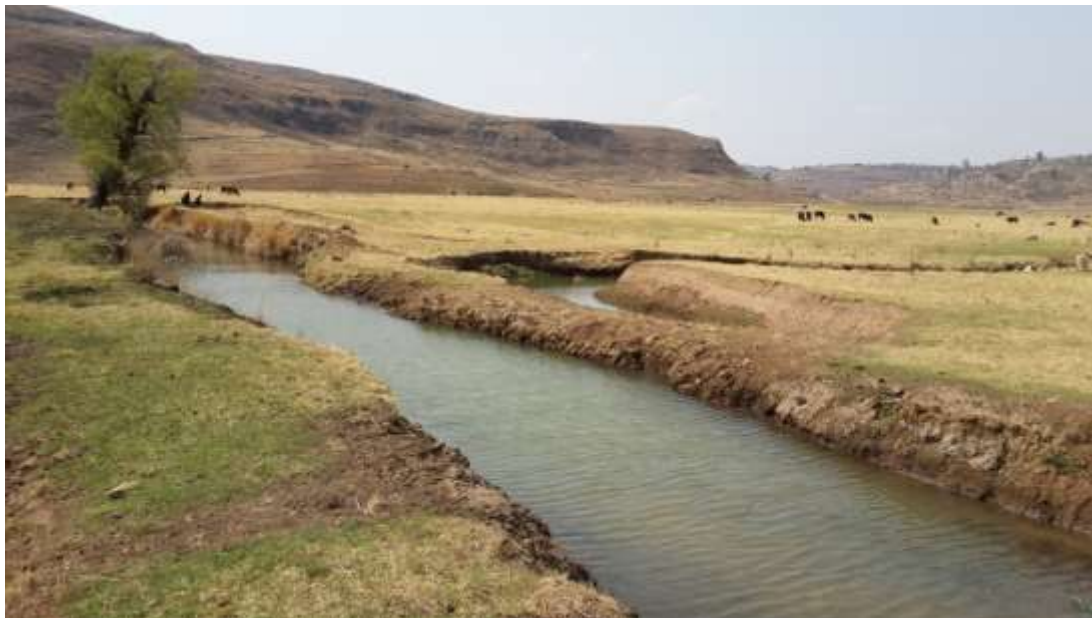
Figure 24: Intervention site C81F-02-207-01 looking upstream from the right bank.

Designer	Danie Louw
Design Date	October 2013
Intervention Description	Earth berm (Maintenance)
Rehabilitation Objective	Raise existing earth berm to prevent flows entering drain on left bank
Latitude (D°M'S")	28°33'32.09 S"
Longitude (D°M'S")	28°44'49.66 E"
Engineering Drawings	C81F-02-207-01

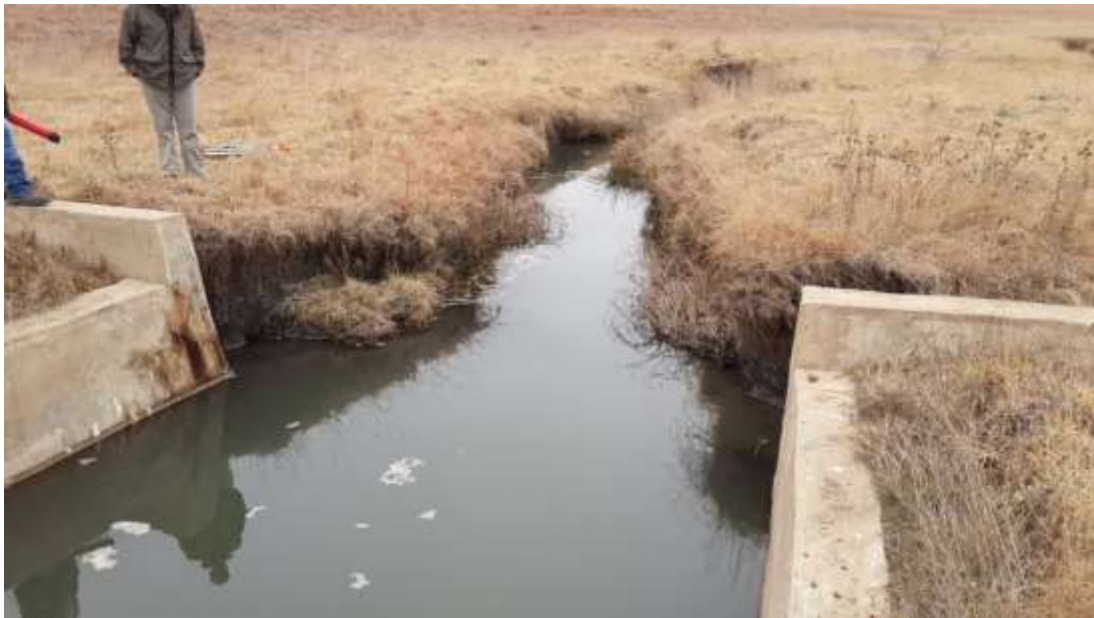
Figure 27: Intervention site C81H-11-202-01

Designer	Danie Louw
Design Date	October 2013
Intervention Description	Maintenance
Rehabilitation Objective	Maintenance on existing concrete drop inlet weir
Latitude (D°M'S")	28°19'01.45 S"
Longitude (D°M'S")	28°53'53.18 E"
Engineering Drawings	C81H-11-202-01

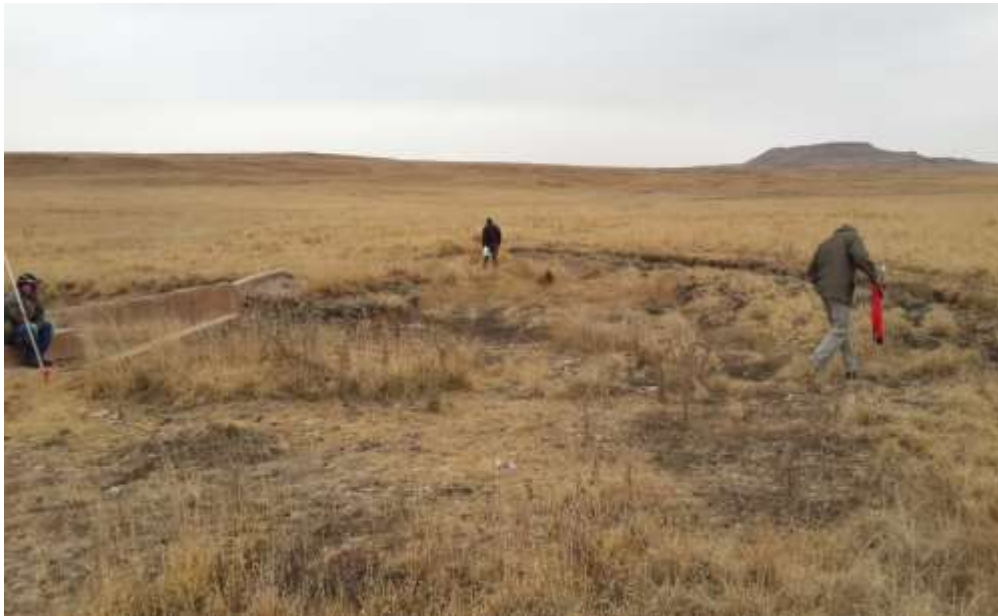
Figure 28: Intervention site C81H-11-203-01

Designer	Danie Louw
Design Date	October 2013
Intervention Description	Fence and ecologs
Rehabilitation Objective	Fence off existing structure to prevent cattle trampling
Latitude (D°M'S")	28°18'59.96 S"
Longitude (D°M'S")	28°53'55.50 E"
Engineering Drawings	C81H-11-203-01

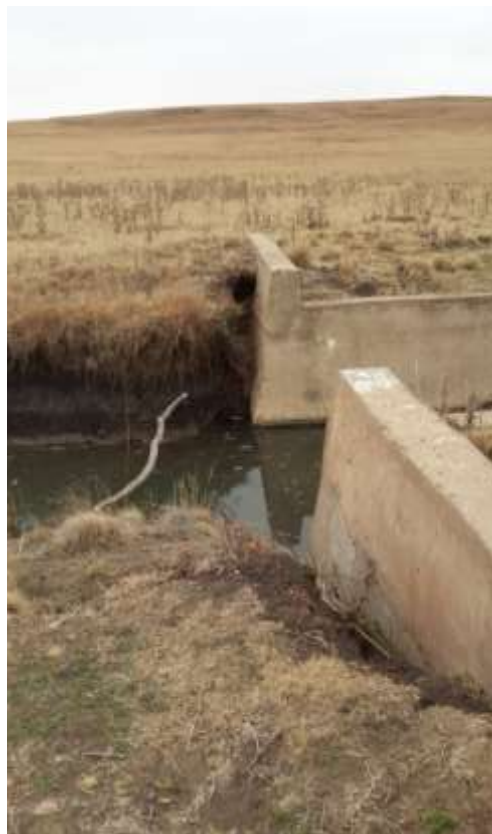
Figure 29: Intervention site C81H-11-204-01.

Designer	Danie Louw
Design Date	October 2013
Intervention Description	Maintenance
Rehabilitation Objective	Maintenance on concrete drop inlet weir
Latitude (D°M'S")	28°19'03.71 S"
Longitude (D°M'S")	28°53'57.19 E"
Engineering Drawings	C81H-11-204-01

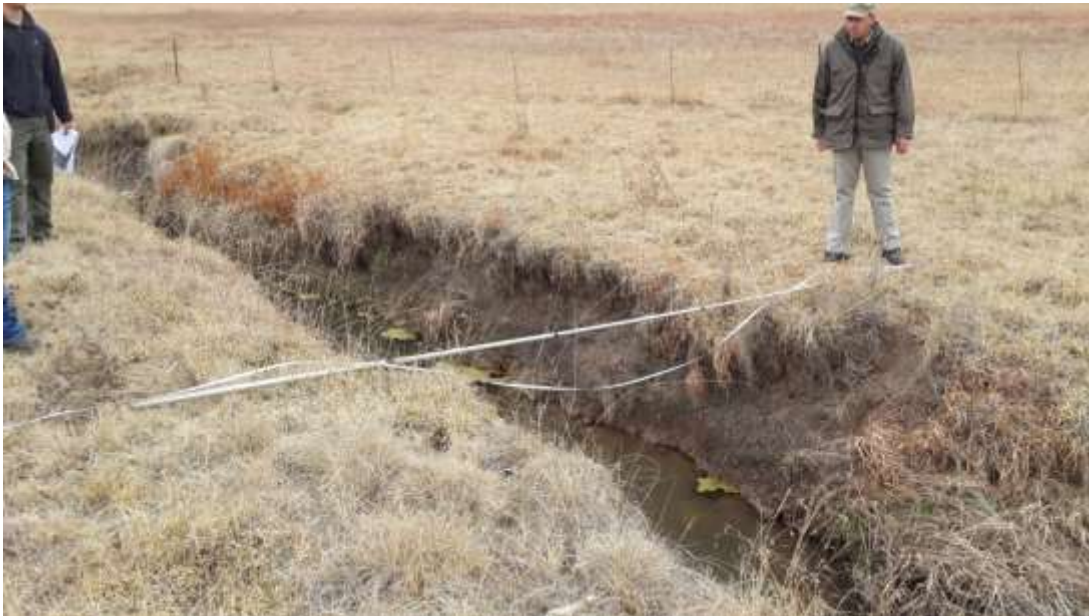
Figure 30: Intervention site C81H-11-201-00 looking upstream from the right bank.

Designer	Danie Louw
Design Date	October 2013
Intervention Description	Concrete weir
Rehabilitation Objective	To raise the water level in the channel and encourage re-wetting of adjacent wetland areas
Latitude (D°M'S")	28°18'58.02 S"
Longitude (D°M'S")	28°53'47.00 E"
Engineering Drawings	C81H-11-201-00

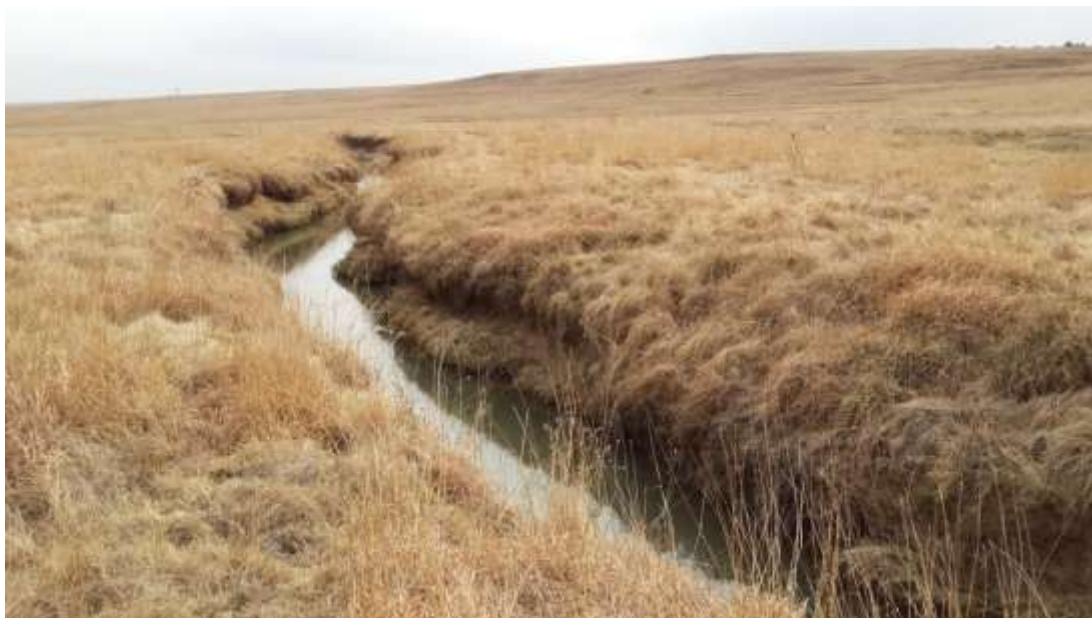
Figure 31: Intervention site C81H-11-205-00 looking upstream from the right bank.

Designer	Danie Louw
Design Date	October 2013
Intervention Description	Concrete Weir
Rehabilitation Objective	To raise the water level in the channel
Latitude (D°M'S")	28°19'11.31 S"
Longitude (D°M'S")	28°54'02.09 E"
Engineering Drawings	C81H-11-205-00

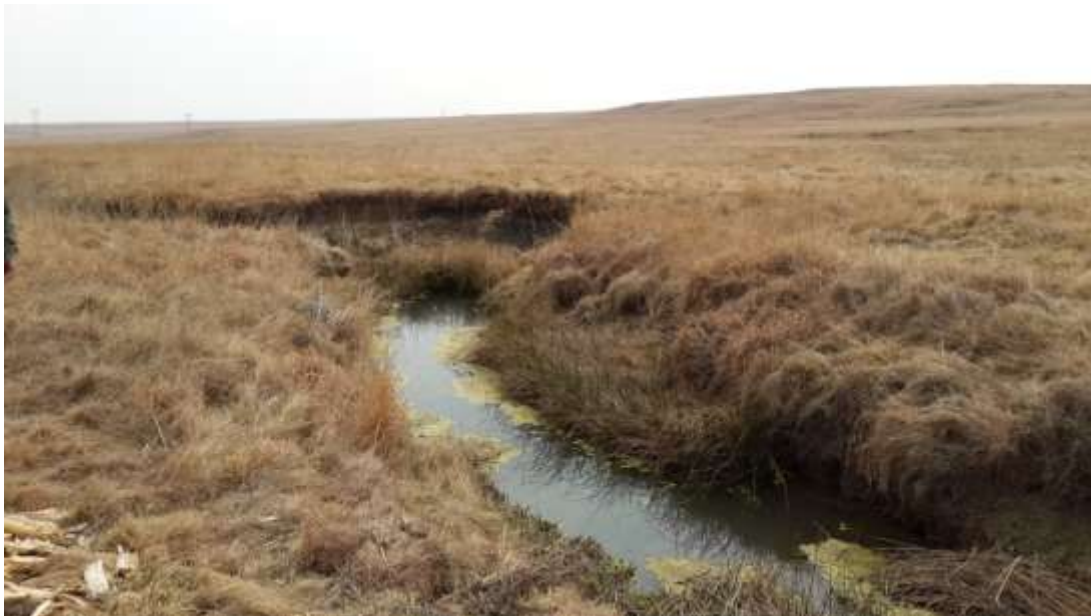
Figure 32: Intervention site C81H-11-206-00 looking upstream from the right bank.

Designer	Danie Louw
Design Date	October 2013
Intervention Description	Concrete Weir
Rehabilitation Objective	To raise the water level in the channel
Latitude (D°M'S")	28°19'15.26 S"
Longitude (D°M'S")	28°54'04.48 E"
Engineering Drawings	C81H-11-206-00

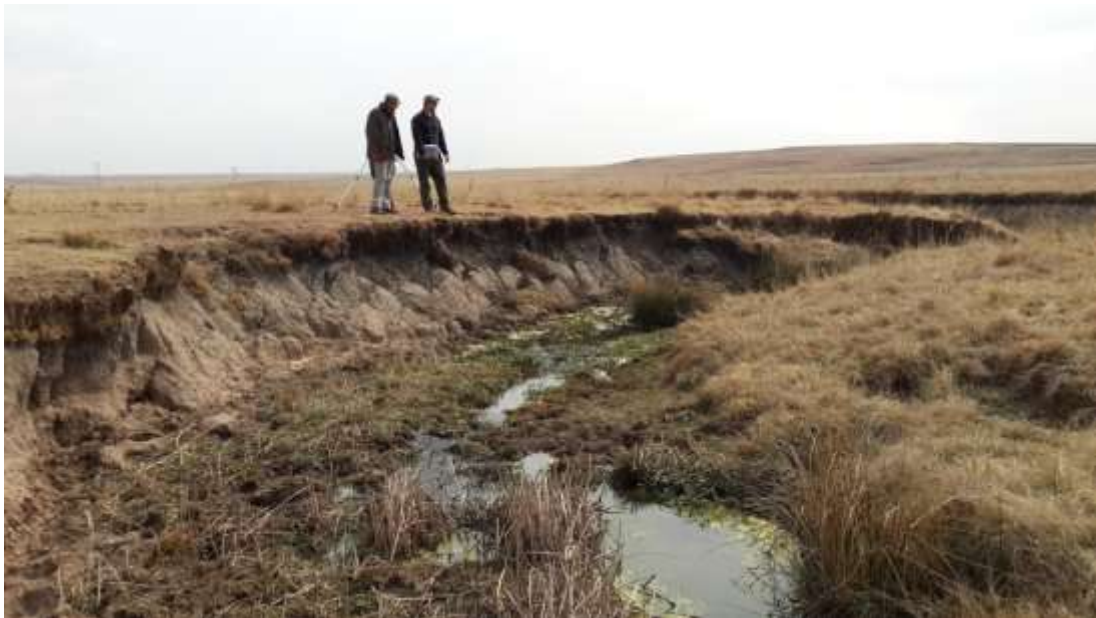
Figure 33: Intervention site C81H-11-207-00 looking upstream.

Designer	Danie Louw
Design Date	October 2013
Intervention Description	Earthworks, slope 1:4
Rehabilitation Objective	Slope eroded bank and prevent further slumping
Latitude (D°M'S")	28°19'17.82 S"
Longitude (D°M'S")	28°54'04.79 E"
Engineering Drawings	C81H-11-207-00

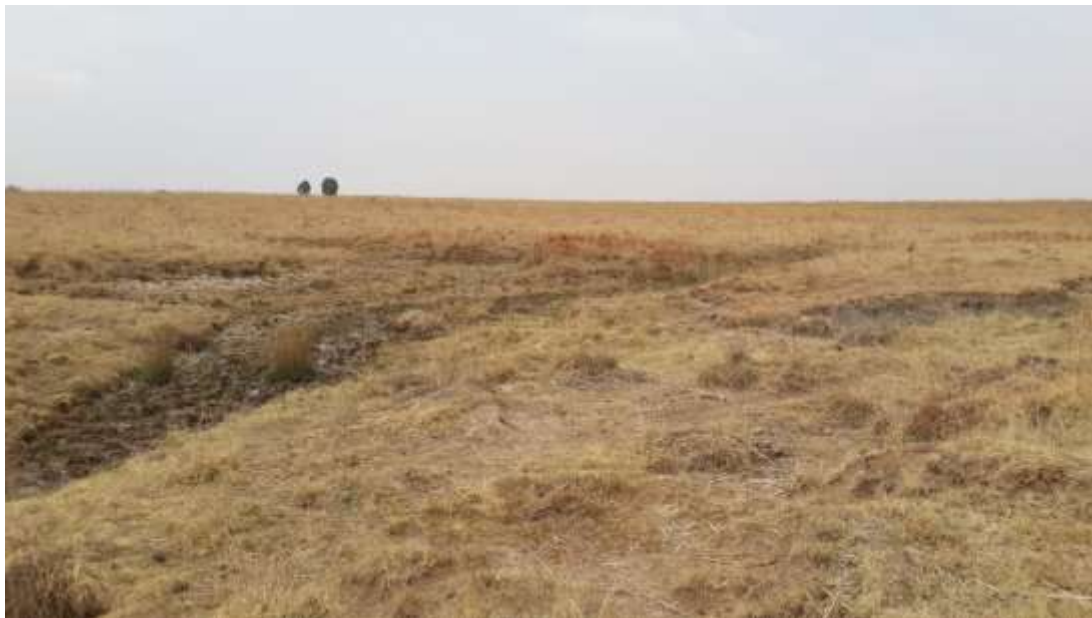
Figure 34: Intervention site C81H-11-208-00.

Designer	Danie Louw
Design Date	October 2013
Intervention Description	Fence and ecologs
Rehabilitation Objective	Fencing of existing structure to prevent cattle trampling
Latitude (D°M'S")	28°19'23.77 S"
Longitude (D°M'S")	28°54'07.63 E"
Engineering Drawings	C81H-11-208-00
