REHABILITATION PLAN FOR THE WORKING FOR WETLANDS PROGRAMME, LIMPOPO

PROJECT: KRUGER NATIONAL PARK B90E, X24B, X24E, X31M, X40D

REHABILITATION PLAN FOR THE KRUGER NATIONAL PARK WETLAND PROJECT, LIMPOPO: PLANNING YEAR 2014

AS PART OF THE WORKING FOR WETLANDS PROGRAMME

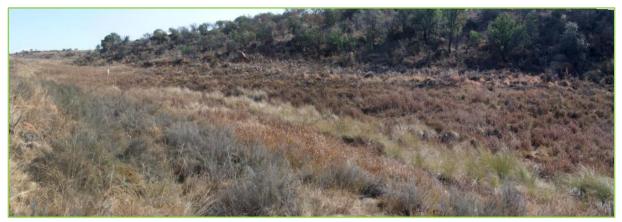
Plate A: A large, seasonal wetland identifiable by the characteristic flora. This wetland contained no surface water at the time of the photograph.

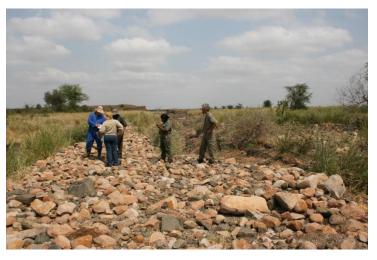
Figure 9: Site Photos of the Langtoon Dam Wetland

Downstream view indicating effect from channelling the water

Rocks washed down the system

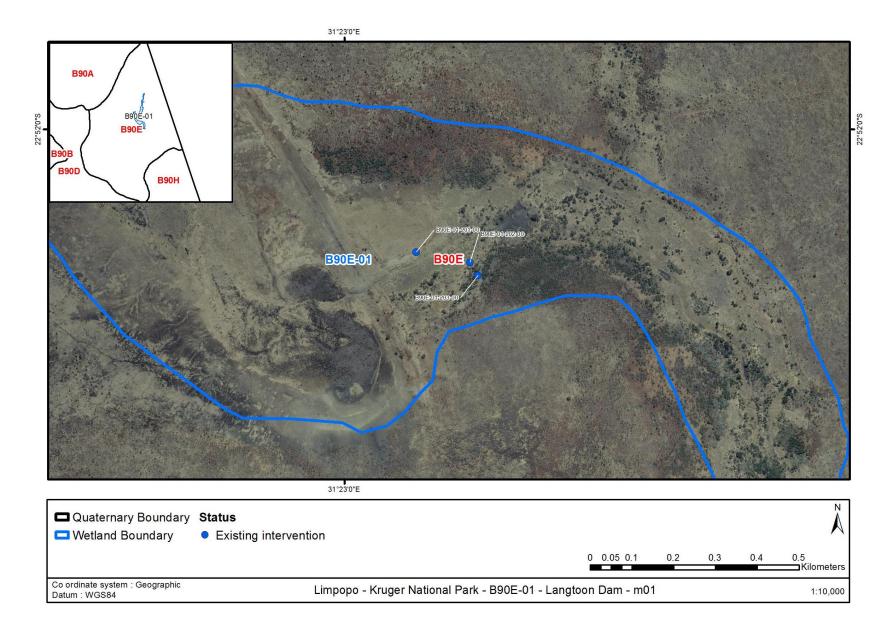
Figure 10: Wetland map, B90E-01 with proposed new wetland interventions indicated.

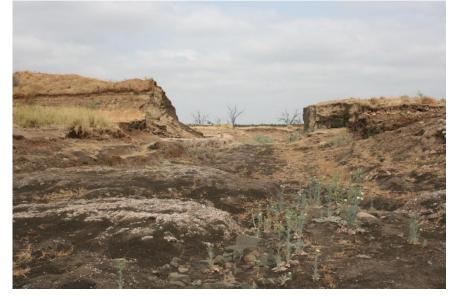
Figure 11: Site of intervention B90E-01-201-00

Intervention Description	Earthworks
Rehabilitation Objective	Remove earth dam and encourage natural flow of water across floodplain.
Latitude (DºM'S")	22°52'12.28"S
Longitude (DºM'S")	31°23'1.88"E

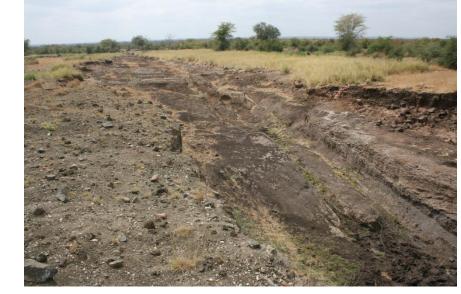
Figure 12: Site of intervention B90E-01-202-00

Intervention Description	Trapping sediment using in-situ rocks
Rehabilitation Objective	Arresting erosion and trapping sediment
Latitude (DºM'S")	22°52'8.04"S
Longitude (DºM'S")	31°23'11.35"E

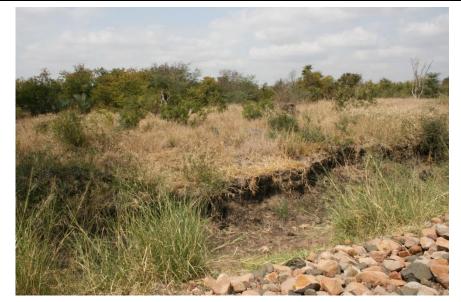
Figure 13: Site of intervention B90E-01-203-00

Intervention Description	Stabilise donga and headcut
Rehabilitation Objective	Arrest erosion
Latitude (DºM'S")	22°52'5.82"S
Longitude (DºM'S")	31°23'13.55"E

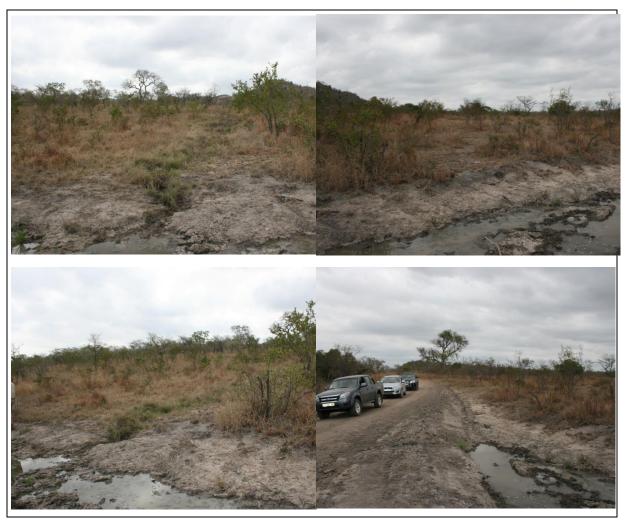
Figure 14: Photo's indicate the impacts that the road have on the surrounding area in the Stolsnek area

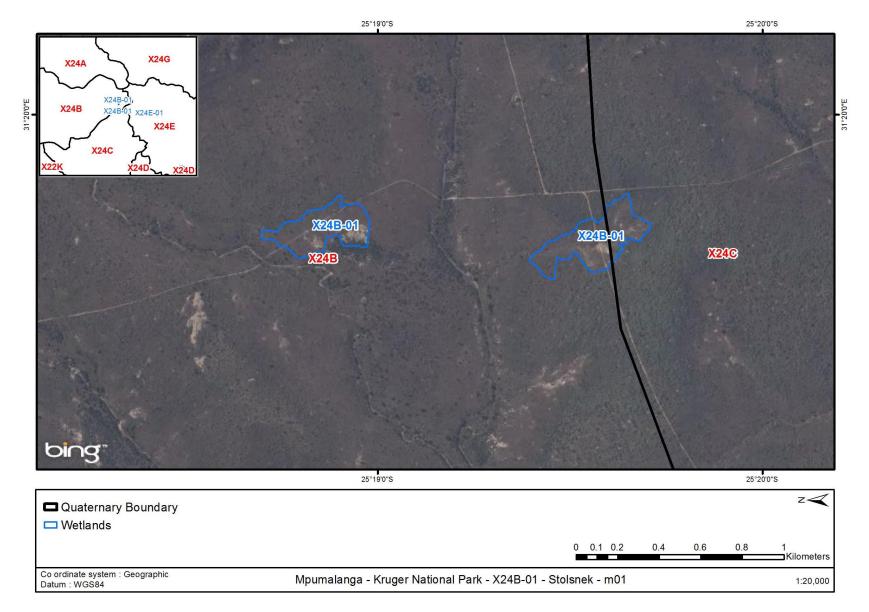
Figure 15: Wetland map, X24B-01 with proposed new wetland interventions indicated

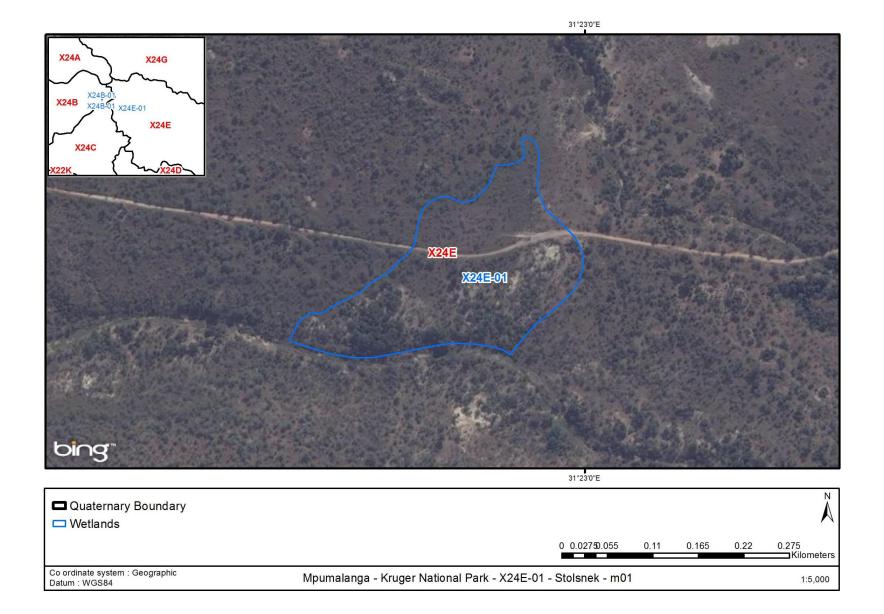
Figure 16: Wetland map, X24E-01 with proposed new wetland interventions indicated

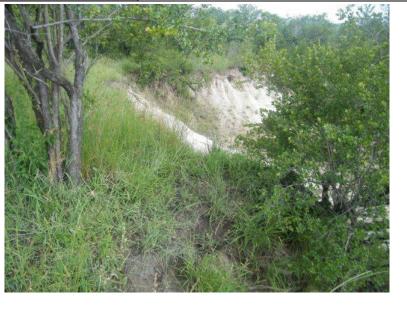
Figure 17: Intervention X24B-01-201-00

Intervention Description	Arrest erosion and control stormwater run-off	
Rehabilitation Objective	Arrest erosion and Control storm water road run- off, earth plugs, contour berms and retaining logs	
Latitude (DºM'S")	25°19'36.1"S	
Longitude (DºM'S")	31°19'38.4"E

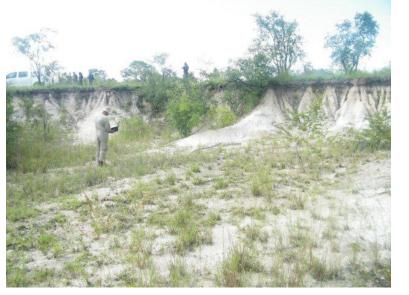
Figure 18: Intervention X24B-01-202-00

Designer	H. Manema of Conceptual Engineering		
Design Date	March 2014		
Intervention Description Road contour berms and mitred drain			
Rehabilitation Objective	Arrest erosion and control storm water run-off		
Latitude (DºM'S")	25°19'41.7"S		
Longitude (DºM'S")	31°22'21.7"E		
Engineering Drawings	P00 007Z001 to 003

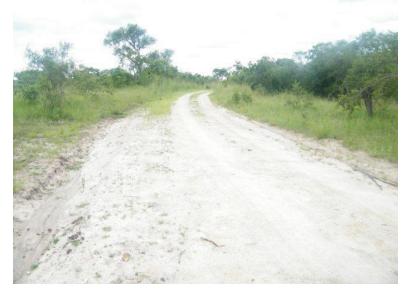
Figure 19: Intervention X24B-01-203-00

Designer	H. Manema of Conceptual Engineering	
Design Date	March 2014	
Intervention Description	Gabion drop inlet	
Rehabilitation Objective	Arrest gully erosion and headcut which has migrated into road	
Latitude (DºM'S")	25°19' 58.9"S	
Longitude (DºM'S")	31°18' 17.2"E	
Engineering Drawings	P00 007Z001 to 003

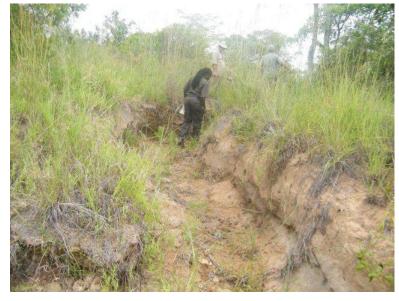
Figure 20: Intervention X24B-01-204-00

Designer	H. Manema of Conceptual Engineering			
Design Date	March 2014			
Intervention Description	Gabion drop inlet of drain head cut and drain re alignment of mitre drain			
Rehabilitation Objective	Arrest gully erosion and headcut which has migrated into road			
Latitude (DºM'S")	25° 20' 6.4"S			
Longitude (DºM'S")	31° 17' 25.4"E			
Engineering Drawings	Drop inlet and concrete drift details

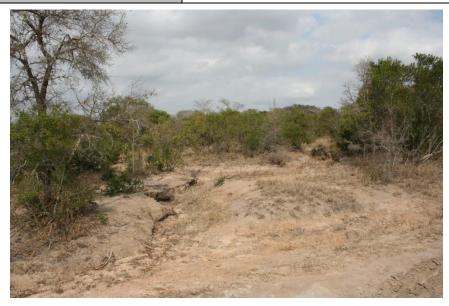
Figure 21: Intervention X24B-01-205-00

Designer	H. Manema of Conceptual Engineering
Design Date	March 2014
Intervention Description	Earth plugs, contour berms, Rock packs and infilling dropinlet, re-vegetation and brush packing
Rehabilitation Objective	Arrest erosion and Control storm water road run- off
Latitude (DºM'S")	25°19'9.98"S
Longitude (DºM'S")	31°19'46.9"E
Engineering Drawings	P00 007Z001 to 003

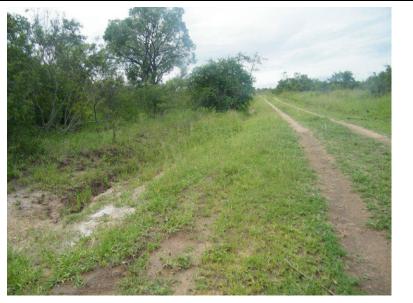
Figure 23: Intervention X24B-01-207-00

Designer	H. Manema of Conceptual Engineering
Design Date	March 2014
Intervention Description	Main access road from Stolsnek station to western border; one berm every 40 m upslope of or in wetland/stream crossings
Rehabilitation Objective	Mitigate hillslope flow interruption (thus draining) and erosion of road in wetland
Latitude (DºM'S")	25°19'12.58"S
Longitude (DºM'S")	31°20'41.02"E
Engineering Drawings	P00 007Z001 to 003

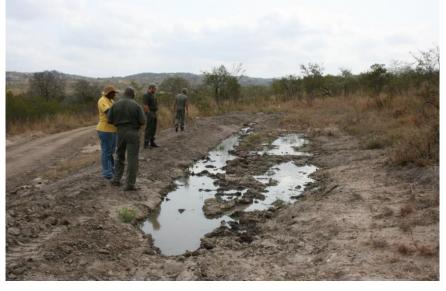
Figure 24: Intervention X24E-01-201-00

Designer	H. Manema of Conceptual Engineering
Design Date	March 2014
Intervention Description	Gabion retaining wall with earthworks
Rehabilitation Objective	Arrest erosion and control storm water road run- off
Latitude (DºM'S")	25°19'48.2"S
Longitude (DºM'S")	31°22'58.5"E
Engineering Drawings	Gabions and mattresses arrangement for site 1

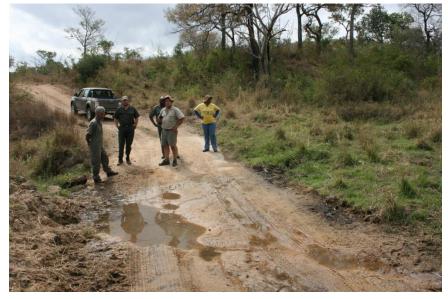
Figure 27: Intervention X24E-01-204-00

Designer	H. Manema of Conceptual Engineering
Design Date	March 2014
Intervention Description	Road berms as part of the access road
Rehabilitation Objective	Arrest erosion and Control storm water road run- off
Latitude (DºM'S")	25°19'35.2"S
Longitude (DºM'S")	31°21'53.2"E
Engineering Drawings	P00 007Z001 to 003

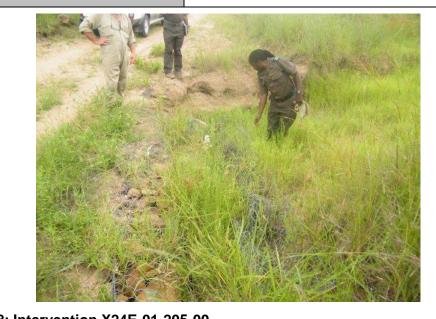
Figure 28: Intervention X24E-01-205-00

Designer	H. Manema of Conceptual Engineering		
Design Date	March 2014		
Intervention Description	Add splashwall and freeboard		
Rehabilitation Objective	Secure gabion and arrest gully erosion		
Latitude (DºM'S")	25°19'27.1"S		
Longitude (DºM'S")	31°21'26.6"E		
Engineering Drawings	Drop inlet and concrete drift details

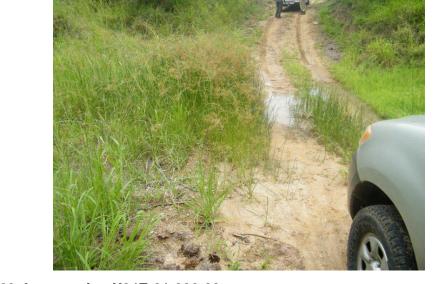
Figure 29: Intervention X24E-01-206-00

Designer	H. Manema of Conceptual Engineering		
Design Date	March 2014		
Intervention Description	Concrete drift and earthworks		
Rehabilitation Objective	Arrest erosion and control storm water road run- off		
Latitude (DºM'S")	25°19'19.0"S		
Longitude (DºM'S")	31°21'09.2"E		
Engineering Drawings	Drop inlet and concrete drift details

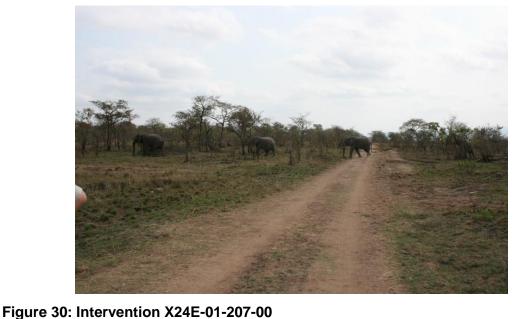
Designer	H. Manema of Conceptual Engineering		
Design Date	March 2014		
Intervention Description	Road contour berms and mitred drains		
Rehabilitation Objective	Build up road		
Latitude (DºM'S")	25°19'15.7"S		
Longitude (DºM'S")	31° 20'28.1"E		
Engineering Drawings	P00 007Z001 to 003

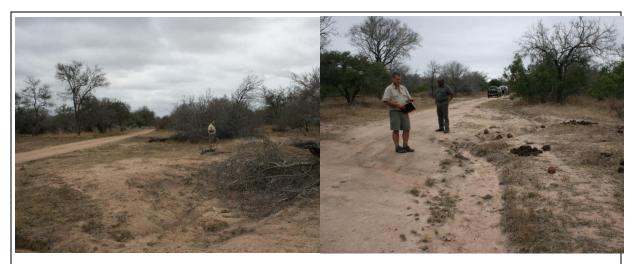
The road entering a sodic patch in the wetland

Image shows how the absence of mitre drains enhances the erosion capacity of water run-off in the road reserve

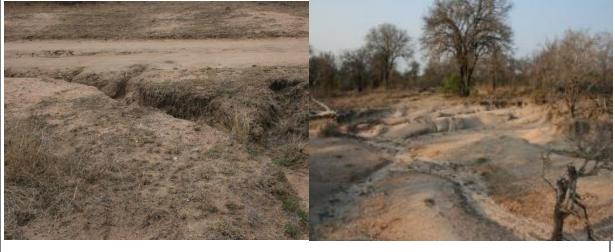
Erosion as a result of water run-off from the road

Donga which has resulted in a sodic patch due to run-off from the road

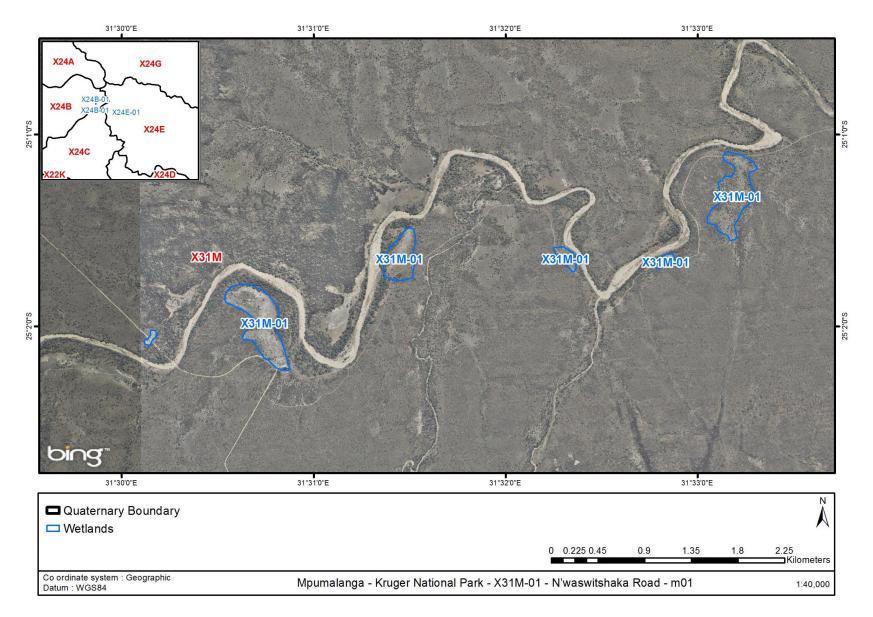
Figure 32: Wetland map, X31M-01 with proposed new wetland interventions indicated.

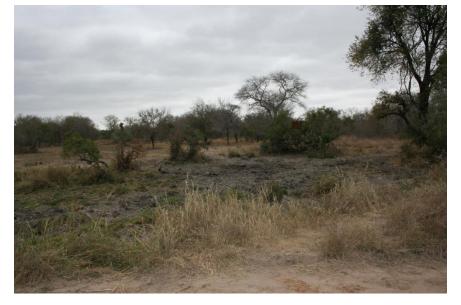
Figure 33: Site of intervention X31M-01-201-00

Intervention Description	Earth works
Rehabilitation Objective	Redirect water flow from the road by constructing earth berms at the top of the gully to divert water away and brush pack exposed areas in order to facilitate restoration.
Latitude (DºM'S")	24°49'26.06"S
Longitude (DºM'S")	31°50'07.02"E

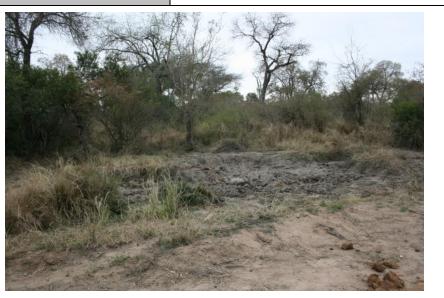
Figure 34: Site of intervention X31M-01-202-00

Intervention Description	Earthworks, road maintenance and re-vegetation		
Rehabilitation Objective	Re-route the existing road to avoid sensitive areas		
Latitude (DºM'S")	25°1'6.89"S		
Longitude (DºM'S")	31°33'11.62"E

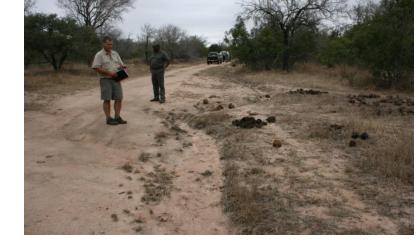
Figure 35: Site of intervention X31M-01-203-00

Intervention Description	Road maintenance		
Rehabilitation Objective	Re-routing and stabilisation of the existing road using Earthberms and rock packs.		
Latitude (DºM'S")	25°1'28.05"S		
Longitude (DºM'S")	31°33'0.01"E

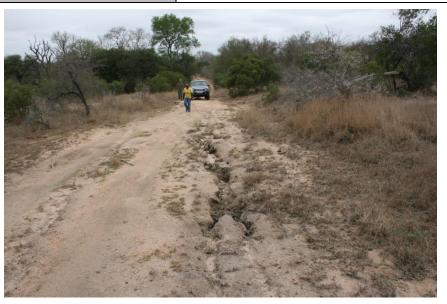
Figure 37: Site of intervention X31M-01-205-00

Intervention Description	Extend existing berms	
Rehabilitation Objective	Divert water from road	
Latitude (DºM'S")	25°1'37.80"S	
Longitude (DºM'S")	31°32'17.59"E

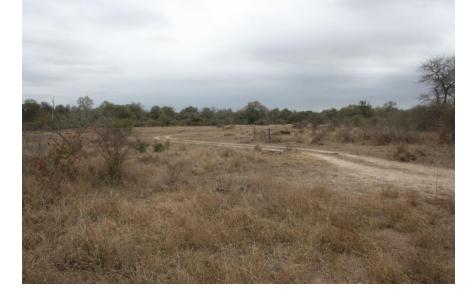
Figure 38: Site of intervention X31M-01-206-00

Intervention Description	Road maintenance and brush packing
Rehabilitation Objective	Re-route the existing road away from sensitive sodic areas and encourage re-growth of vegetation
Latitude (DºM'S")	25°1'40.67"S
Longitude (DºM'S")	31°31'30.56"E

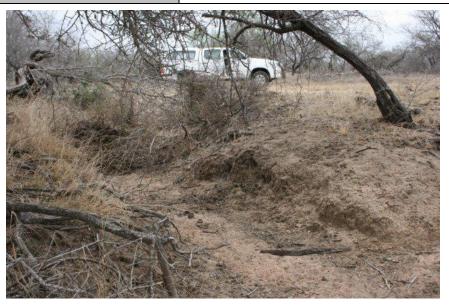
Figure 39: Site of intervention X31M-01-207-00

Intervention Description	Re-vegetation
Rehabilitation Objective	Stabilise disturbed area
Latitude (DºM'S")	25°2'22.36"S
Longitude (DºM'S")	31°31'1.58"E

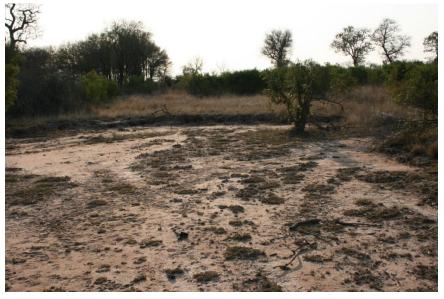
Figure 40: Site of intervention X31M-01-208-00

Intervention Description	Sediment trapping using brush packing, logs and relocating mitre drains.
Rehabilitation Objective	Stabilise eroded areas and direct water run-off to controlled areas
Latitude (DºM'S")	25°2'4.29"S
Longitude (DºM'S")	31°30'9.12"E

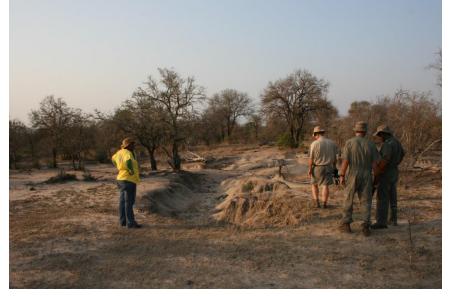
Figure 41: Site of intervention X31M-01-209-00

Intervention Description	Rock packs to trap sediment
Rehabilitation Objective	Direct water away from the erosion gully, trap sediment and enhance vegetation
Latitude (DºM'S")	25°1'8.72"S
Longitude (DºM'S")	31°29'13.37"E

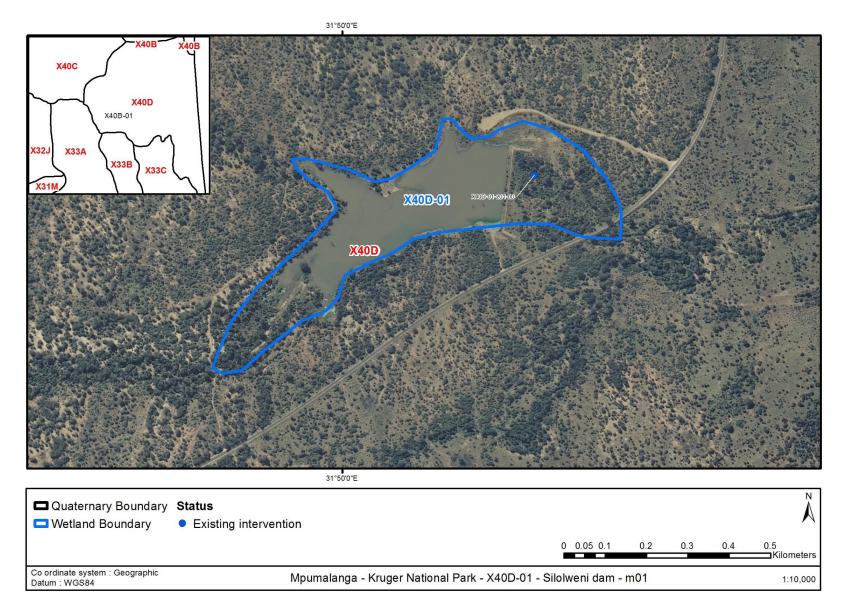
The objective of the intervention is to deactivate a drain that has formed at the opening of the breached dam and spread the water across the wetland in a natural flow pattern. Also, the removal of an artificial waterpoint in line with the SANParks review of the waterpoint policy and in line with wetland conservation objectives. The most appropriate and cost effective method of doing this was considered to involve the removal of the remainder of the dam wall to promote the flow of water into the wetland.

Figure 43: Wetland map, X40D-01 with proposed new wetland interventions indicated.

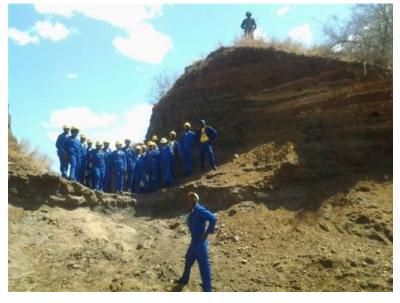
Figure 44: Intervention X40D-01-201-00

Intervention Description	Breaching of Dam wall		
Rehabilitation Objective	Remove earth dam and encourage natural flow of water across floodplain.		
Latitude (DºM'S")	24° 49' 26.06"		
Longitude (DºM'S")	31° 50' 07.02"
