REHABILITATION PLAN FOR THE WORKING FOR WETLANDS PROGRAMME, NORTHERN CAPE

PROJECT: KAMIESBERG F30A, F30C, F50A, F50E, F50G

**REHABILITATION PLAN FOR THE KAMIESBERG WETLAND PROJECT, NORTHERN
CAPE: PLANNING YEAR 2014**

MAIN REPORT

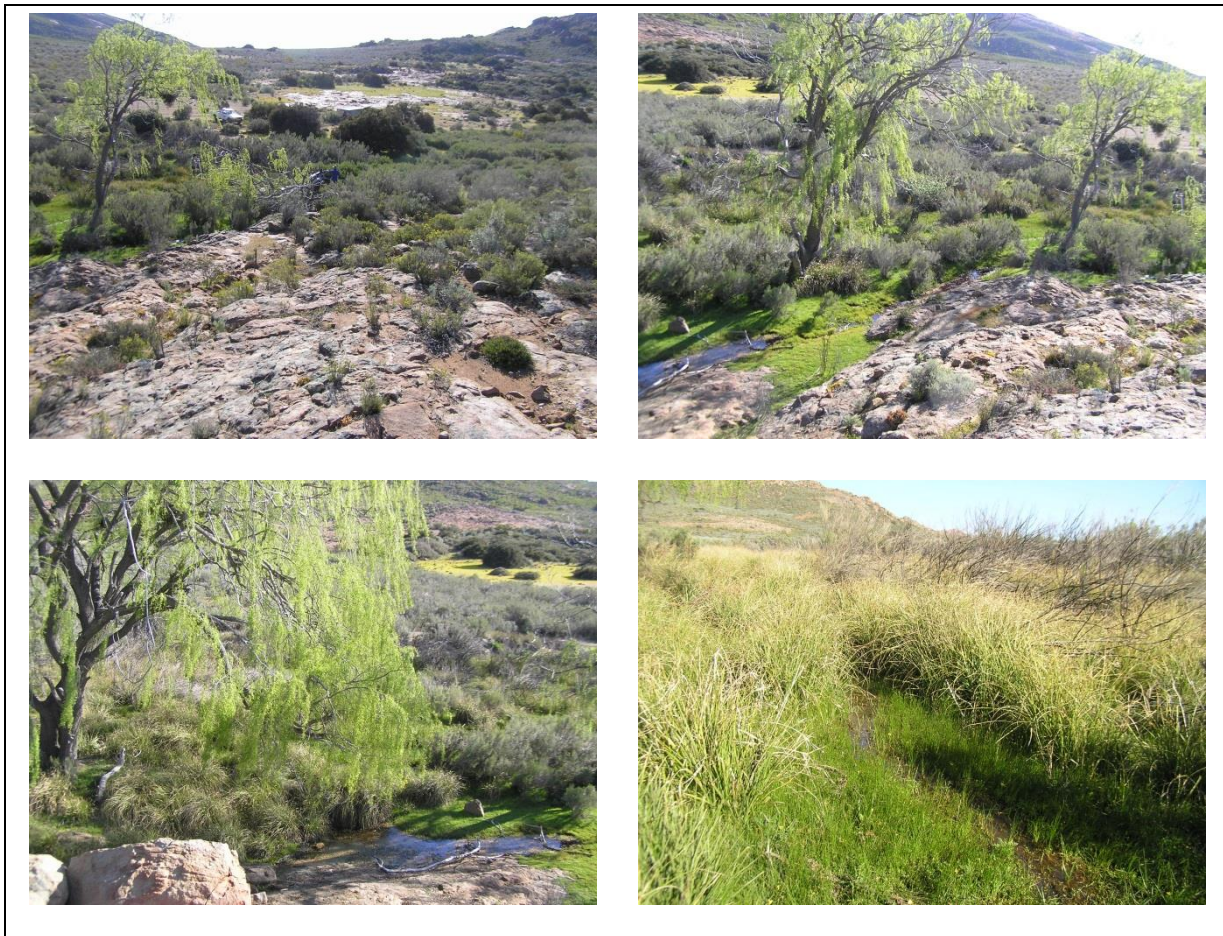
Figure 8: Site photos of the Kleikop wetland (Courtesy: Donovan Kotze)

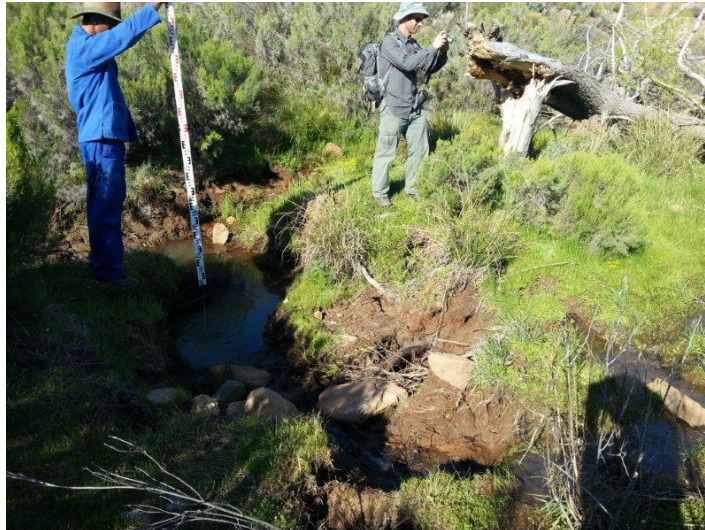
Designer	David Townsend
Design Date	October 2013
Intervention Description	Concrete weir
Rehabilitation Objective	Arrest migration of headcut erosion through wetland
Latitude (D°M'S")	30°17'44.2"S
Longitude (D°M'S")	18°04'56.7"E
Engineering Drawings	F30A-03-205-00

Figure 10: Intervention site F30A-03-205-00

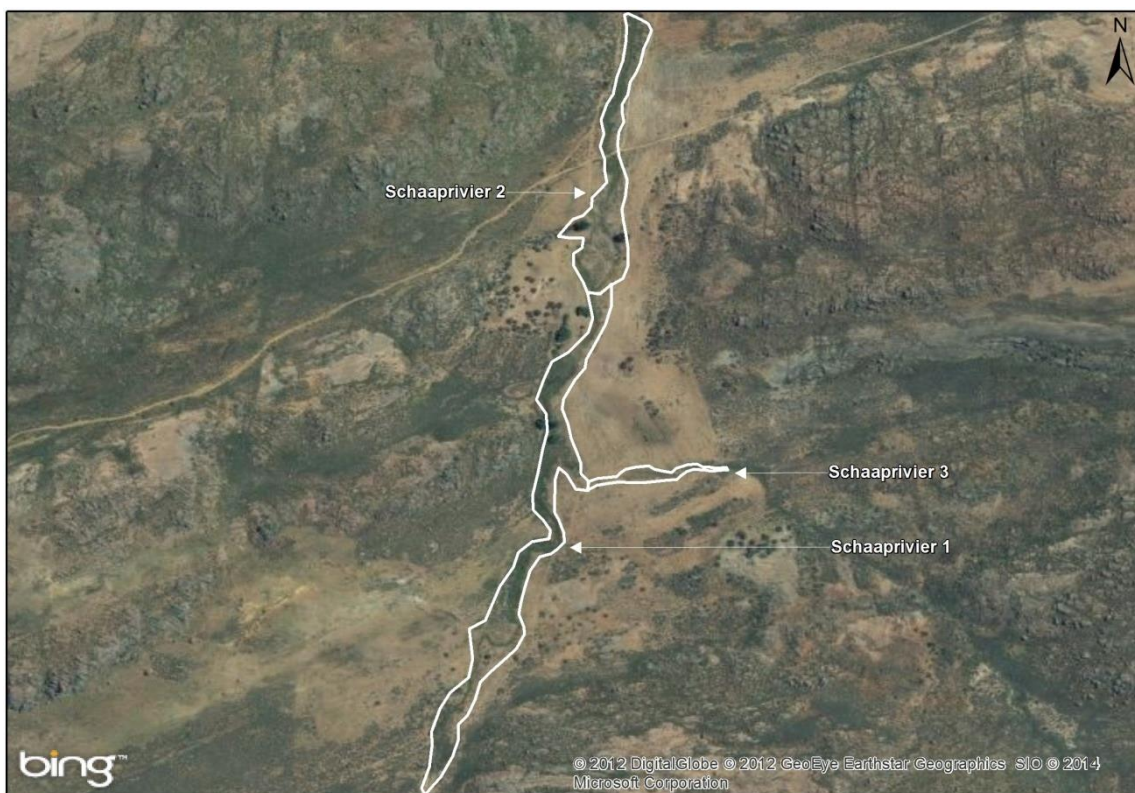
Wetland comprises a valley bottom hydrogeomorphic setting and comprises of 3 units in which two main units run along the Schaaprivier itself as a naturally channelled valley bottom, Unit 1 the upper and Unit 2 the lower. In contrast, Unit 3 comprises an unchannelled side branch of the wetland fed by a small tributary. Most of the wetland is dominated by natural to semi-natural vegetation, Unit 2 shows signs of extensive recent erosion and Unit 3 is under threat of future erosion.

Figure 11: Units within the Schaaprivier wetland (Courtesy: Donovan Kotze)

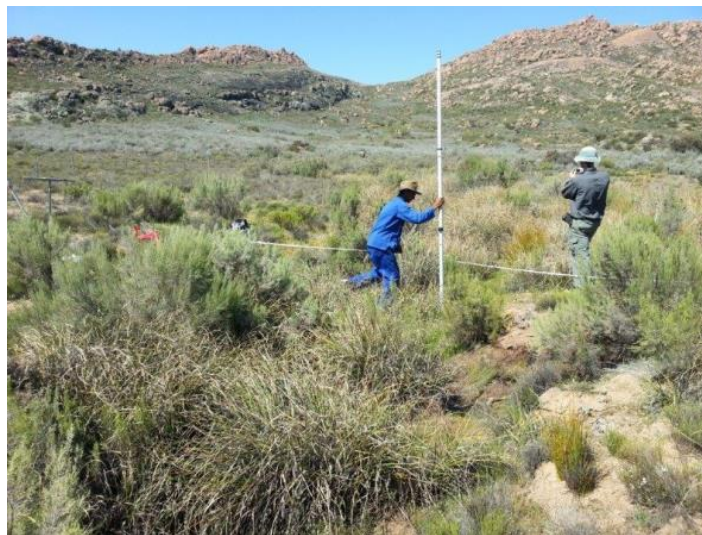
Designer	David Townsend
Design Date	October 2013
Intervention Description	Gabion weir
Rehabilitation Objective	Arrest migration of headcut erosion
Latitude (D°M'S")	30°18'54.20"S
Longitude (D°M'S")	18°06'16.60"E
Engineering Drawings	F30A-06-201-00

Figure 14: Intervention site F30A-06-201-00 looking in a south-westerly direction

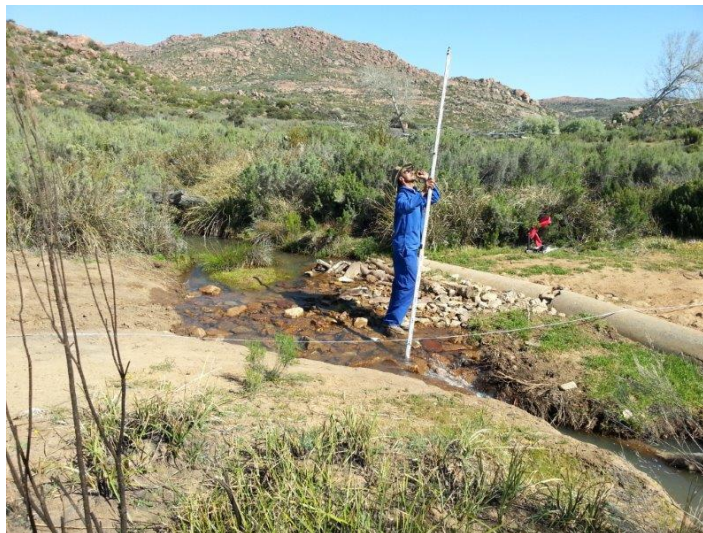
Designer	David Townsend
Design Date	October 2013
Intervention Description	Concrete weir
Rehabilitation Objective	Arrest migration of headcut erosion
Latitude (D°M'S")	30°18'39.80"S
Longitude (D°M'S")	18°06'14.80"E
Engineering Drawings	F30A-06-202-00

Figure 15: Intervention site F30A-06-202-00

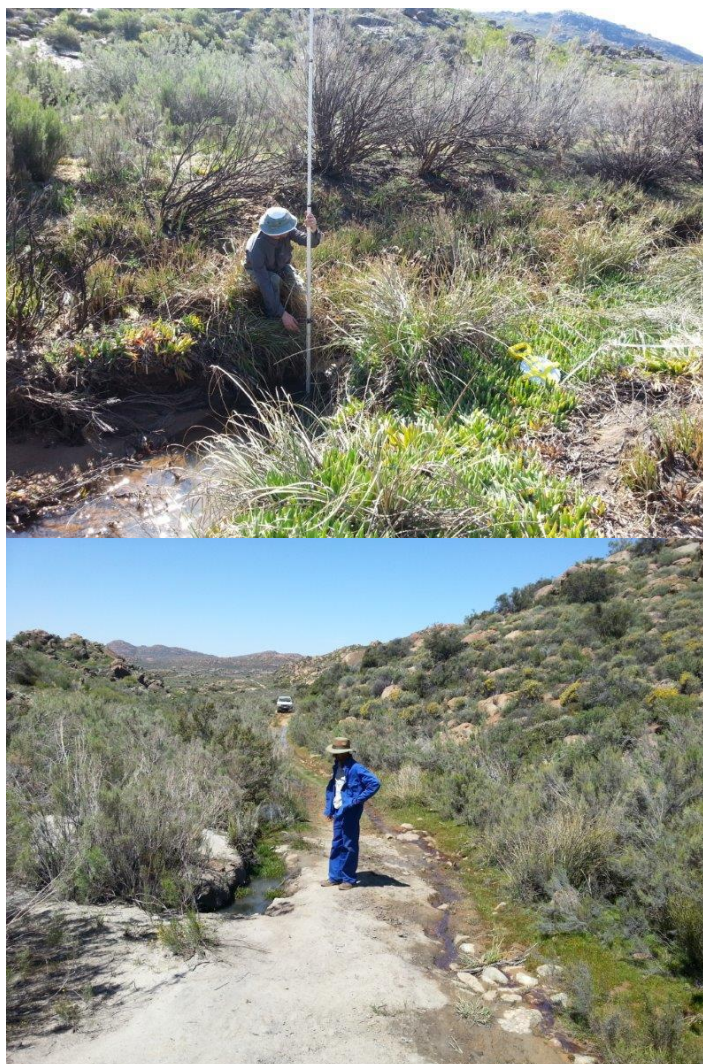
Designer	David Townsend
Design Date	October 2013
Intervention Description	Concrete weir
Rehabilitation Objective	Arrest migration of headcut erosion
Latitude (D°M'S")	30°18'33.80"S
Longitude (D°M'S")	18°06'15.70"E
Engineering Drawings	F30A-06-204-00

Figure 16: Intervention site F30A-06-204-00

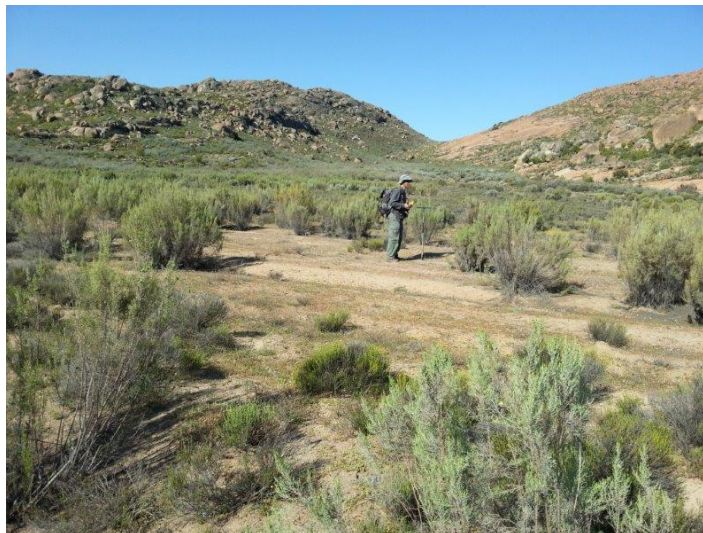
Intervention Description	Brushpacks and re-seeding
Rehabilitation Objective	Create micro-habitats and encourage the re-establishment of wetland vegetation species
Latitude (D°M'S")	30°18'55.60"S
Longitude (D°M'S")	18°06'14.40"E

Figure 17: Intervention site F30A-06-206-00

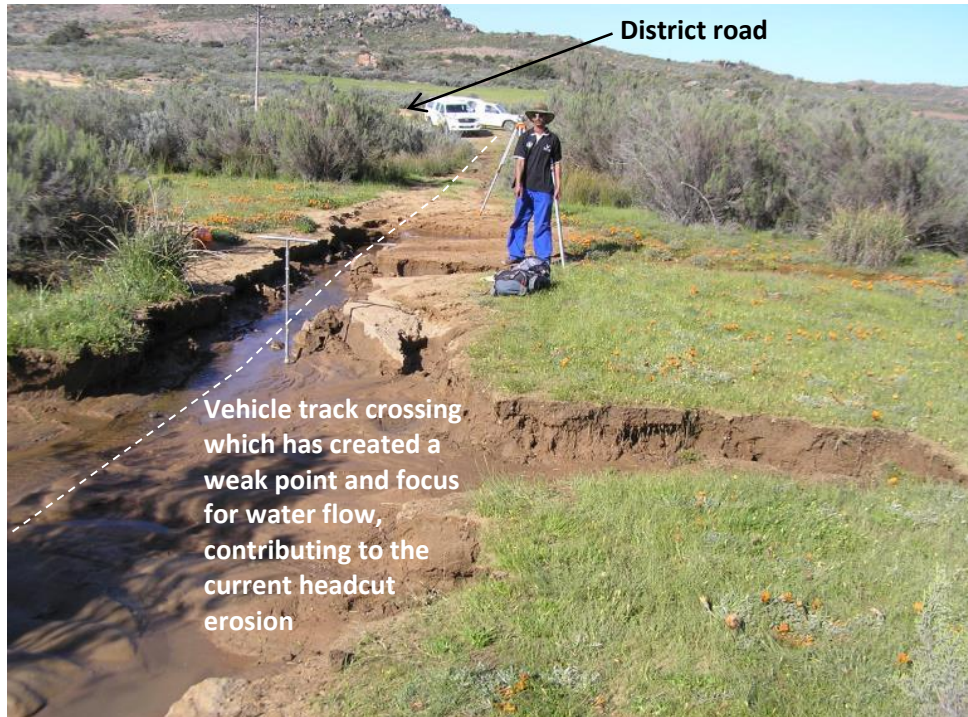
The main impacts to this wetland are associated with historic disturbance, the current road alongside the wetland and erosion, which is currently very active (see **Figure 19**). Increasing intensity of runoff from the upstream catchment also contributes to erosion in the wetland.

Figure 19: Headcut erosion in a road crossing the Langvlei wetland (Courtesy: Donovan Kotze)

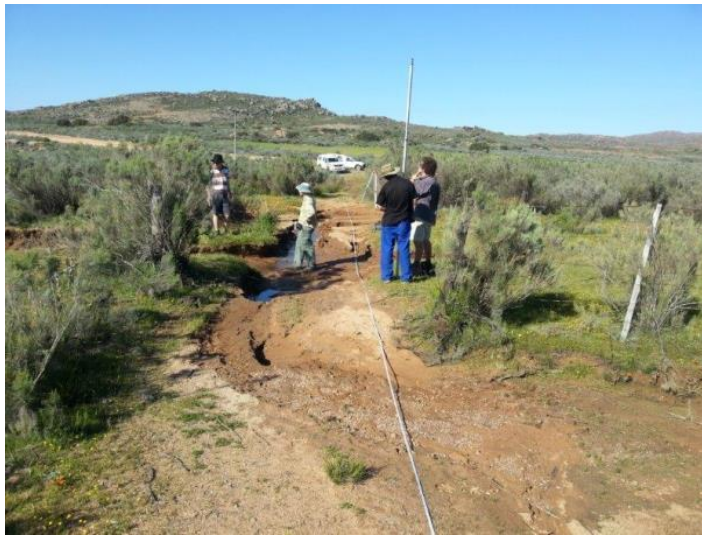
Designer	David Townsend
Design Date	October 2013
Intervention Description	Gabion weir with concrete capping and geocells
Rehabilitation Objective	Arrest migration of headcut erosion
Latitude (D°M'S")	30°17'29.54"S
Longitude (D°M'S")	18°03'10.19"E
Engineering Drawings	F30A-08-201-00

Figure 21: Intervention site F30A-08-201-00

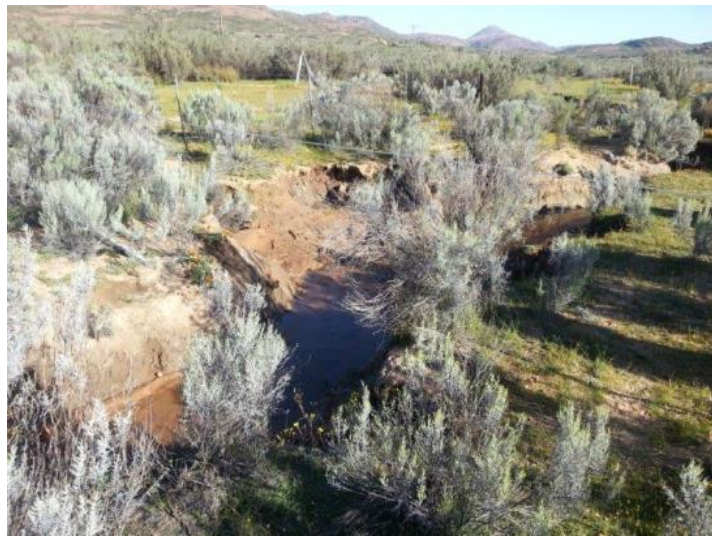
Designer	David Townsend
Design Date	October 2013
Intervention Description	Gabion weir with concrete capping and geocells
Rehabilitation Objective	Arrest migration of headcut erosion
Latitude (D°M'S")	30°17'28.80"S
Longitude (D°M'S")	18°03'09.96"E
Engineering Drawings	F30A-08-202-00

Figure 22: Intervention site F30A-08-202-00

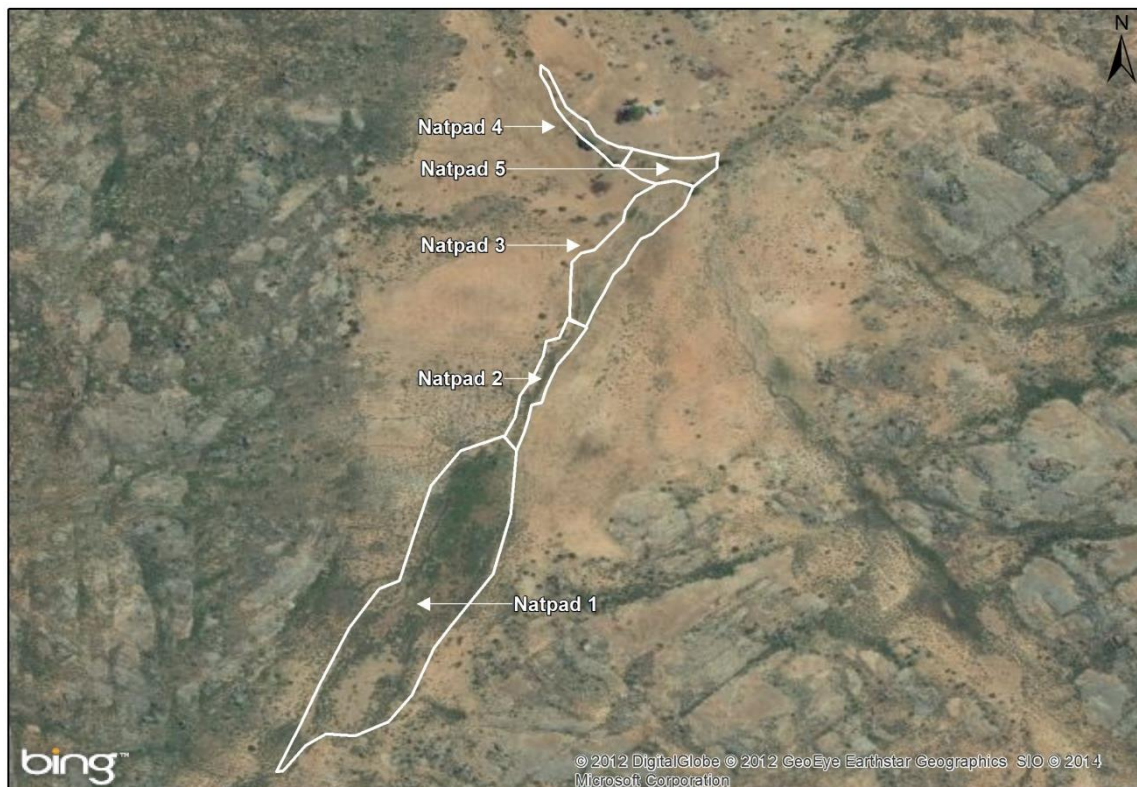
The levels of impacts and threats to the wetland hydrology are high. Although upstream catchment related impacts have a relatively low impact on the wetland unit, localized higher impacts from the degraded old lands adjacent to the wetland are very likely. The most important impact on hydrology within the wetland is the incision of the stream channel flowing through the wetland.

Figure 23: Units within the Natpad wetland (Courtesy: Donovan Kotze)

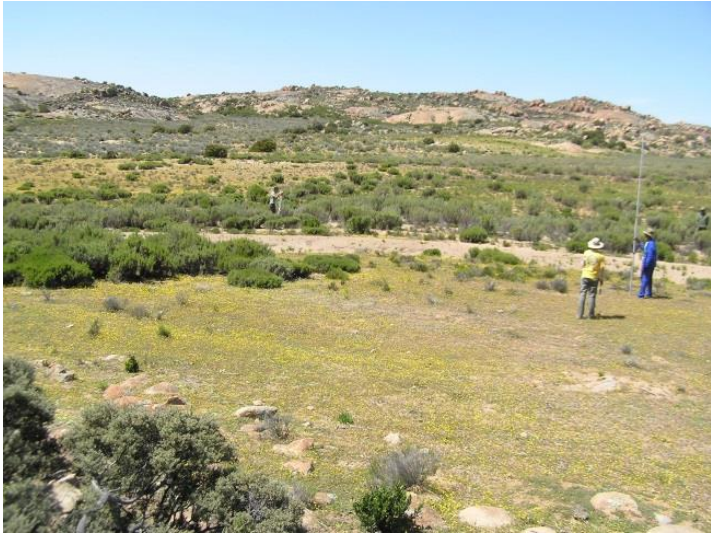
Intervention Description	Fencing
Rehabilitation Objective	Promote vegetation recovery
Latitude (D°M'S")	30°21'04.2"S
Longitude (D°M'S")	18°09'38.8"E

<p>Figure 26: Intervention site F30A-09-201-00</p>

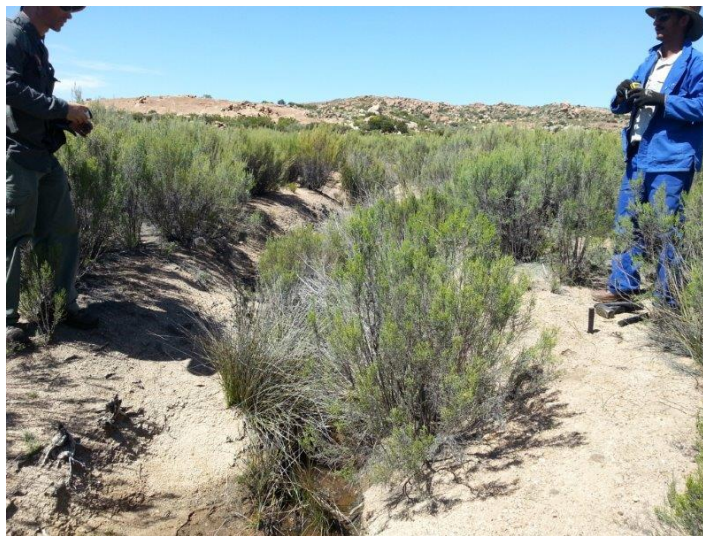
Designer	David Townsend
Design Date	October 2013
Intervention Description	Gabion weir
Rehabilitation Objective	To attenuate floods and sediments
Latitude (D°M'S")	30°21'12.12"S
Longitude (D°M'S")	18°09'31.88"E
Engineering Drawings	F30A-09-202-00

Figure 27: Intervention site F30A-09-202-00

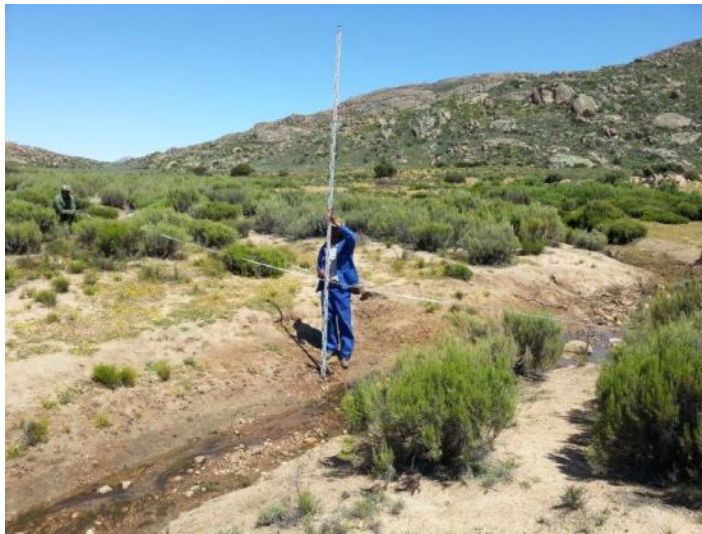
Figure 29: Intervention site F30A-09-205-00

Designer	David Townsend
Design Date	October 2013
Intervention Description	Gabion weir
Rehabilitation Objective	To attenuate floods and sediments
Latitude (D°M'S")	30°21'12.12"S
Longitude (D°M'S")	18°09'31.88"E
Engineering Drawings	F30A-09-205-00

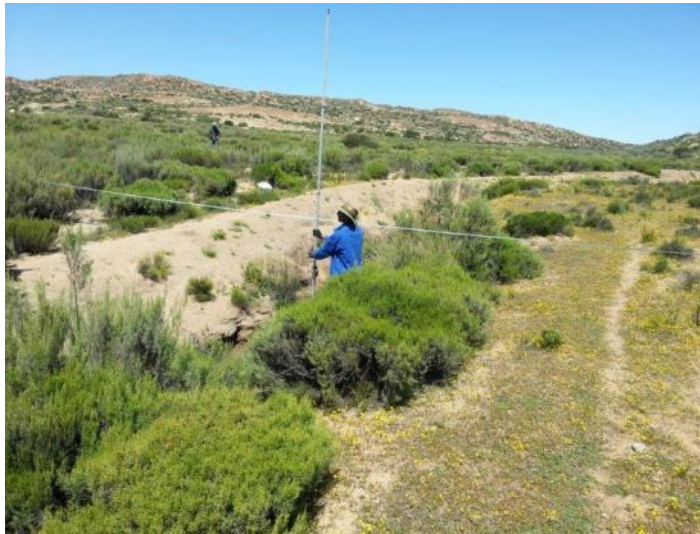
Figure 30: Intervention site F30A-09-206-00

Designer	David Townsend
Design Date	October 2013
Intervention Description	Gabion weir
Rehabilitation Objective	To attenuate floods and sediments
Latitude (D°M'S")	30°20'59.62"S
Longitude (D°M'S")	18°09'40.304"E
Engineering Drawings	F30A-09-206-00

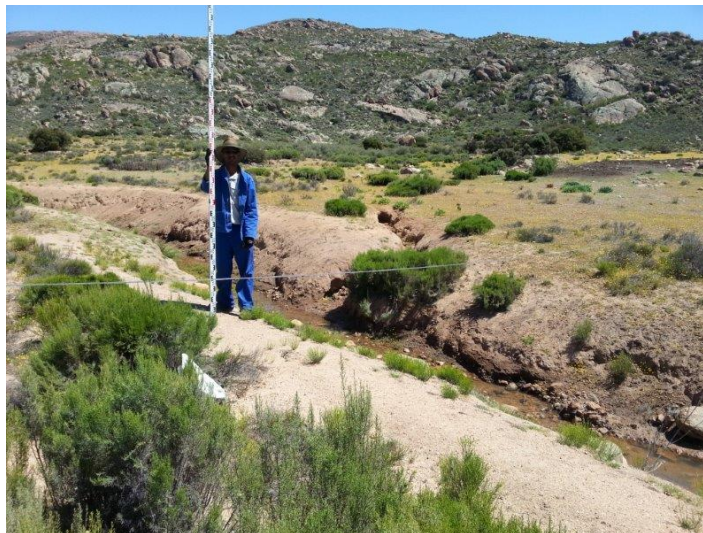
Figure 31: Intervention site F30A-09-207-00

Designer	David Townsend
Design Date	October 2013
Intervention Description	Gabion weir
Rehabilitation Objective	To attenuate floods and sediments
Latitude (D°M'S")	30°21'22.20"S
Longitude (D°M'S")	18°09'39.57"E
Engineering Drawings	F30A-09-207-00

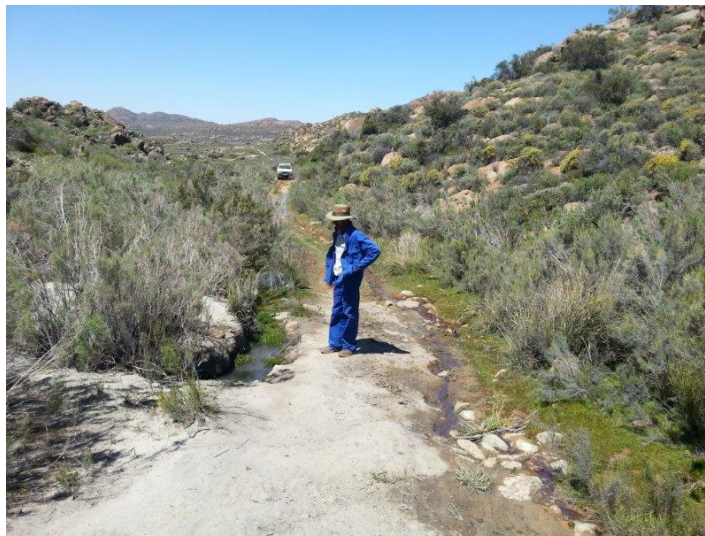
Figure 32: Intervention site F30A-09-208-00

Designer	David Townsend
Design Date	October 2013
Intervention Description	Gabion weir & earthworks
Rehabilitation Objective	To attenuate floods and sediments
Latitude (D°M'S")	30°20'01.30"S
Longitude (D°M'S")	18°09'05.70"E
Engineering Drawings	F30A-09-208-00

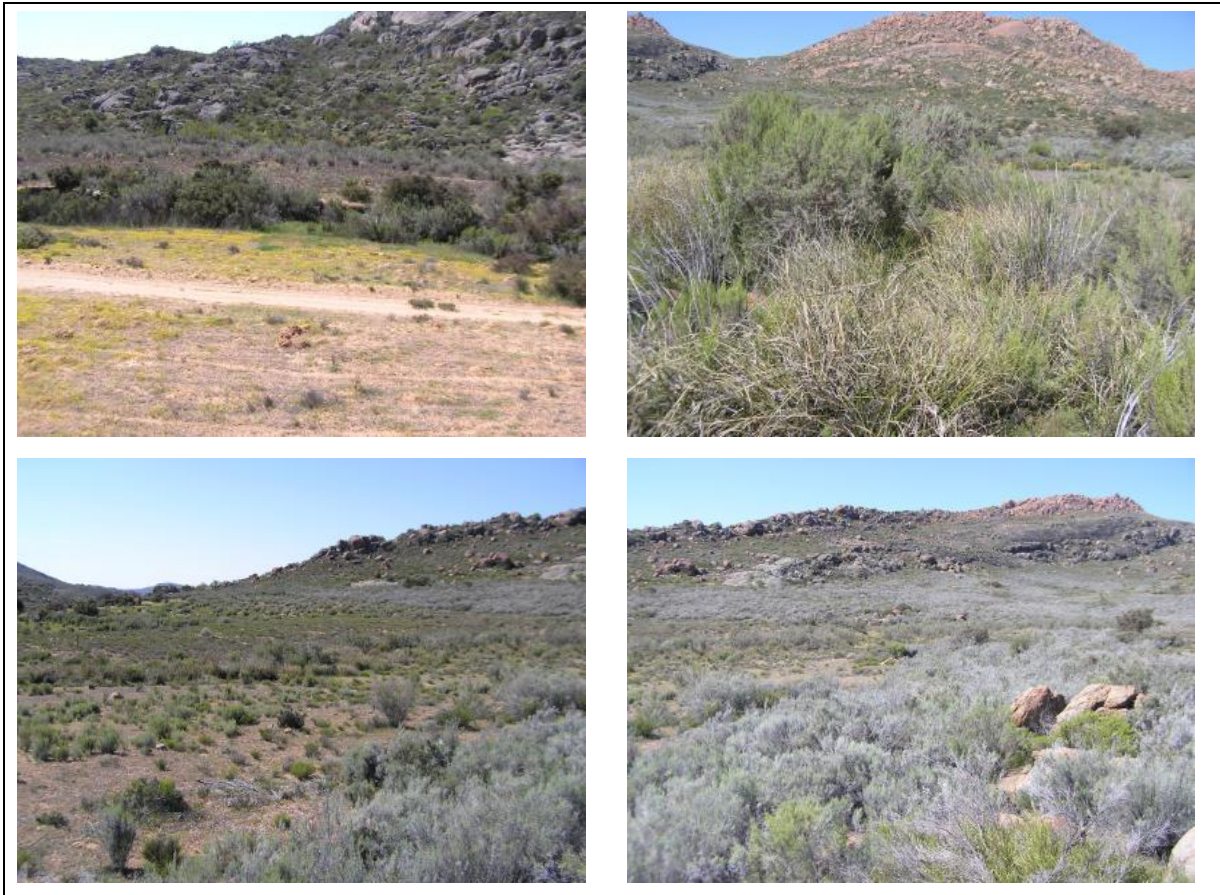
Figure 33: Site photos of the Windpoort wetland (Courtesy: Donovan Kotze)

The wetland has been subjected to a number of impacts (**Figure 33**) associated with historic disturbance and erosion, which is now currently active. Impacts from the upstream catchment are limited, but adjacent old lands are likely to have slightly increased runoff peaks. A further increase in pioneer species is anticipated where further channel incision is predicted, and thus a slight decline in vegetation condition is anticipated over the next five years. A slight decline in hydrological condition is anticipated as a result of the incision which is predicted to continue. Another slight decline in geomorphological condition is anticipated over the next five years as a result of the incisional erosion which is predicted to continue, but not dramatically so.

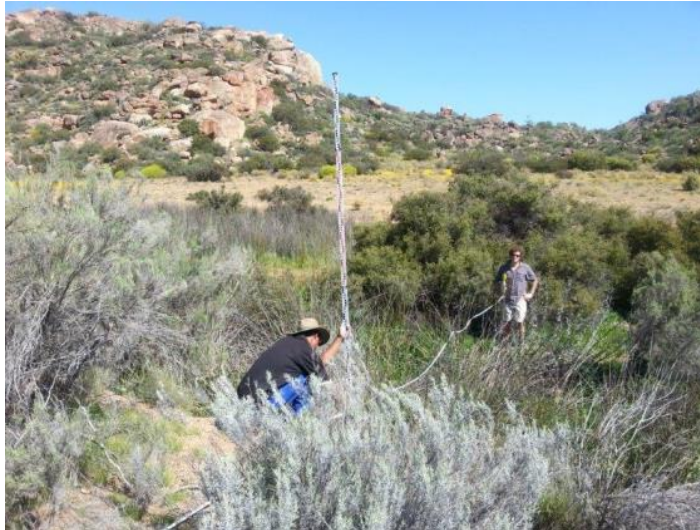
Figure 35: Intervention site F30A-10-201-00

Designer	David Townsend
Design Date	October 2013
Intervention Description	Gabion weir
Rehabilitation Objective	Reduce incision in wetland and lift water table
Latitude (D°M'S")	30°14'18.64"S
Longitude (D°M'S")	18°04'13.65"E
Engineering Drawings	F30A-10-201-00

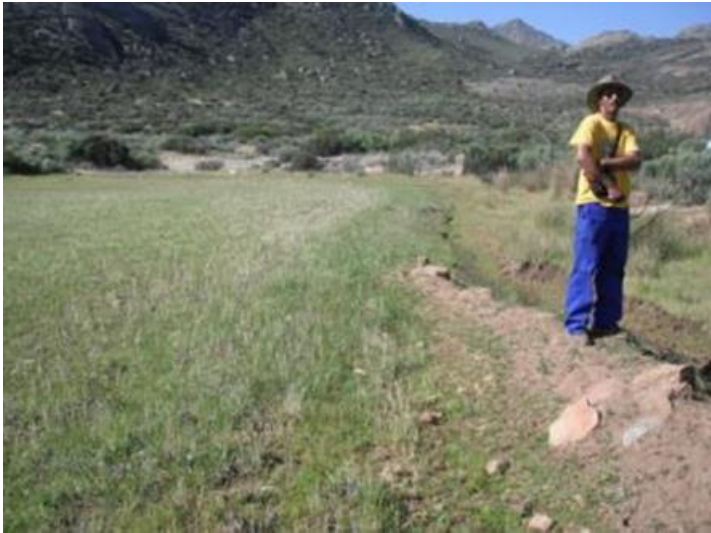
<p>Figure 38: Intervention site F30C-01-201-00</p>

Intervention Description	Earthworks
Rehabilitation Objective	Restore hydrology and vegetation
Latitude (D°M'S")	27°17'48.45"S
Longitude (D°M'S")	30°29'04.66"E

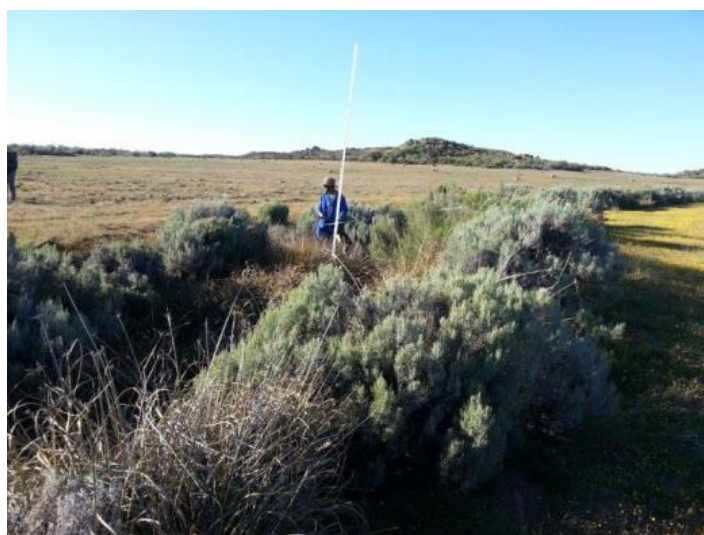
Figure 41: Intervention site F50A-07-217-00

Designer	David Townsend
Design Date	October 2013
Intervention Description	Concrete weir
Rehabilitation Objective	Rehydrate wetland
Latitude (D°M'S")	30°20'26.60"S
Longitude (D°M'S")	18°06'23.80"E
Engineering Drawings	F50A-07-217-00

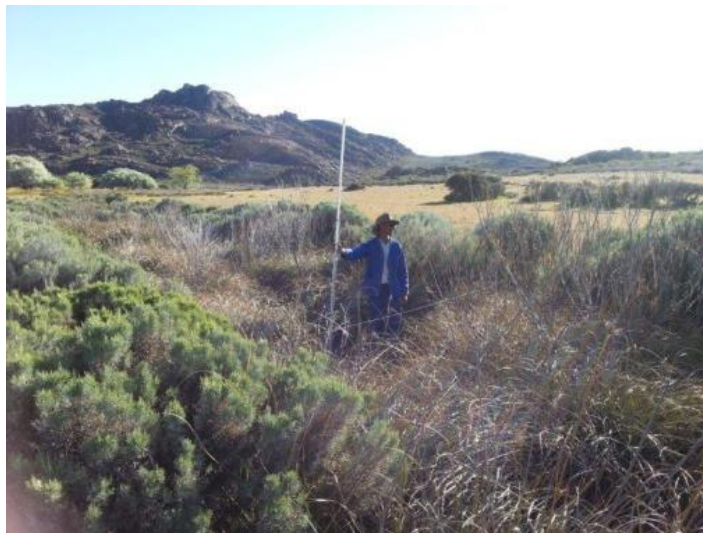
Figure 42: Intervention site F50A-07-218-00

Designer	David Townsend
Design Date	October 2013
Intervention Description	Concrete weir
Rehabilitation Objective	Rehydrate wetland
Latitude (D°M'S")	30°20'25.20"S
Longitude (D°M'S")	18°06'24.50"E
Engineering Drawings	F50A-07-218-00

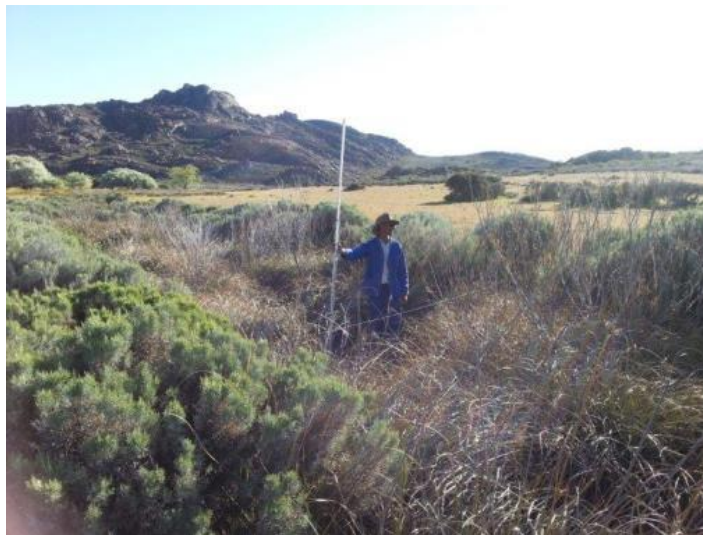
Figure 43: Intervention site F50A-07-219-00

Intervention Description	Silt fence
Rehabilitation Objective	Rehydrate wetland
Latitude (D°M'S")	30°20'25.20"S
Longitude (D°M'S")	18°06'24.50"E

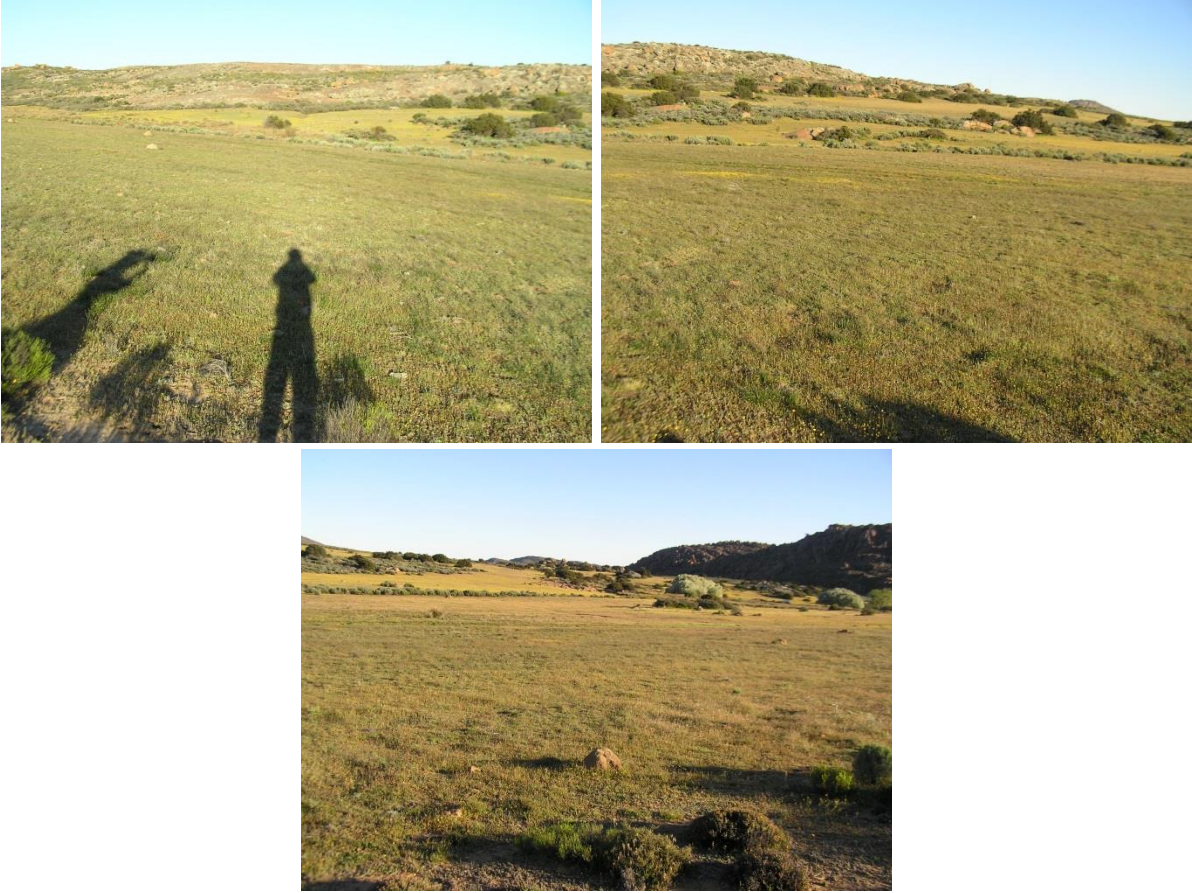
FPP Number	Xharas-01	
GPS Location (DMS)	Latitude	27°17'48.45"S
	Longitude	30°29'04.66"E
Description of Photography Point		
Type/ Orientation: Panoramic view of wetland

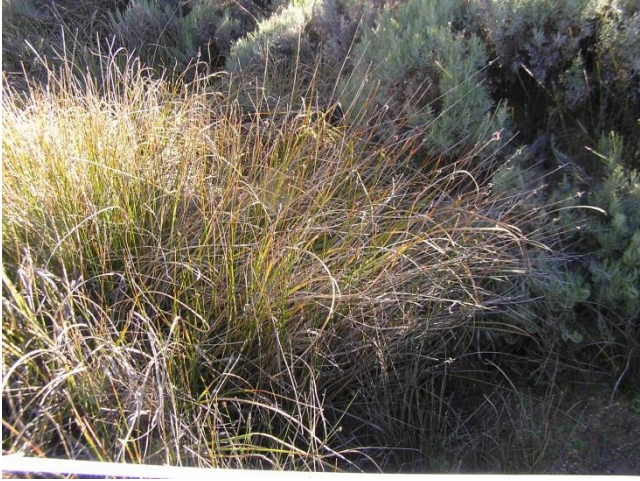
FPP Number	Xharas-02	
GPS Location (DMS)	Latitude	30°20'26.81"S
	Longitude	18°06'23.8"E
Description of Photography Point		
Type/ Orientation: 20°

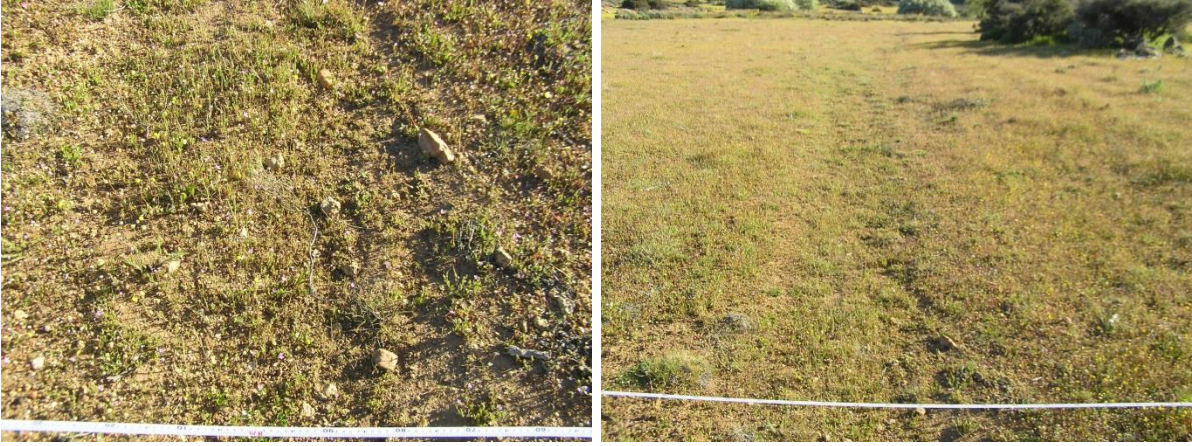
FPP Number	Xharas-03	
GPS Location (DMS)	Latitude	30°20'25.69"S
	Longitude	18°06'25.31"E
Description of Photography Point		
Type/ Orientation: 20°

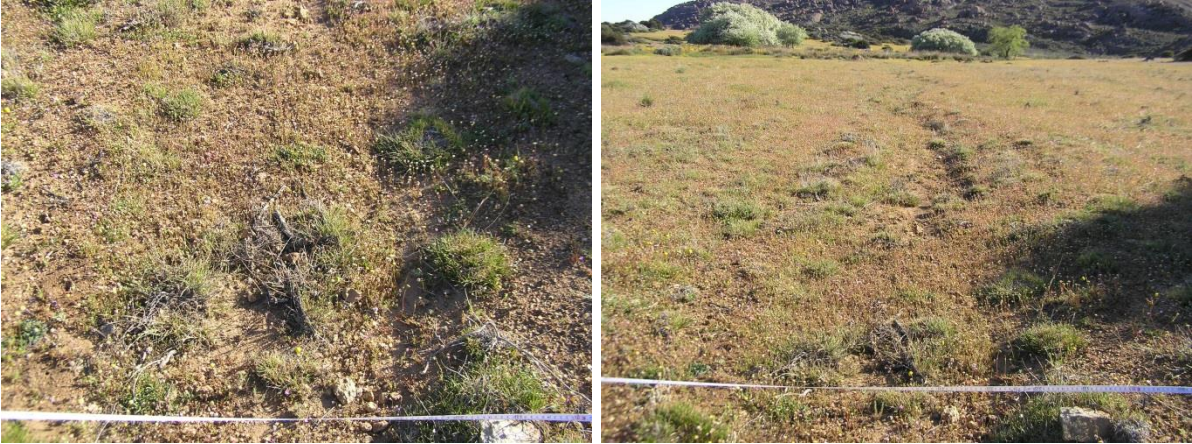
FPP Number	Xharas-04	
GPS Location (DMS)	Latitude	30°20'24.5"S
	Longitude	18°06'25.81"E
Description of Photography Point		
Type/ Orientation: 20°

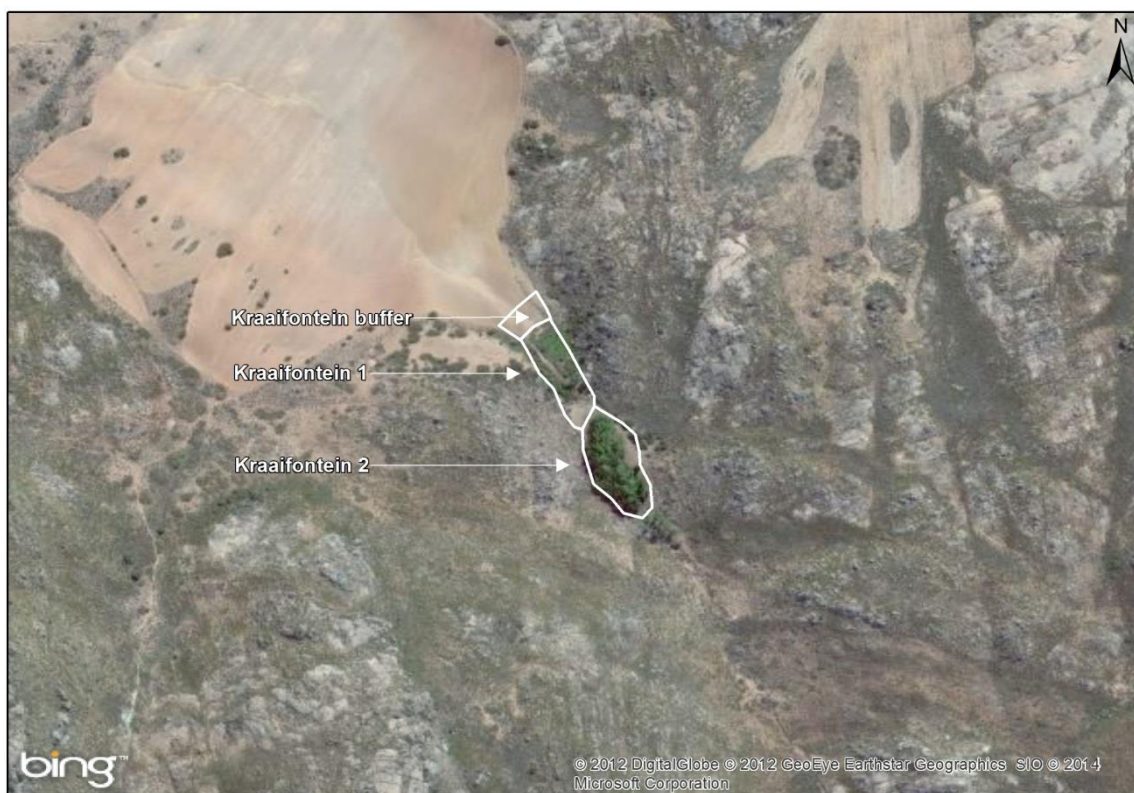
The Kraaifontein wetland consists of two units. Unit 1 is a hillslope seep, which lies immediately upstream of Kraaifontein unit 2, a channelled valley bottom. Although most of Kraaifontein unit 1 supports natural vegetation, a road within the wetland runs down the full length of it. Much of Kraaifontein unit 2 is occupied by a tall stand of poplars.

Figure 45: Units within the Kraaifontein wetland (Courtesy: Donovan Kotze)

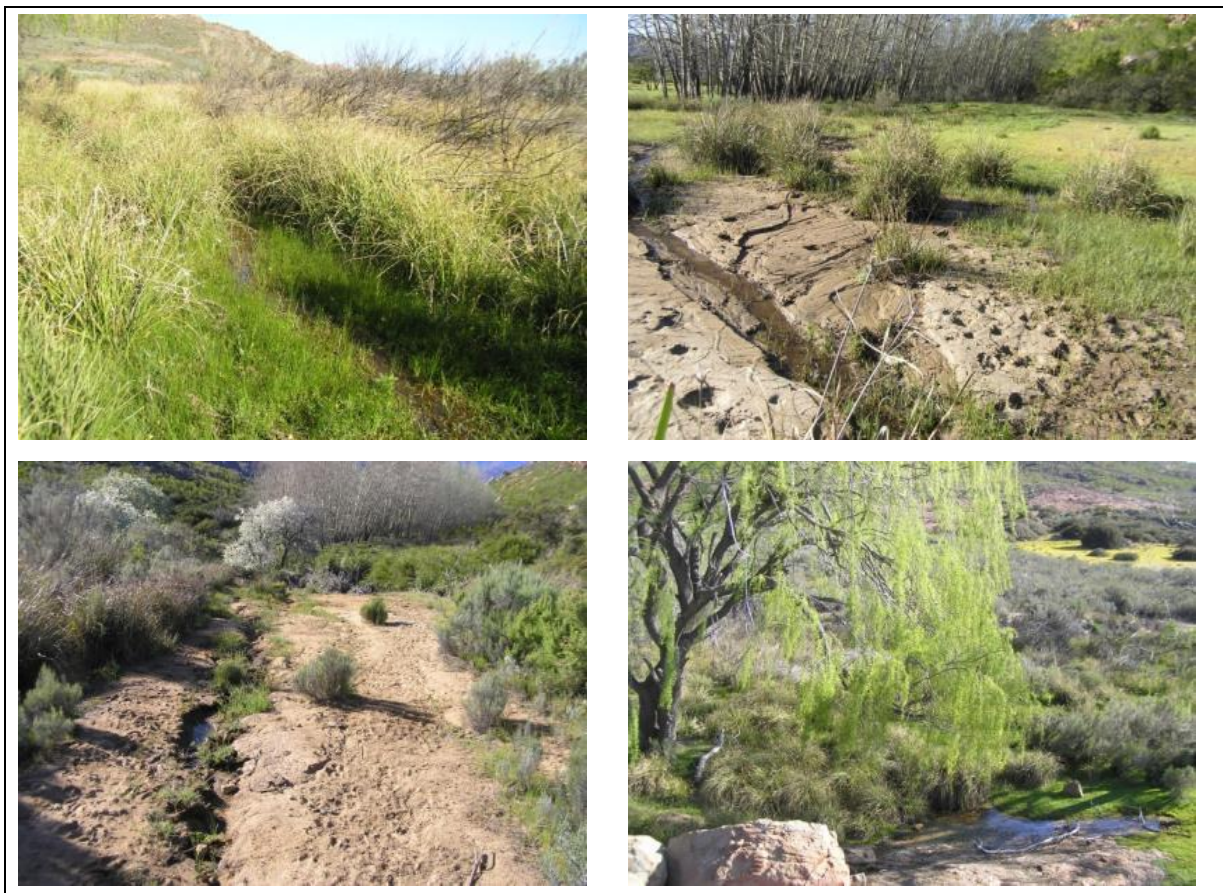
Figure 46: Site photos of the Kraaifontein wetland (Courtesy: Donovan Kotze)

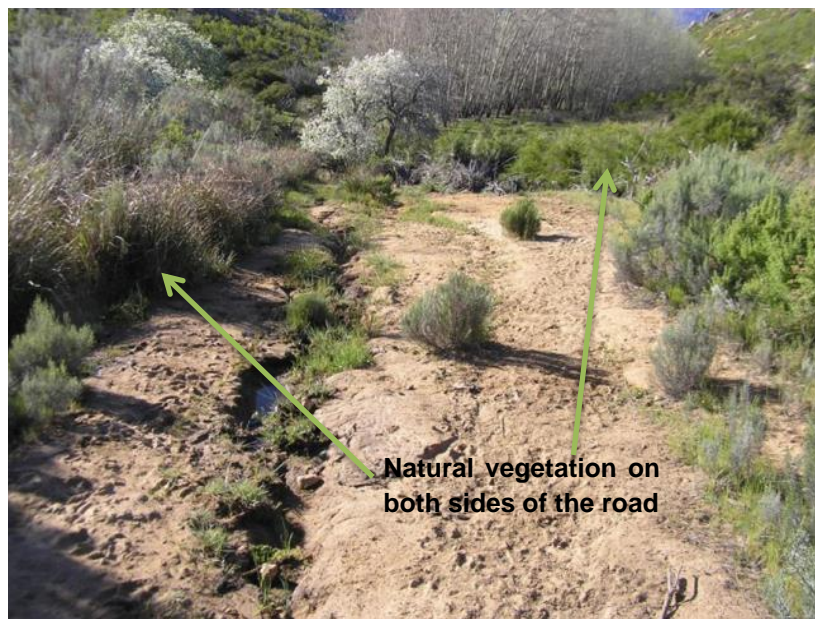
Figure 47: A photo of the road currently cutting through the Kraainfontein wetland (Courtesy: Donovan Kotze)

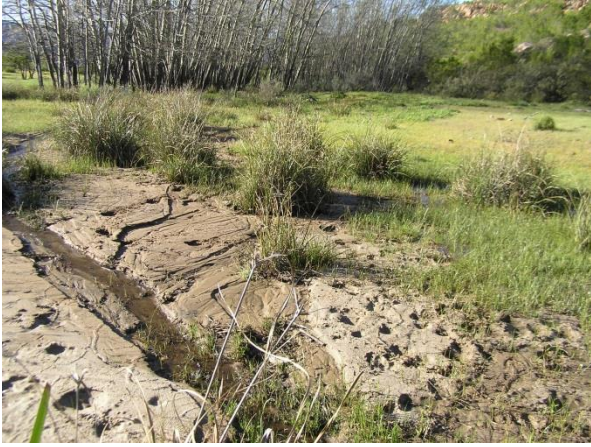
FPP Number	Kraaifontein-01	
GPS Location (DMS)	Latitude	27°17'48.45"S
	Longitude	30°29'04.66"E
Description of Photography Point		
Type/ Orientation: 160°

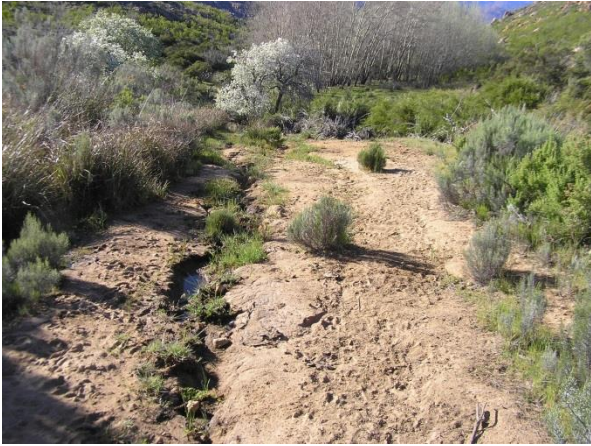
FPP Number	Kraaifontein-02	
GPS Location (DMS)	Latitude	30°14'29.29"S
	Longitude	18°00'09.94"E
Description of Photography Point		
Type/ Orientation: 160°

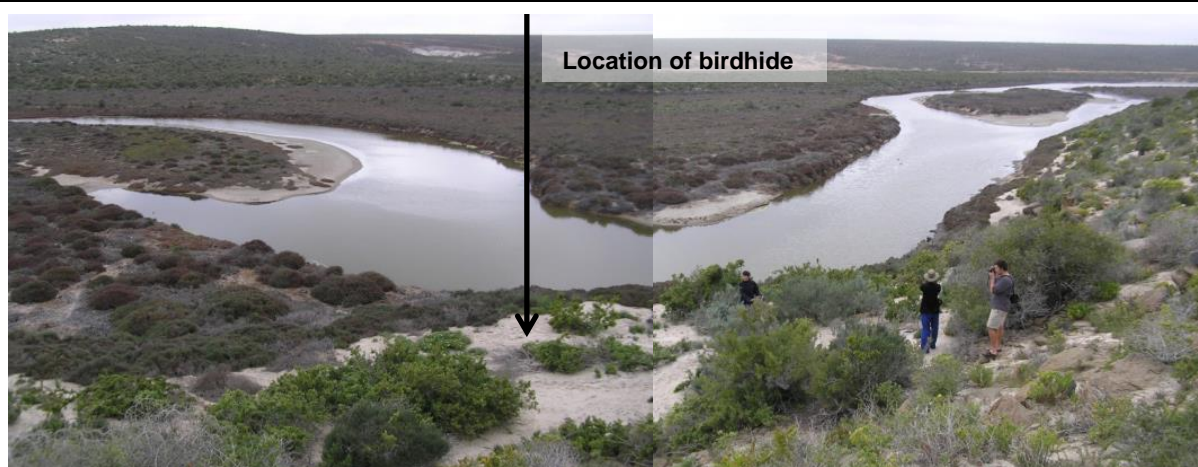
Designer	-
Design Date	-
Intervention Description	Birdhide
Rehabilitation Objective	Avoid trampling of saltmarsh and increase awareness among visitors
Latitude (D°M'S")	30°50'02.5"S
Longitude (D°M'S")	17°34'33.7"E
Engineering Drawings	Detailed design to be finalised closer to implementation (generic drawing available in Appendix C)

Figure 52: Location of intervention F50G-01-202-00 (Courtesy: Donovan Kotze)
