# Choje Windfarm Preliminary Geotechnical Investigation

**Document No.:** PP224951-PE-R-02-A

Preliminary Geotechnical Investigation for the proposed Choje Windfarm, Eastern Cape, South Africa

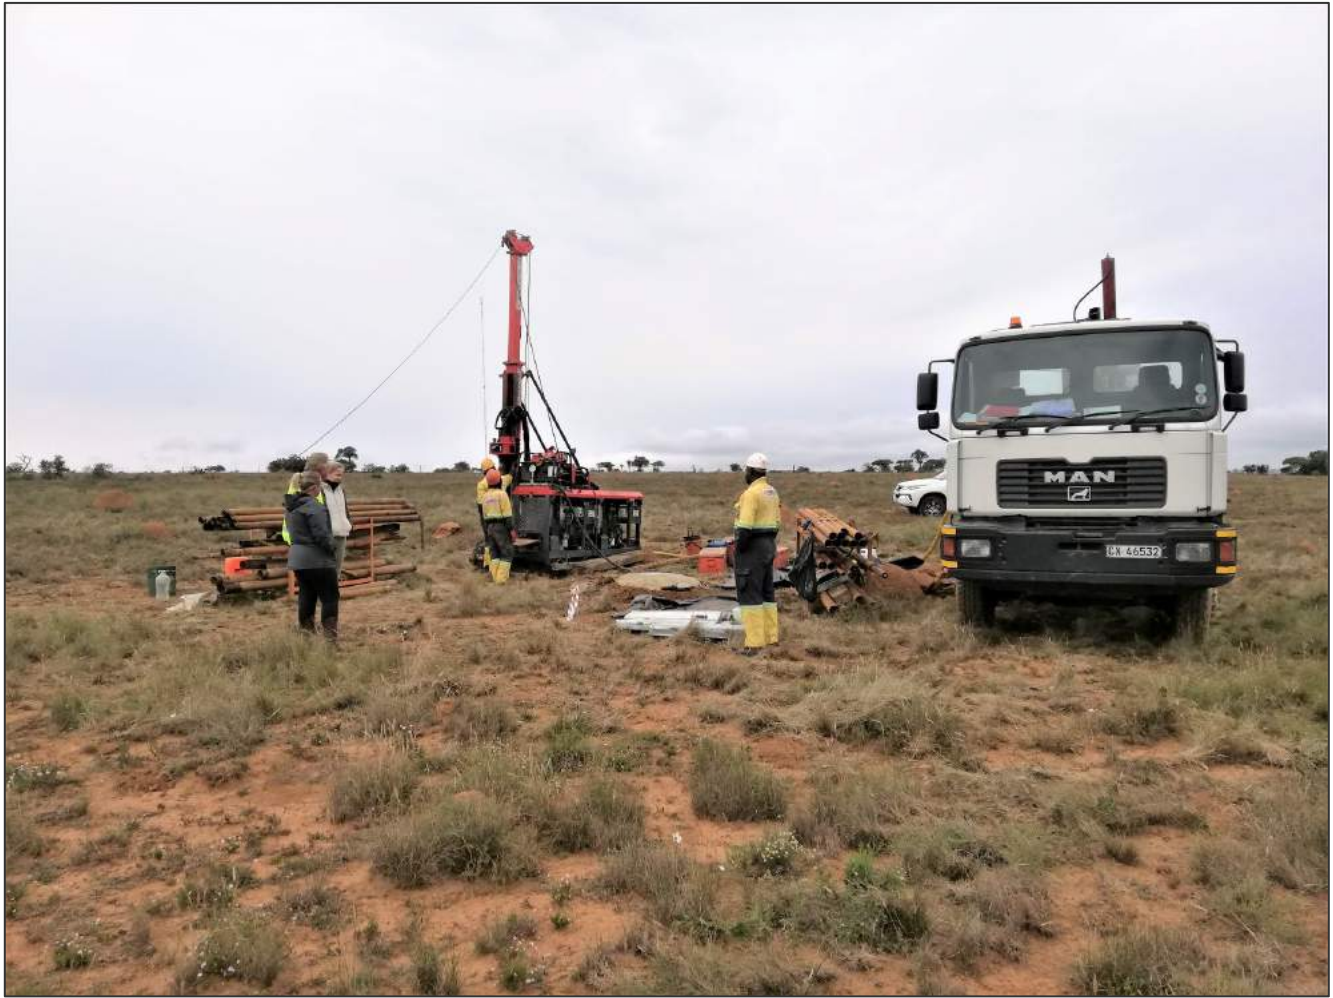
**Plate 1: Rotary core drilling at borehole position E64**

Nine (9) boreholes were drilled at predetermined WTG positions utilising rotary core drilling methods, on a HQ3 drill-string size by the drilling Contractor *EarthTech Geotechnical Services*. Sampling during the exploration was performed using Standard Penetration Test (SPT) where possible, although SPTs widely refused across the site owing to dense residual soils and weathered rock. Split spoon tube sampling was also attempted, however geological conditions did not cater for any successfully being retrieved. The positions of all WTG boreholes are illustrated in Figure 1. The soil conditions and rock strata described using standard methods and terminology outlined by *Jennings et al. (1973)* and the *Core Logging Committee of South Africa (1976)*. Borehole logs and photographic plates are included in Annexure B.

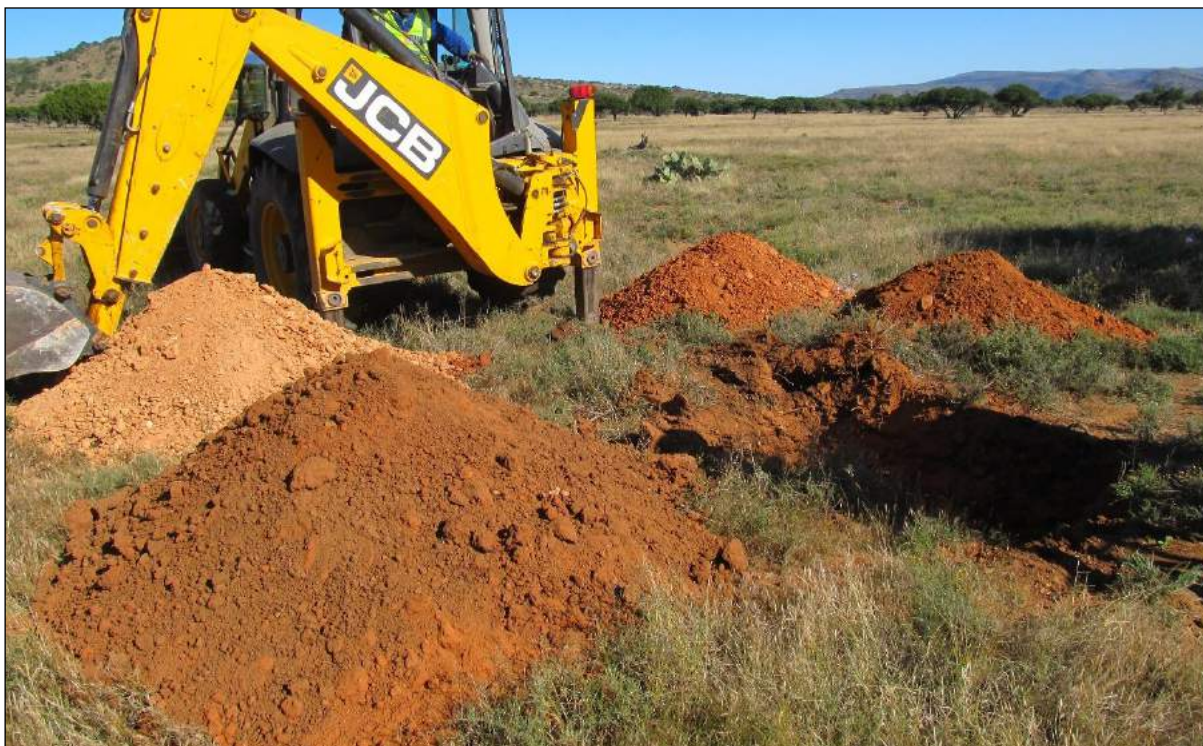
**Plate 2: Trial pit excavation at W417 position** (photo credit: Outeniqua Geotechnical Laboratory)

One (1) trial pit, at each of the WTG founding positions was excavated to a depth of 3.00m or refusal, whichever came first. In addition, one (1) trial pit, was excavated approximately 50-70m away at each of the potential crane platform positions. Four (4) trial pits were also excavated as the proposed Eastern Block substation position, to a depth of 3.00m each or refusal, whichever came first. Another four (4) trial pits were additionally excavated at the proposed 400 MTS position on the Western Block.

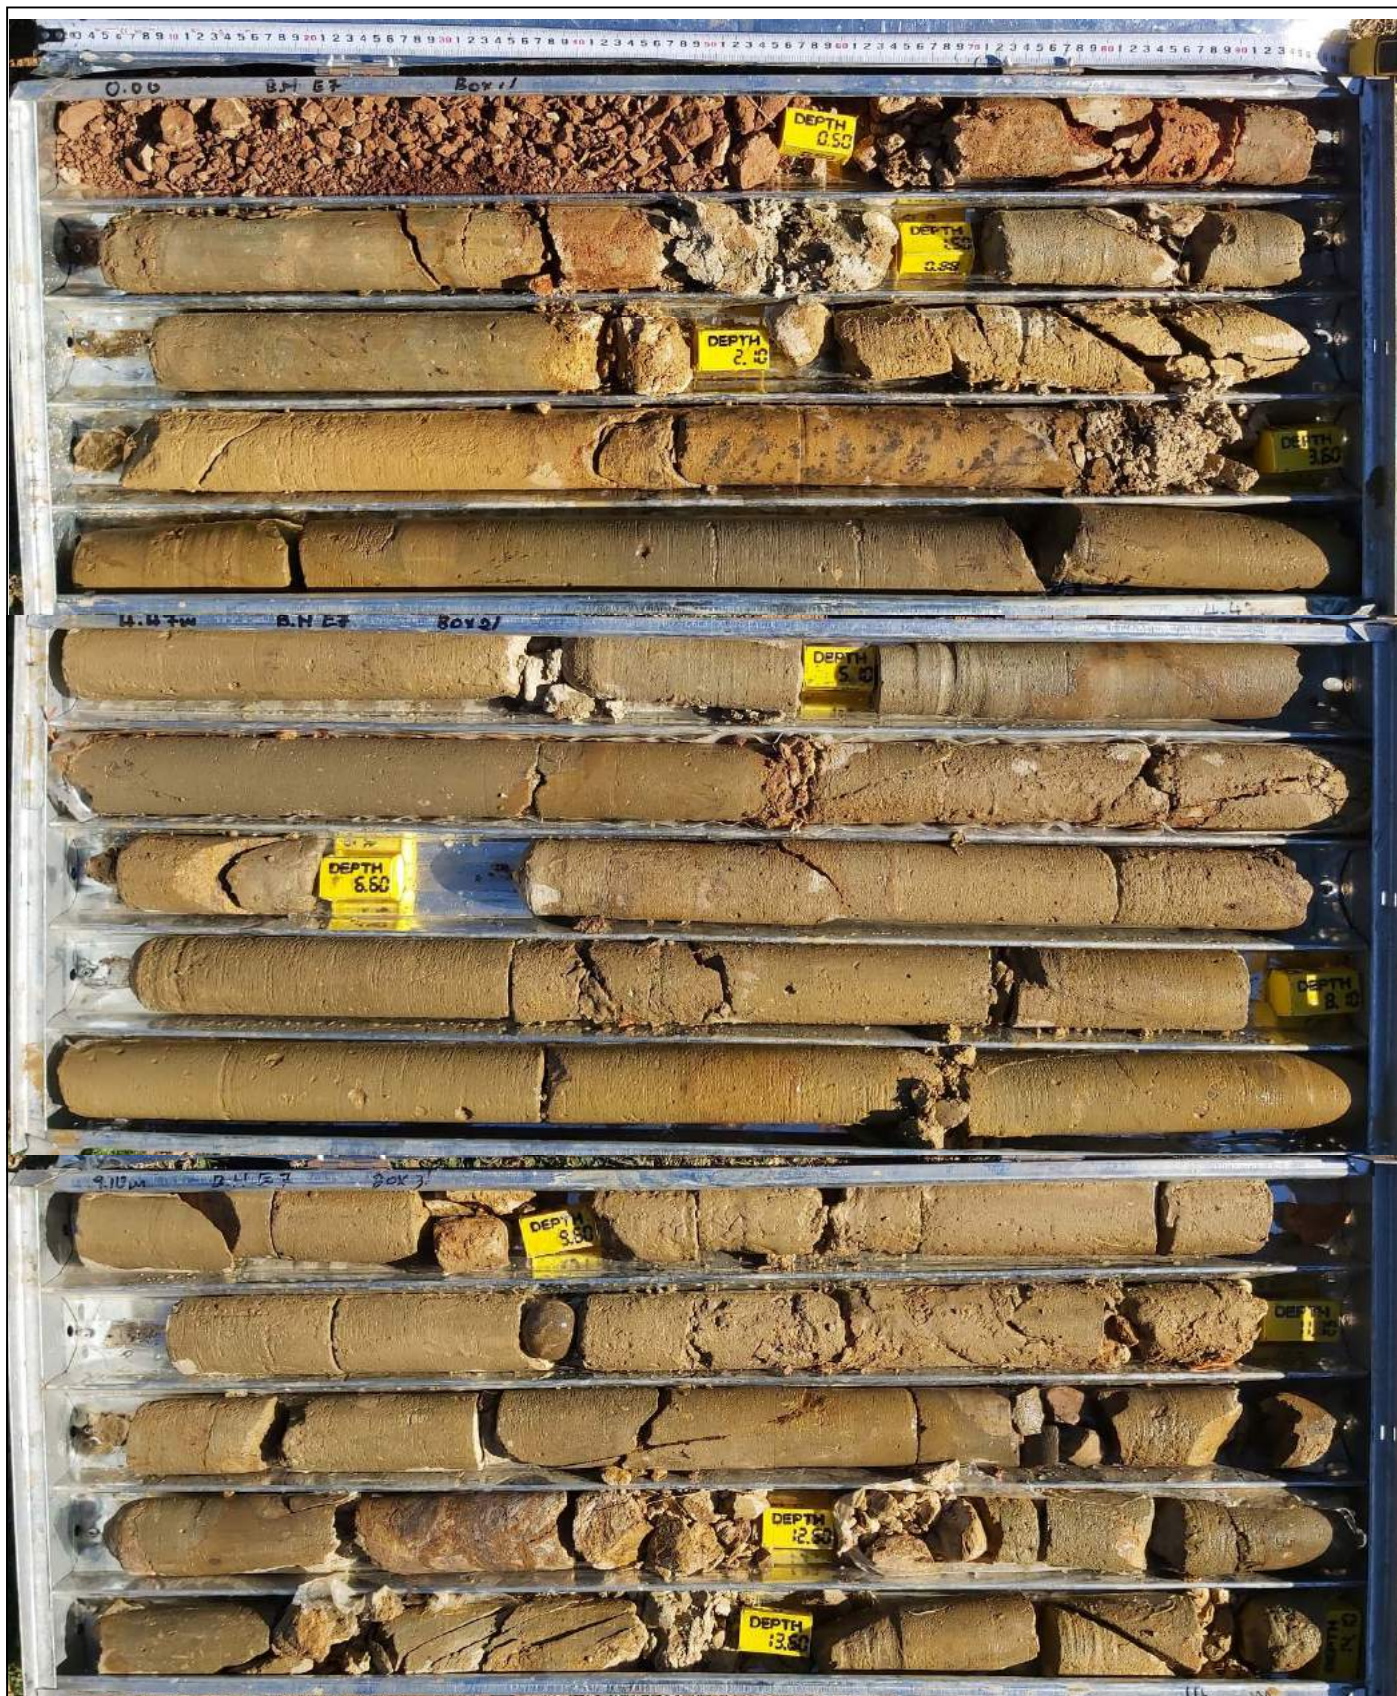
BOREHOLE NO: BH E7 SHEET 1/3

Significant variation in the hardness of the tillite was observed between boreholes (compare logs from E7 and E64), associated with the degree of weathering the tillite has been subjected to under the influence of groundwater. Significant core loss was recorded in a number of the boreholes at shallow founding depth of

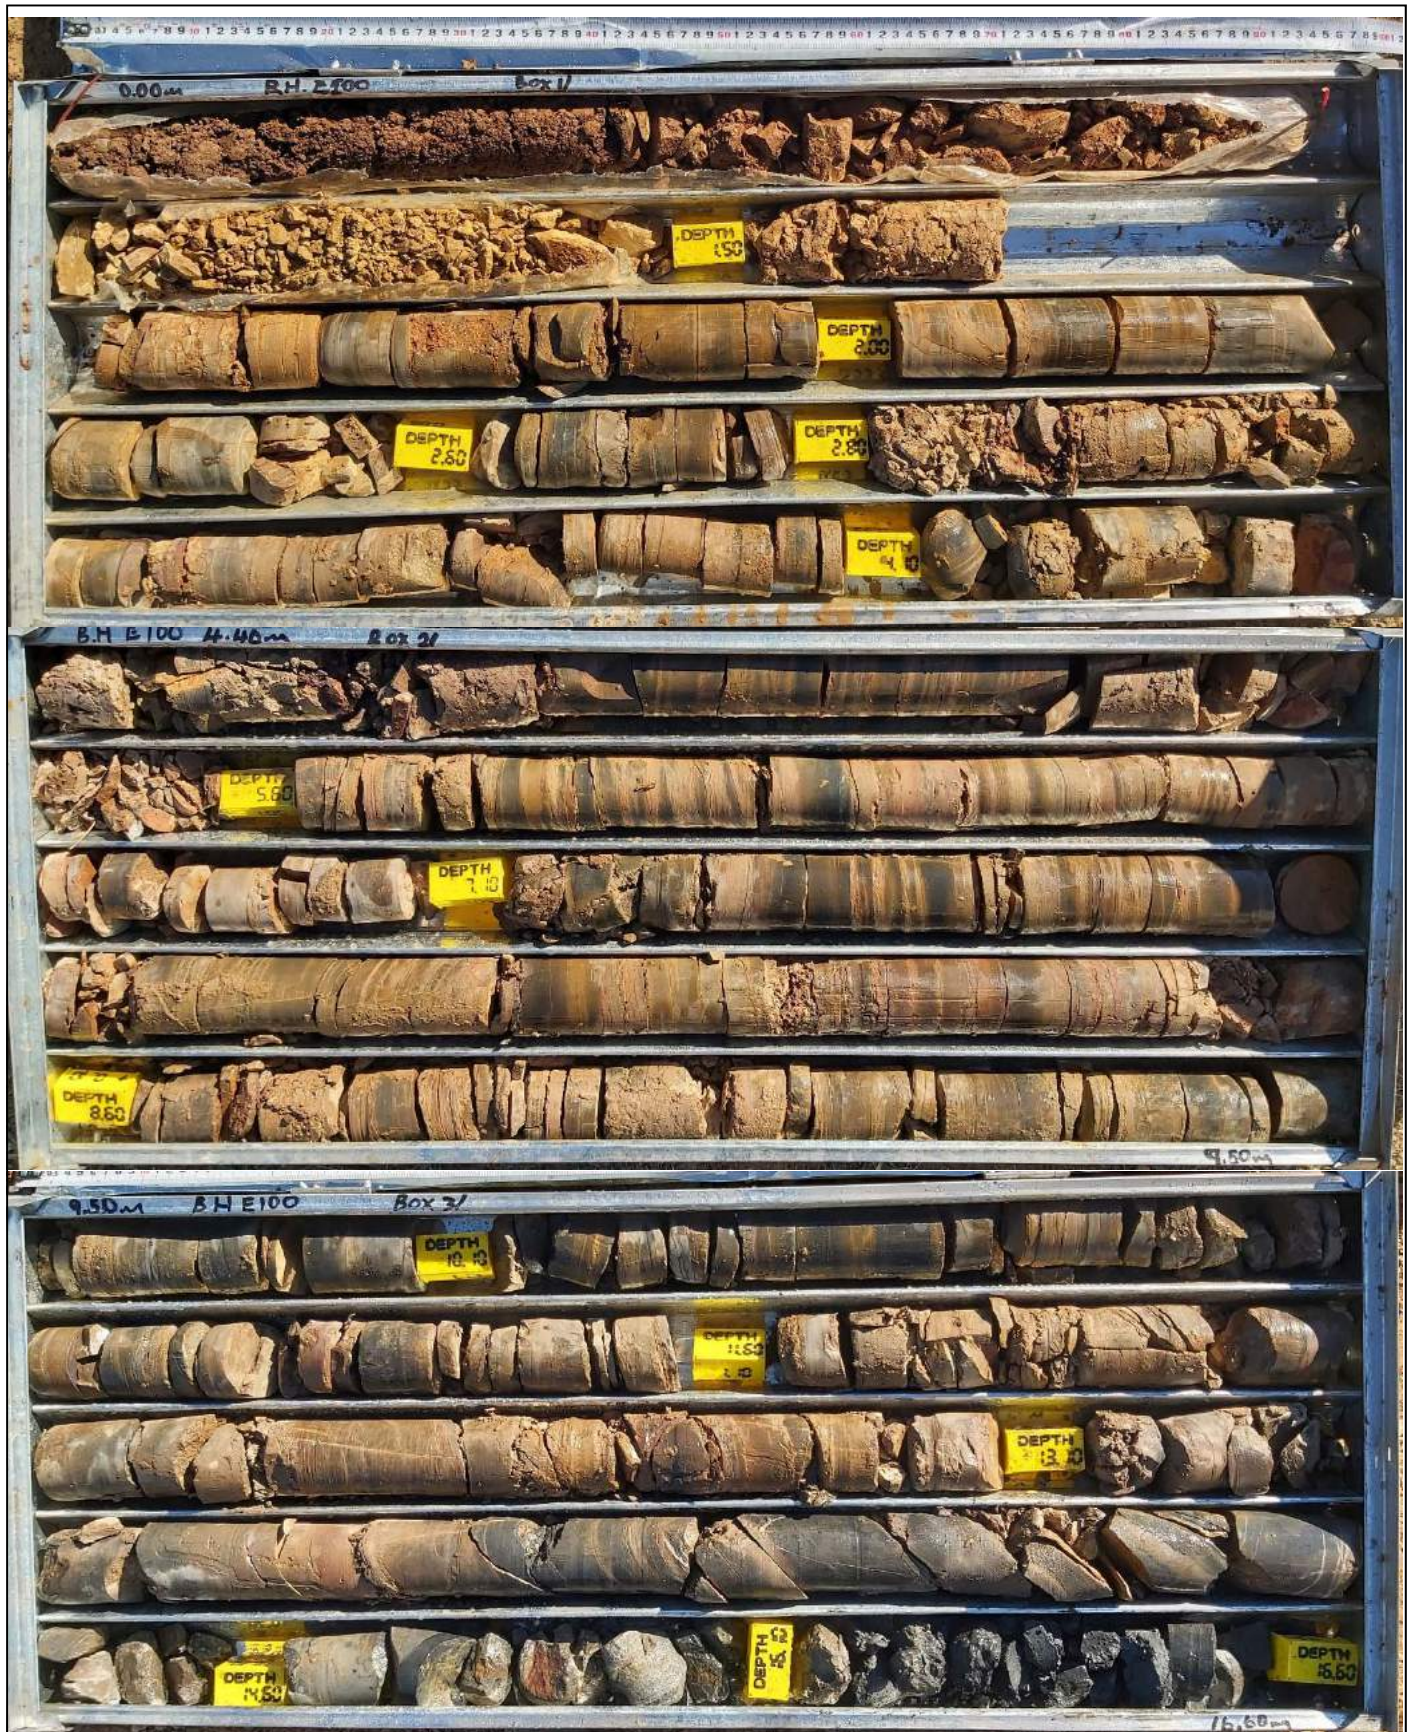
BOREHOLE NO: BH E100 SHEET 1/2

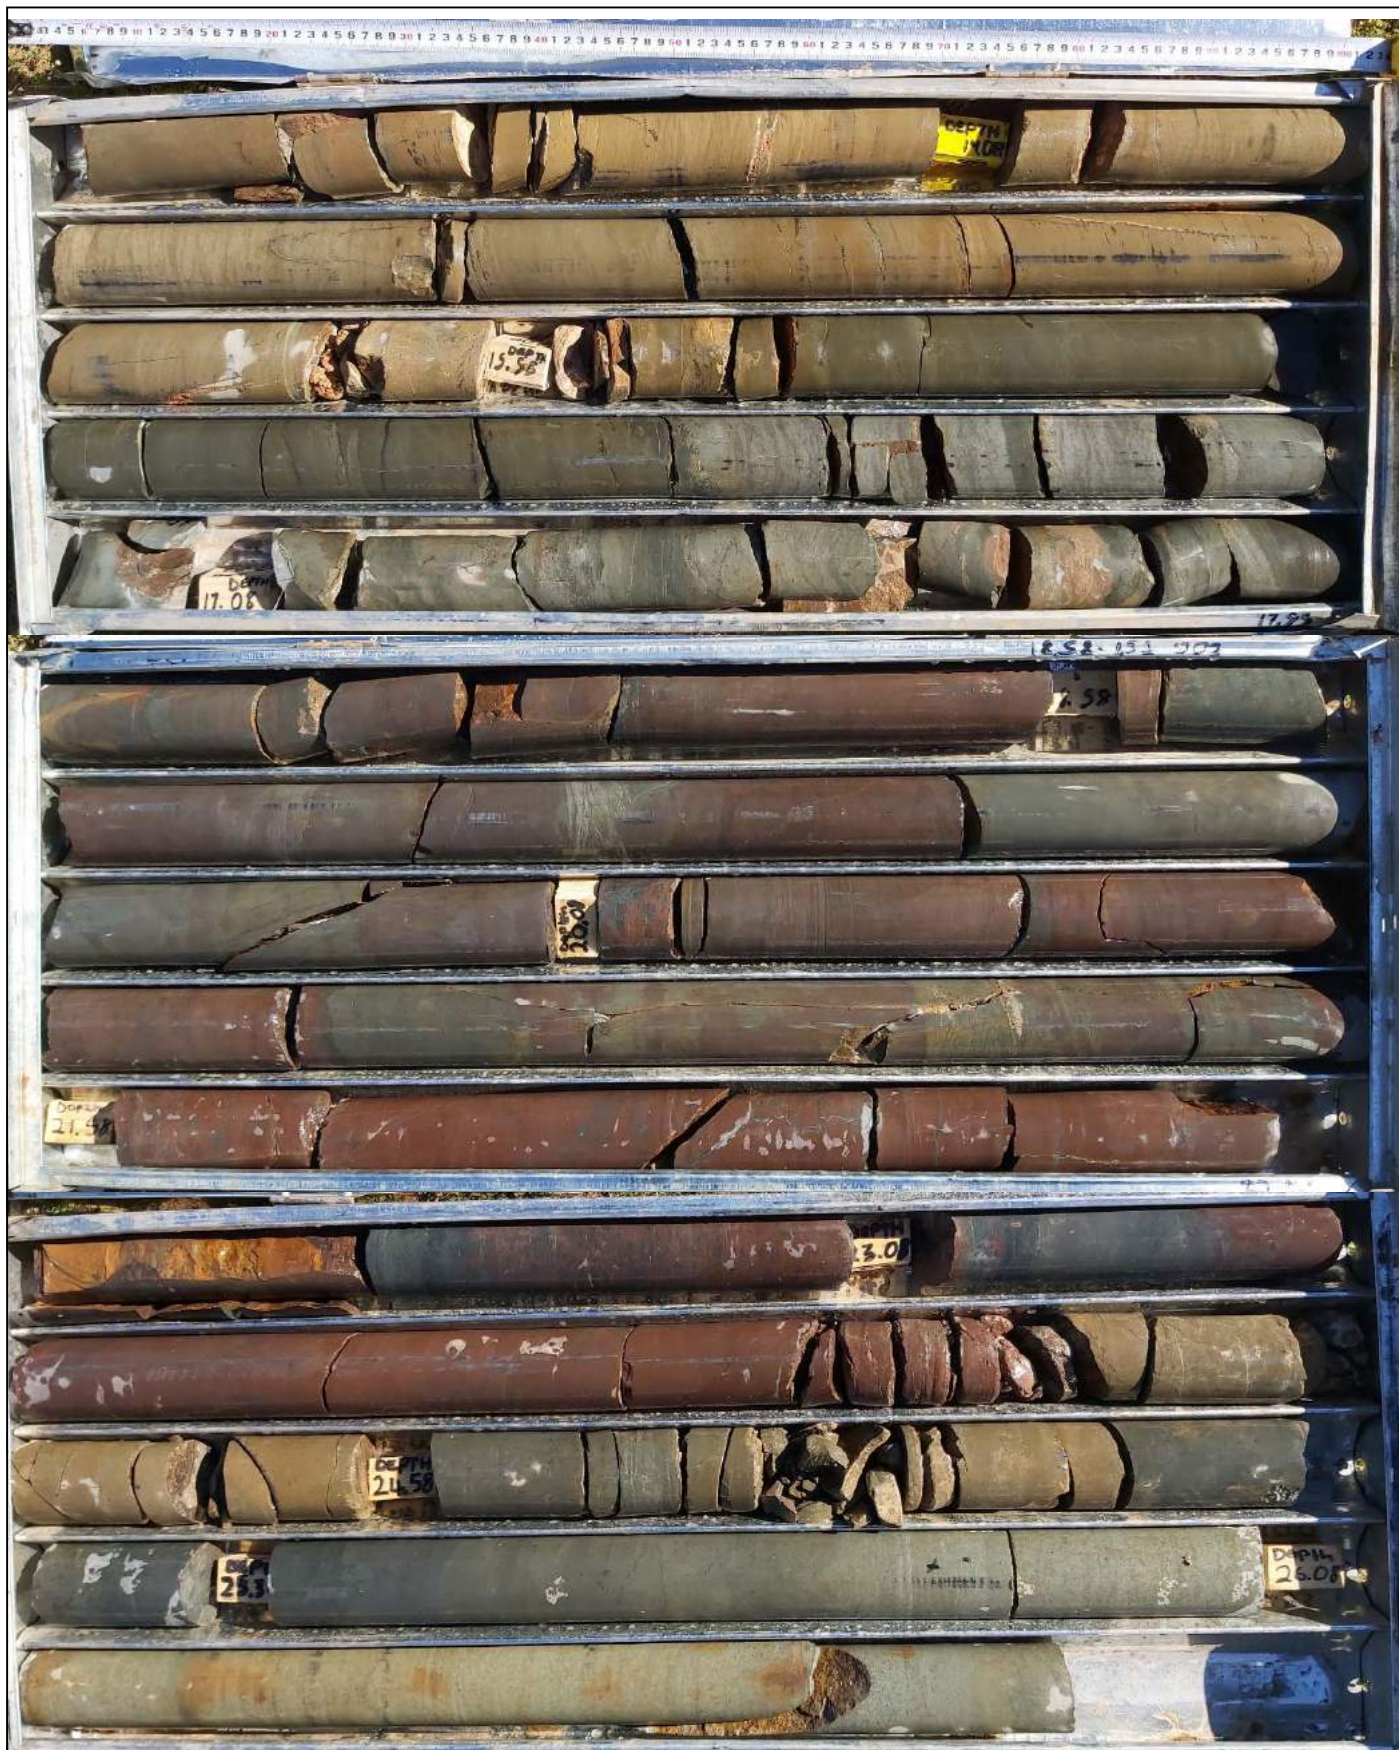
BOREHOLE NO: BH W417 SHEET 2/3

2-4m (e.g. E6, W411, W417 – See Appendix B). Core loss in calcareous soils is unsurprising (W417), as fines wash out during the drilling process, however core loss in rock is largely due to the highly fractured, highly weathered and soft nature of shallow rock at these positions.

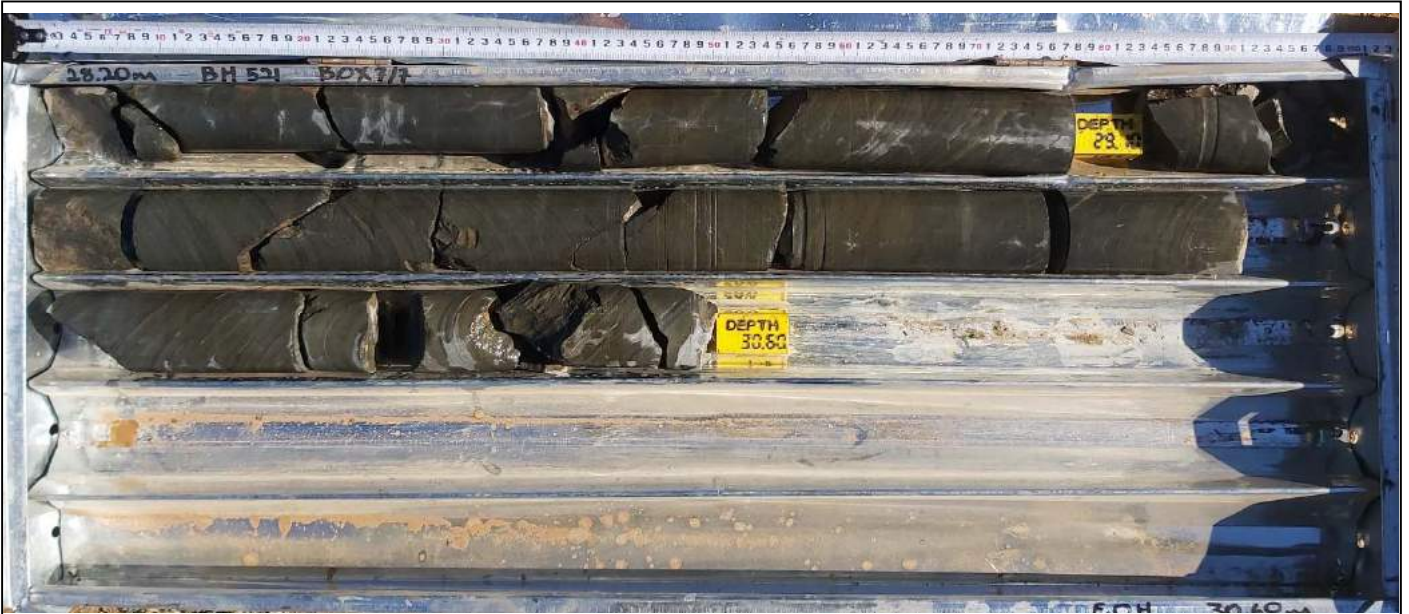
<b>CONTRACT: CHOJE WIND FARM, EASTERN CAPE</b>	<b>BOREHOLE NO: BH W521 SHEET 3/3</b>
<b>CLIENT: DNV GL/WIND RELIC</b>
