## SUPPORTING DOCUMENTS VISUAL IMPACT ANALYSIS

CLIENT:  
INCITE CHURCH

PROJECT NAME:  
INCITE BALCONY

STATUS:  
AMAFI APPLICATION

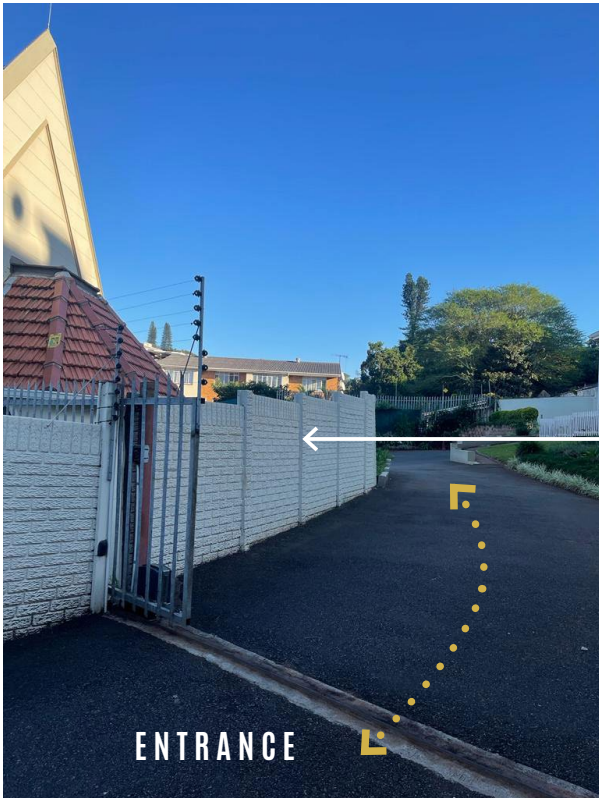
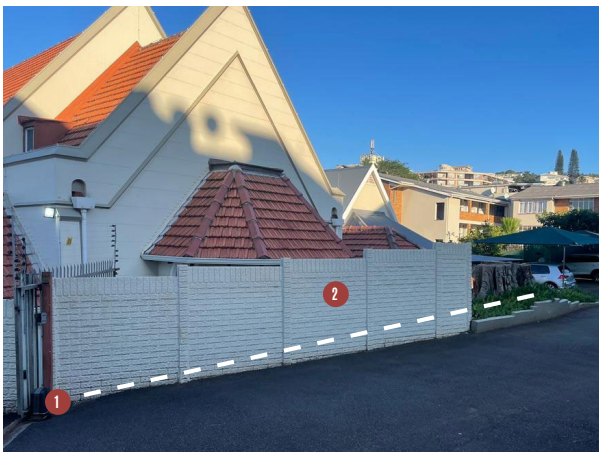
VISUALLY INACCESSIBLE PRECAST WALL TO BE DEMOLISHED

1. PROPOSED LINE OF NEW RETAINING WALL. RETAINING WALL AND BALUSTRADE TO BE VISUALLY NON-IMPEDING
2. PRECAST FENCE TO BE REMOVED

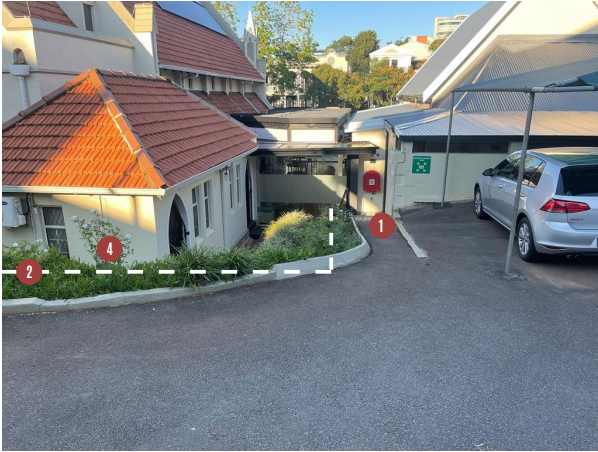
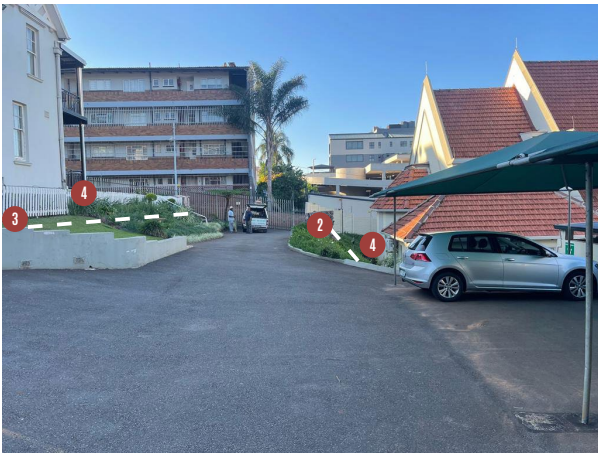
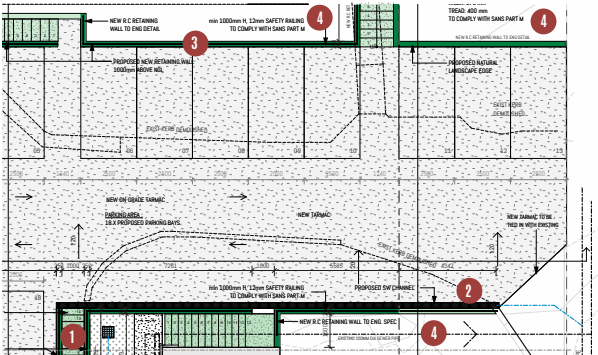
1. CURRENT STAIRS WIDTH NOT COMPLIANT TO SANS 10400 PART M
2. LINE OF NEW RETAINING WALL IMPROVING THE VISUAL ACCESSIBILITY TO THE BUILDINGS
3. LINE OF NEW RETAINING WALL NOT VISUALLY IMPEDING
4. PLANTING TO RE-PLANTED AT NEW LEVEL
