WETLAND ASSESSMENT REPORT:

ZAALKLAPSPRUIT WETLAND (B20G-01)

Report No: EP60-03

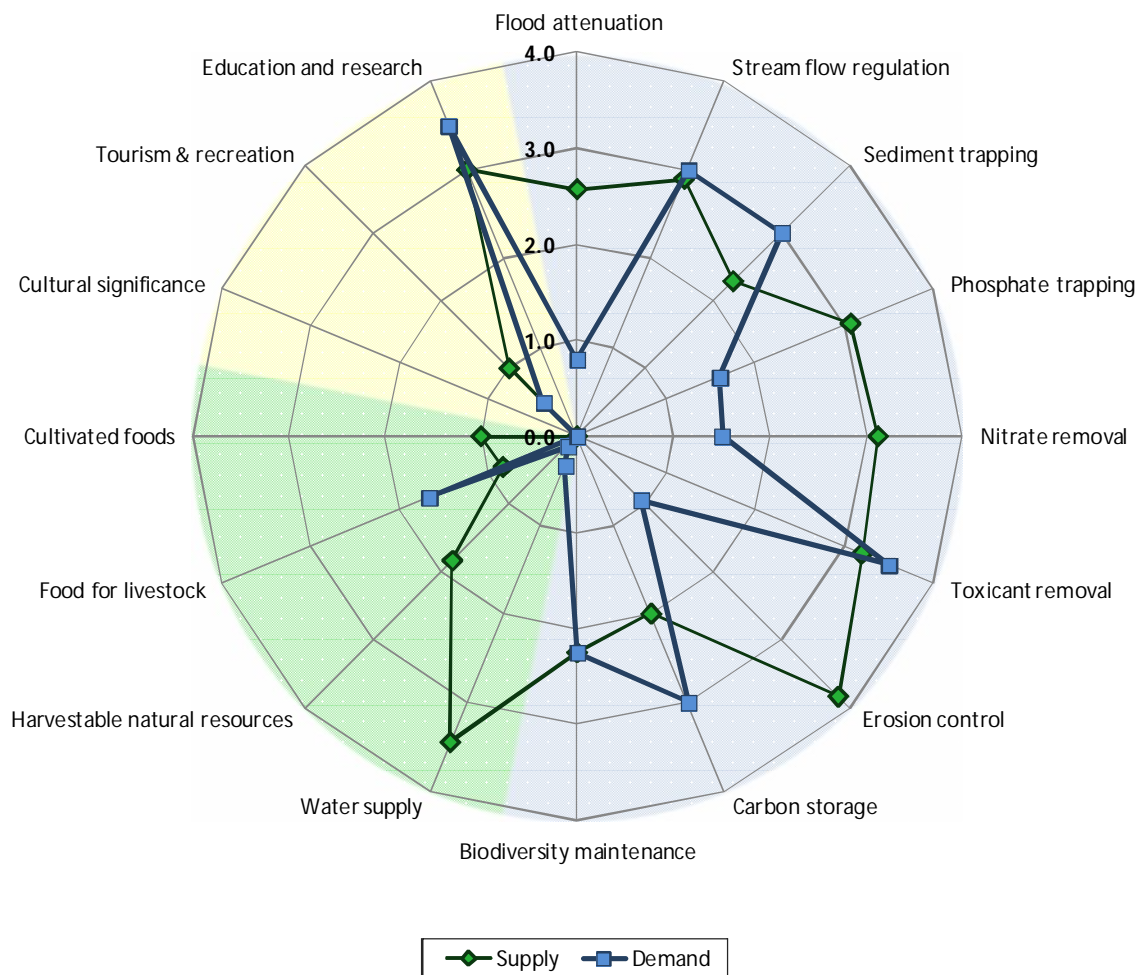
Figure 5. Spider diagram illustrating the relative demand and supply of ecosystem goods and services provided by the Zaalklapspruit wetland.

A breakdown of the current levels of benefit provision (supply) and demand for a range of ecosystem goods and services associated with the Zaalklapspruit wetland is presented in graphically in Figure 5 and in more detail in Table 12. This suggests toxicant removal, stream flow regulation and sediment trapping are the most important regulating services provided by the wetland. Given the suitability of the wetland for research into the ability of wetlands to address acid mine drainage, education and research opportunities are regarded as high. While sections of the wetland are used by livestock, the value of direct provisioning services is limited.

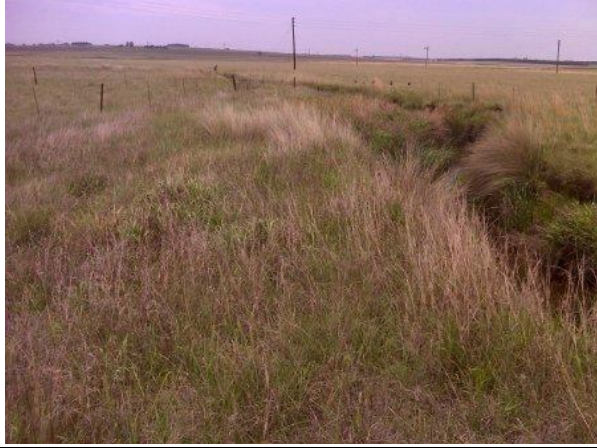
P 69 Evidence of a berm on the eastern section of the main channel.

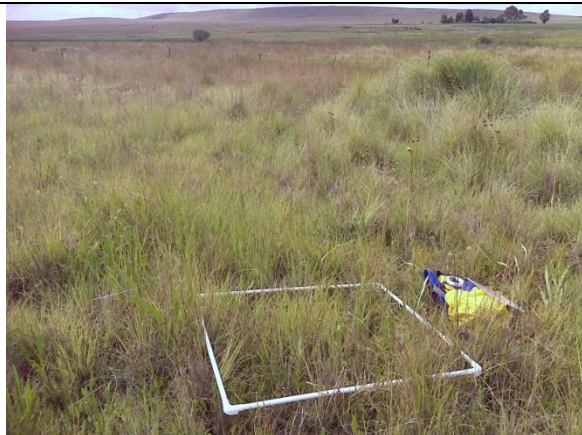
<p>Q14-01 Grass dominated area between old ridges. Soils appear temporarily wet at this point.</p>

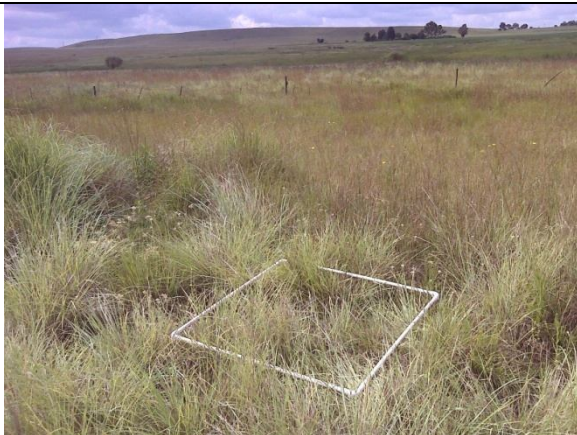
<p>Q14-02 Grass dominated ridge.</p>

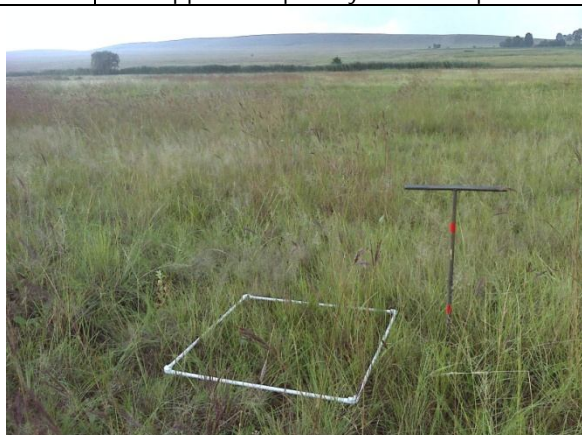
<p>Q14-03 Edge of ridge and furrow area close to inflow point of secondary seepage wetland. Dominated by grass species, principally <i>Eragrostis</i> spp. With some forbs and <i>T.triandra</i> present.</p>

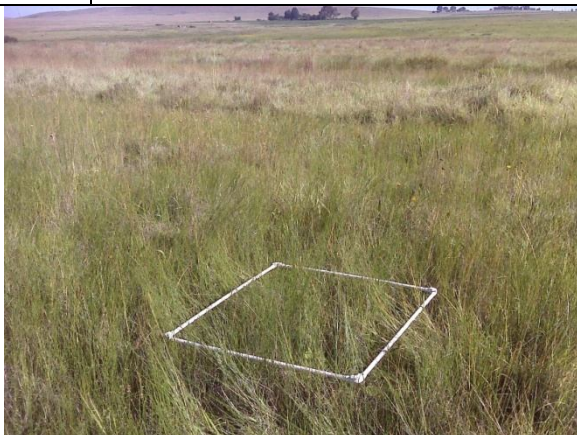
<p>Q14-04 Located between 2 berms downstream of planned intervention. Area characterised by a mix of grasses, forbs and species such as <i>F.complanata</i>.</p>

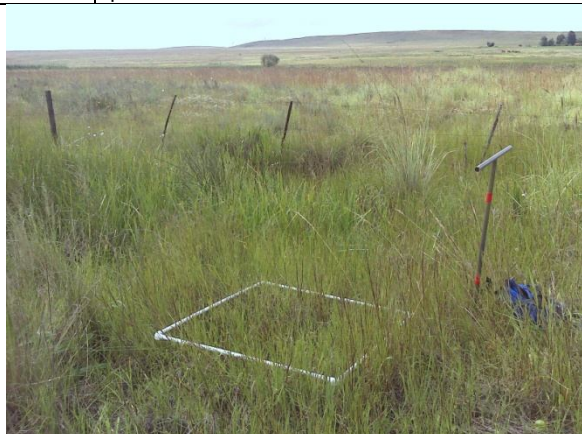
<p>Q15-01 Grass dominated zone with <i>Cyperus</i> and other obligate wetland species in the nearby channel. Quad located just south of low point.</p>

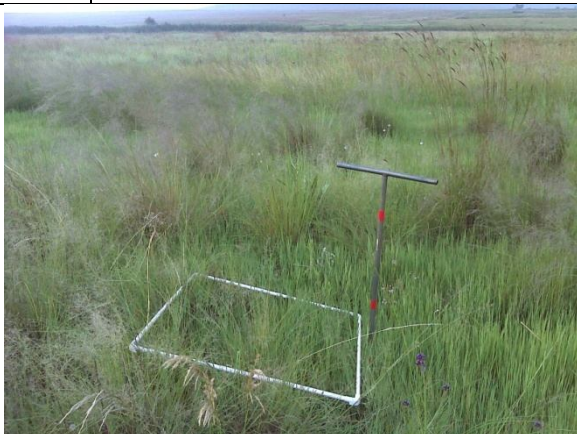
<p>Q15-02 Shallow drain dominated by wild rice grass (<i>Leersia hexandra</i>) but with occasional patches of <i>E. Curvula</i> and occasional <i>Kniphoffia</i> plants.</p>

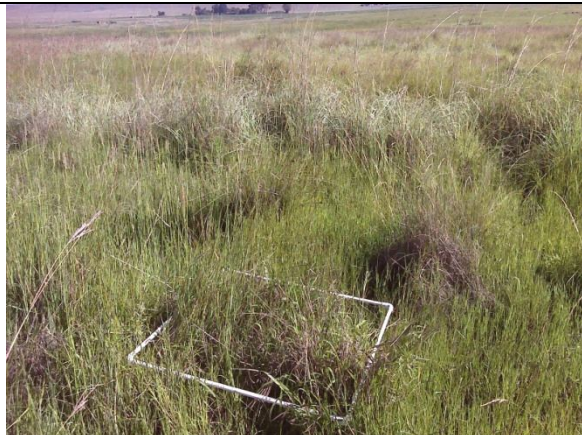
<p>Q15-03 Located within side channel of low lying area. Very diverse range of species including range of grasses and obligate wetland species.</p>

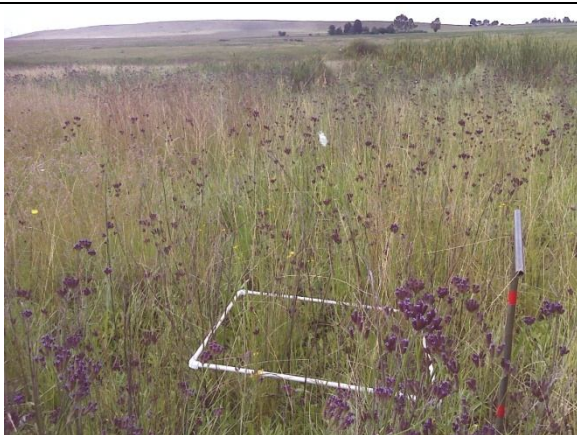
<p>Q16-01 Clearly disturbed area dominated by ruderal weeds with patches dominated by grass species such as <i>T.triandra</i>, <i>A.lacnantha</i> and <i>Eragrostis spp.</i></p>

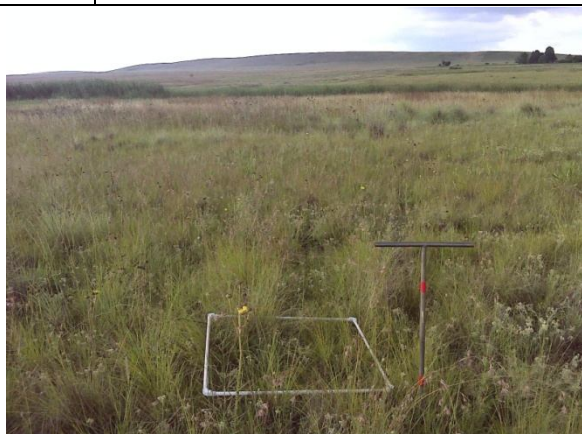
<p>Q16-02 Area affected by historic ridge and furrow cultivation. Dominated by terrestrial grass species such as <i>T. Triandra</i>, <i>Eragrostis spp.</i> and terrestrial forbs.</p>

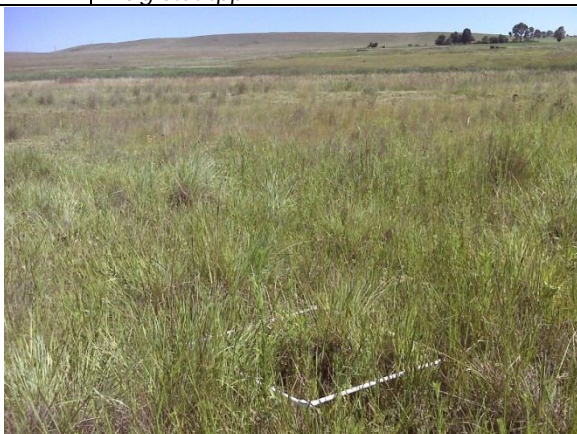
<p>Q16-03 Ridge and furrow area. Area dominated by <i>Eragrostis spp.</i> And forbs with some <i>T. Triandra</i> present.</p>

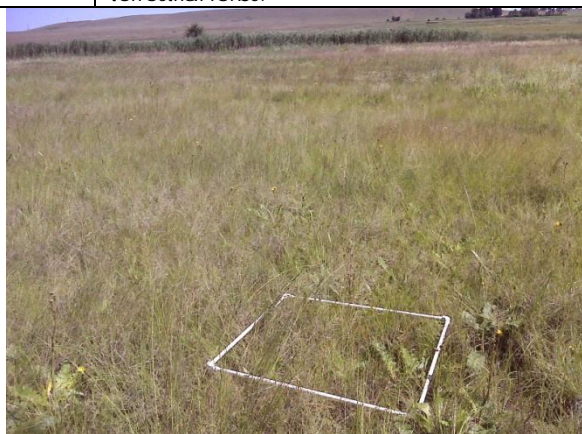
<p>Q16-04 Area affected by ridge and furrow cultivation. Dominated by grass species including <i>I.cylindrica</i>, <i>H.turgidulum</i> and a range of forb species.</p>

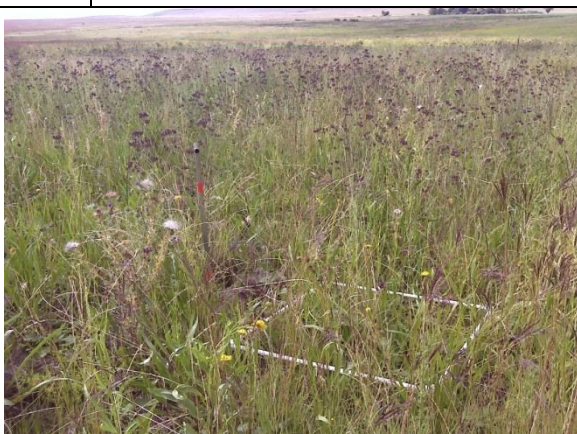
<p>Q17-01 Clearly disturbed zone north of main channel. Dominated primarily by grasses and a range of terrestrial forb species.</p>

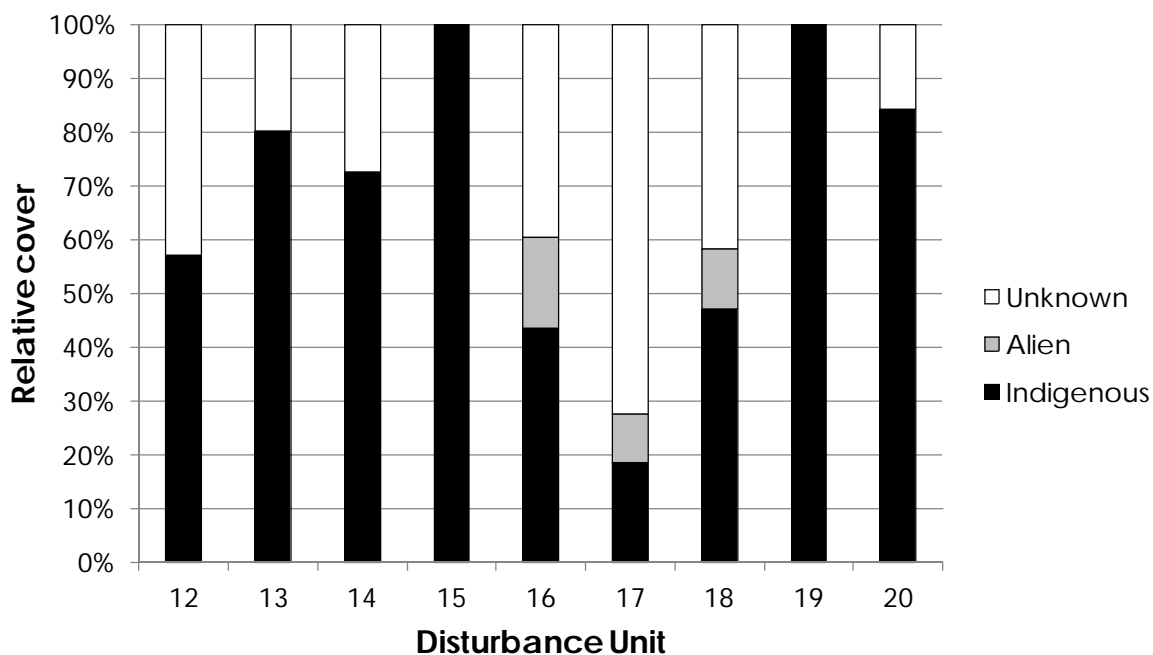
Figure 2. Relative cover of alien and indigenous species.⁷

⁷ Note: Unknown species refer to a range of forbs which were not identified to a species level.
