Draft Basic Assessment Report for a Photovoltaic (PV) Solar Facility Proposed by
SolaireDirect at Glen Thorne Farm (No. 2163) near Bloemfontein, Free State Province

APPENDIX C: Facility illustrations

DRAFT SCOPING REPORT

BIODIVERSITY AND ECOLOGY; GLEN THORNE PV SITE, FREE STATE.

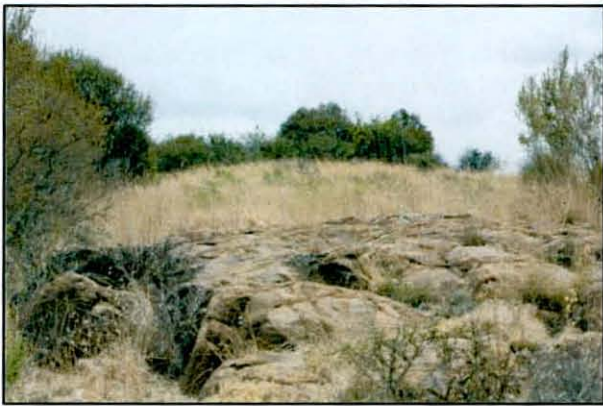
Photo 1. The rocky outcrop which occurs towards the southwestern boundary of the site. The koppie is the only rocky area within the site and contains a number of tree species which do not occur elsewhere at the site including *Olea europaea* subsp. *africana*, *Eretia rigida*, *Rhus burchellii* and *R.pyroides*.

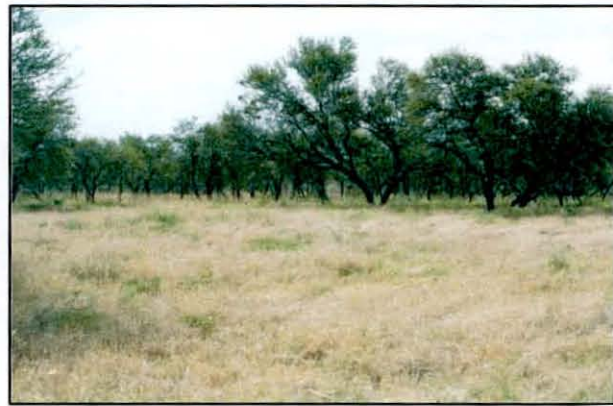
Photo 2. The floodplain of the Modder River consists of well-wooded areas interspersed with more open areas. The larger vegetation is dominated by *Acacia karoo*, with occasional other tree species such as *Rhus lancea* and *Ziziphus mucronata*.

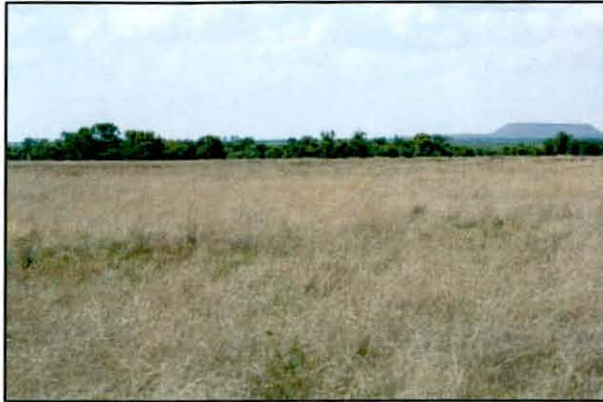
Photo 3. The open grasslands on the floodplain of the Modder River. The lack of trees in these areas is probably related to soil properties such as seasonal waterlogging. These areas are very flat and dominated by species such as *Themeda triandra*, *Salsola glabrescens*, and *Ranunculus multifidus*.

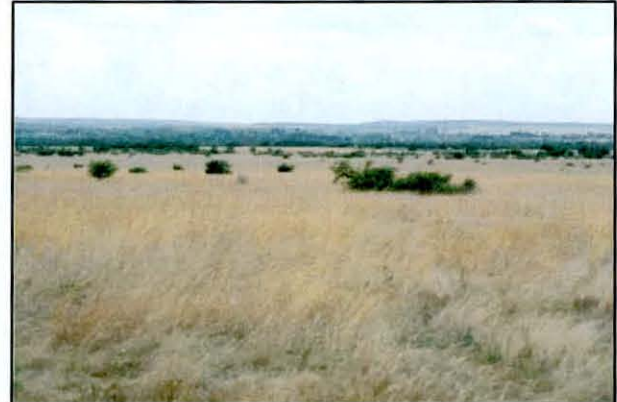
Photo 4. The open grasslands of the higher-lying parts of the site, with scattered *Acacia karoo*, *Rhus pyroides* and *Asparagus lariginus* shrubs. Common and dominant grass species include *Themeda triandra*, *Setaria sphacelata* and *Cymbopogon pospischilii*.

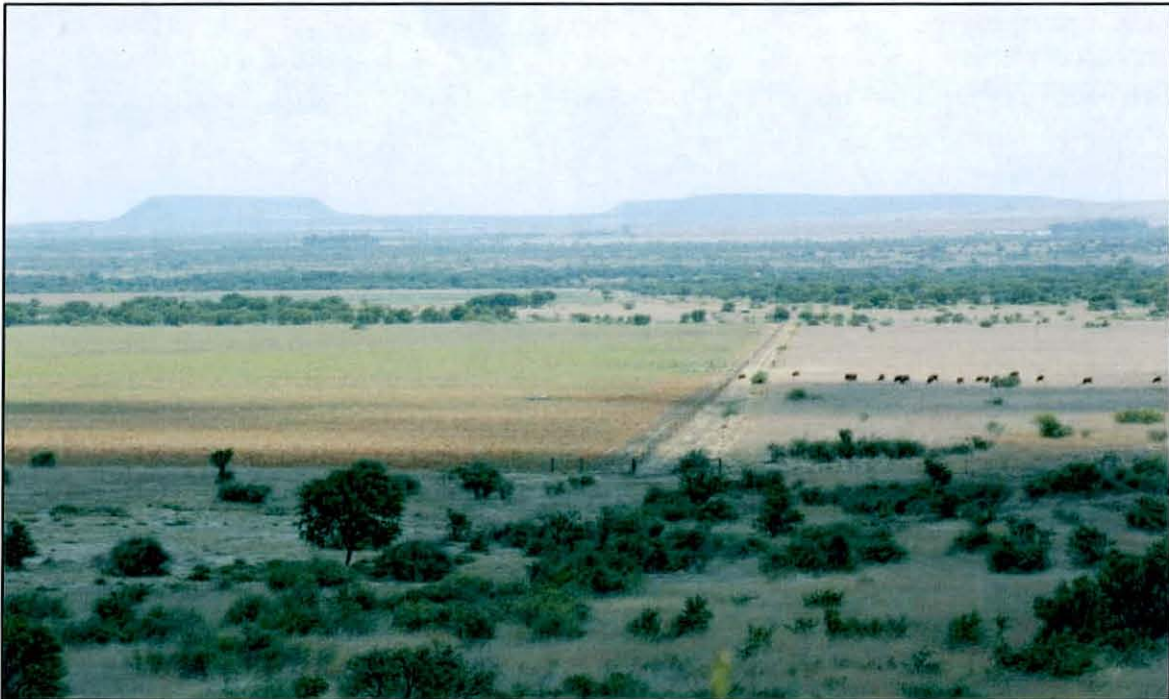
Photo 5. Looking north over the southern portion of the site from the small koppie. The large fallow field which can be seen on the left and the open grasslands to the right, represent the best development opportunities at the site as they have moderate to low biodiversity value. The wooded areas in the distance indicate the extent of the floodplain of the Modder River and represent an ecologically sensitive habitat that should be avoided as far as possible.

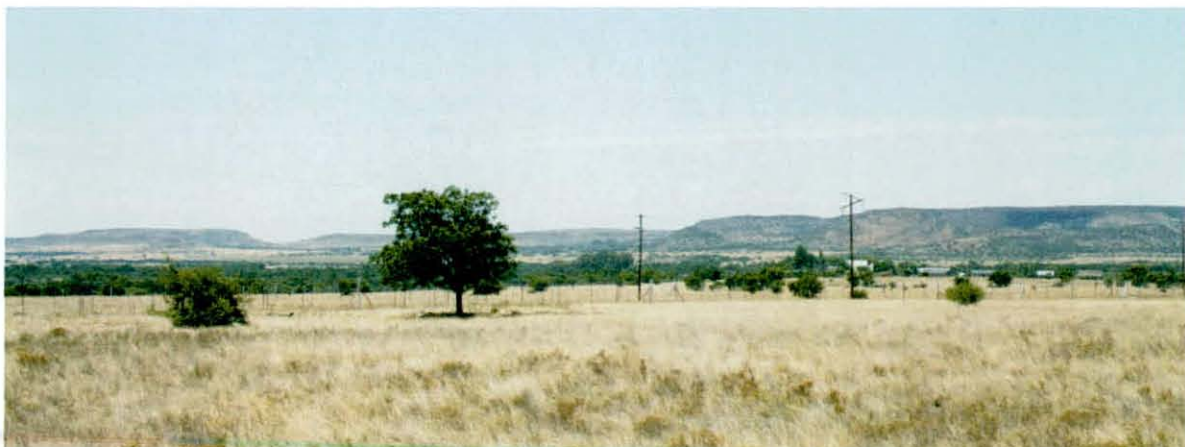
Figure 3: Topography and natural environment around the proposed development site.
