Draft Basic Assessment Report for a Photovoltaic (PV) Solar Facility Proposed by
SolaireDirect at Knapdaar Farm (No. 14) near Springfontein, Free State Province

Appendix D.1 Biodiversity and Ecology Impact Assessment Report

DRAFT SCOPING REPORT
BIODIVERSITY AND ECOLOGY; VALLEYDORA PV SITE, FREE STATE.

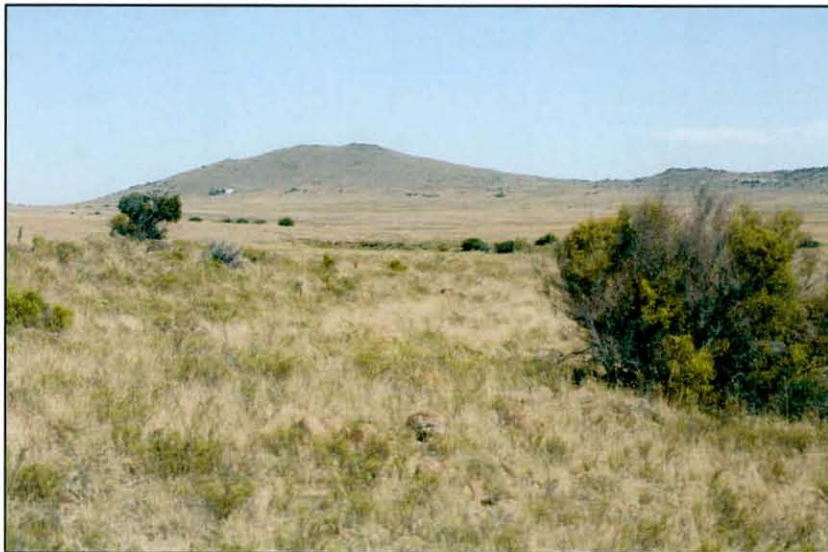
Photo 1. Rocky ridge towards the south-western extent of the site. The large shrub in the foreground is *Rhus incisa* and the darker shrub in the distance is *Diospyros lycioides*. The ground layer is dominated by widespread species such as *Chrysocoma ciliata* and *Eragrostis lehmanniana*.

The vegetation of the rocky outcrops of the site were highly distinct from the adjacent grasslands. As mentioned above the vegetation of the rocky outcrops corresponds to the Besemkaree Koppies Shrubland vegetation type and was characterised by the presence of large shrubs and small trees such as *Rhus erosa*, *R.burchellii*, *Diospyros lycioides*, *D.austro-africana* and *Aloe broomi*. Other species observed within the koppies which were not observed within the grassland habitat include *Euphorbia clavarioides*, *Pollichia campestris*, *Stomatium bolusiae* and *Dianthus caespitosus*. Due to the restricted nature and the presence of the low trees and various succulents within this habitat type it is ecologically sensitive from a flora perspective and should be avoided by the development on these as well as faunal grounds.

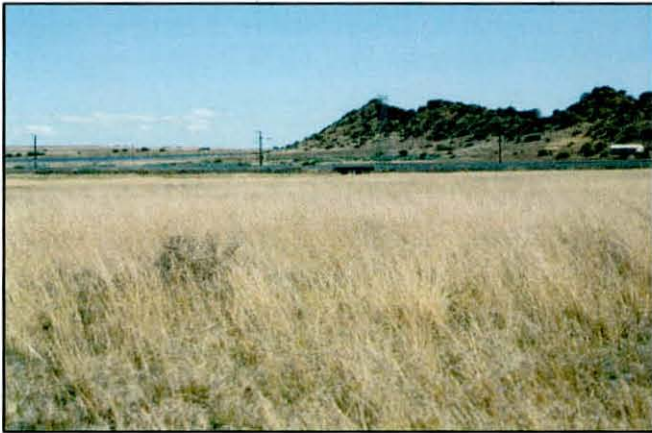
Photo 2. Dense grassland consisting largely of *Themeda triandra* within the drainage area towards the low-lying southern boundary of the site. The culvert which allows runoff to flow beneath the railway line can be seen in the distance.

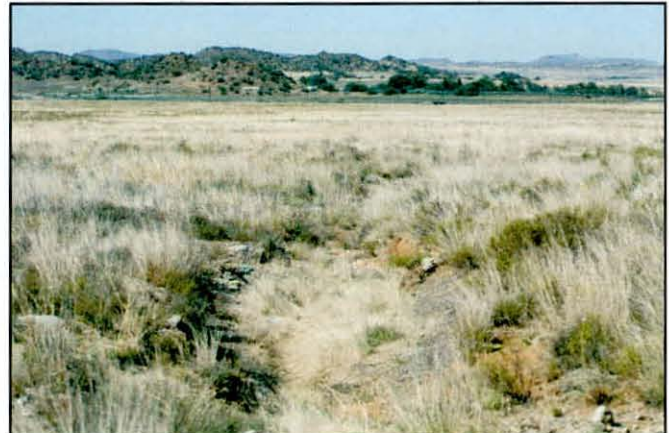
Photo 3. The drainage line which enters the top of site before becoming dispersed into the veld. Some erosion control has historically been carried out in this area suggesting that erosion remains a high risk in this area.

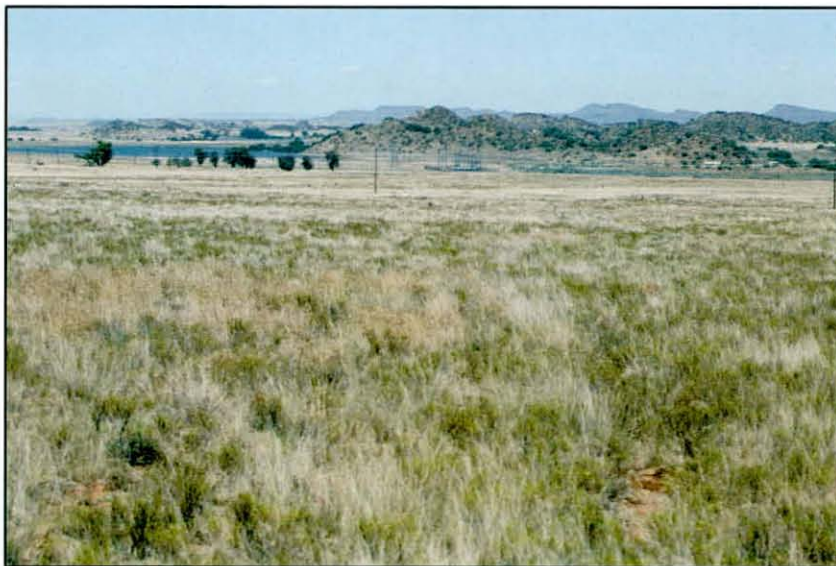
Photo 4. Looking south over the site, illustrating the generally homogenous nature of the site. The preponderance of *Chrysocoma cilliata* which can be seen as the green hue within the grassland is indicative of poor veld condition.

Overall the vegetation condition of the site can be considered to be in a poor to average condition. Although palatable grass species such as *Themeda triandra* were common within the run-on areas, unpalatable species such as *Chrysocoma ciliata* which increase as a result of overgrazing were dominant across large parts of the site.

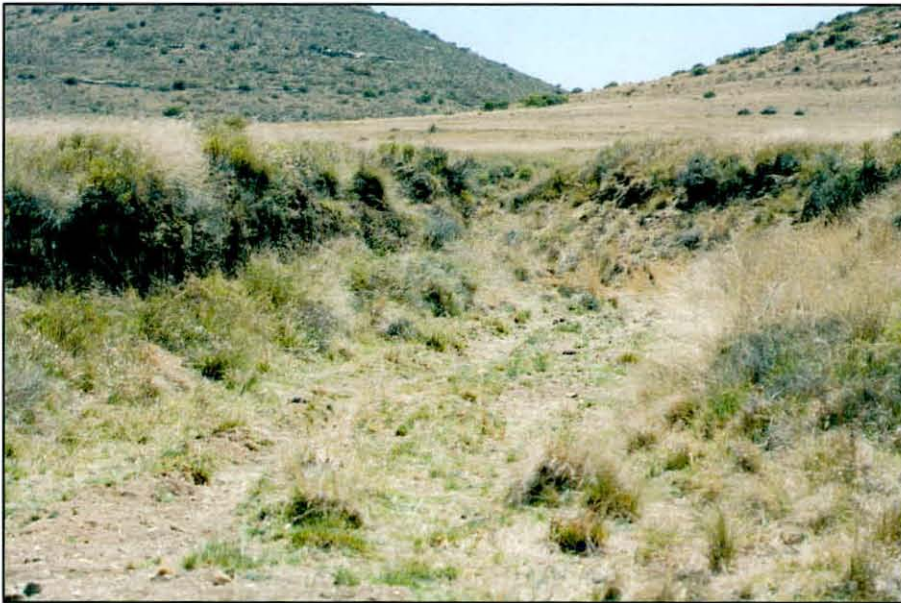
Photo 5. An incised drainage line just upslope of the study area, illustrating the vulnerability of the site to erosion. This drainage line flows into the site, but the lower slope and some erosion control has resulted in the drainage line “opening out” towards the top of the site.

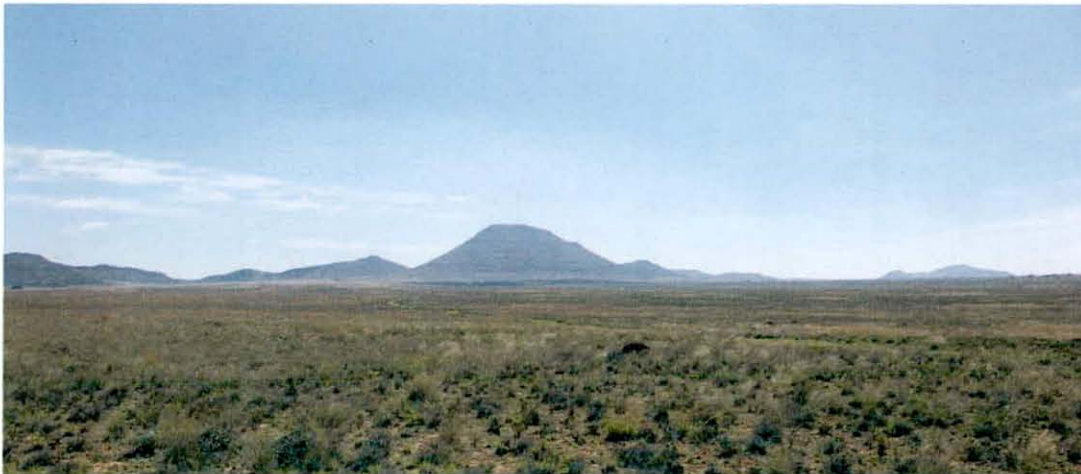
View across the site to the north. Signal Hill is in the background.

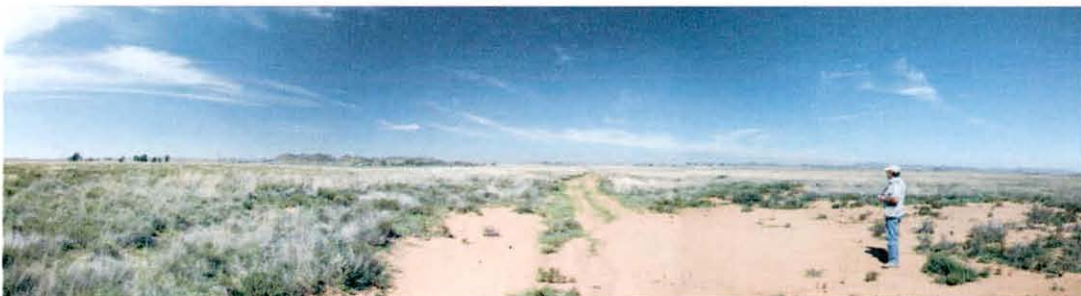
Panorama from the north. In the background the trees at the farmstead are visible as the power and railway lines.

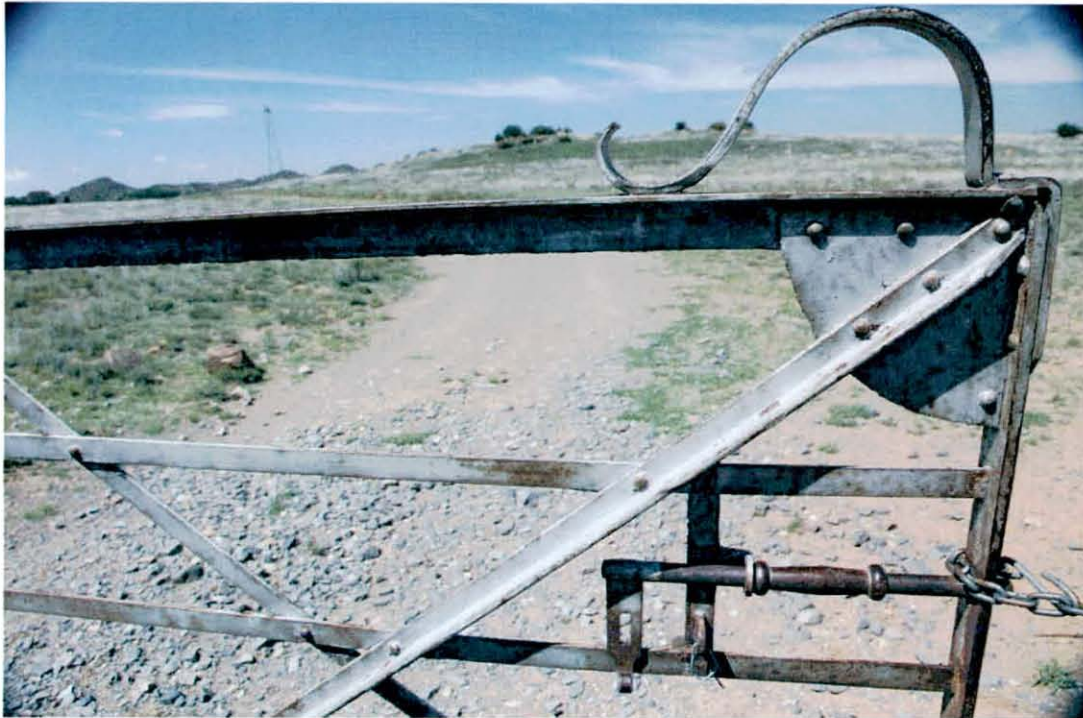
Gate at the railway crossing.

The gates at the railway crossing into the study area are made of wrought iron and are a testament to the blacksmith's art. They should be preserved.

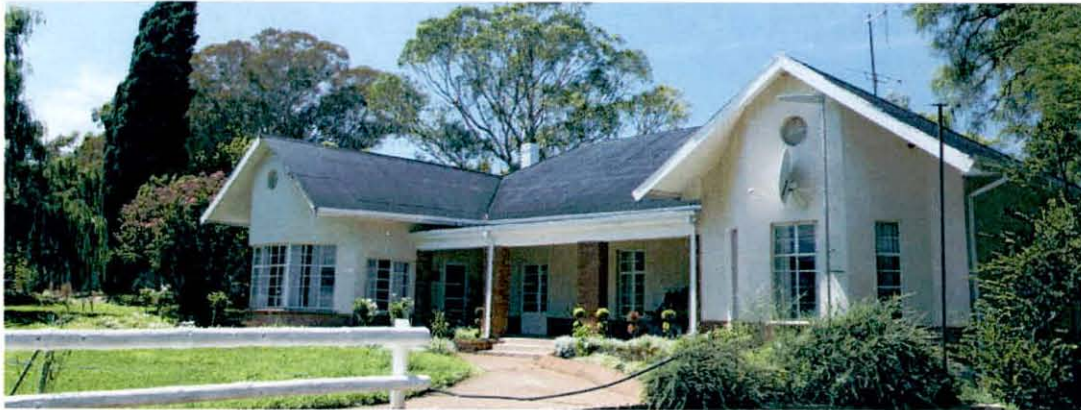
The farmhouse, probably extensively altered.

Although the farmhouse and outbuildings are not situated in the study area, the farmstead and some of the outbuildings are certainly older than 60 years and might even be older than 100 years. Although the main farmstead has been substantially altered over the years, the mature trees surrounding the farmstead are a sure indication of the age of the settlement here. The pepper tree alone at the farmstead is one of the biggest pepper trees that the author has encountered anywhere in the Free State.

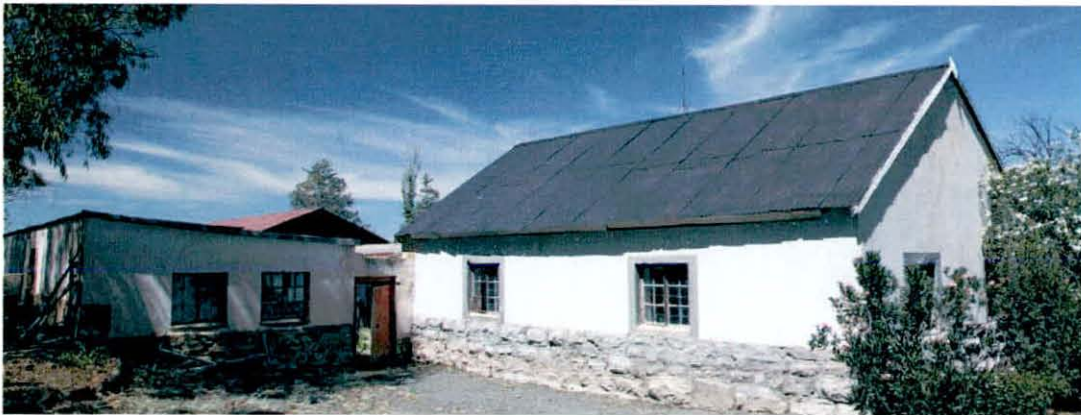
One of the outbuildings.

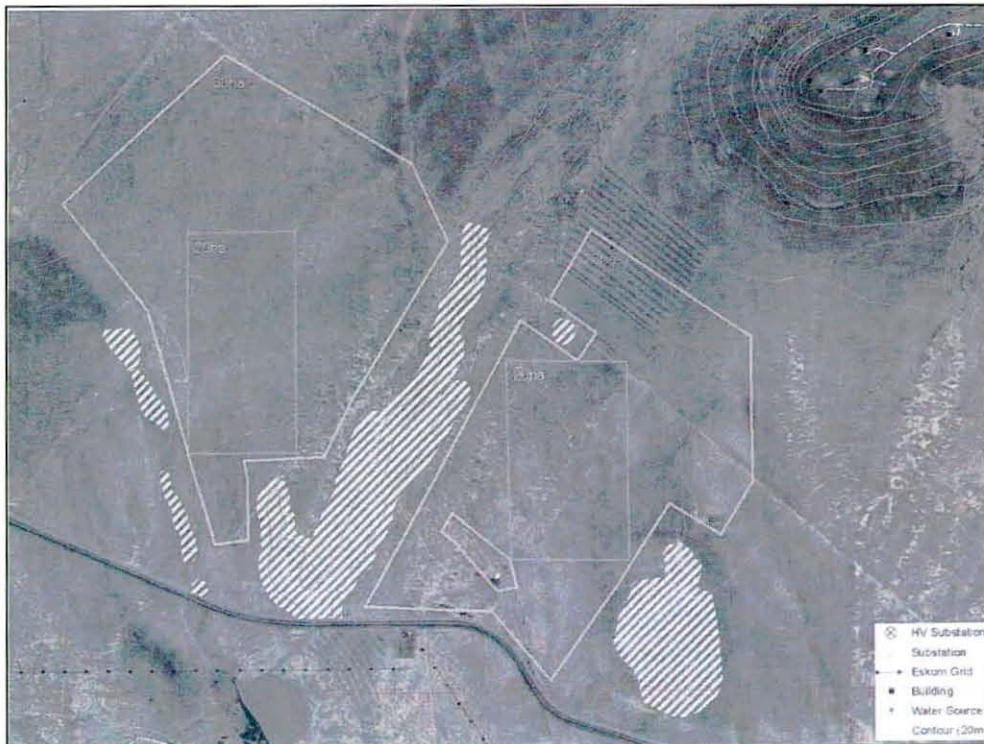
Map 2 Placing of the proposed developments on a land cover map of Knapdaar 14, Springfontein (3025BC).
