**Draft Basic Assessment Report**

**PROPOSED CONSTRUCTION OF A  
POTABLE WATER GRAVITY PIPELINE  
AND APPURTENANT WORKS FROM  
BRAKFONTAIN FARM TO LADYSMITH  
WATER TREATMENT WORKS,  
EMNAMBITHI / LADYSMITH  
MUNICIPALITY KWAZULU-NATAL.**

**September 2015**

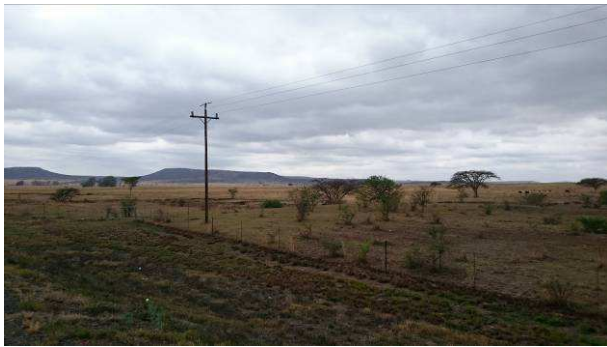
**PLATE 13: Pipeline corridor within grazing lands. Area prone to erosion and dispersive soils.**

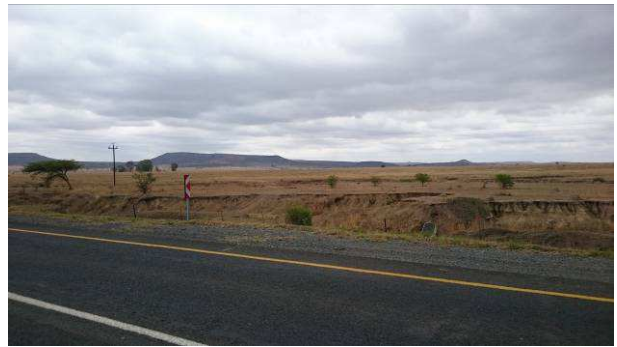
**PLATE 124: Pipeline corridor within grazing lands. Gully erosion evident in the foreground.**

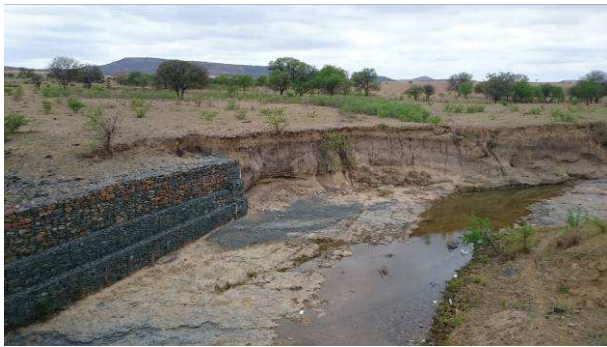
**PLATE 15: Pipeline corridor, upstream crossing of the Flagstone river. Area prone to erosion and dispersive soils.**

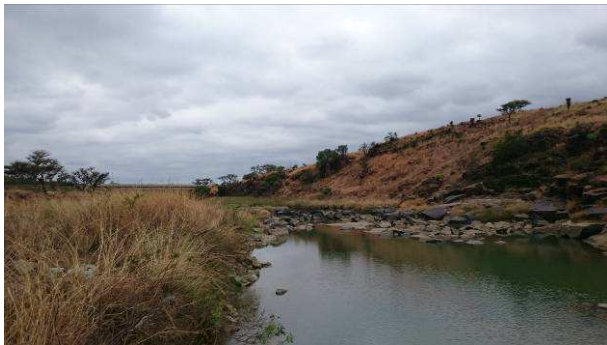
**PLATE 23: Pipeline corridor the vicinity of the second Klip River crossing (upstream of the R103 crossing with sensitive riparian vegetation area in the foreground).**

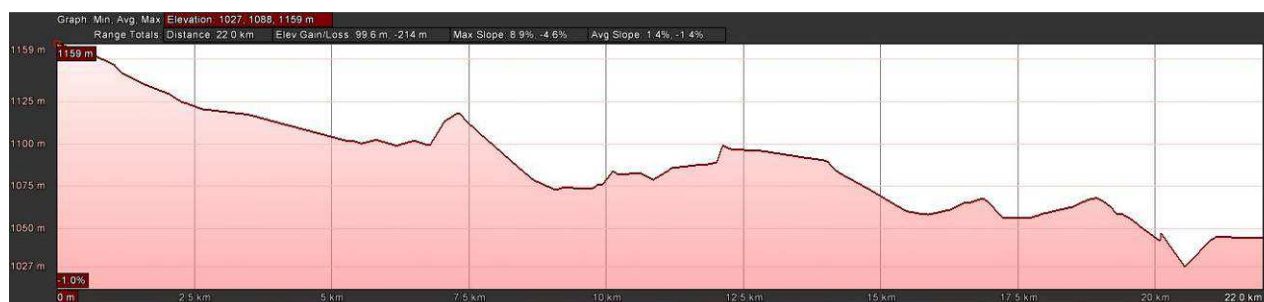
Figure 7: Gradient of the pipeline corridor from Brakfontein Farm to Ladysmith Water Treatment Works.

The overall gradient of the corridor alignment is gently undulating from Brakfontein Farm towards the Ladysmith Water Treatment Works. Figure 7 provides an illustration of the gradient along the proposed pipeline corridor.

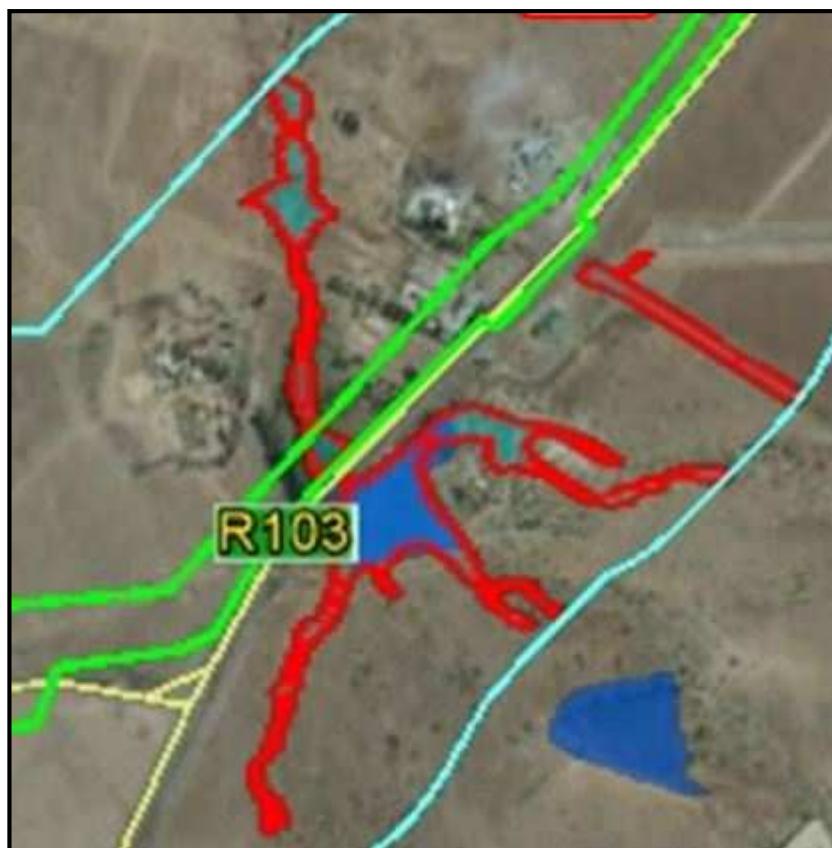
**Figure 10: Wetland at the N11-R103 intersection.**

The next wetland system occurs at the N11 – R103 road junction in the peri-urban area of Ladysmith (28° 35' 7.9" S; 29° 44' 14.9" E) and is a tributary of the Flagstone Spruit (Figure 10). According to the specialist upstream (east) of the road it consists of an old dam which has now been broken and a number of radiating arms most of which are severely degraded as a result of erosion, and drying out. This portion of the system is in a Present Ecological State (PES) Class E (Poor quality & highly modified). Downstream of the road, where the crossing is proposed, this wetland has been almost entirely destroyed. It is severely invaded by *Eucalyptus* trees *Syringa* (*Melia azerdarach*), and Silver Poplar (*Populus x Canescens*). The system is eroded and consists primarily of a system of gullies which is up to 15 m wide in places and which appears to be a stream rather than a wetland. This system is in PES Class E at this point, however further downstream there is some recovery and the PES is raised to Class C or Class D. The lower ranking is the result of a small, and largely defunct, dam.

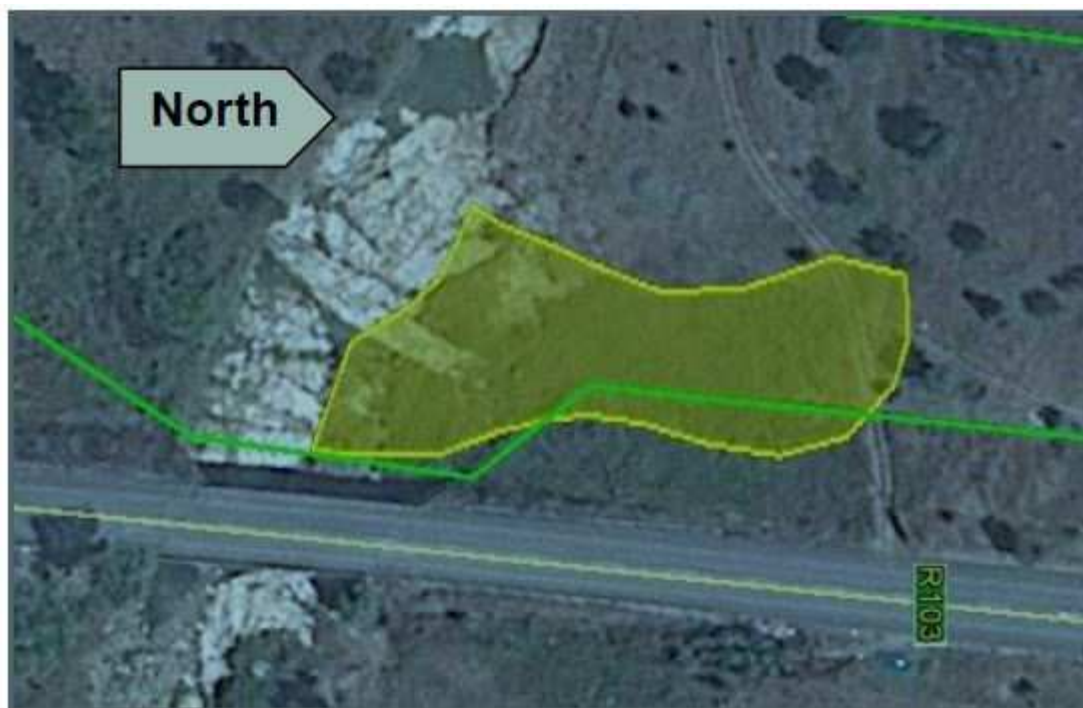
**Figure 11: Seep area north of the Flagstone River Downstream crossing delineated in yellow.**

The second downstream crossing of the Flagstone Spruit is on Road R103. According to the specialist the river channel morphology is very different to that at the upstream crossing site in that it has certain characteristics of a floodplain, although lateral wetland development is very weak. Typically it comprises a bare bedrock channel of 20m to 30m in width with low earth banks which are well vegetated and are up to a metre in height. On the northern side this bank forms a platform; the crest of this bank probably represents the channel width for all but the largest floods. In places along the edges of both banks are strips of seepage which are of environmental sensitivity in relation to possible impacts. Typically these are marked by stands of Cottonwool Grass (*Imperata cylindrica*) but in a few places are sparse stands of Knotweed (*Persicaria* sp.) Bullrushes (*Typha capensis*), and Broomgrass (*Miscanthus capensis*). However, on the north bank is a wider area which is linked to water flowing down from the nearby hillside. This seep area could be considered to be a wetland but, since it is so closely associated with the river crossing the specialist included it as part of the river assessment (Figure 11).

At the time of the specialist assessment the full extent of the seep area could not be determined as the grass had been burned in places but the feature is probably a weakly developed hillslope or toeslope seep.
